SUBJECT: Action Memorandum for a Removal Action at the Ogden June 2024 Mercury Spill Site pursuant to the On-Scene Coordinator's delegated authority under CERCLA Section 104.

Site Name: Ogden June 2024 Mercury Spill
Site Spill ID (SSID): B8K8
NRC Case Number: 1400761
CERCLIS Number: UTN000826432
Site Location: Harrison and 1100 St, Ogden, UT 84404
Lat/Long: 41.27553/-111.95143
Potentially Responsible Party (PRP):
NPL Status: Non-NPL
Removal Start Date: June 4, 2024

ATTACHMENT 1:
Initial Site Visit
Report Prepared by
Utah DEQ

SITE VISIT REPORT

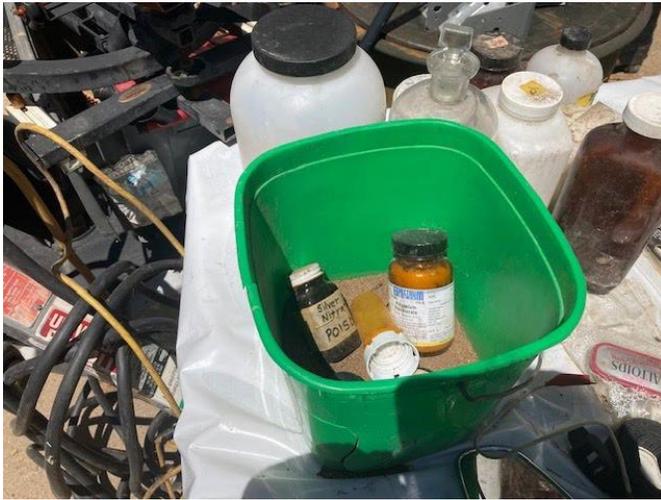
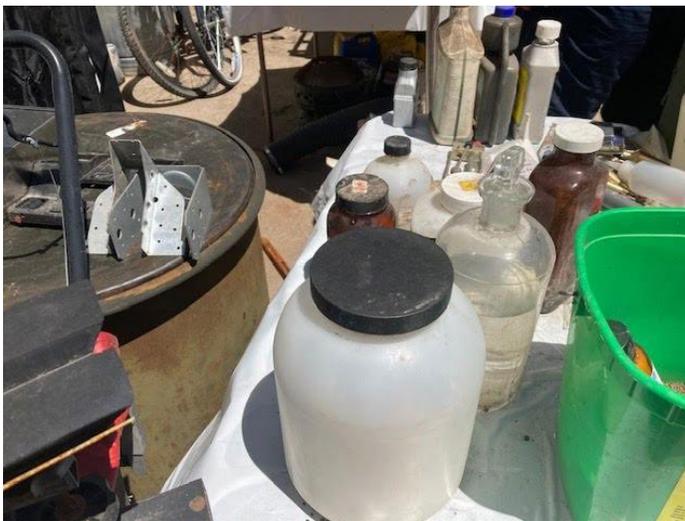
The family had removed most items stored in the detached shed before discovering the mercury taking up most of the driveway. A few small bottles of mercury and other chemicals had also been removed from the shed and placed in a container on a table.

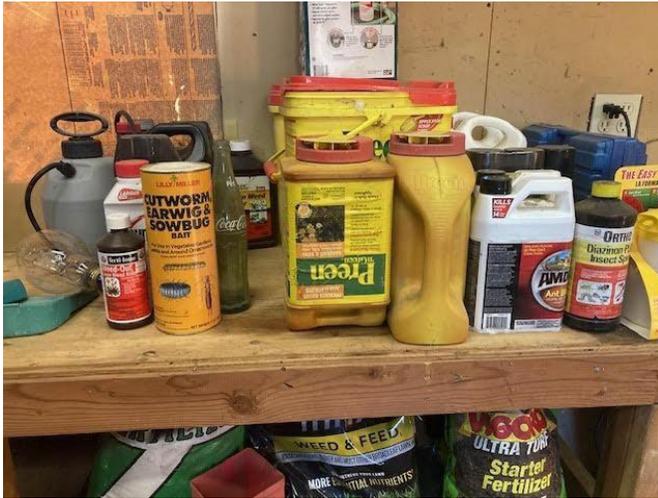
Several bottles of pesticides and fertilizers were located on a workbench on the south side of the shed.

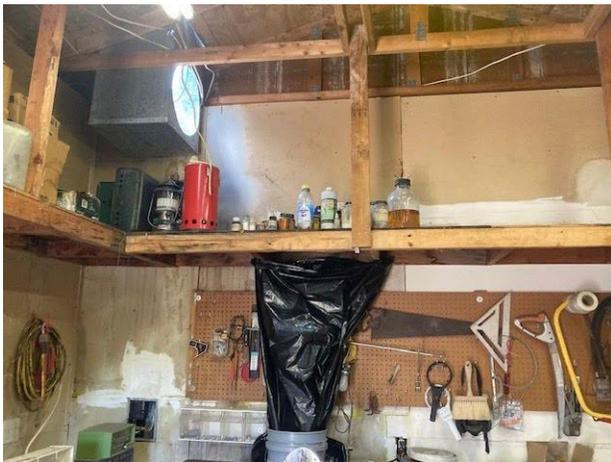
An elevated shelf along the east and north sides of the shed contained several bottles of other chemicals including the leaking bottle of mercury.

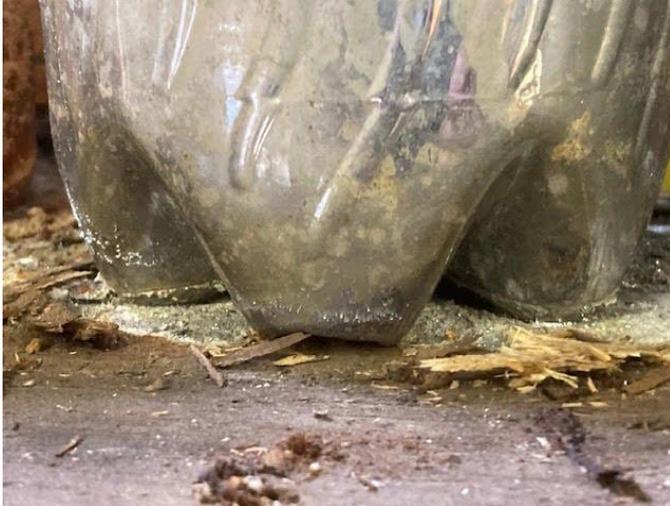
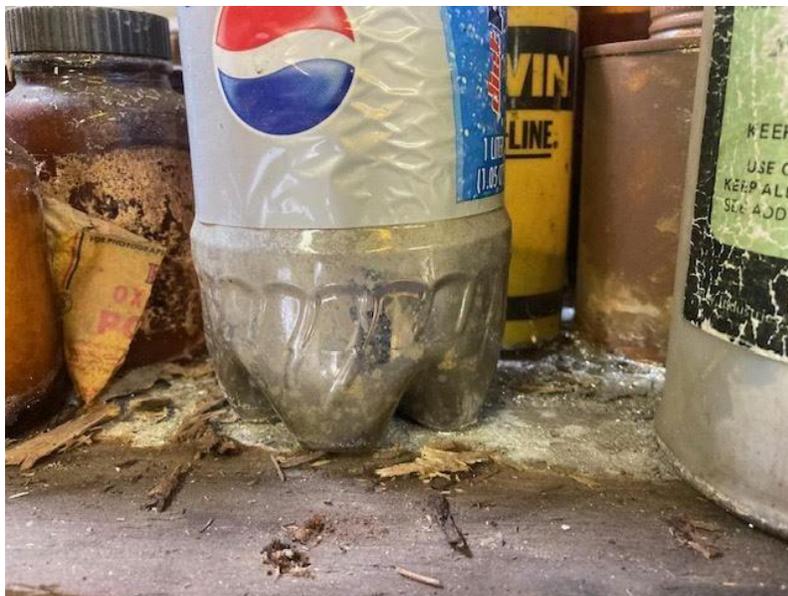
Free mercury was observed leaking from the bottom of a 1-liter plastic bottle, the mercury appeared to have saturated the underlying shelf.

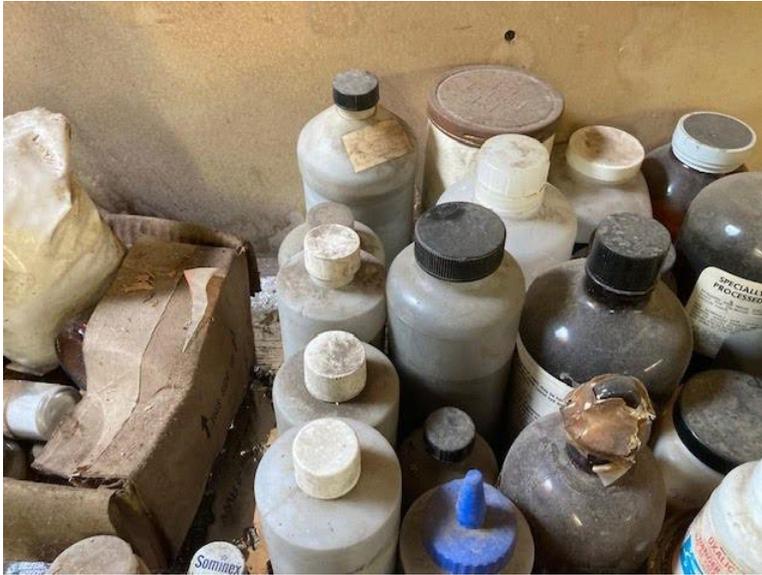
Another 4 - 5 liter bottles of mercury were located on the shelf as well

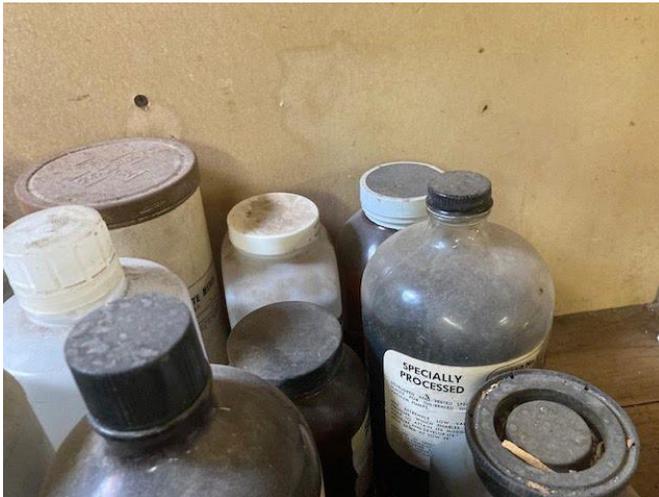
There were probably another 30 - 40 bottles of miscellaneous chemicals with weathered labels
