Anglo Saxon Crib Wall Stabilization

Photo Log

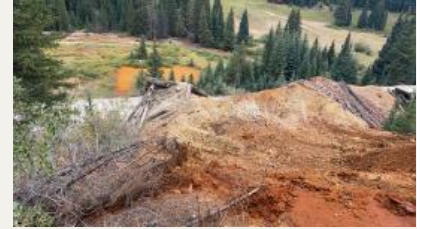
Description: Day 1 Top of crib wall close to drainage ditch.

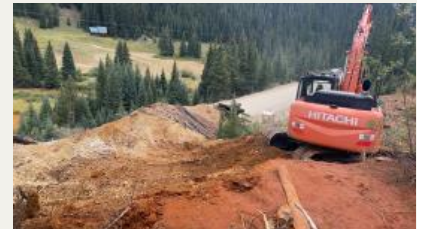
Description: Day 1 Top of crib wall away from drainage channel.

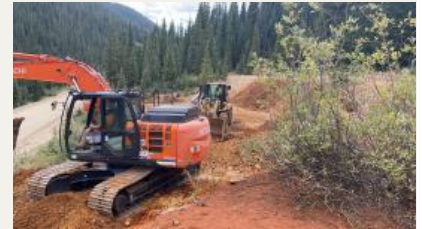
Description: Day 1 Working in repository above crib wall.

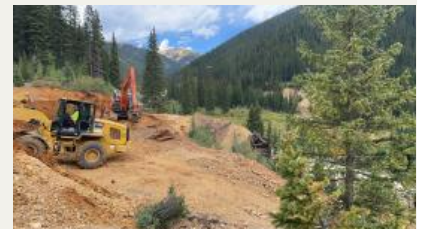
Description: Day 1 Looking from the far end of repository. Crib wall is on the right.

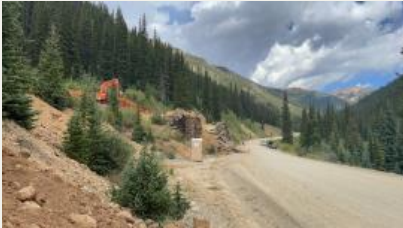
Description: Day 1 Excavator working from the top, moving waste rock from behind the crib wall, to reduce the pressure on the wall. You can see where the wall previously gave way.

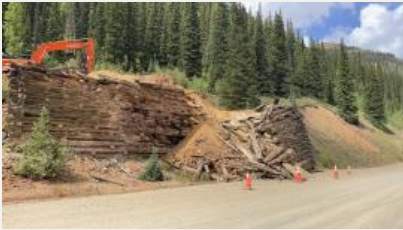
Description: Day 1 Showing where crib wall collapsed prior to start of this project.

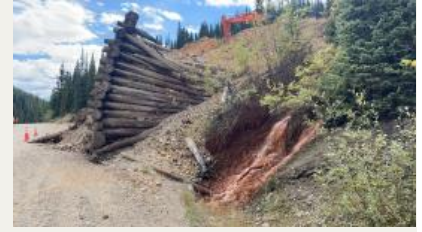
Description: Two of the projects goals are to protect drainage under road and keep debris out of the of road while removing crib wall.

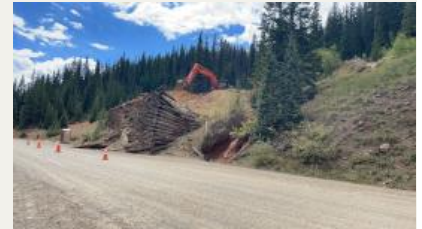
Description: Day 1 Moving waste rock from behind crib wall. Picture from road looking up.

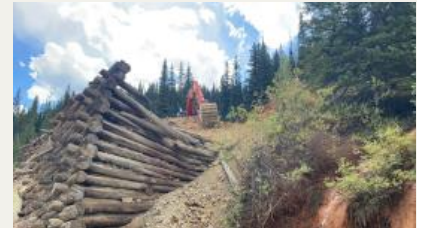
Description: Pulling back waste rock from back of wall.

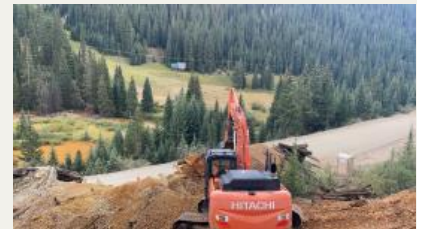
Description: Top of crib wall coming down

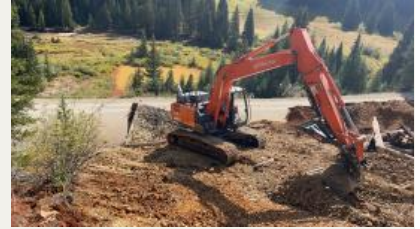
Description: Day 2 Focus has been working on the corner wall.

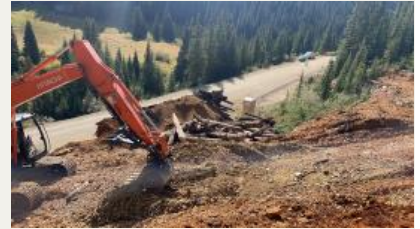
Description: Day 2 Logs coming off the top of the wall.

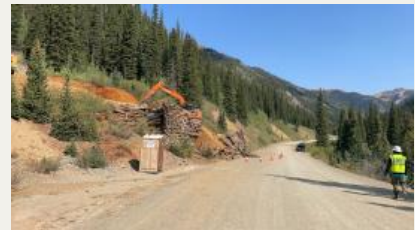
Description: Day 2 Road view of wall. You can see corner wall has been reduced a bit. You can see the logs on the left side of wall.

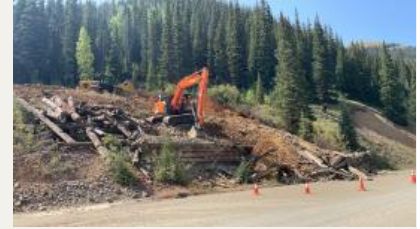
Description: Day 2 End of excavator working from above crib wall.

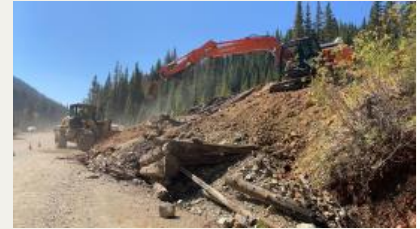
Description: Day 3 Most of crib wall down.

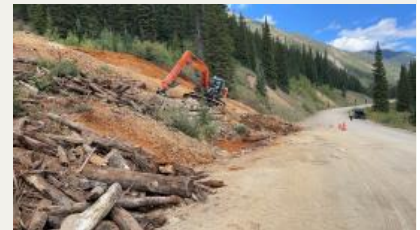
Description: Day 4 Starting to take down final part of crib wall.

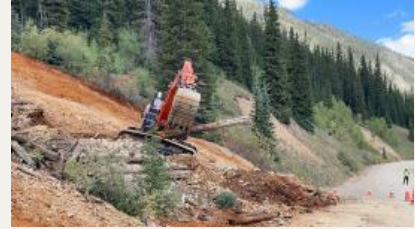
Description: Day 4 Log from crib wall being removed.

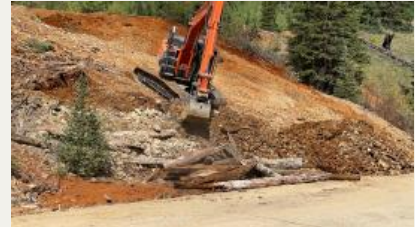
Description: Day 4 Last of wall coming down.

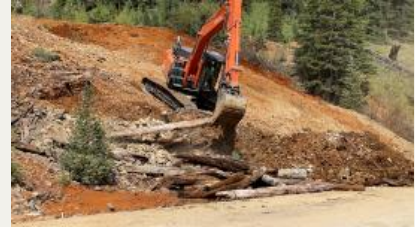
Description: Last log of crib wall being removed.

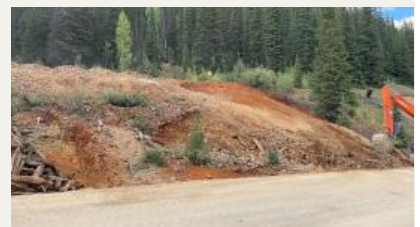
Description: Day 4 Crib wall is completely down.

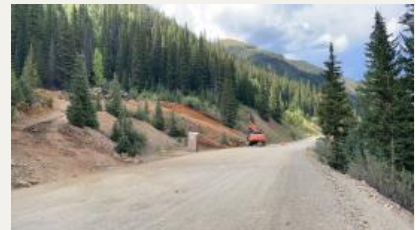
Description: Day 4 Removing final waste rock from tow of hill.

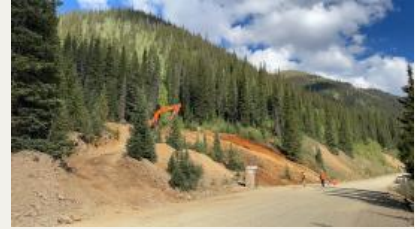
Description: Day 5 Completing the final grading.

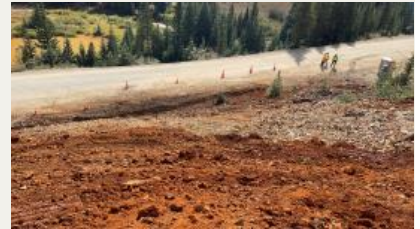
Description: Day 5 Grade is less than angle of repose.

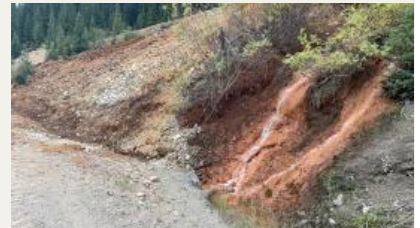
Description: Day 5 Drainage area has been protected.

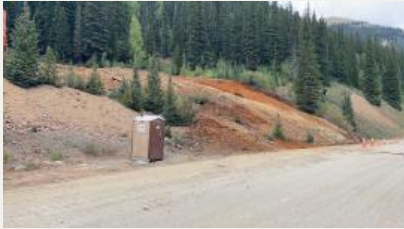
Description: Day 5 - Final slope. The crib walls wood has been transported off site to be shredded and used as mulch.

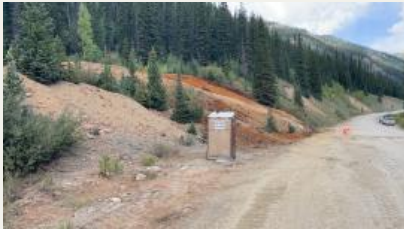
Description: Day 5 Showing angle of final slope.
