Site Features Inventory Report

Barite Hill Mine McCormick, South Carolina

Prepared By: Michael Gobla, P.E.

July 2007

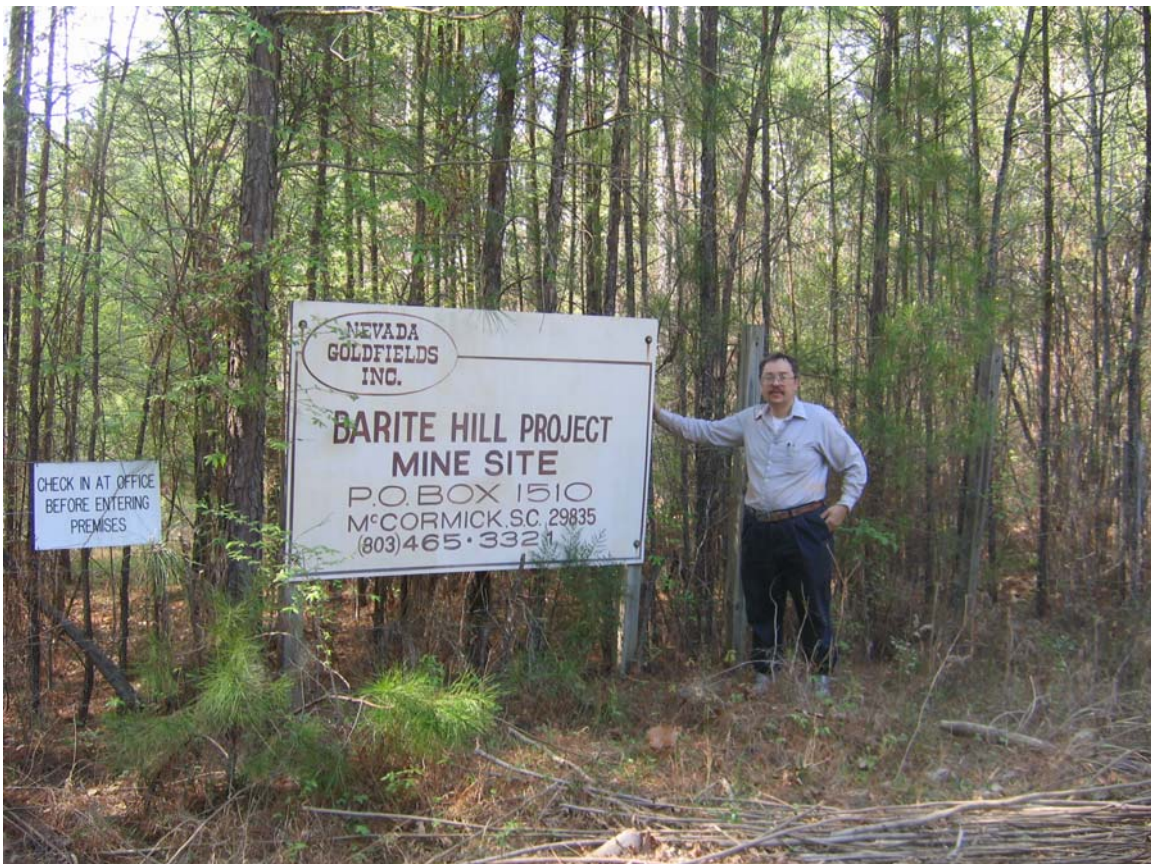
Figure 2. This sign adjacent to the site entrance gate identifies the mine and is visible from Road 30. The small sign at the left stating “check in at office before entering premises,” is no longer valid and should be removed.

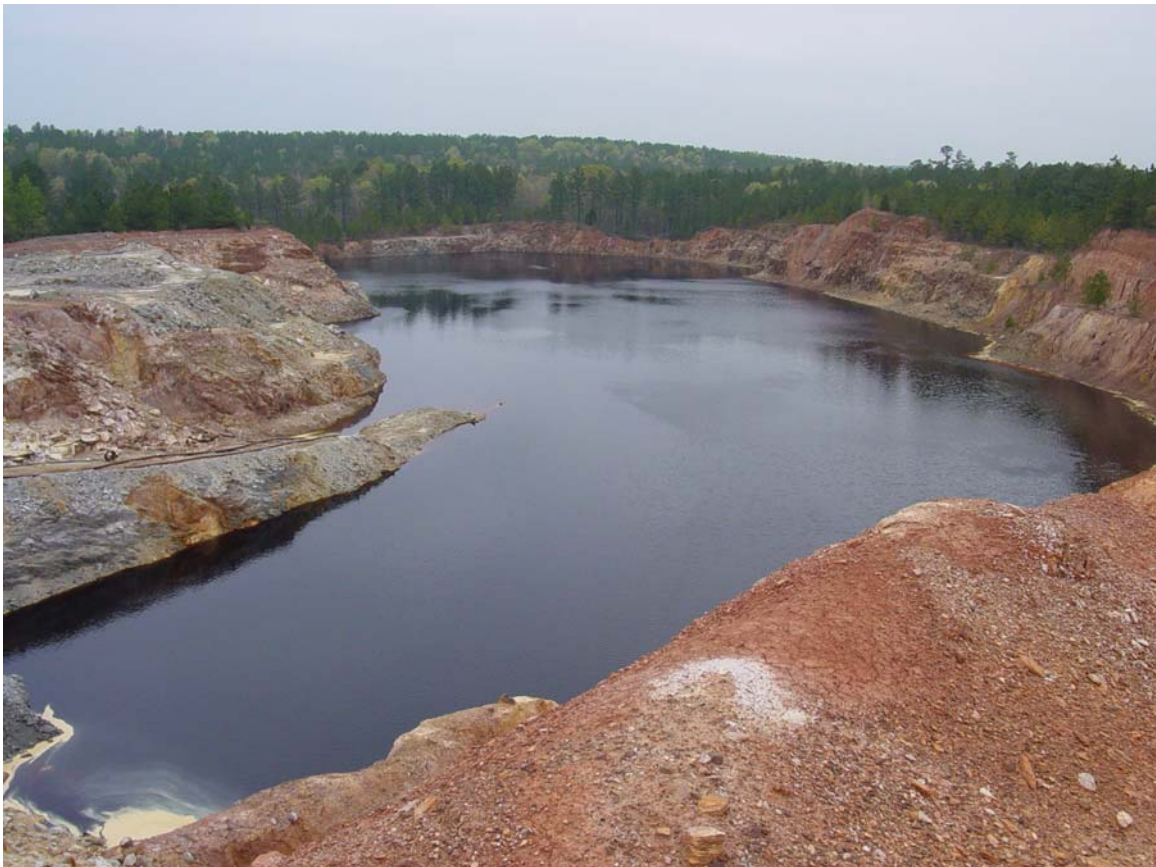
Figure 9. The most significant hazard remaining at the site is the Barite Hill Pit.

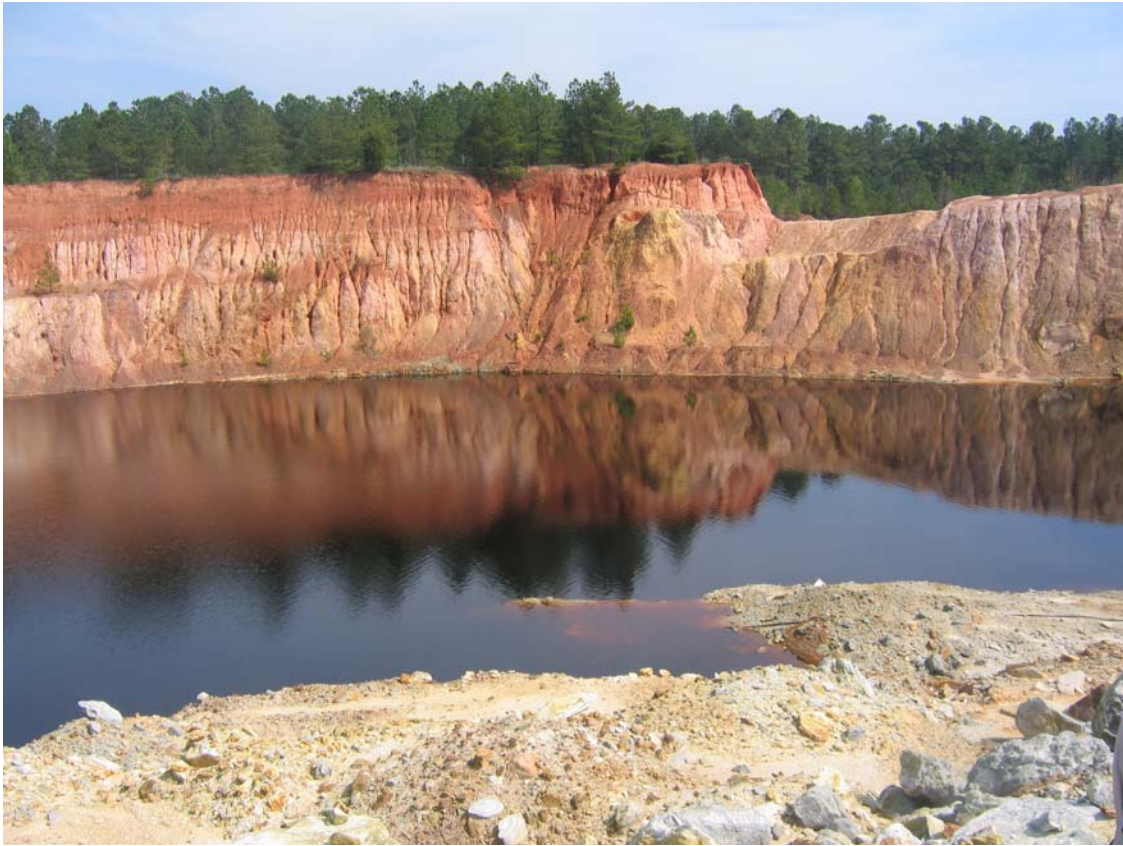
Figure 10. Photograph looking towards east side of the pit. The east highwall area shows signs of volunteer vegetation and it likely has a relatively low permeability. In the upper right part of the photograph, the excavation from the clay borrow area can be seen which removed the top layer of red-colored clay soil.

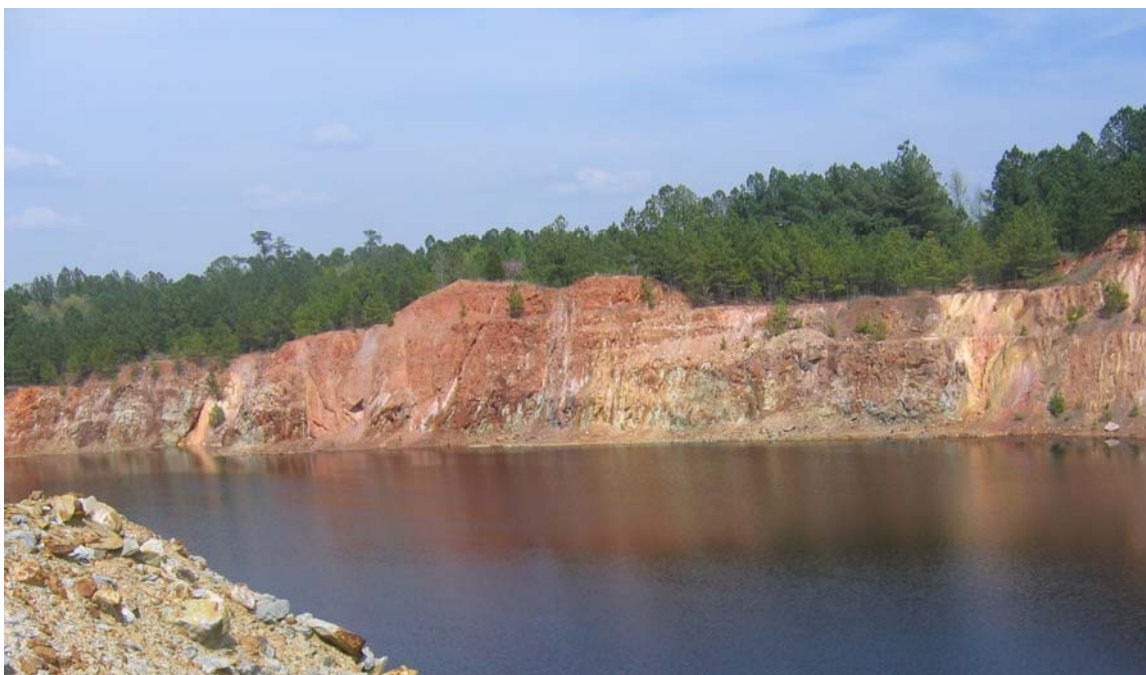
Figure 12. Photograph of the highwall on the northeast side of the pit. The grey to yellow rocks in the highwall are acid generating rock. The red colored rocks and overlying soil likely do not generate acid and show volunteer vegetation.

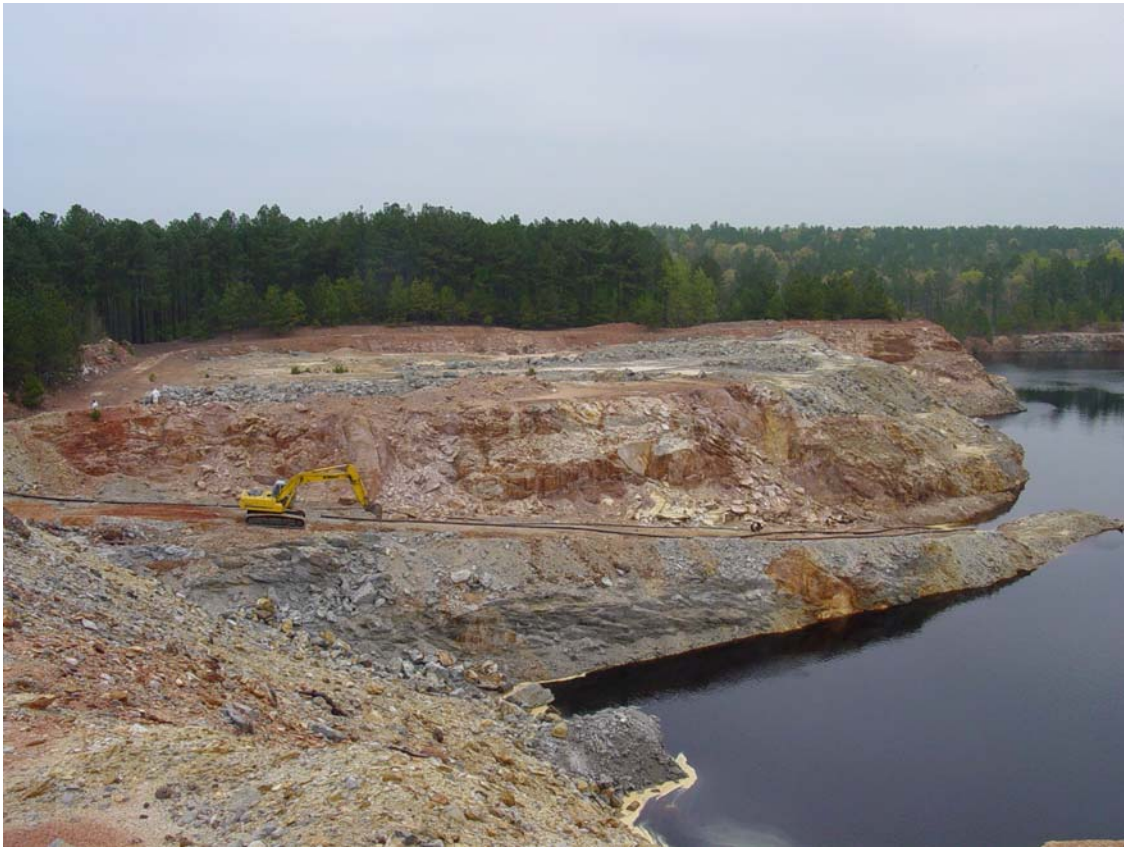
Figure 13. View of grey-colored rocks rich in pyrite on the west side of the pit.

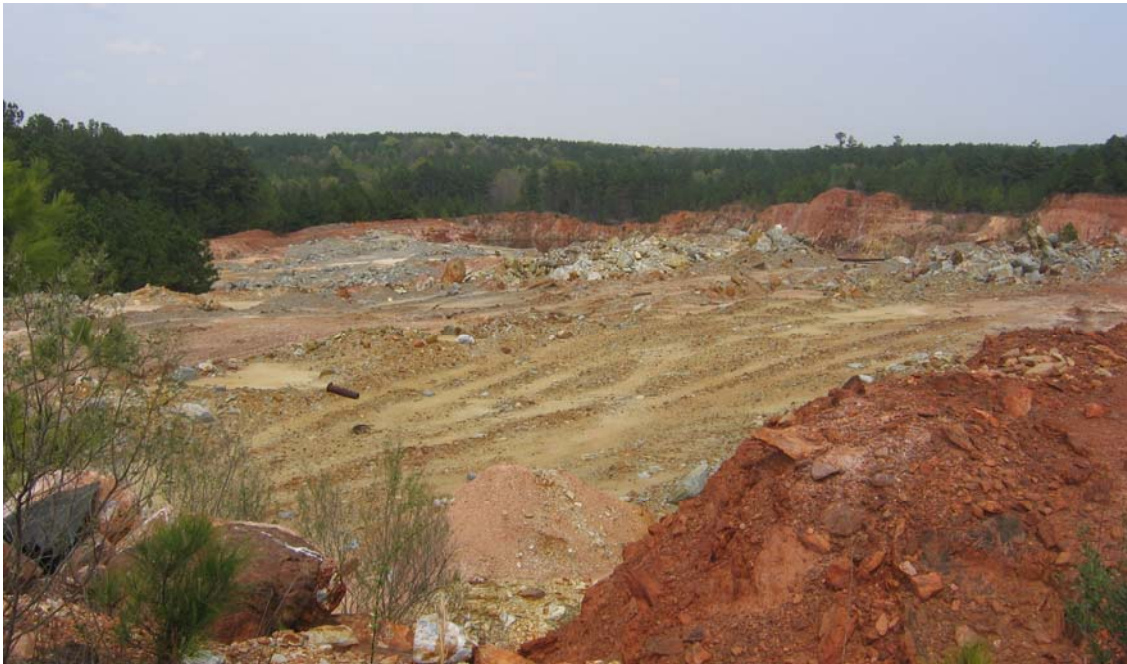
Figure 14. Photograph showing the disturbed area on the southwest side of the Barite Hill Pit. This is a major source area for acid water draining into the pit.

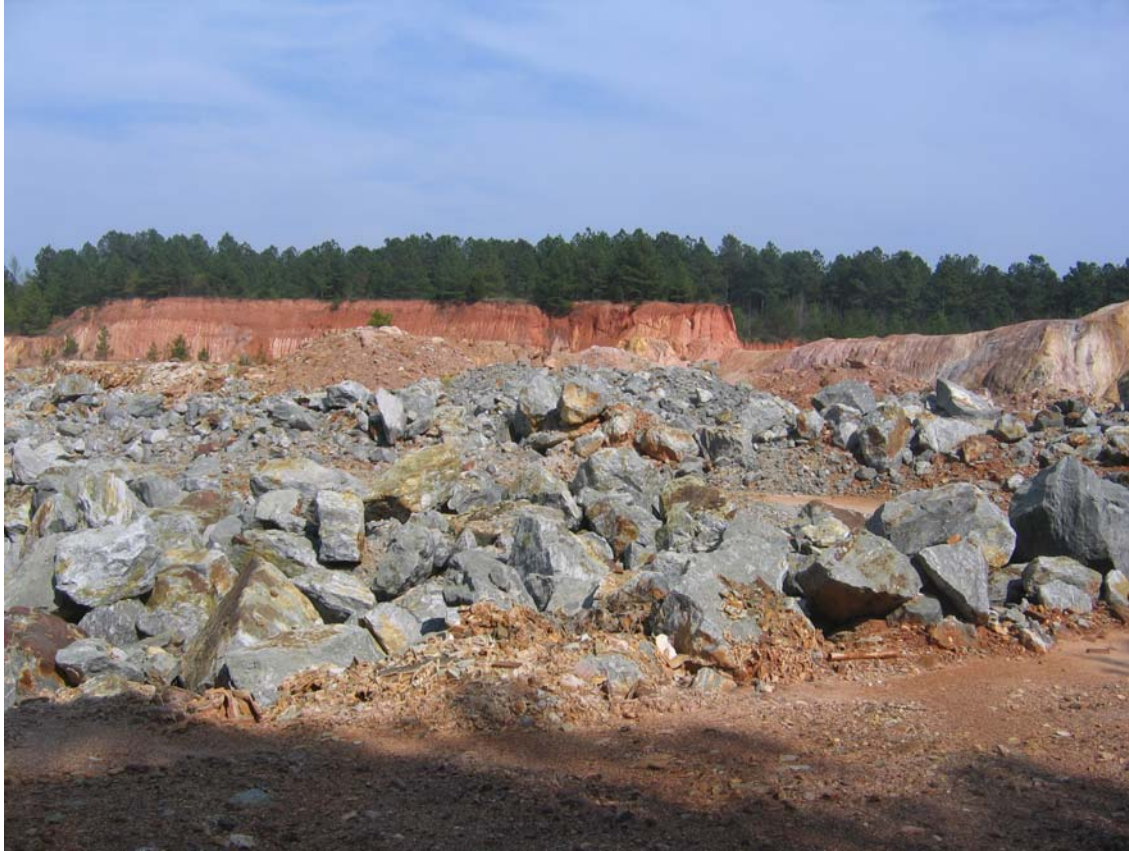
Figure 15. Close-up view of some of the pyrite-containing waste rock piles dumped onto the upper benches on the west side of the Barite Hill Pit.

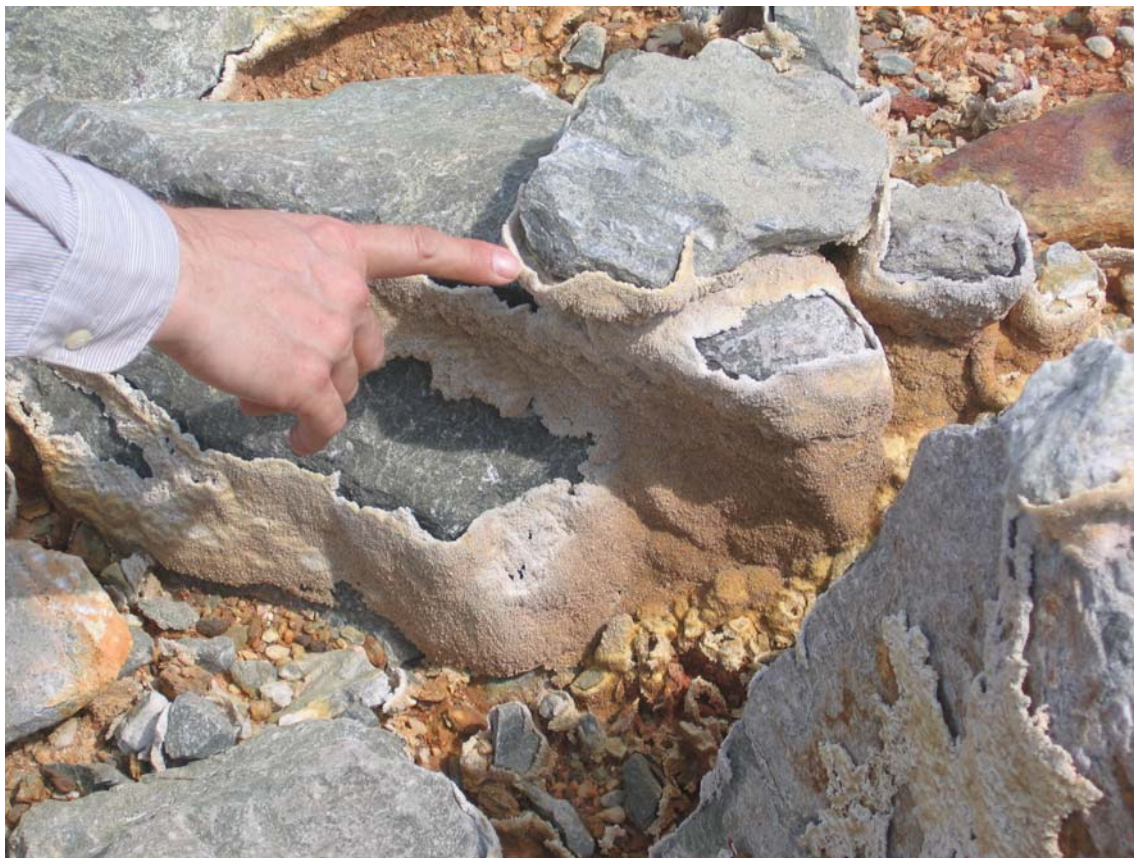
Figure 16. Photograph of damaged “guniting” coating on pyrite-rich waste rock left exposed in the upper benches of the Barite Hill Pit. The coating is a failed attempt to mitigate the acid drainage originating from this waste rock.

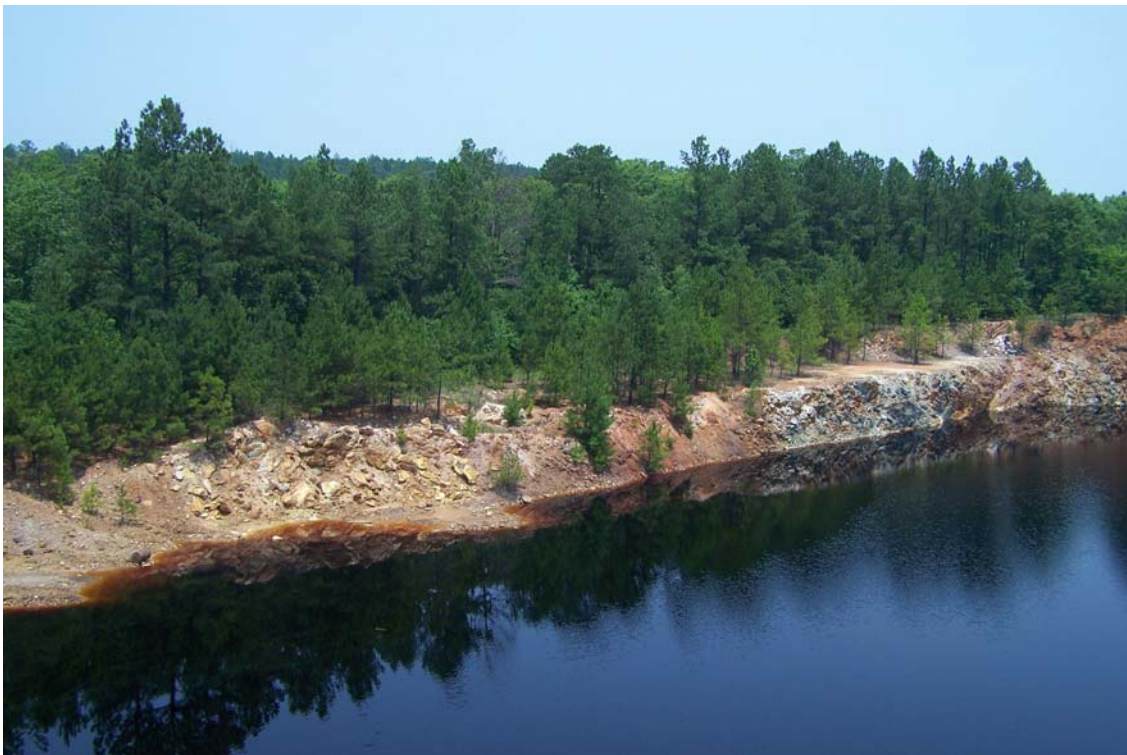
Figure 18. View of the north pit wall where outflow from the pit will eventually occur.

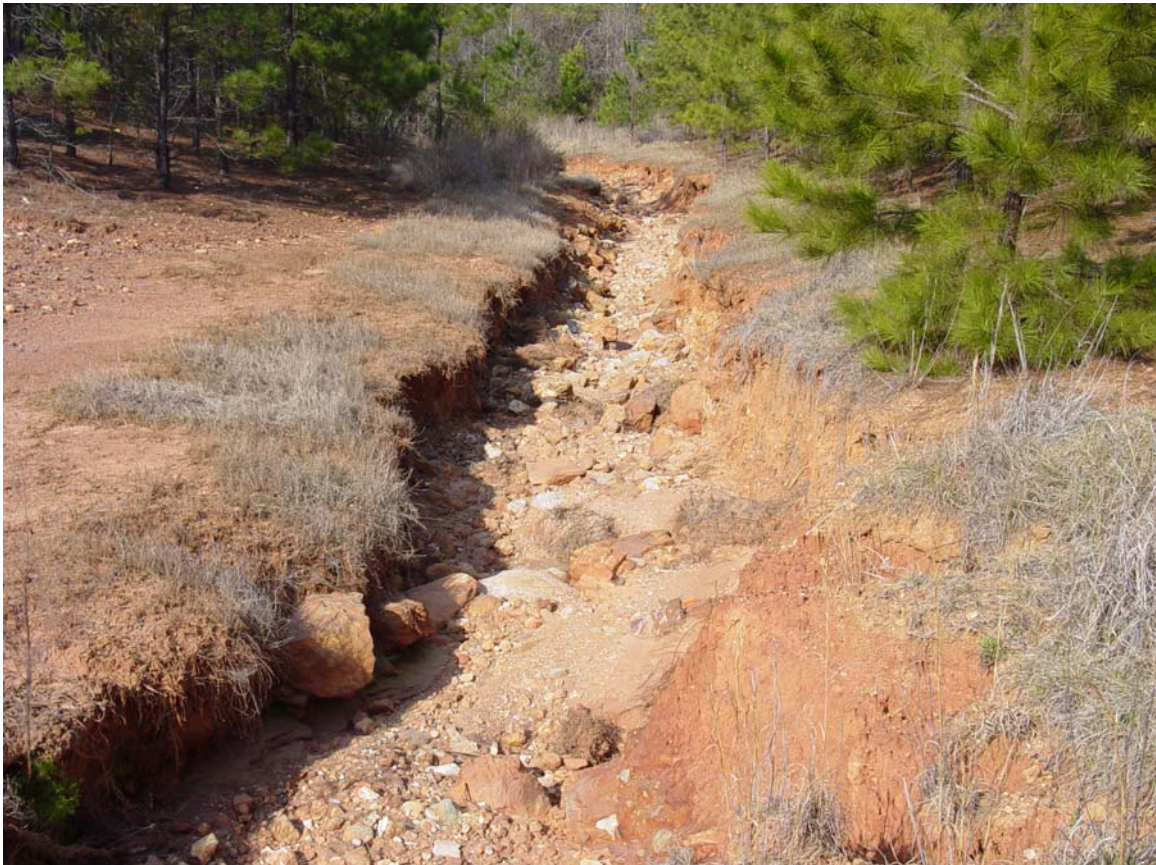
Figure 21. View to the west of the eroded diversion ditch on the north side of Waste Rock Disposal Area A. Significant amounts of pyrite rich waste rock are present in this eroded channel which is likely a source of acid drainage.

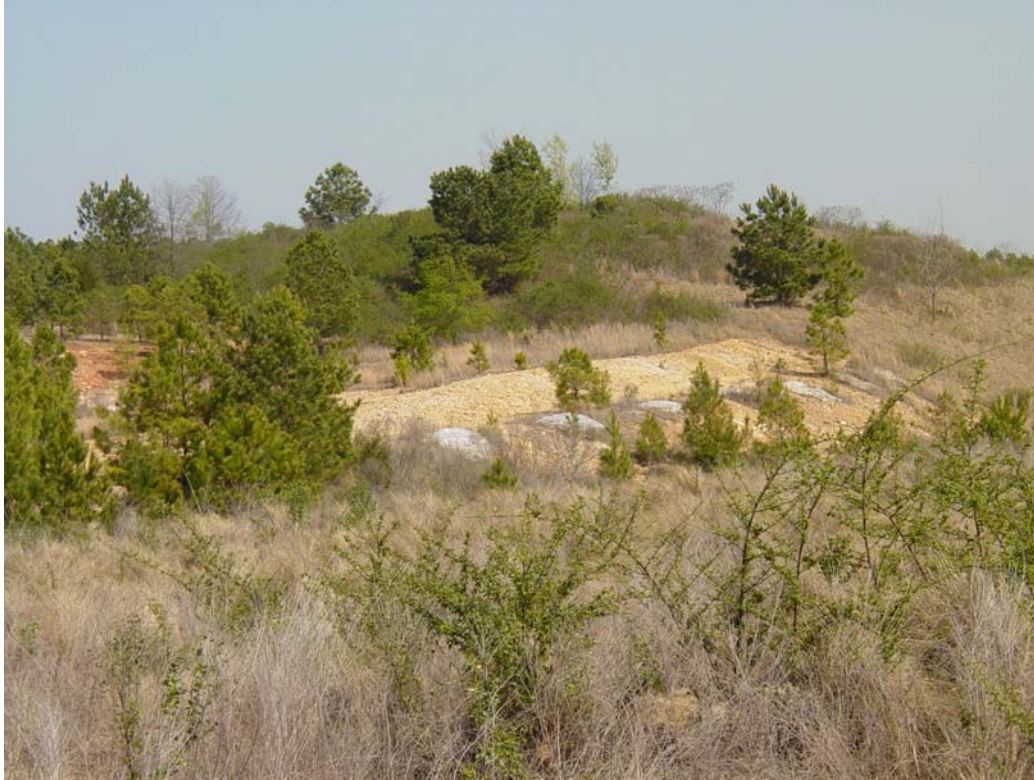
Figure 23. View of incomplete reclamation on the west side of the Industrial Solid Waste Landfill. Note that organic matter (brown ring around white piles) and slaked lime (white piles) have been dumped but were not spread and incorporated into the mine waste. One deep erosion gully (see Fig. 24) cuts down through this unreclaimed slope to the right and a shallow gully (see Fig. 24) is eroding the unreclaimed area on the left side of the photograph.

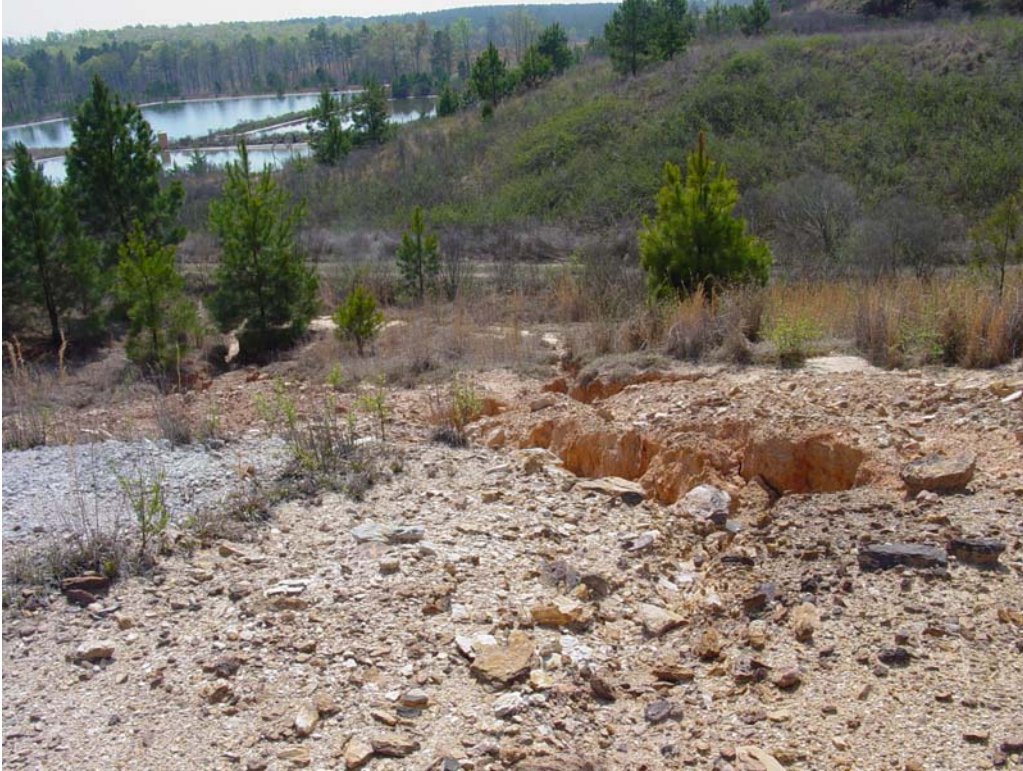
Figure 24. Deeply incised erosion gully in un-reclaimed slope of the Industrial Solid Waste Landfill.

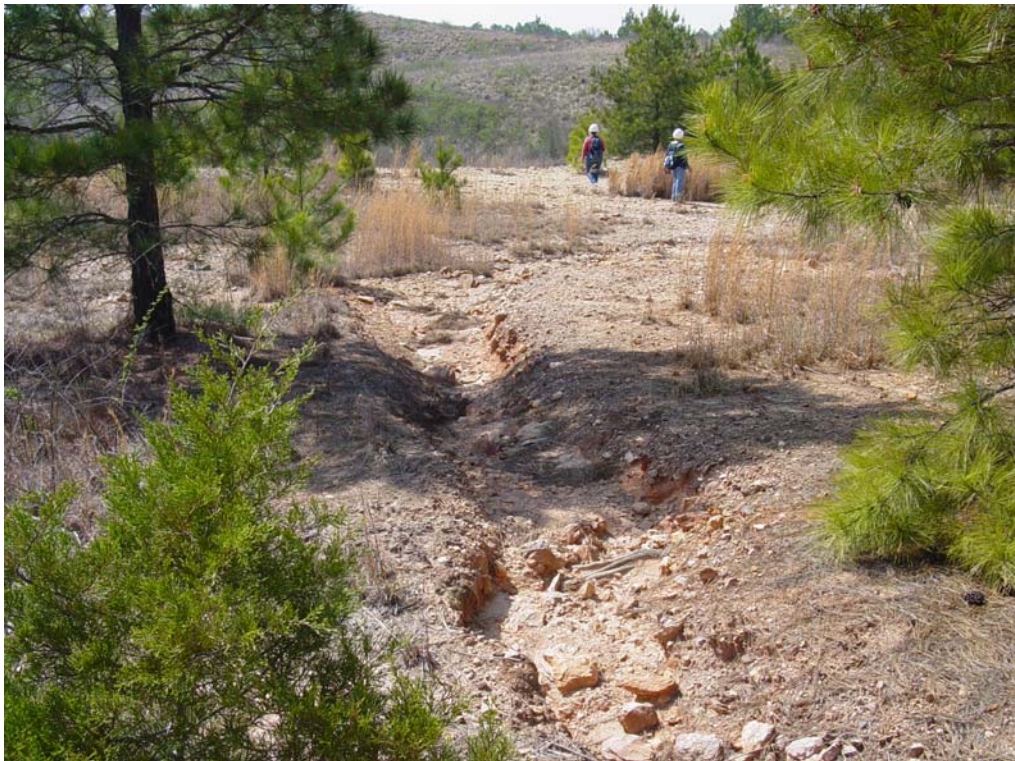
Figure 25. Shallow erosion gully formed in an un-reclaimed area on the gently sloping top of the Industrial Solid Waste Landfill.

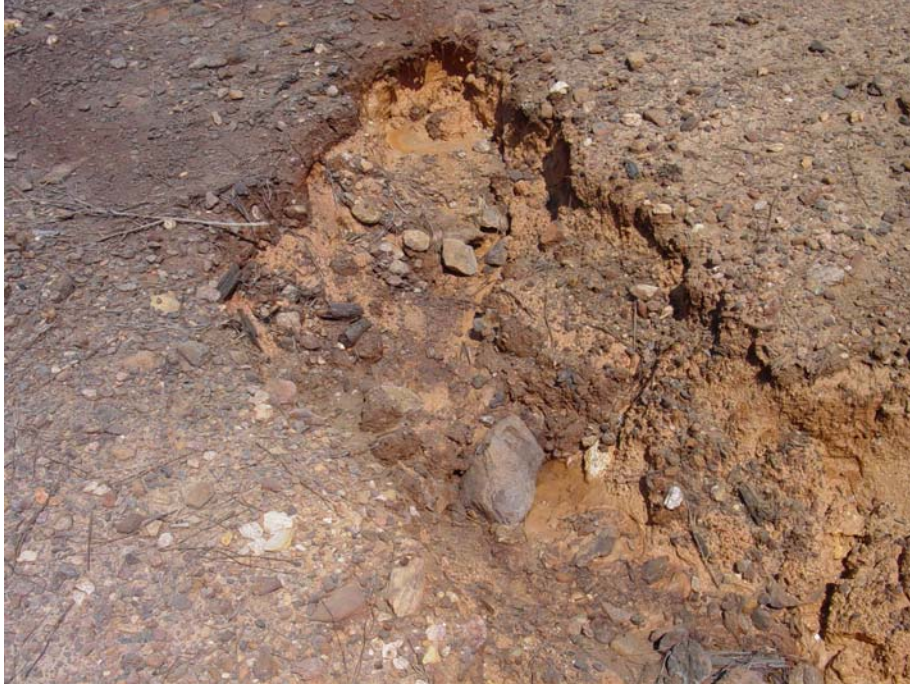
Figure 26. Seepage discharging from near the bottom of the slope of the west side of the Industrial Solid Waste Landfill.

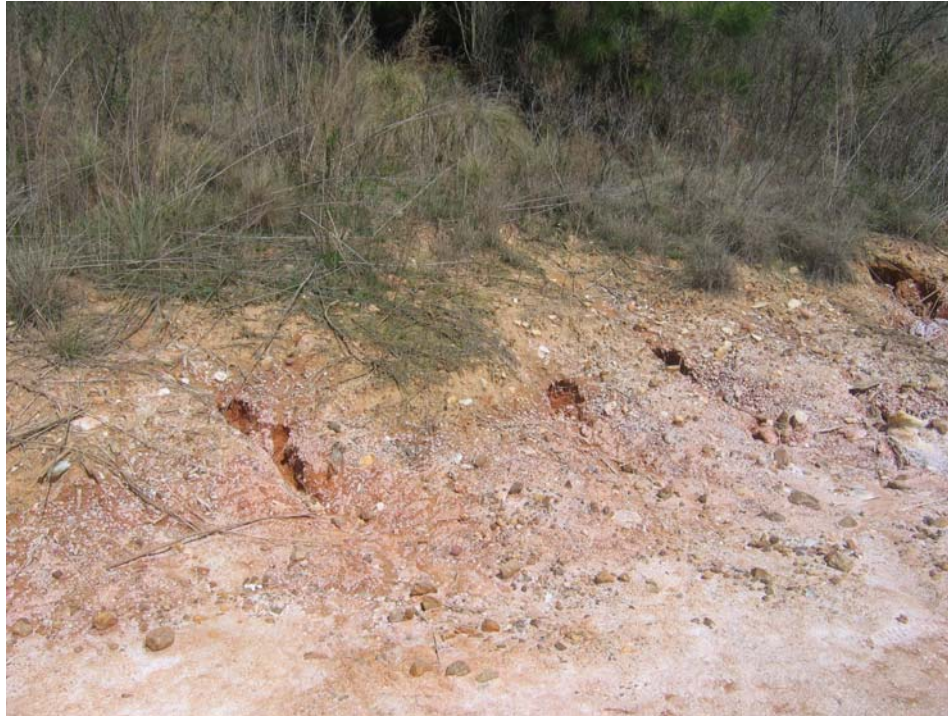
Figure 28. Acid seepage killing vegetation and causing piping like internal erosion at the south toe of the Permanent Heap Leach Pad.

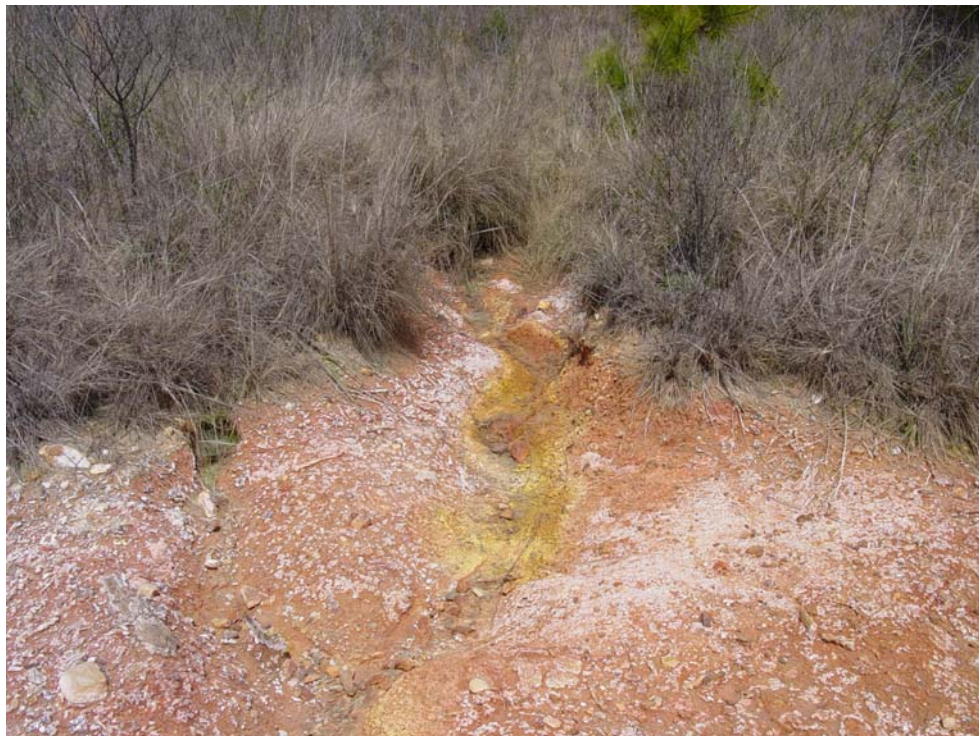
Figure 29. Photograph of the largest of the acid seeps emerging from the southeast side of the Permanent Heap Leach Pad. Yellow staining is the result of precipitation of iron hydroxides. The white coatings on the adjacent bare soil are thought to be the iron sulfate mineral melanterite.

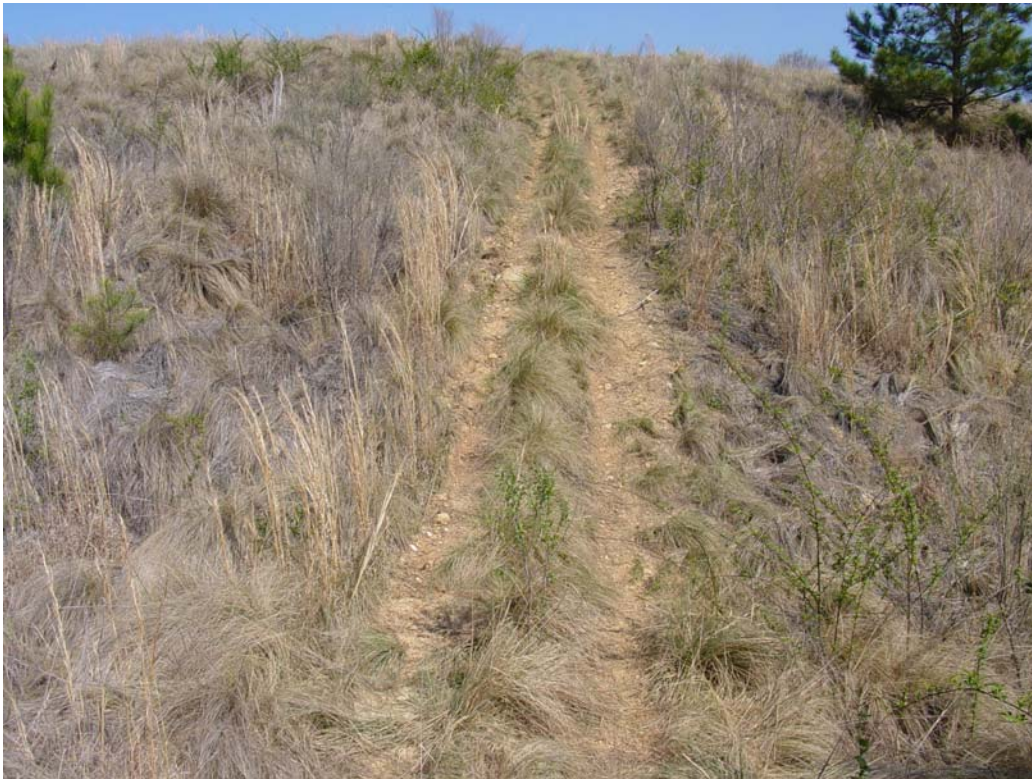
Figure 30. Rutting on the Permanent Heap caused by ATV use.

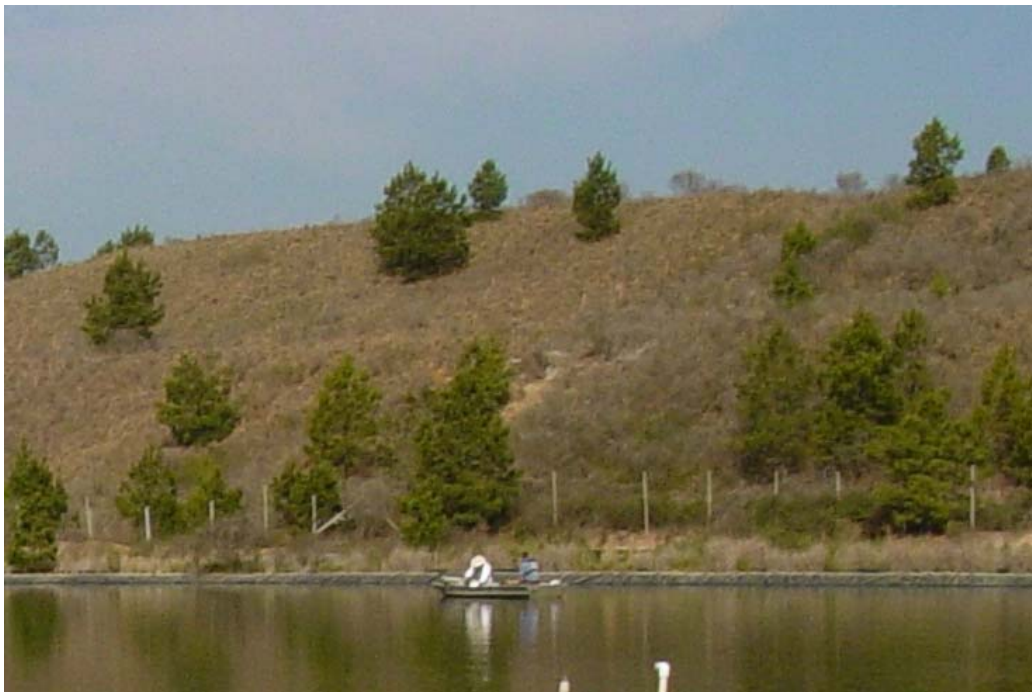
Figure 31. Erosion of drainage down chute can be seen as the disturbed area on the hill side above the men in the boat.

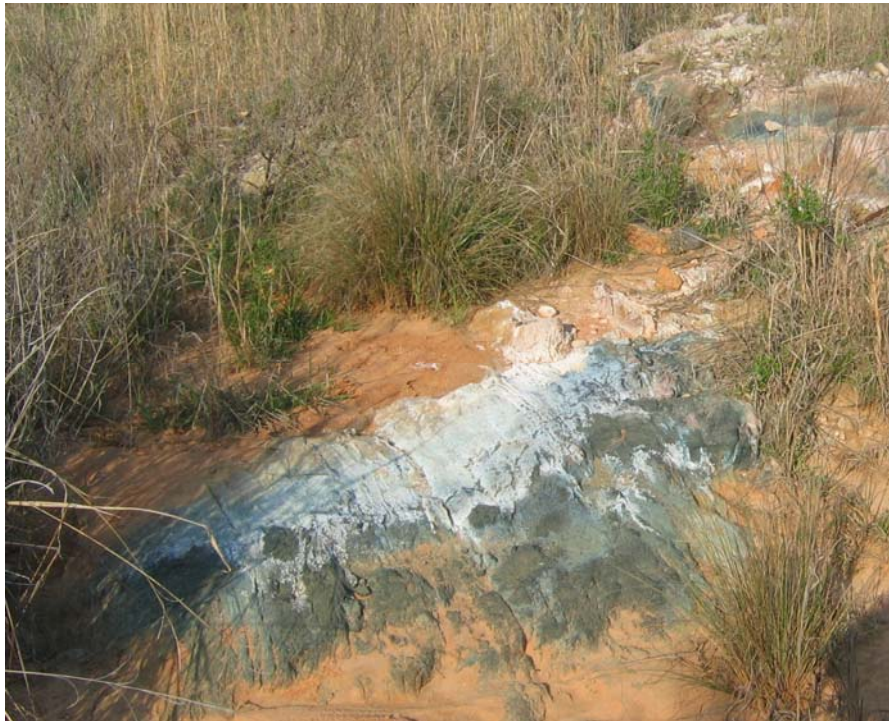
Figure 49. Prussian blue stains on bedrock in the crusher area.

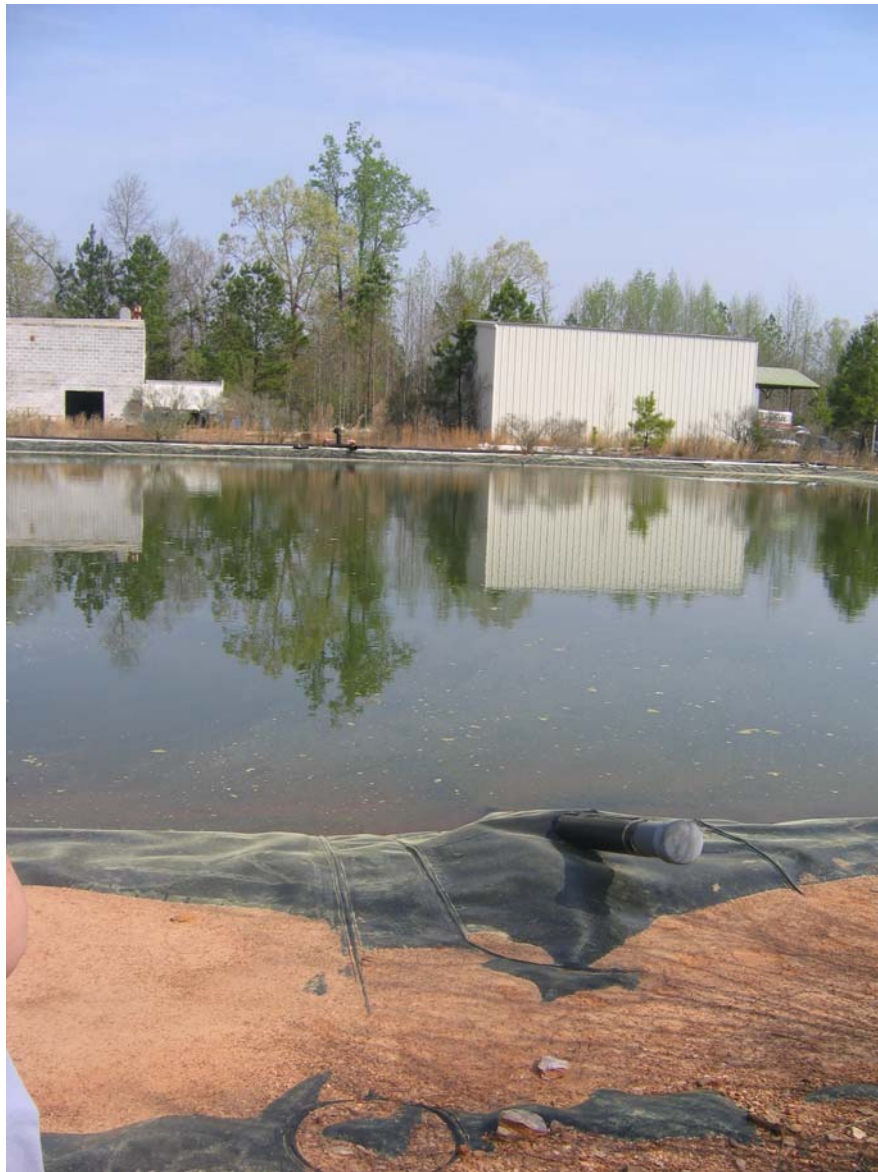
Figure 52. Photograph showing the Process Plant Barren Pond and leak detection sump riser pipe.

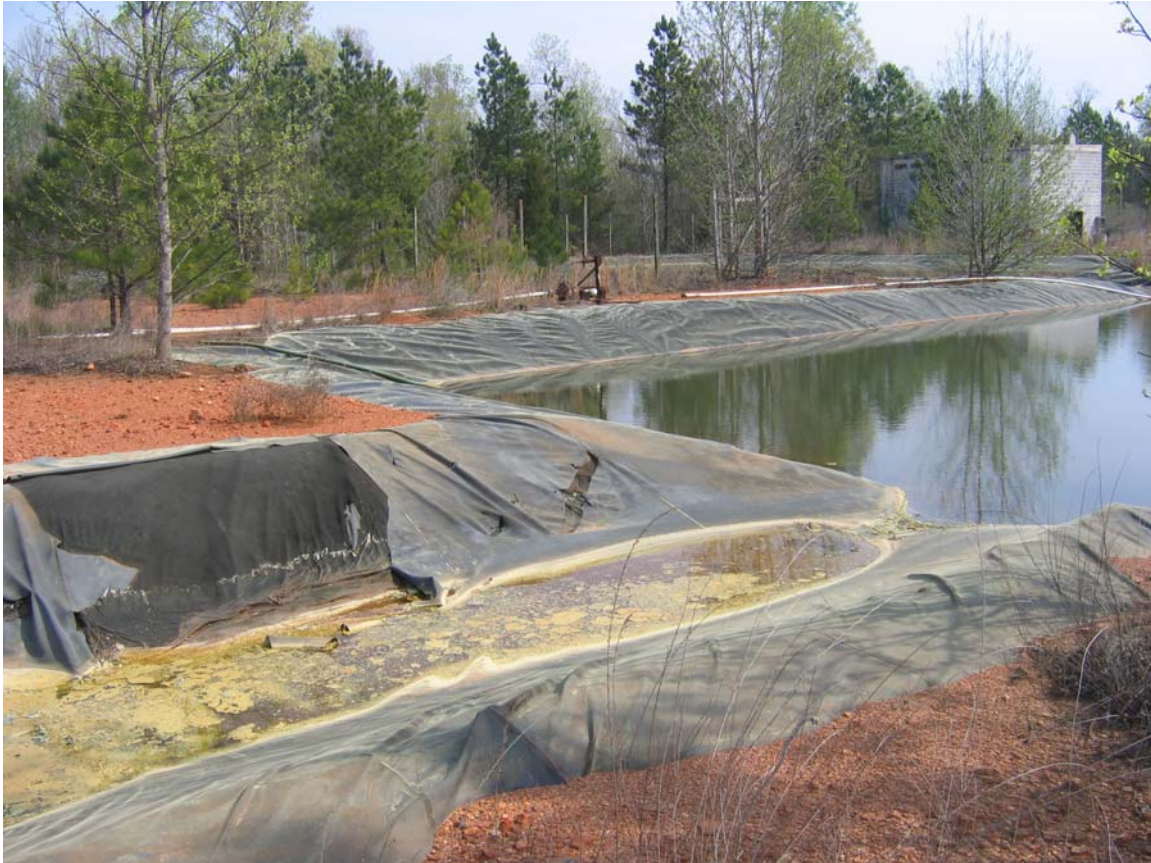
Figure 53. Discharge channel and the west portion of the Process Plant Rinse Pond. This pond, like those upstream of it, is full, all additional precipitation results in discharge to the unlined Process Plant Contingency Pond.

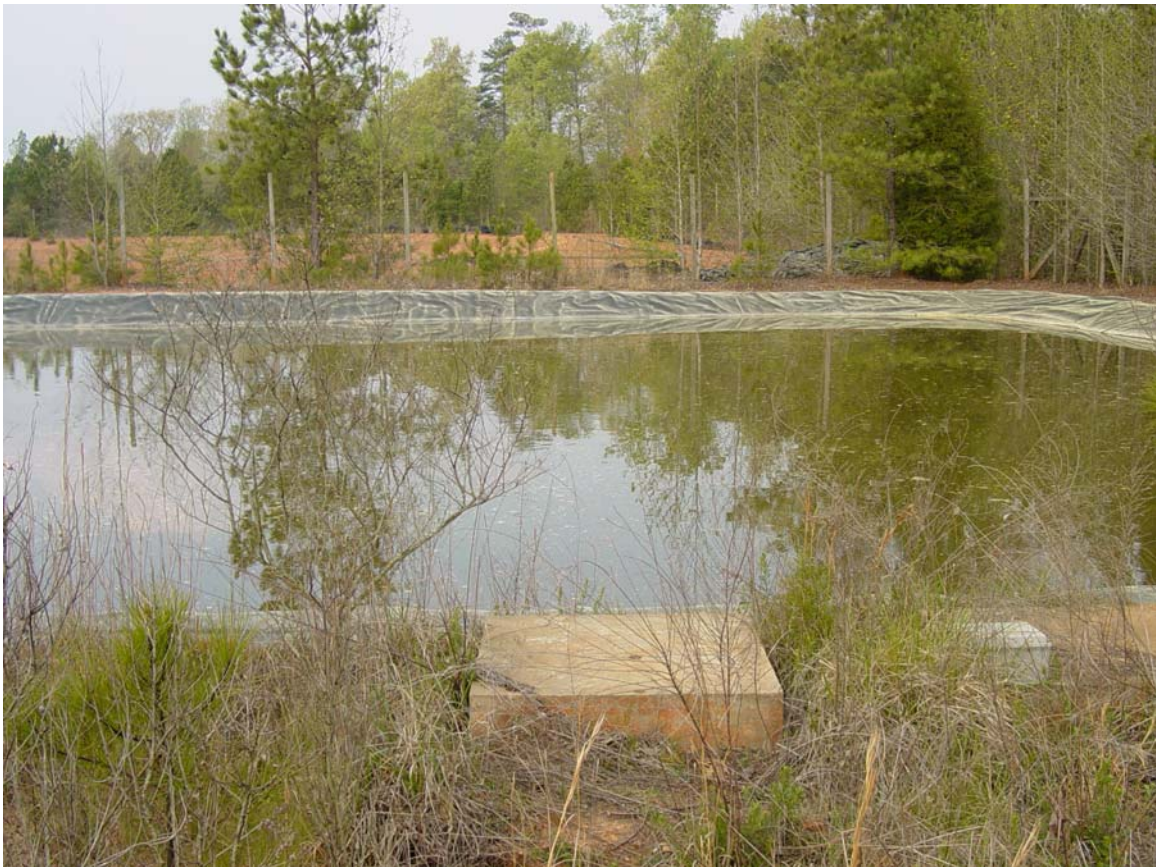
Figure 54. Photograph of the Process Plant Carbon Pond. The electric pump has been removed from its concrete base.

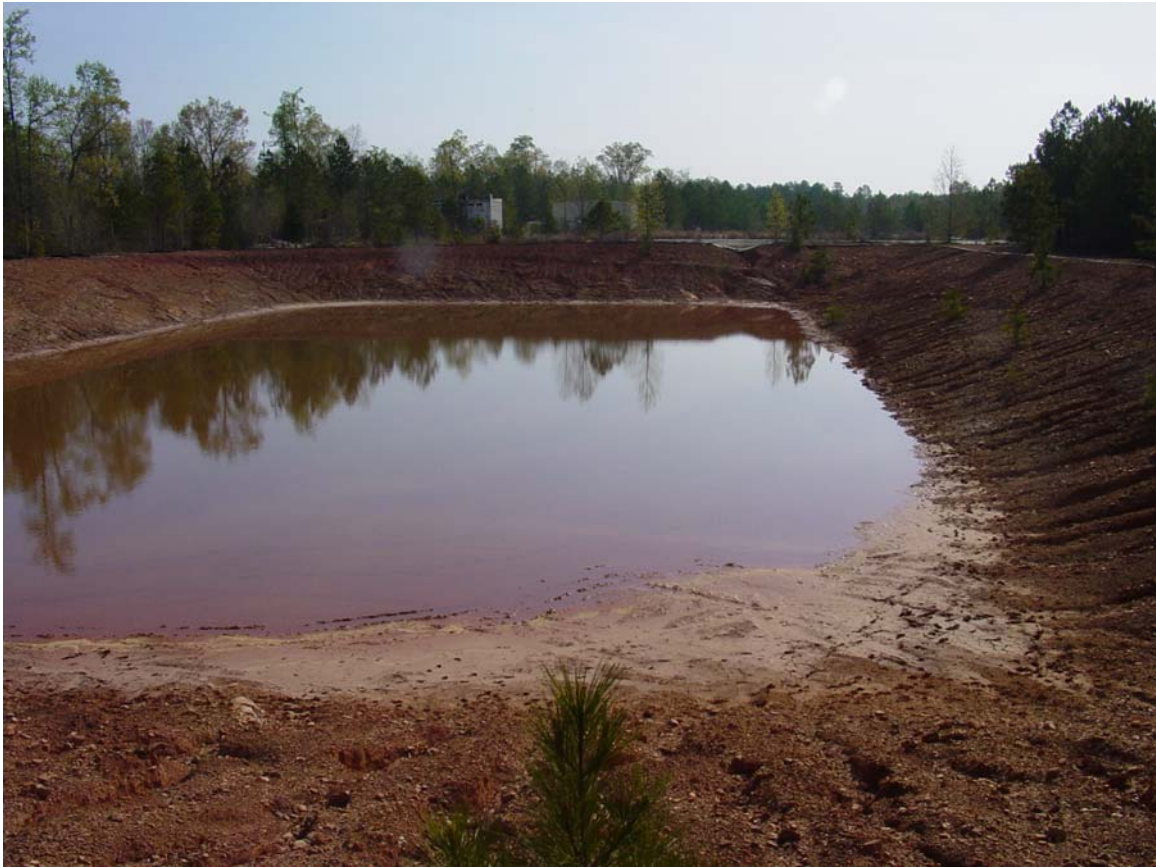
Figure 55. View of the Plant Contingency Pond (view looking towards the west). Note that the liner has been cut and removed. The slope in the right side of the photograph is weathered bedrock. The slope in the left side of the photograph is a fill embankment through which water is seeping.

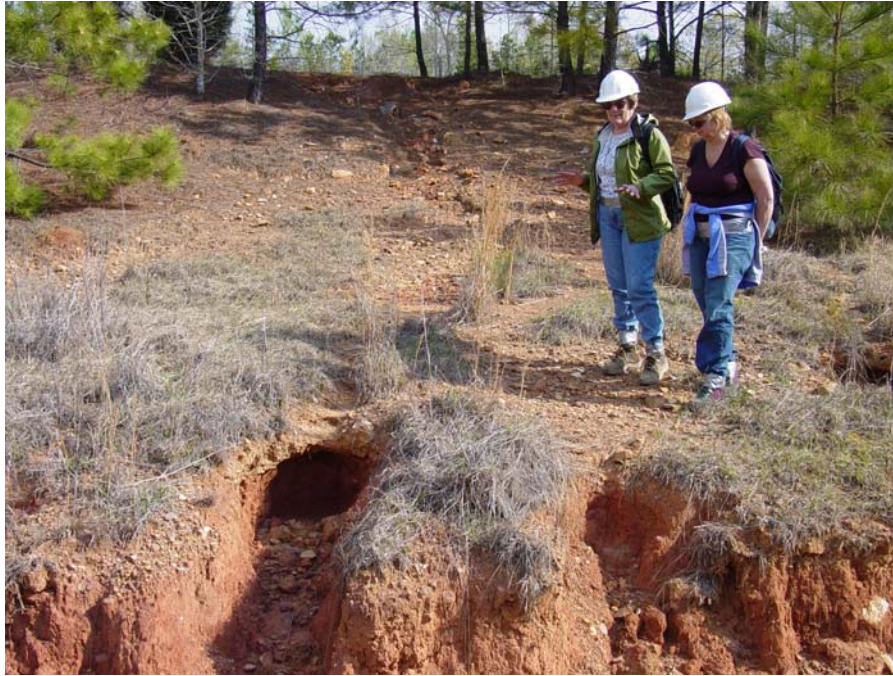
Figure 56. Signs of erosion and piping of the outslope of the fill embankment supporting the contingency pond.

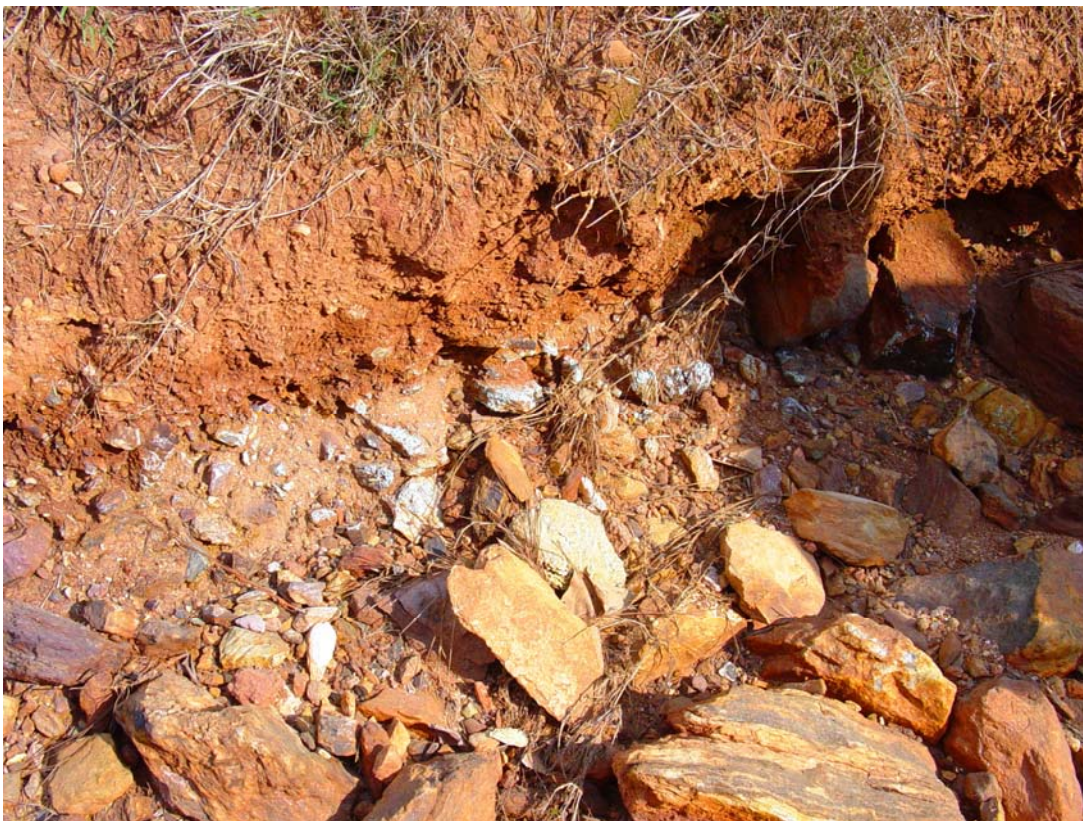
Figure 57. Damp soil at the seepage line along the toe of the fill embankment supporting the Process Plant Contingency Pond. Note the prussian blue coating the rocks below the damp soil.
