Site Features Inventory Report

Barite Hill Mine McCormick, South Carolina

Prepared By: Michael Gobla, P.E.

July 2007

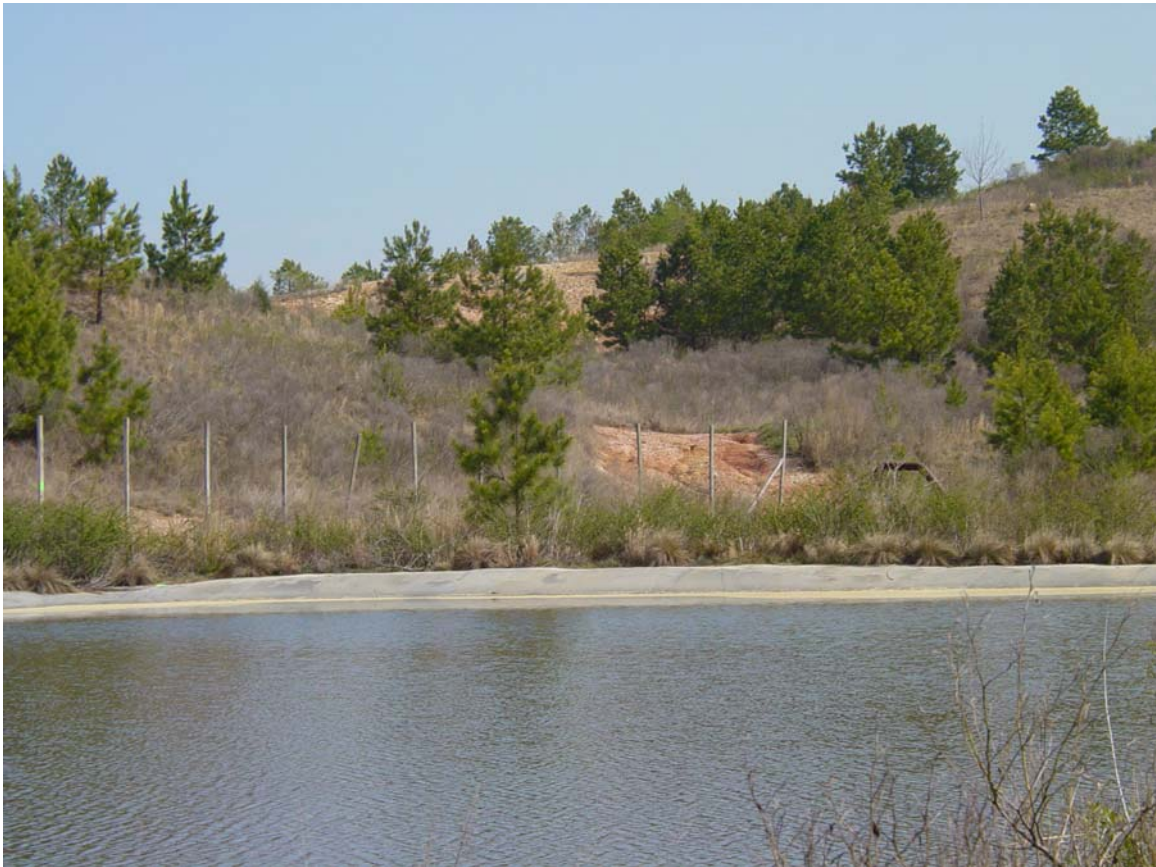
Figure 59. View of the Permanent Heap Rinse Pond. The disturbed area just above the pond is the location of a major acid seep from the Permanent Heap Leach Pad which is lowering the pH of this pond.

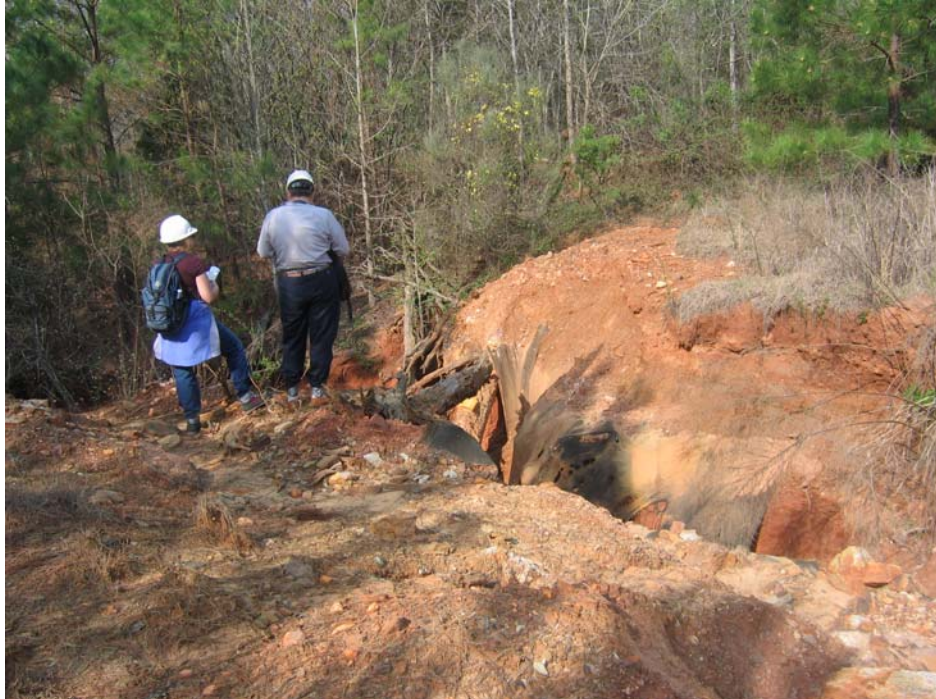
Figure 64. Failed sediment control structure on eroded diversion ditch near the Process Plant Contingency Pond.

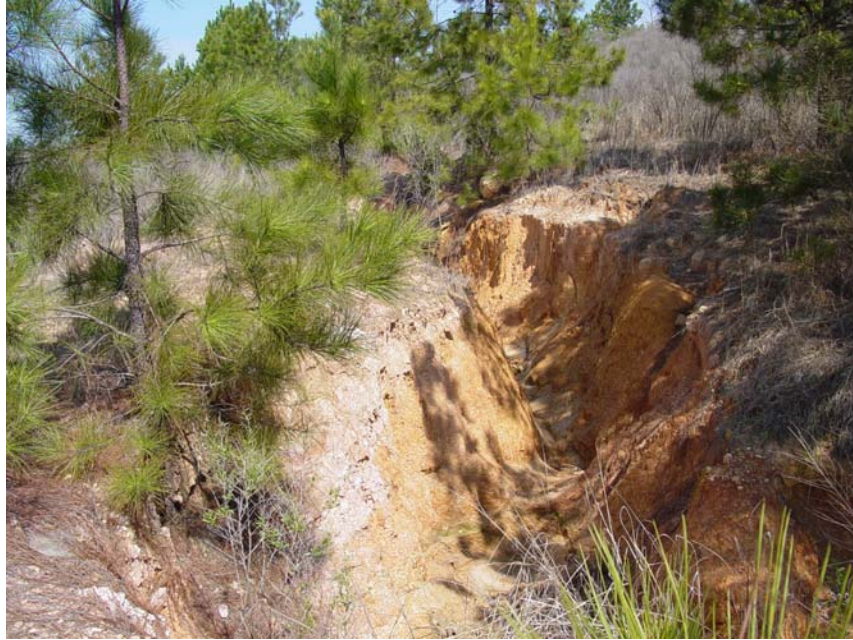
Figure 65. Erosion of diversion ditch adjacent to the Industrial Solid Waste Landfill.

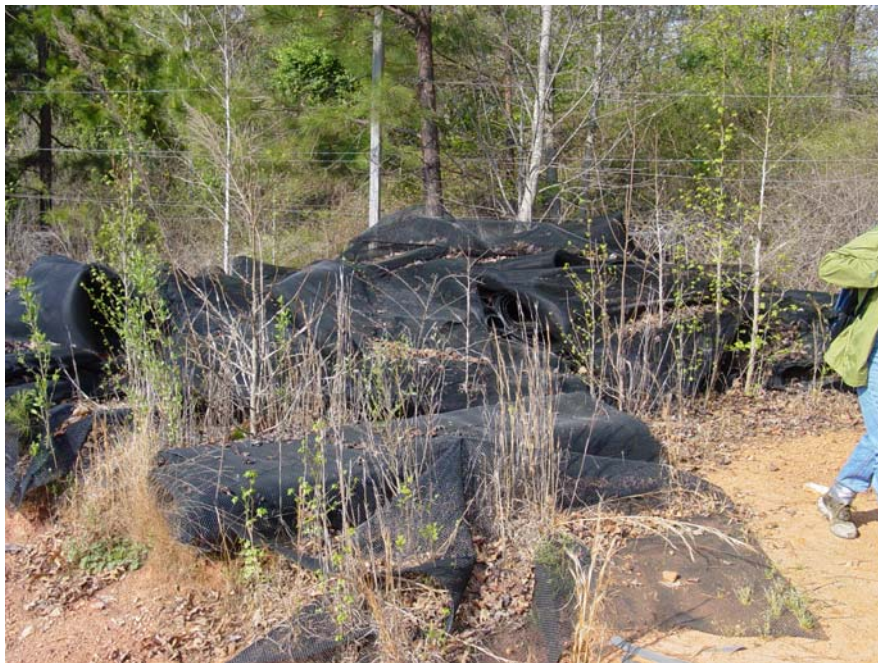
Figure 68. Discarded geonet drain material lies next to the Contingency Pond.

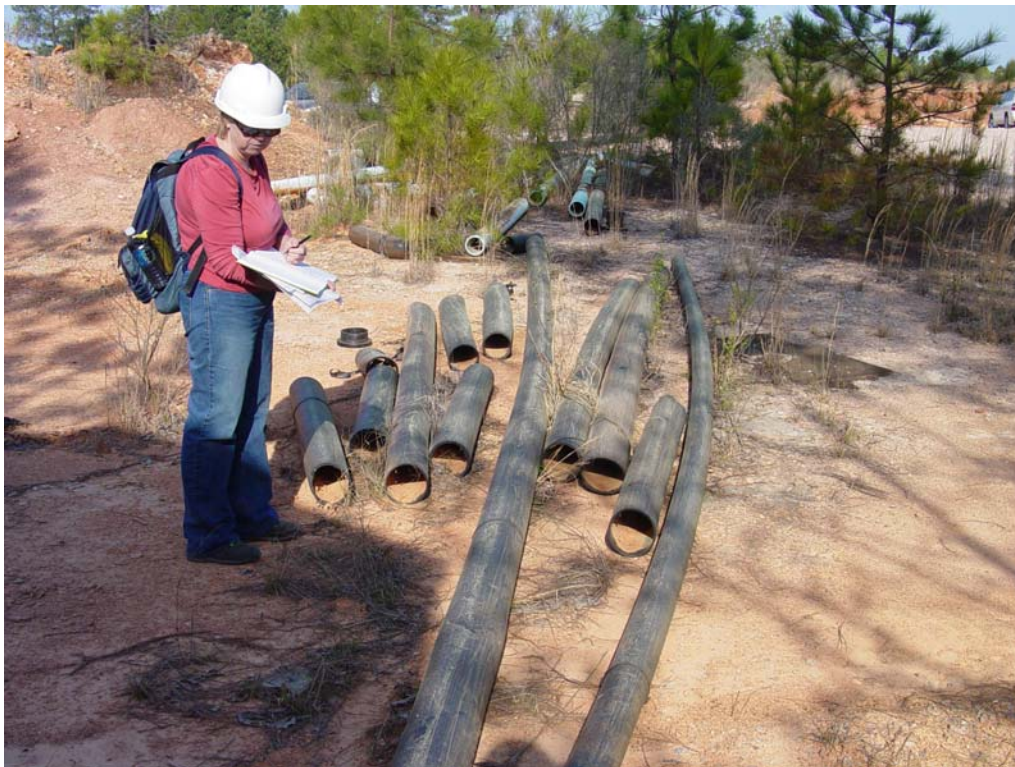
Figure 70. Piles of pipe located near the Mine Office. The HDPE pipe in the foreground should be retained. Pipe in the background is of no value.
