SMOKE STACK CONDITION STUDY

at the Quincy Smelter for

Keweenaw
NATIONAL
HISTORICAL
PARK

May 2008

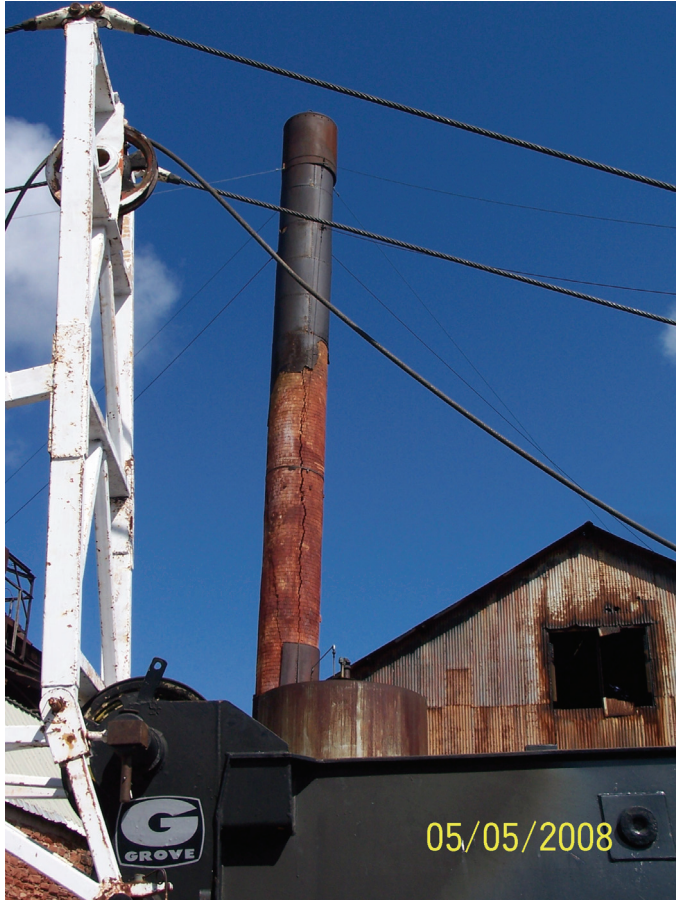
Photo #1
View of Stack from the south.

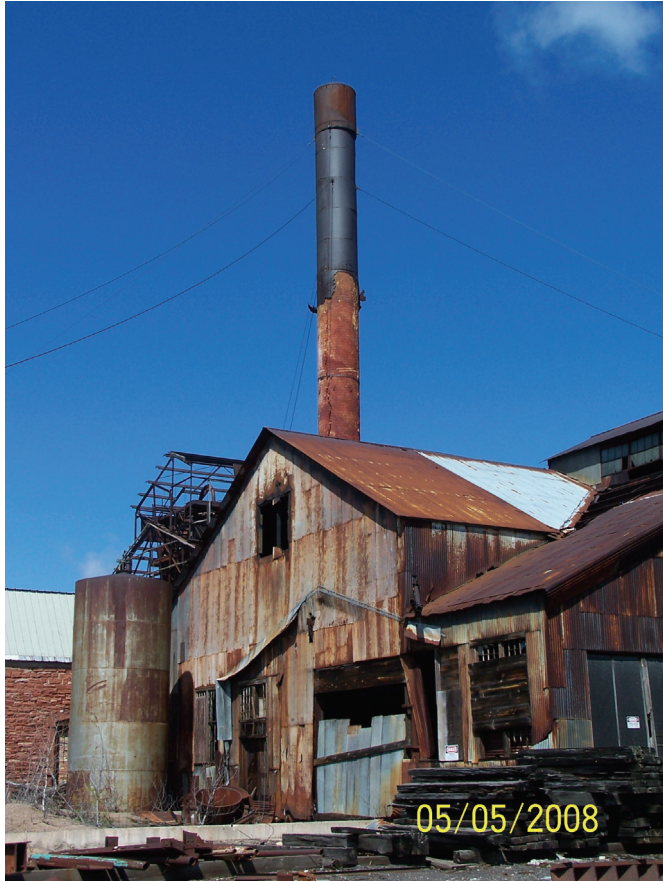
Photo #2
View of stack from the southeast.

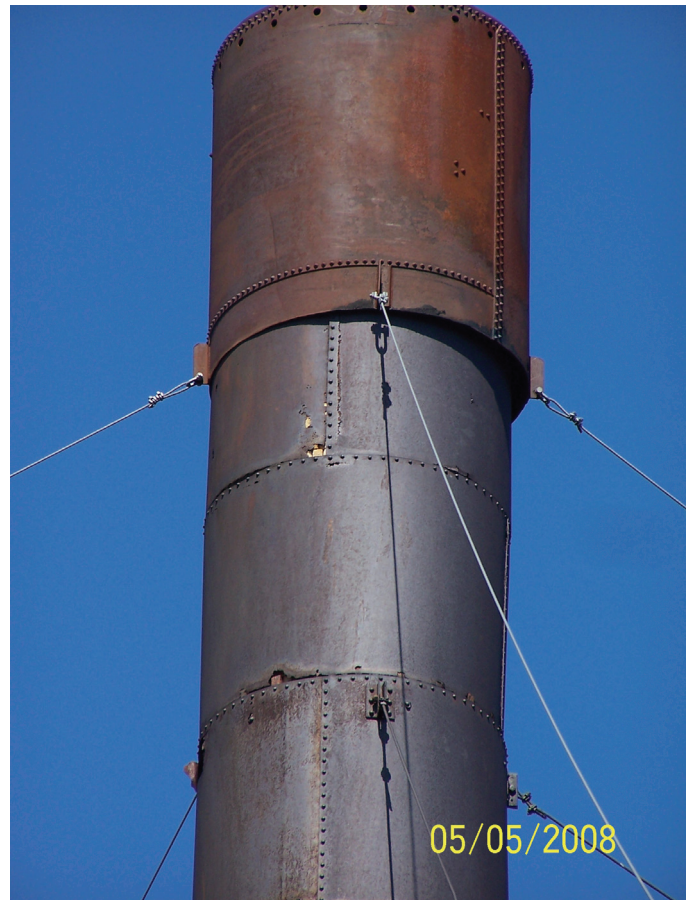
Photo #3
View of temporary stack cap from the south.

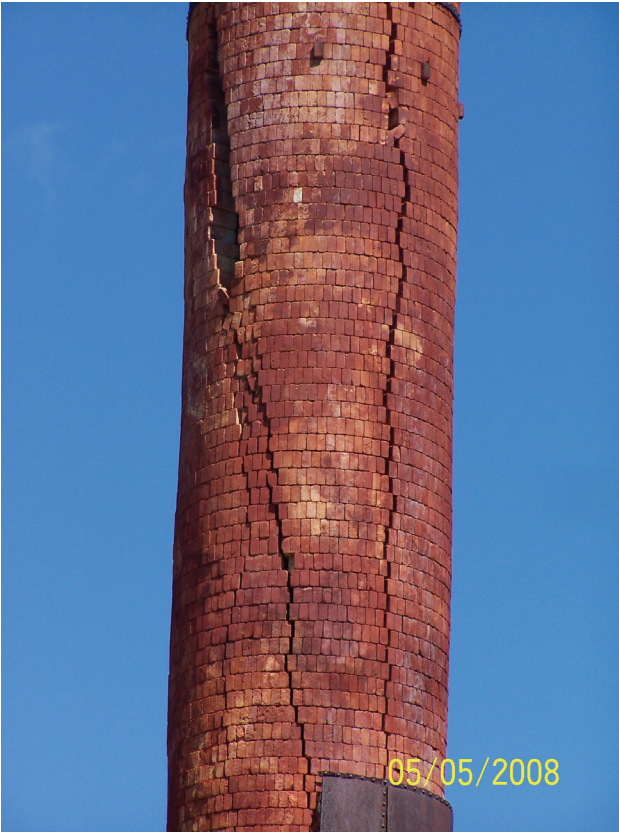
Additionally, a new and more serious crack from the southwest direction has developed. It is about 2” wide in most places, however there is a 6 foot vertical length of crack that is about 6 inches wide. This crack is 6 inches wide because brick has been falling out of the cracked opening.

Photo #4
View of converging south and southwest
cracks.

1. Asbestos abatement work cannot be done safely within the 200-foot fall radius of the smokestack under any wind conditions.
2. The smokestack should be removed down to approximately 15 feet above the top of the roof. This location is at the approximate point of the two conveying south and southwest cracks.
3. The stack should be topped or pulled over towards the south in order to minimize damage to the existing adjacent structures.

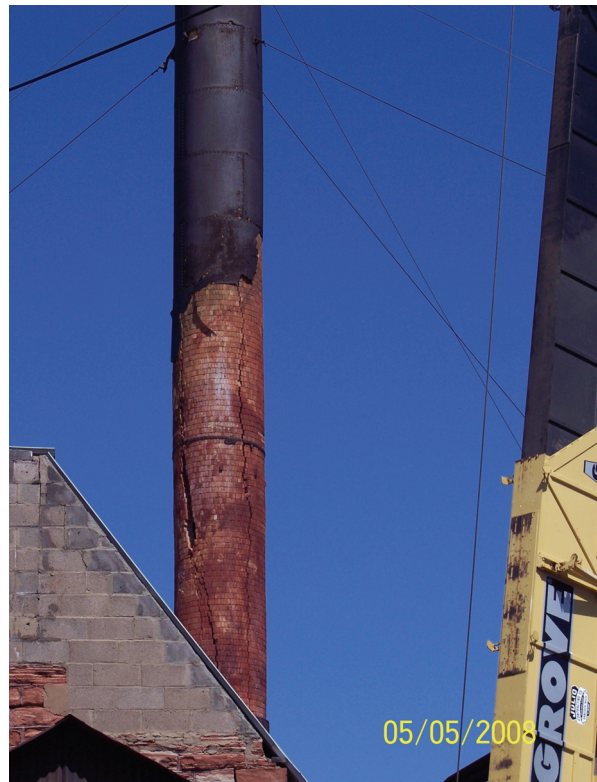
The previous (2002) inspection report noted the vertical crack in the brick on the south side, but was only about 5/8” to 3/4” inch wide. (Crack width was not noticed any larger in summer of 2007 when temporary steel cap was installed.) Now this south side crack is about 1-1/2” wide. Also, you can see another vertical crack developing on the opposite side of (northside) 1/4” to 1/2” wide. This is evident in that you can see daylight directly through the center of the stack.

Photo #5
View of south and southwest side cracks.

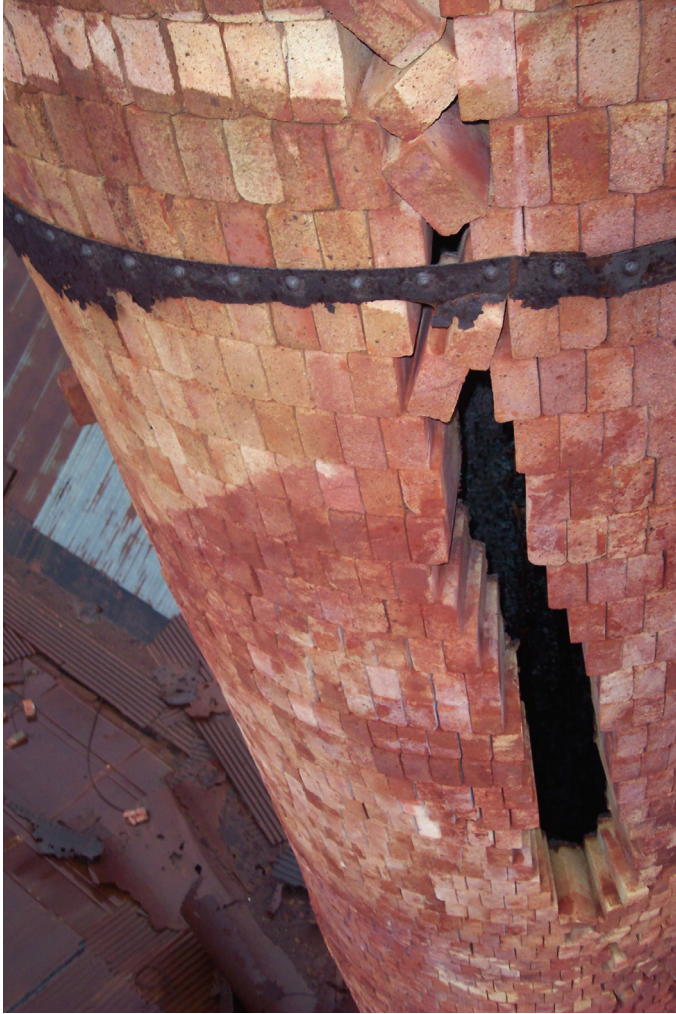
Photo #6
View of opening of southwest crack.

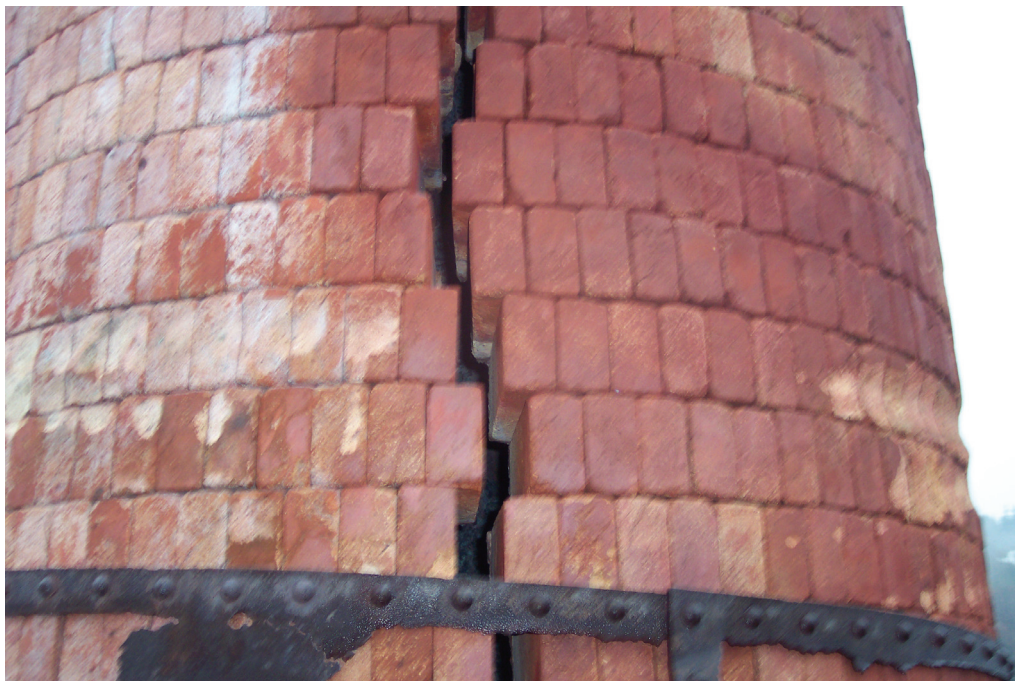
Photo #7
View of 1-1/2" to 2" opening size of south side crack.

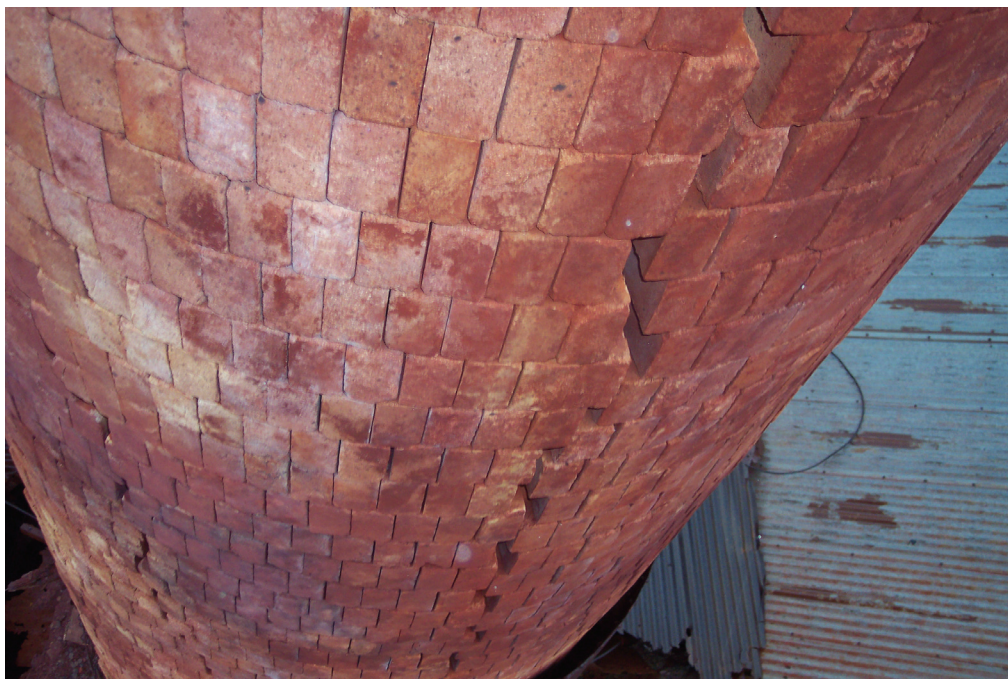
Further, and most serious of all, is that a portion of the brick stack is beginning to become oval or “egg-shaped” on this south side. This is a sign that “stack failure” is beginning.

Photo #8
View looking down at both the south and southwest side crack. Circular stack shape starting to become "egg-shaped".

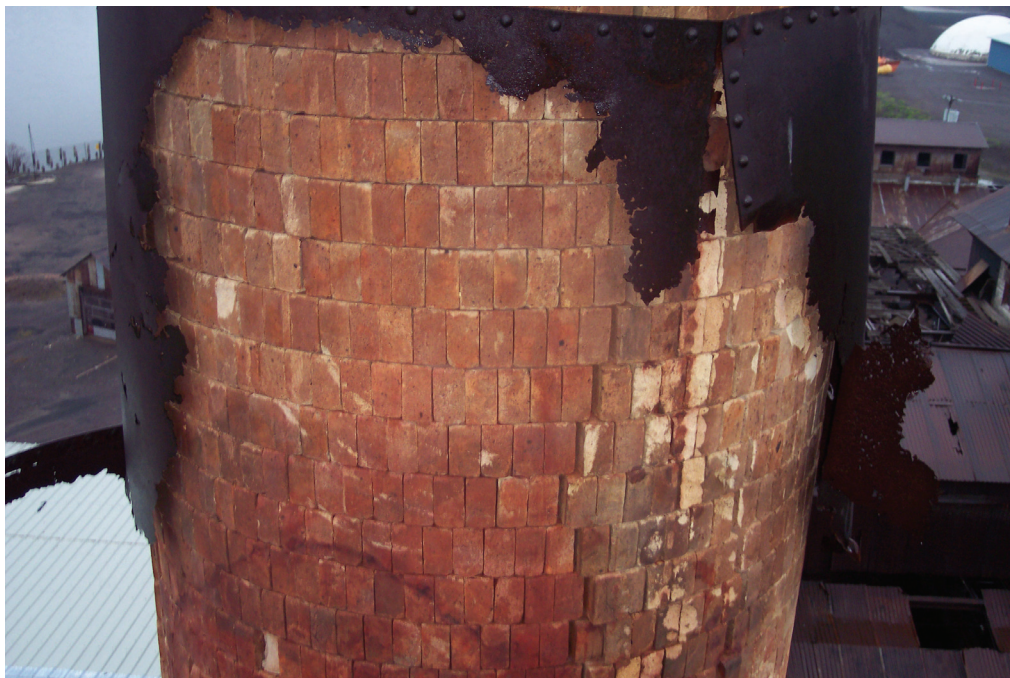
Photo #9
View of deteriorating steel shell and crack on east side.

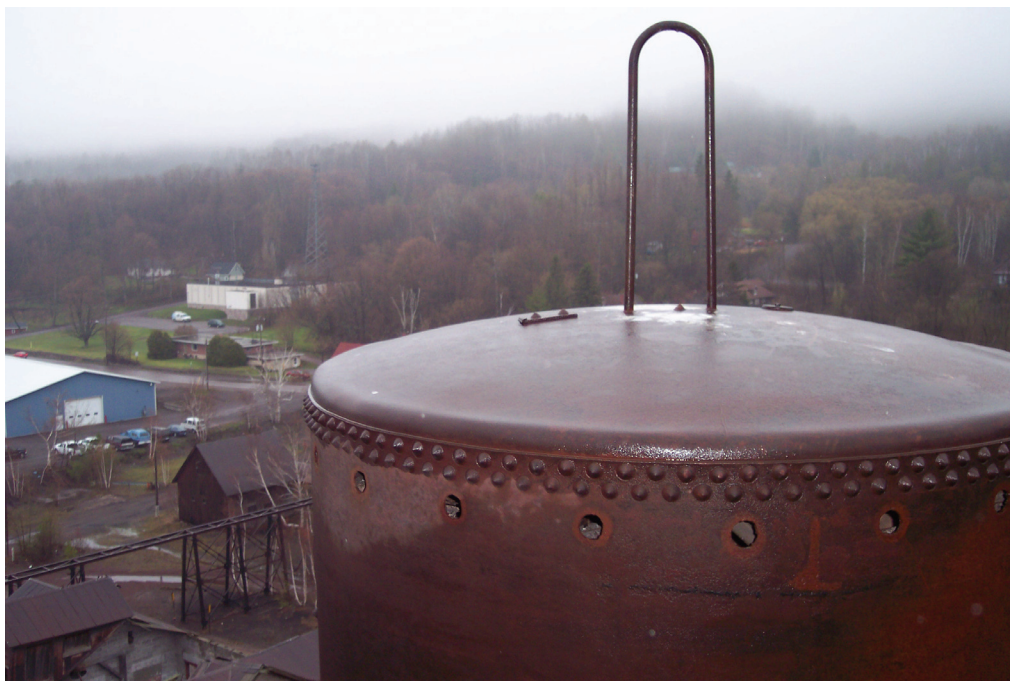
Photo #10
View of top of temporary stack cap.

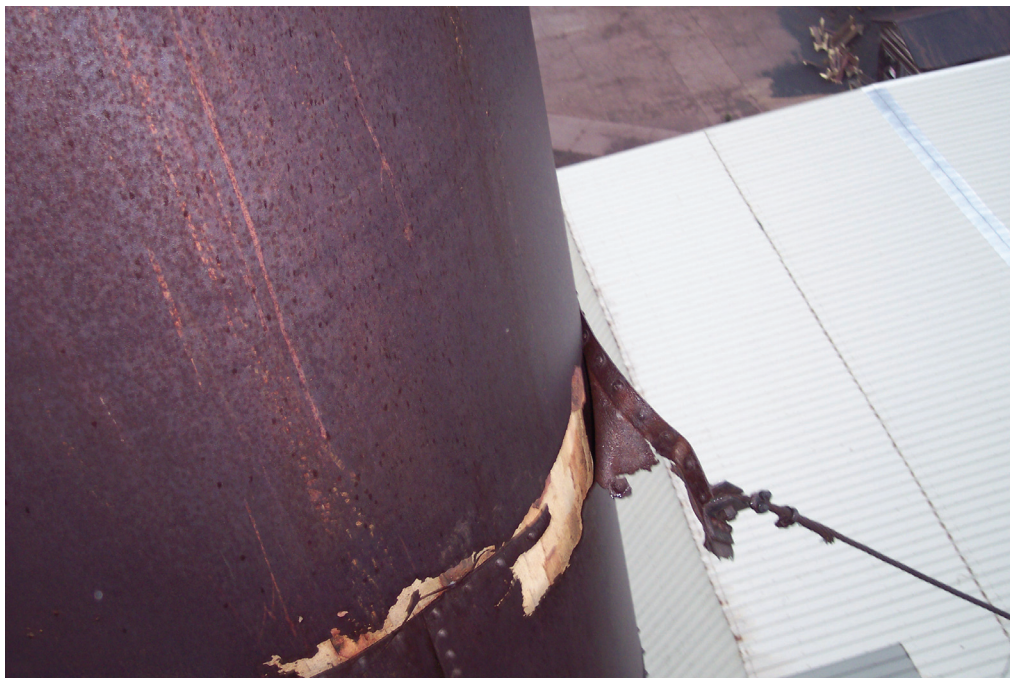
There is no change in the existing three (3) guy wires remaining, other than their attachment to the stack shell is getting more deteriorated.

Photo #11
View of “failed” northwest guy wire cable connection.

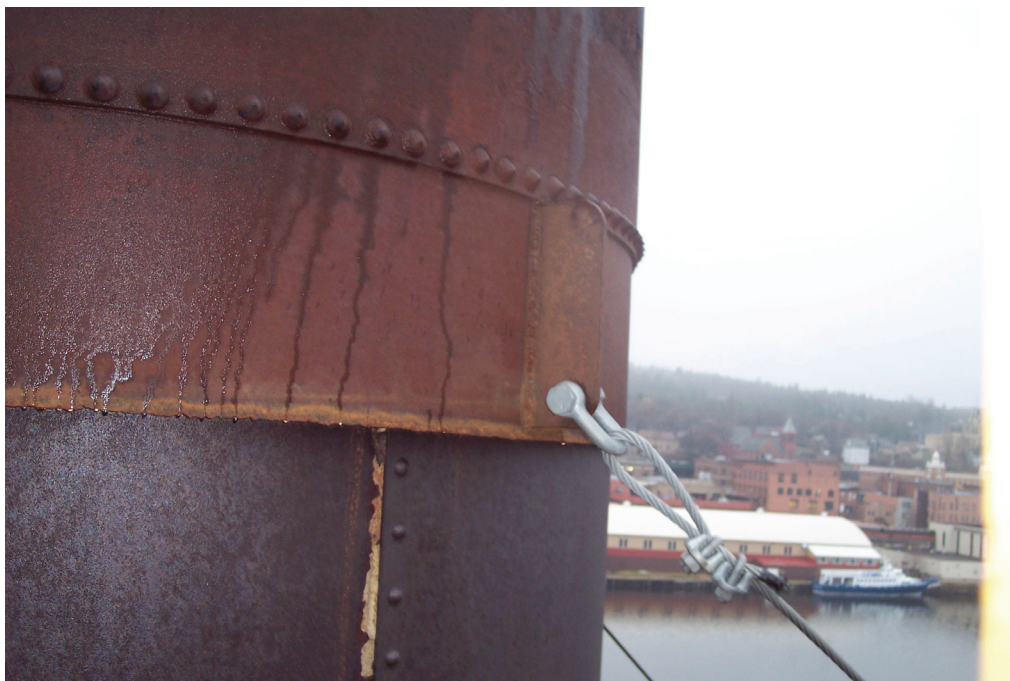
Photo #12
View of new guy wire cable on temporary stack cap just above.

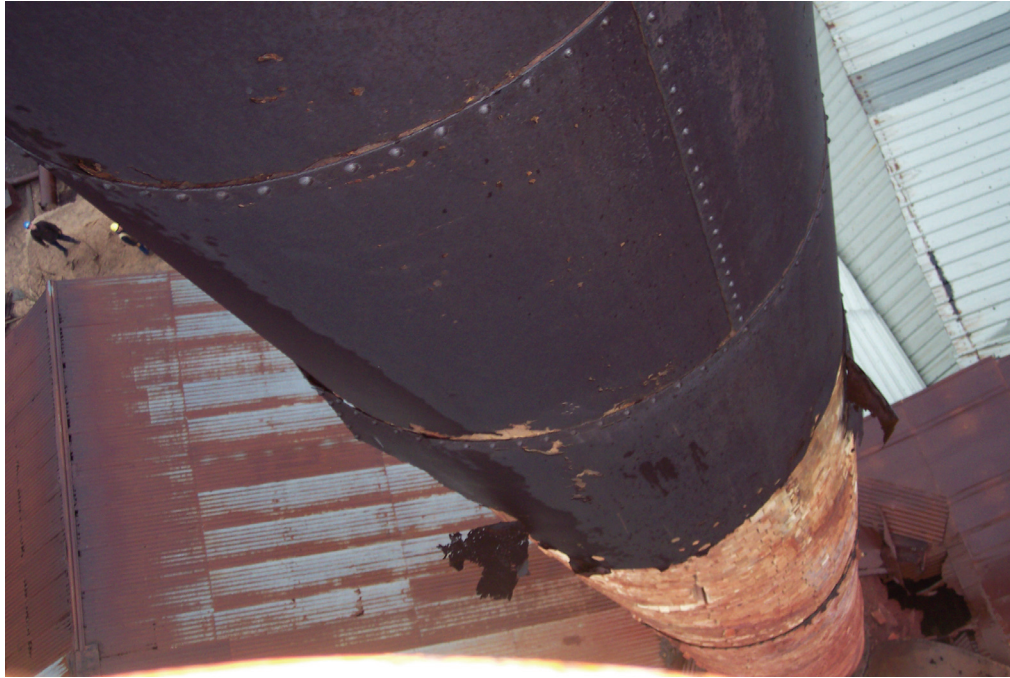
Only the top 30 feet (and 15 feet at the roof line) of the steel stack shell remains in place. This steel shell provides very little structural support for the stack, other than providing a few anchorage points for the old guy wire cables.

Photo #13
View of remaining steel shell of stack on north side.

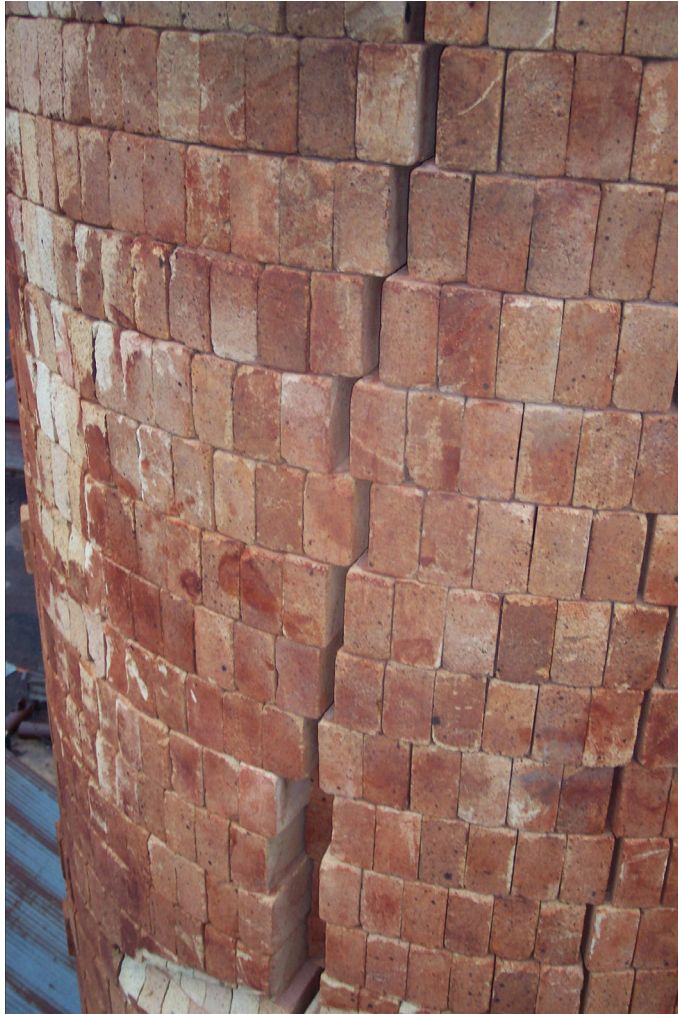
Photo #14
View of cracks in stack forming on the north side.

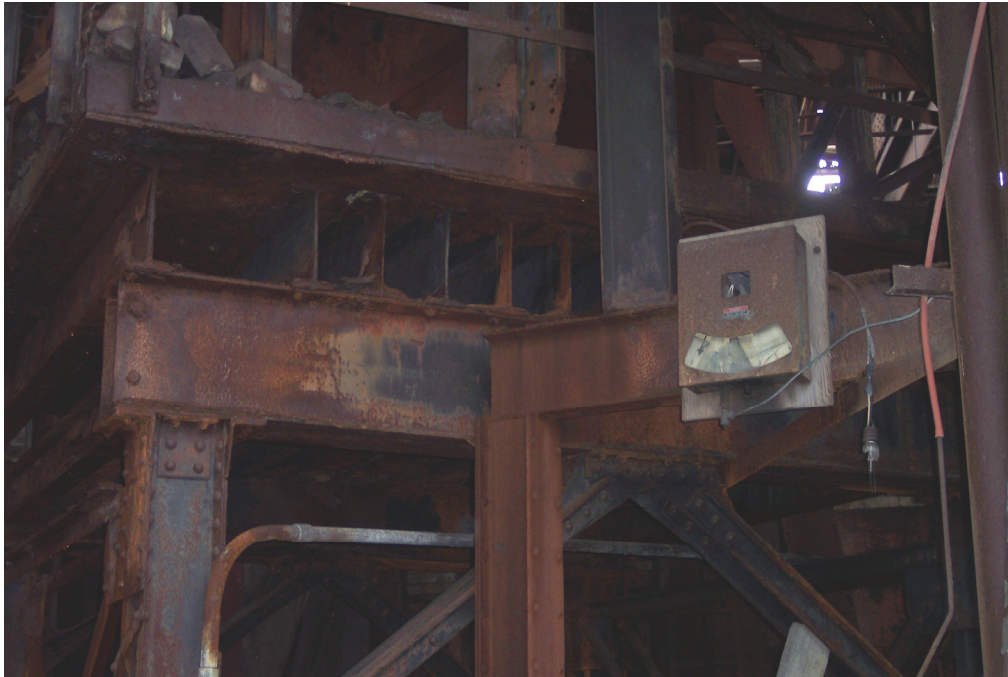
Photo #15

The structural steel frame base which rises about 11 feet off the floor, has deteriorated over the years due to moisture entering the building and corroding these steel members. We estimate that this frame has deteriorated to a point that its capacity is about 60% of its original maximum capacity. The beams, columns, and plate decking have a range of reduced capacities of 40 to 80 percent of their original capacity.

View of east side of structural steel frame base from smokestack.

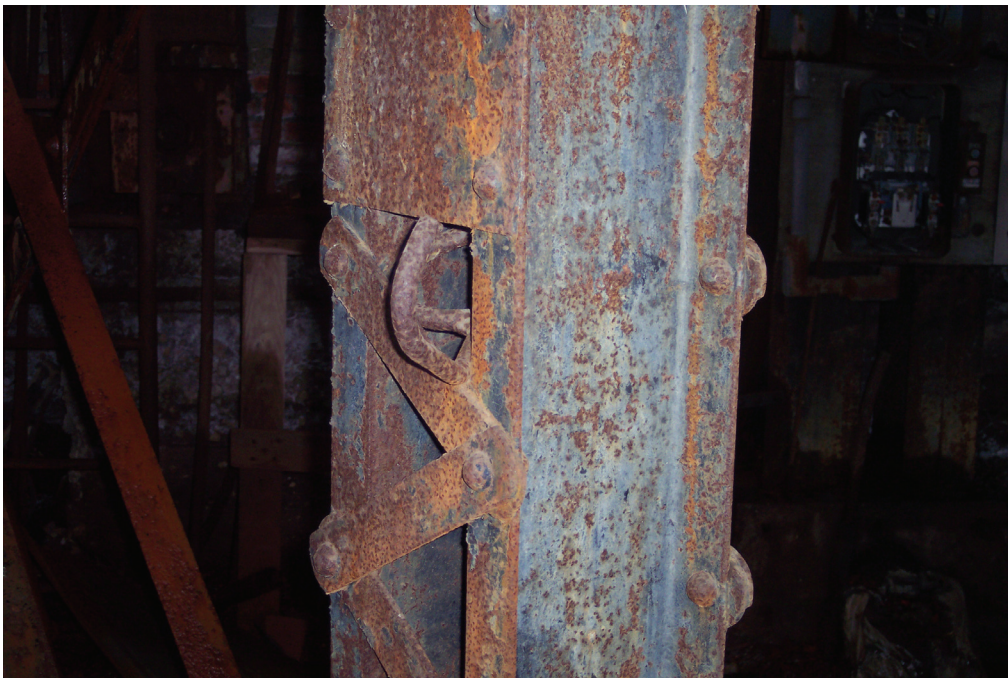
Photo #16

Typical one of four structural steel lattice columns on smokestack base.

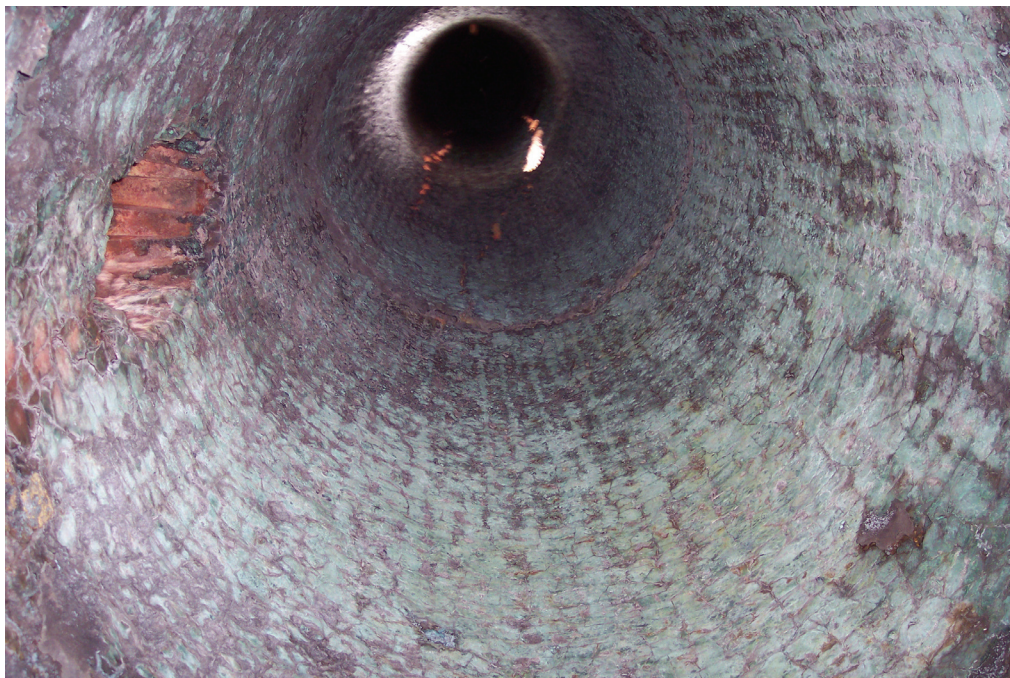
Photo #17

View of inside of smokestack. Note: Lots of daylight coming in from the southwest side crack.

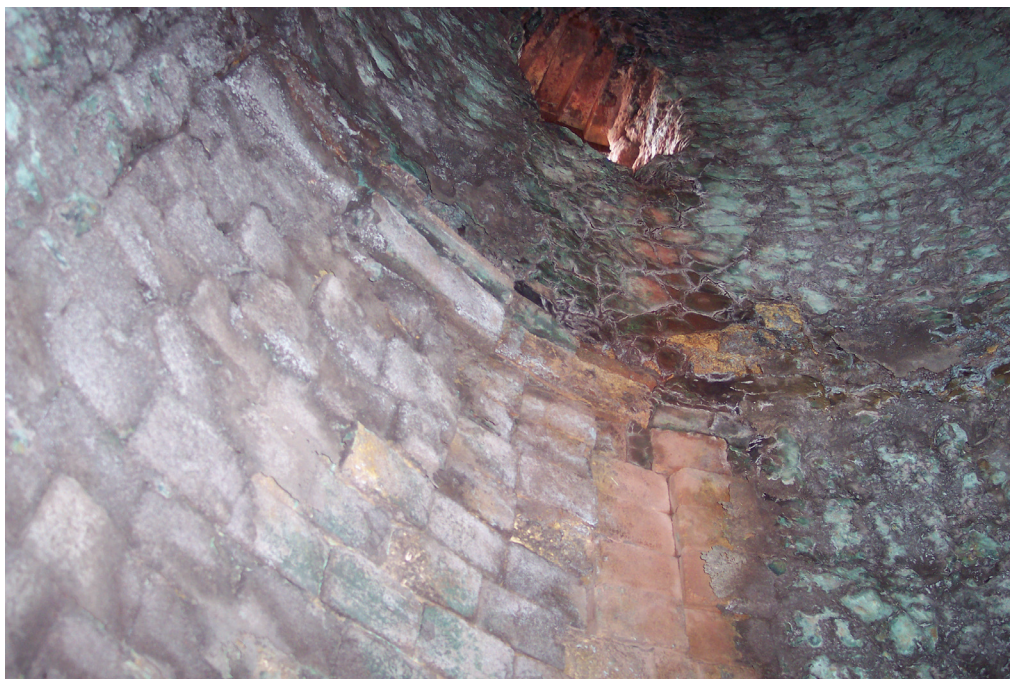
Photo #18

View of inside the stack wall and brick lining. Note: Hole made in southeast side for pipe penetration of some kind.
