**ANALYTICAL REPORT  
PREPARED FOR**

Quincy Smelter Site  
48991 Maple  
Ripley, MI

**Project Dates: June 10, 2008 through June 13, 2008**

*RE: Environmental Consulting Services Associated with Air Monitoring and Abatement Activities at Quincy Smelter Site. ETC Job #: R-123392-08.*

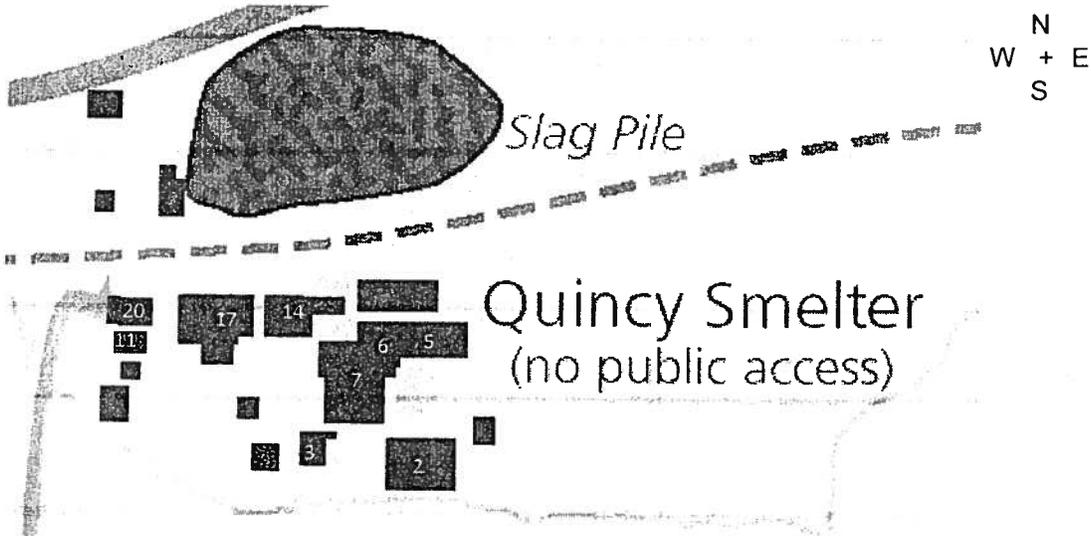
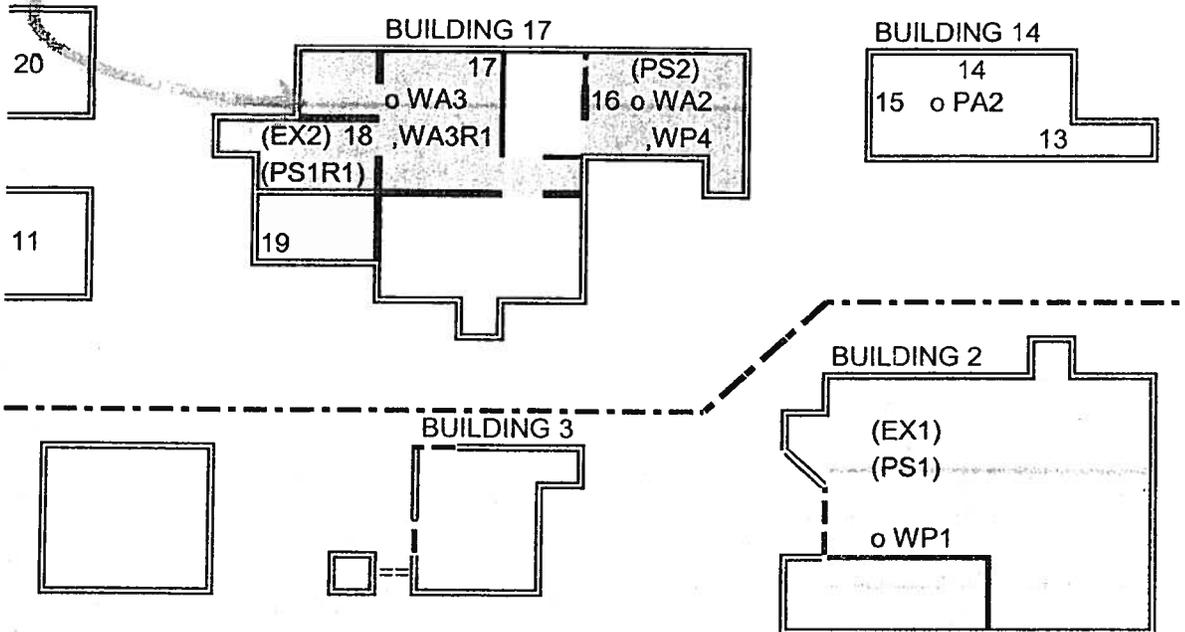
Temporary waste storage continues in building 20 and additional storage is added into building 17.
