September 15, 2008

**Subject: Final CERCLA Emergency Response Letter Report
Crossville Tanker Rollover
Crossville, Cumberland County, Tennessee
Technical Direction Document (TDD) No. TTEMI-05-001-0067**

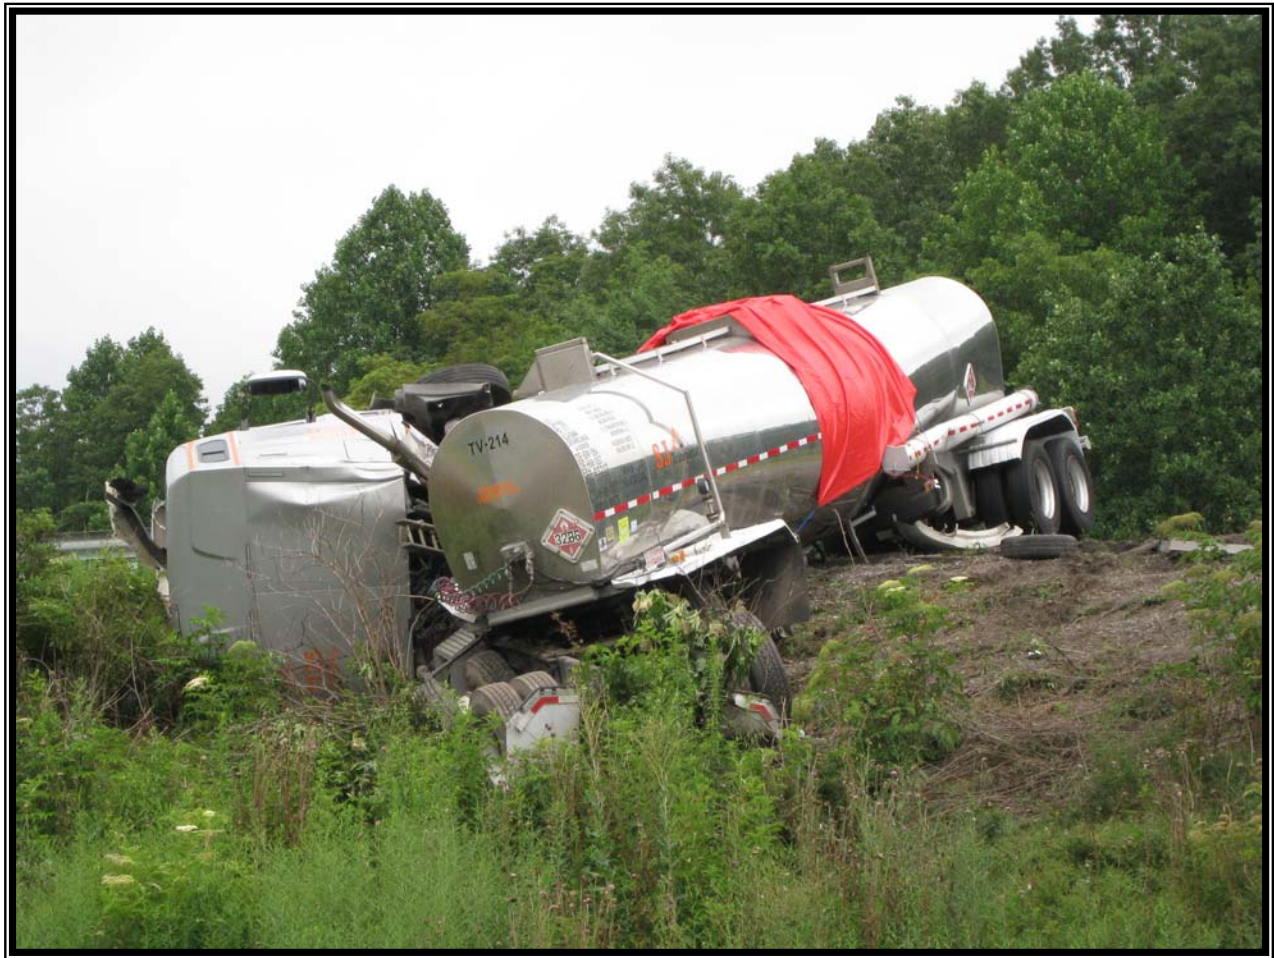
OFFICIAL PHOTOGRAPH NO. 1
U.S. ENVIRONMENTAL PROTECTION AGENCY

TDD Number:	TTEMI-05-001-0067	Location:	Interstate 40 (mile marker 332) Crossville, TN
Orientation:	Northwest	Date:	July 13, 2008
Photographer:	Brian Croft, Tetra Tech	Witness:	Kyle Russell, Tetra Tech
Subject:	The tanker truck as it came to rest following the accident.

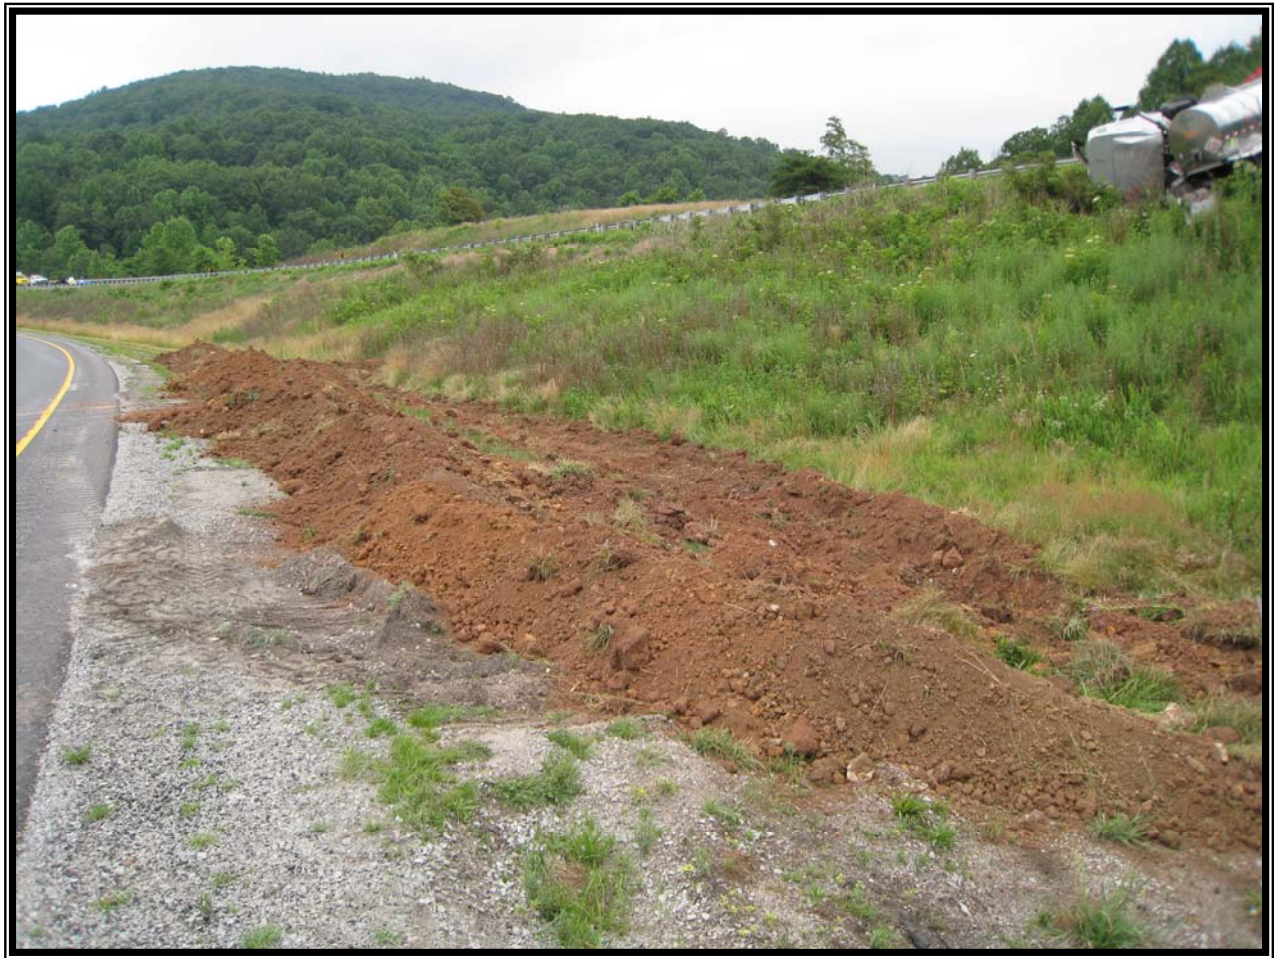
OFFICIAL PHOTOGRAPH NO. 2
U.S. ENVIRONMENTAL PROTECTION AGENCY

TDD Number:	TTEMI-05-001-0067	Location:	Interstate 40 (mile marker 332) Crossville, TN
Orientation:	Northwest	Date:	July 13, 2008
Photographer:	Brian Croft, Tetra Tech	Witness:	Kyle Russell, Tetra Tech
Subject:	A soil berm that was constructed by the Crossville Fire Department along Interstate 40 downgradient of the tanker to contain any releases.

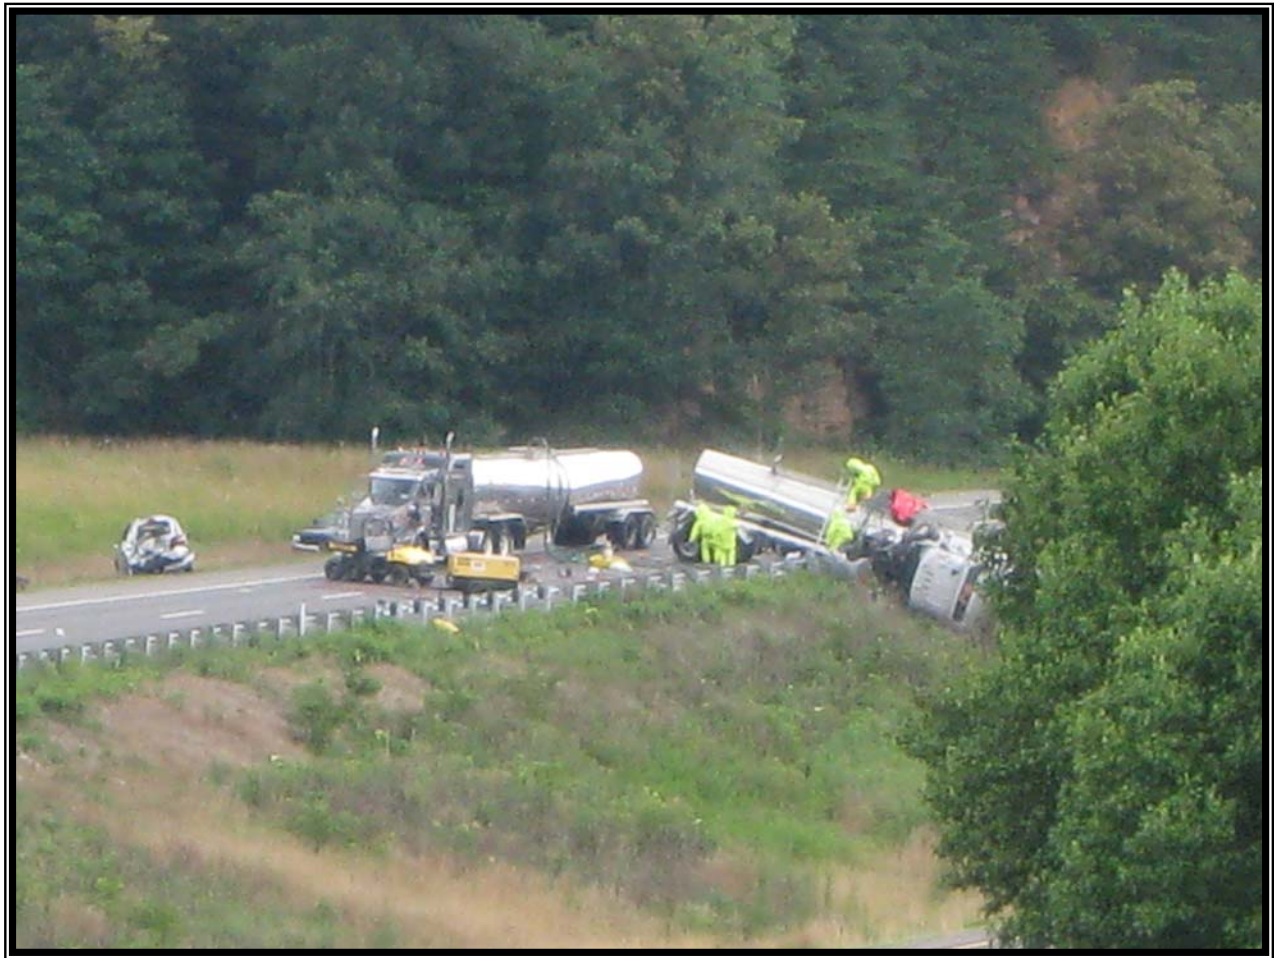
OFFICIAL PHOTOGRAPH NO. 3
U.S. ENVIRONMENTAL PROTECTION AGENCY

TDD Number:	TTEMI-05-001-0067	Location:	Interstate 40 (mile marker 332) Crossville, TN
Orientation:	East	Date:	July 13, 2008
Photographer:	Brian Croft, Tetra Tech	Witness:	Didi Fung, Tetra Tech
Subject:	Transfer operations in process. HEPACO team attempts to attach the hose connecting the damaged tanker to the transfer tanker.

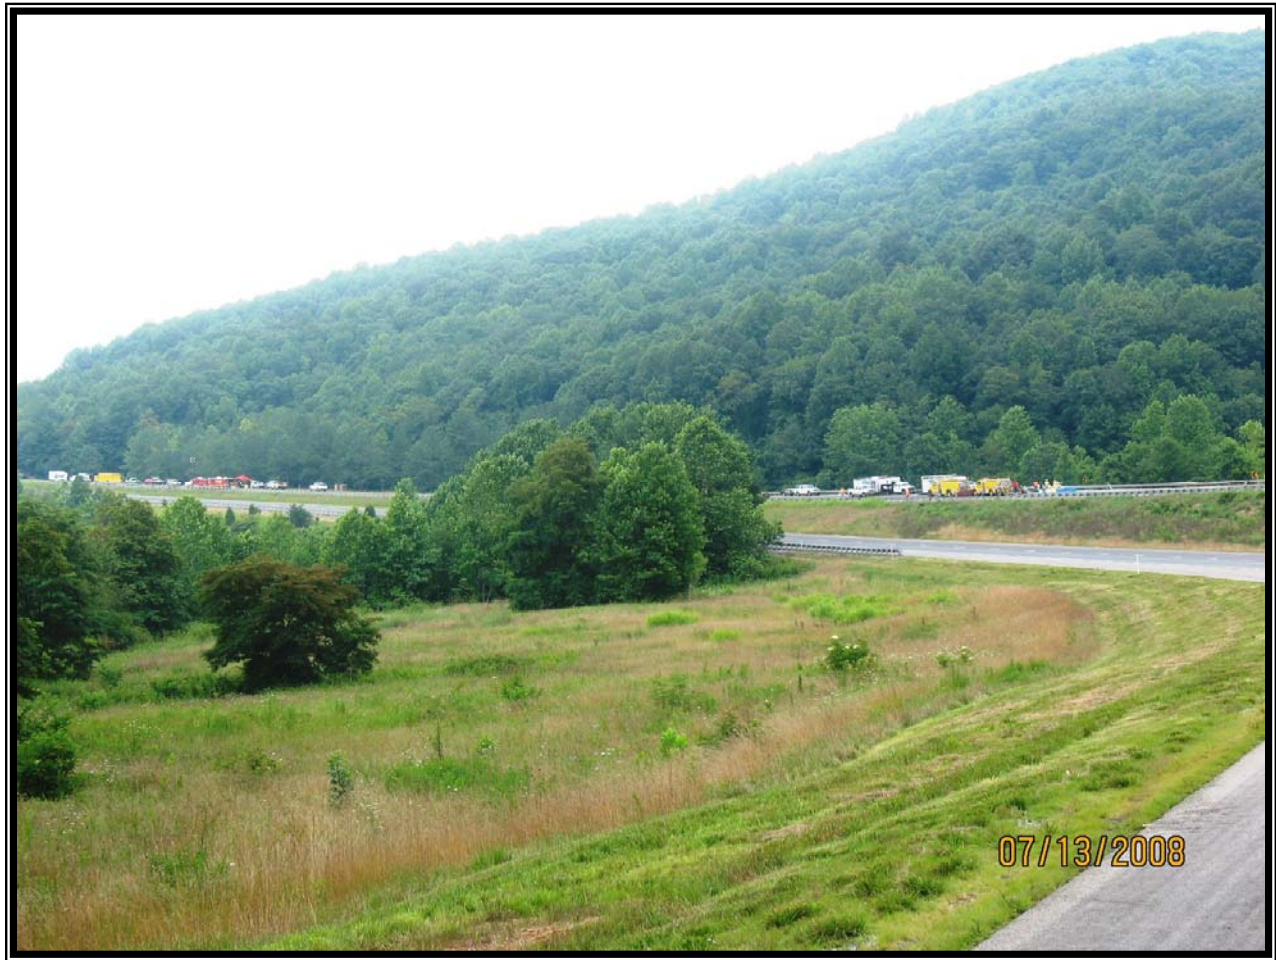
OFFICIAL PHOTOGRAPH NO. 4
U.S. ENVIRONMENTAL PROTECTION AGENCY

TDD Number:	TTEMI-05-001-0067	Location:	Interstate 40 (mile marker 332) Crossville, TN
Orientation:	West	Date:	July 13, 2008
Photographer:	Jody Sumner, Tetra Tech	Witness:	Kyle Russell, Tetra Tech
Subject:	Staging area along Interstate 40 West. In order from right to left (closest to furthest from crash site): HEPACO, Crossville Fire Department, EPA/START.

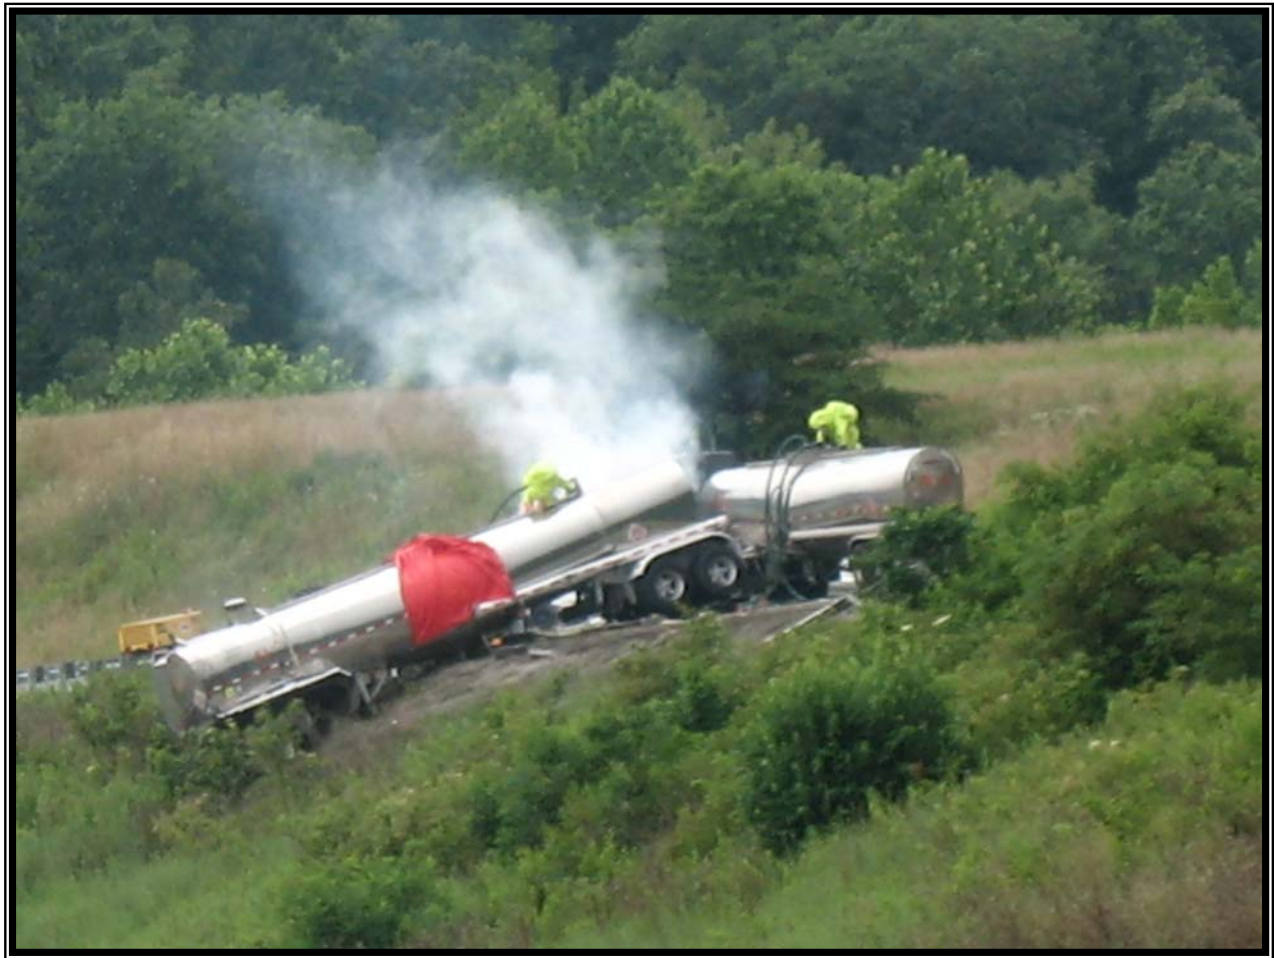
OFFICIAL PHOTOGRAPH NO. 5
U.S. ENVIRONMENTAL PROTECTION AGENCY

TDD Number:	TTEMI-05-001-0067	Location:	Interstate 40 (mile marker 332) Crossville, TN
Orientation:	Northwest	Date:	July 13, 2008
Photographer:	Kyle Russell, Tetra Tech	Witness:	Jody Sumner, Tetra Tech
Subject:	Release of white fumes (hydrochloric acid and titanium compounds) during the transfer process. Multiple attempts by HEPACO were made to equalize pressures in the tankers before the waste began transferring at around 1700 on July 13, 2008.

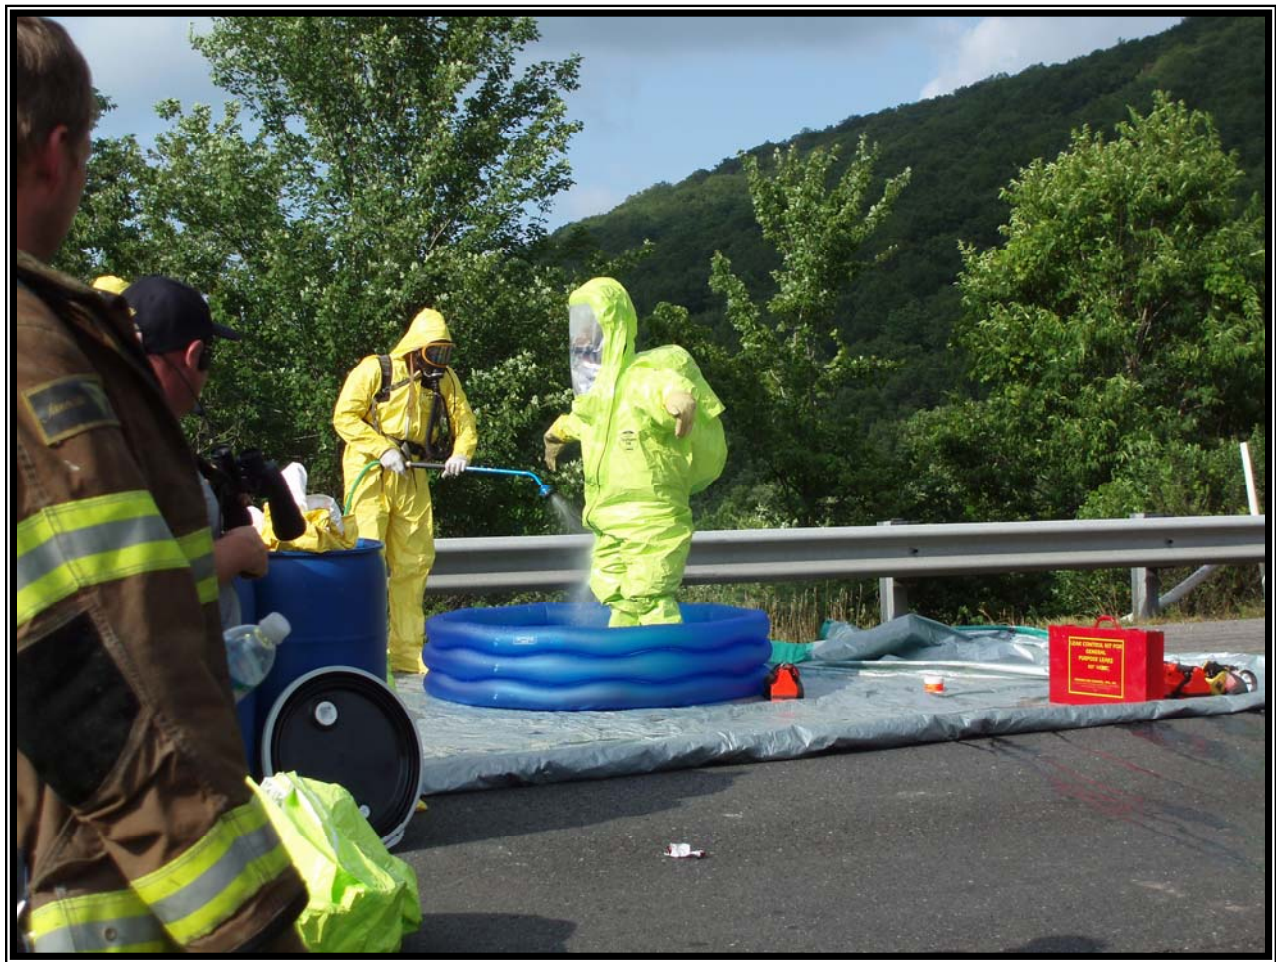
OFFICIAL PHOTOGRAPH NO. 6
U.S. ENVIRONMENTAL PROTECTION AGENCY

TDD Number:	TTEMI-05-001-0067	Location:	Interstate 40 (mile marker 332) Crossville, TN
Orientation:	North	Date:	July 13, 2008
Photographer:	Didi Fung, Tetra Tech	Witness:	Brandon Foskey, Tetra Tech
Subject:	Decontamination area set up by HEPACO upwind from the site.

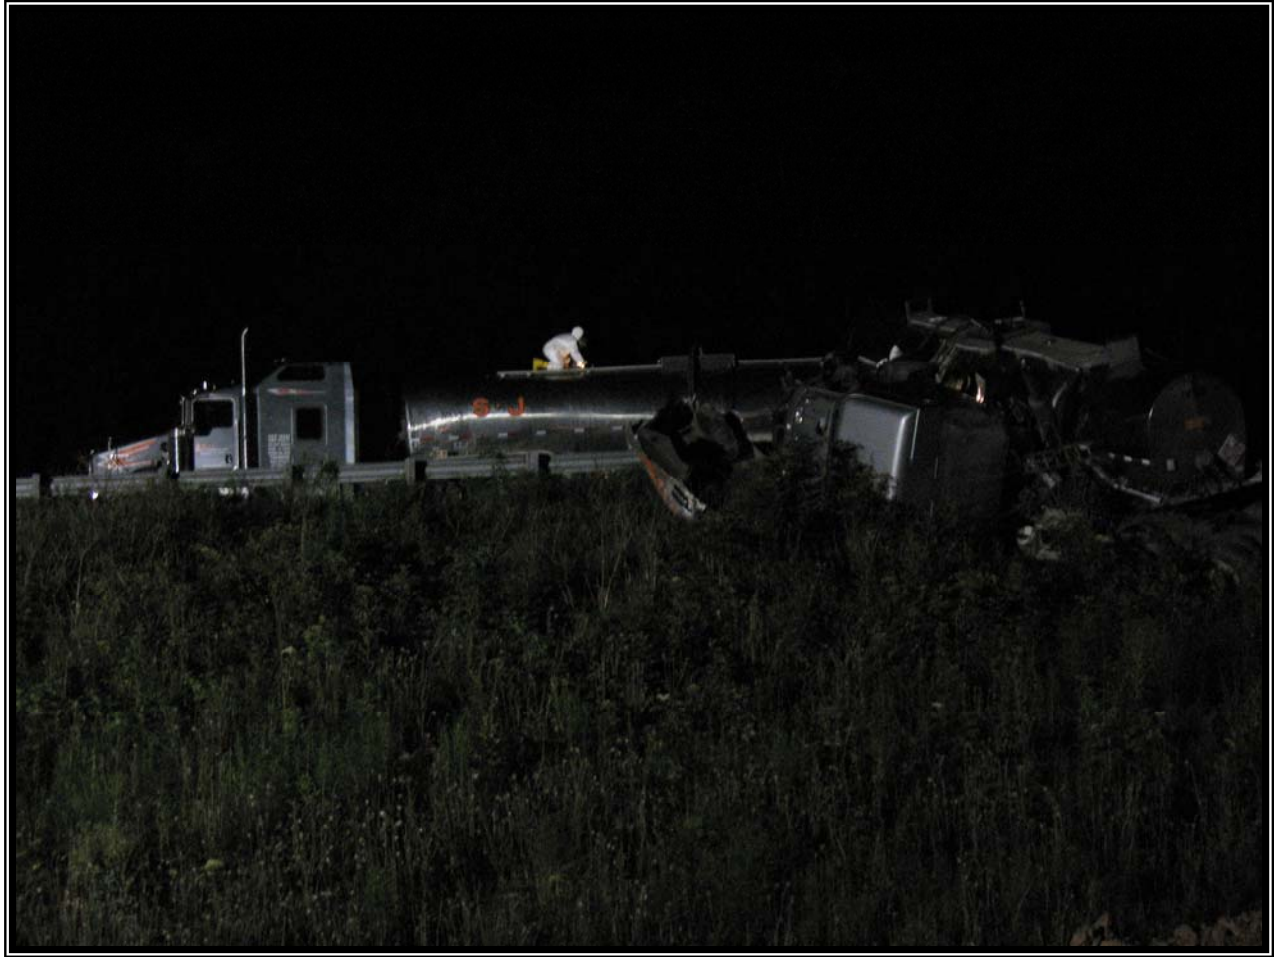
OFFICIAL PHOTOGRAPH NO. 7
U.S. ENVIRONMENTAL PROTECTION AGENCY

TDD Number:	TTEMI-05-001-0067	Location:	Interstate 40 (mile marker 332) Crossville, TN
Orientation:	North	Date:	July 13, 2008
Photographer:	Jody Sumner, Tetra Tech	Witness:	Kyle Russell, Tetra Tech
Subject:	Transfer operations continued into the night and were completed at approximately 2330 on July 13, 2008.
