**LOUISIANA ABANDONED OIL FACILITY
SITE ASSESSMENT SUMMARY REPORT**

**Quality Petroleum, Inc.-Hoffman, et al.
Caddo Parish, Louisiana
FPN: E06614
EPA ID: 09-E-1181**

May 23, 2008

**Prepared by:
Ecology & Environment, Inc.
Baton Rouge, Louisiana**

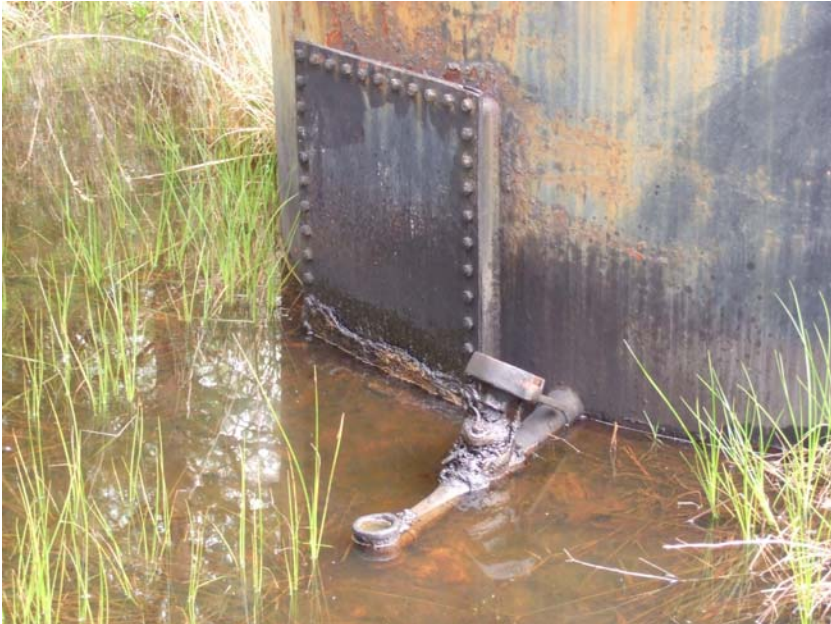
Oily liquid seeping through delaminated metal at the base of AST1 and AST3 created areas of oil-saturated soil in most of CONT1. Soil cores revealed that oil-saturated soil extended to a maximum depth of 1 foot BGS. A breach eroded in southern earthen berm of CONT1 significantly reduced the containment capacity and allowed it to drain oily water to adjacent waterways. Water with an oily sheen was pooled up to a depth of 0.5 foot in the southern portion of CONT1. Medium pines and vegetation were present in CONT1. Lack of maintenance was evident from the heavily overgrown condition, eroding berms, and the oil-saturated soil in CONT1.

Site Name: Quality Petroleum, Inc.-Hoffman, et al. **Project No.:** E06614
Photo No.: 0207 **Direction:** NW **Contract No.**
Date: 04/05/2008 **Time:** 9:37:00 AM **Photographer/Witness:** Sekerka, Robert/Johnson, Colin
Description: E06614: Rust, corrosion and oily liquid seeping through the delaminated metal on the man way at the base AST1.

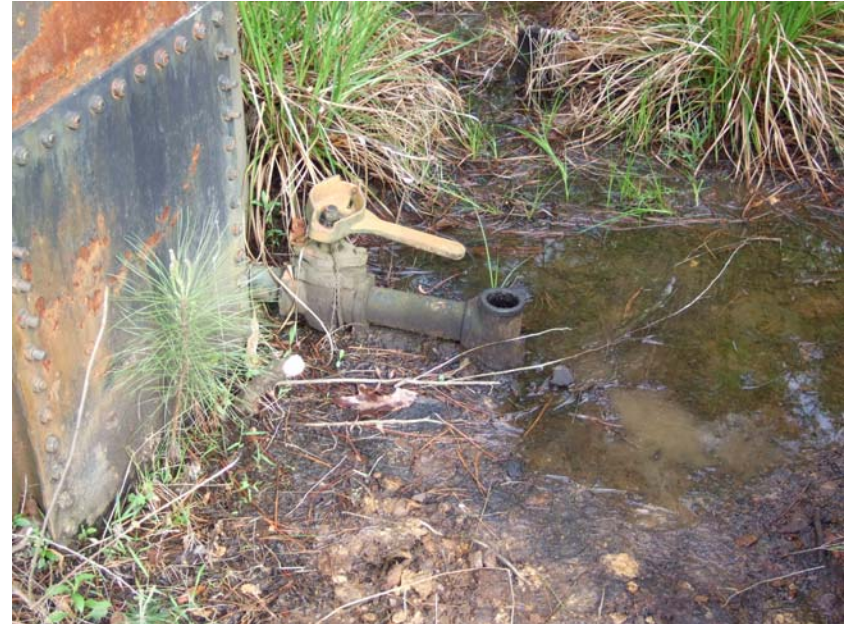
Site Name: Quality Petroleum, Inc.-Hoffman, et al. **Project No.:** E06614
Photo No.: 0209 **Direction:** Down **Contract No.**
Date: 04/05/2008 **Time:** 9:38:00 AM **Photographer/Witness:** Sekerka, Robert/Johnson, Colin
Description: E06614: Oil saturated soil surrounding valve on AST2.

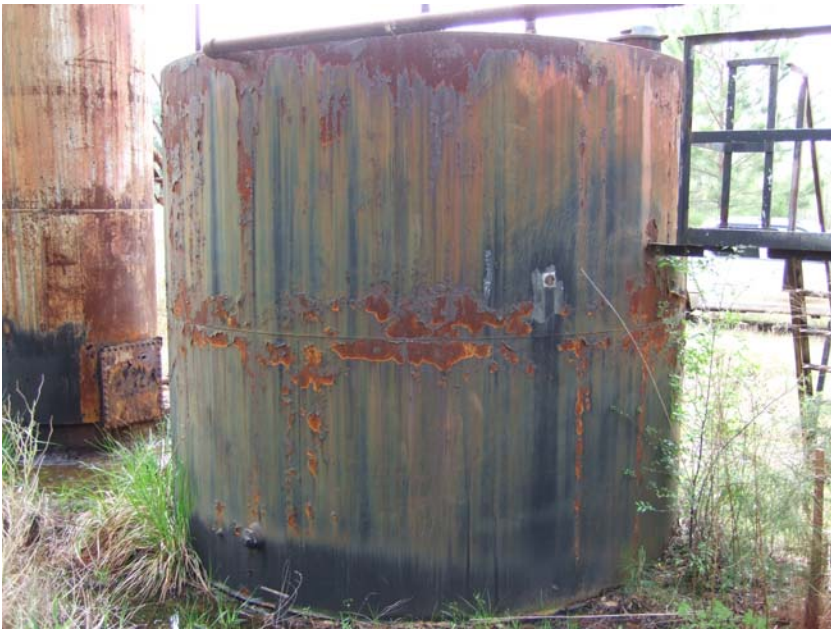
Site Name: Quality Petroleum, Inc.-Hoffman, et al. **Project No.:** E06614
Photo No.: 0210 **Direction:** E **Contract No.:**
Date: 04/05/2008 **Time:** 9:39:00 AM **Photographer/Witness:** Sekerka, Robert/Johnson, Colin
Description: E06614: Rust, corrosion and delaminated metal on AST2.

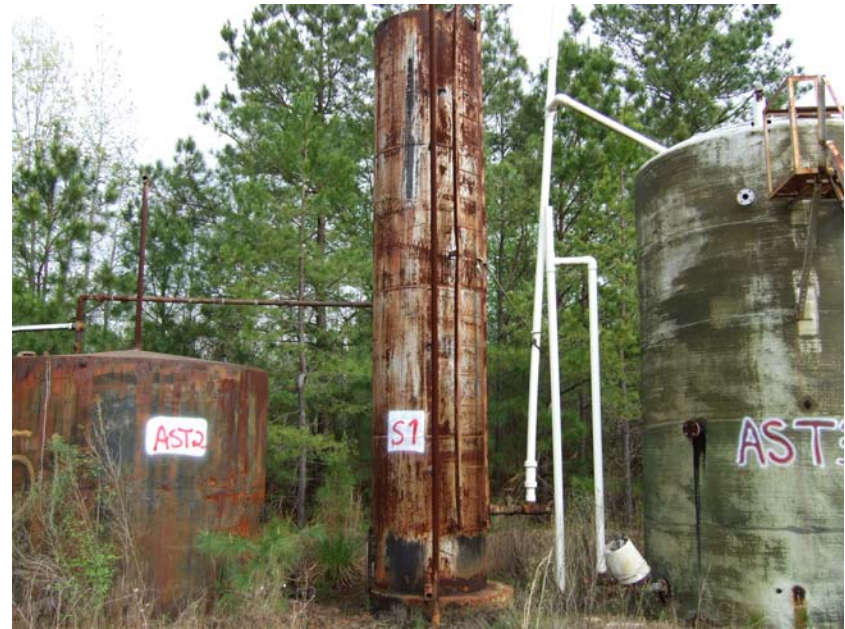
Site Name: Quality Petroleum, Inc.-Hoffman, et al. **Project No.:** E06614
Photo No.: 0211 **Direction:** W **Contract No.:**
Date: 04/05/2008 **Time:** 9:40:00 AM **Photographer/Witness:** Sekerka, Robert/Johnson, Colin
Description: E06614: Rust, corrosion and delaminated metal on S1.

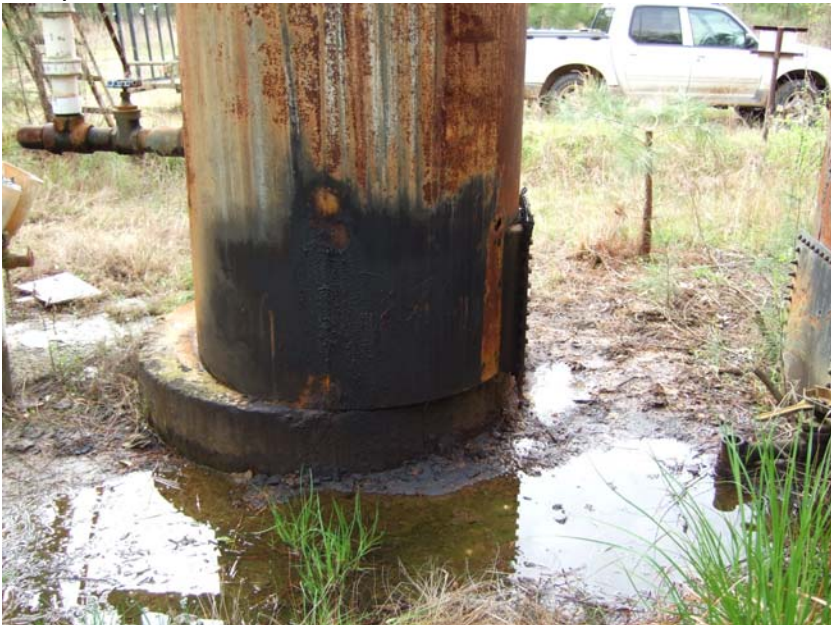
Site Name: Quality Petroleum, Inc.-Hoffman, et al. **Project No.:** E06614
Photo No.: 0213 **Direction:** E **Contract No.:**
Date: 04/05/2008 **Time:** 9:41:00 AM **Photographer/Witness:** Sekerka, Robert/Johnson, Colin
Description: E06614: Rust, corrosion and delaminated metal at base of S1 and evidence of prior oil release.

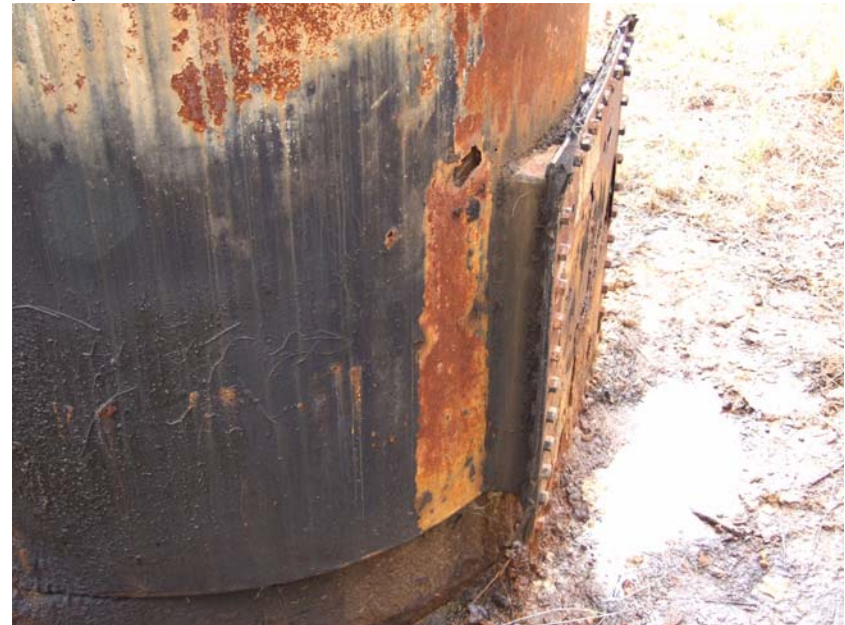
Site Name: Quality Petroleum, Inc.-Hoffman, et al. **Project No.:** E06614
Photo No.: 0214 **Direction:** Down **Contract No.:**
Date: 04/05/2008 **Time:** 9:42:00 AM **Photographer/Witness:** Sekerka, Robert/Johnson, Colin
Description: E06614: Rust, corrosion and delaminated metal on S1.

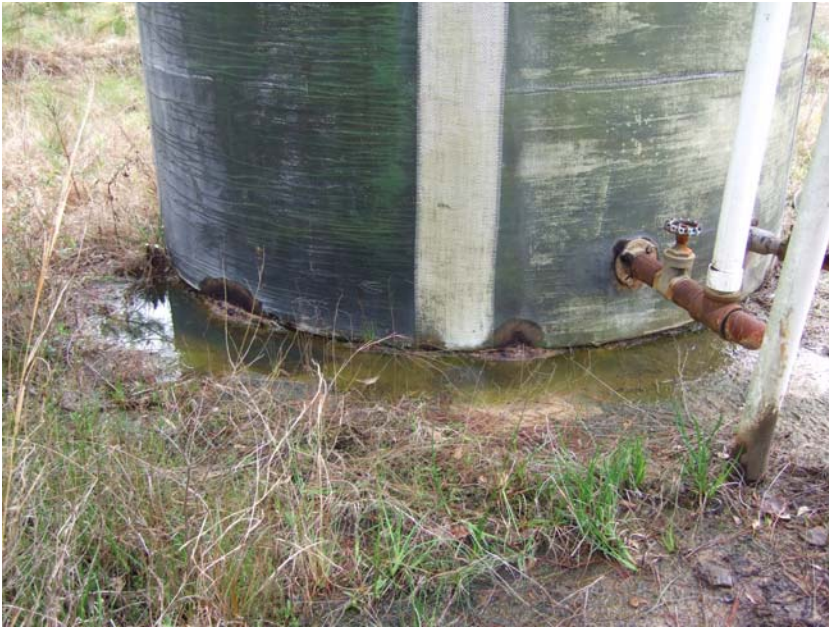
Site Name: Quality Petroleum, Inc.-Hoffman, et al. **Project No.:** E06614
Photo No.: 0216 **Direction:** Down **Contract No.**
Date: 04/05/2008 **Time:** 9:44:00 AM **Photographer/Witness:** Sekerka, Robert/Johnson, Colin
Description: E06614: Oily liquid seeping through the chipped and peeling fiberglass at the base of AST3.

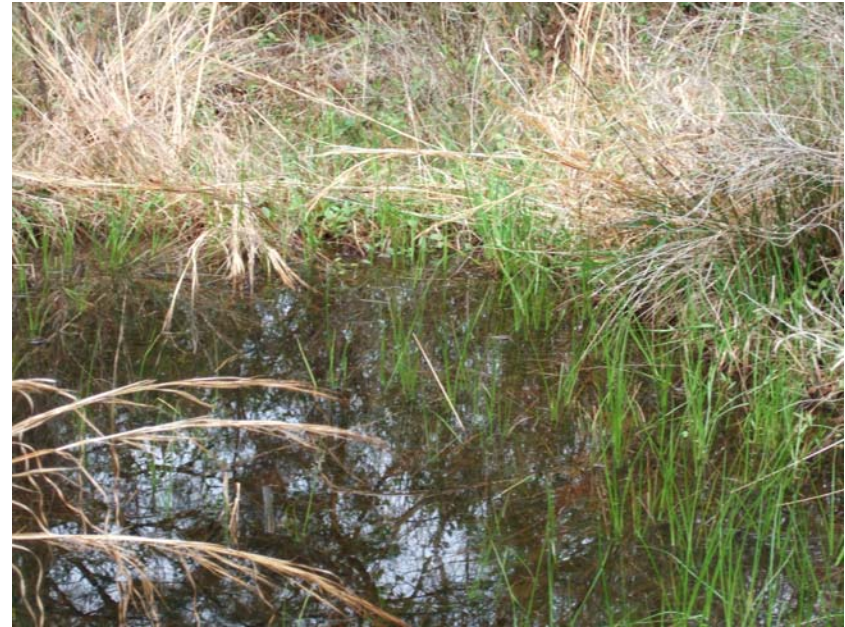
Details: A breach eroded in southern earthen berm of CONT1 significantly reduced the containment capacity and allowed it to drain oily water to adjacent waterways.

Site Name: Quality Petroleum, Inc.-Hoffman, et al. **Project No.:** E06614
Photo No.: 0222 **Direction:** SW **Contract No.**
Date: 04/05/2008 **Time:** 10:13:00 A **Photographer/Witness:** Sekerka, Robert/Johnson, Colin
Description: E06614: Oily sheen on water pooled in southwest end of CONT1 (Note breach through CONT1 in background).

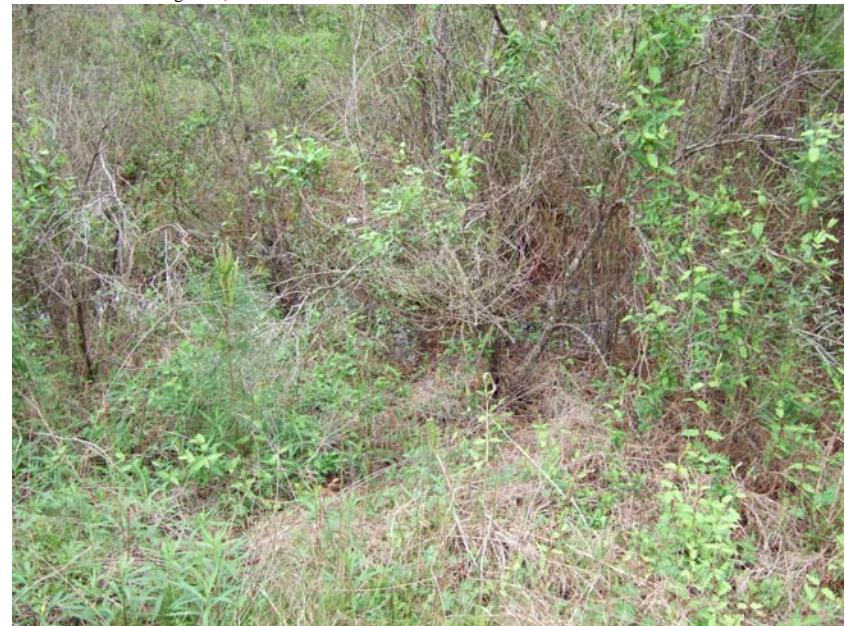
Site Name: Quality Petroleum, Inc.-Hoffman, et al. **Project No.:** E06614
Photo No.: 0226 **Direction:** S **Contract No.**
Date: 04/05/2008 **Time:** 10:16:00 A **Photographer/Witness:** Sekerka, Robert/Johnson, Colin
Description: E06614: Drainage pathway to NHD tributary to Caddo Lake south of access road.
