**Site:** Ohio Cast Products

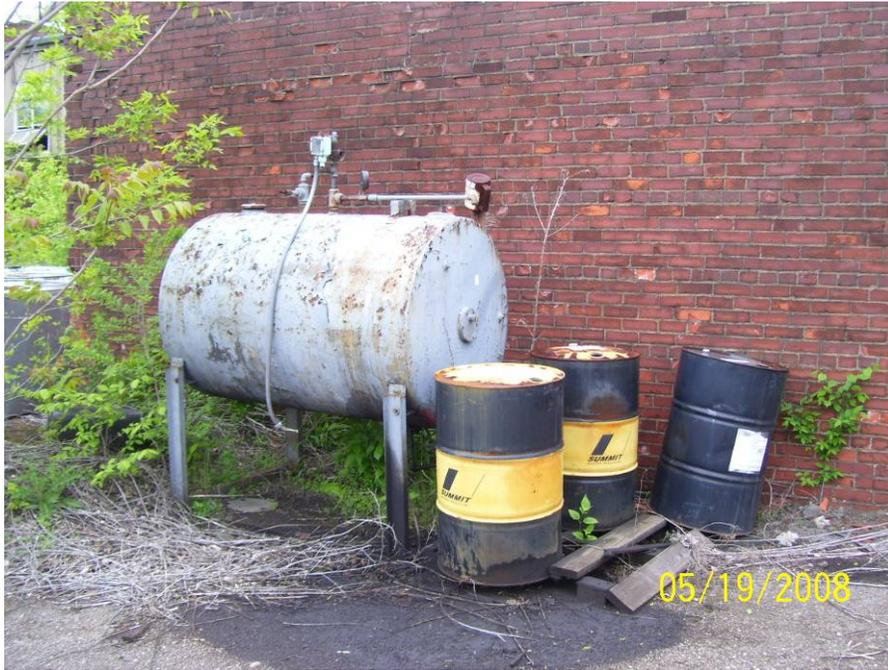
**Photo Number:** 1

**Subject:** Leaking aboveground fuel tank and waste oil drums in Area 8.

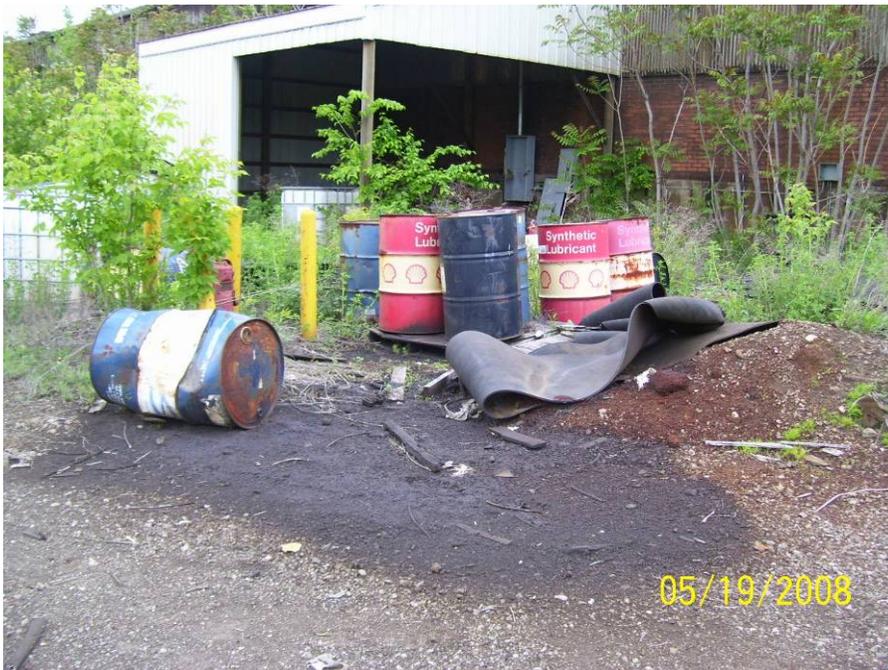
**Photo Number:** 2

**Subject:** Leaking waste oil drums in Area 8.

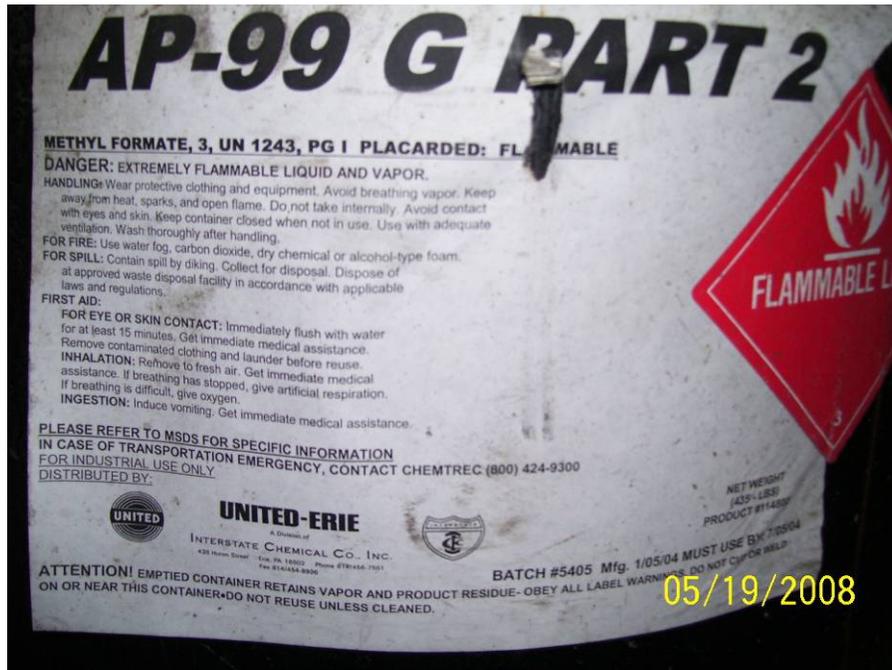
**Photo Number:** 3

**Subject:** Drum labeled methyl formate, flammable liquid in Area 5.

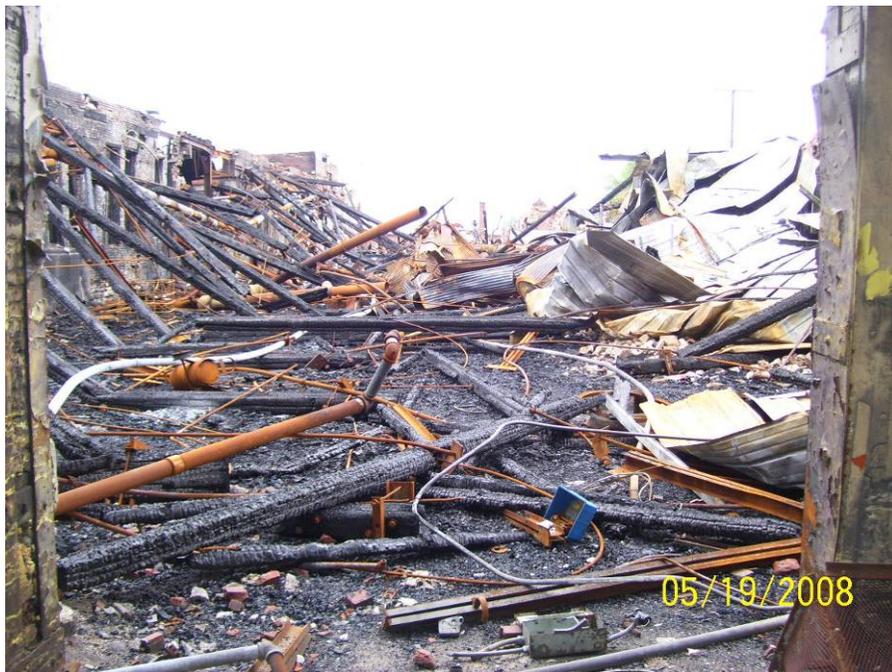
**Photo Number:** 4

**Subject:** Fire-damaged portion of the facility in Area 6.

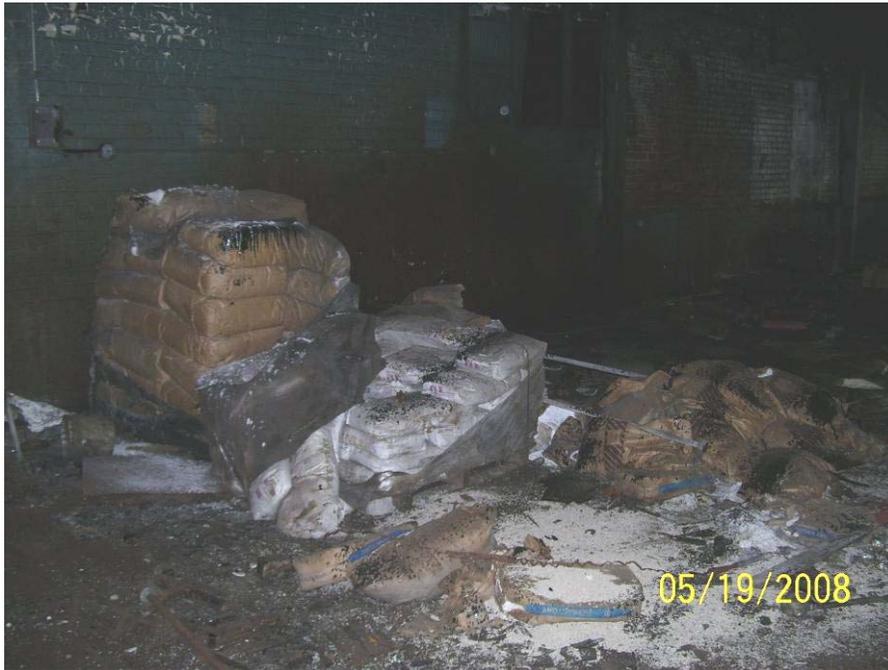
**Photo Number:** 5

**Subject:** Bagged solid material on pallets and spilled onto the floor in Area 5.

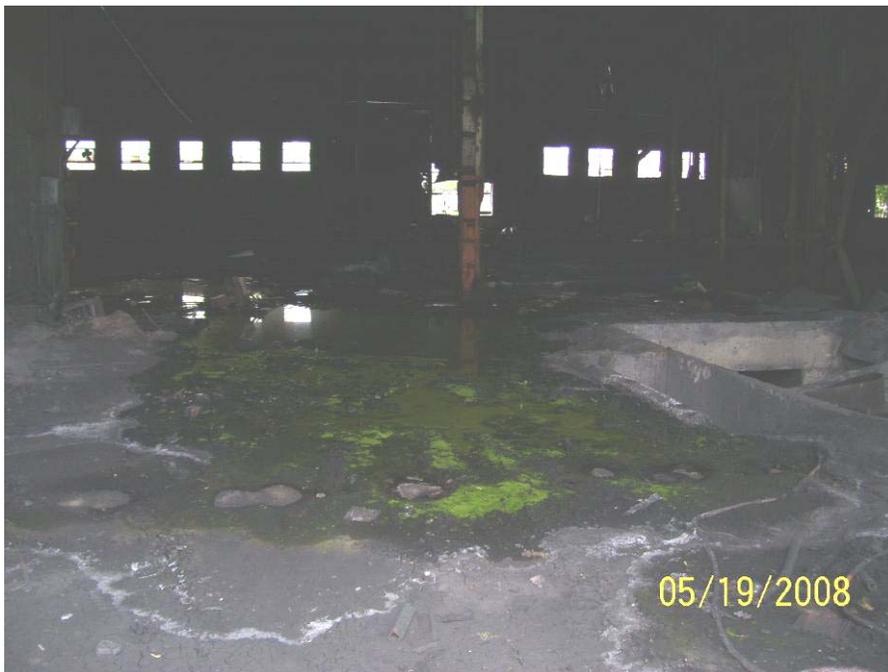
**Photo Number:** 6

**Subject:** Collection area of a soil sample (OCP-SS-052208-03) for VOCs in Area 5.

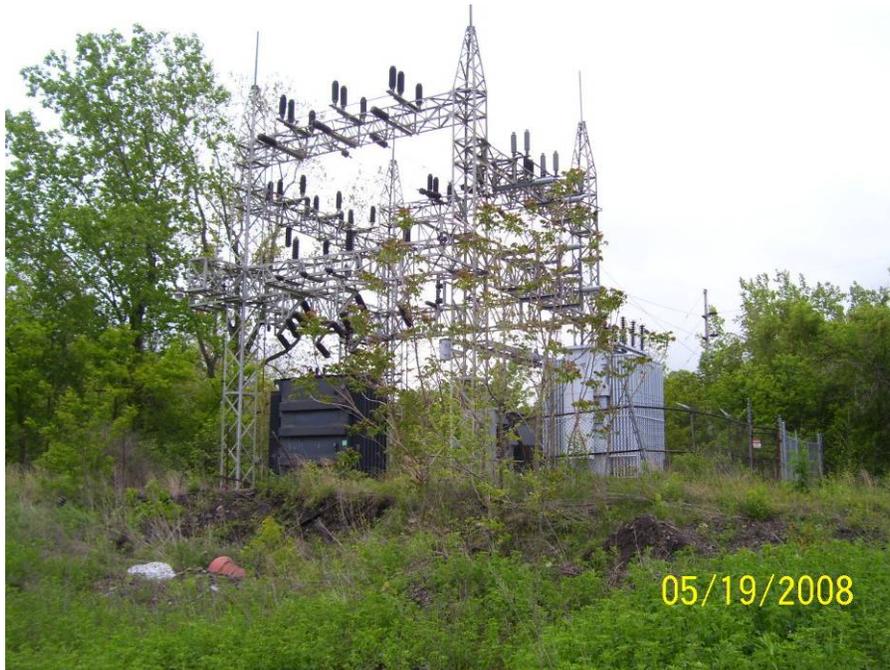
**Photo Number:** 7

**Subject:** Outdoor Electrical substation on the south portion of the Site.

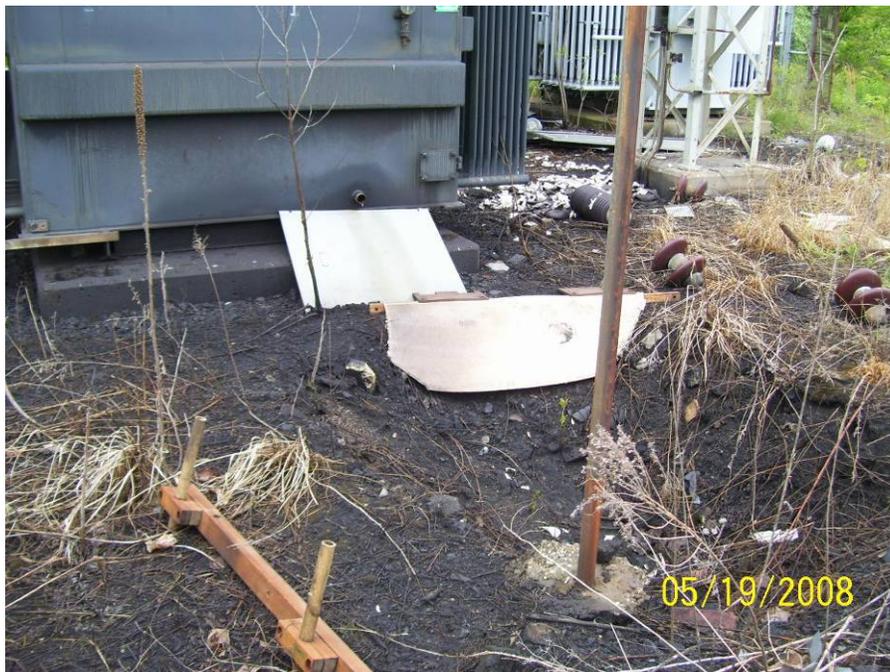
**Photo Number:** 8

**Subject:** Stained soil north of the transformer pad at the outdoor electrical substation (sample OCP-SS-052208-02).

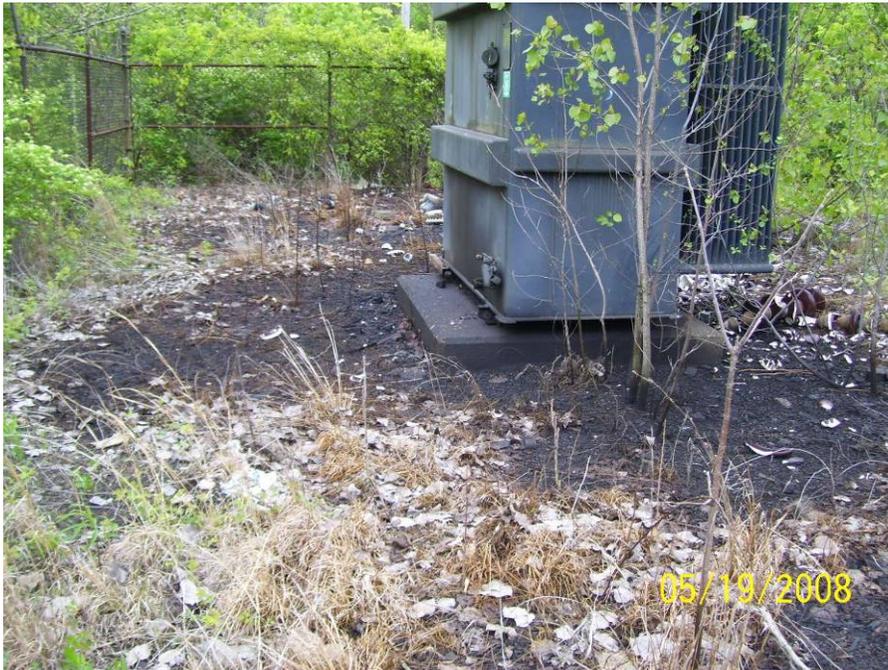
**Photo Number:** 9

**Subject:** Stained soil and distressed vegetation surrounding a transformer pad at the outdoor electrical substation.

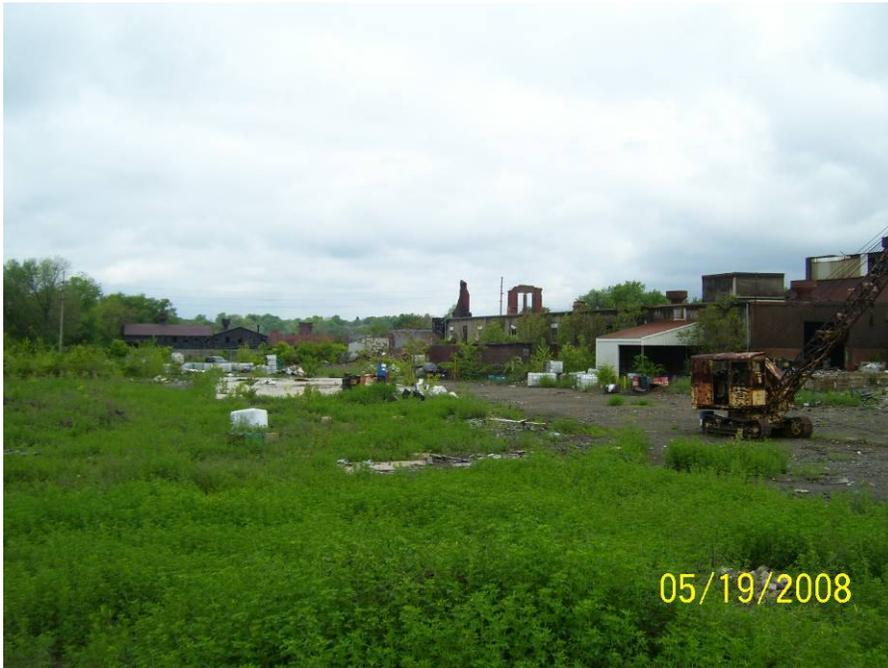
**Photo Number:** 10

**Subject:** South portion of the Site, including Areas 7, 8, and 9.

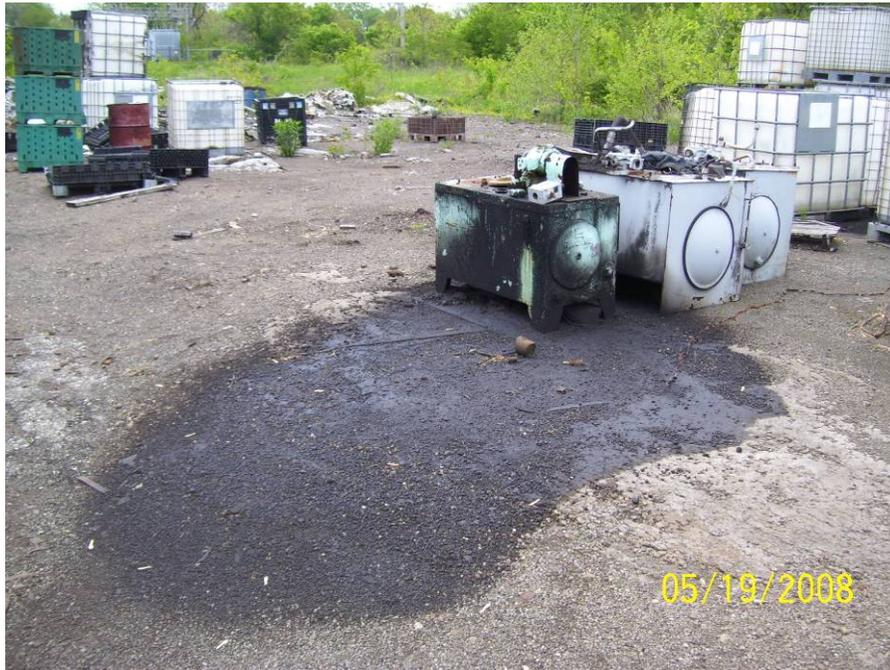
**Photo Number:** 11

**Subject:** Stained soil surrounding three leaking process tanks in Area 7.

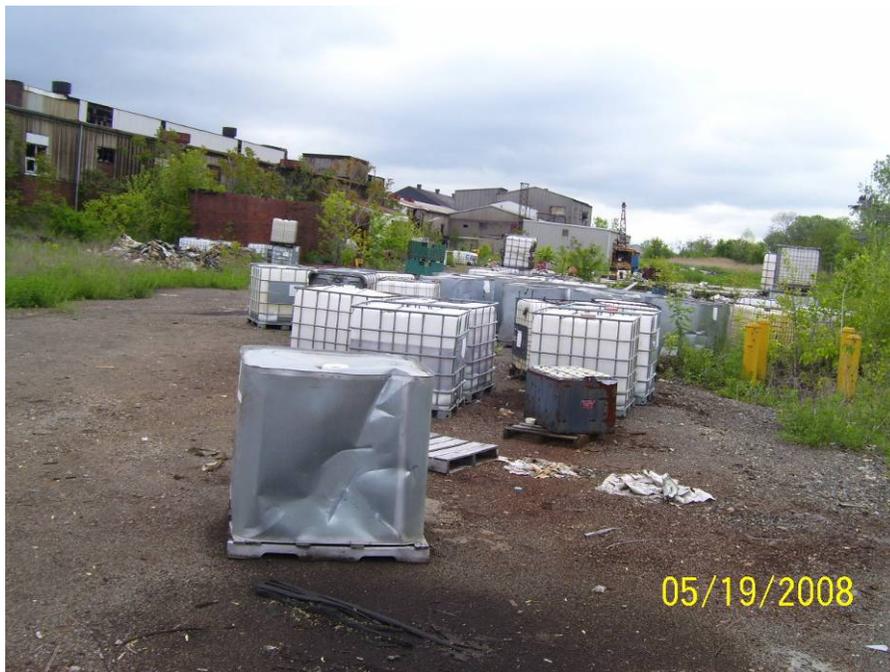
**Photo Number:** 12

**Subject:** Abandoned totes in Area 7.

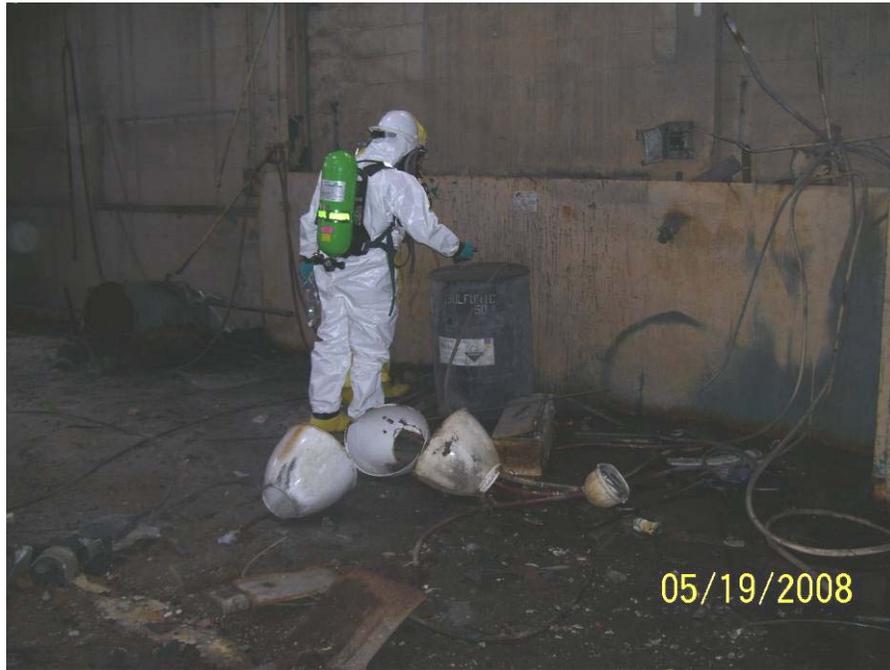
**Photo Number:** 13

**Subject:** Collection of a drum sample for field characterization testing in Area 5.

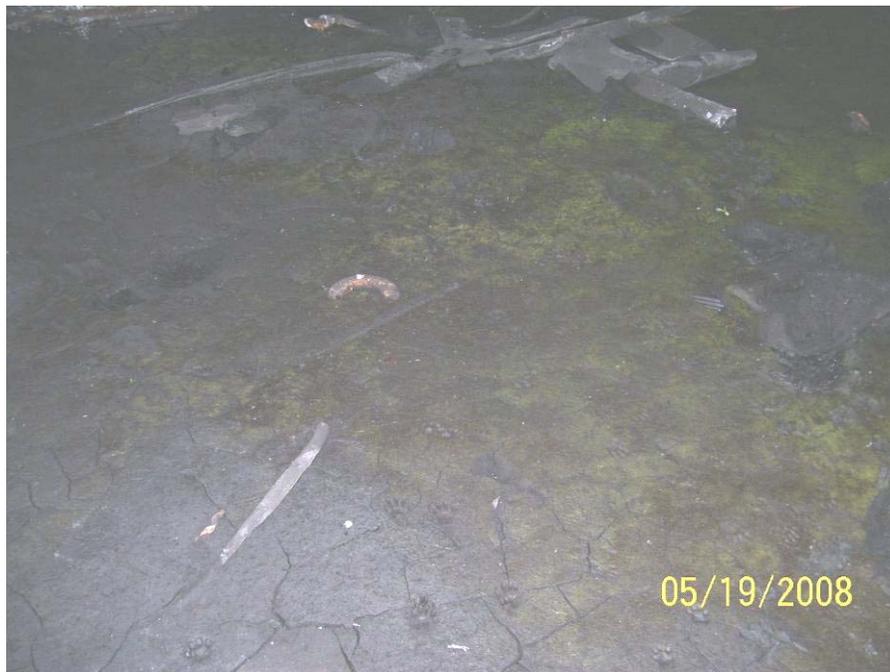
**Photo Number:** 14

**Subject:** Animal tracks inside the facility, located in the southeast corner of Area 5.

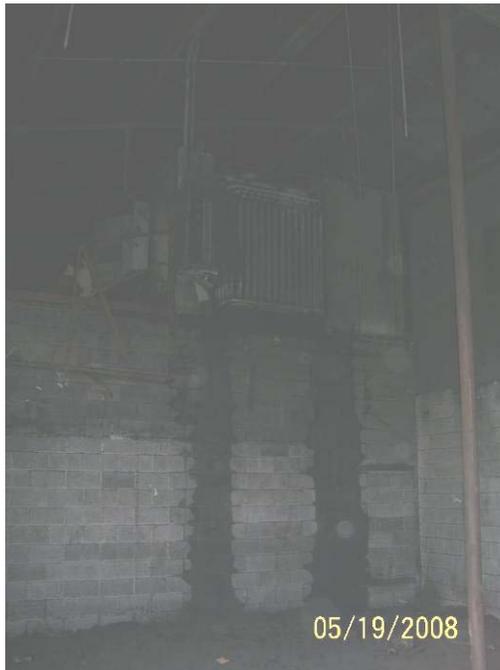
**Photo Number:** 15

**Subject:** Surface staining on the western wall of Area 5 from a leaking transformer.
