December 23, 2008

**Subject: Fracture Trend Analysis Letter Report
 Barite Hills Nevada Goldfields Site
 McCormick, McCormick County, South Carolina
 Contract No. EP-W-05-053
 Technical Direction Document (TDD) No.: TNA-05-003-0049**

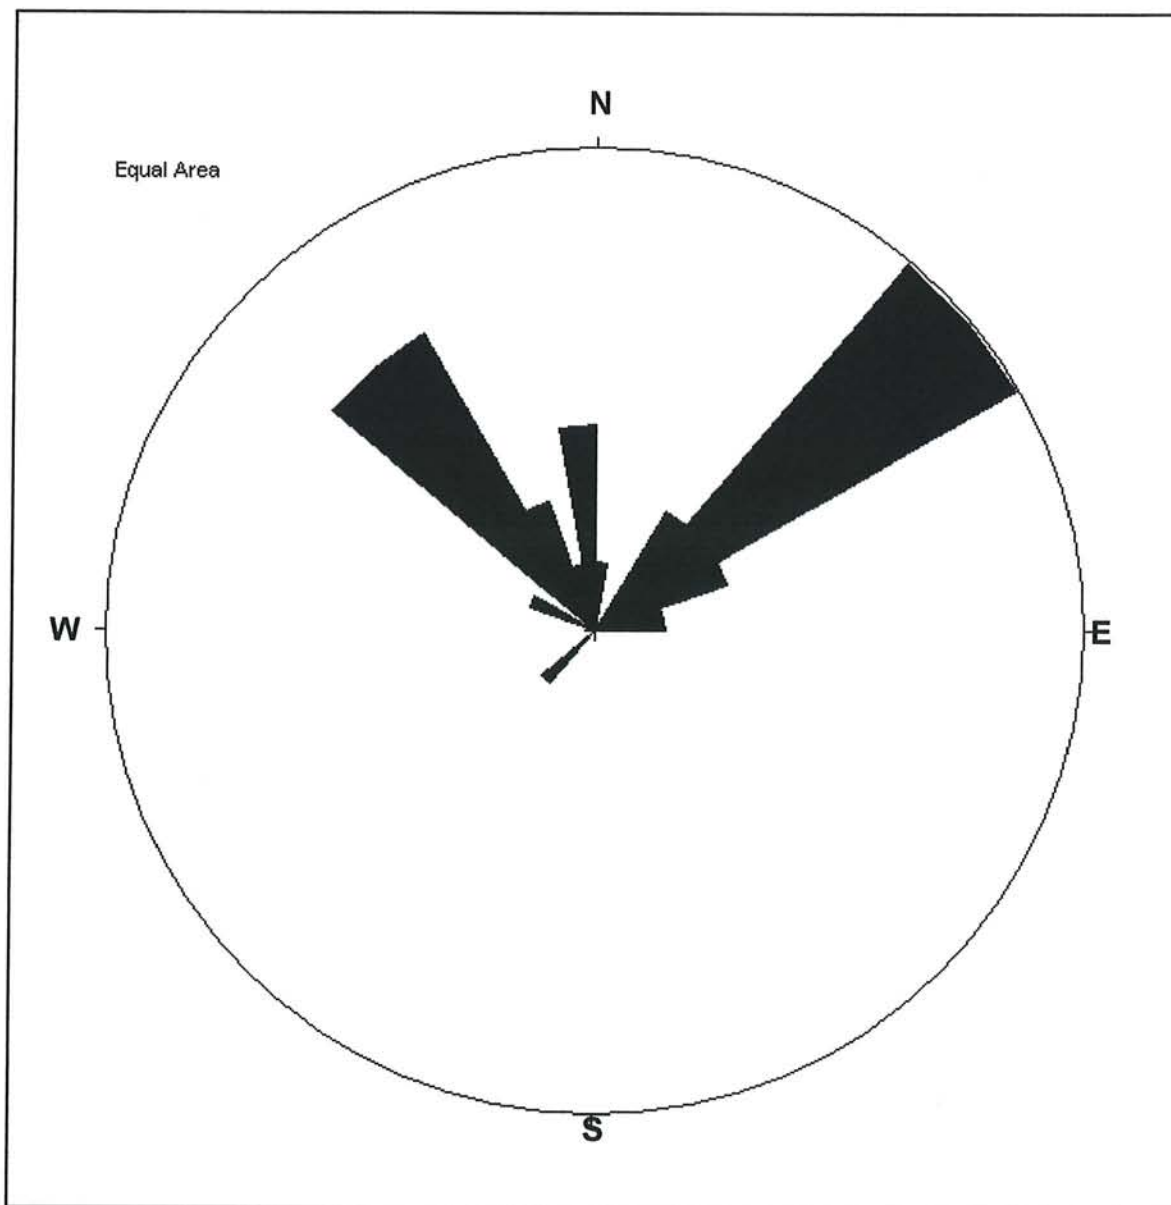
FIGURE 2

Figure 2 is a rose diagram with all fracture orientations. From this diagram, one major fracture set is illustrated. Orientations lie between 40°-60° and 310°-330° azimuth. The angle between the two fracture orientations ranges from 70° to 120°. The mean fracture set of LFV is 45° and 325° with an average angle of 90°. US mean fracture set is 52° and

313° with an average angle of 99°. Zones of weakness following this trend are highlighted in Figure 3.

Rose diagram illustrating fracture orientation trends, n=35.

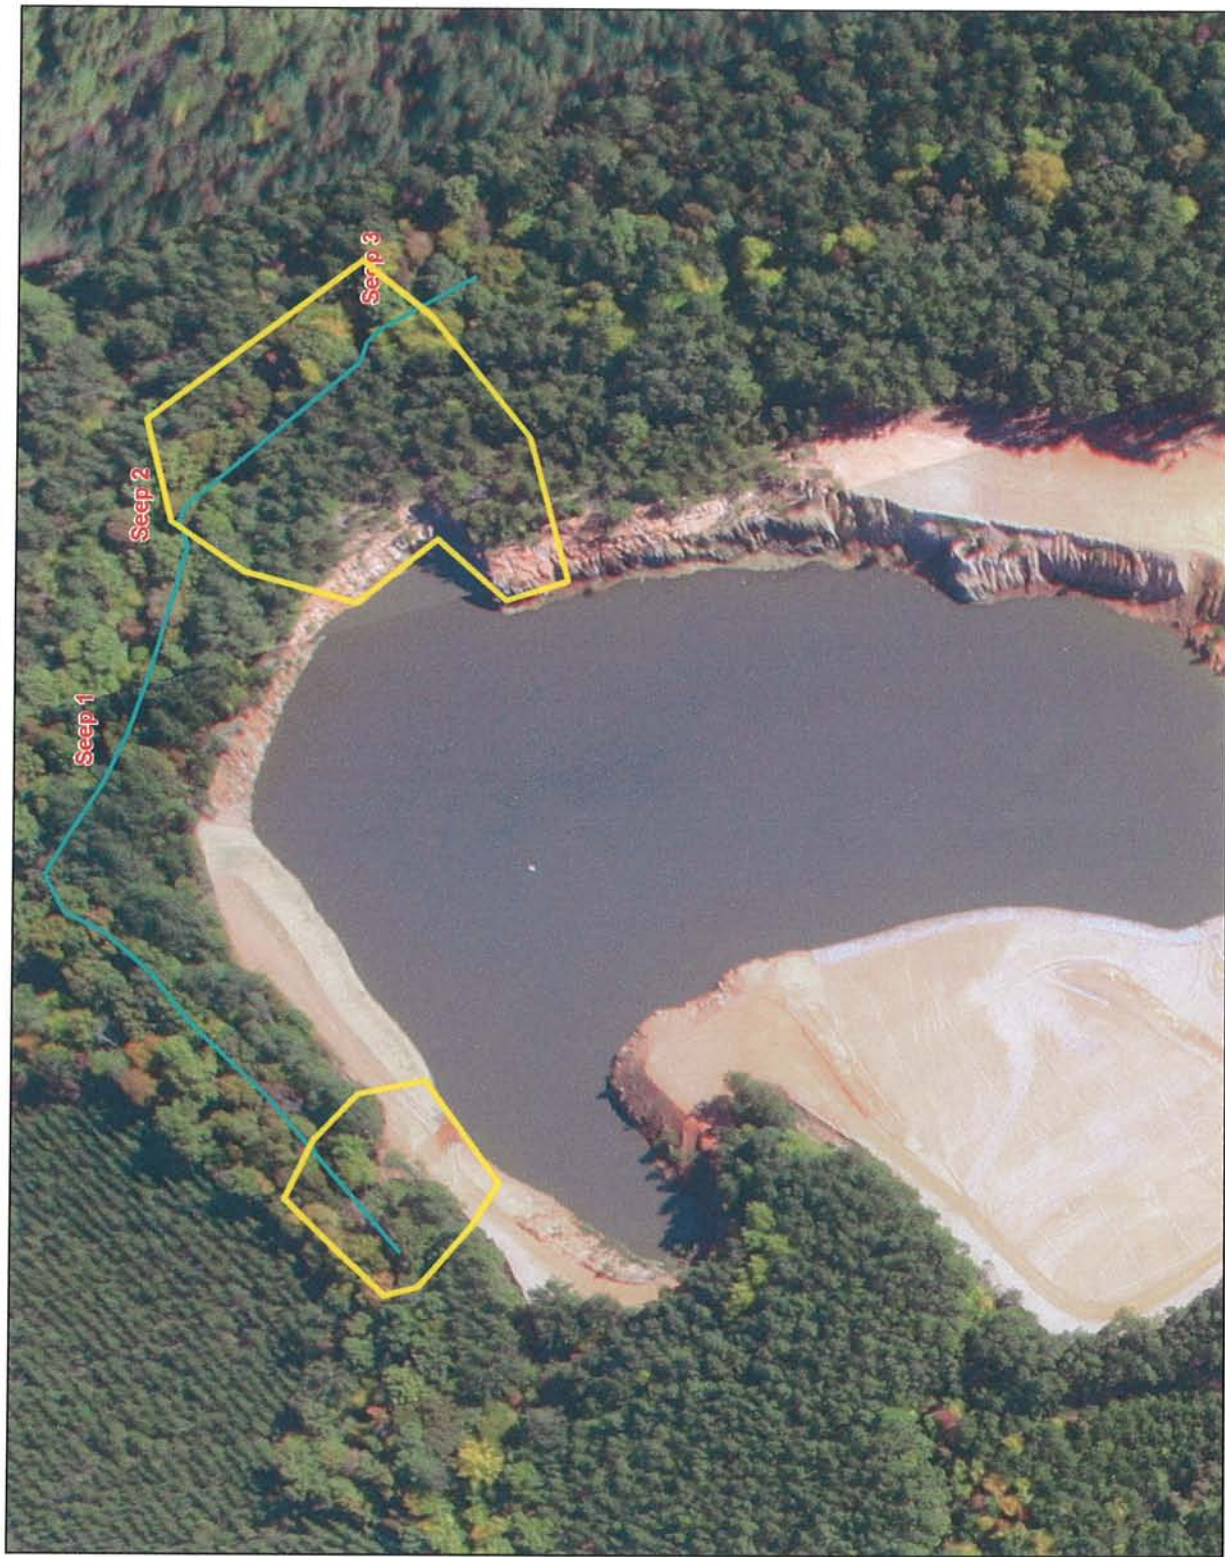
FIGURE 3

ROCK UNIT
FRACTURE ZONES

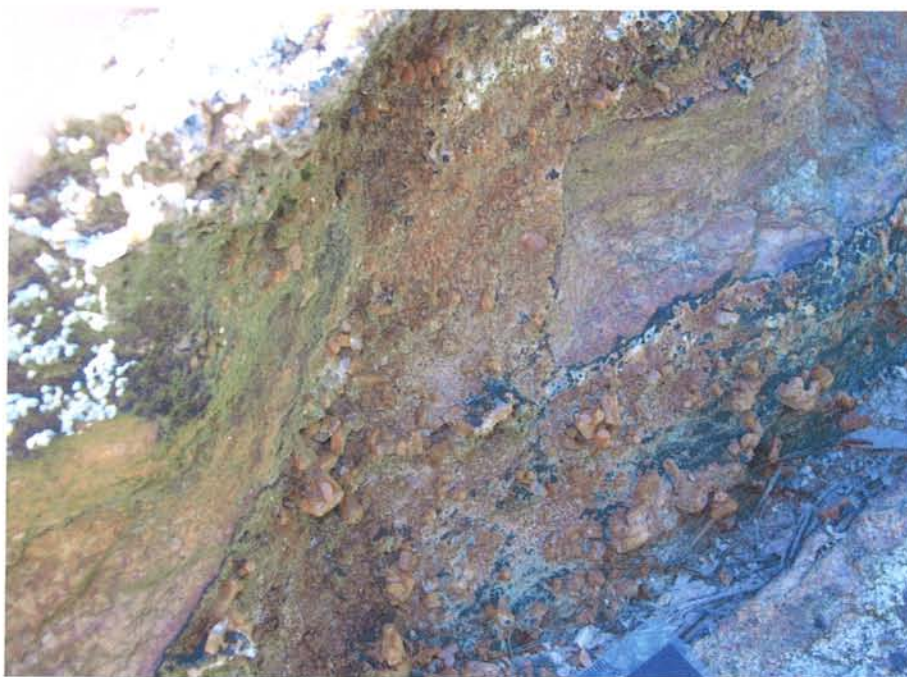
Official Photograph No. 1

Iron oxide mineralization was observed on fracture surfaces near the Main Pit wall. Stormwater run-off near the lake will follow the fractures and contact mineralization before discharging into the pit lake. See Attachment B photographic log.

Site Name:	Barite Hills	Date:	November 19, 2008
Location:	McCormick, McCormick Cnty., S. Car.	TDD No:	TNA-05-003-0049
Photographer:	Dannena Bowman, START		
Subject:	Facing west, east side of Main Pit, iron oxide crystals on fracture surface.

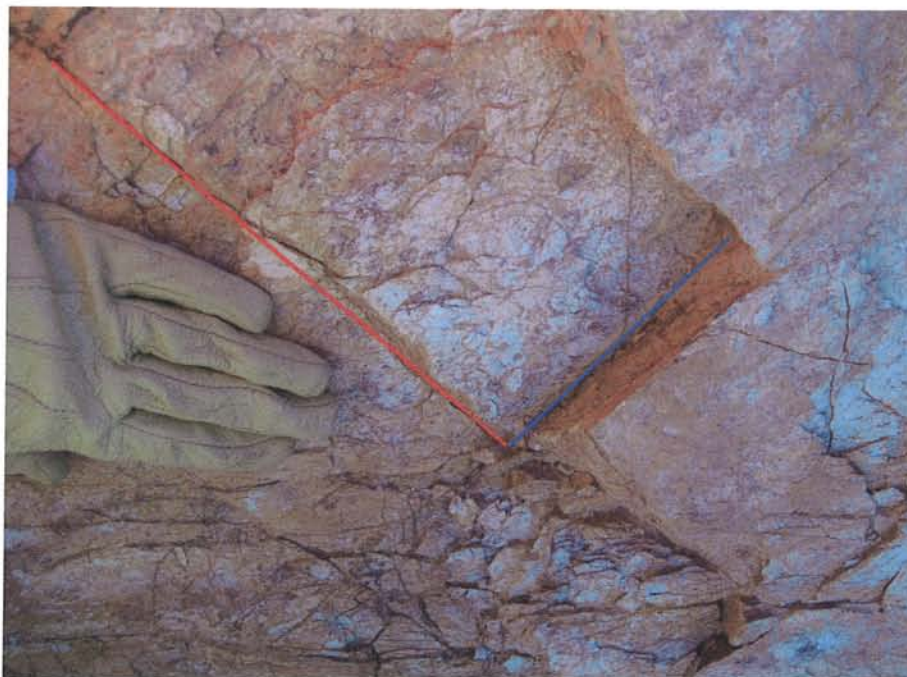
Official Photograph No. 2

Site Name:	Barite Hills	Date:	November 19, 2008
Location:	McCormick, McCormick Cnty., S. Car.	TDD No:	TNA-05-003-0049
Photographer:	Dannena Bowman, START		
Subject:	Facing east, major fractures in rock outcrop alongside lake pit. Red line is approximate trend of fracture. Blue line is approximate trend of secondary fracture.

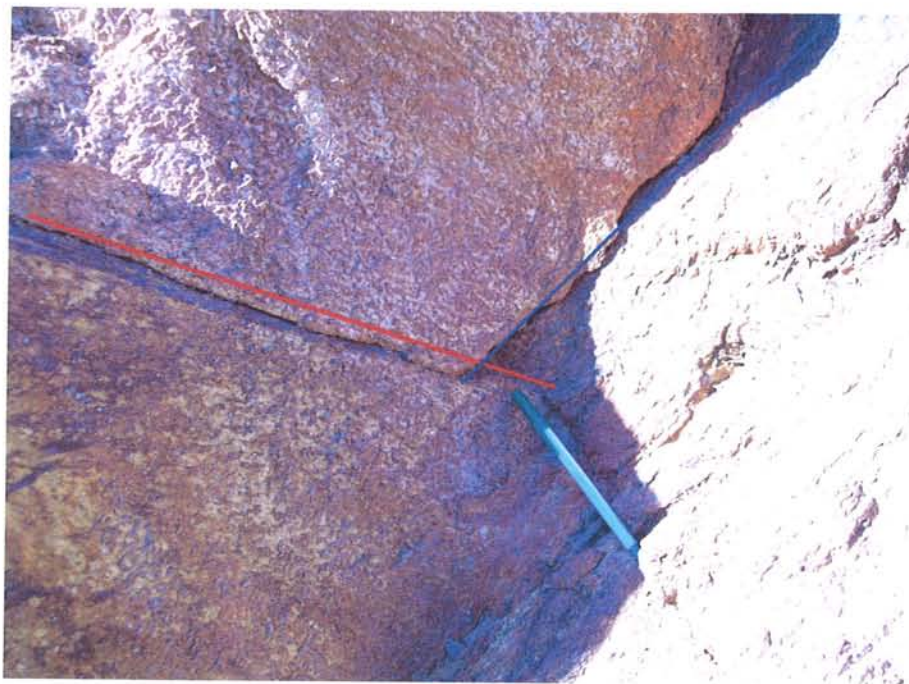
Official Photograph No. 3

Site Name: Barite Hills **Date:** November 19, 2008
Location: McCormick, McCormick Cnty., S. Car. **TDD No:** TNA-05-003-0049
Photographer: Dannena Bowman, START
Subject: Facing northwest, fracture surfaces along west wall of Main Pit. Red line is approximate trend of fracture. Blue line is approximate trend of secondary fracture.

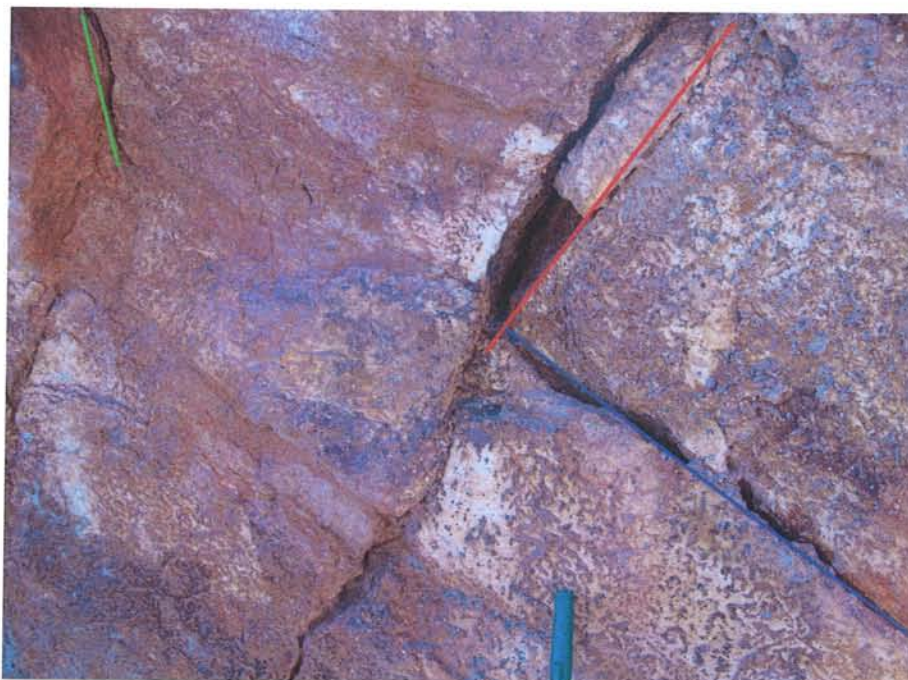
Official Photograph No. 4

Other smaller subparallel fractures are observable in the rock units. These fractures were not measured because they were irregular and erratic, not consistent with on-site trends or regional trends. Surfaces of these fractures are curved unlike the planar fracture sets observed in the competent units. These irregular fractures were only observed around the pit and not in the creek. The fractures are most likely associated with blasting during mining and not naturally occurring.

Site Name: Barite Hills **Date:** November 19, 2008
Location: McCormick, McCormick Cnty., S. Car. **TDD No:** TNA-05-003-0049
Photographer: Dannena Bowman, START
Subject: Facing northwest, fracture surfaces along west wall of Main Pit. Red and blue lines same as previous photo, green line is irregular blast fracture.

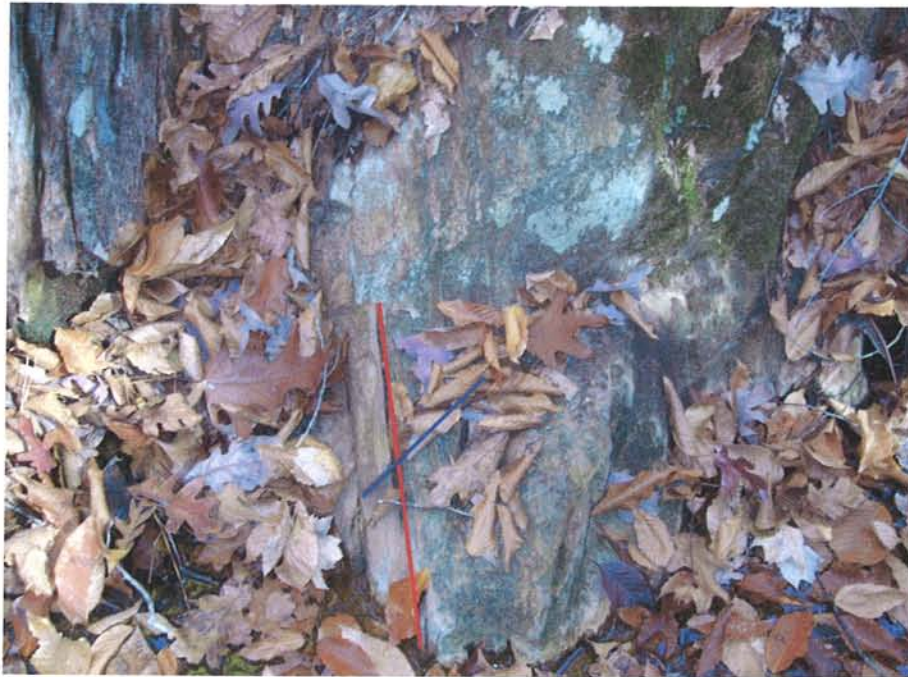
Official Photograph No. 5

Site Name: Barite Hills **Date:** November 21, 2008
Location: McCormick, McCormick Cnty., S. Car. **TDD No:** TNA-05-003-0049
Photographer: Dannena Bowman, START
Subject: Facing northeast, major fractures in rock outcrop alongside creek near Seep 2. Red line is approximate trend of fracture. Blue line is approximate trend of secondary fracture.

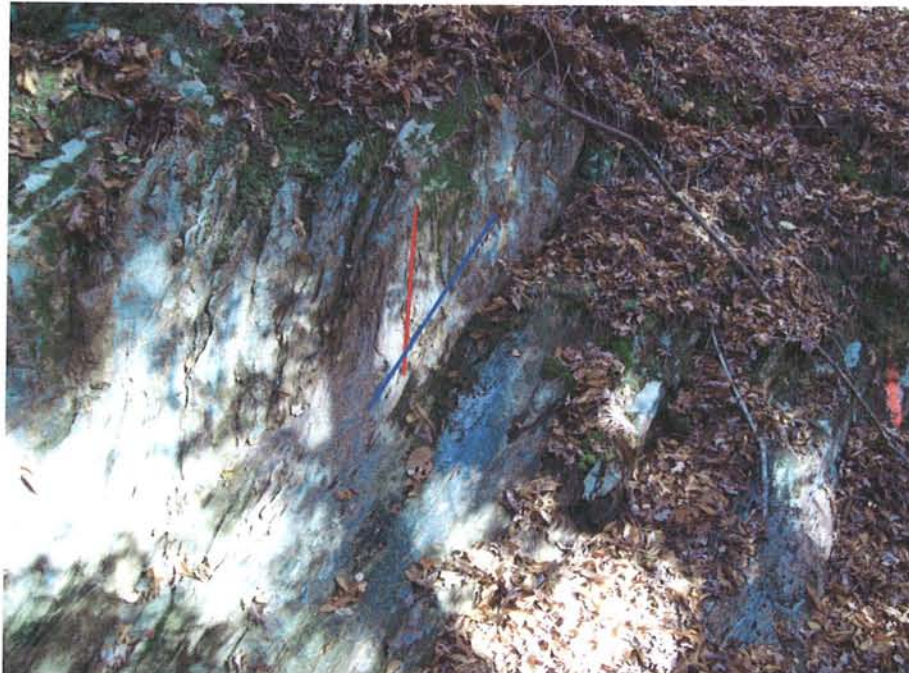
Official Photograph No. 6

Site Name: Barite Hills **Date:** November 19, 2008
Location: McCormick, McCormick Cnty., S. Car. **TDD No:** TNA-05-003-0049
Photographer: Dannena Bowman, START
Subject: Facing east, major fractures in rock outcrop alongside creek near Seep 2. Red line is approximate trend of fracture. Blue line is approximate trend of secondary fracture.
