February 10, 2009

**Subject: Final Removal Letter Report
ESB (Exide) Fund Lead
EPA Contract No. EP-W-05-054 (START III, Region 4)
Technical Direction Document No. TTEMI-05-001-0002**

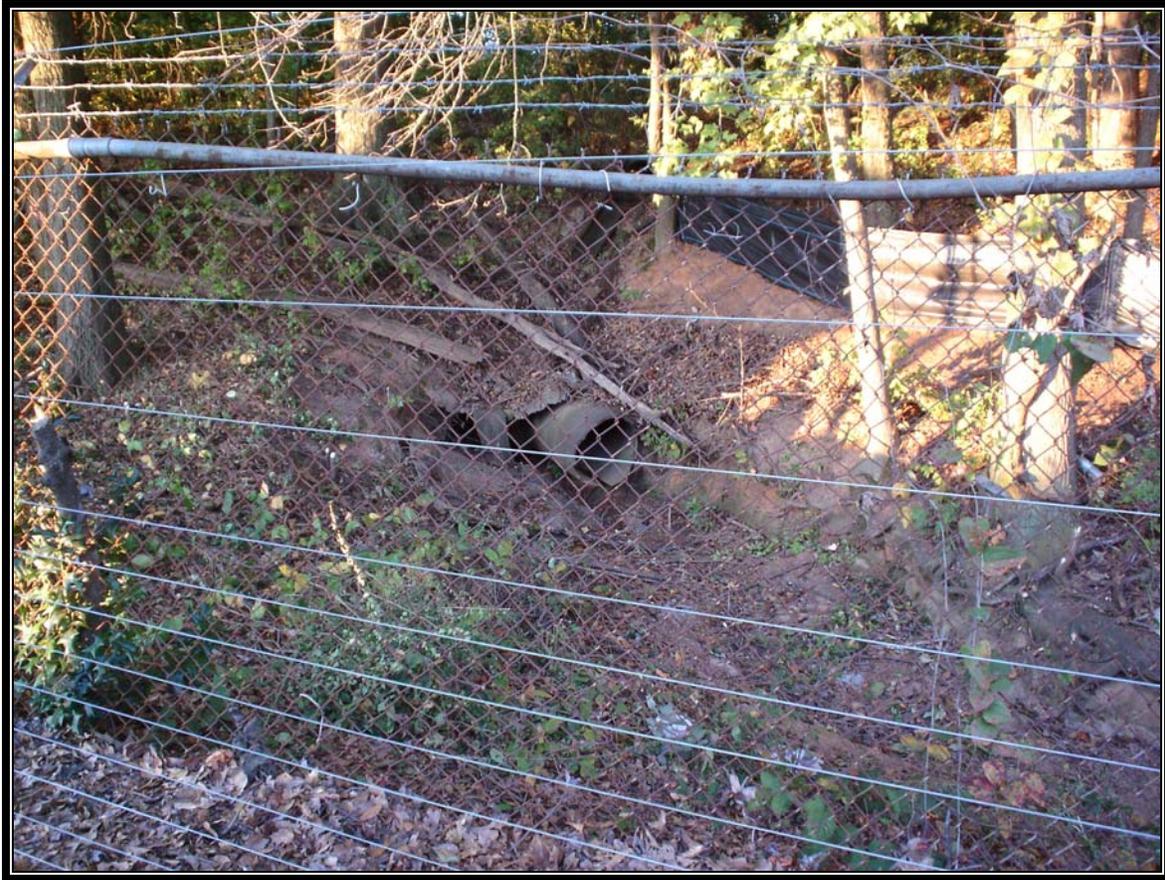
**OFFICIAL PHOTOGRAPH NO. 1
U.S. ENVIRONMENTAL PROTECTION AGENCY**

TDD Number: TTEMI-05-001-0002 **Location:** ESB (Exide) Fund Lead
Orientation: Southwest **Date:** September 25, 2008
Photographer: Scott Covode, Tetra Tech **Witness:** Scott Covode, Tetra Tech
Subject: Outfall from former ESB facility into ditch located on west side of Great Dane Trucking property.

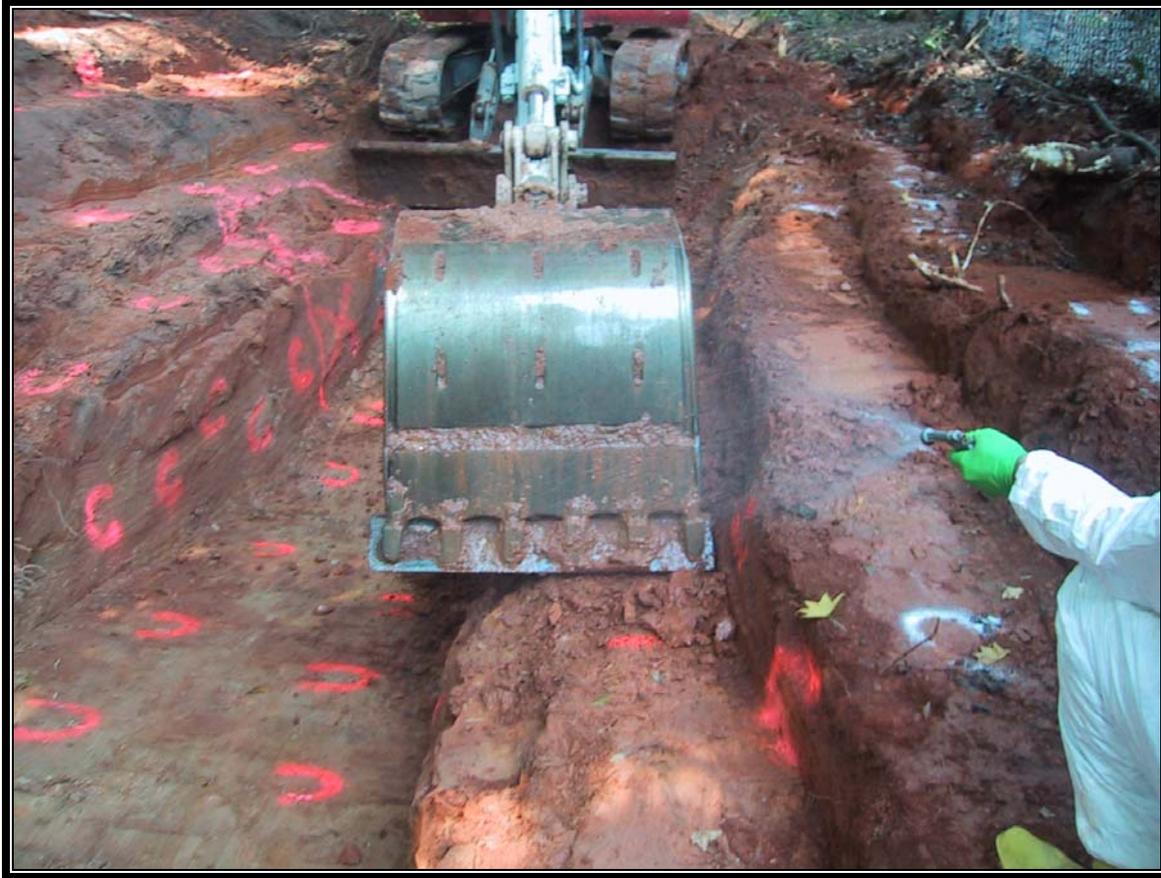
**OFFICIAL PHOTOGRAPH NO. 2
U.S. ENVIRONMENTAL PROTECTION AGENCY**

Subject: Environmental Restoration (ER), LLC, wetting ditch area during excavation. Tetra Tech START performed in-situ soil screening using x-ray fluorescence (XRF). Areas less than the removal action level (RAL) for lead were marked with "C" for no additional excavation required, and areas greater than the RAL "X" for additional excavation required.

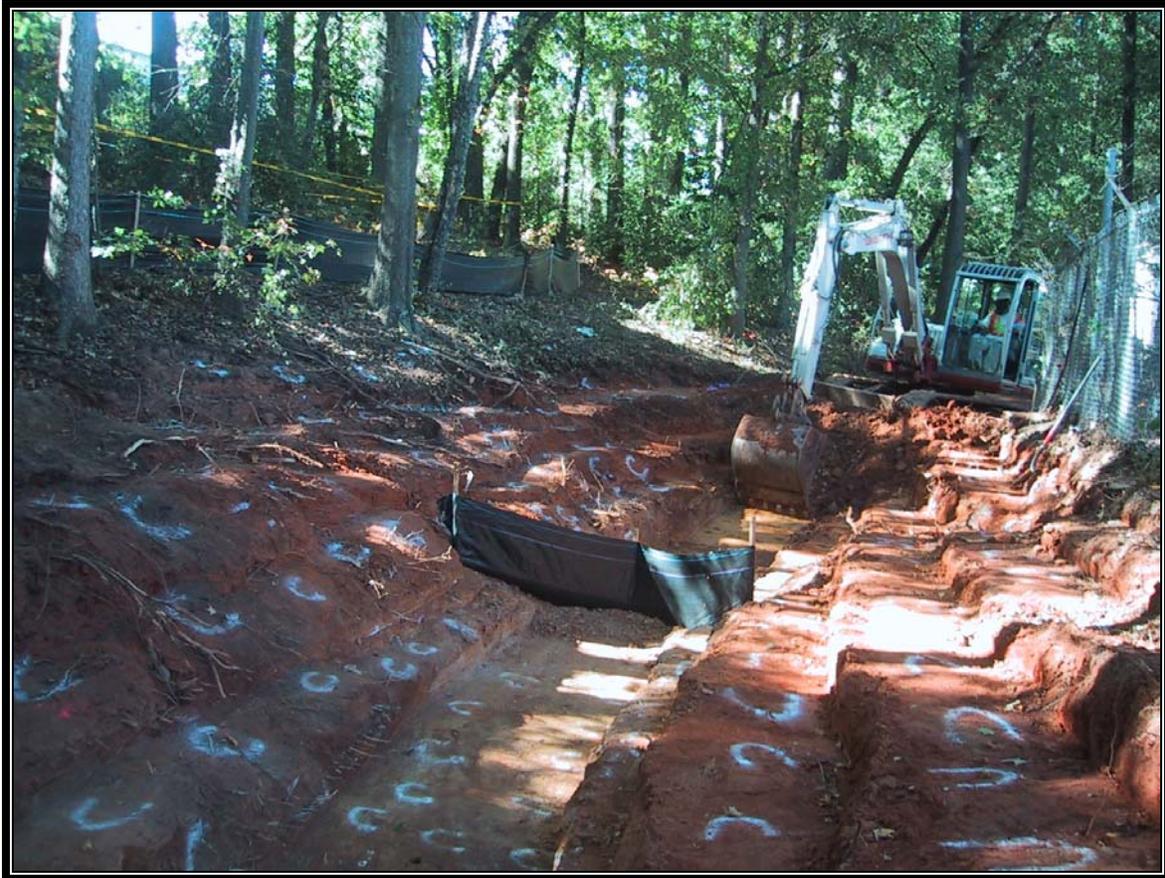
**OFFICIAL PHOTOGRAPH NO. 3
U.S. ENVIRONMENTAL PROTECTION AGENCY**

Subject: ER excavating ditch area on west side of Great Dane Trucking property. Tetra Tech START performed in-situ soil screening using XRF. Areas less than the RAL for lead were marked with "C" for no additional excavation required.

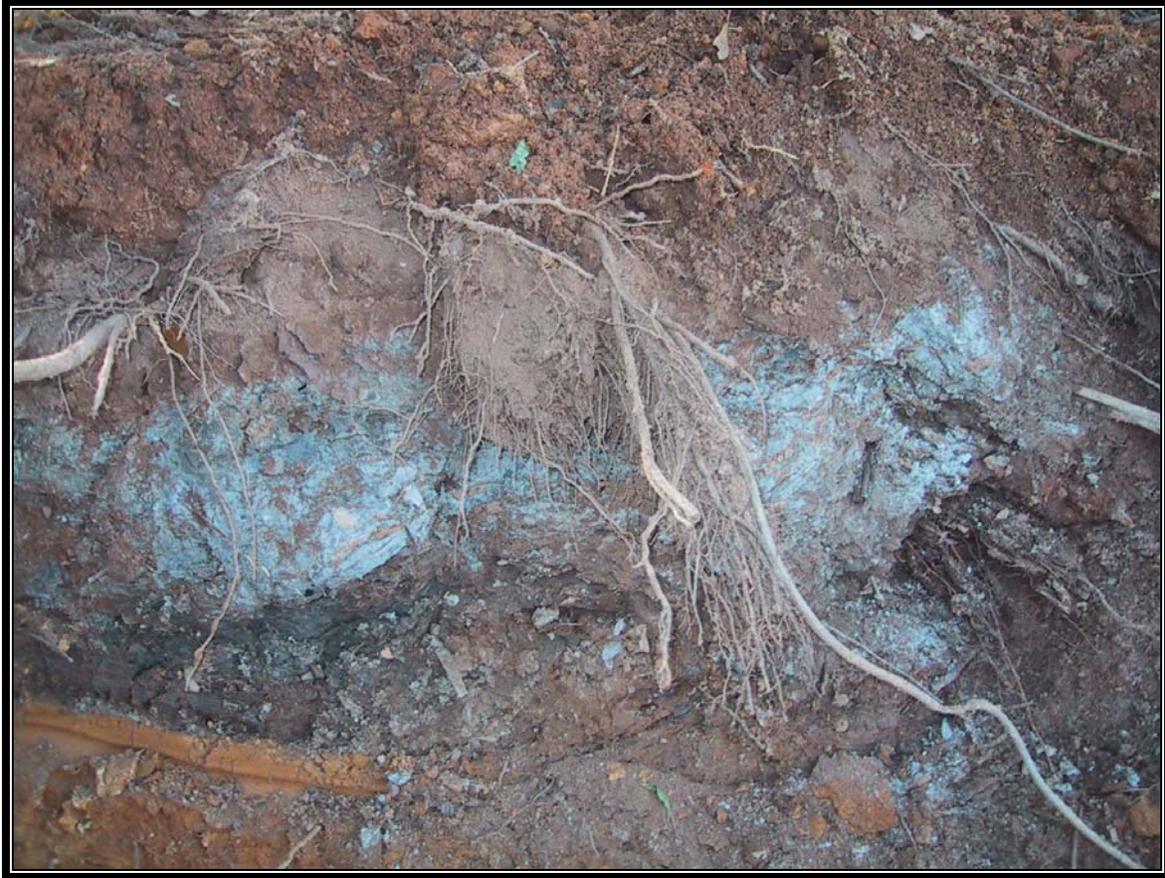
OFFICIAL PHOTOGRAPH NO. 4
U.S. ENVIRONMENTAL PROTECTION AGENCY

Subject: Close-up of gray clay along the sidewall of the ditch. Assuming the gray clay was the source of contamination, ER removed the soil until the clay was no longer visible and XRF screening resulted in lead levels below the site-specific RAL.

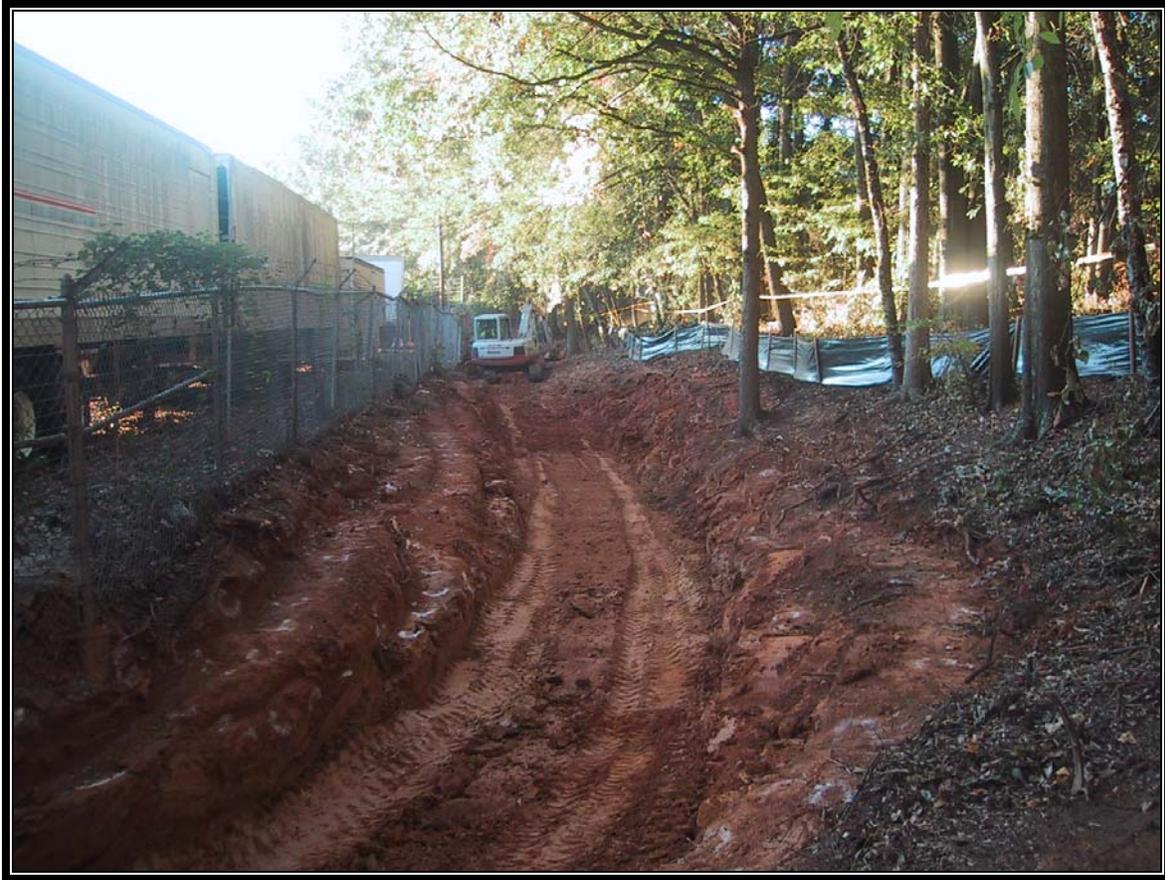
OFFICIAL PHOTOGRAPH NO. 5
U.S. ENVIRONMENTAL PROTECTION AGENCY

Subject: ER backfilling ditch area on west side of Great Dane Trucking property near the outfall.

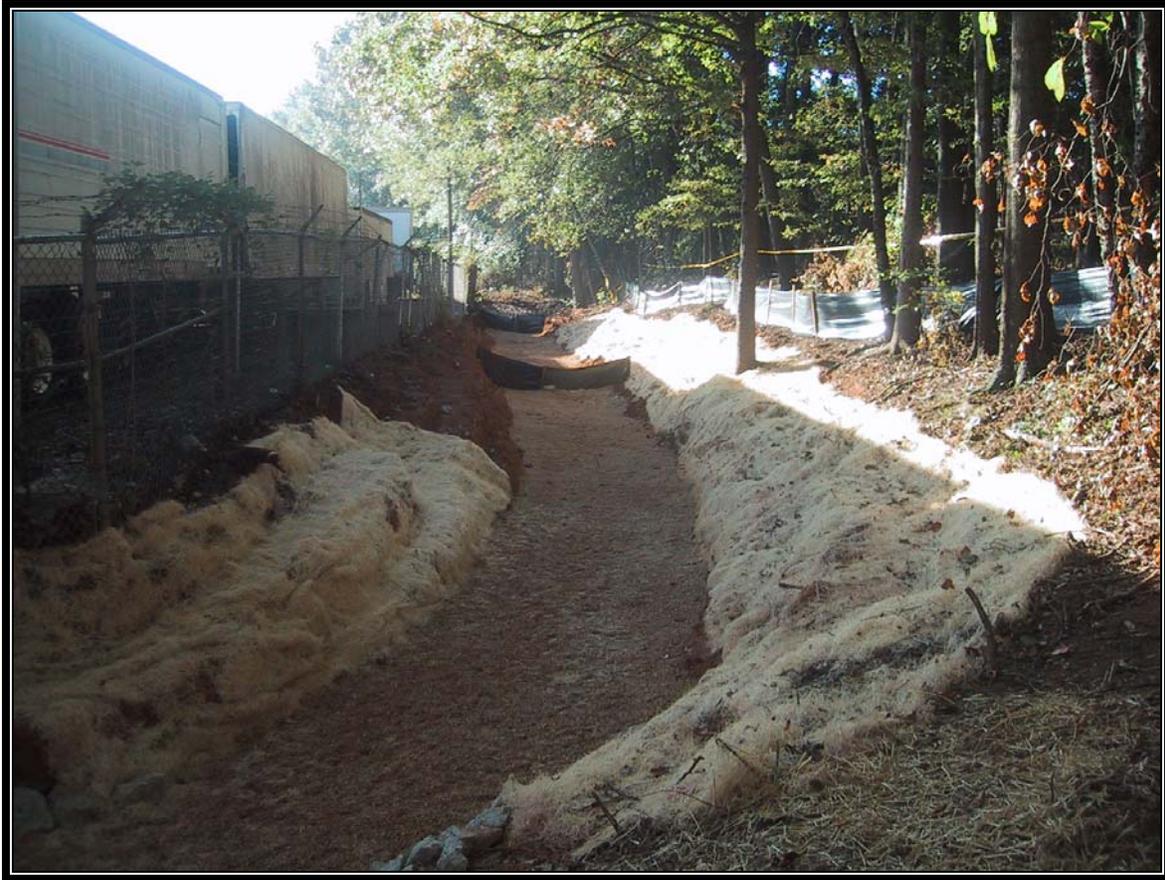
OFFICIAL PHOTOGRAPH NO. 6
U.S. ENVIRONMENTAL PROTECTION AGENCY

Subject: Ditch area on west side of Great Dane Trucking property. Restoration consisted of filling the ditch with rip rap and pea gravel, placing coconut netting on the banks to inhibit erosion, and seeding the area with a rye-fescue grass blend.

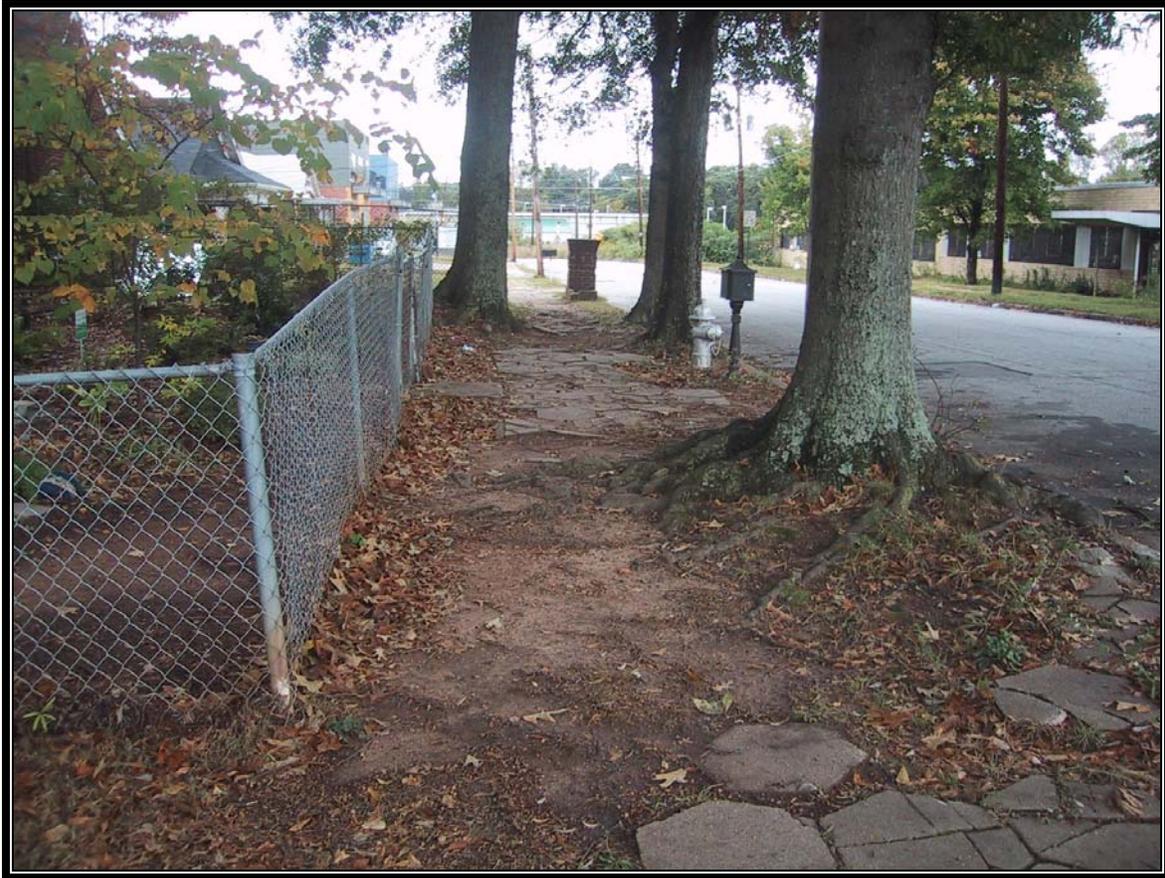
OFFICIAL PHOTOGRAPH NO. 7
U.S. ENVIRONMENTAL PROTECTION AGENCY

TDD Number: TTEMI-05-001-0002 **Location:** ESB (Exide) Fund Lead
Orientation: North **Date:** October 9, 2008
Photographer: Paul Prys, Tetra Tech **Witness:** Paul Prys, Tetra Tech
Subject: Front walkway of 1263 Allene Avenue prior to excavation.

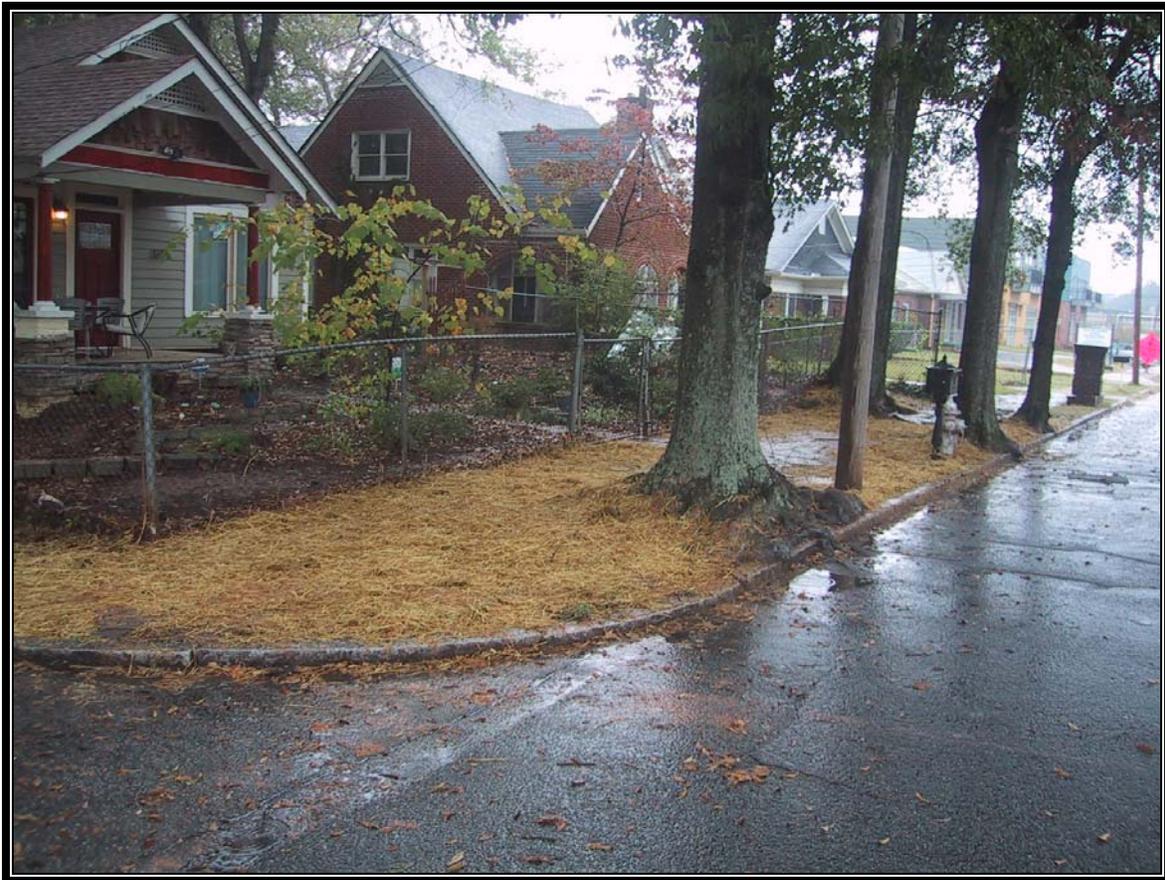
**OFFICIAL PHOTOGRAPH NO. 8
U.S. ENVIRONMENTAL PROTECTION AGENCY**

Subject: Front walkway of 1263 Allene Avenue after restoration activities. Restoration consisted of backfilling the excavated areas with topsoil, seeding the area with a ryefescue grass blend, and covering the area with straw.

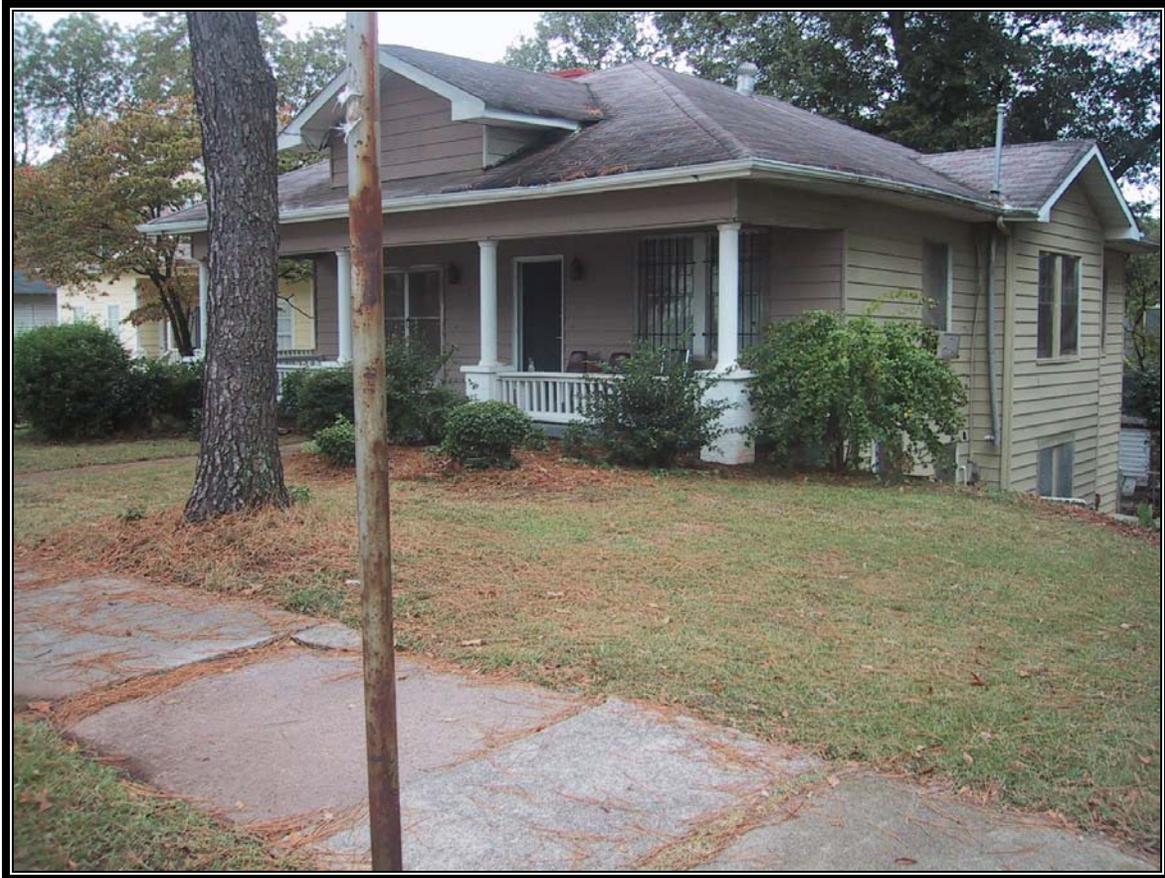
**OFFICIAL PHOTOGRAPH NO. 9
U.S. ENVIRONMENTAL PROTECTION AGENCY**

Subject: Front yard of 1273 Allene Avenue prior to excavation.

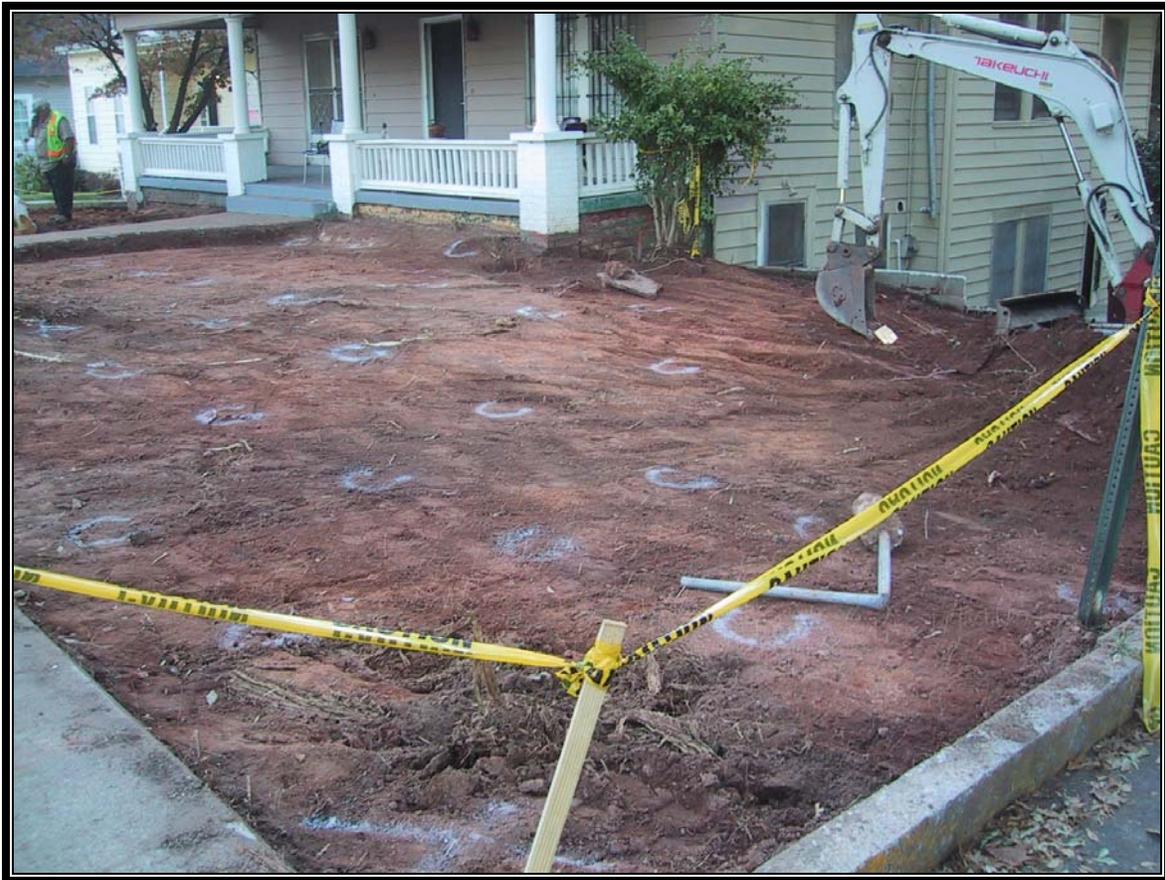
OFFICIAL PHOTOGRAPH NO. 10
U.S. ENVIRONMENTAL PROTECTION AGENCY

Subject: Front yard of 1273 Allene Ave; ER performed excavation using track hoe with a straight-edged bucket. Tetra Tech START conducted XRF in-situ soil screening. Areas less than the RAL for lead were marked with "C" for no additional excavation required, and areas greater than the RAL "X" for additional excavation required.

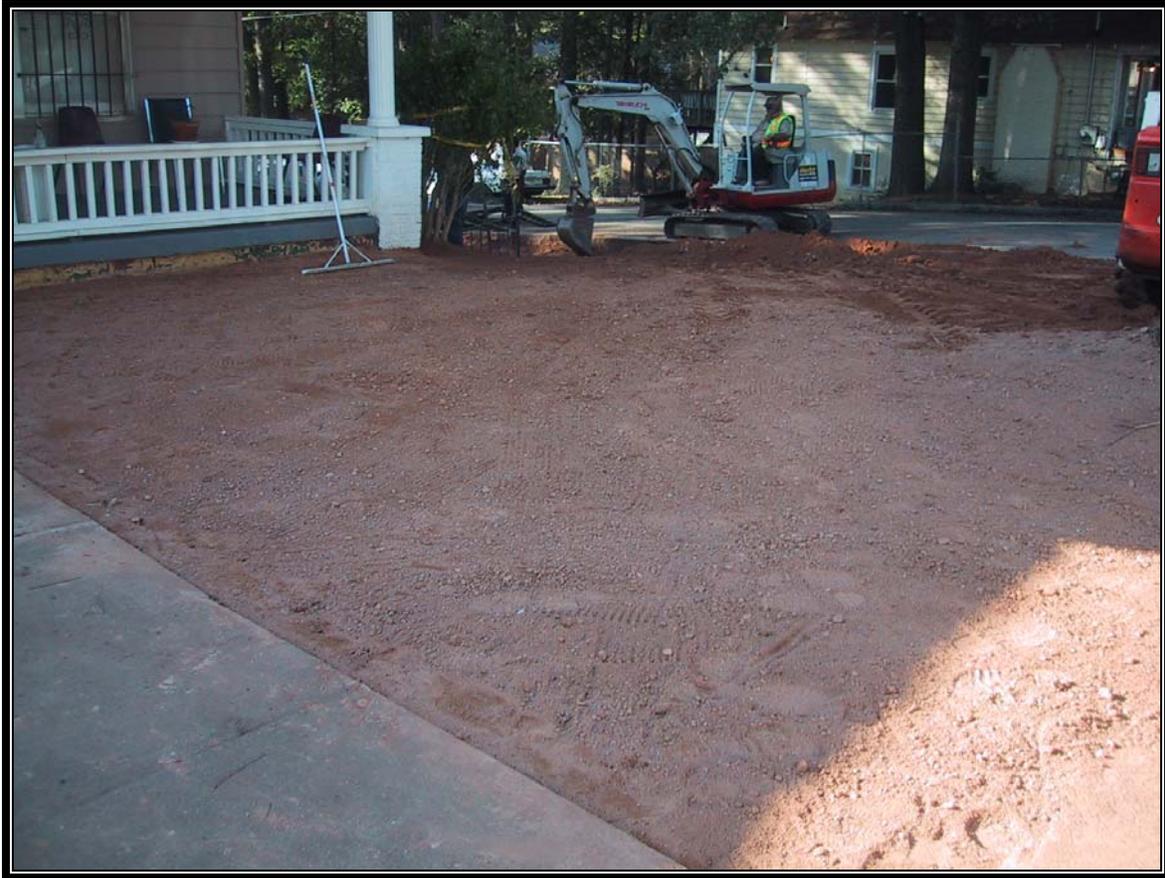
**OFFICIAL PHOTOGRAPH NO. 11
U.S. ENVIRONMENTAL PROTECTION AGENCY**

Subject: Front yard of 1273 Allene Avenue. ER backfilled and graded the yard using a track hoe and a skid steer.

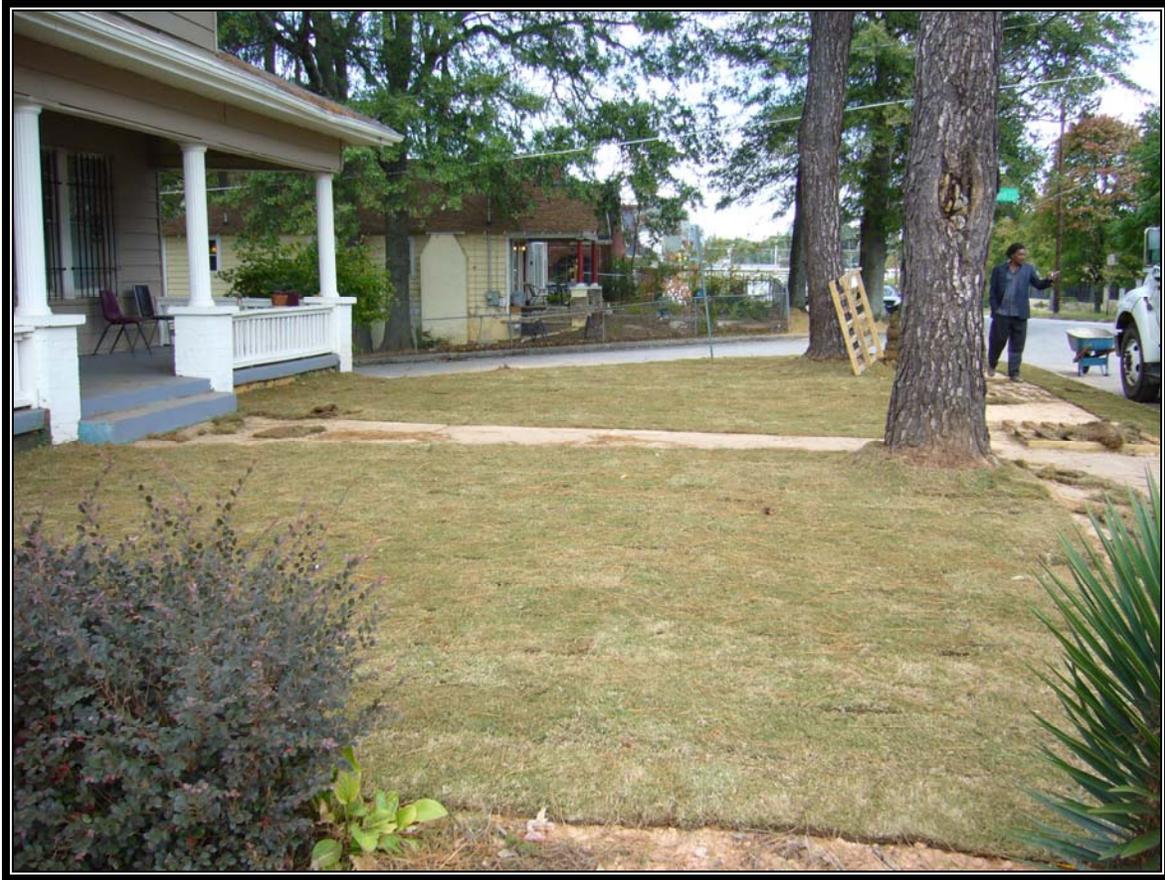
OFFICIAL PHOTOGRAPH NO. 12
U.S. ENVIRONMENTAL PROTECTION AGENCY

TDD Number: TTEMI-05-001-0002 **Location:** ESB (Exide) Fund Lead
Orientation: North **Date:** October 23, 2008
Photographer: Paul Prys, Tetra Tech **Witness:** Paul Prys, Tetra Tech
Subject: Solid Rock Landscape installing Bermuda sod in the front yard of 1273 Allene Avenue.

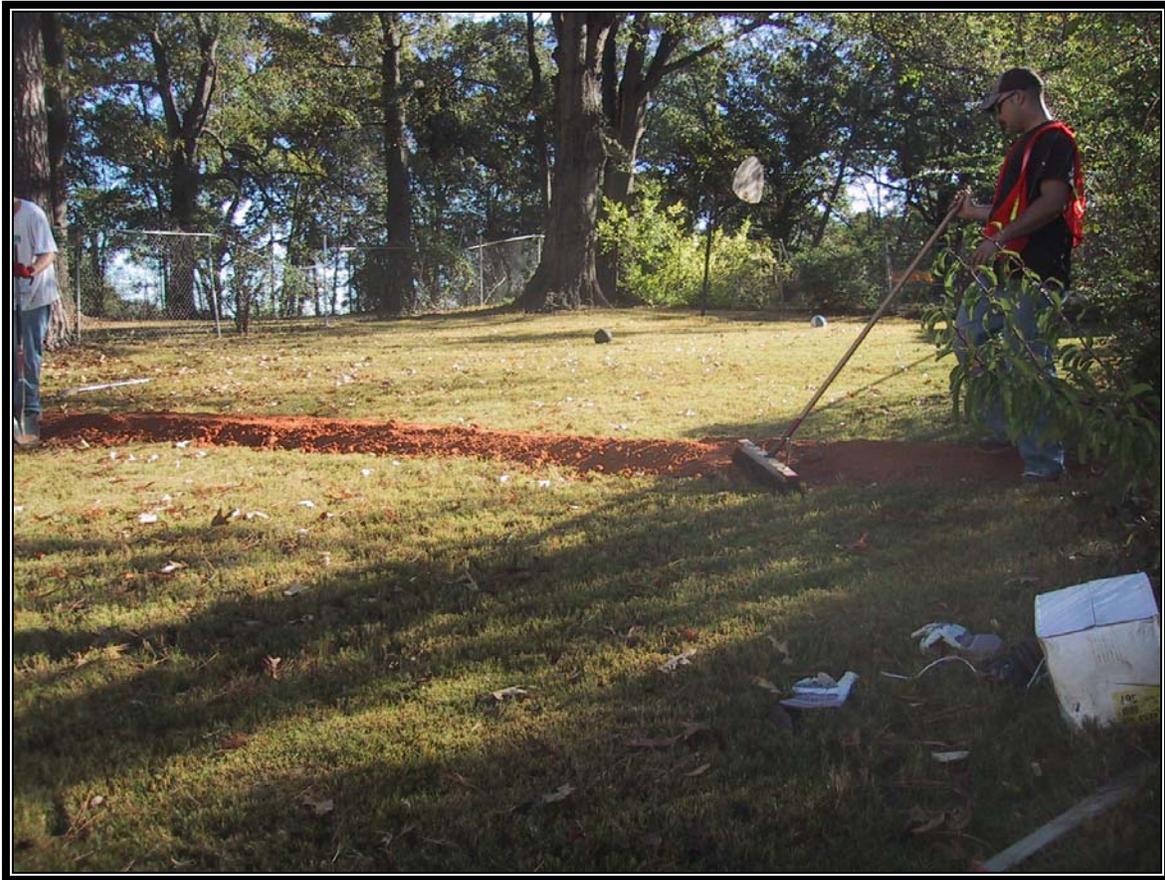
**OFFICIAL PHOTOGRAPH NO. 13
U.S. ENVIRONMENTAL PROTECTION AGENCY**

Subject: ER installing soil berm to control erosion and stormwater runoff in the back yard of 1280 Allene Avenue.

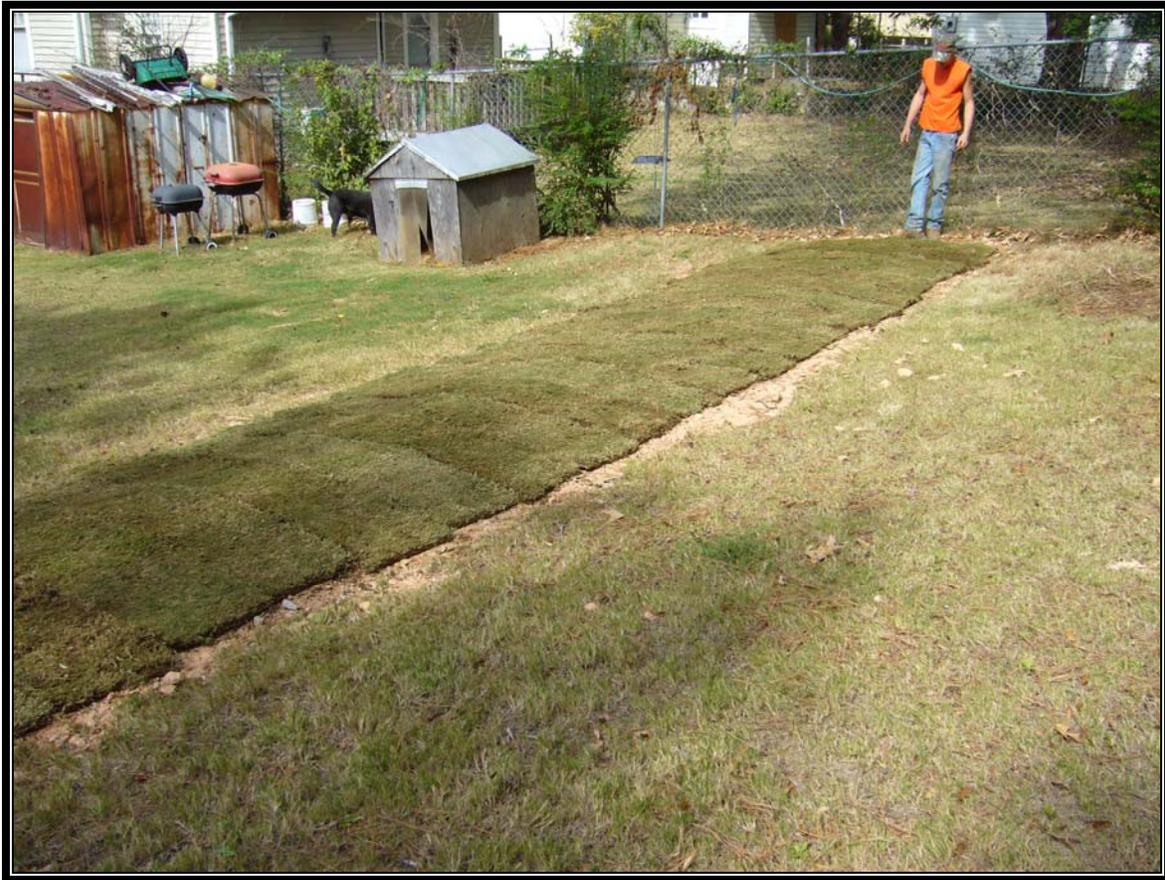
**OFFICIAL PHOTOGRAPH NO. 14
U.S. ENVIRONMENTAL PROTECTION AGENCY**

Subject: Solid Rock Landscape completing the installation of Bermuda sod on top of the soil berm in the back yard of 1280 Allene Avenue.

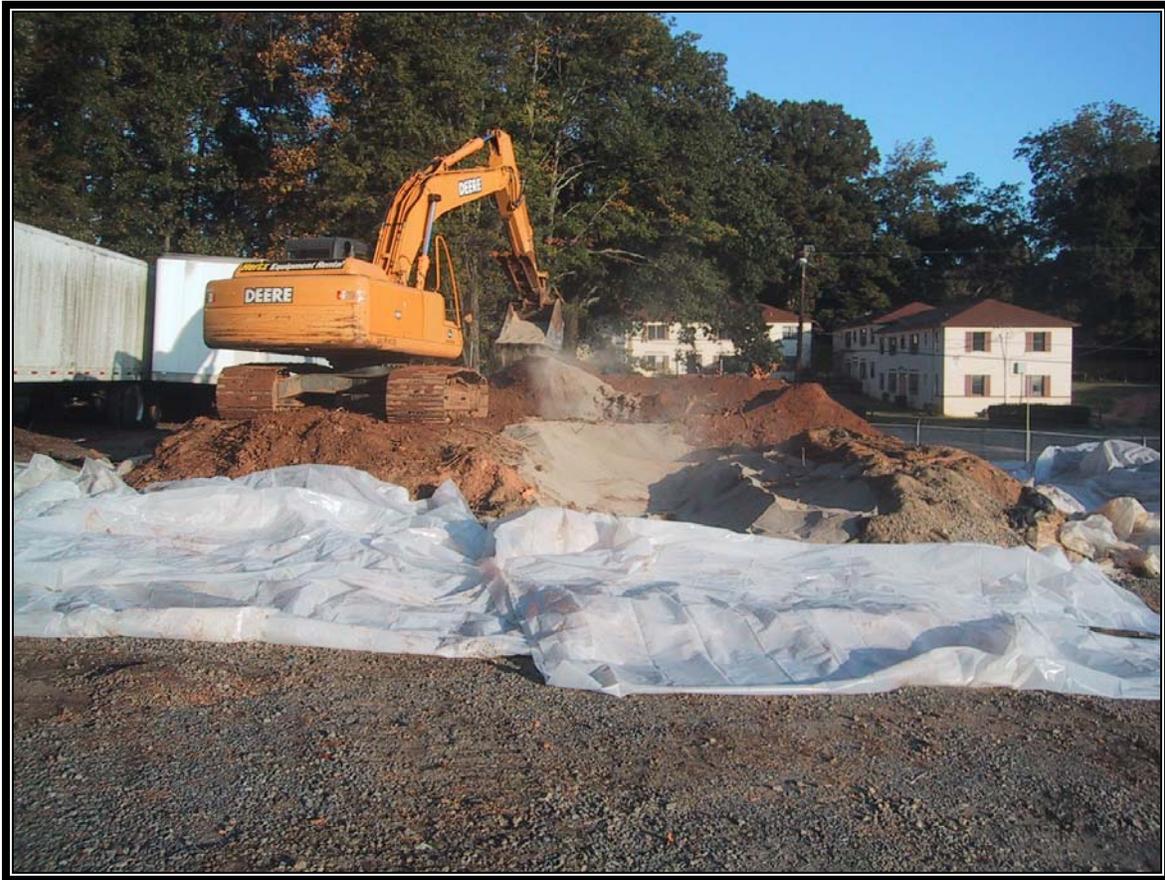
**OFFICIAL PHOTOGRAPH NO. 15
U.S. ENVIRONMENTAL PROTECTION AGENCY**

Subject: ER mixing staged, lead-contaminated soil located in the northwest corner of the Great Dane Trucking property with Free Flow 100[®] to chemically stabilize and reduce leaching of metals from the soil.

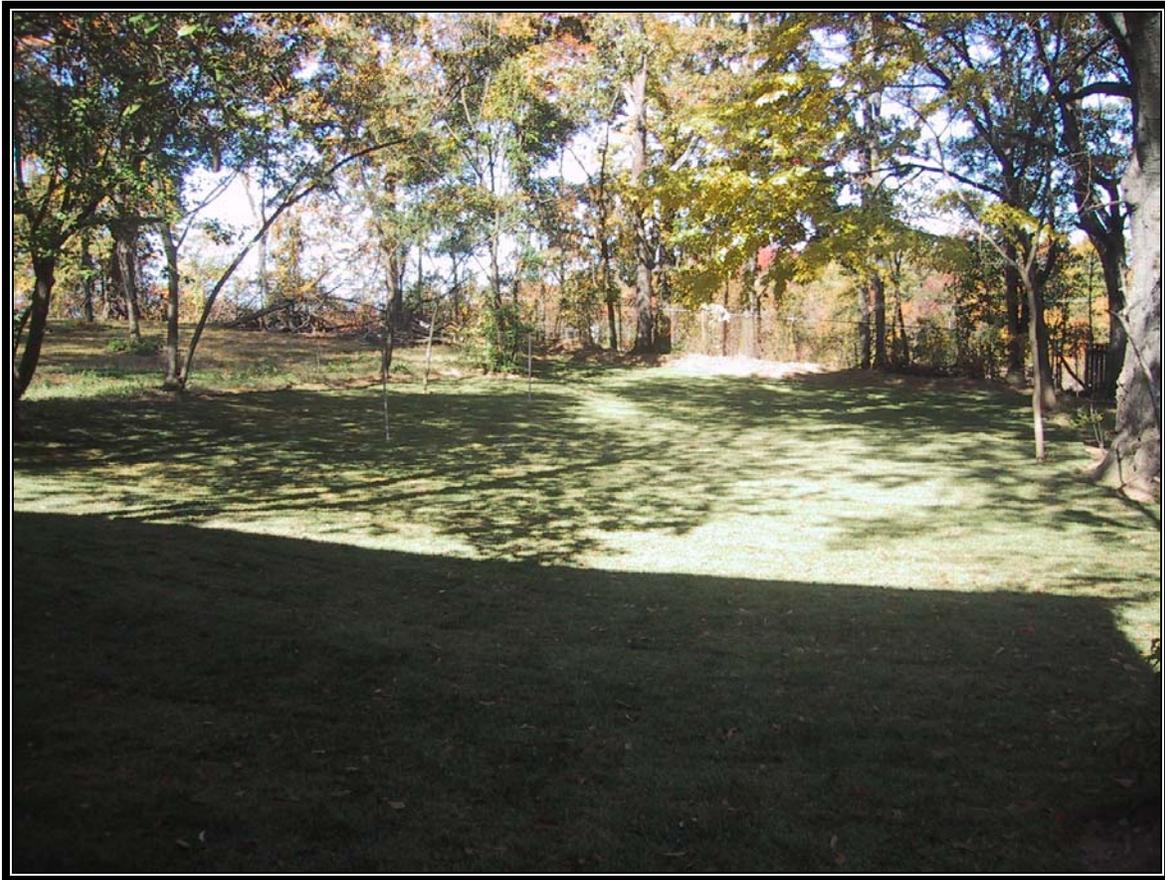
OFFICIAL PHOTOGRAPH NO. 16
U.S. ENVIRONMENTAL PROTECTION AGENCY

During the removal activities conducted in 2006 and 2007, Bermuda sod had been installed at 713 Erin Avenue. The sod failed to grow due to the high amount of shade in the backyard, and the resident requested EPA address the matter. On November 6, 2008, Solid Rock Landscape replaced the Bermuda sod located in the backyard of the property with Fescue sod.

TDD Number: TTEMI-05-001-0002 **Location:** ESB (Exide) Fund Lead
Orientation: Northwest **Date:** November 6, 2008
Photographer: Courtney Roden, Tetra Tech **Witness:** Courtney Roden, Tetra Tech
Subject: Fescue sod installed in the back yard of 713 Erin Avenue.

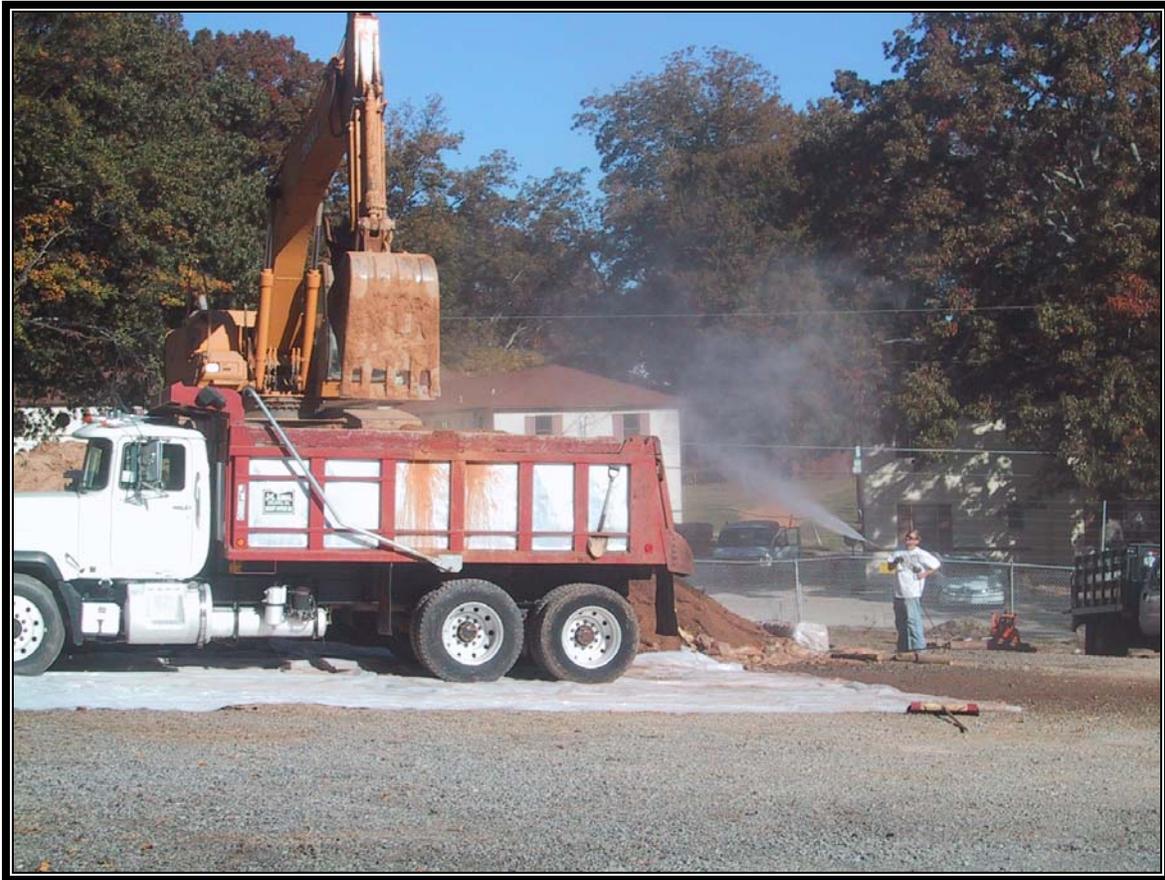
**OFFICIAL PHOTOGRAPH NO. 17
U.S. ENVIRONMENTAL PROTECTION AGENCY**

Subject: ER loading dump trucks with treated soil for disposal as non-hazardous waste for transportation to Pine Ridge Landfill. Note the use of misting water for dust control.

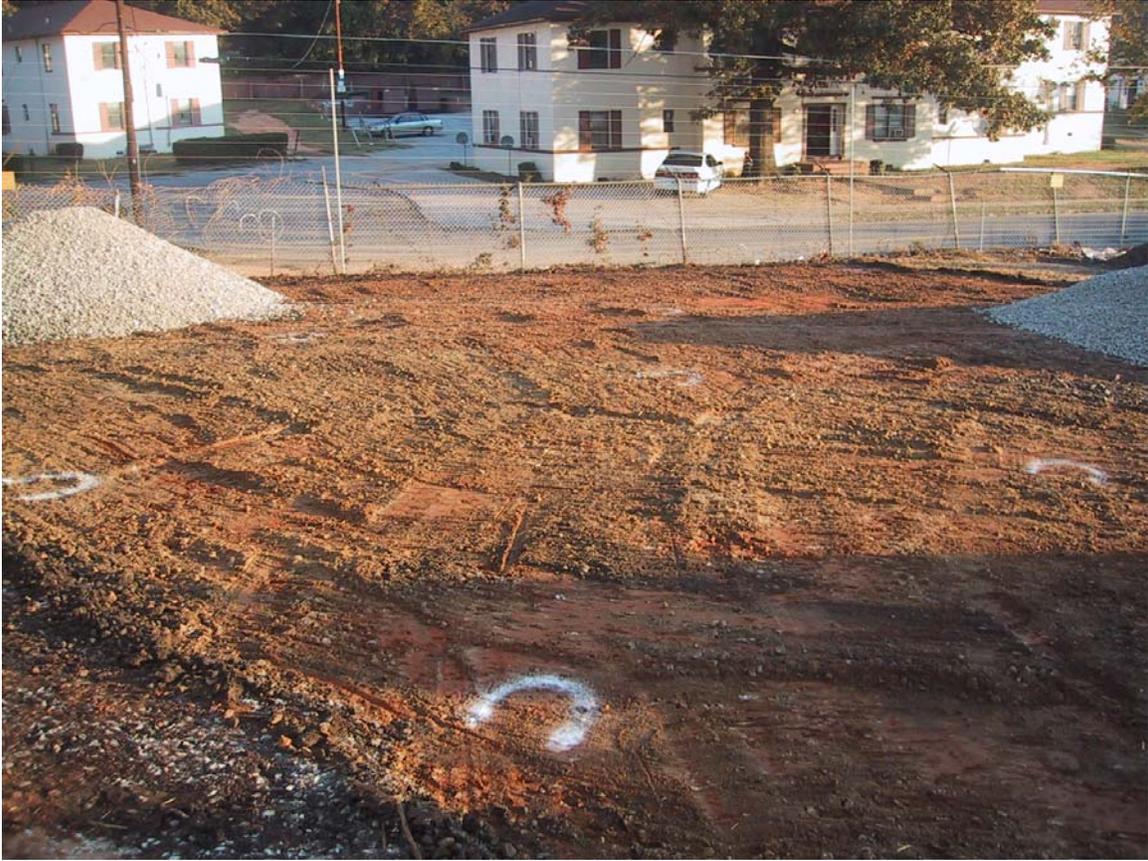
OFFICIAL PHOTOGRAPH NO. 18
U.S. ENVIRONMENTAL PROTECTION AGENCY

Subject: ER completed scraping soil from a section of the Great Dane Trucking lot used to stage soil excavated from the ditch area. Tetra Tech START performed in-situ soil screening using XRF. Areas less than the RAL for lead were marked with "C" for no additional excavation required. ER excavated approximately 2 to 4 inches of surface material prior to Tetra Tech START collecting confirmation soil samples.

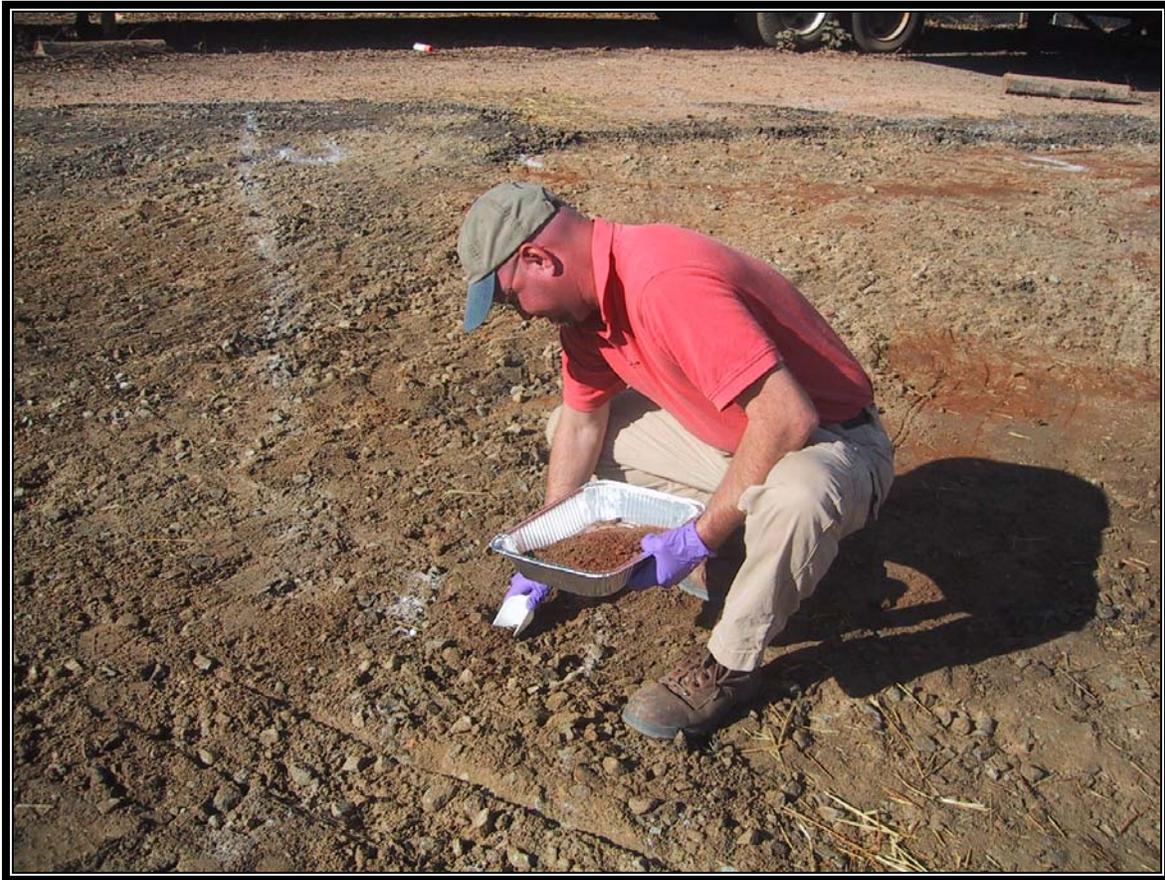
OFFICIAL PHOTOGRAPH NO. 19
U.S. ENVIRONMENTAL PROTECTION AGENCY

Subject: Tetra Tech START conducting confirmation soil sampling in staged soil area at Great Dane Trucking.
