**REMOVAL PROGRAM  
AFTER ACTION REPORT  
FOR THE  
STENTON TRUST MILL DRUM SITE  
SANFORD, YORK COUNTY, MAINE  
3 SEPTEMBER 2008 THROUGH 30 SEPTEMBER 2008**

Weston Solutions, Inc.  
Superfund Technical Assessment and Response Team III (START)  
3 Riverside Drive  
Andover, Massachusetts 01810

February 2009

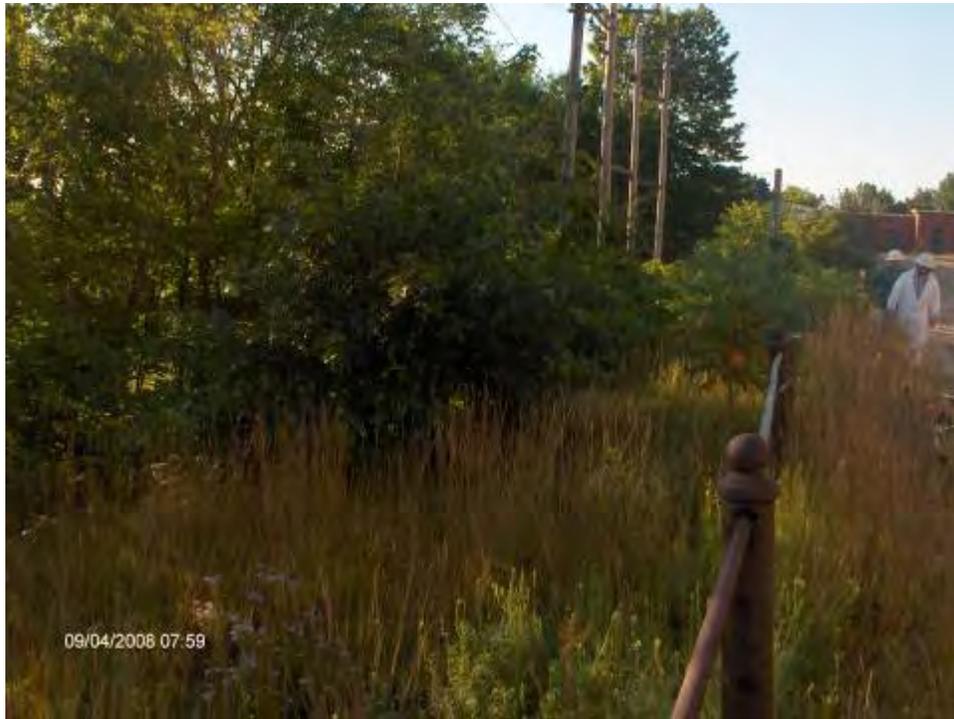
**SCENE:** View of the transformer pad, located east of the on-site building, prior to brush clearing activities. Photograph taken facing south.

ERRS personnel initiated brush clearing activities around the transformer pad located east of the on-site building. The transformer pad was surrounded by thick vegetation and a chain-link fence and contained nine PCB-containing transformers (six GE-manufactured and three Westinghouse Electric-manufactured). START SL Benton gathered necessary T&D information from the nine transformers.

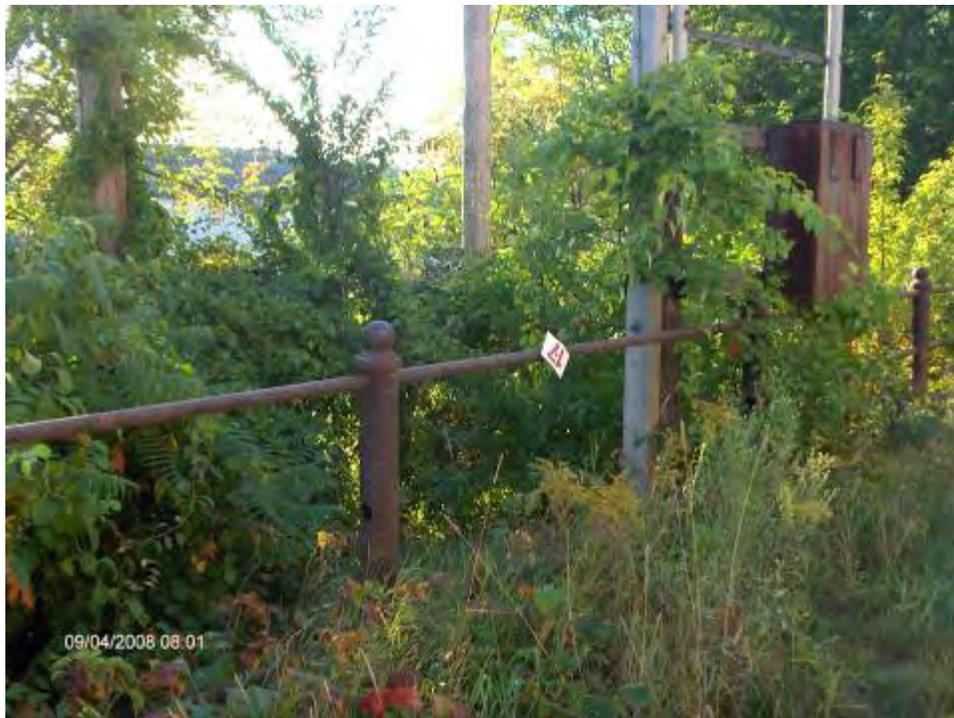
**SCENE:** View of the transformer pad, located east of the on-site building, prior to brush clearing activities. Photograph taken facing southeast.

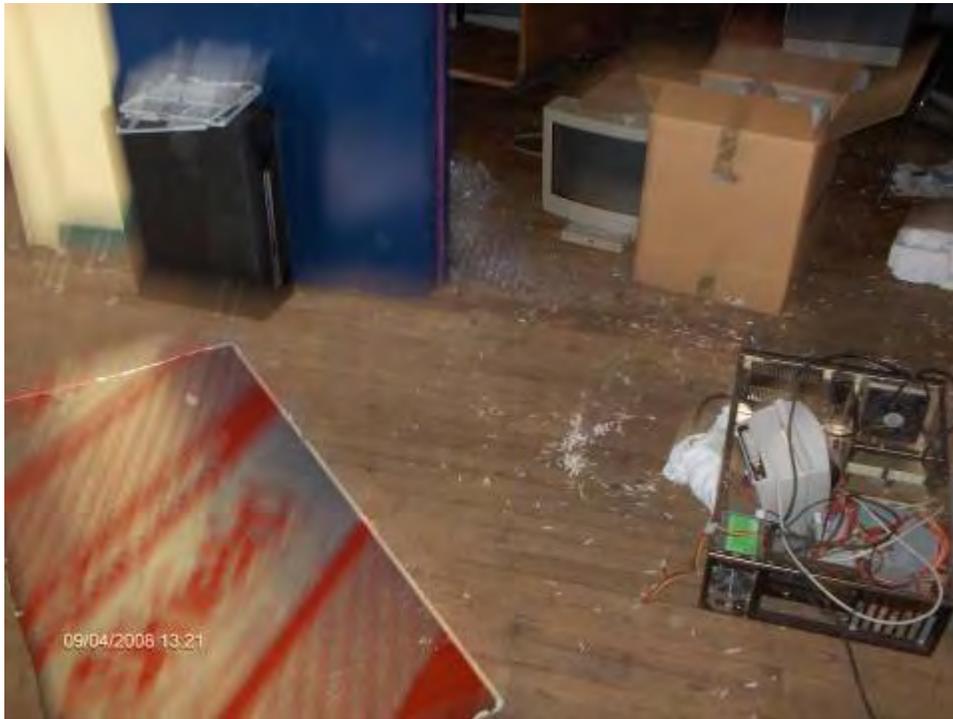
**SCENE:** View of a portion (western section) of the second floor of the West Tower of the on-site building and electronic waste present on the floor surface.

ENPRO personnel completed transporting all the hazardous waste and universal waste, which was spread throughout all floors of the East and West Towers, to the waste staging area. In addition, ENPRO personnel transported all electronic waste present throughout the on-site building to two roll-off containers delivered by ENPRO. The two roll-off containers were delivered and staged north and south of the on-site building. The roll-off container staged north of the on-site building was loaded with electronic waste collected from the first through fifth floors of the East and West Towers. The roll-off container staged south of the on-site building was loaded with electronic waste collected from the basement of the on-site building.

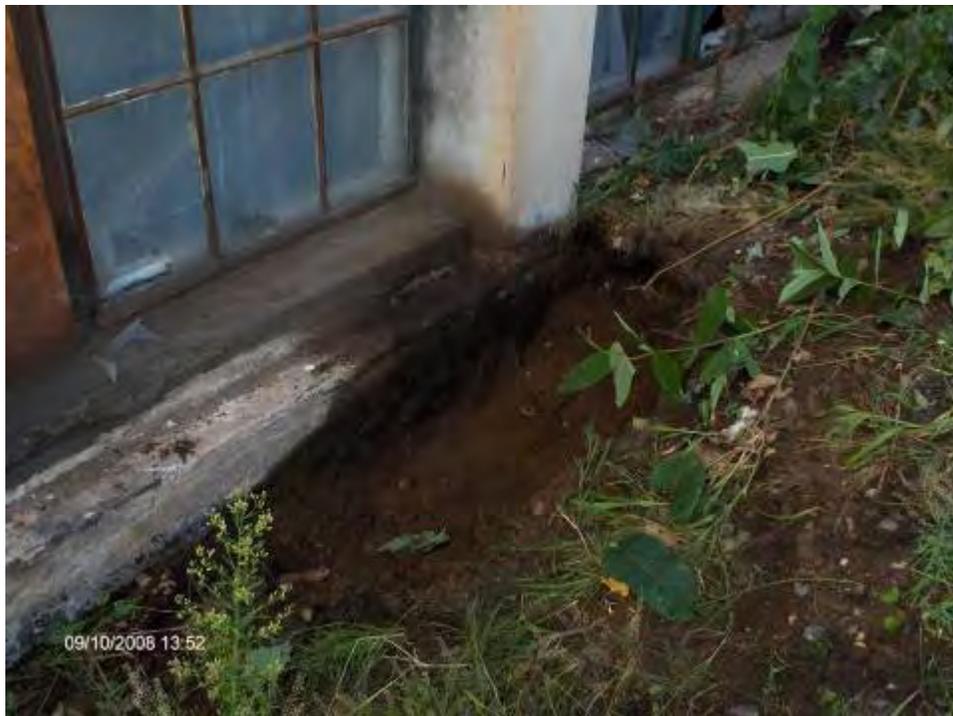
**SCENE:** View of the excavation of petroleum-contaminated soil located adjacent to the East Tower of the on-site building. Photograph taken facing northwest.

ENPRO personnel also completed excavating an area of contaminated soil located east of the on-site building. According to ME DEP personnel, the excavated area was contaminated with petroleum product during UST removal activities. ENPRO personnel excavated an approximately 6-foot by 6-foot area, and containerized the waste soils in two 55-gallon drums. The area was backfilled with soil obtained from the southeastern portion of the Site. START conducted air monitoring throughout excavation activities; no readings above background were recorded.

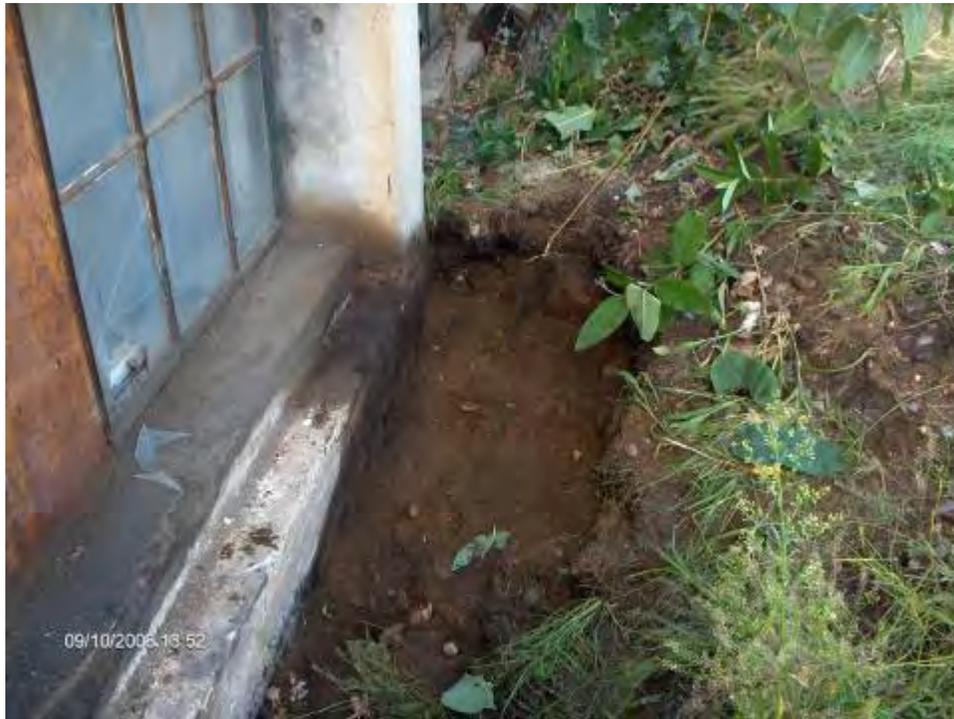
**SCENE:** View of the excavation of petroleum-contaminated soil located adjacent to the East Tower of the on-site building. Photograph taken facing northwest.

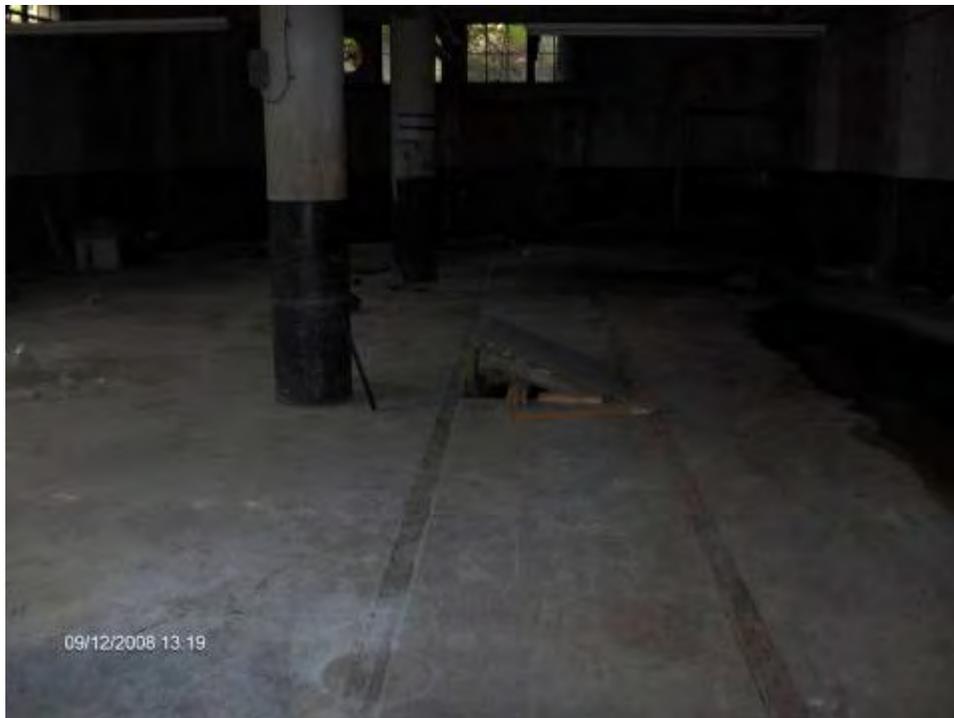
**SCENE:** View of the concrete slab covering a trench located along the eastern portion of the basement in the on-site building.

Per the request of OSC McKeown, ENPRO personnel removed a concrete cover from a trench located along the floor of the basement located in the on-site building. START conducted air monitoring during the removal of the concrete cover; no readings above background were recorded. The trench appeared to be approximately 6 feet deep and extended the length of the eastern portion

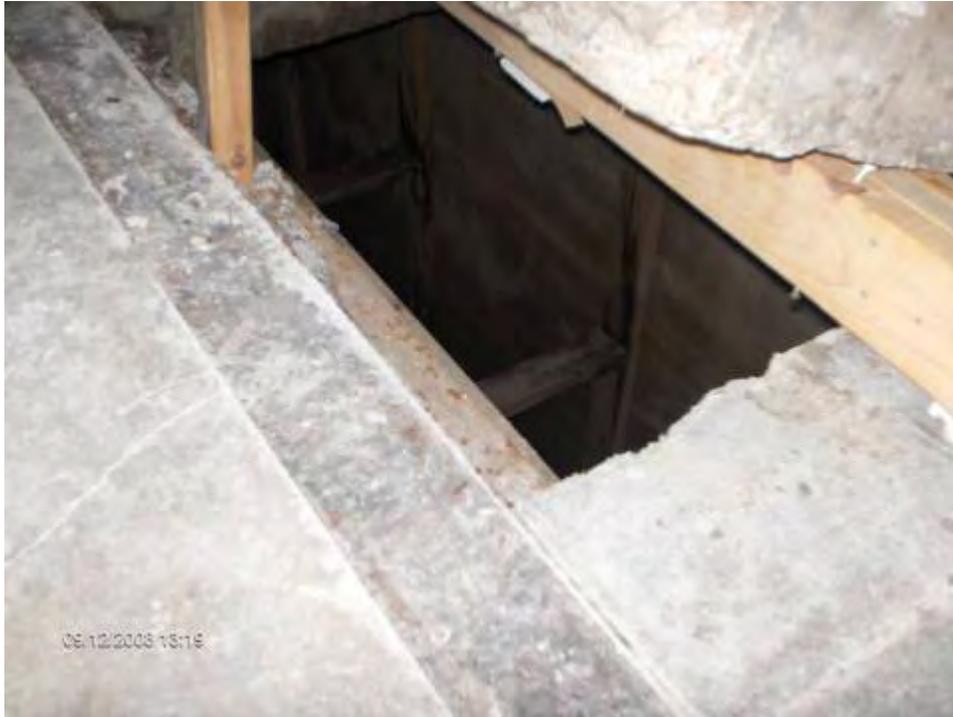
of the basement of the on-site building. No liquid was observed within the trench, which appeared to be designed for former operations conducted on site.

**SCENE:** View of the trench located along the eastern portion of the basement in the on-site building.

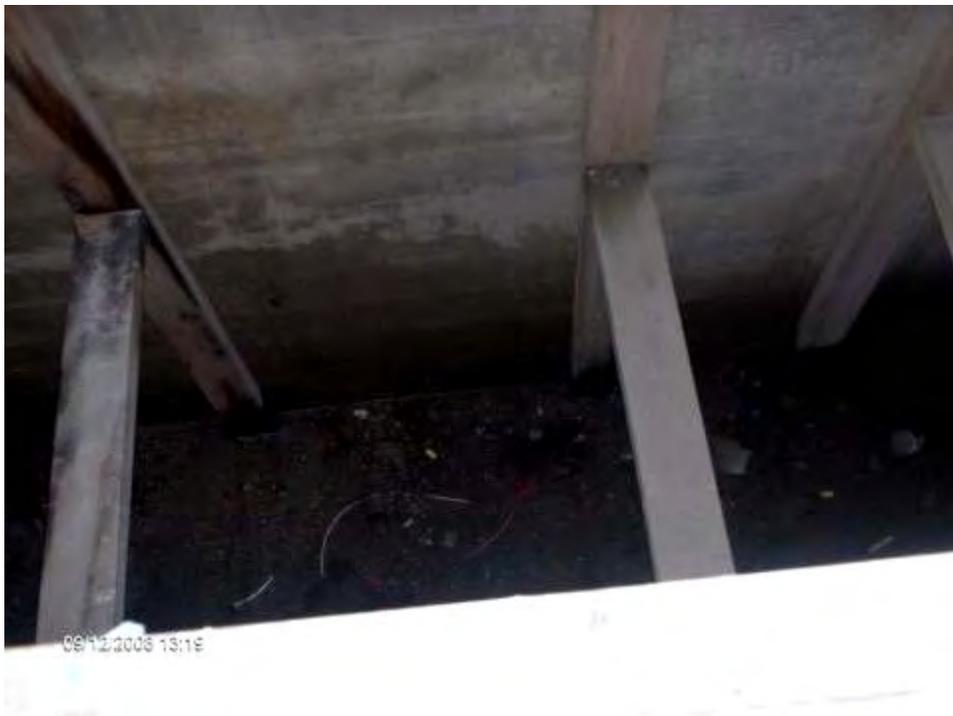
**SCENE:** View within the trench located along the eastern portion of the basement in the on-site building.

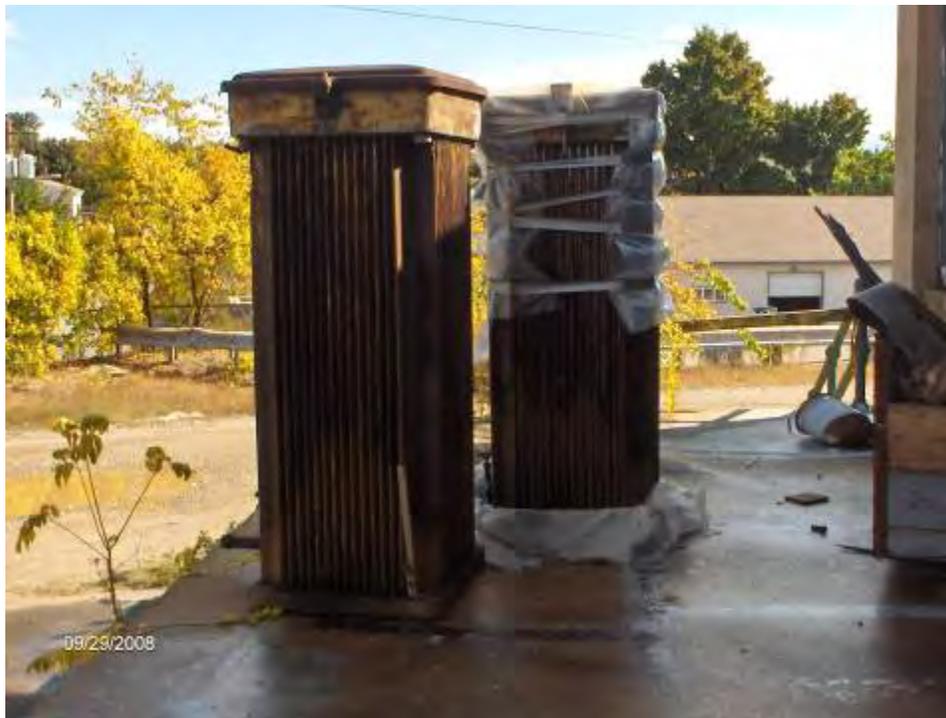
**SCENE:** View of the two transformers that were staged on the loading dock adjacent to the first floor of the East Tower of the on-site building prior to the EPA Removal Action. Photograph taken facing east.

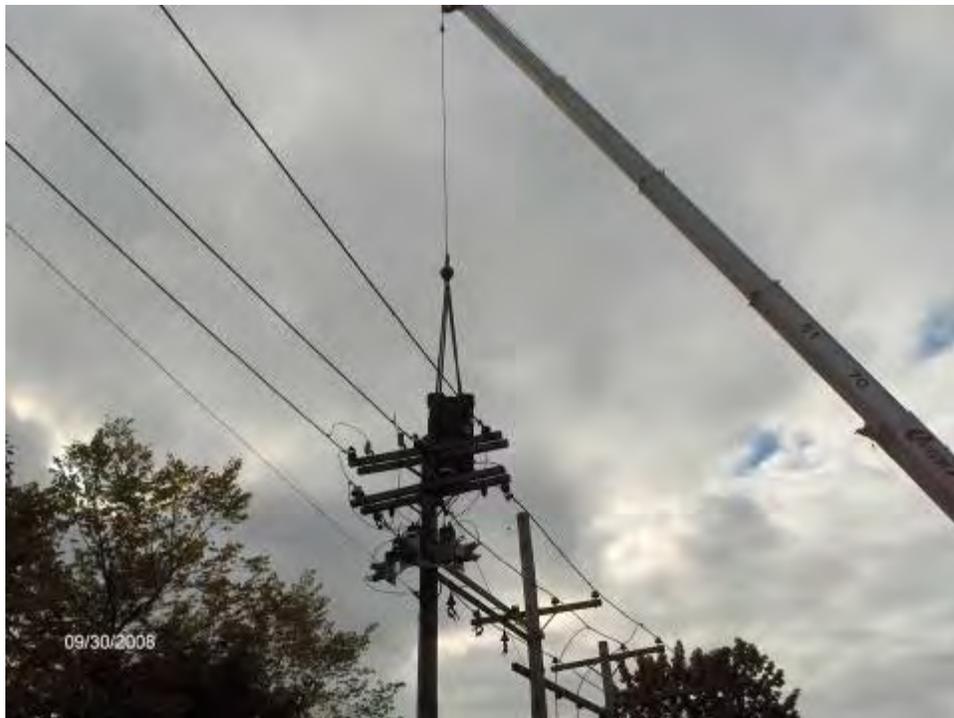
**SCENE:** View of the crane extracting one of the nine transformers from the transformer pad located east of the on-site building. Photograph taken facing southeast.

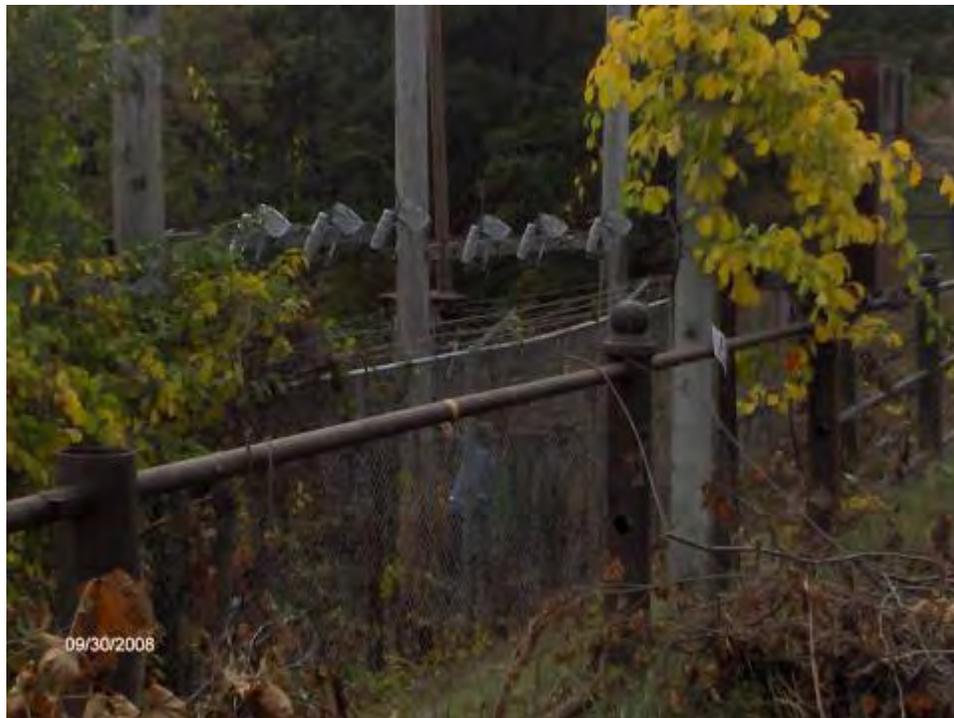
**SCENE:** View of the transformer pad located east of the on-site building after the nine transformers had been removed. Photograph taken facing southeast.
