MEMORANDUM

TO: Des Moines TCE Site File
FROM: Mary Peterson
DATE: May 8, 2008
SUBJECT: Trip Report for Dico Building Demolition Follow-up, April 21-22, 2008

Dico Site Inspection:

Photos from 4-21-08 Dico site inspection

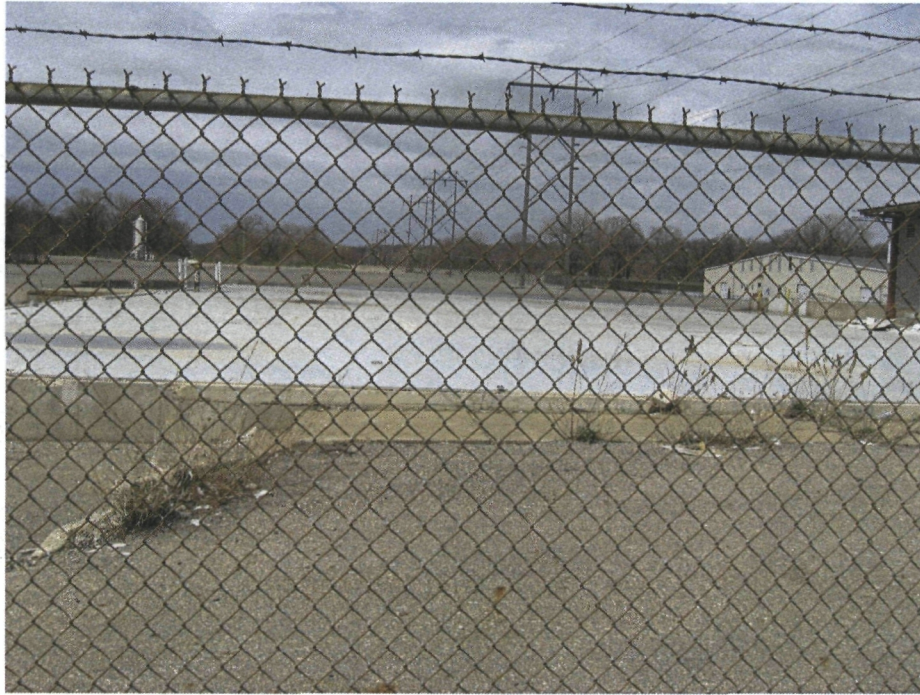
Maintenance Building slab; view from outside fence looking west

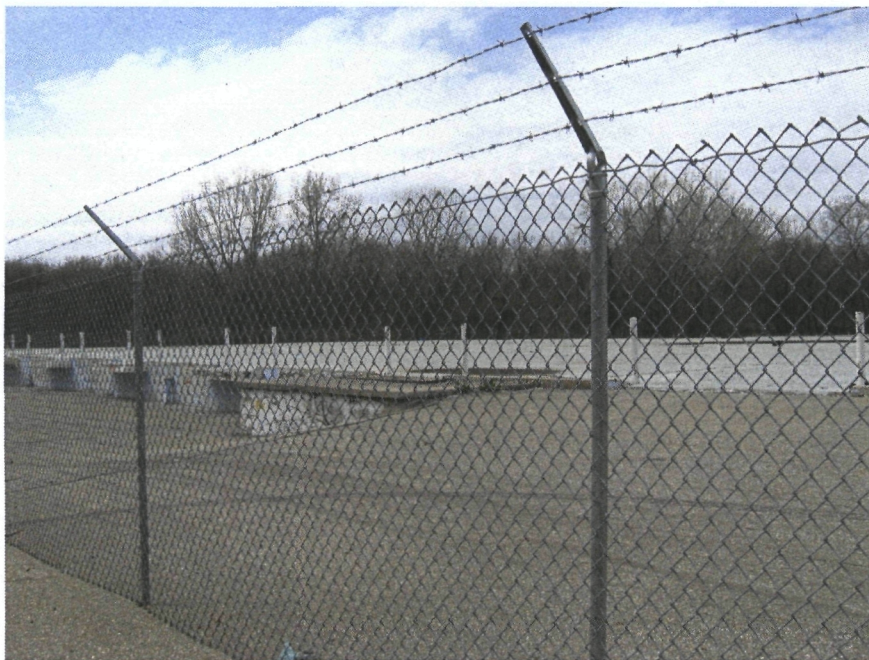
Building 5 slab; view from outside fence looking south

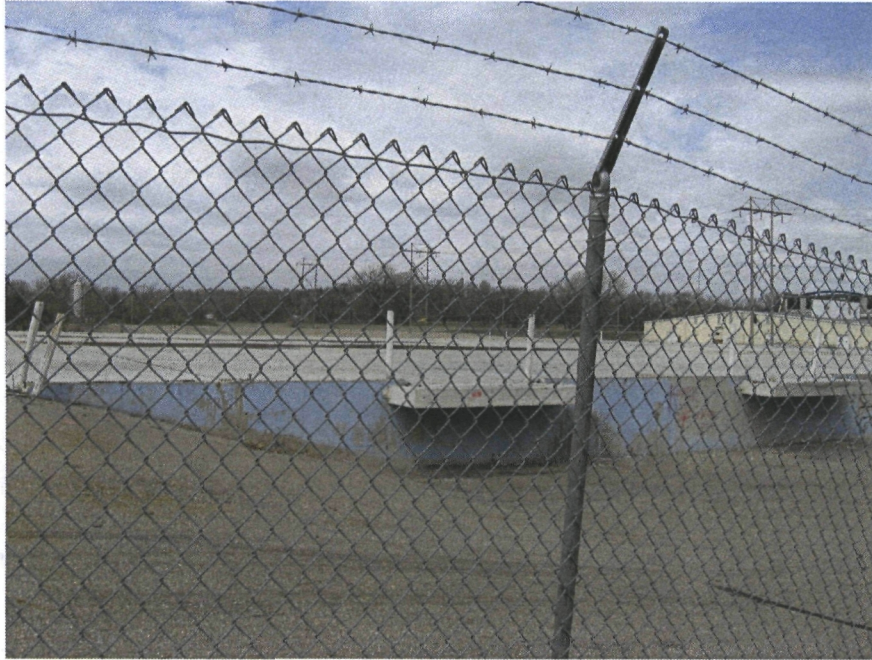
Building 4 slab; view from outside fence looking north

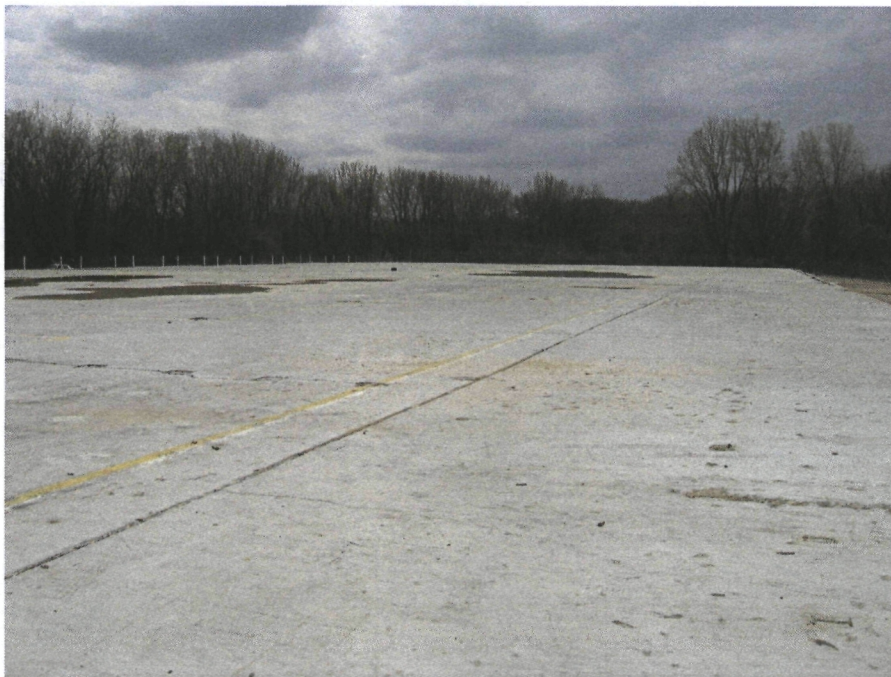
Building 4/5 slab; view from inside fence looking south

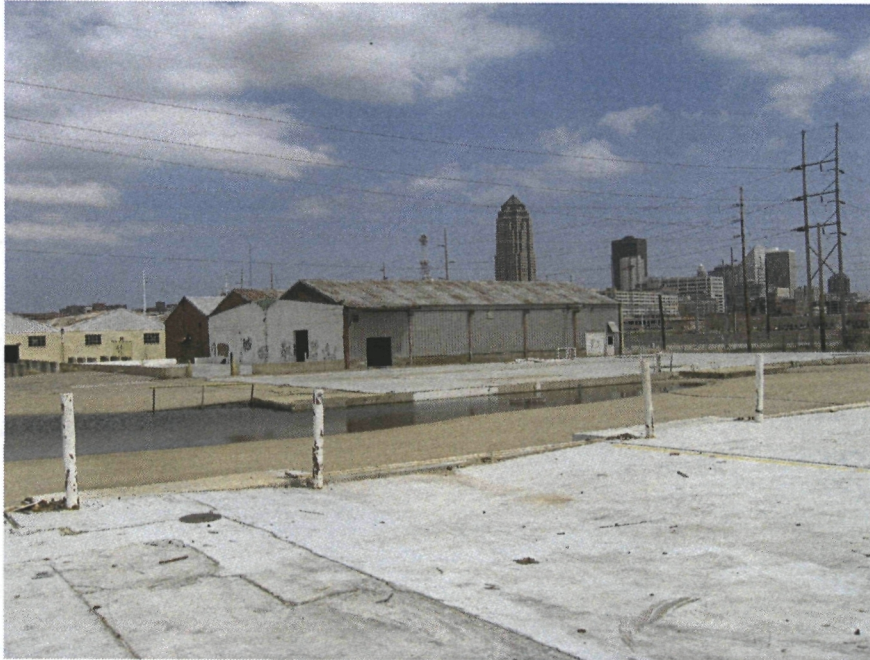
Maintenance Building slab; view from inside fence looking north

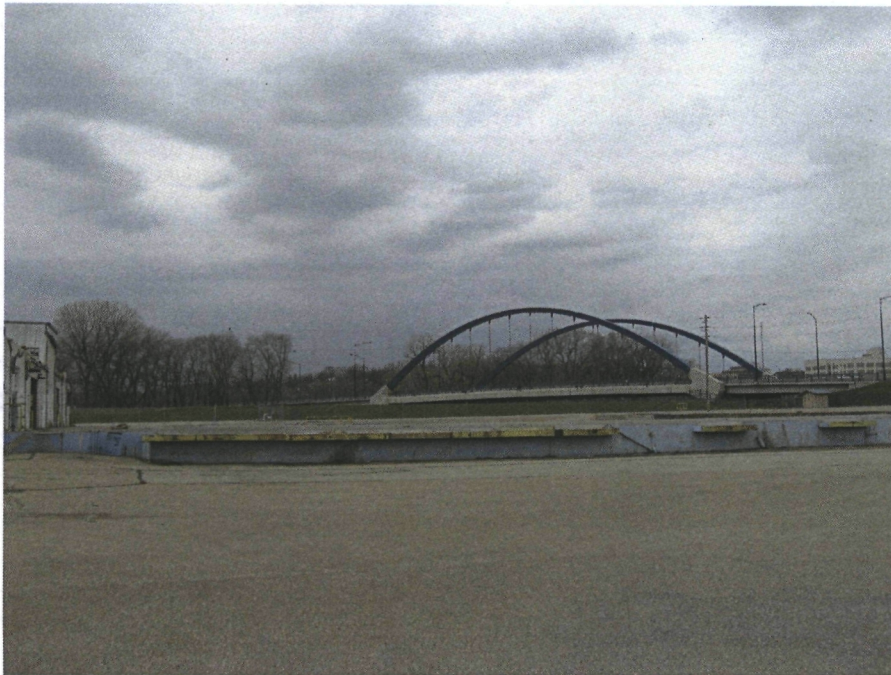
North end of Production Building; view from inside fence looking west
