# Site Inspection Report

Des Moines TCE Site  
September 2007

Superfund

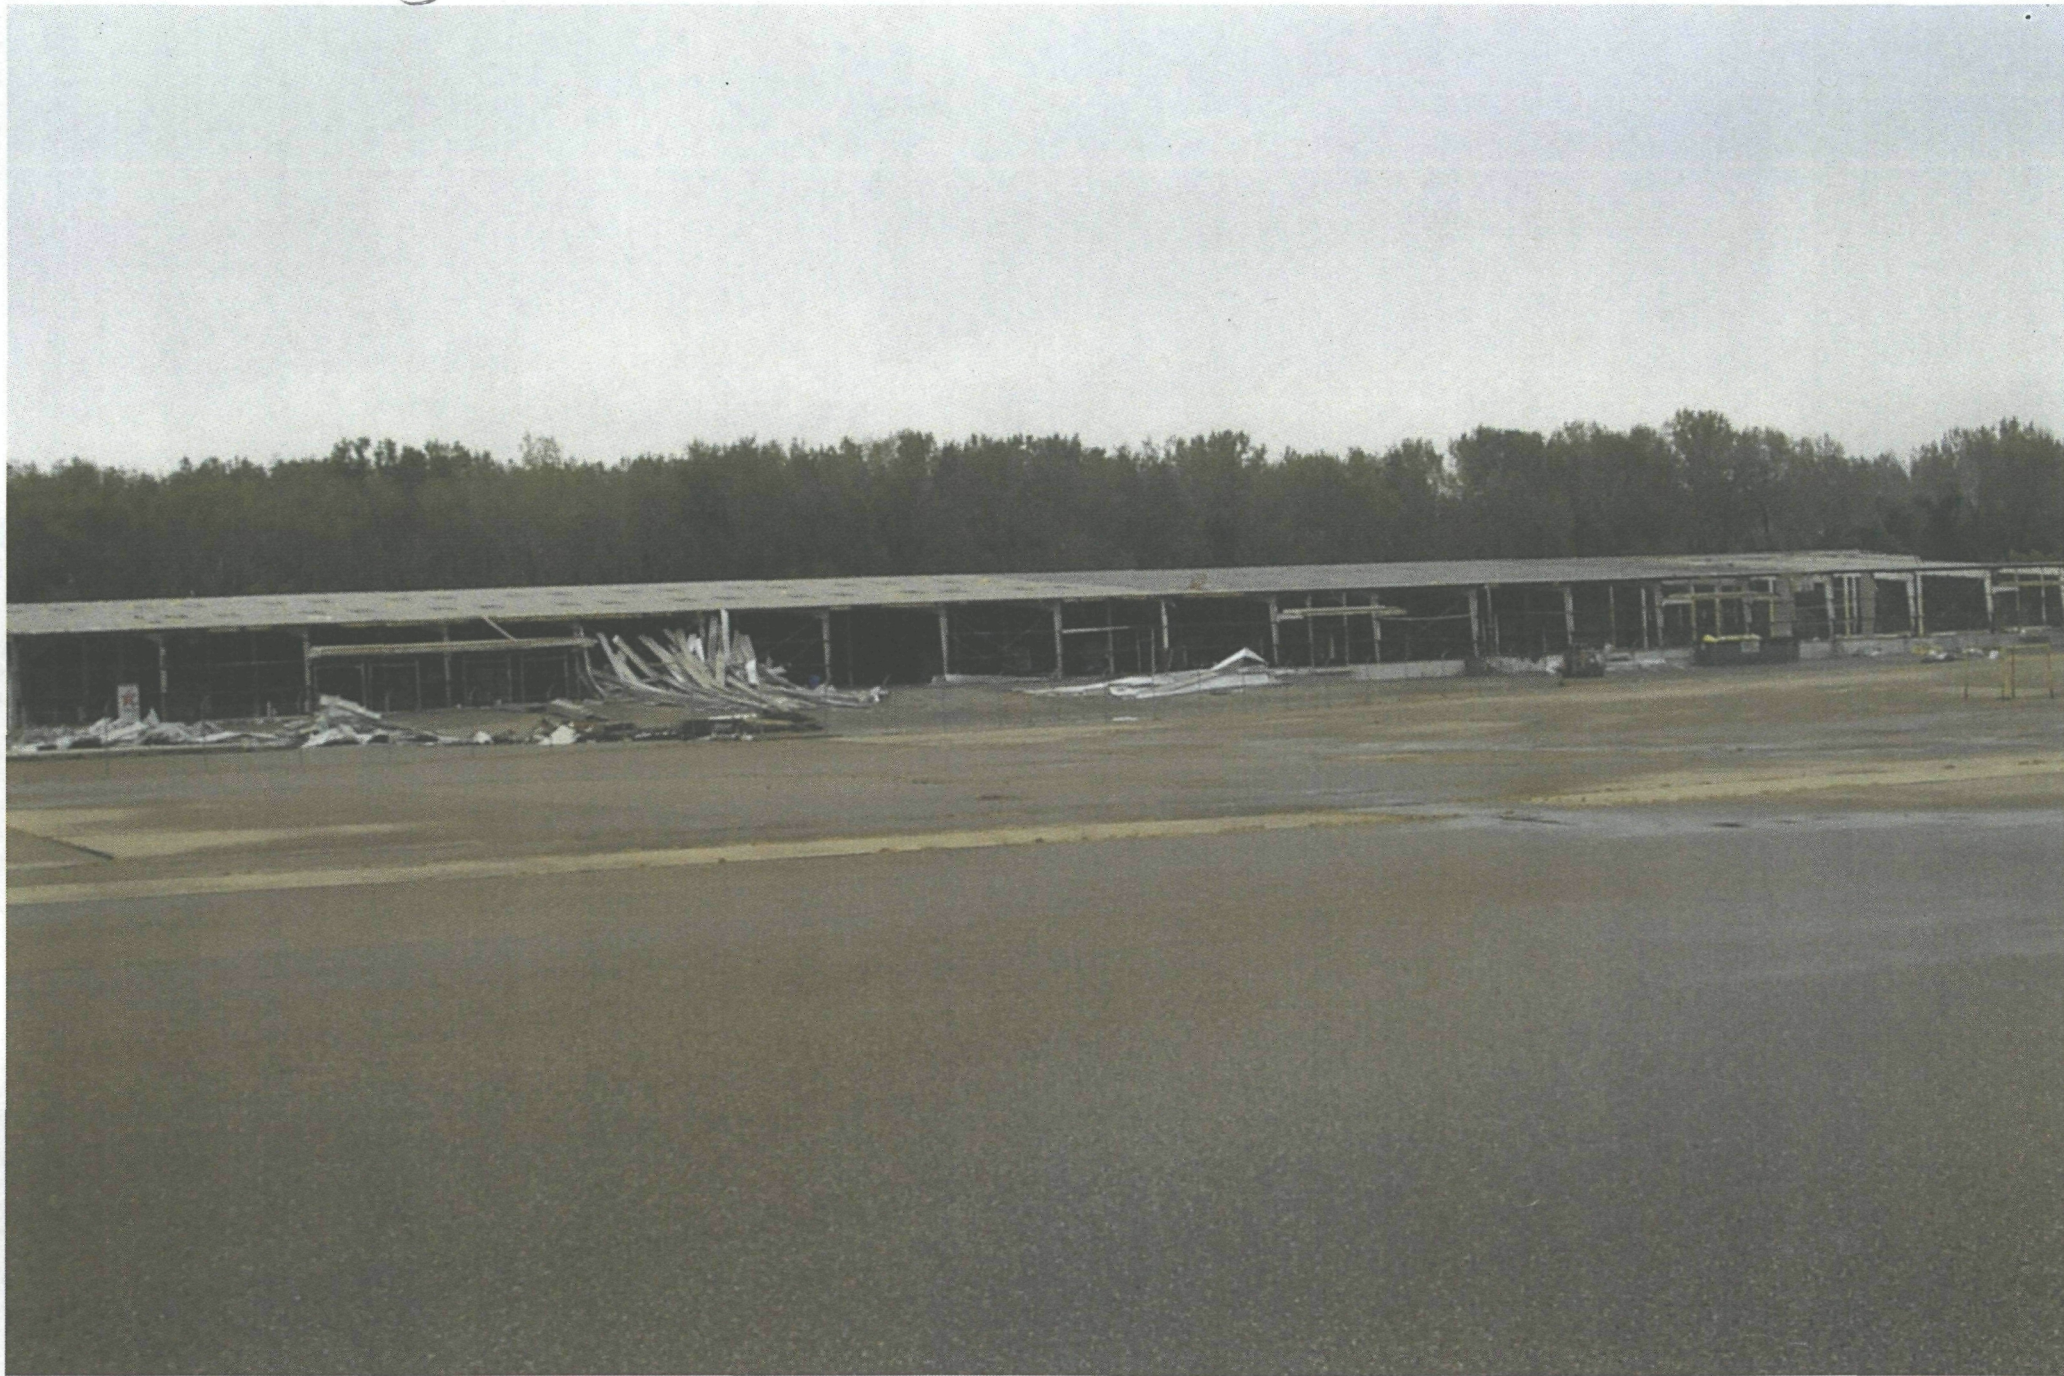
OU2/OU4: The buildings, the asphalt cap, and the South Pond drainage area and ditch east of the site were included in the inspection of OU2 and OU4. The most notable change is the demolition of building 4/5. Dico indicated that the building support structures are being sold and will be erected at another site. Sheet metal will be recycled and other materials will be sent offsite for disposal. The concrete foundation will remain in place. Louis Barrentine indicated that he will provide documentation to EPA regarding the disposition of materials leaving the site. Photographs 1, 2, and 3 depict building 4/5 in the process of demolition.

#1 Olico  
Building 4/5 demolition - view to the east

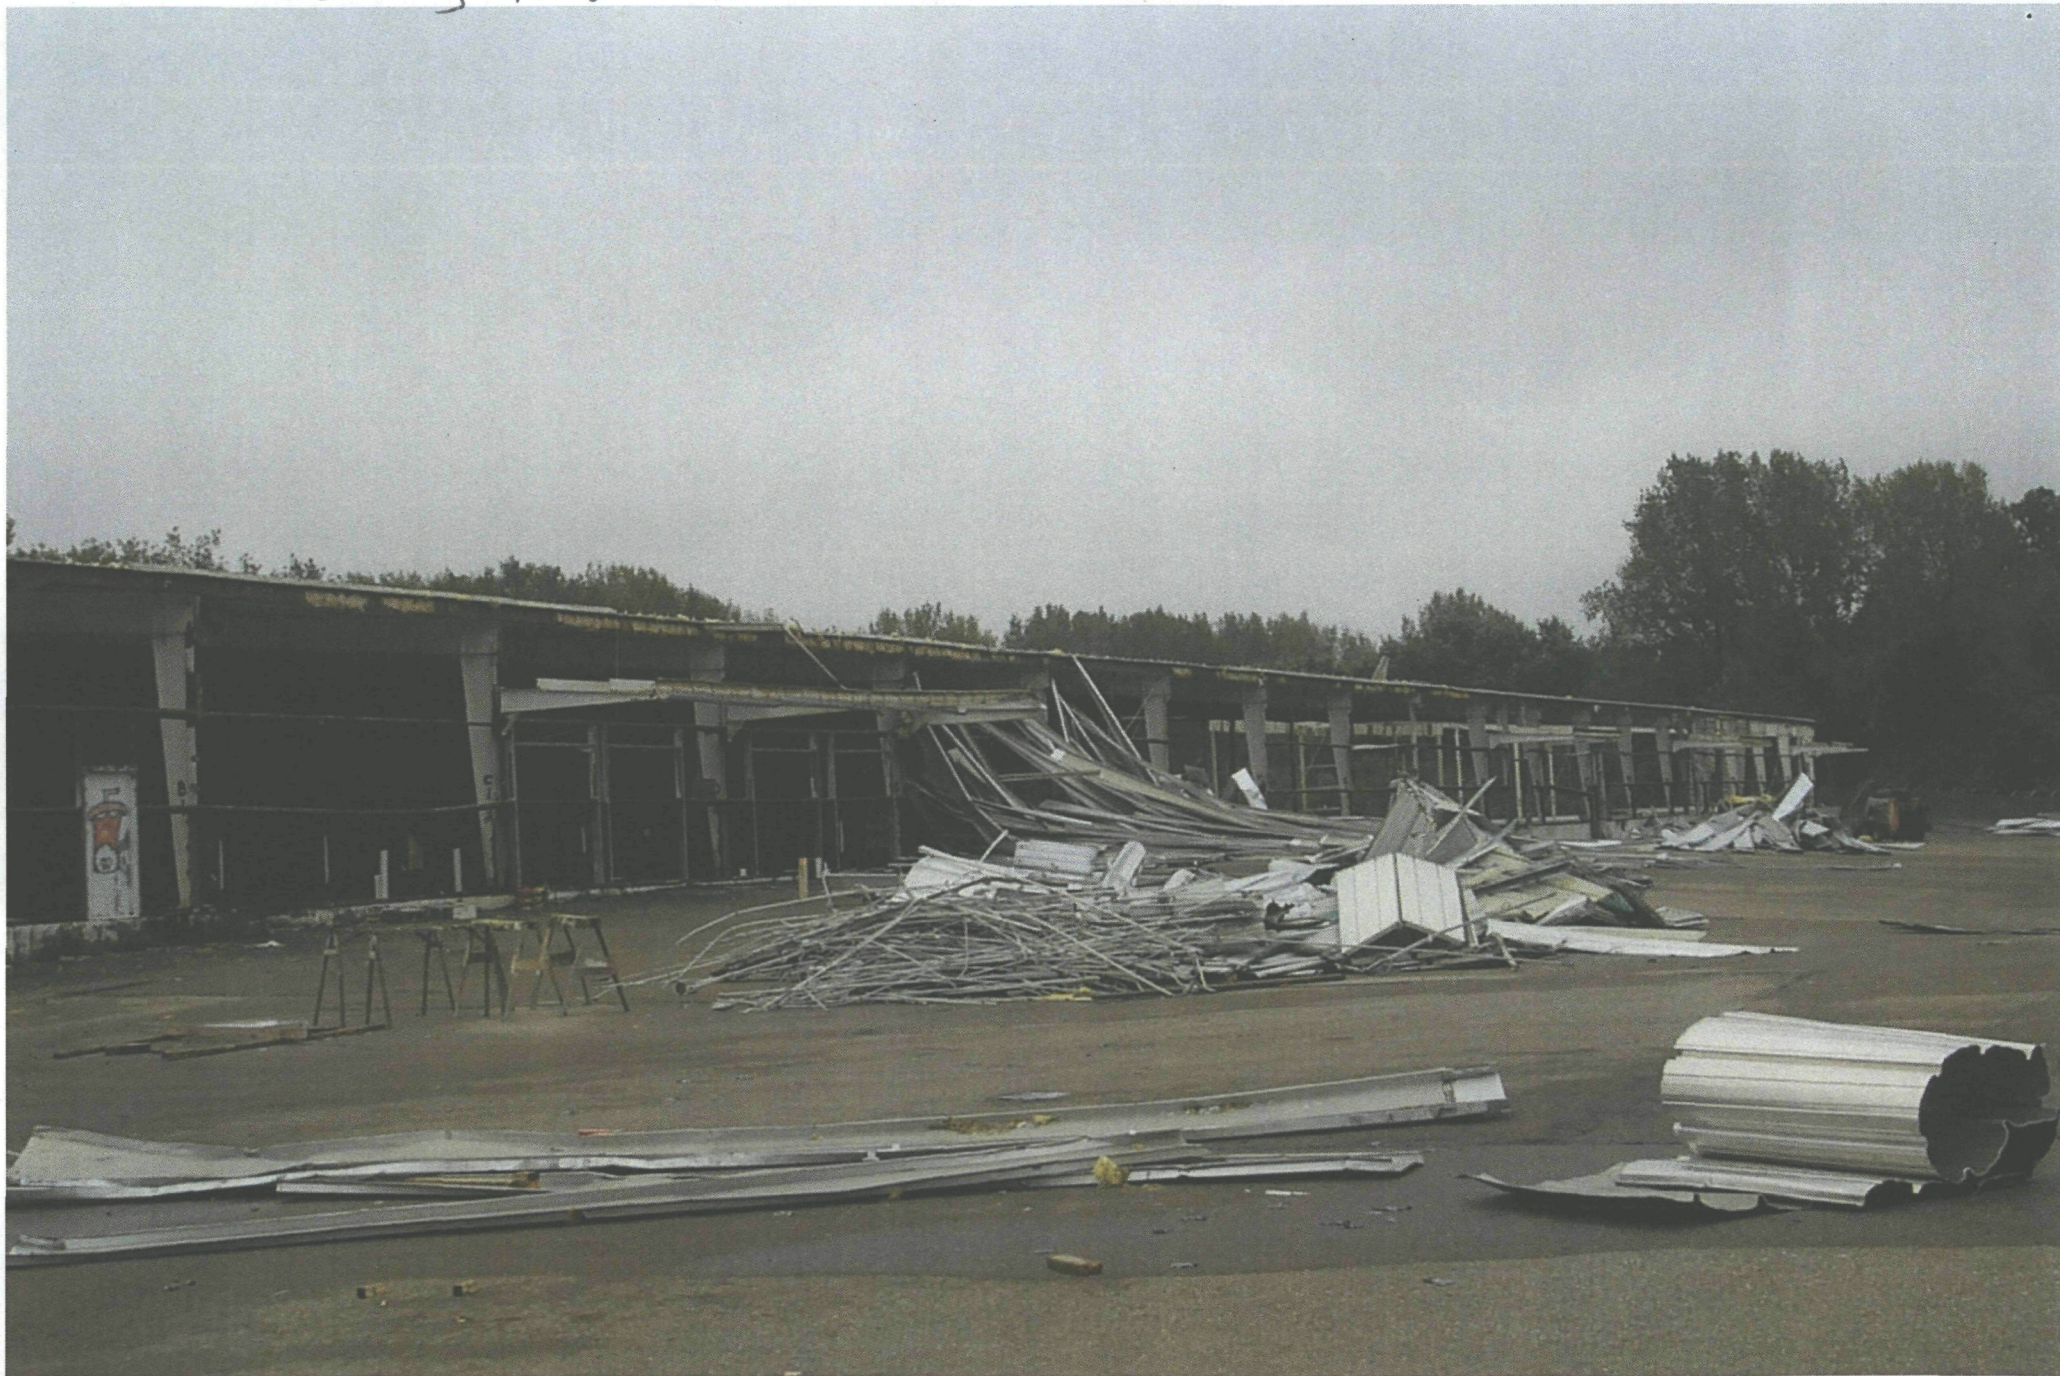
#2

Dico  
Building 4/5 demolition - view to the south

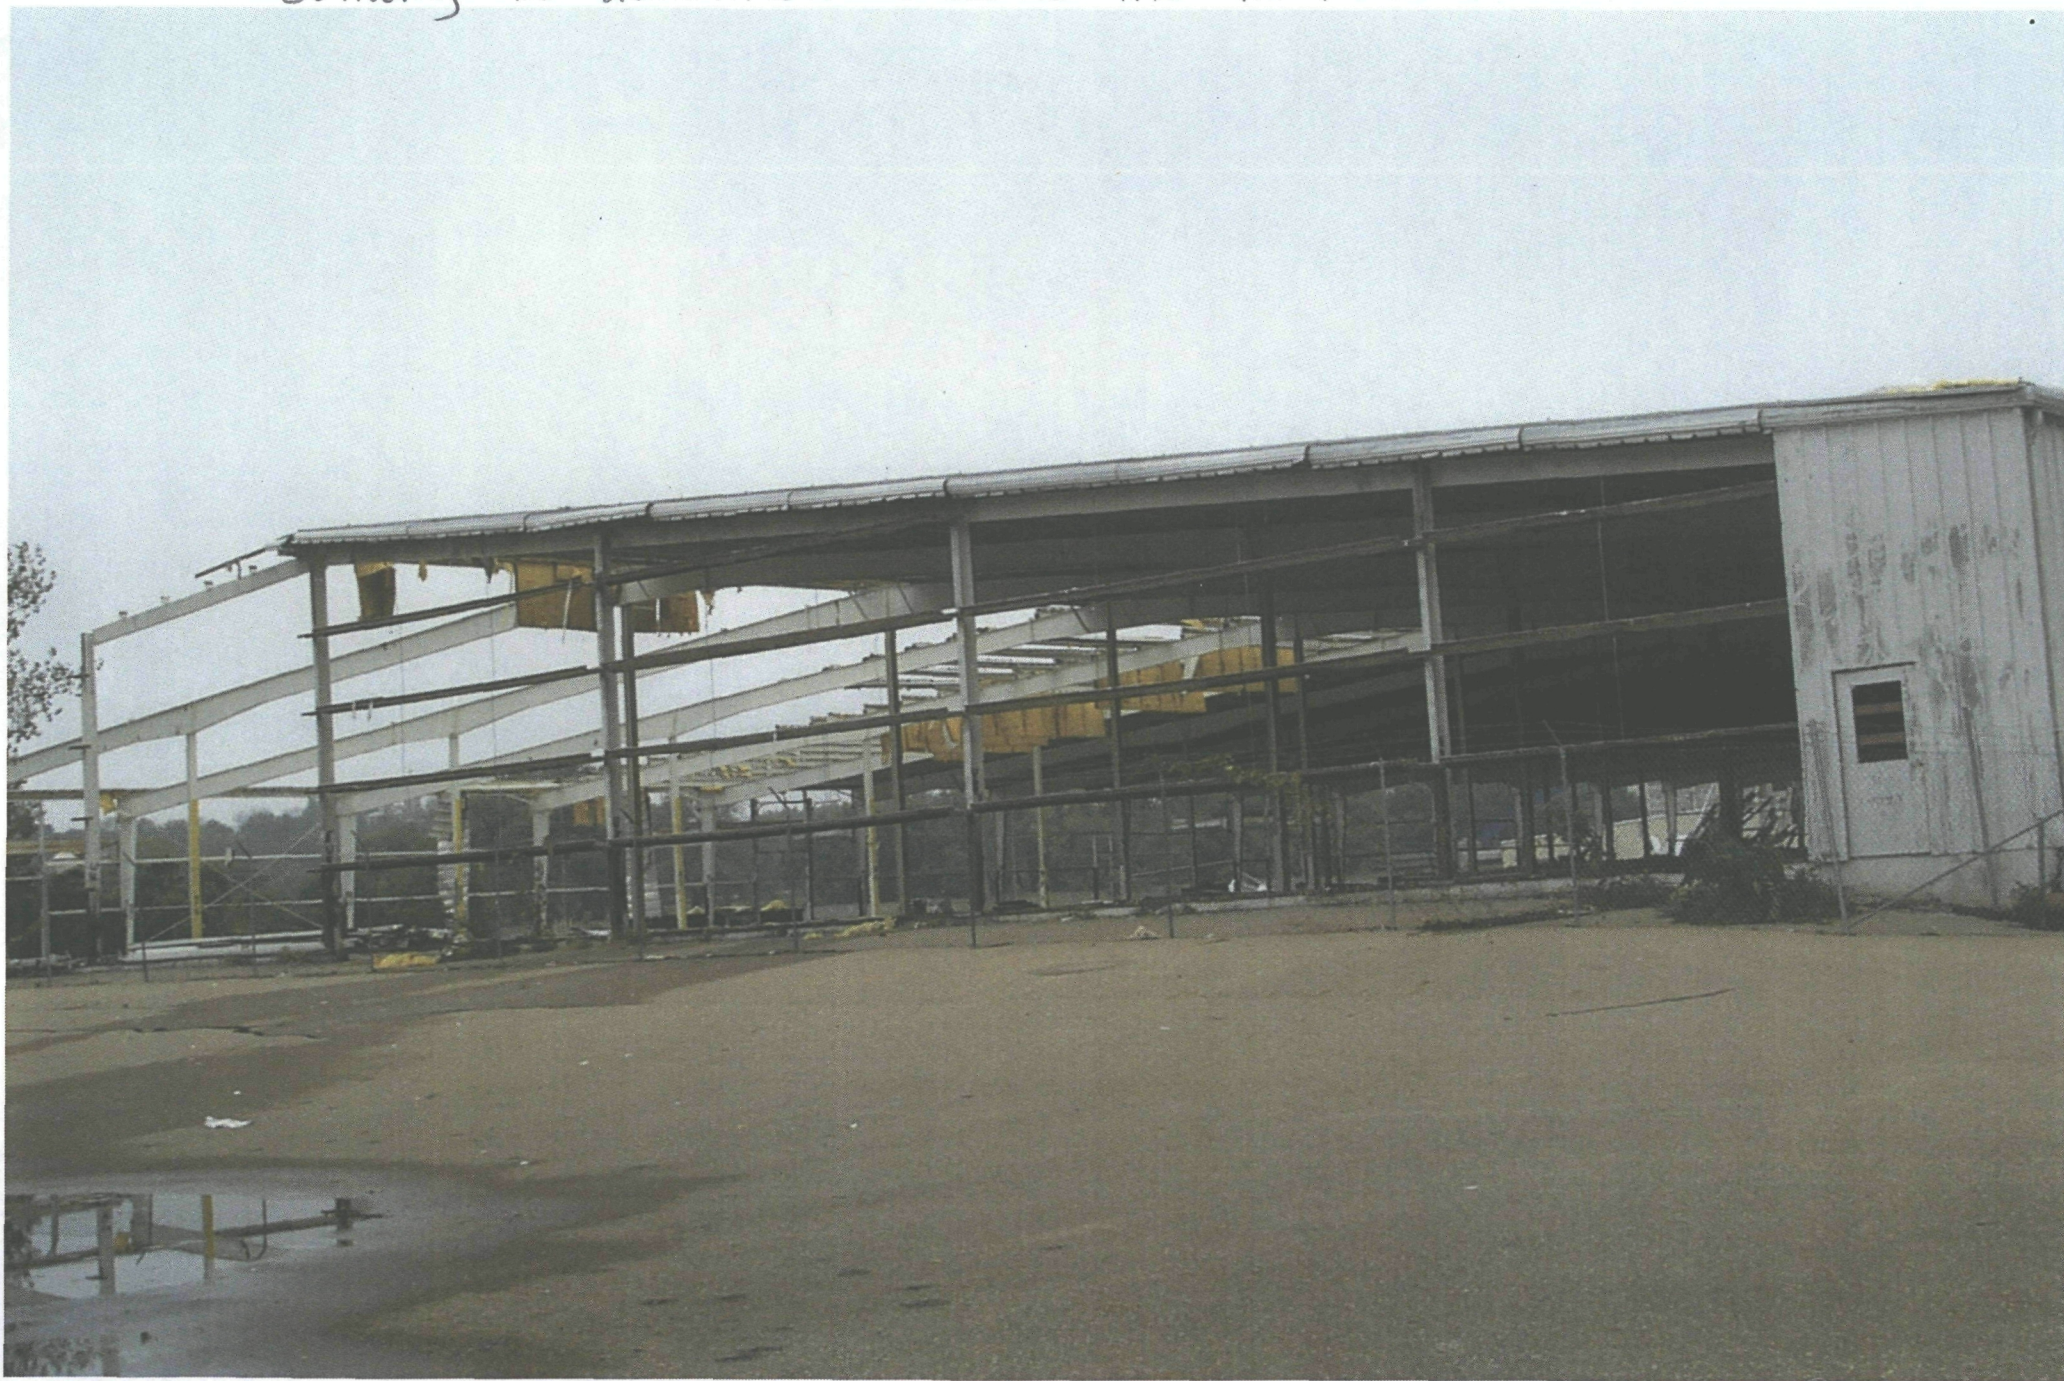
#3

Building 4/5 demolition - view to the north west

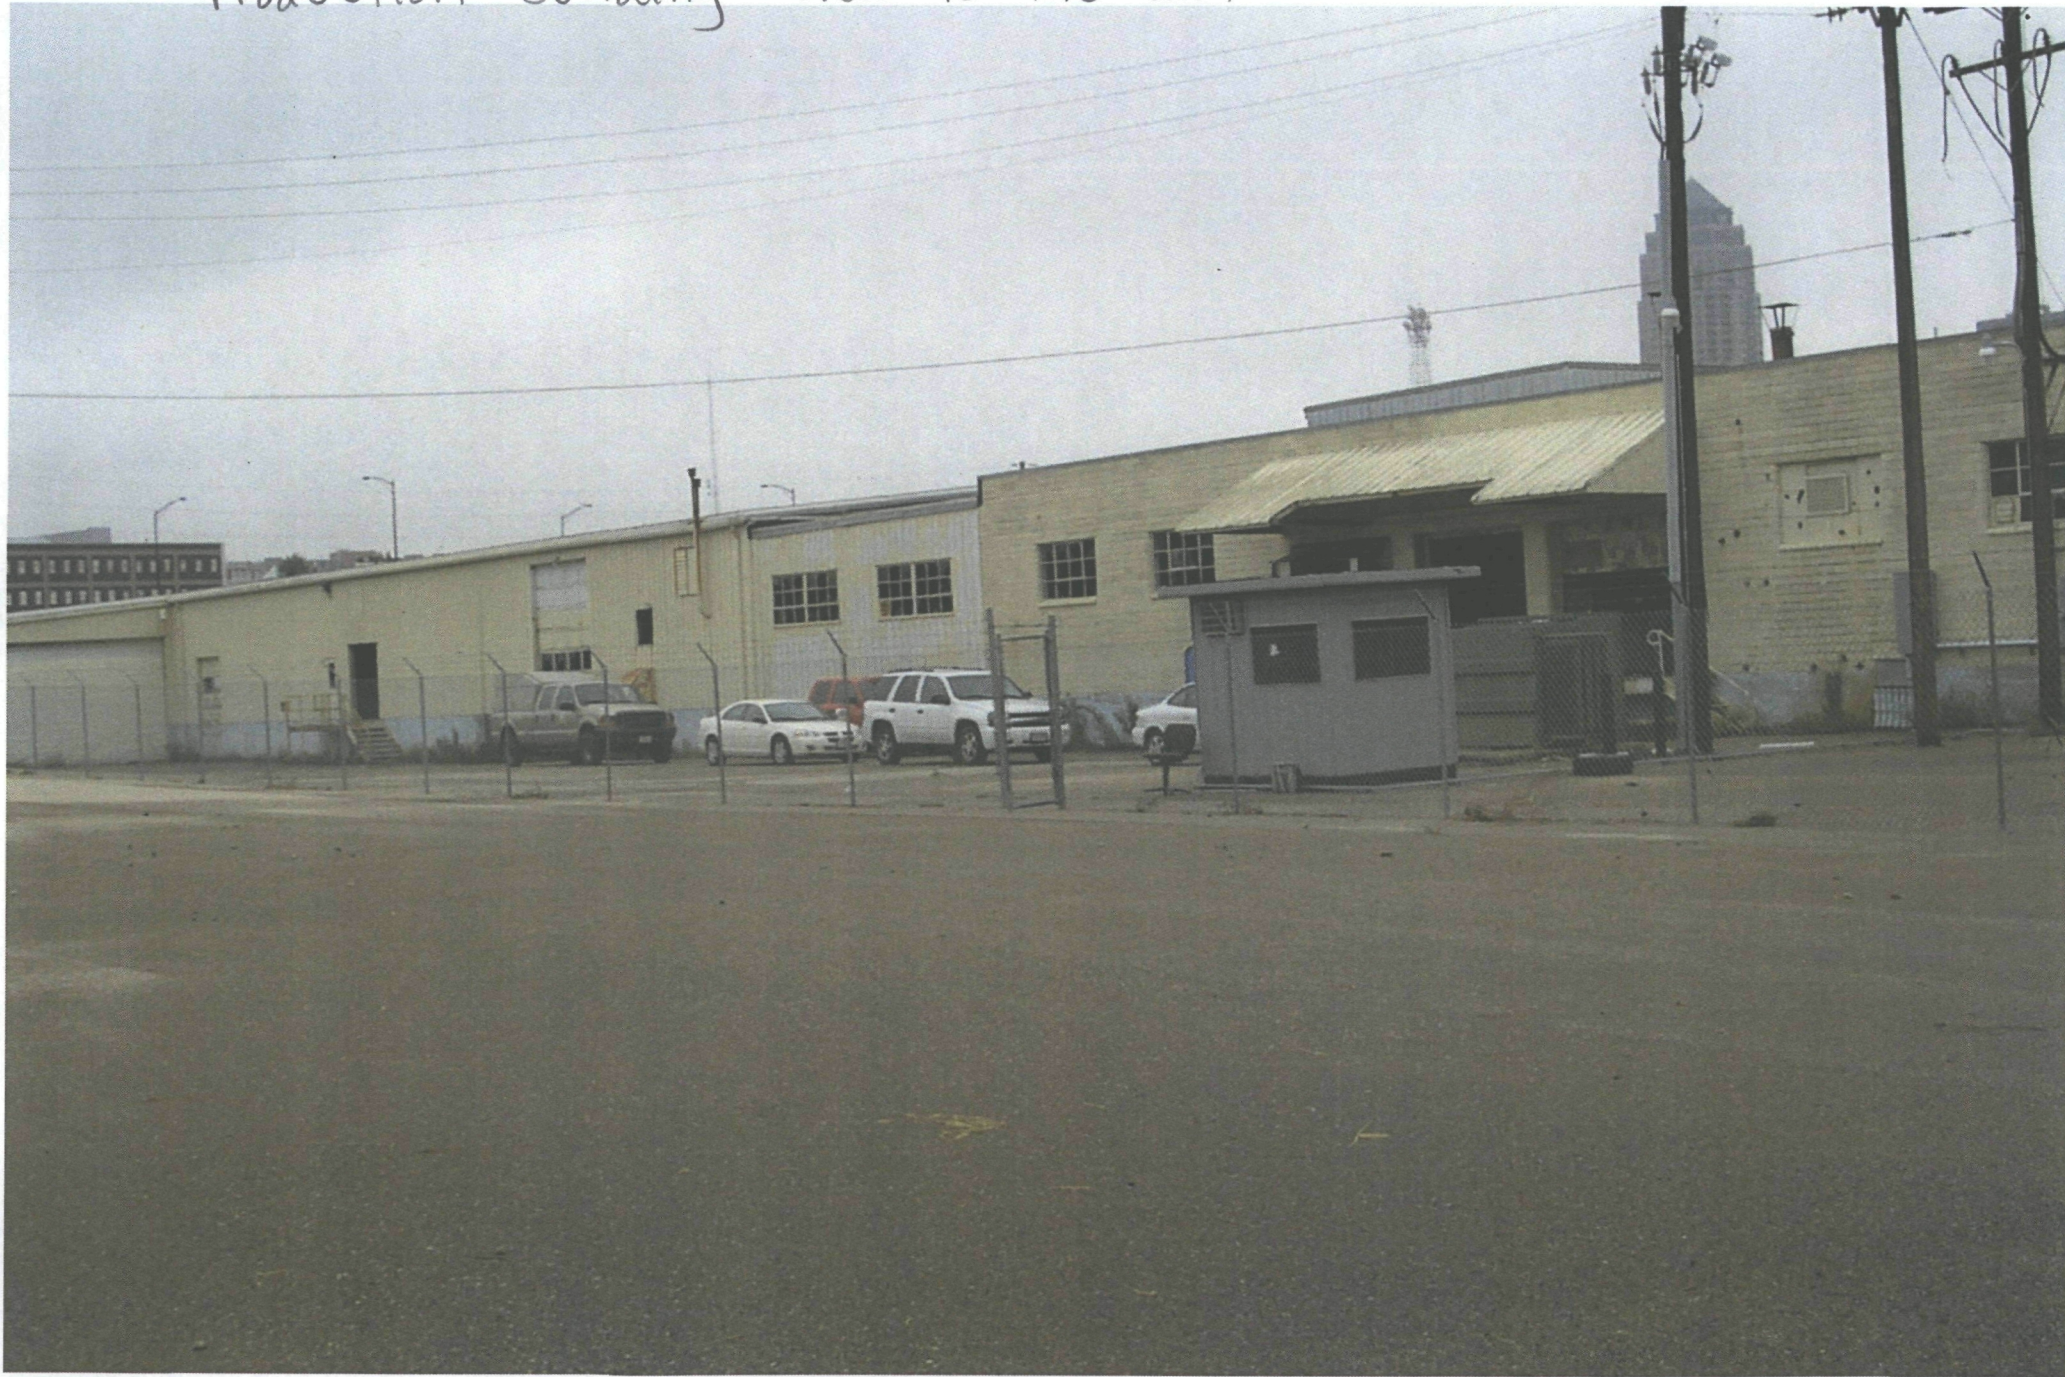
All other buildings remain intact. However, all windows have been broken out and most doors have been knocked in. Approximately 18 months ago, Dico erected a six foot chain link fence with barbed wire across the top to prevent trespassers from accessing the buildings on the property. Photograph 4 shows the fence and the Production building with the guard shack in the foreground. Photograph 5 depicts the general condition of the buildings at the site. Photograph 6 shows buildings 1-3 and the Maintenance building.

# 4 Dico  
Production Building - view to the east

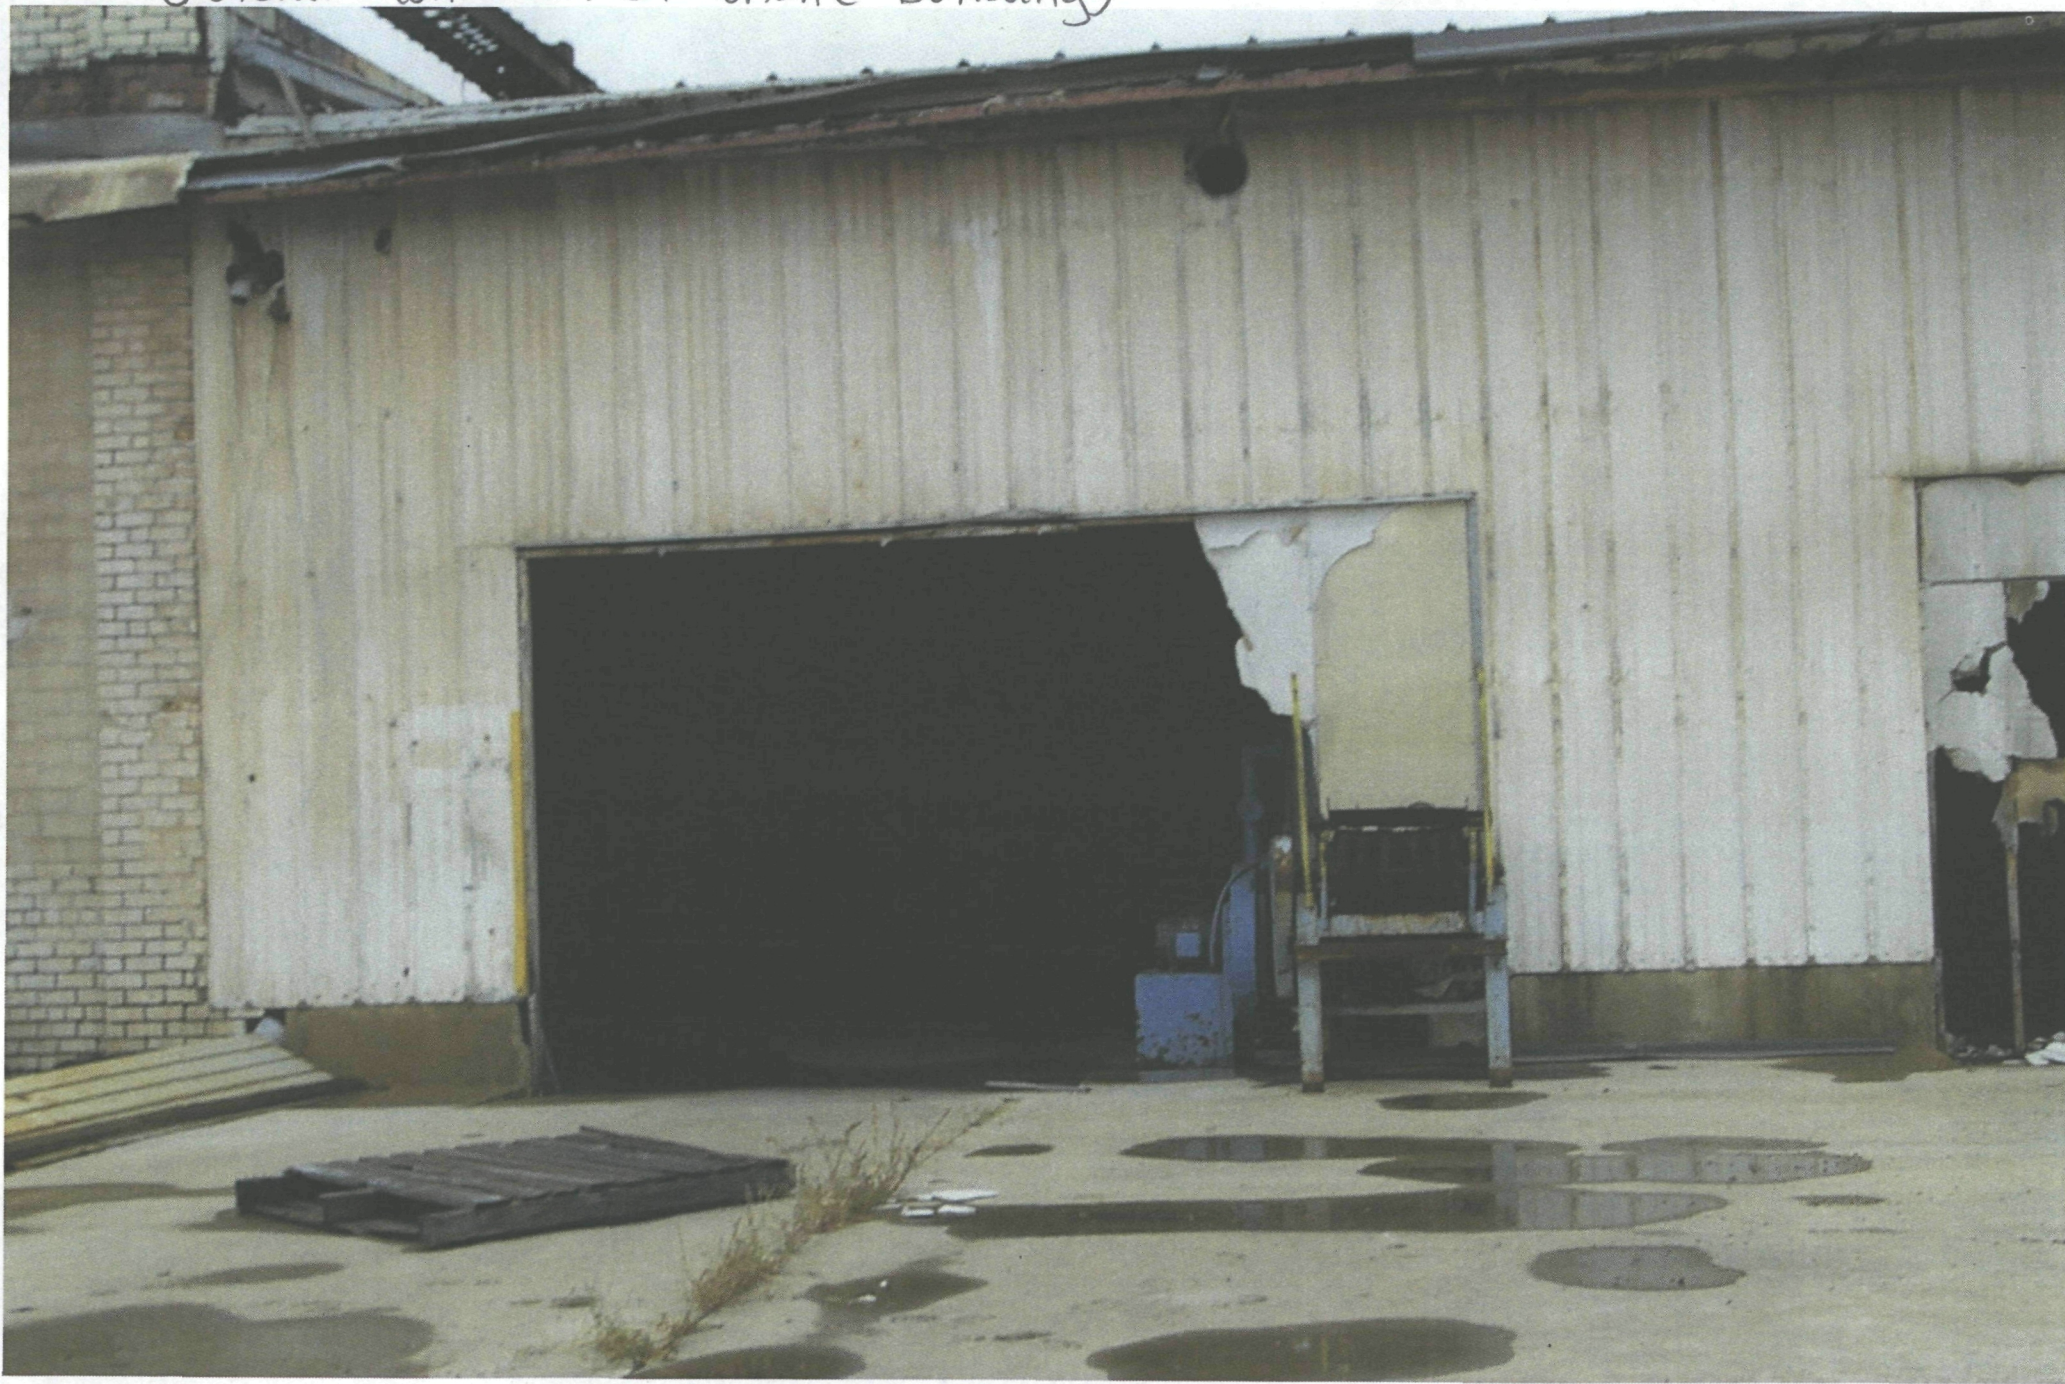
#5 Dico  
General condition of onsite buildings

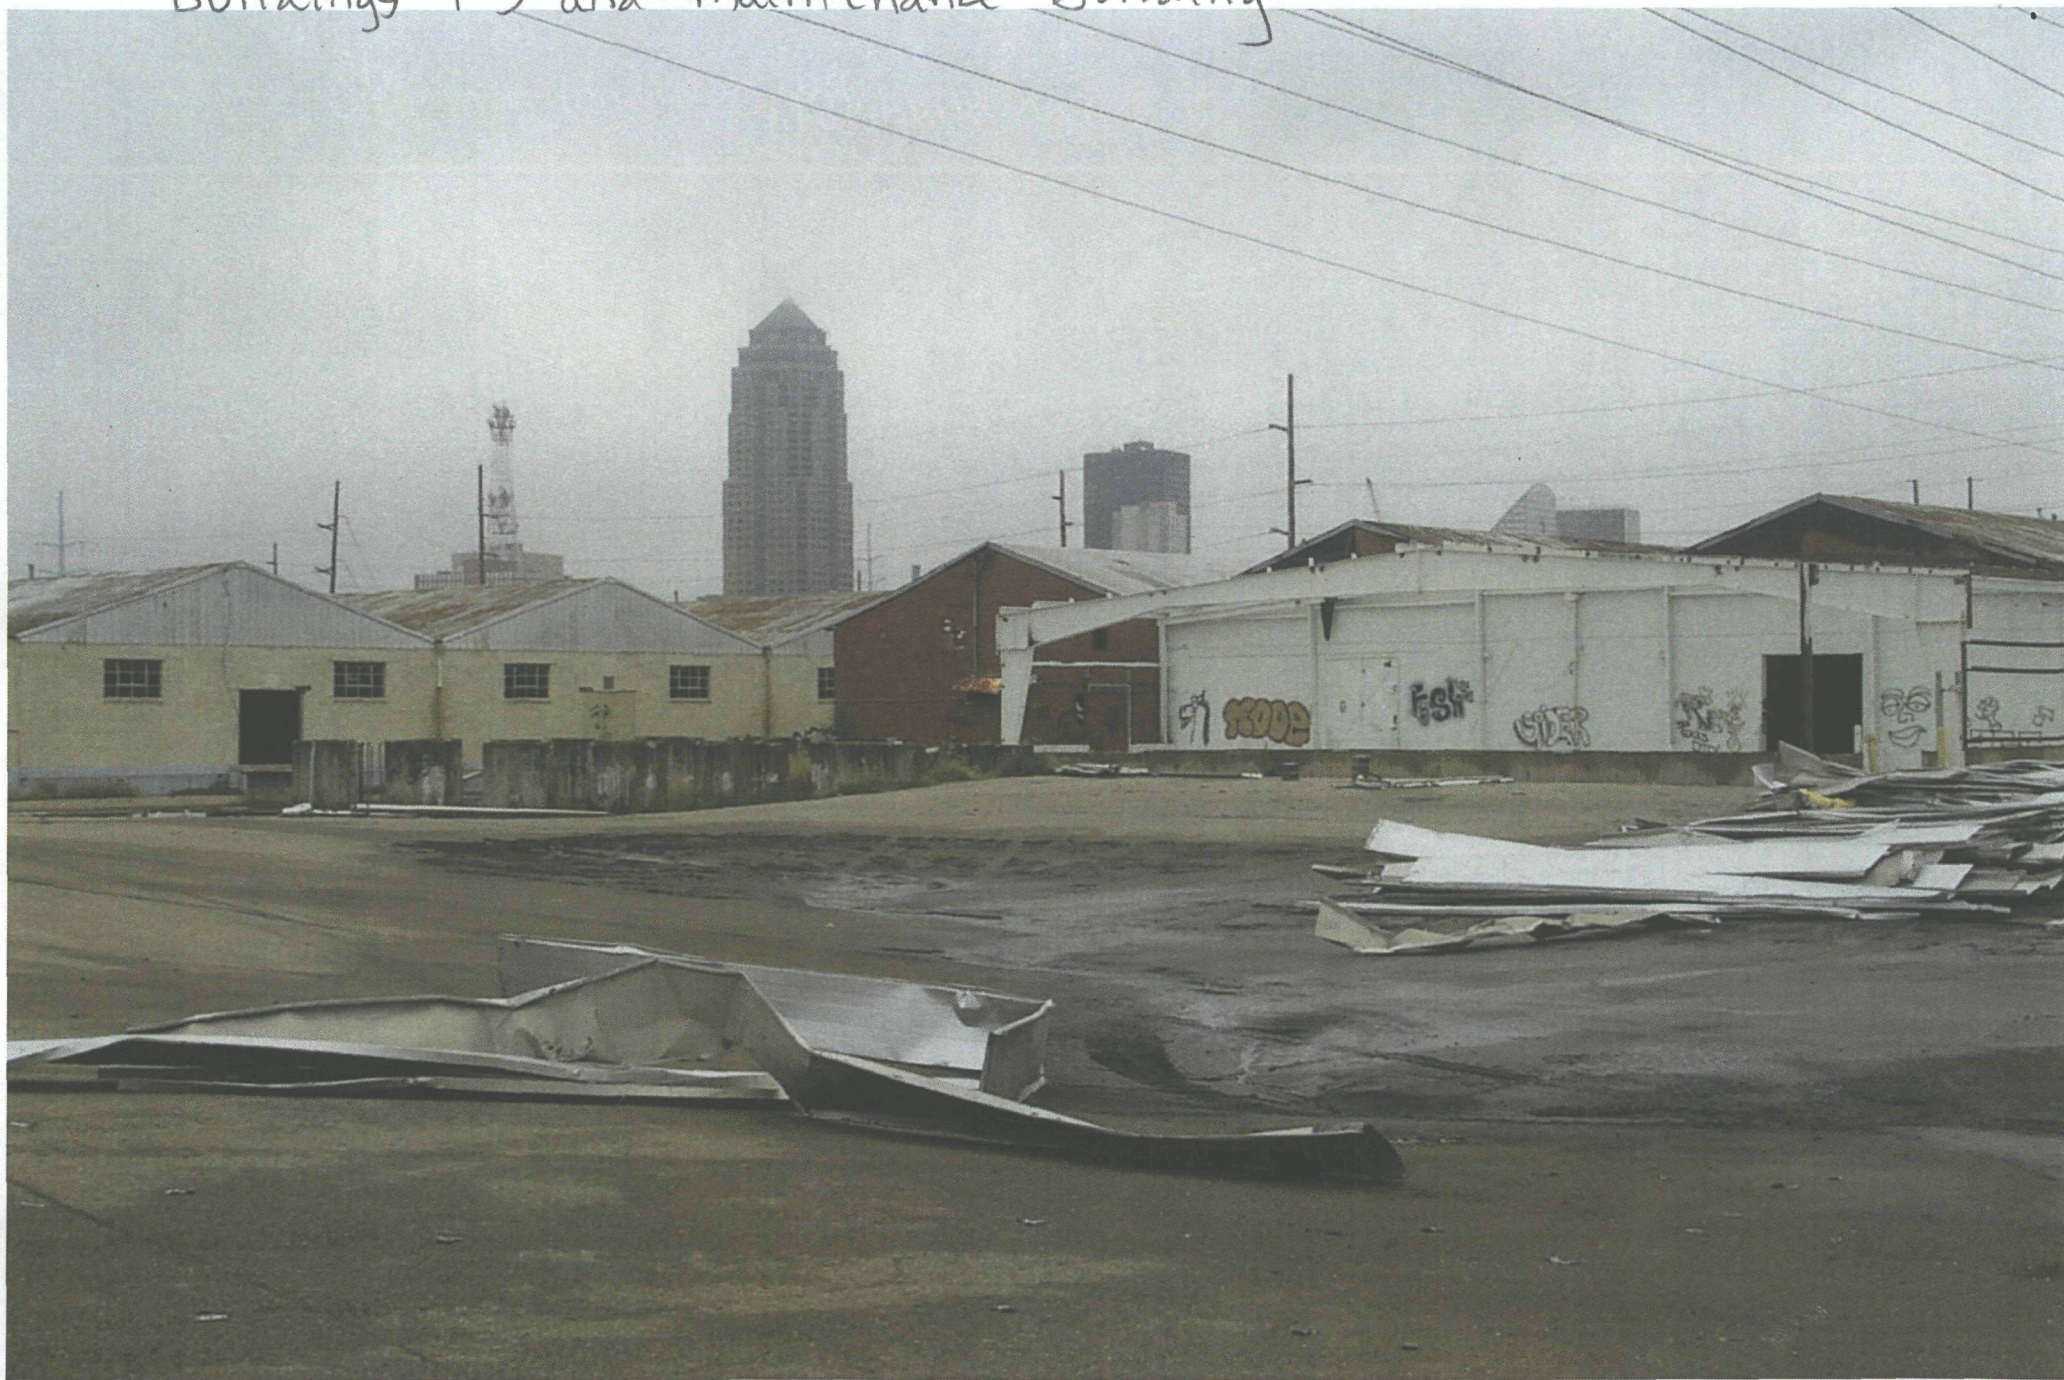
#6 Dico  
Buildings 1-3 and Maintenance Building

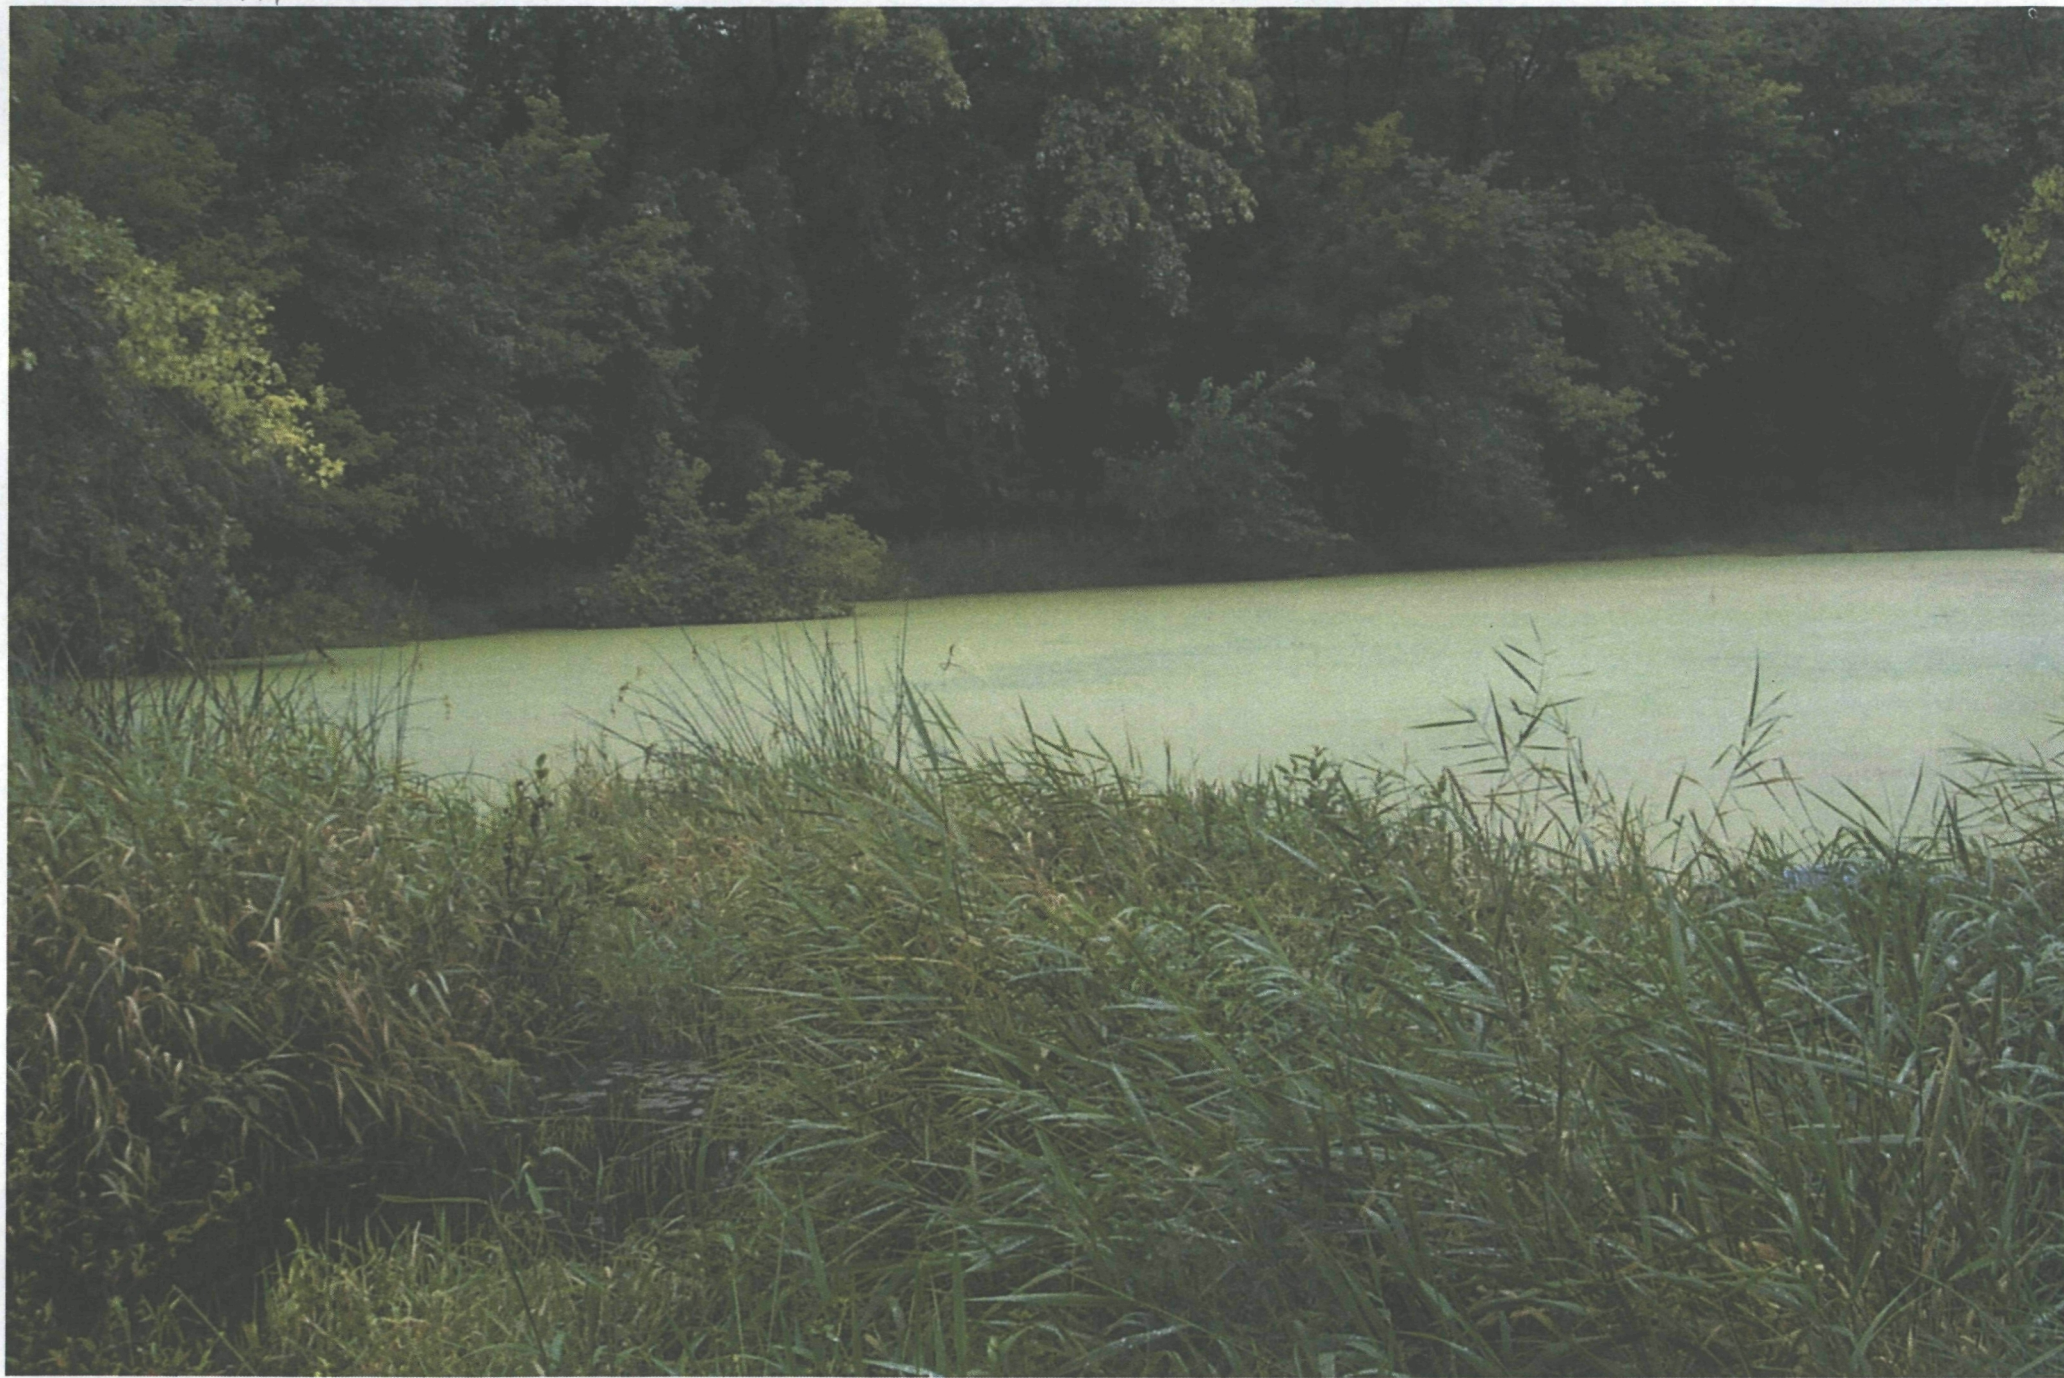
The South Pond area and drainage ditch east of Dico were inspected. The South Pond was full and stagnant with a thick layer of algae on the surface (see photograph 7). The overflow area contained water. Sediments from the overflow area were collected by IDNR and will be analyzed for pesticides of concern. The drainage ditch east of the Dico property was also full and stagnant with algae growing on the surface (see photograph 8).

#7 Dico  
South Pond Area
