# Site Inspection Report

Des Moines TCE Site  
September 2007

Superfund

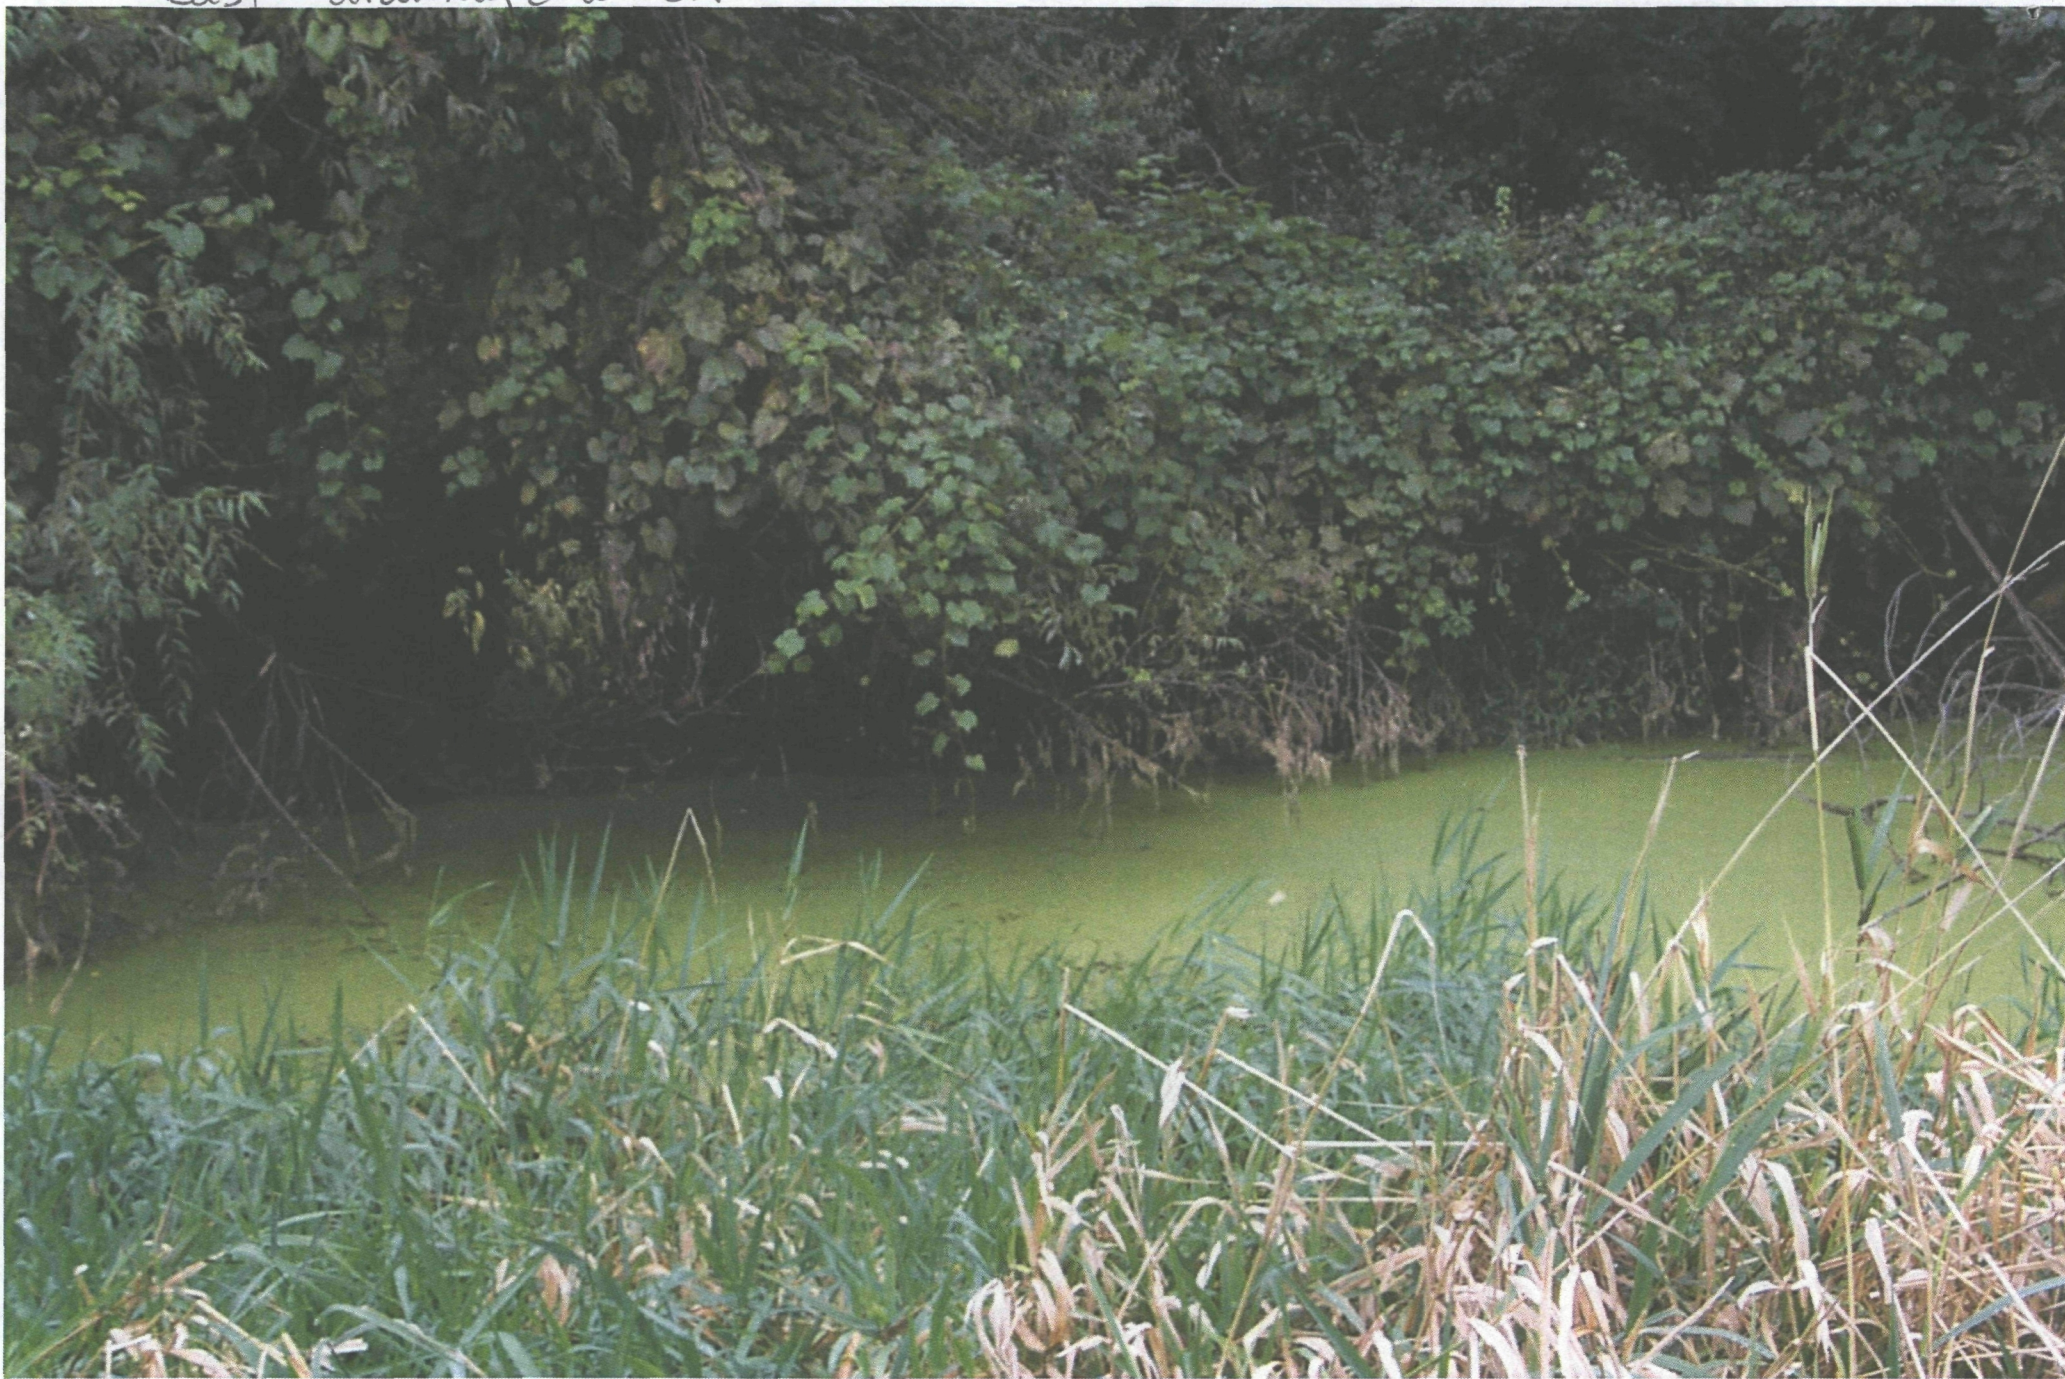
The South Pond area and drainage ditch east of Dico were inspected. The South Pond was full and stagnant with a thick layer of algae on the surface (see photograph 7). The overflow area contained water. Sediments from the overflow area were collected by IDNR and will be analyzed for pesticides of concern. The drainage ditch east of the Dico property was also full and stagnant with algae growing on the surface (see photograph 8).

#8 Dico  
East drainage ditch
