September 30, 2009

**Subject: Final Emergency Response Letter Report  
Goodwater Mercury Spill  
Goodwater, Coosa County, Alabama  
EPA Contract No. EP-W-05-054  
TDD No. TTEMI-05-001-0102**

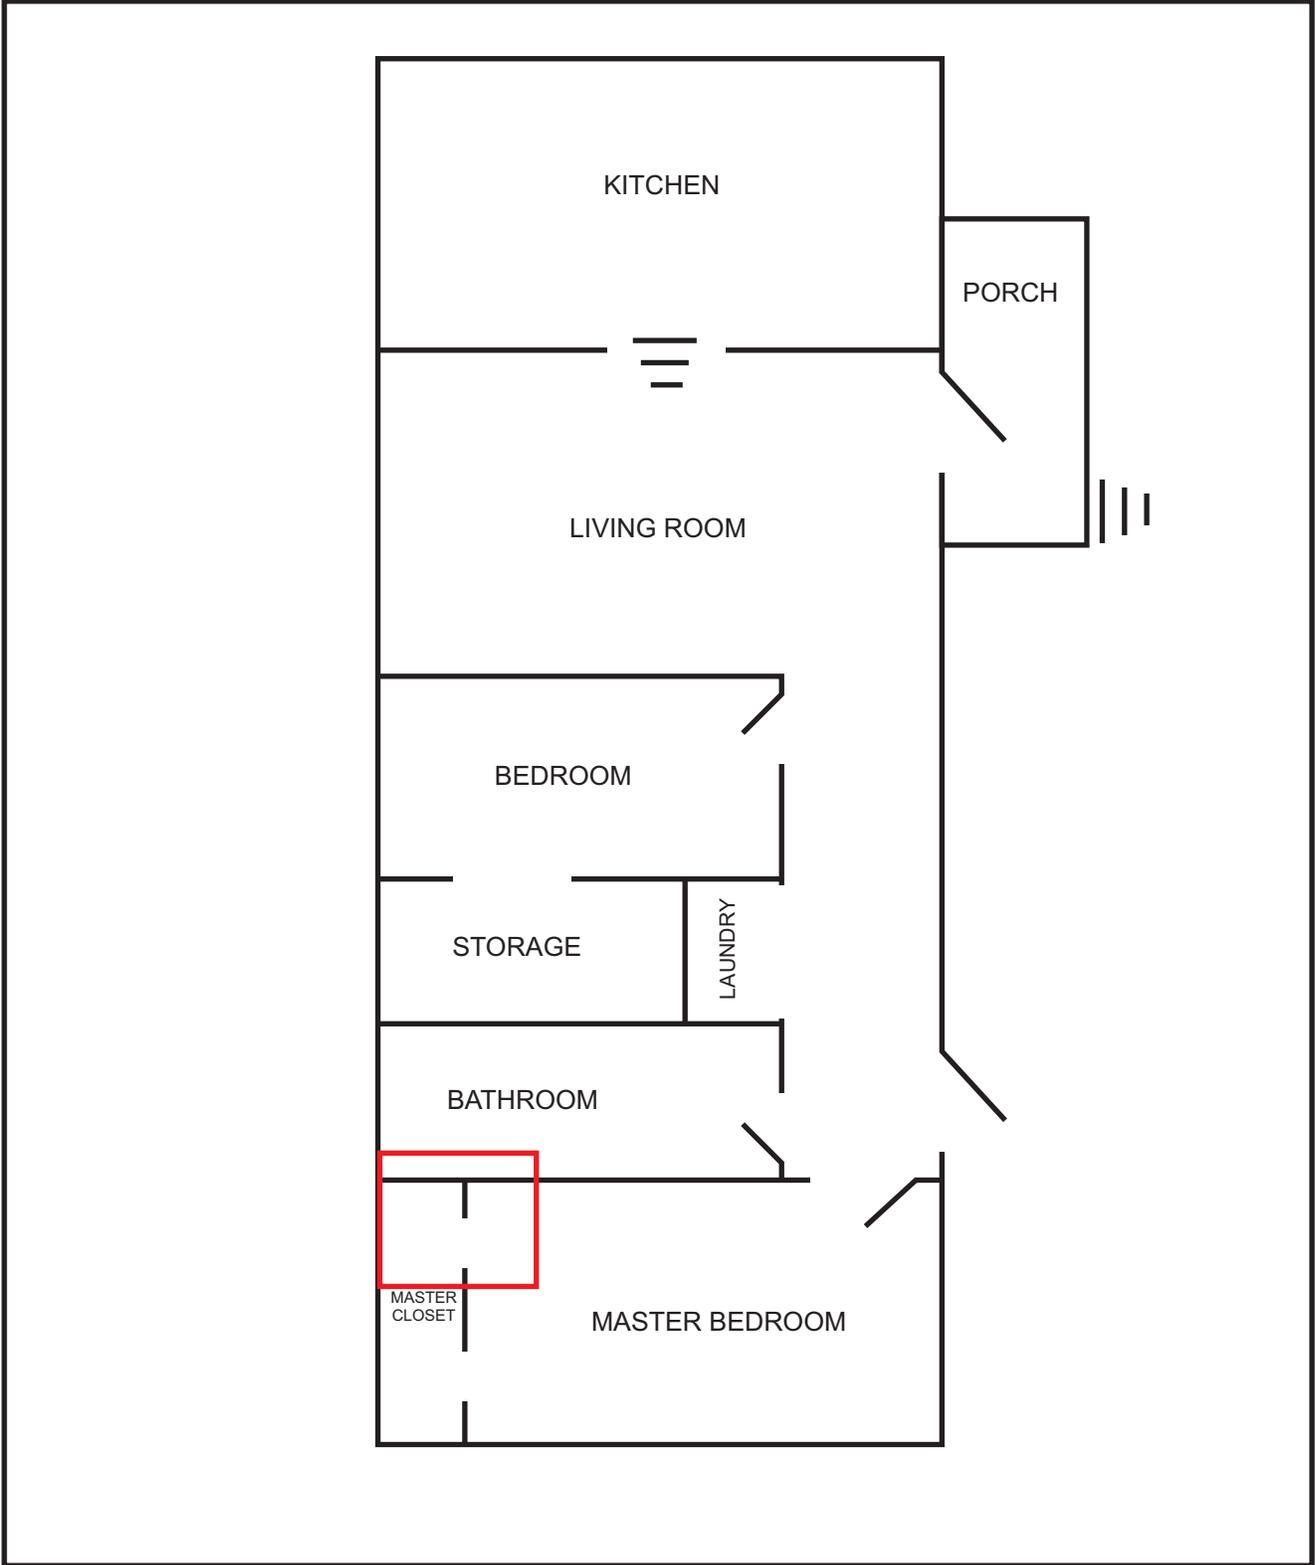
**FIGURE 2  
RESIDENCE LAYOUT**

AREA OF SIGNIFICANT  
STRUCTURAL COMPONENT  
IMPACT

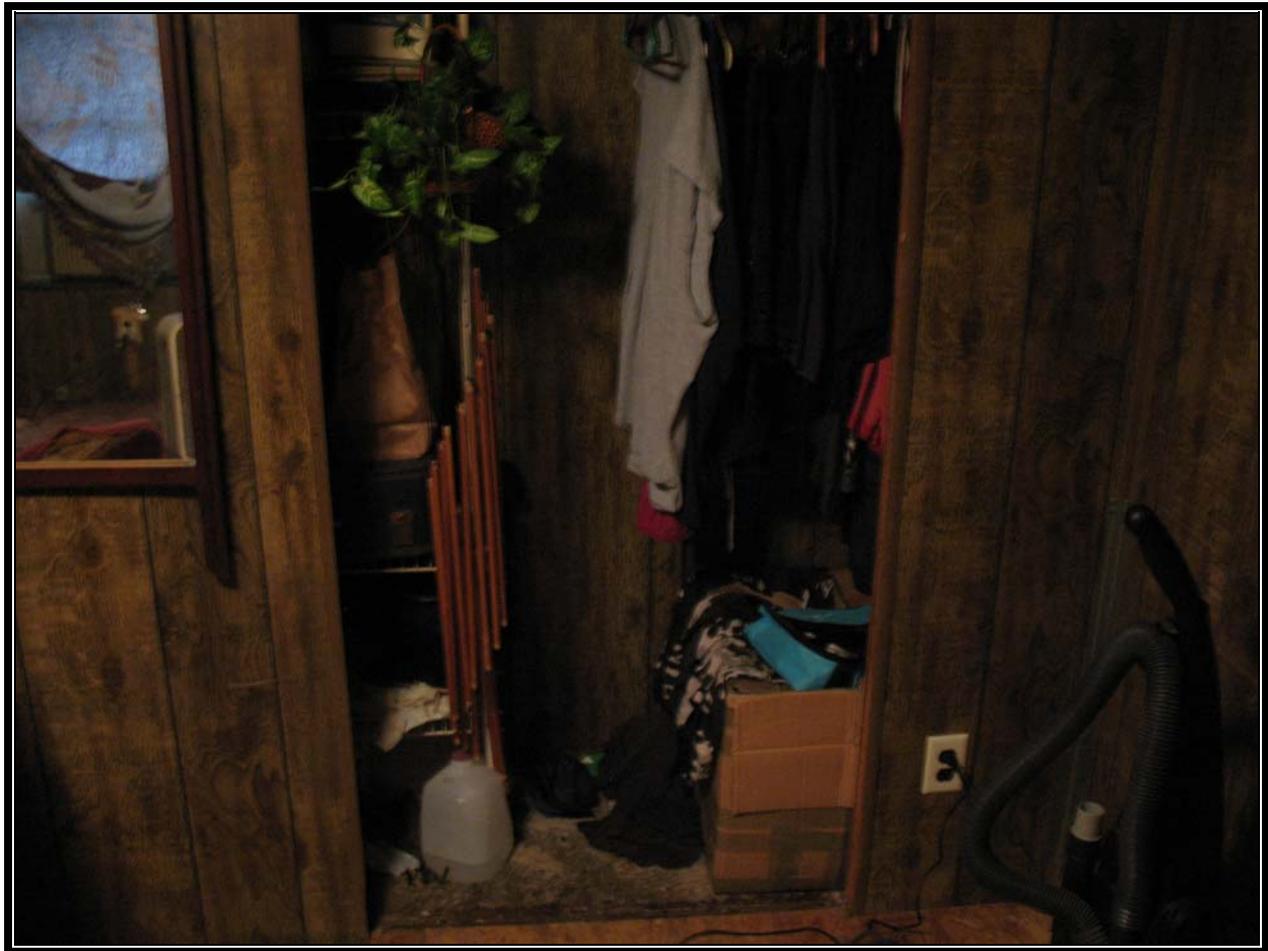
**OFFICIAL PHOTOGRAPH NO. 3  
U.S. ENVIRONMENTAL PROTECTION AGENCY**

**Subject:** The location of the original spill within the master bedroom. The floor slopes to the right of the photograph, with much of the contamination eventually becoming embedded in the partition of the closet.

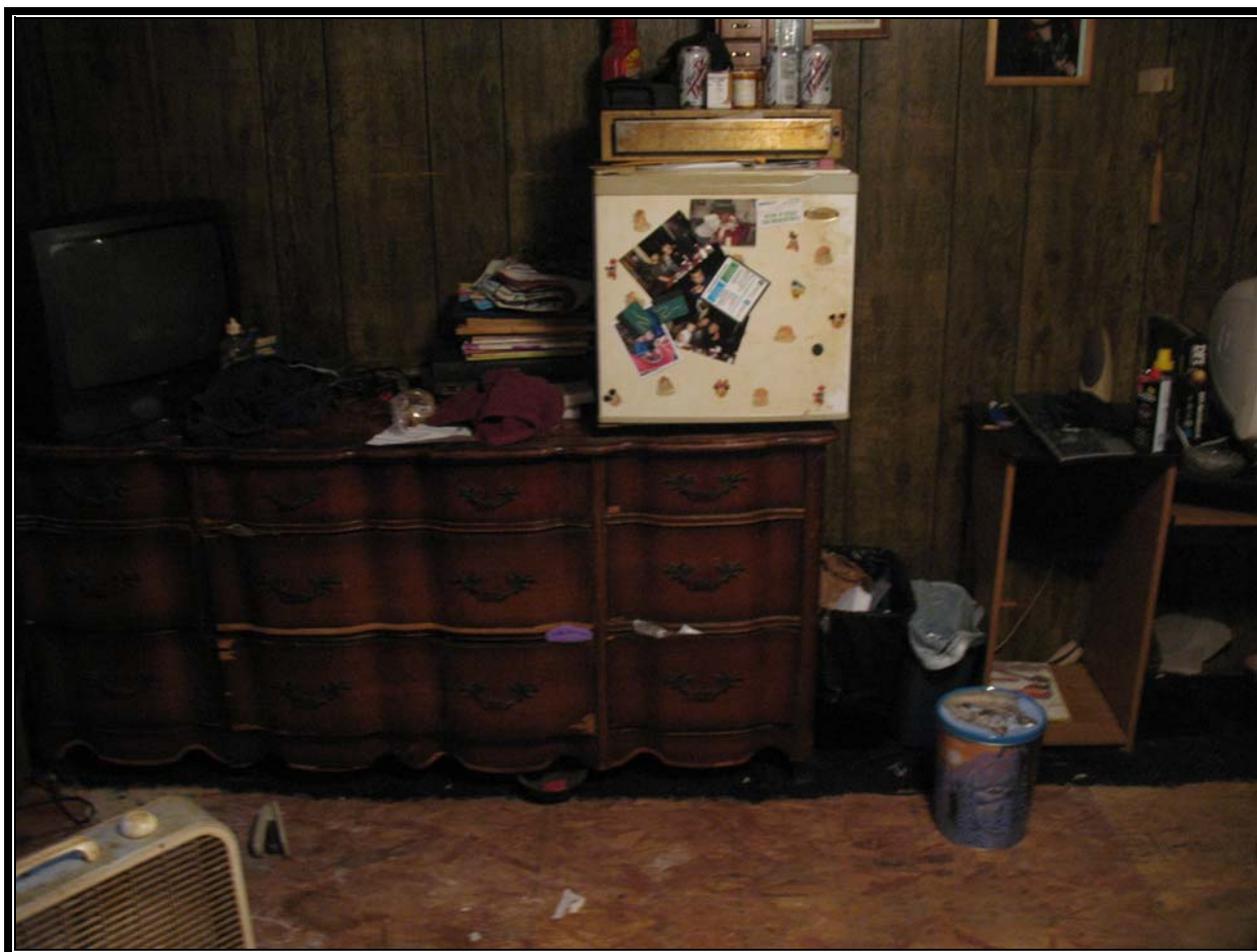
**OFFICIAL PHOTOGRAPH NO. 4**  
**U.S. ENVIRONMENTAL PROTECTION AGENCY**

**Subject:** Furniture in the master bedroom.

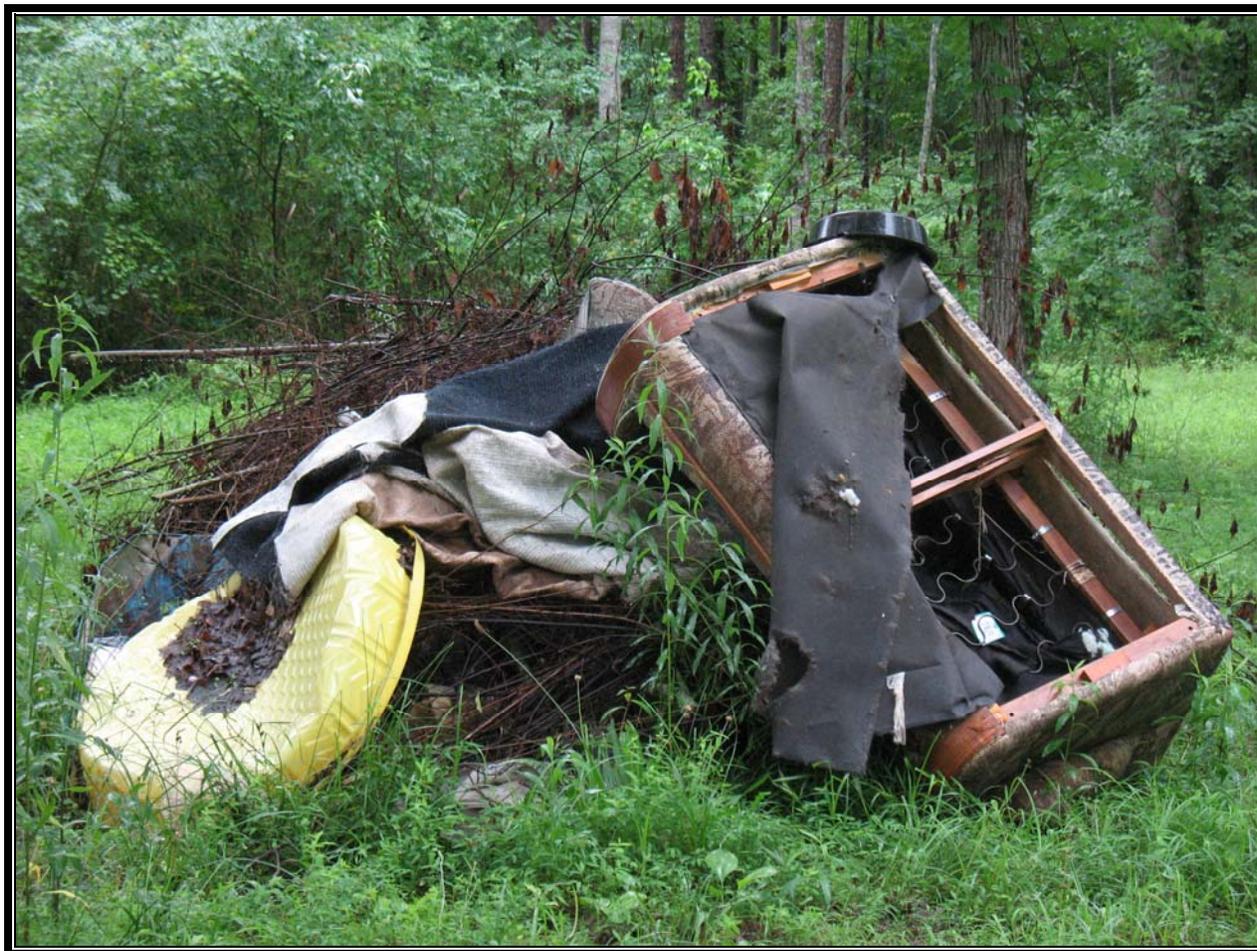
**OFFICIAL PHOTOGRAPH NO. 5**  
**U.S. ENVIRONMENTAL PROTECTION AGENCY**

**Subject:** Furniture and carpeting removed by the homeowner and stored outside before EPA arrived.

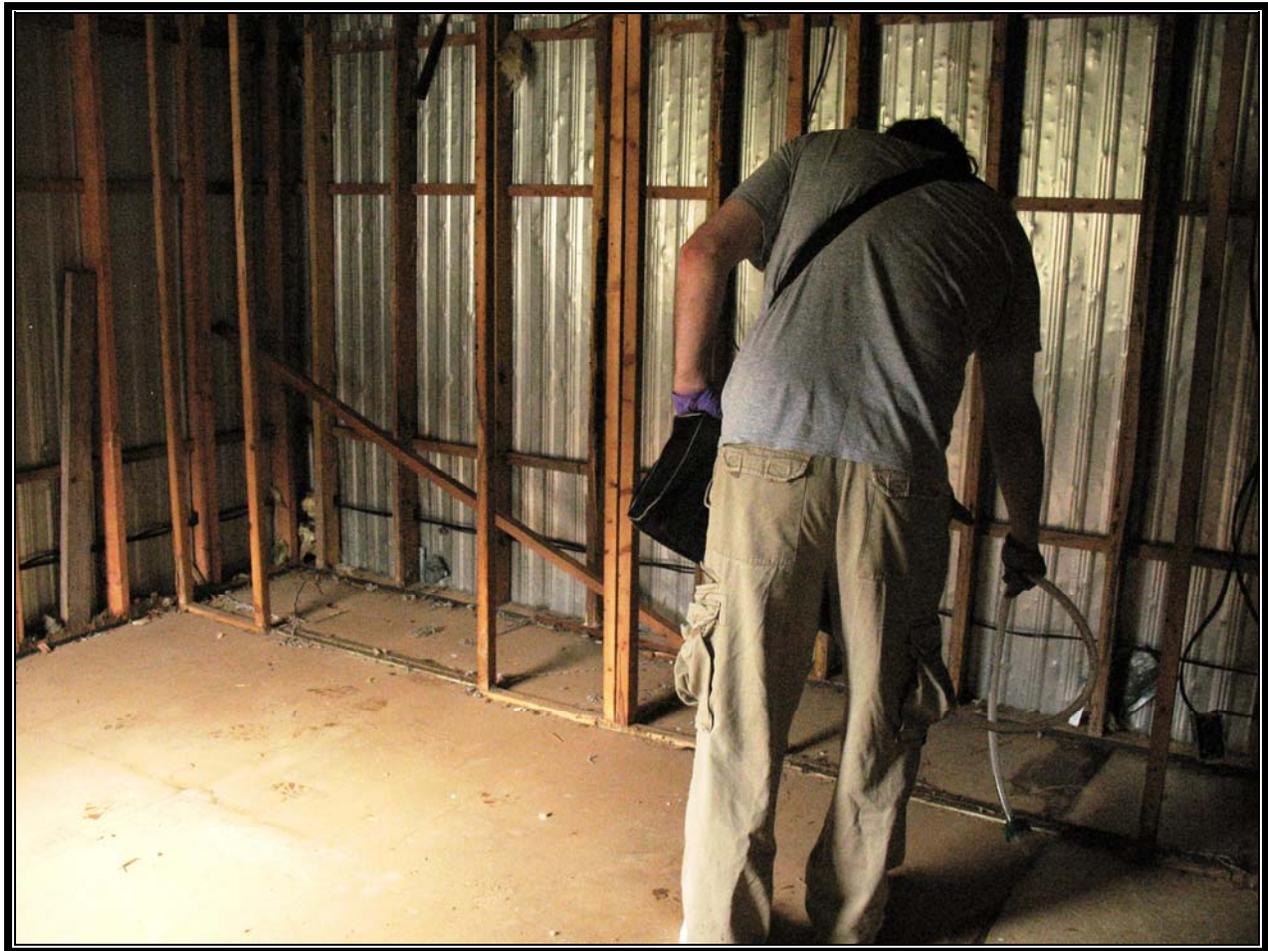
**OFFICIAL PHOTOGRAPH NO. 7**  
**U.S. ENVIRONMENTAL PROTECTION AGENCY**

On the morning of June 14, Tetra Tech assessed the exposed subfloor and wall joists from the master bedroom and identified mercury levels remaining at the surface of more than 40,000  $\text{ng}/\text{m}^3$ . Ambient levels were about 16,000  $\text{ng}/\text{m}^3$ . Based on these levels, OSC Williamson elected to remove additional structural components. In response, USES removed the subfloor, ceiling panels, and ceiling insulation from the master bedroom. Tetra Tech assessed the newly exposed components and found that the mercury contamination had seeped deeply into the structure of the building over the intervening 9 months since the spill occurred. Complicating the cleanup were the extremely high afternoon temperatures, approaching 95°F daily. With the wall and ceiling insulation removed from the master bedroom, daily temperatures inside rose above 100°F, causing ambient mercury vapor concentrations to rise dramatically from the morning to the afternoon. Concerned that, regardless of remedial efforts in the master bedroom, ambient levels in the remainder of the house would remain above the action level, OSC Williamson tasked Tetra Tech with assessing the actual mercury load within the rest of the house. Tetra Tech and USES worked together to build a containment barrier between the master bedroom and the rest of the building. The master bedroom was placed under negative air pressure overnight.

**Subject:** Tetra Tech monitoring recently exposed areas of the bedroom subfloor. Mercury vapor readings were still highly elevated at this point, and the subfloor was subsequently removed.

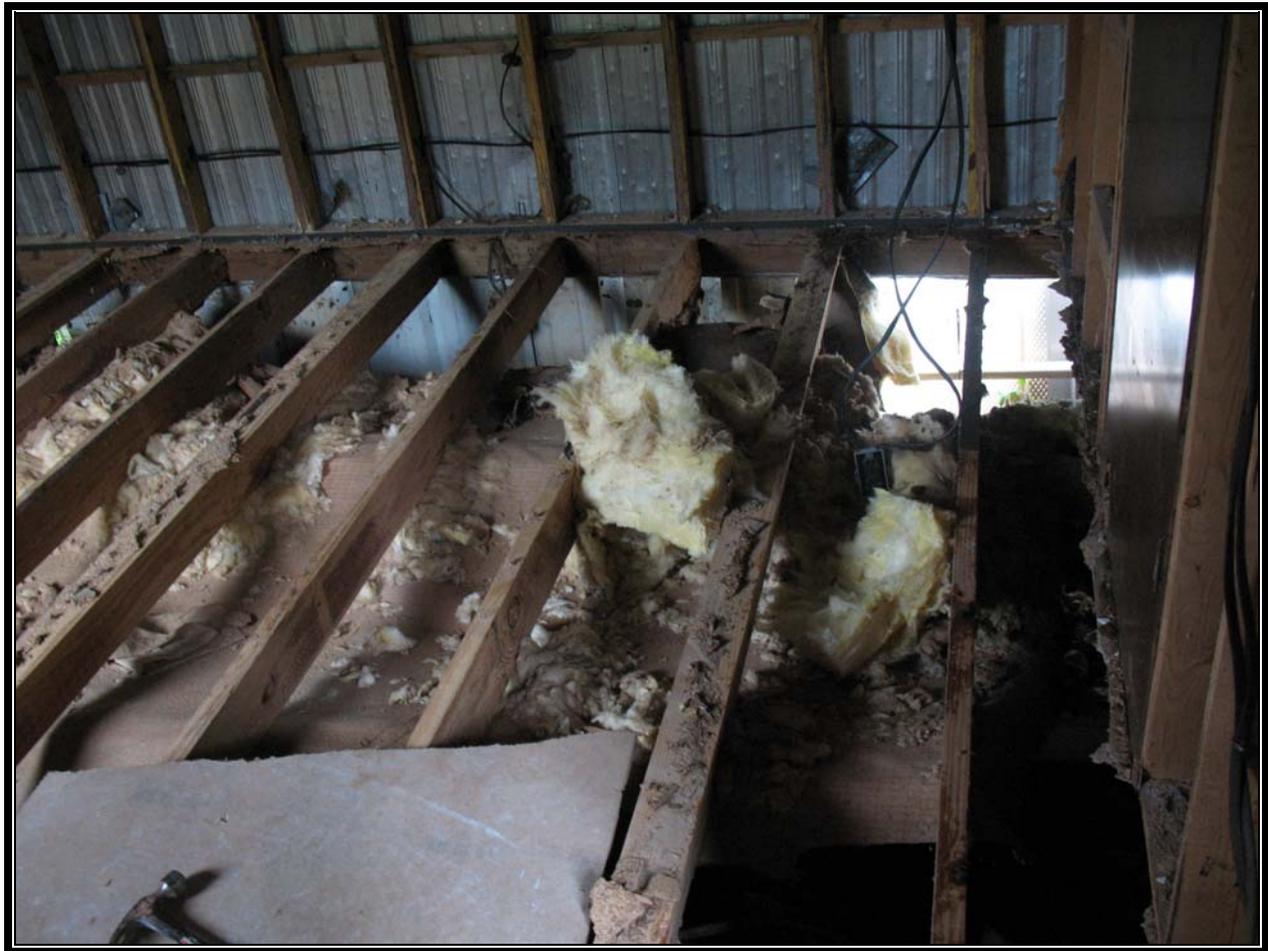
**OFFICIAL PHOTOGRAPH NO. 8**  
**U.S. ENVIRONMENTAL PROTECTION AGENCY**

**Subject:** Exposed floor joists and insulation in the master bedroom. Subsequent mercury vapor monitoring of these structural components revealed deeply embedded mercury contamination.

START recommends ERS contractors take out all floor joists, base plates and studs to master bedroom.

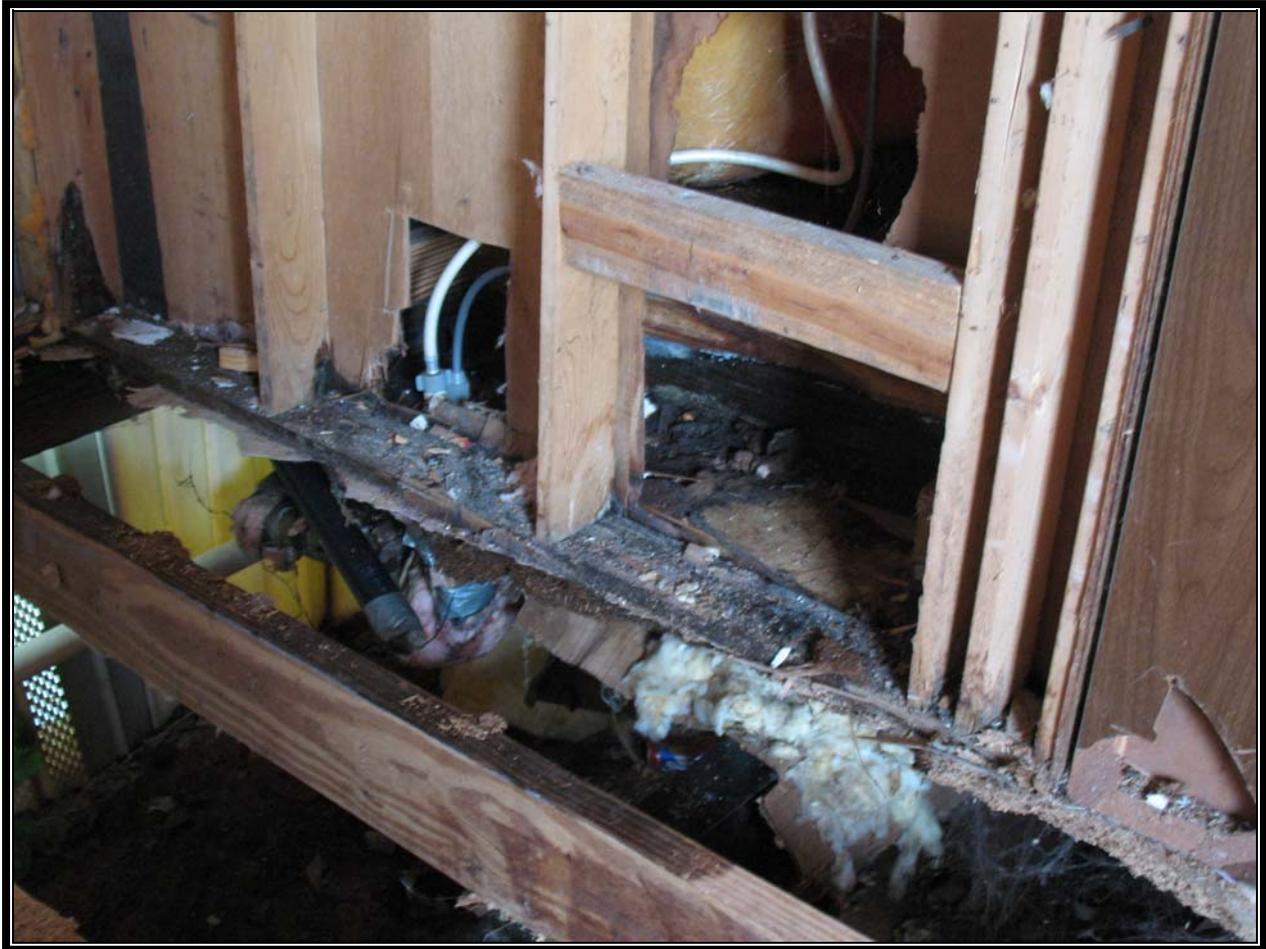
**OFFICIAL PHOTOGRAPH NO. 9  
U.S. ENVIRONMENTAL PROTECTION AGENCY**

**Subject:** Rotten flooring beneath the tub. The condition of this flooring made removal of all mercury-contaminated structural components unfeasible.

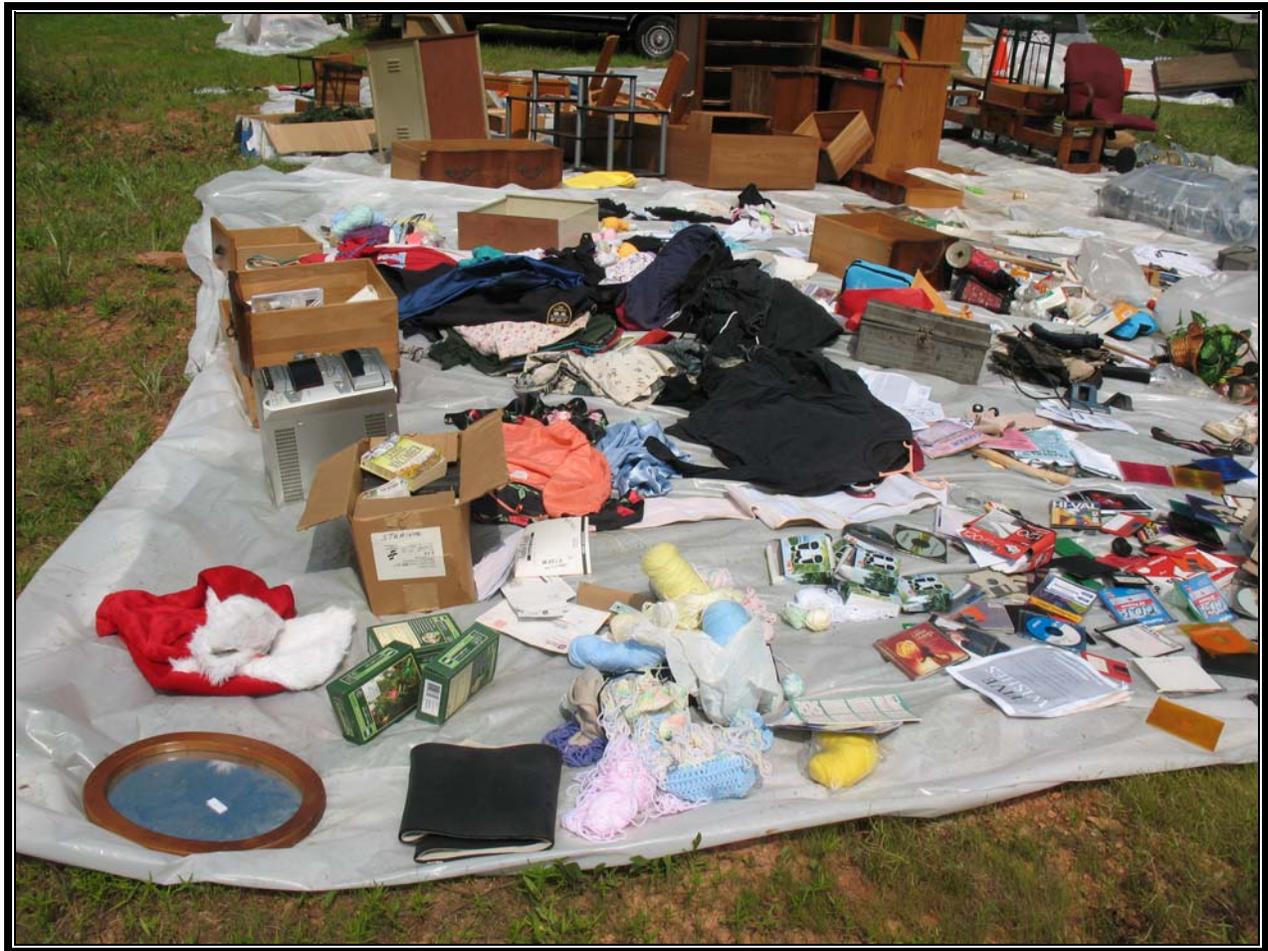
**OFFICIAL PHOTOGRAPH NO. 16  
U.S. ENVIRONMENTAL PROTECTION AGENCY**

**Subject:** Items that the homeowners determined they did not want screened. These items were subsequently disposed of with the remainder of the mercury-contaminated material.

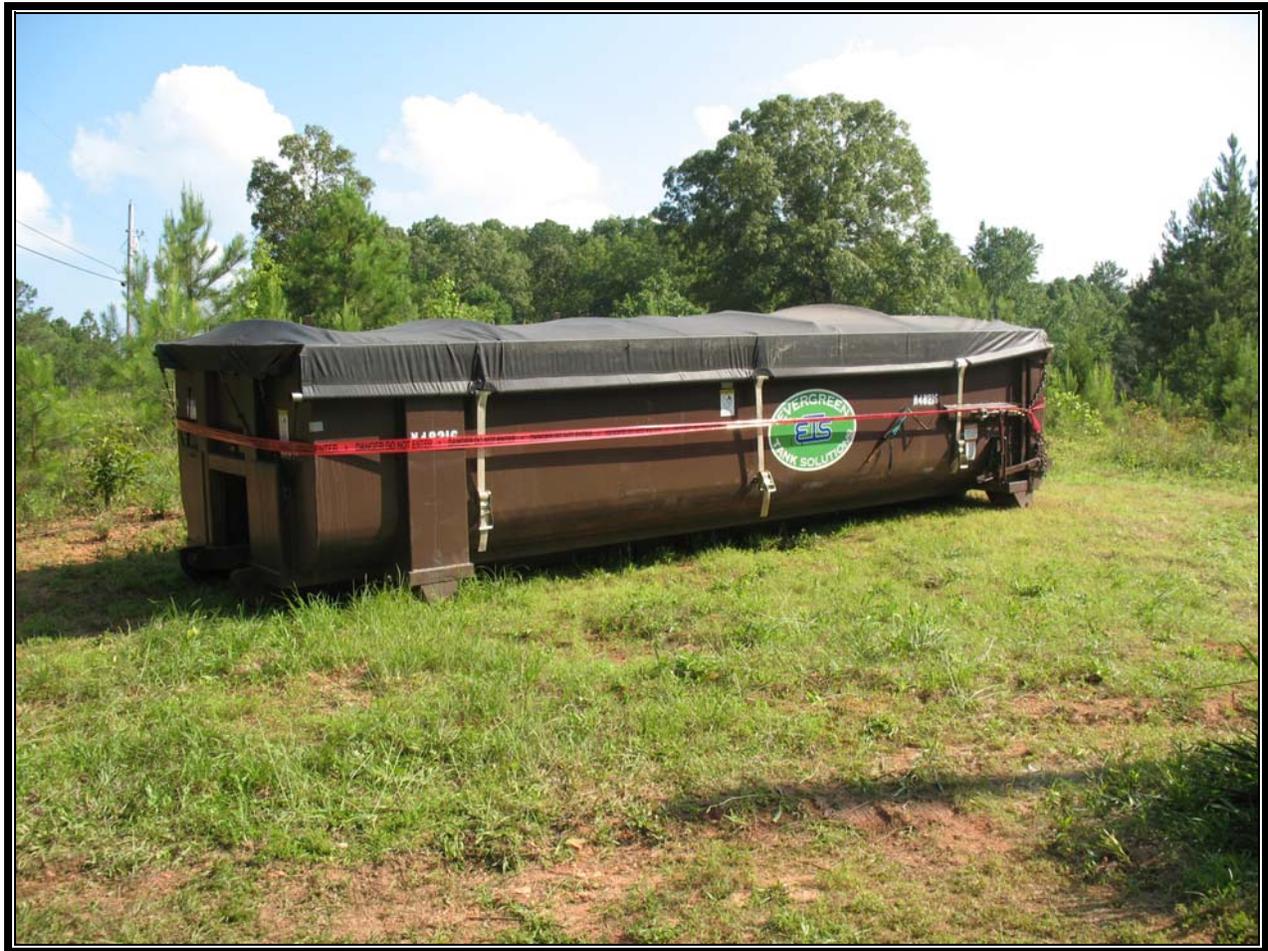
**OFFICIAL PHOTOGRAPH NO. 18**  
**U.S. ENVIRONMENTAL PROTECTION AGENCY**

A total of 5 roll-off boxes of mercury-contaminated, nonhazardous waste were removed from the property, including the crushed remains of the residence.

**Subject:** One of five roll-off boxes containing nonhazardous mercury-contaminated waste generated at the site.
