**REMOVAL PROGRAM
PRELIMINARY ASSESSMENT/
SITE INVESTIGATION REPORT
FOR THE
MARINO PROPERTY
MIDDLETOWN, CONNECTICUT
12 AUGUST 1999**

U.S. Environmental Protection Agency
Region I
Emergency Planning and Response Branch
1 Congress Street, Suite 1100
Boston, MA 02114-2023

Roy F. Weston, Inc. (WESTON®)
Superfund Technical Assessment and Response Team (START)
217 Middlesex Turnpike
Burlington, MA 01803

September 1999

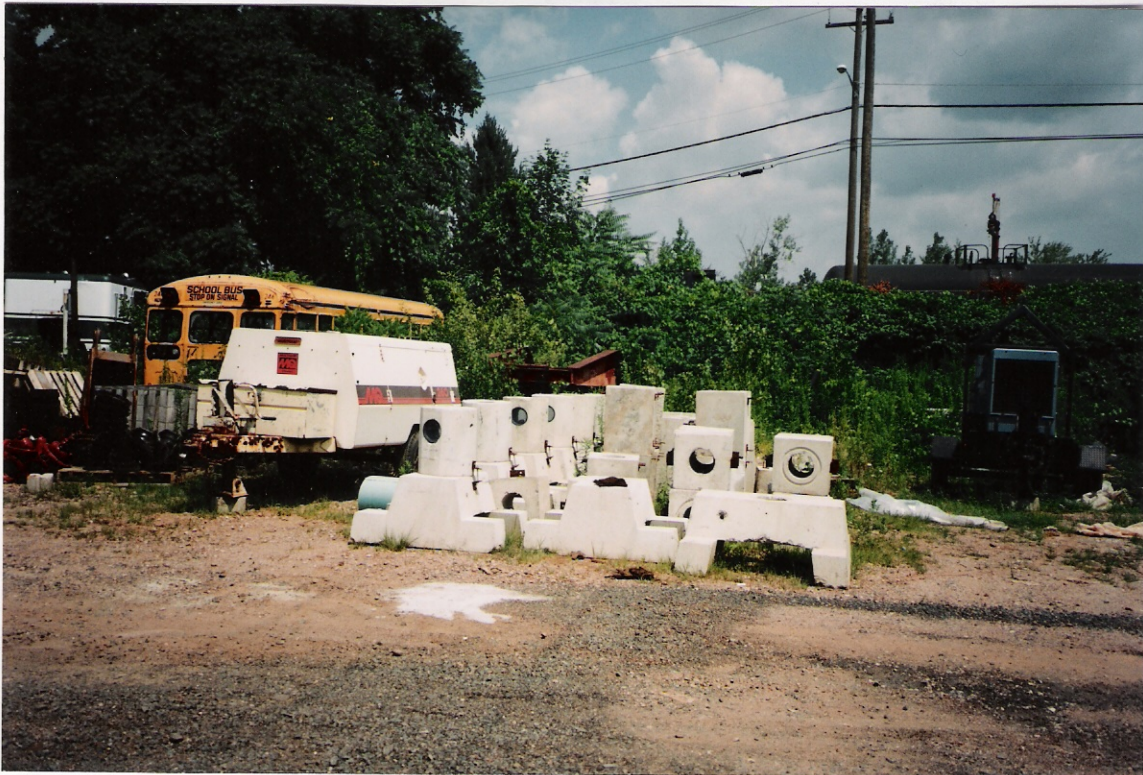
FRAME NUMBER: 2 DATE: 27 July 1999

SCENE: View of construction debris and gravel, panoramic view.

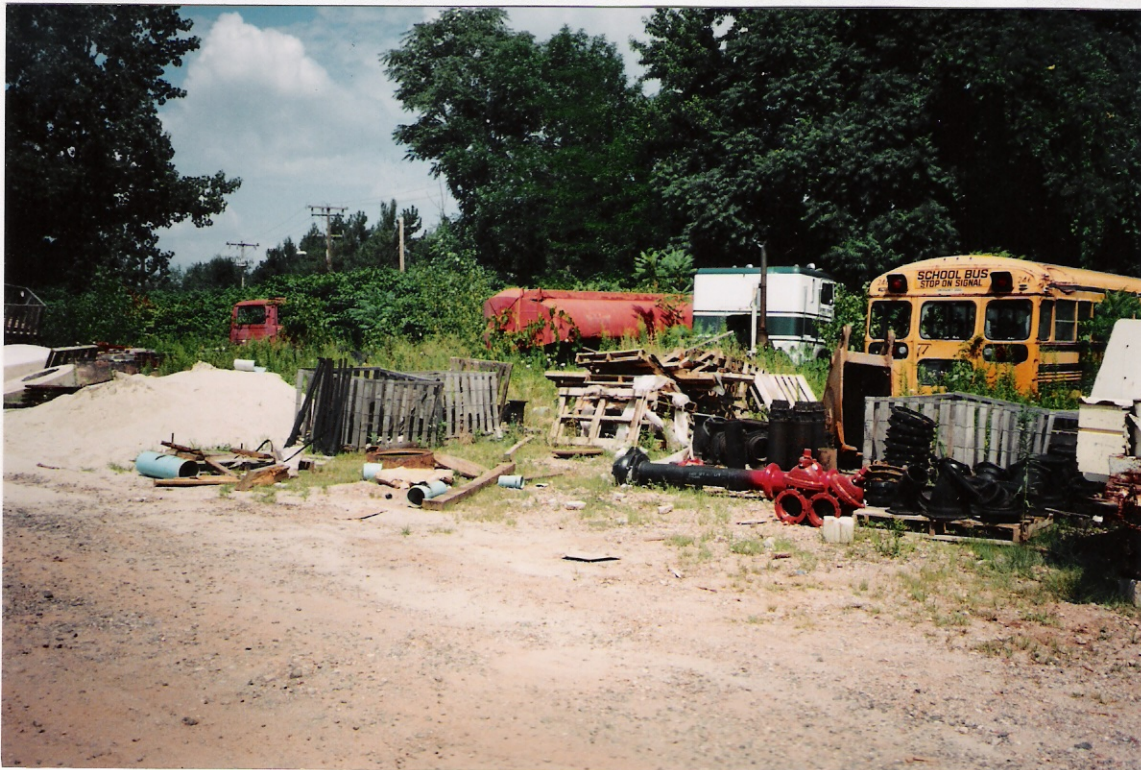
FRAME NUMBER: 3 DATE: 27 July 1999

SCENE: View of construction debris and gravel, panoramic view.

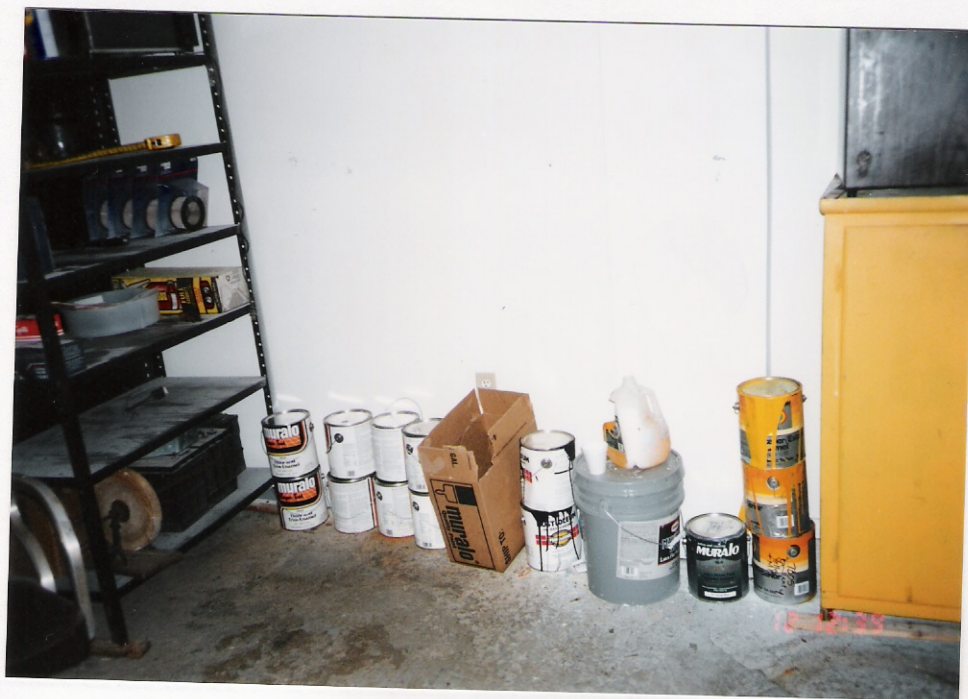
FRAME NUMBER: 3

SCENE: View of miscellaneous paint cans and office supplies in the Marino Brothers of New England office area, facing east.

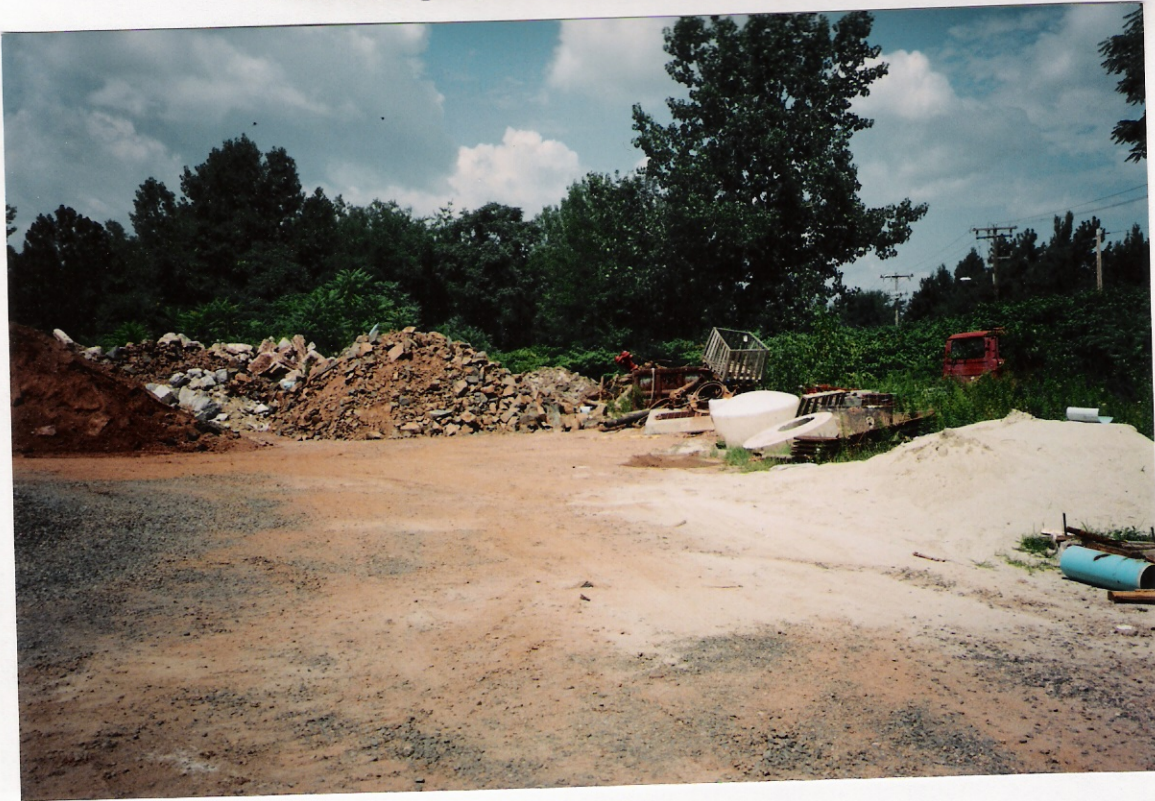
FRAME NUMBER: 4 DATE: 27 July 1999

SCENE: View of construction debris and gravel, panoramic view.

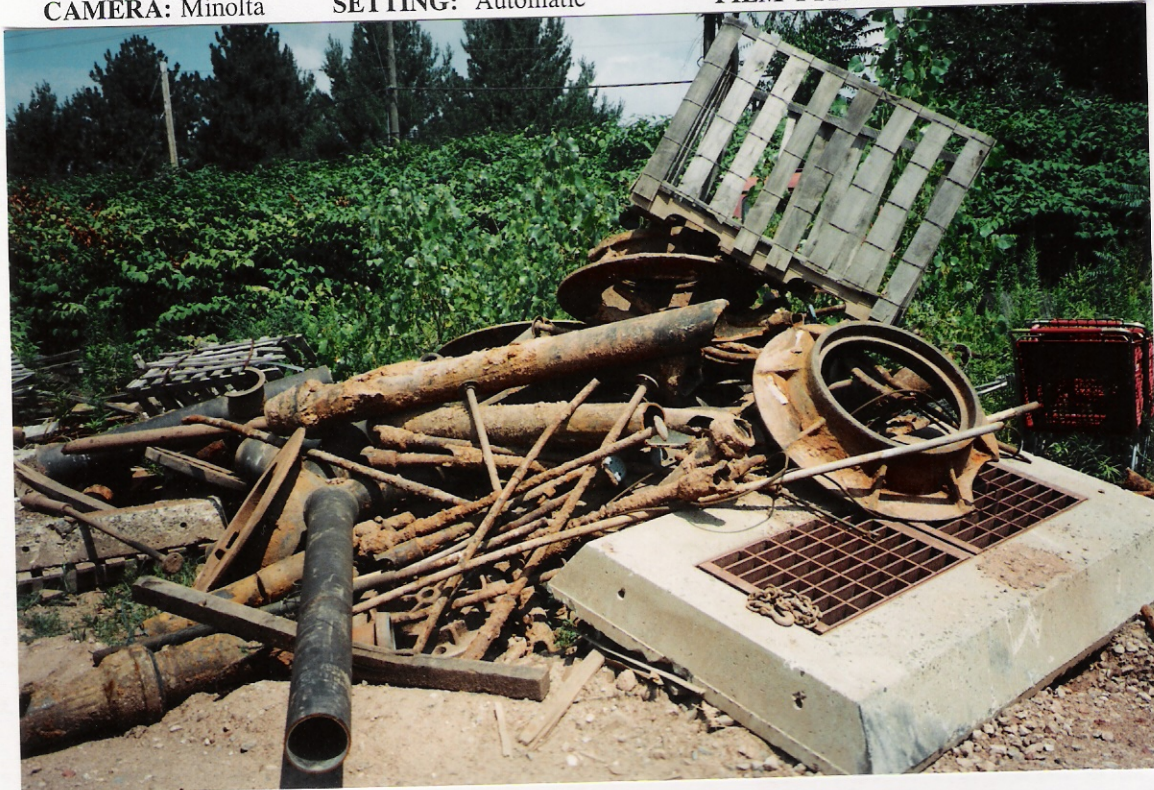
FRAME NUMBER: 5 DATE: 27 July 1999

SCENE: View of concrete, pipes and debris, facing north.

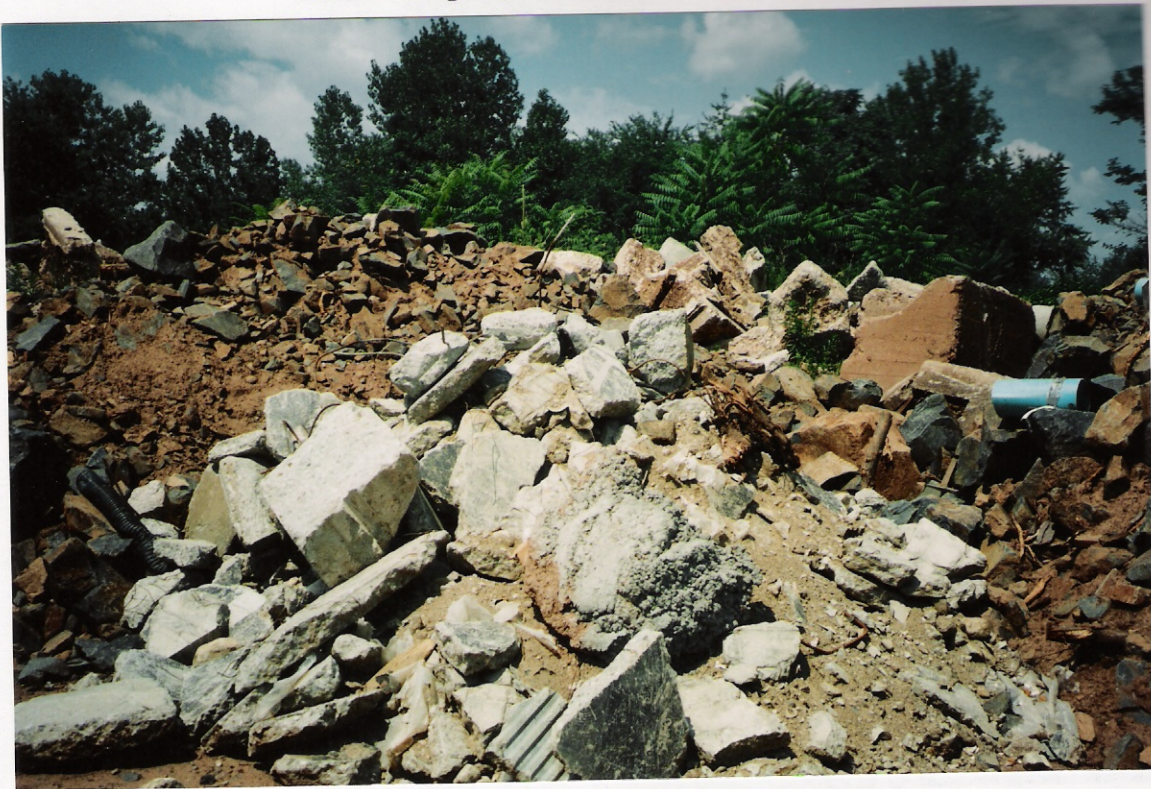
SCENE: View of concrete and brick rubble, facing north.
FRAME NUMBER: 6 DATE: 12 August 1999
PHOTOGRAPH BY: Nancy Haynes
CAMERA: Minolta SETTING: Automatic

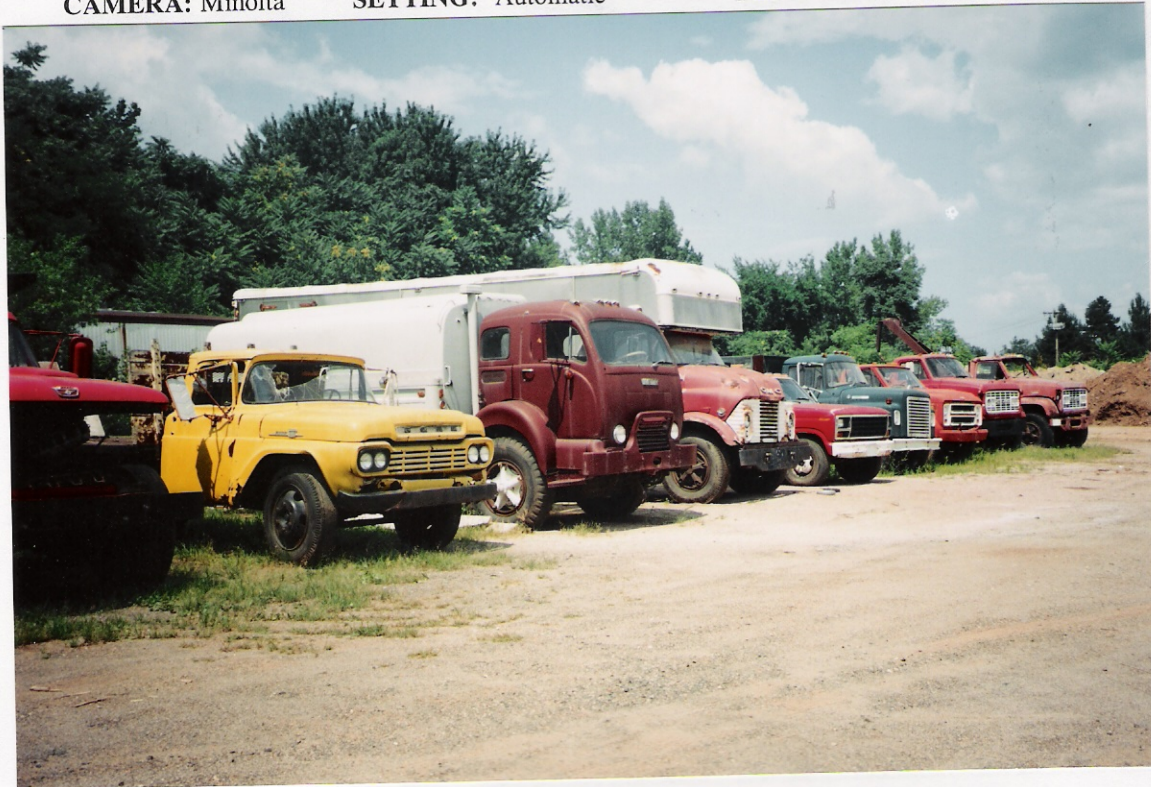
(X) Other:	Several trucks were staged on the property and used by the property owners for storage purposes. (See Appendix D - Film Roll 03375 Frame Number 7).

SCENE: View of various trucks on site, facing west.
FRAME NUMBER: 7 DATE: 27 July 1999
PHOTOGRAPH BY: Nancy Haynes
CAMERA: Minolta SETTING: Automatic

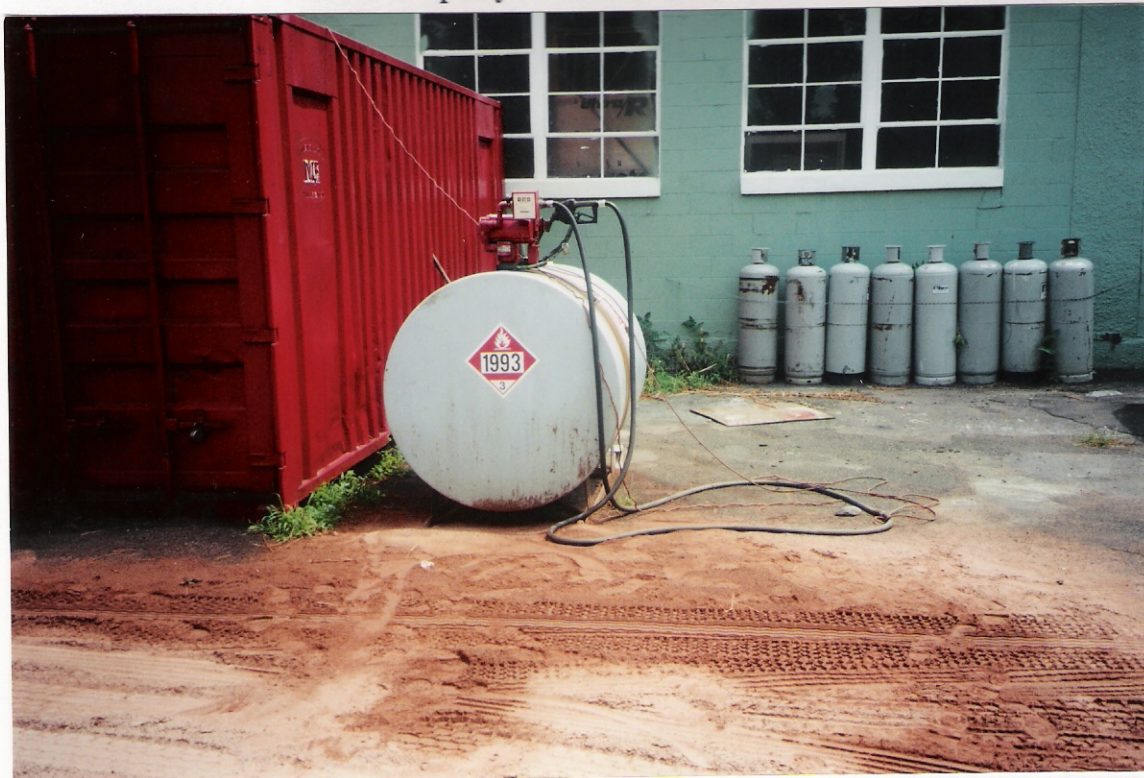
(X) Piles:	Piles of soil, brick, concrete, metal debris, wood, and rock are located in the northwest and southwest corners of the property.
(X) Stained Soil:	Uncontained AST containing diesel fuel located adjacent to a red storage box (see Appendix D - Film Roll 03375 Frame Numbers 9 and 10).
() Sheens:	
() Stressed Vegetation:

SCENE: View of oil tank with recent spill, facing east.
FRAME NUMBER: 10 DATE: 27 July 1999
PHOTOGRAPH BY: Nancy Haynes
CAMERA: Minolta SETTING: Automatic

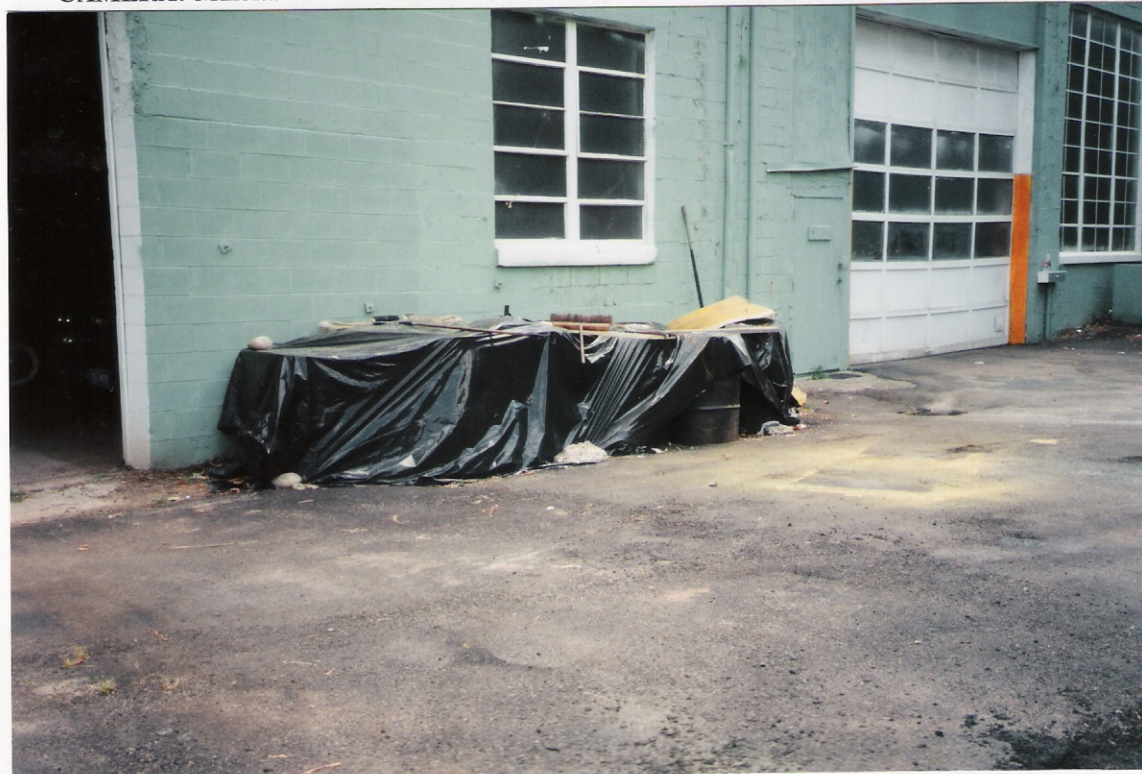
<u>Parameter</u>	<u>Quantities/Extent</u>
(X) Cylinders:	Several miscellaneous cylinders were observed.
(X) Drums:	Several drums covered by a tarp were observed staged outside the main building (see Appendix D - Photodocumentation Log Frame Numbers 8 and 11).
() Lagoons:

SCENE: View of drums covered by tarp, facing east.
FRAME NUMBER: 11 DATE: 27 July 1999
PHOTOGRAPH BY: Nancy Haynes
CAMERA: Minolta SETTING: Automatic

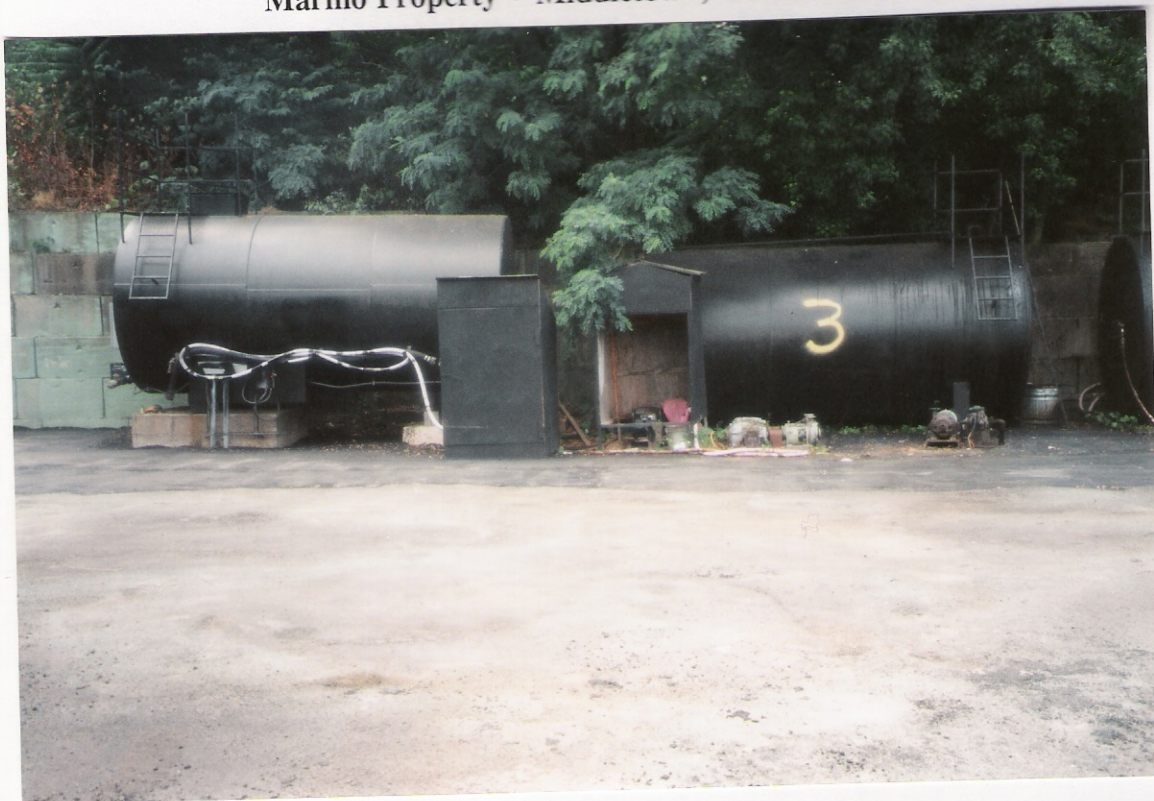
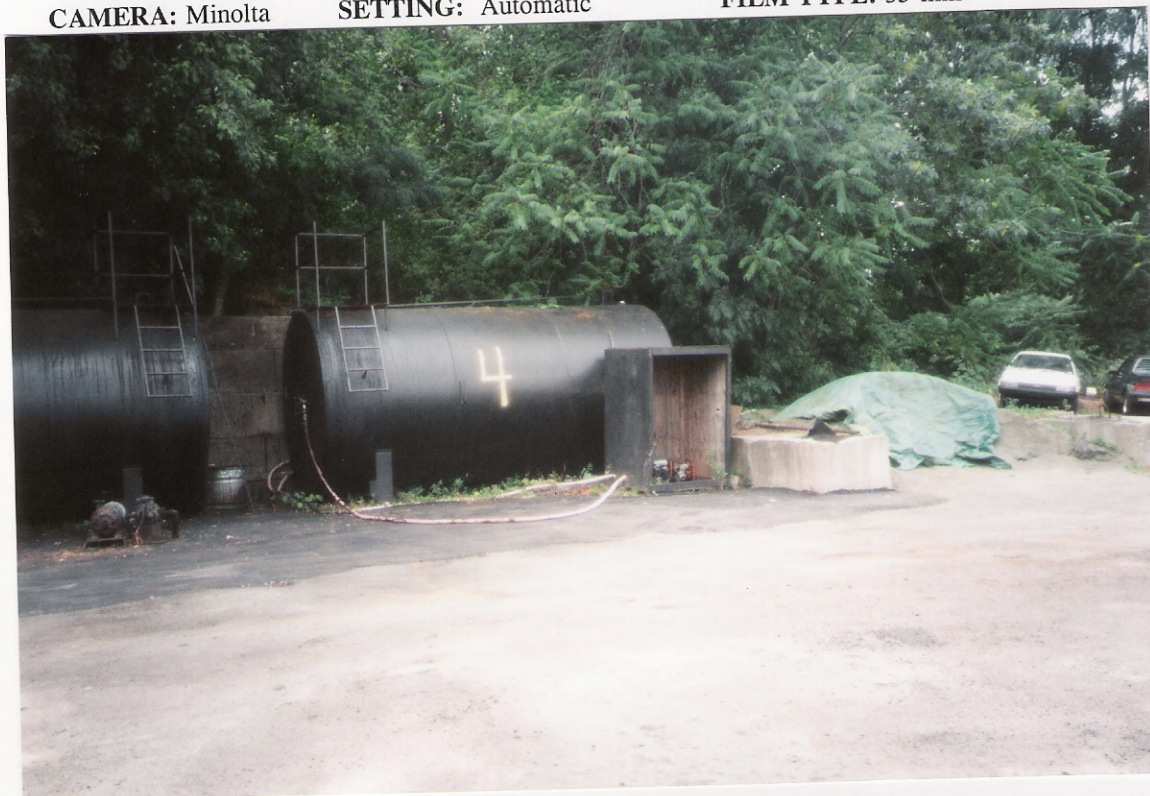
(X) Tanks:	
(X) Above:	Four ASTs along the southern border of the property (see Appendix D - Film Roll 03375 Frame Numbers 12 and 13).
(X) Below:	Two former USTs (see Appendix D - Film Roll BC100203 Frame Numbers 12 and 13)
() Asbestos:

SCENE: View of above ground storage tanks, facing south.
FRAME NUMBER: 12 DATE: 27 July 1999
PHOTOGRAPH BY: Nancy Haynes
CAMERA: Minolta SETTING: Automatic

SCENE: View of above ground storage tanks, facing south.
FRAME NUMBER: 13 DATE: 27 July 1999
PHOTOGRAPH BY: Nancy Haynes
CAMERA: Minolta SETTING: Automatic

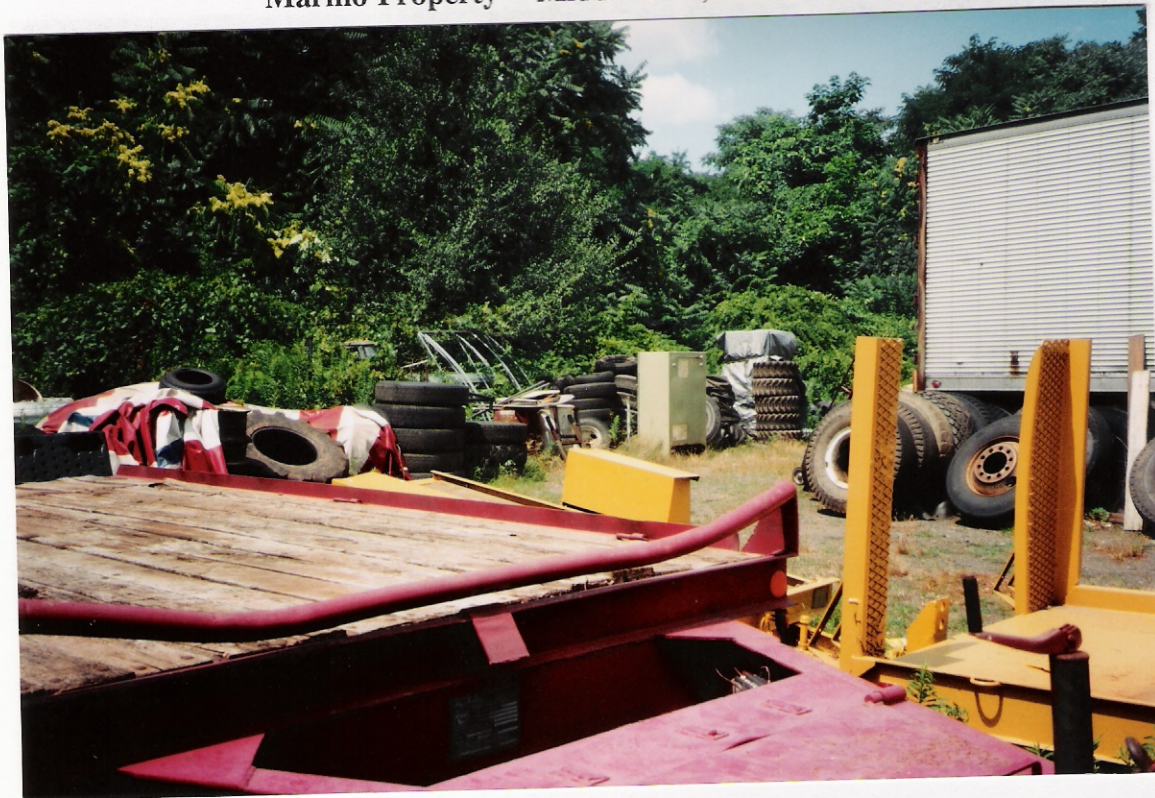
FRAME NUMBER: 14 **DATE:** 27 July 1999

SCENE: View of tires, debris and abandoned truck, facing northwest.

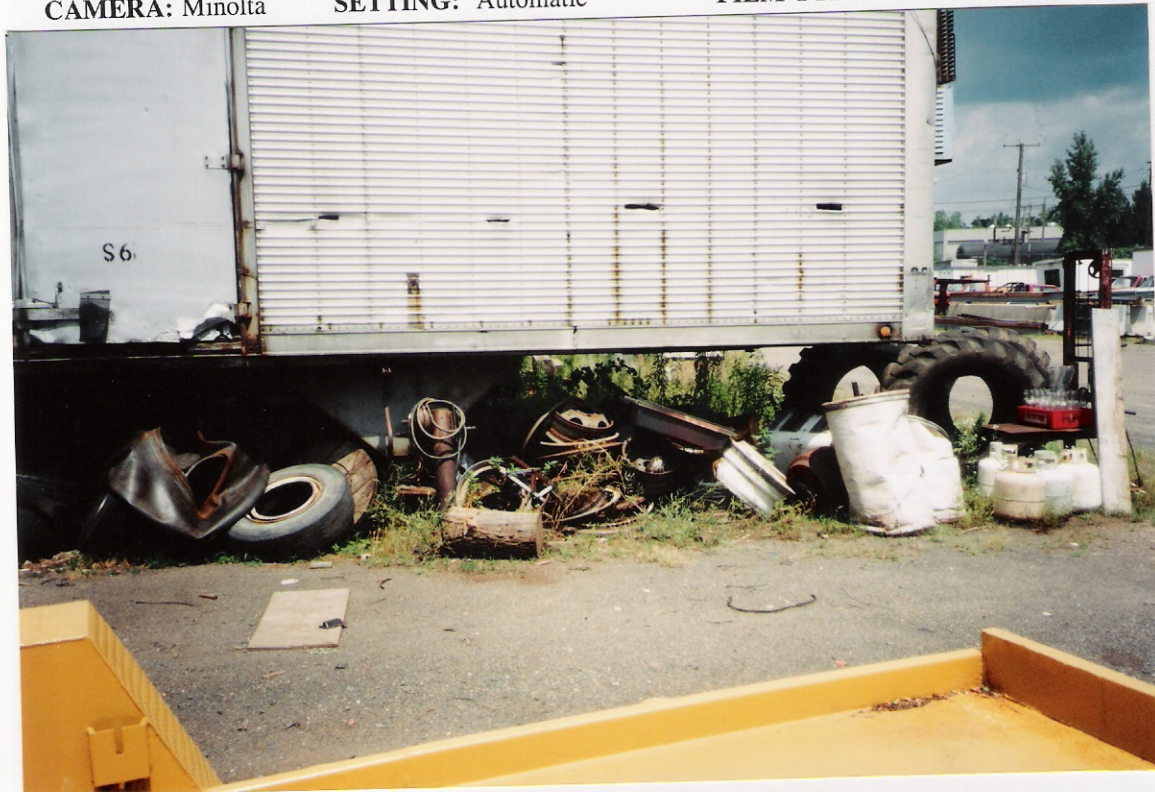
FRAME NUMBER: 15 **DATE:** 27 July 1999

SCENE: View of tires, debris and abandoned truck, facing northeast.

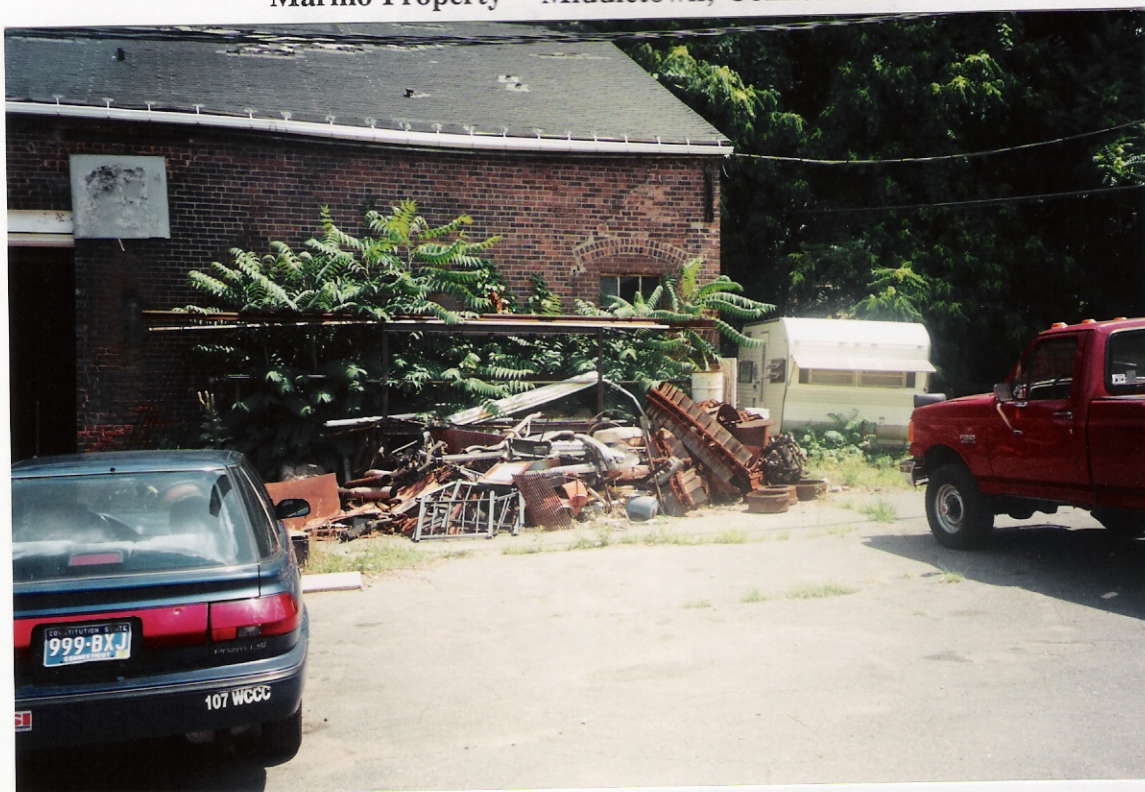
FRAME NUMBER: 16 DATE: 27 July 1999

SCENE: View of metal debris in front of building, facing east.

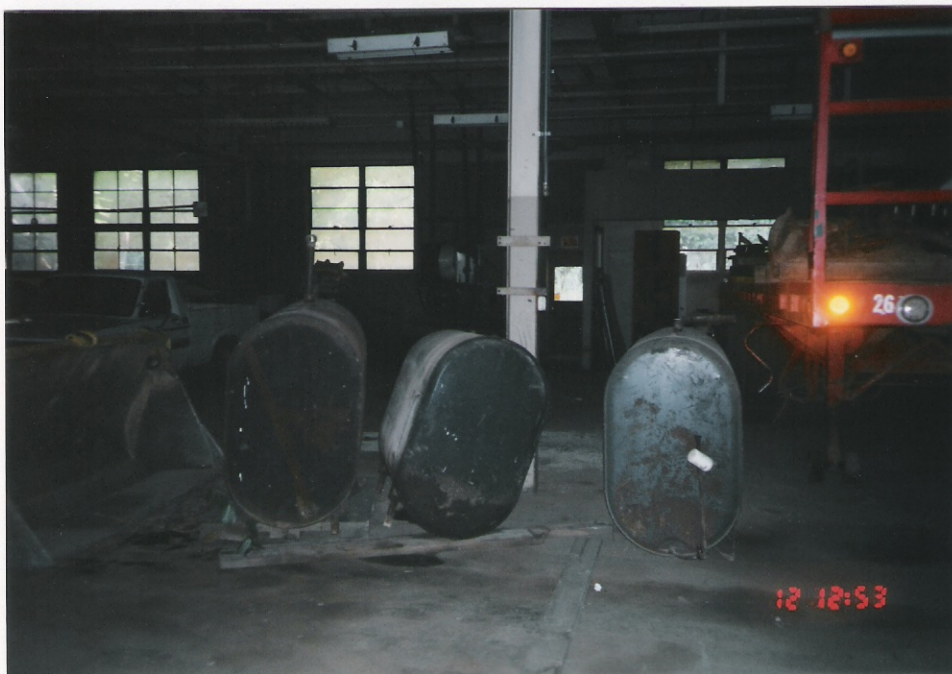
SCENE: SCENE: View of three empty, home heating oil aboveground storage tanks, facing south.
FRAME NUMBER: 7
SKY CONDITION: Indoor
CAMERA: Minolta
FILM TYPE: 35 mm
DATE: 12 August 1999
PHOTO BY: Julie Geissler
SETTING: Automatic
FILM ROLL: BC100203
TIME: 1253
WITNESS(ES): Eric Ackerman

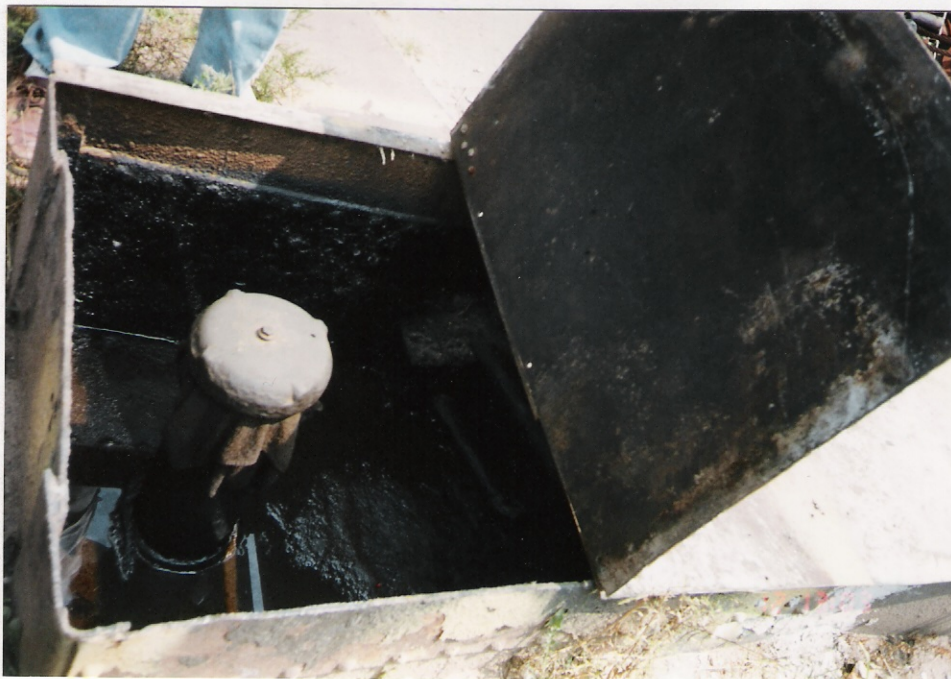
FRAME NUMBER: 12

Mr. Marino stated that when he bought the property, a 2,000-gallon underground storage tank (UST) containing No. 2 fuel oil and a 10,000-gallon UST containing home heating fuel existed on the property. The 10,000-gallon UST has been closed and filled with sand.

SCENE: View of the fill pipe of the 10,000-gallon underground storage tank that was filled with sand, facing south.

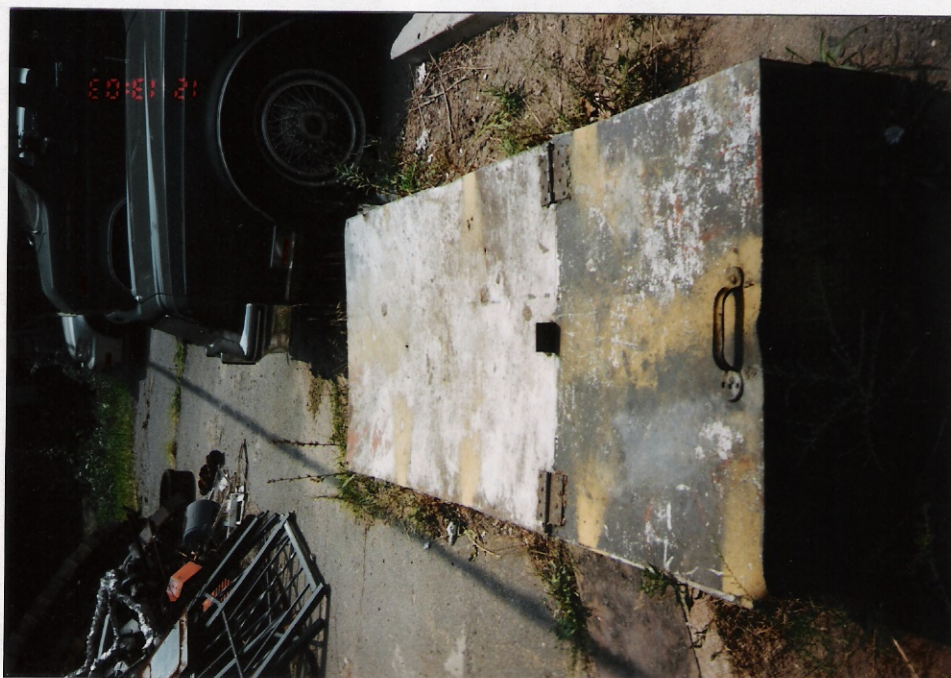
FRAME NUMBER: 13

SCENE: View of the cover on the 10,000-gallon underground storage tank that was filled with sand, facing west.

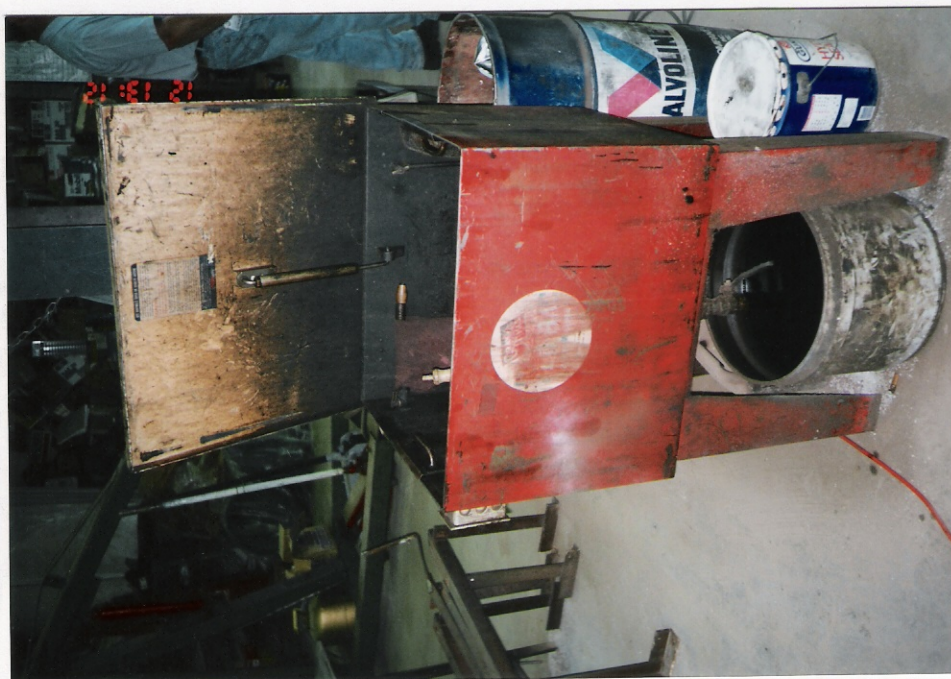
FRAME NUMBER: 21

SCENE: View of parts washer in the mechanic repair shop, facing south.

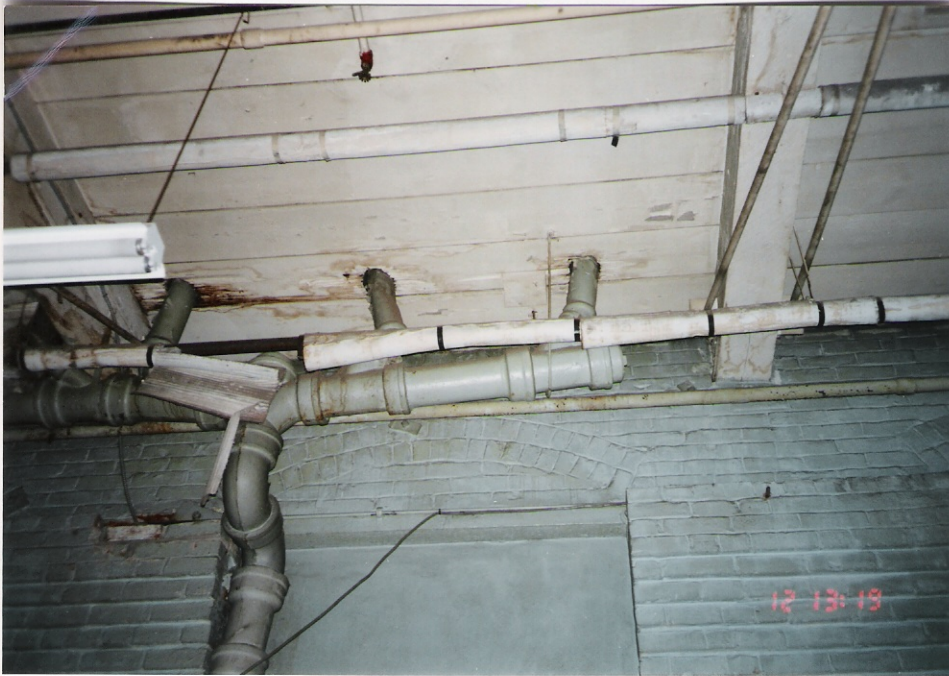
SCENE: View of potential asbestos-containing material in the former OMO Rubber manufacturing area (currently a storage area).
FRAME NUMBER: 24 **DATE:** 12 August 1999 **TIME:** 1319
KEY CONDITION: Indoor **PHOTO BY:** Julie Geissler **WITNESS(ES):** Eric Ackerman
CAMERA: Minolta **SETTING:** Automatic
FILM TYPE: 35 mm **FILM ROLL:** BC100203

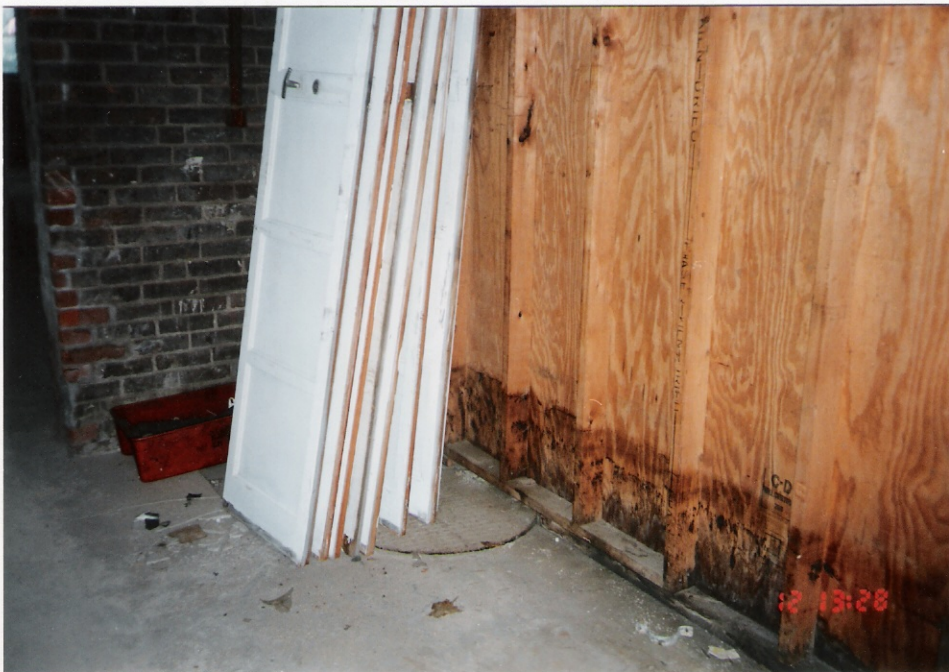
SCENE: View of a manhole cover in a side room, facing southwest.
FRAME NUMBER: 25 **DATE:** 12 August 1999 **TIME:** 1328
KEY CONDITION: Indoor **PHOTO BY:** Julie Geissler **WITNESS(ES):** Eric Ackerman
CAMERA: Minolta **SETTING:** Automatic
FILM TYPE: 35 mm **FILM ROLL:** BC100203
