INSPECTION REPORT

STREET: GRAND AVE.	MAP #1:	MH: NN9-02
CITY: ST LOUIS, MO.	MAP #2:	MH: NN5-01
LOCALE: private property	TAPE #: EMA-1	TV'D LGTH: 83.1 ft

INSPECT REASON: gen. condition	PIPE SIZE: 10"
SECTION TYPE: combined wastewater ?	MATERIAL: cast iron JT LGTH:
AREA:	LINING:
	RSRVD:

REMARK: CARTER CARBURETOR SITE

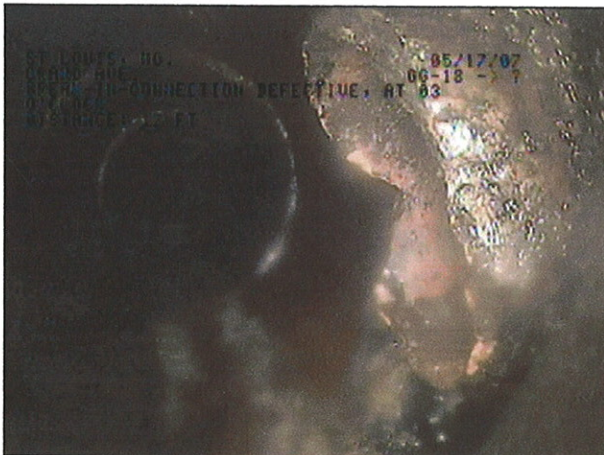
1:462	POSITION	CODE	OBSERVATION	VCR #	PH	RATE
	0.00	0	inspection begins at downstream manhole	00:55:26	47a	0
	17.00	160	break-in-connection defective, at 03 o'clock	00:58:36	48a, b	1

IMAGE: 48a, TAPE #: EMA-1, 00:58:36
17FT, break-in-connection defective, at 03 o'clock

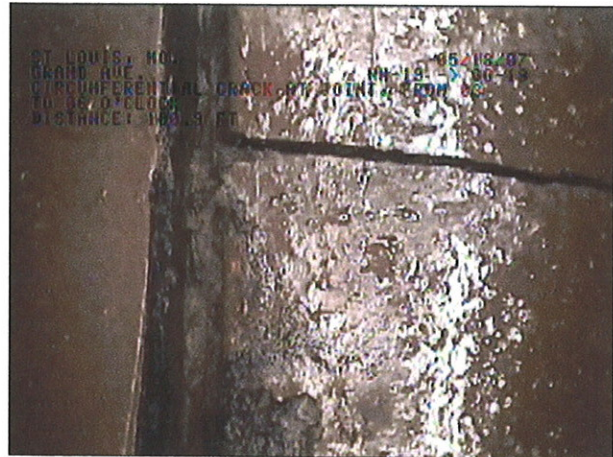
IMAGE: 106a, TAPE #: EMA-1, 01:31:15
100.9FT, Circumferential Crack at joint, from 03 to 06 o'clock

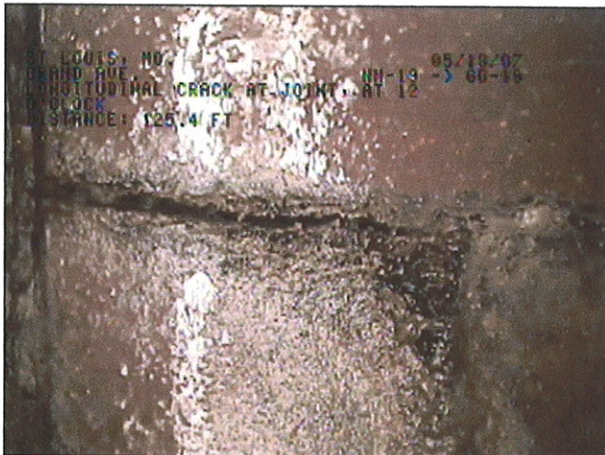
IMAGE: 107a, TAPE #: EMA-1, 01:31:57
125.4FT, Longitudinal Crack at joint, at 12 o'clock

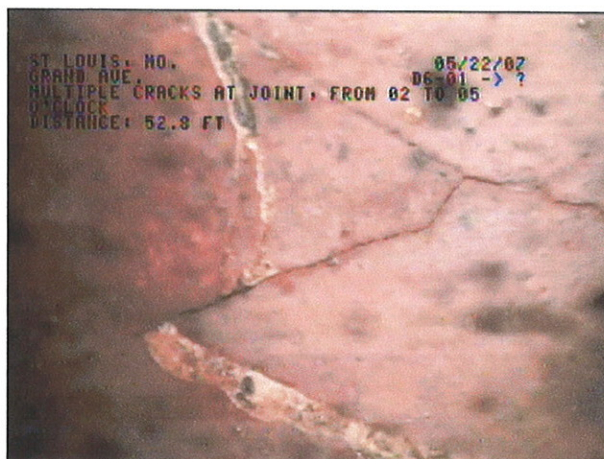
35.70	250	intruding break-in-connection, at 10 o'clock	02:12:37	163a, b	2
	41.50	160	service connection defective, at 09 o'clock	02:13:00	164a	1
	52.80	400	Multiple Cracks at joint, from 02 to 05 o'clock	02:13:30	165a	3

IMAGE: 164a, TAPE #: EMA-1, 02:13:00
41.5FT, service connection defective, at 09 o'clock

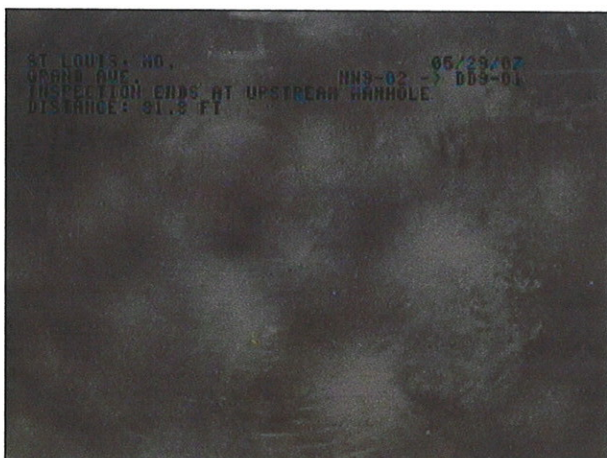
0.00	0	inspection begins at downstream manhole	02:22:35	182a	0
	44.50	0	pipe bends right	02:24:49		0
	67.70	160	service connection defective, at 09 o'clock	02:25:30	184a	1
	81.80	0	inspection ends at upstream manhole	02:26:55	185a	0

IMAGE: 184a, TAPE #: EMA-1, 02:25:30
67.7FT, service connection defective, at 09 o'clock
