**REMOVAL PROGRAM
PRELIMINARY ASSESSMENT/
SITE INVESTIGATION REPORT
FOR THE
FORMER WATERBURY CLOCK FACTORY
WATERBURY, NEW HAVEN COUNTY, CONNECTICUT
8 JULY 2019, 4 SEPTEMBER 2019, AND
21 THROUGH 24 OCTOBER 2019**

U.S. Environmental Protection Agency
Region I
Emergency Planning and Response Branch
5 Post Office Square, Suite 100
Boston, Massachusetts 02109-3912

Weston Solutions, Inc.
Region I
Superfund Technical Assessment and Response Team
101 Billerica Avenue, Building 5, Suite 103
North Billerica, Massachusetts 01862

December 2019

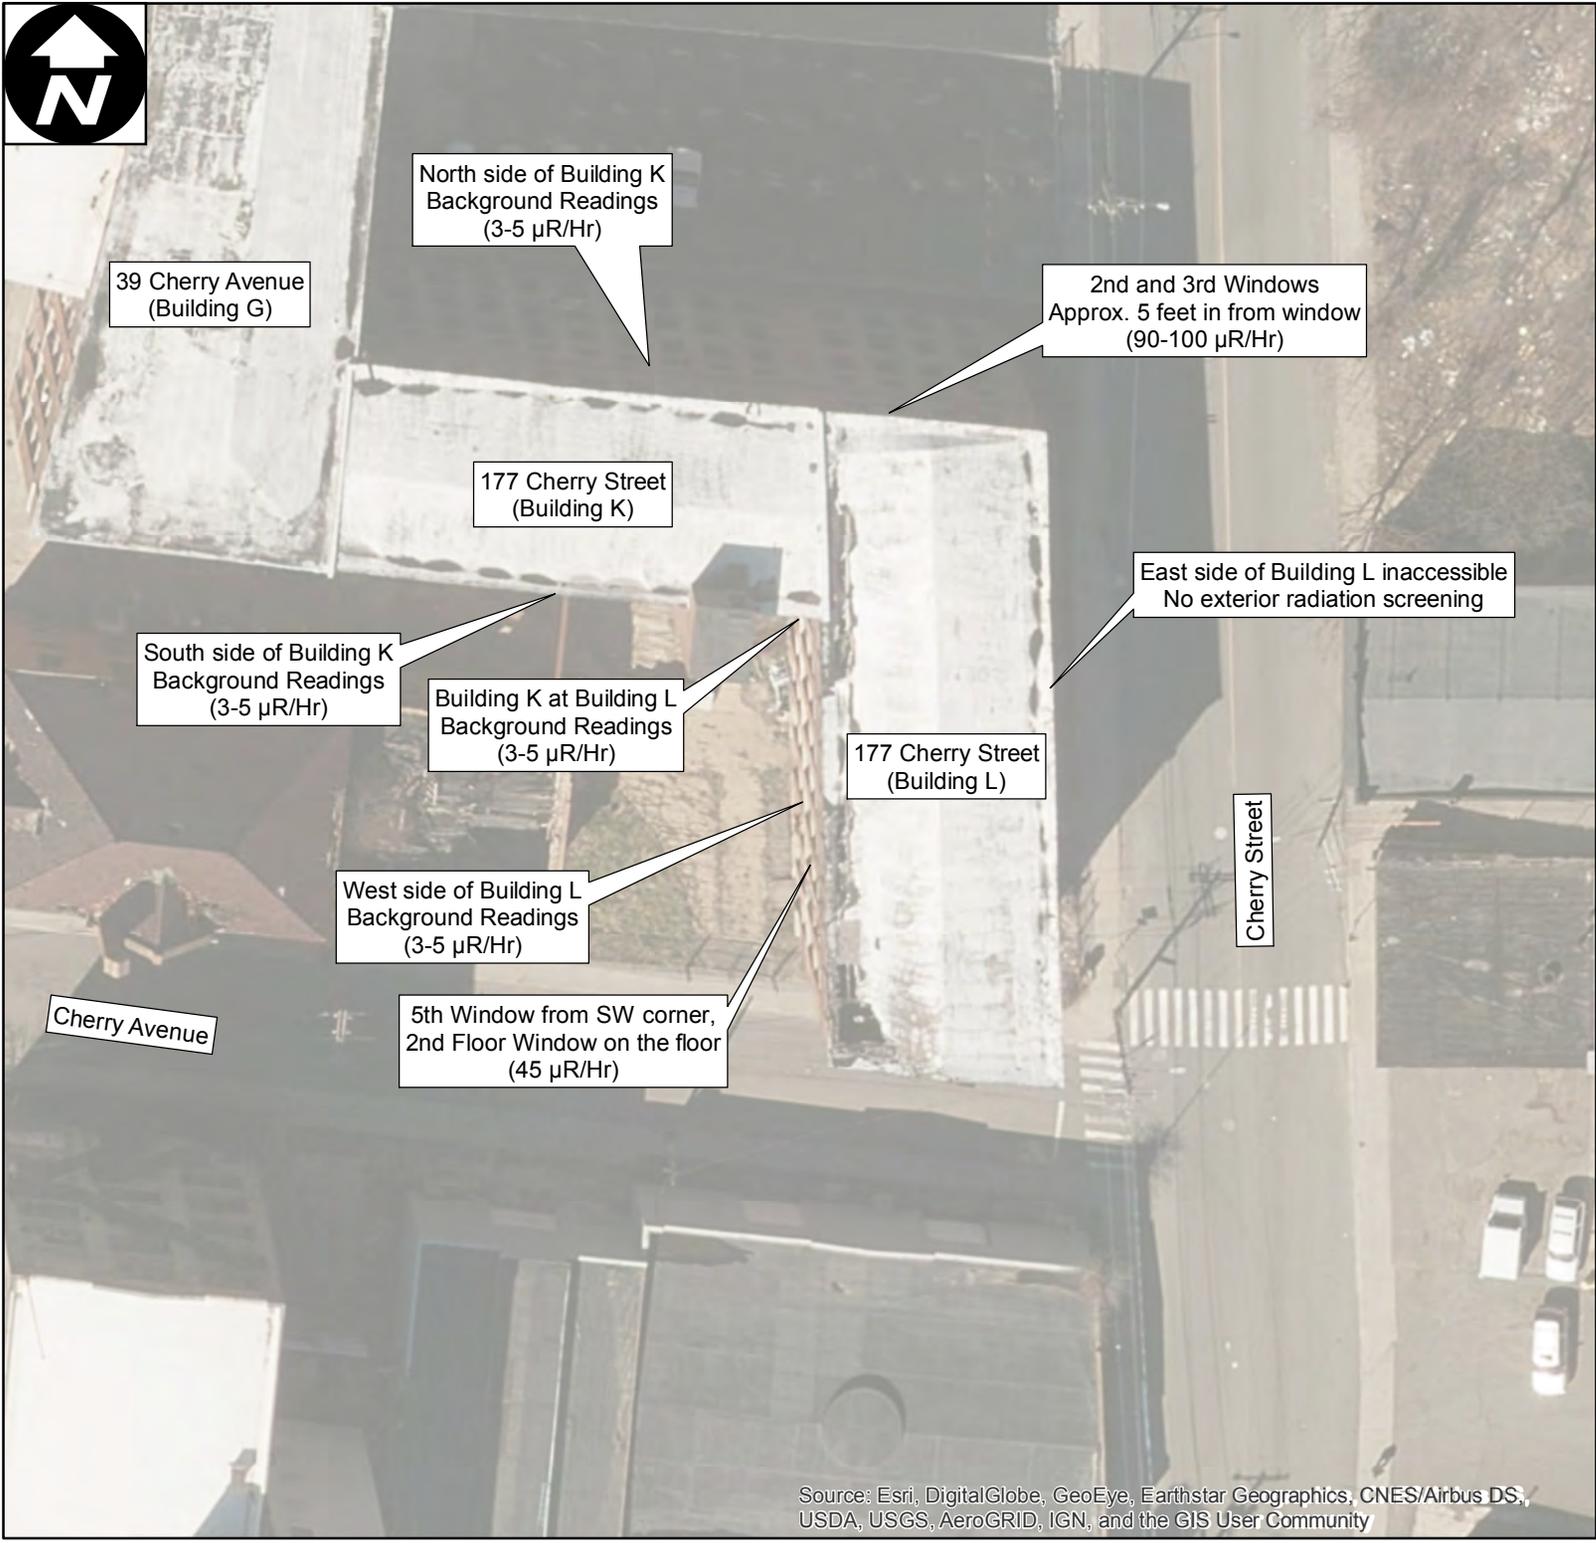
Figure 7
Building K & L
Exterior Radiation Readings
Former Waterbury Clock Factory
177 & 215 Cherry Street
Waterbury, Connecticut

START member Callahan conducted a tailgate health and safety meeting, and START member Ackerman discussed the day's operations, before all personnel signed the tailgate attendance sheet. EPA and START personnel continued to complete the building assessments. START member Ackerman used an extension ladder to access the third and fourth floors of Buildings K and L from the exterior due to the building's dilapidated interior condition. START member Ackerman scanned the window sills and interior walls below the window sills with the Model 2241 with 44-10 pancake probe, and used the Model 77-6 with the 8-foot Stretch scope to scan the floors and ceilings of Buildings K and L. The readings from the window sills on Buildings K and L were all below background levels. The readings from window sills, floors, and ceilings along Building K were also all below background levels. On the western portion of Building L, on the southern side at the fifth window from the southwest corner, there was an elevated reading of 45 $\mu\text{R/hr}$ on the floor. All other readings were below background levels. In addition, at the second and third windows of Building K, there was an elevated reading of 90-100 $\mu\text{R/Hr}$ on the floor, approximately 5 feet from the window. All other readings for Building K were below background (see Appendix A, Figure 7).

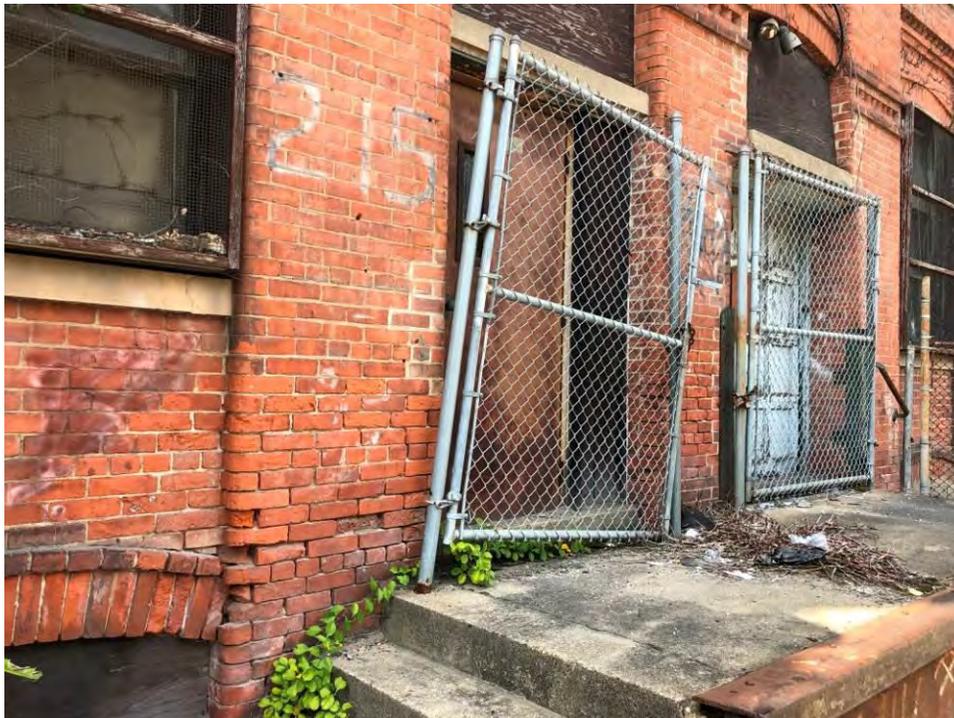
START member Kelly noted a high level of 350 $\mu\text{R/hr}$ on the EPA Ludlum 19A in the vicinity of the interior side of the loading dock (eastern wall) near the location where elevated radiation level measurements had been noted outside the building. EPA NCRFO/RERT member Faller noted that he obtained a reading of 400-450 $\mu\text{R/hr}$ on his radiation unit. START member Kelly noted that Faller had scanned a large area of the wall and floor within this area and obtained the higher result near the base of the wall at floor level. EPA Faller also noted that he had also obtained elevated readings, up to 250 $\mu\text{R/hr}$ on his radiation unit, along an interior hallway wall within the interior of Building 3/R, west of the loading dock area. No PID readings were noted above background within the areas of Building 3/R entered by START.

SCENE: View of area of location of elevated radiation reading on brick wall surface, adjacent to loading dock for 215 Cherry Building 3/R. Photograph taken facing north-northwest.

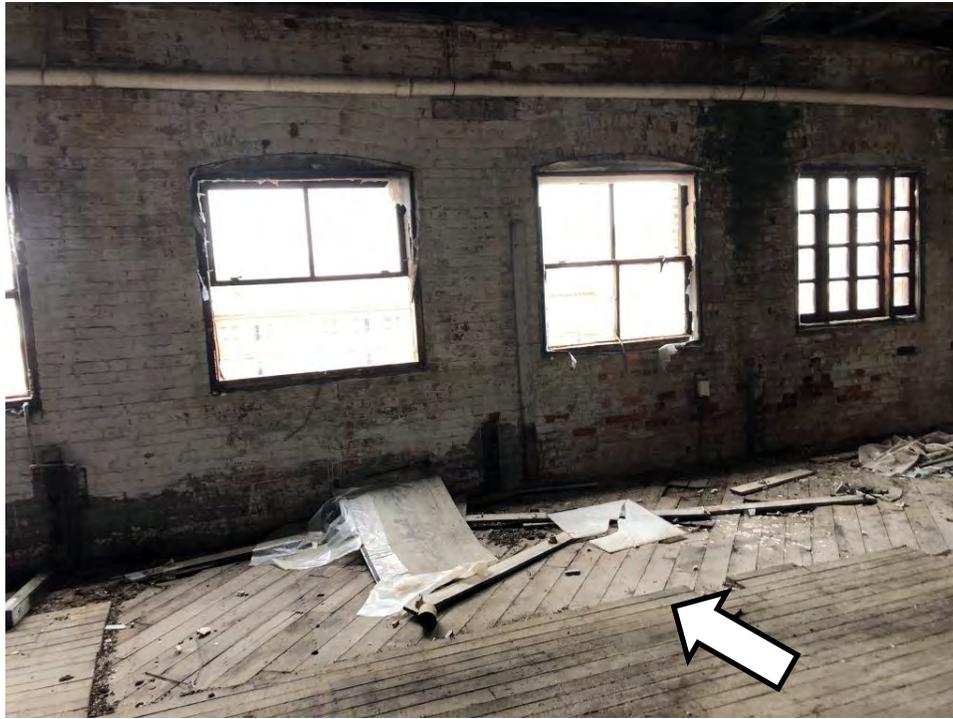
SCENE: View of Building G, Floor 4 with portions of the flooring removed (arrow) that contained elevated Radium-226 (Ra-226). Photograph taken facing west.

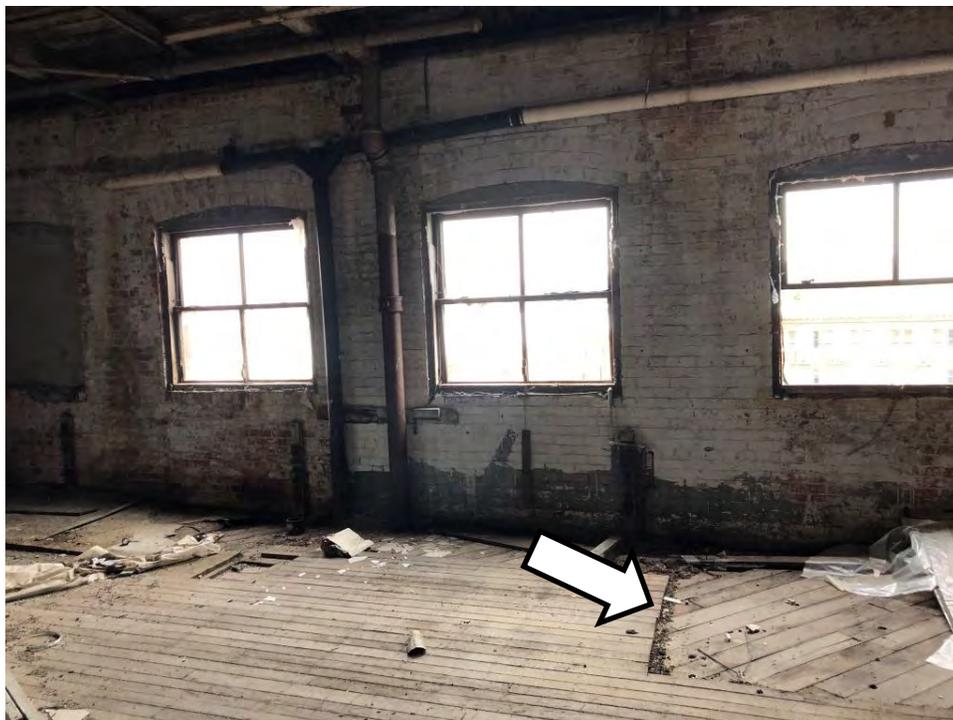
SCENE: View of Building G, Floor 4 with portions of the flooring removed (arrow) that contained elevated Radium-226. Photograph taken facing west.

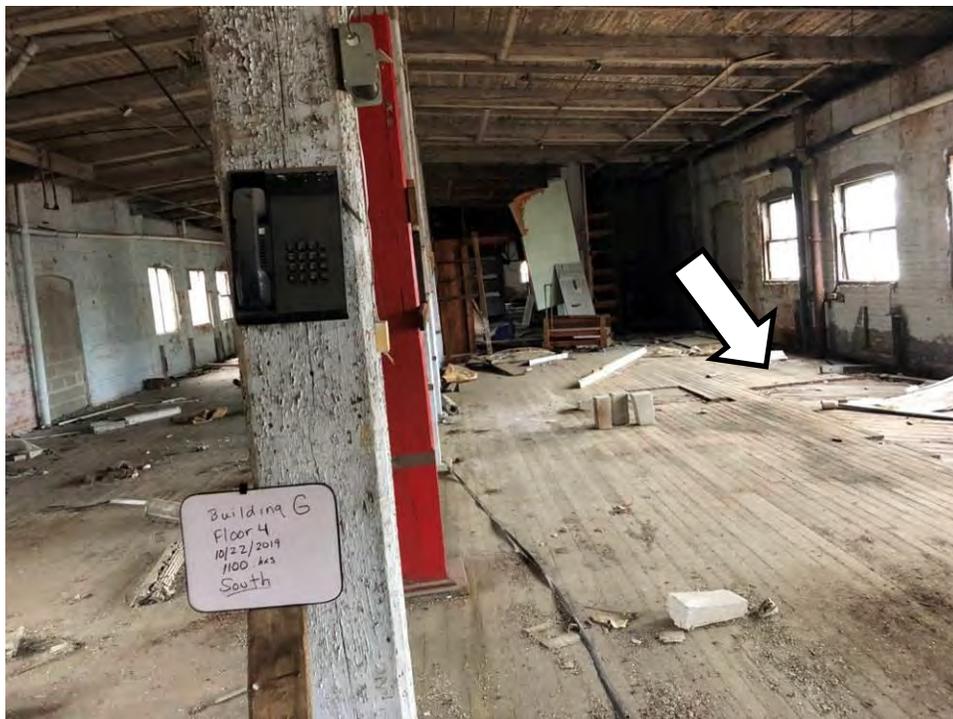
SCENE: View of Building G, Floor 4 with portions of the flooring removed (arrow) that contained elevated Ra-226.
Photograph taken facing south.

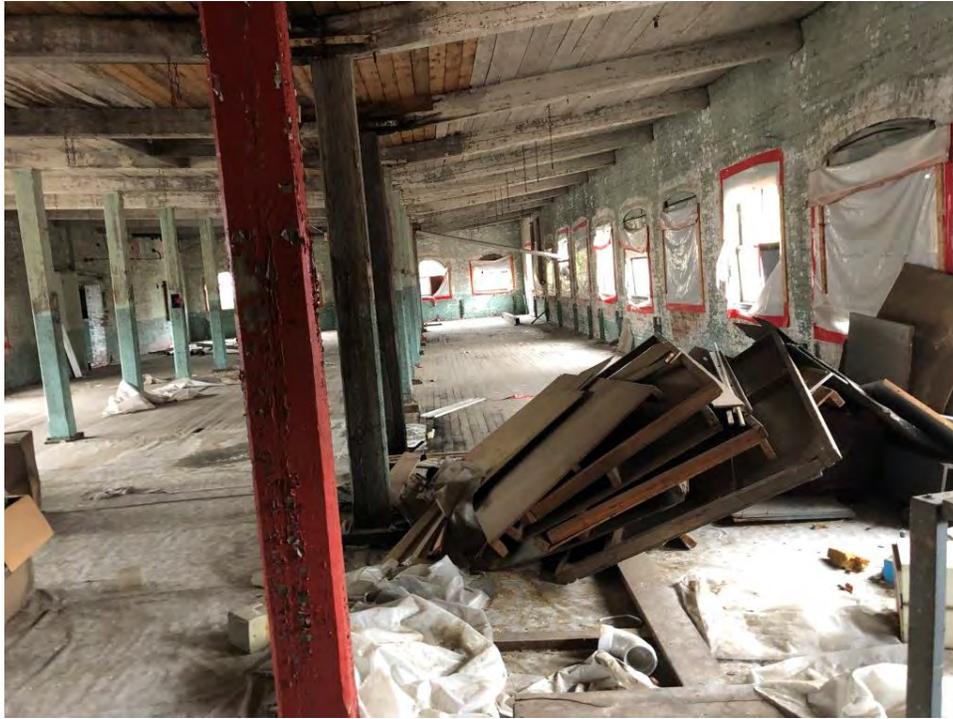
SCENE: View of Building R, Floor 4 with debris and plastic sheeting covering rotting floor. Photograph taken facing east.

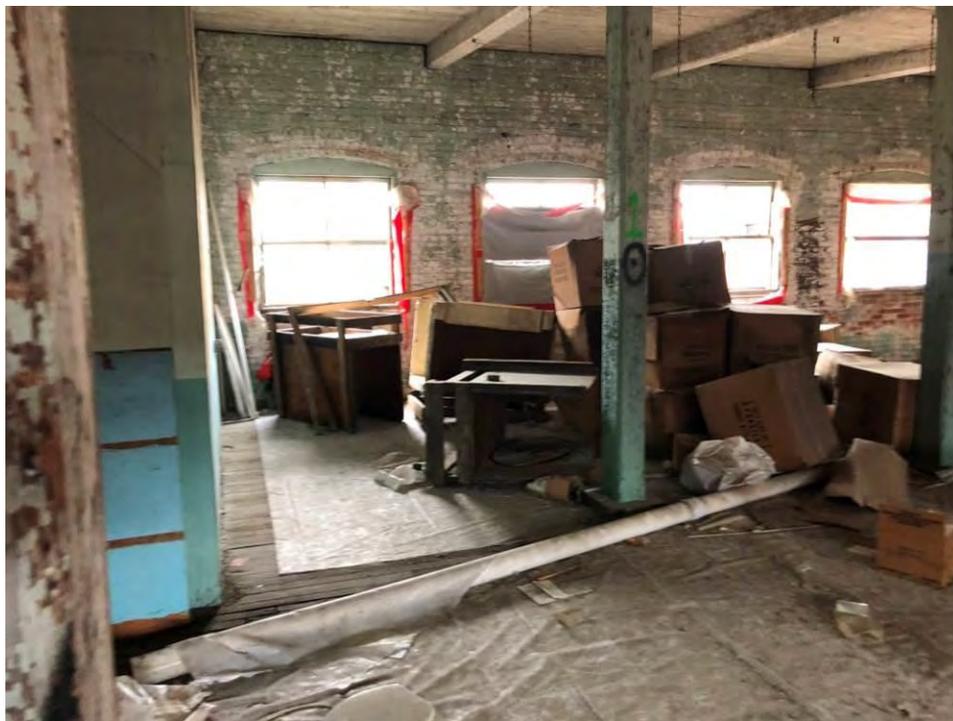
SCENE: View of Building R, Floor 4 with debris and plastic sheeting covering rotting floor. Photograph taken facing north.

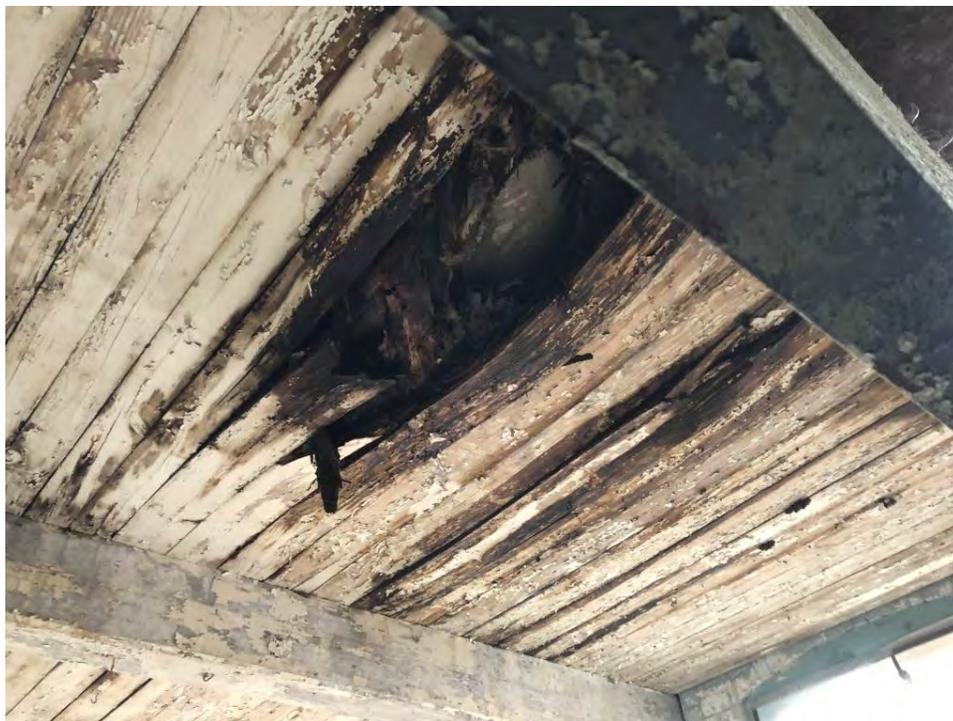
SCENE: View of rotting floorboards of Building R, Floor 4 (looking up from Floor 3).

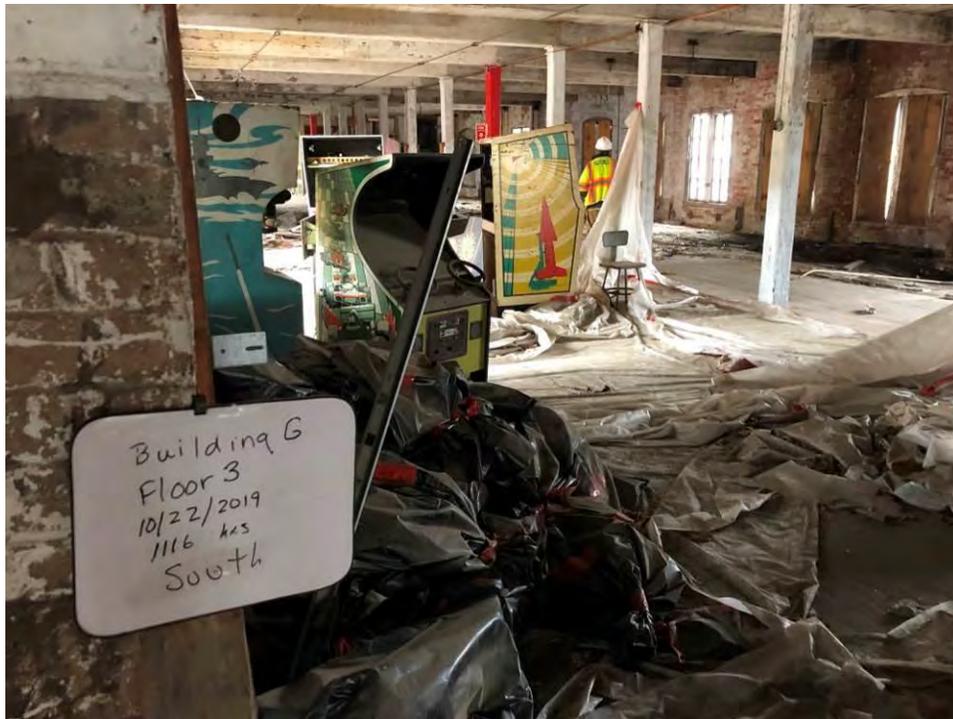
SCENE: View of Building G, Floor 3 with video arcade game carcasses and black “asbestos” waste bags. Photograph taken facing south.

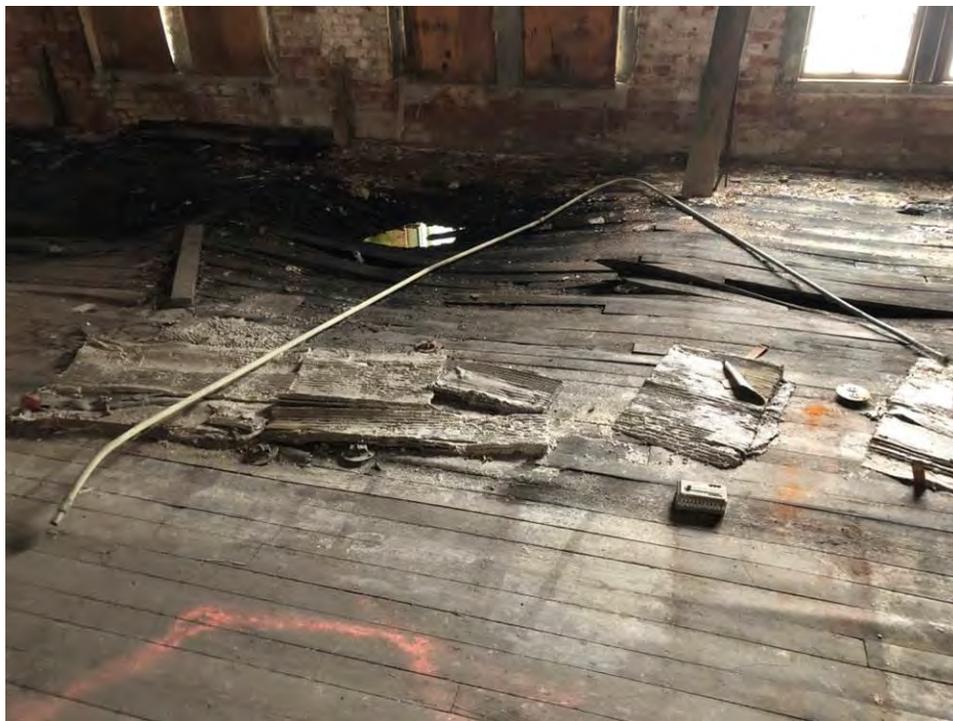
SCENE: Close-up view of orange paint denoting elevated Ra-226 and suspected asbestos-containing material (ACM) pipe wrap on the 3rd Floor of Building G. Photograph taken facing west.

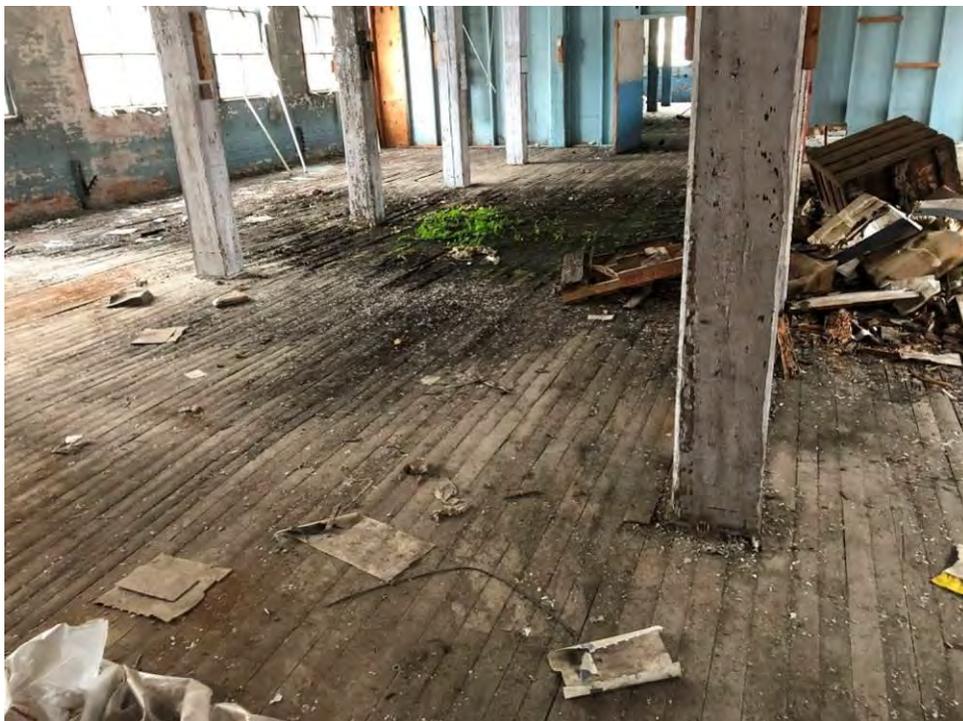
SCENE: View of Building R, Floor 2 with vegetation growing on the floor. Photograph taken facing east.

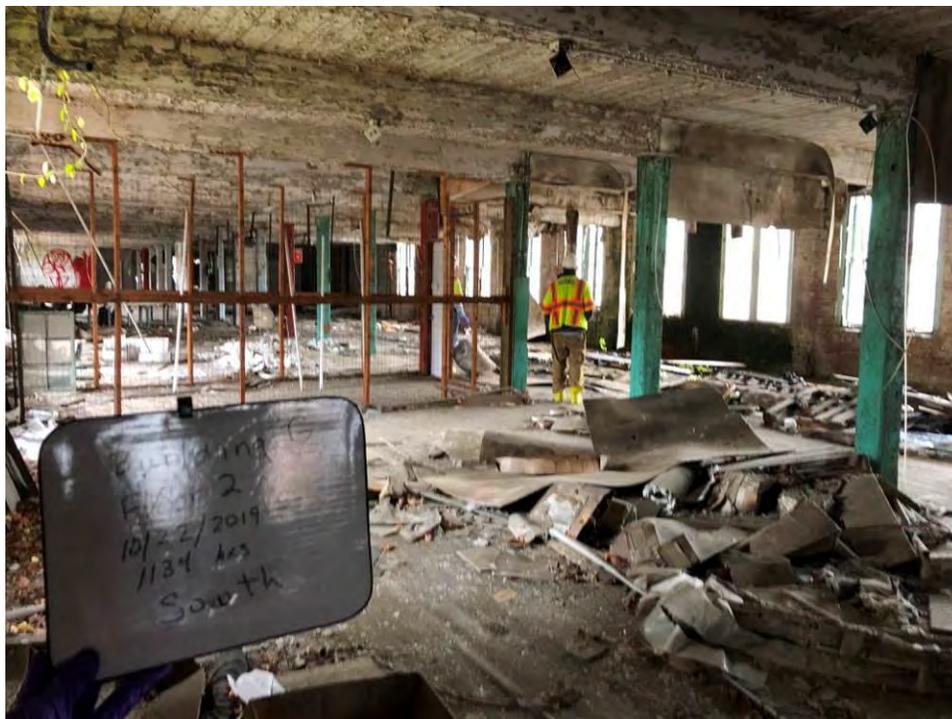
SCENE: View of Building G, Floor 2 with debris and compromised floor. Photograph taken facing south.

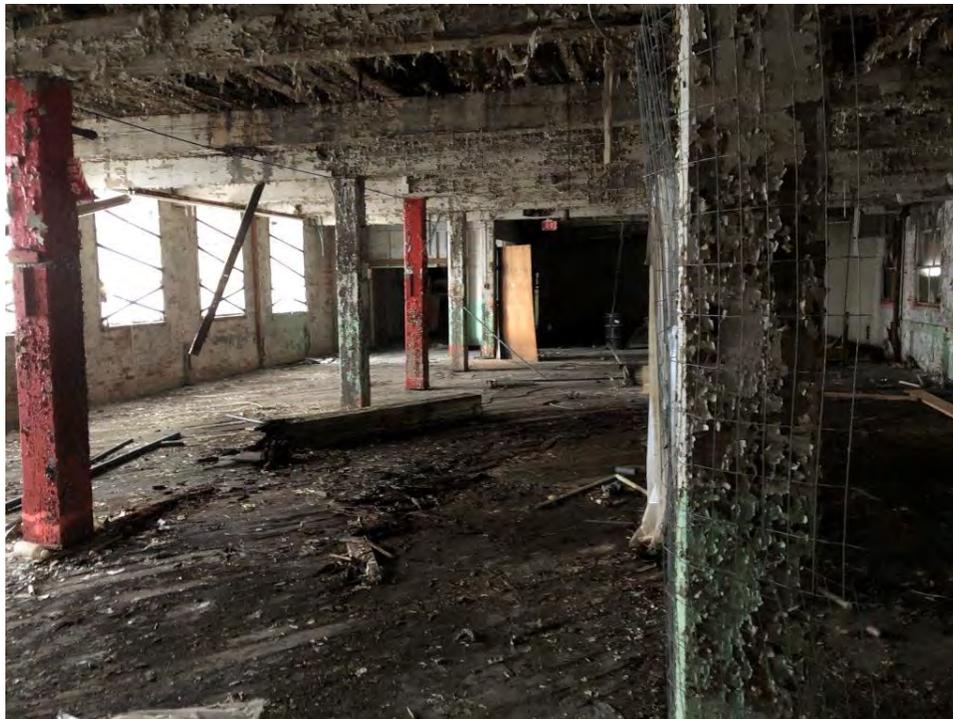
SCENE: View of Building R, Floor 1; note the collapsed column on the left. Photograph taken facing east.

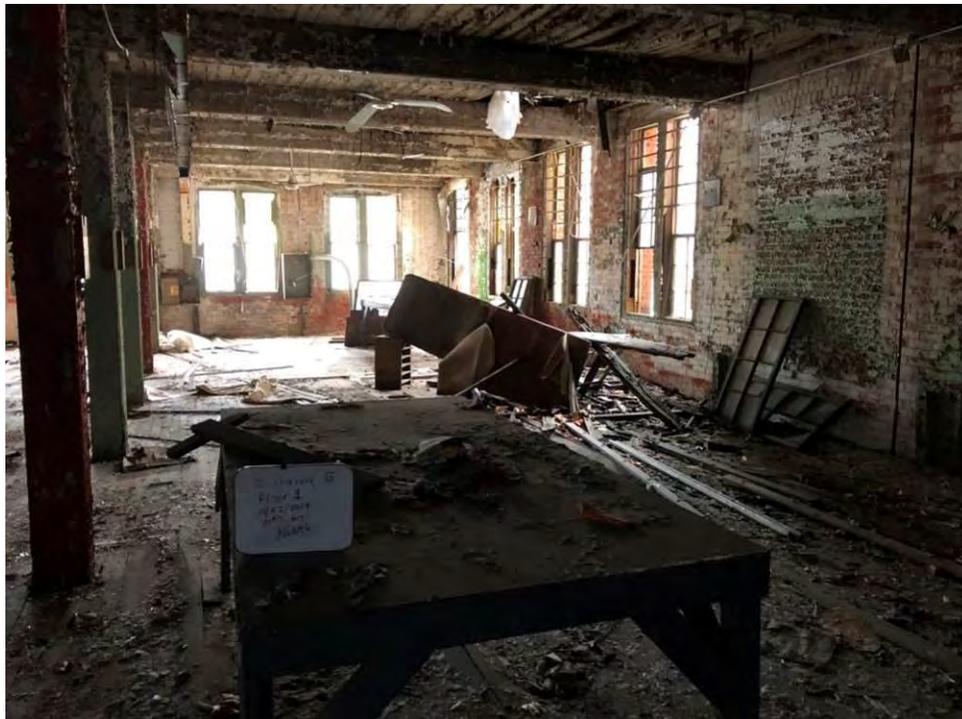
SCENE: View of Building G, Floor 1 with debris and hole in ceiling. Photograph taken facing north.

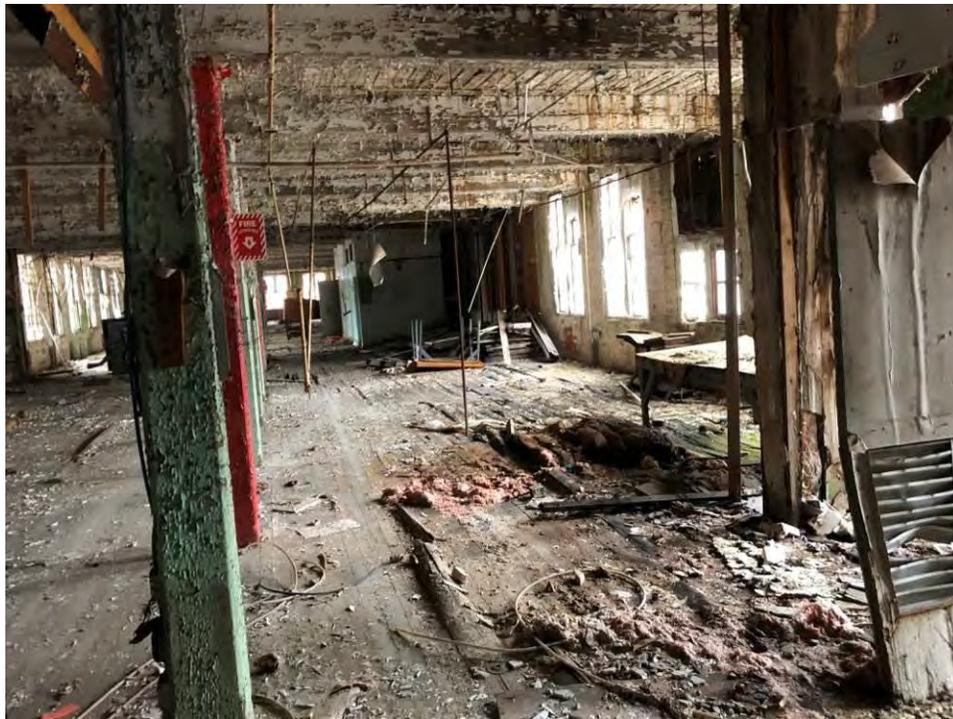
SCENE: View of Building G, Floor 1 with compromised floor. Photograph taken facing south.

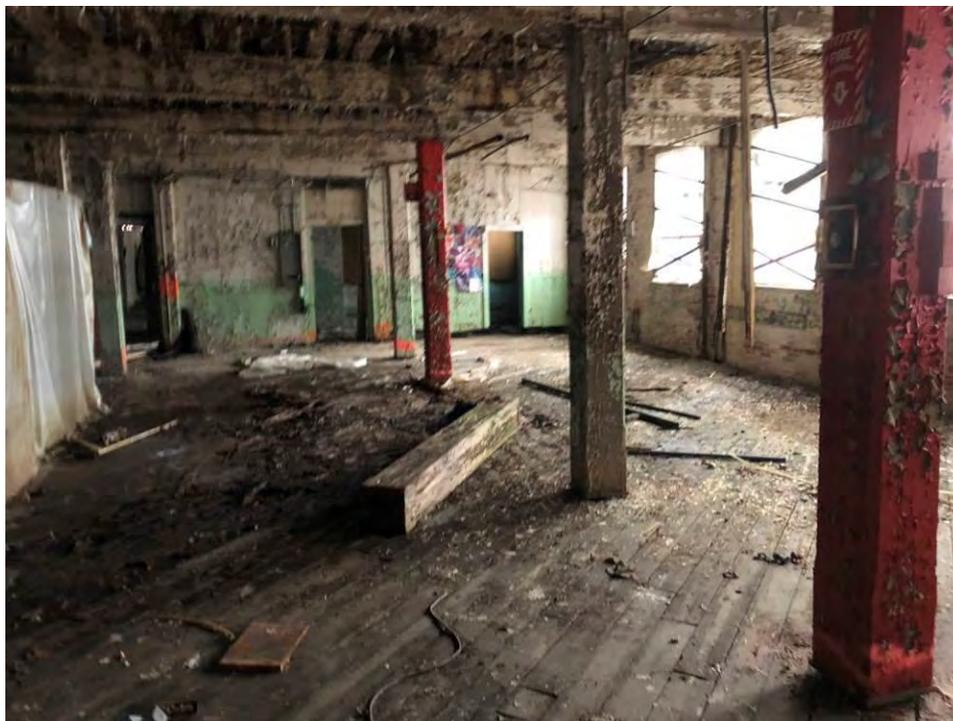
SCENE: View of Building R, Floor 1 with collapsed column. Photograph taken facing northwest.

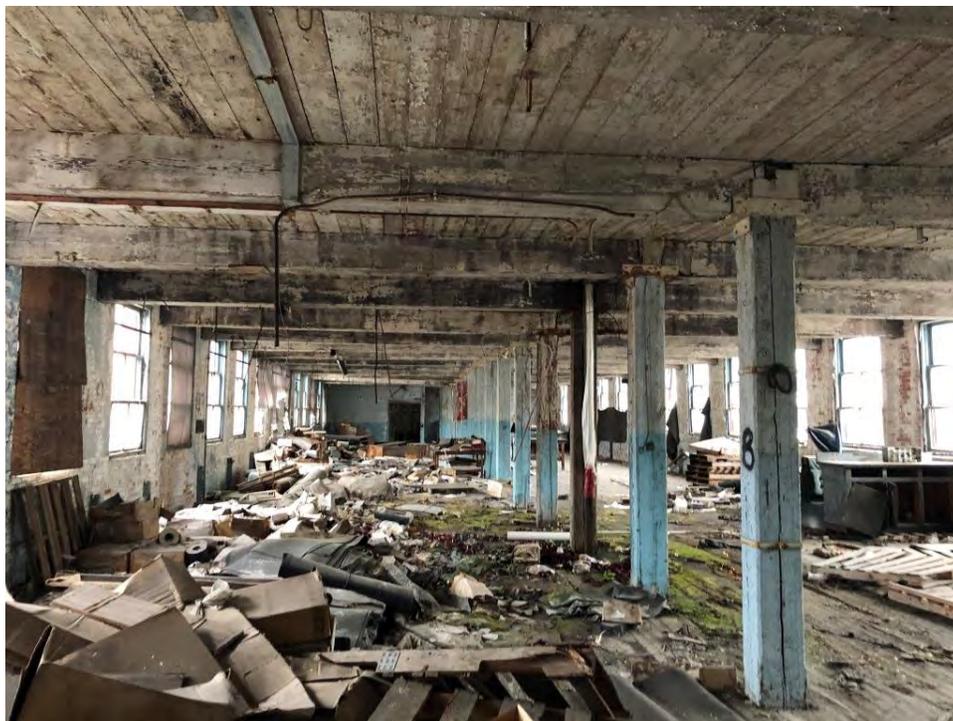
SCENE: View of Building T, Floor 3 with debris including suspected ACM, cardboard and paperwork along with vegetation on the floor indicating how wet it is. Photograph taken facing north.

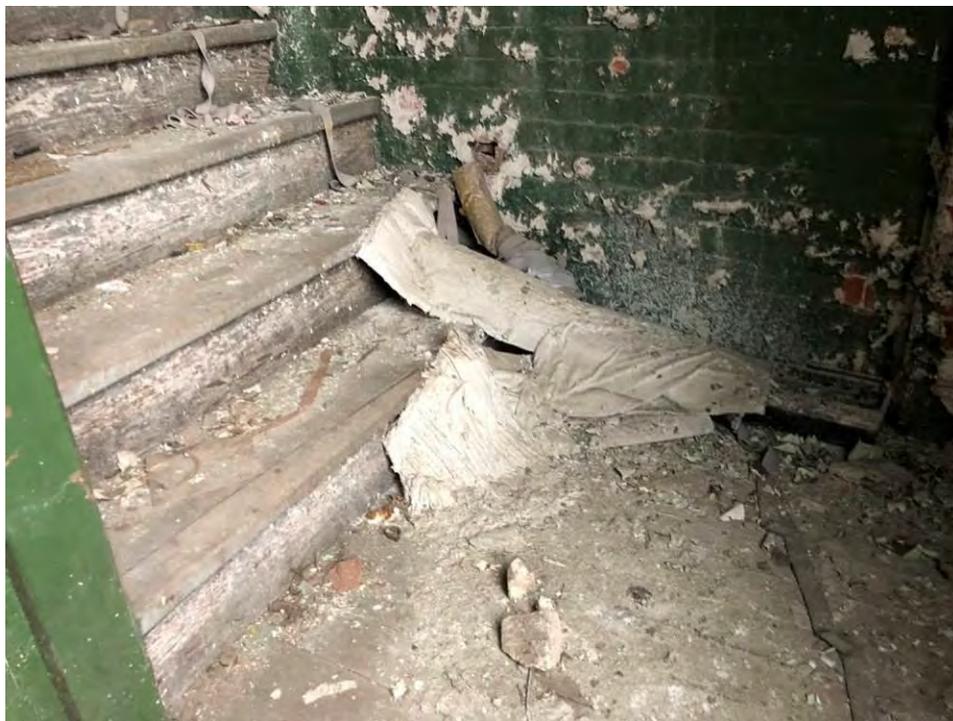
SCENE: View of stairwell with suspected ACM pipe wrap. Photograph taken facing south.

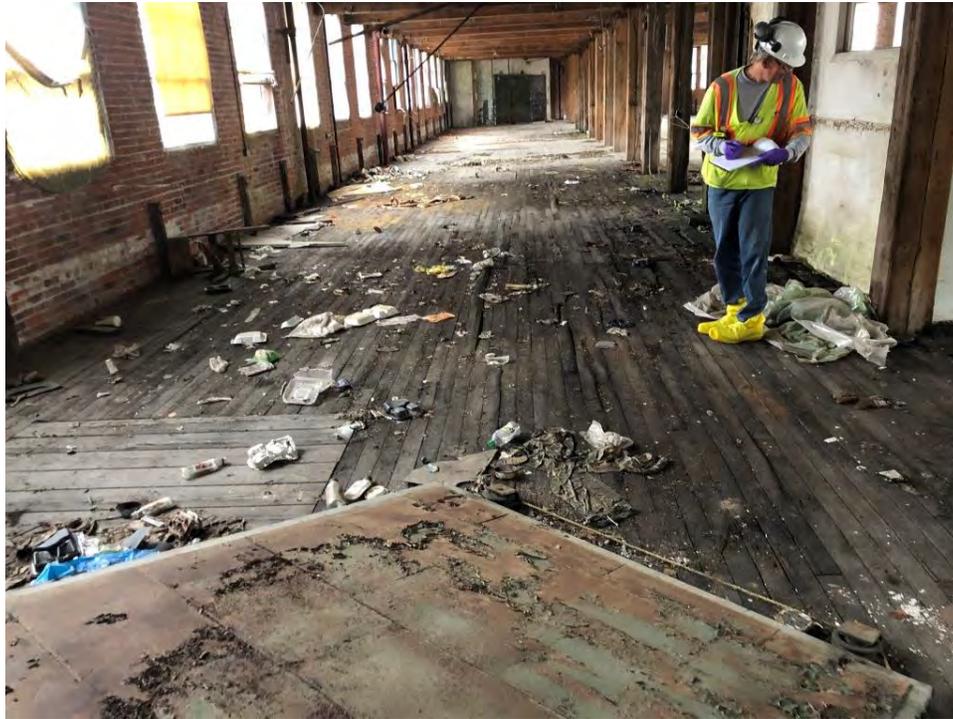
SCENE: View of Building T, Floor 2 with compromised floor. Photograph taken facing north.

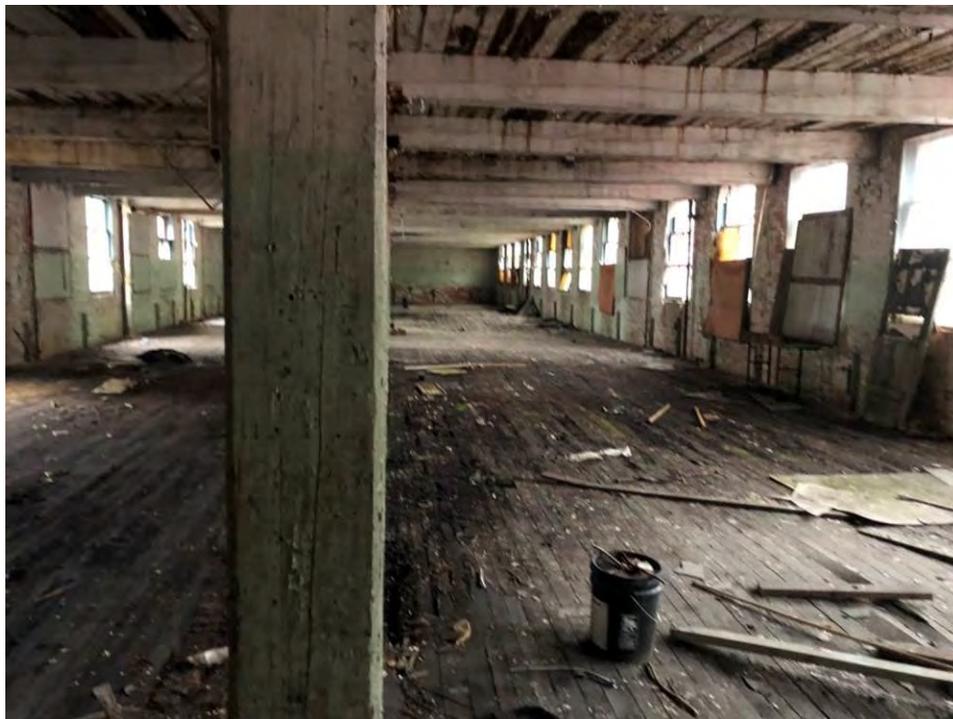
SCENE: View of Building T, Floor 1 with wet, compromised floor. Photograph taken facing north.

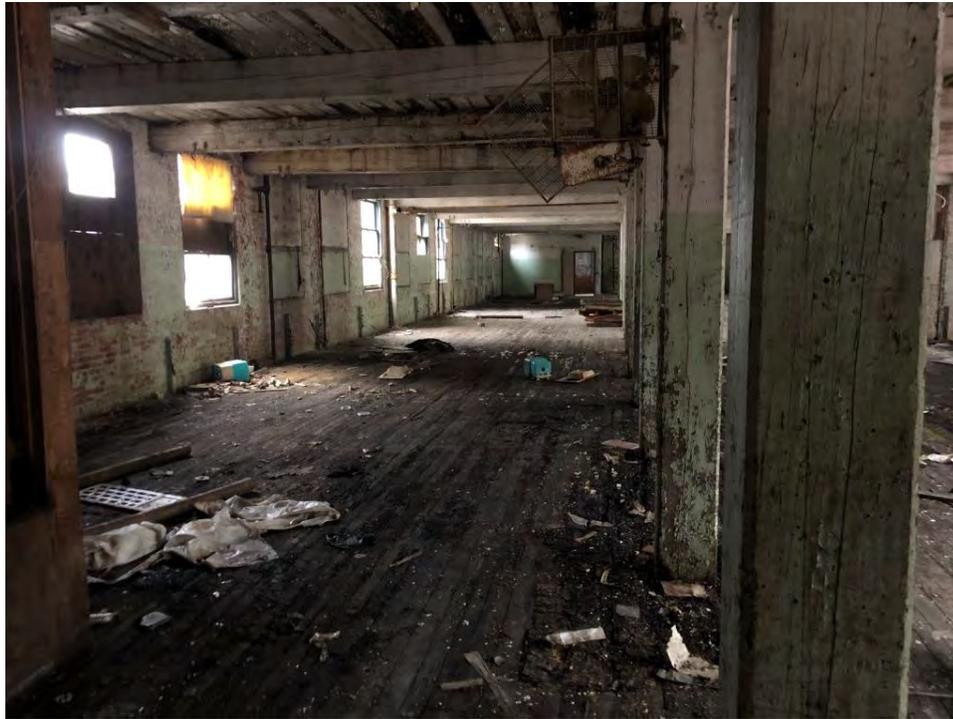
SCENE: View of Building T, Floor 1 with wet, compromised floor. Photograph taken facing north.

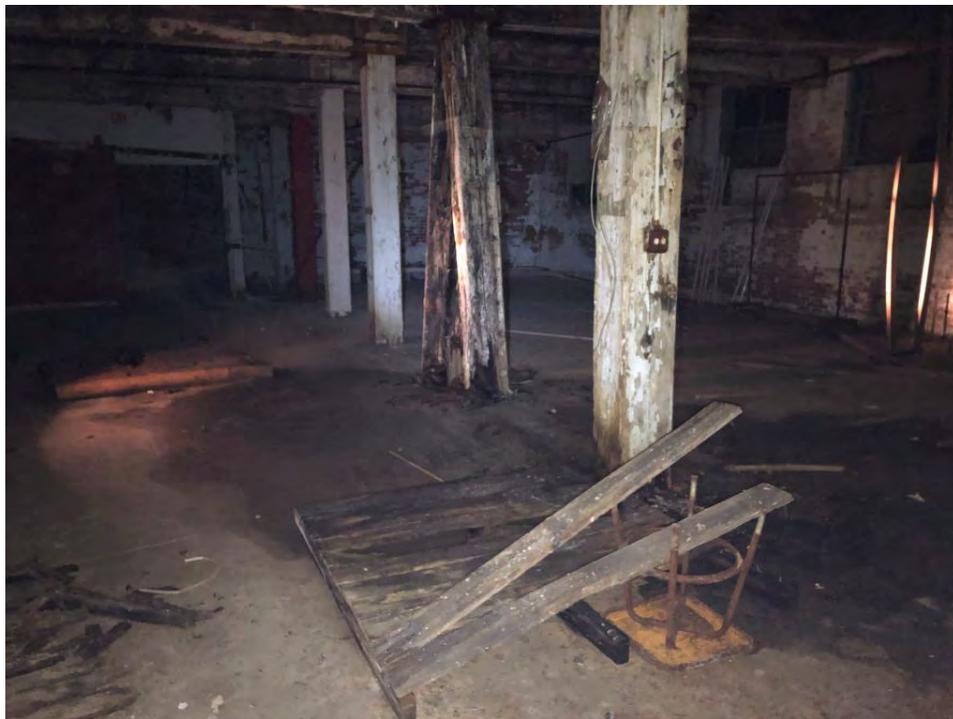
SCENE: View of the split column in the Building T Basement. Photograph taken facing east.

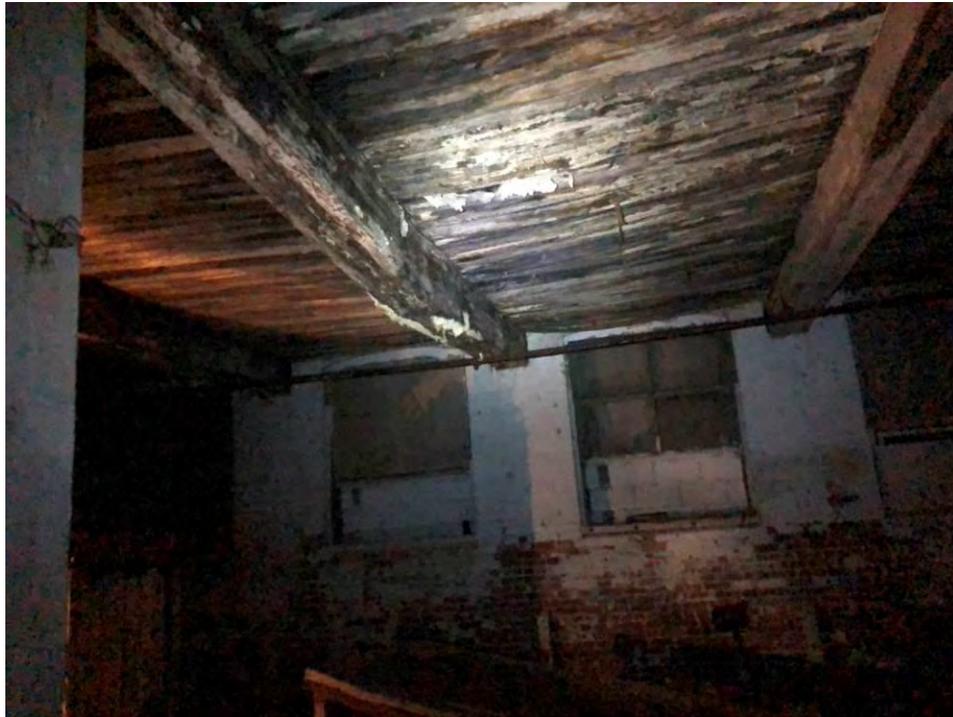
SCENE: View of damaged beam in the Building T basement. Photograph taken facing east.

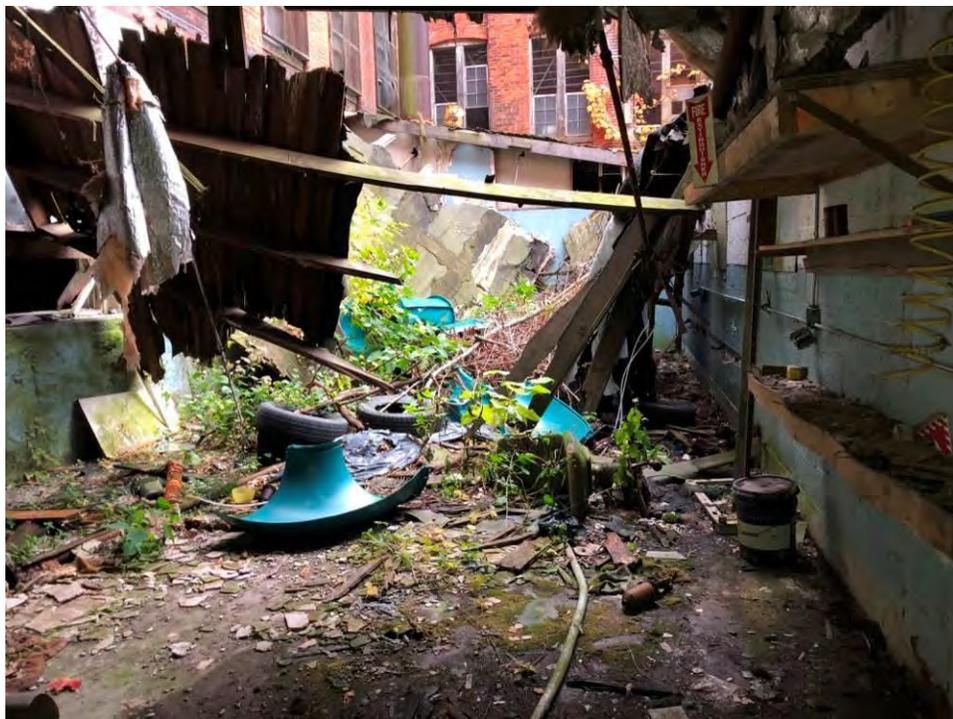
SCENE: View of damaged shed between Buildings R and T. Photograph taken facing west.

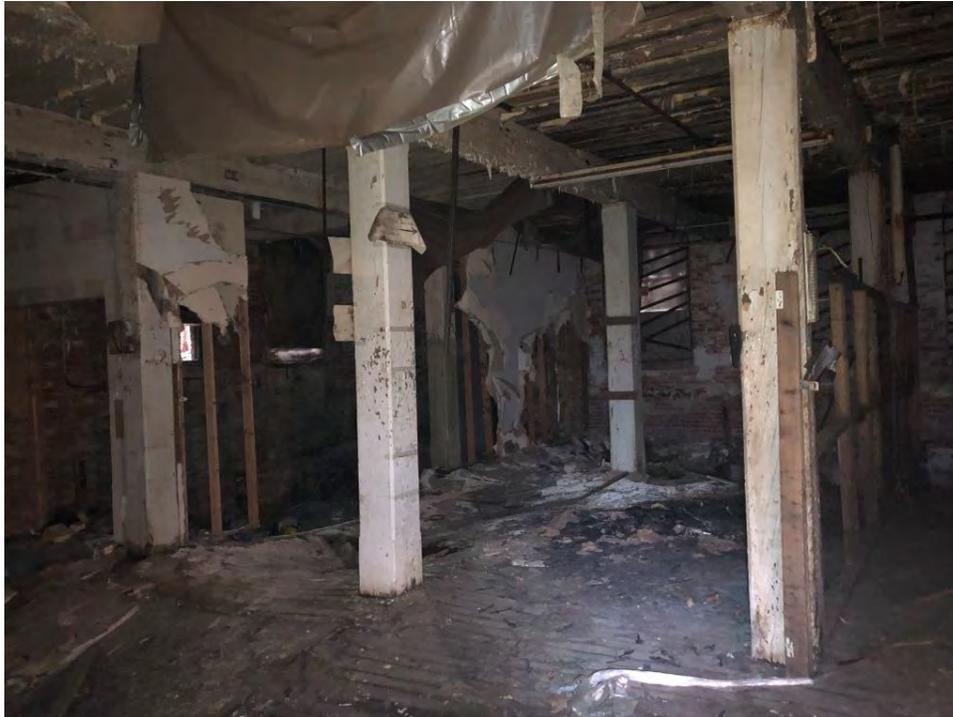
SCENE: View of Building R, Basement with damaged ceiling/floor from above. Photograph taken facing south.

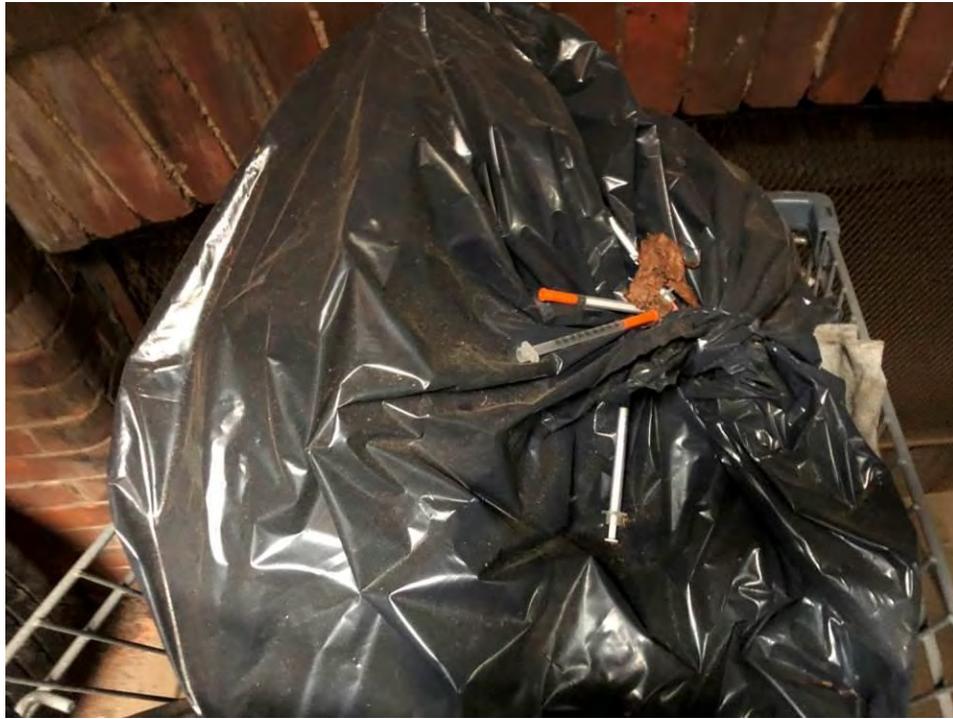
SCENE: View of hypodermic needles on a shopping cart on the wooden walkway leading to the entrance to Building R.
Photograph taken facing north.

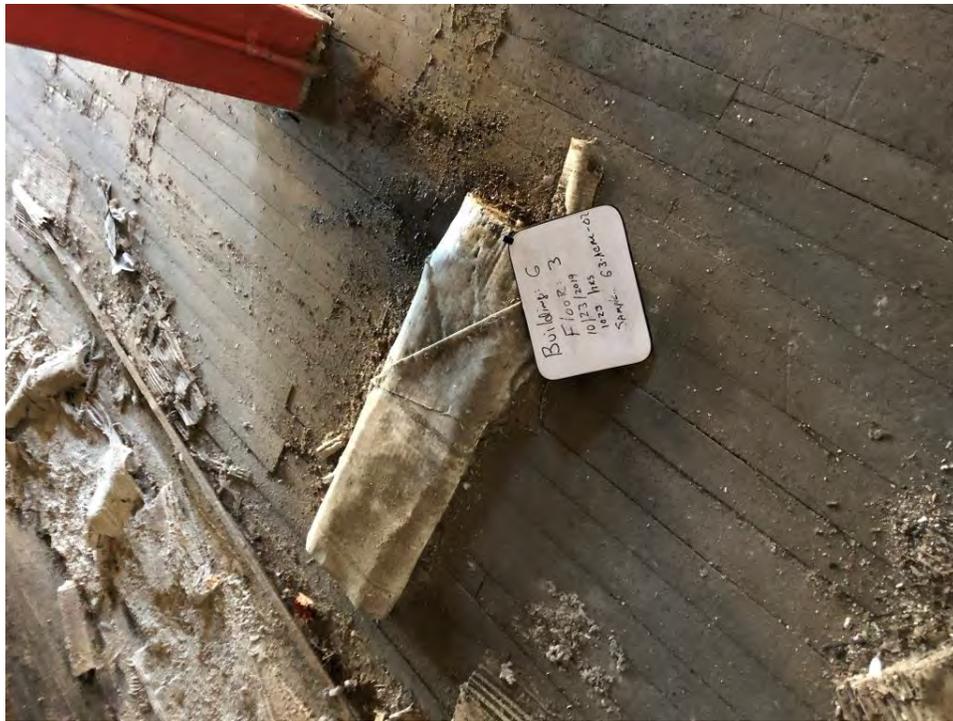
SCENE: View of bulk asbestos sample location G3-ACM-02, collected from pipe wrap on the floor of Building G, Floor 3.
Photograph taken facing south.

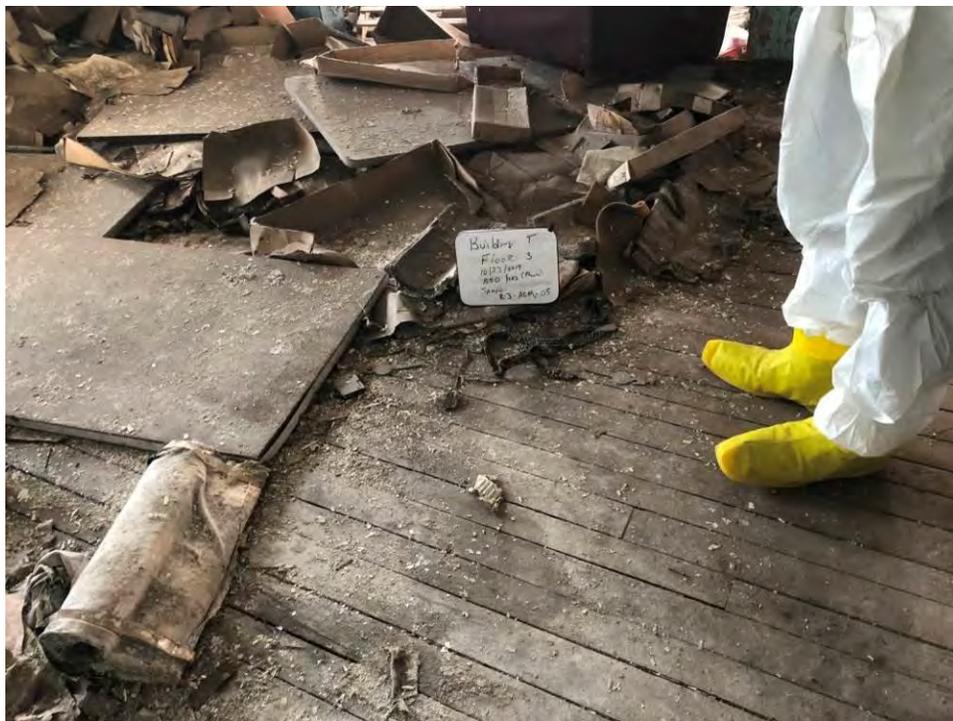
SCENE: View of bulk asbestos sample location R3-ACM-05, collected from pipe wrap on the floor of Building T, Floor 3. Photograph taken facing east.
