**REMOVAL PROGRAM
PRELIMINARY ASSESSMENT/
SITE INVESTIGATION REPORT
FOR THE
FORMER WATERBURY CLOCK FACTORY
WATERBURY, NEW HAVEN COUNTY, CONNECTICUT
8 JULY 2019, 4 SEPTEMBER 2019, AND
21 THROUGH 24 OCTOBER 2019**

U.S. Environmental Protection Agency
Region I
Emergency Planning and Response Branch
5 Post Office Square, Suite 100
Boston, Massachusetts 02109-3912

Weston Solutions, Inc.
Region I
Superfund Technical Assessment and Response Team
101 Billerica Avenue, Building 5, Suite 103
North Billerica, Massachusetts 01862

December 2019

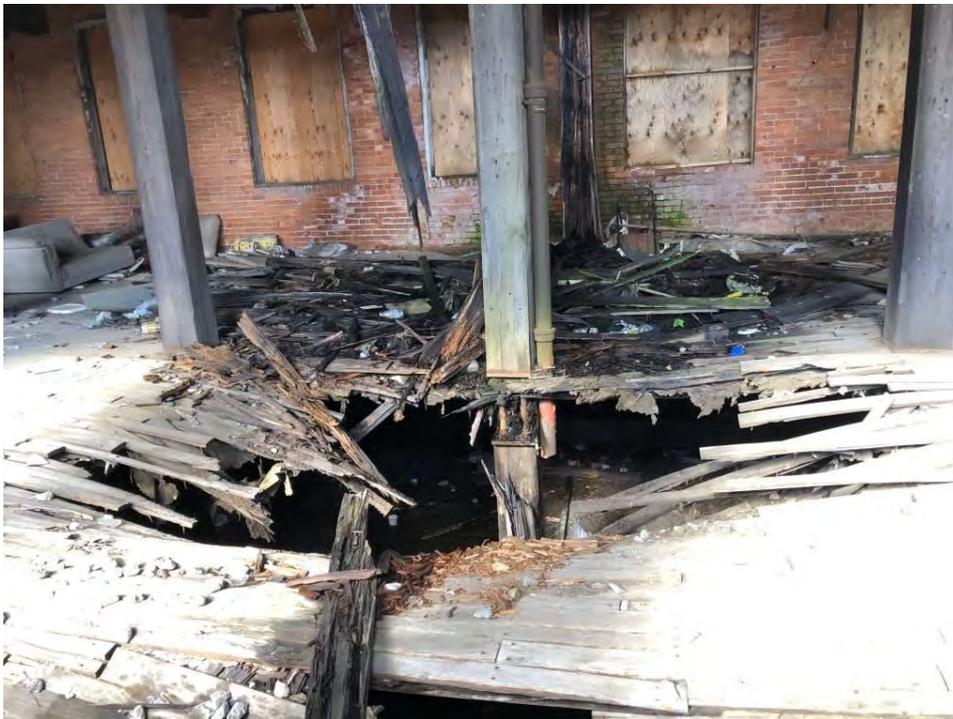
SCENE: View of compromised flooring inside the interior of Building K. Photograph taken facing north.

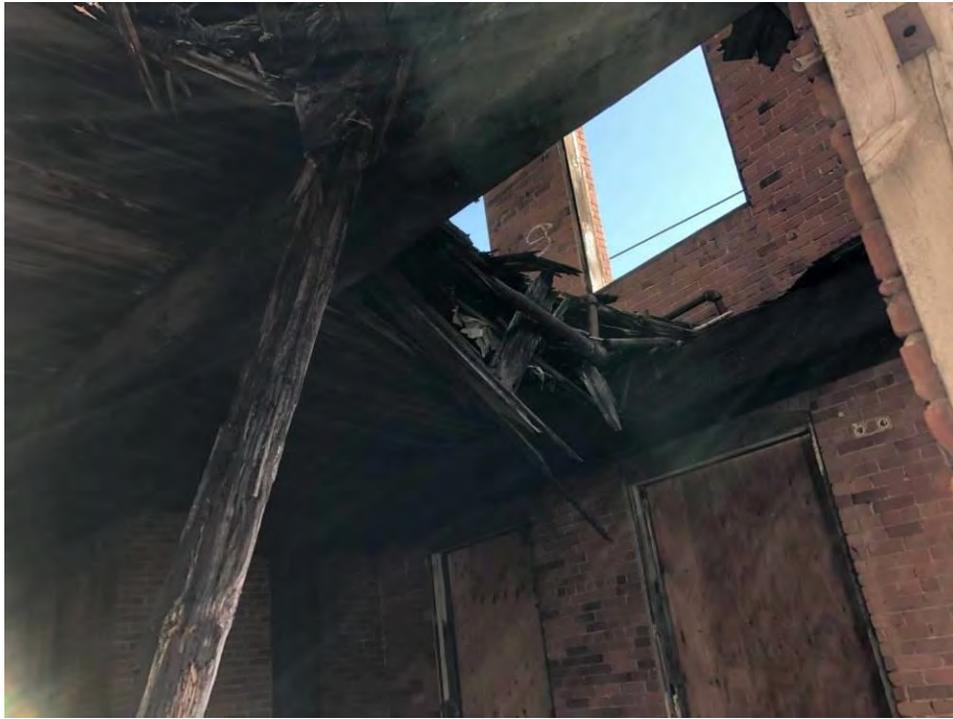
SCENE: View of compromised flooring inside the interior of Building L. Photograph taken facing southeast.

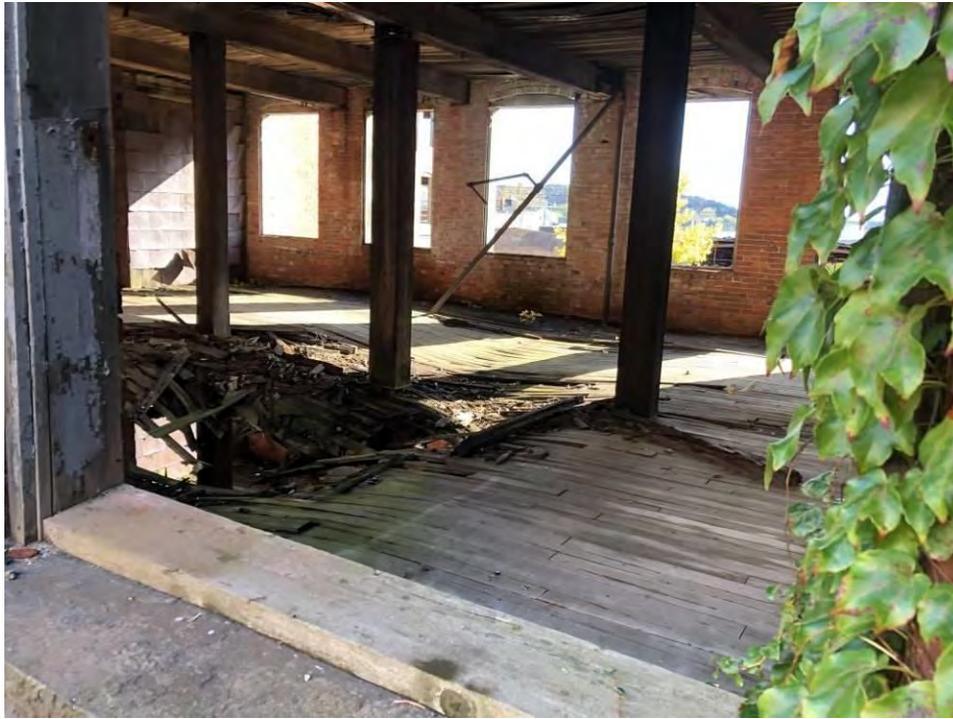
SCENE: View of compromised flooring inside the interior of Building K. Photograph taken facing southeast.

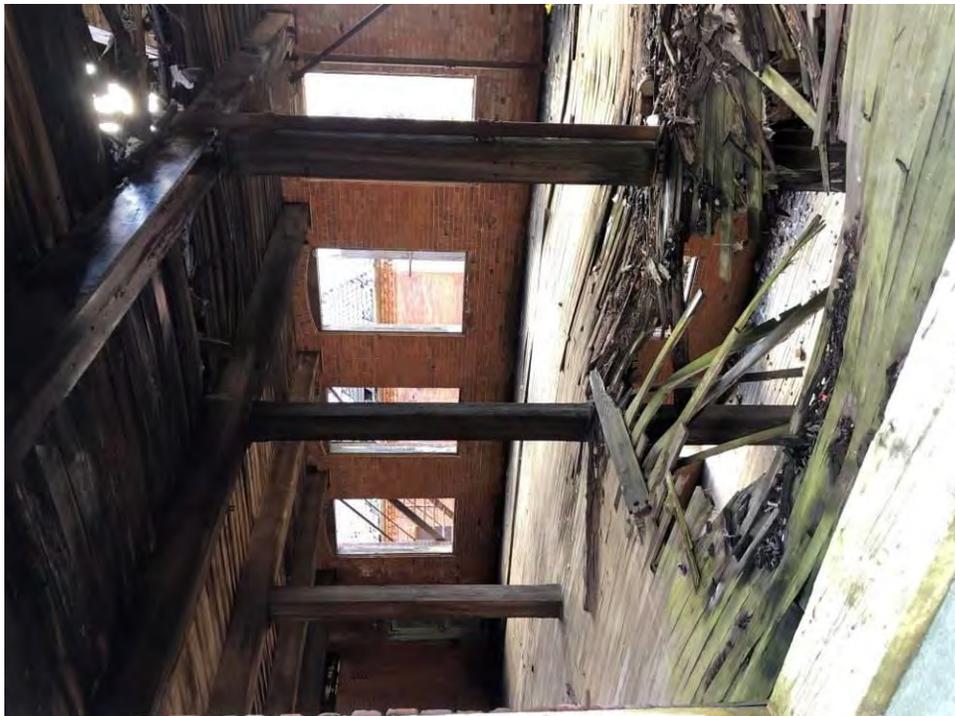
SCENE: View of compromised flooring inside the interior of Building K. Photograph taken facing southeast.

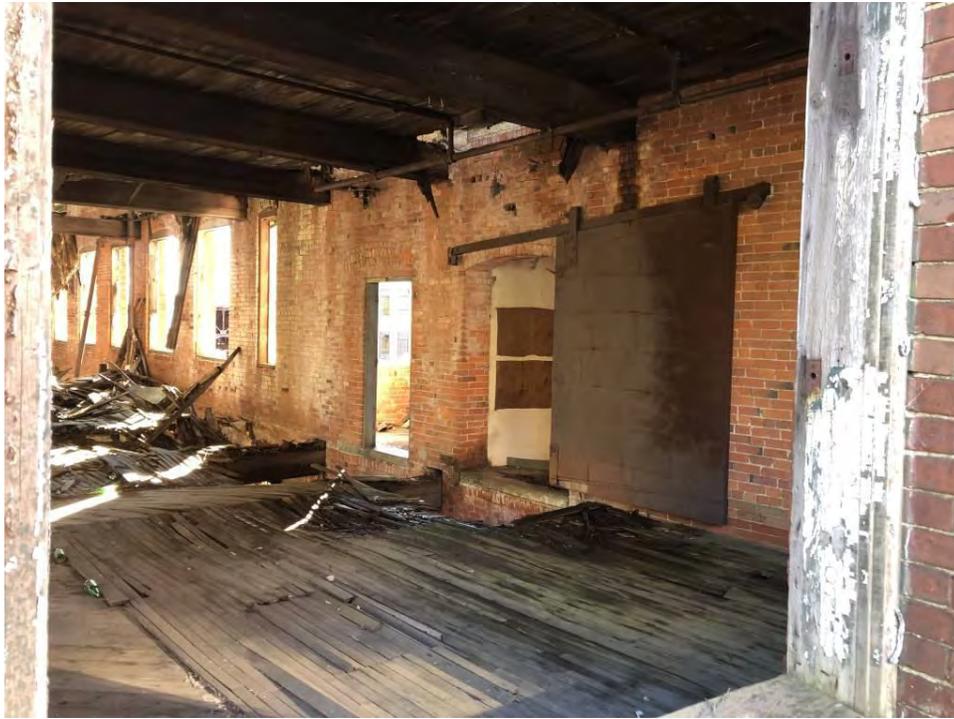
SCENE: View of compromised flooring inside the interior of Building L. Photograph taken facing southwest.

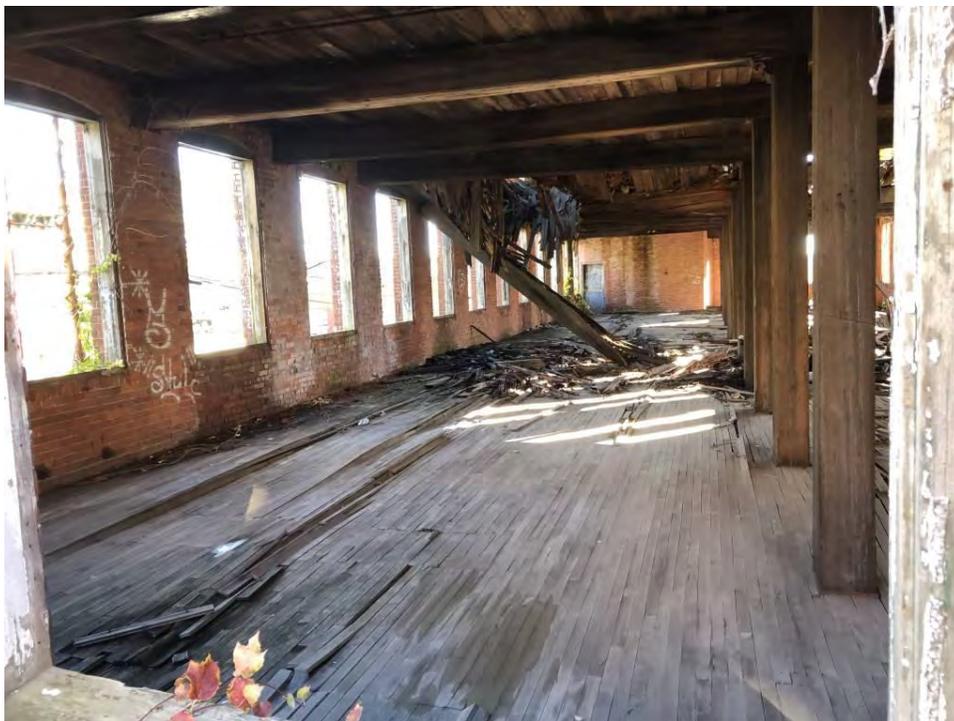
SCENE: View of compromised flooring inside the interior of Building L. Photograph taken facing south.
