This report is a combined Lead-Based Paint Inspection and Risk Assessment Report for the single-family residential property located at 1705 Read Avenue in Chattanooga, Tennessee. The owners of record for this property are also the occupants, Terry and Vanessa Kimbrough. A complete paint inspection and environmental sampling was conducted on November 24<sup>th</sup>, 2010 in anticipation of a rehabilitation project that may involve a partnership agreement with the Tennessee Lead Elimination Action Program (TNLEAP). TNLEAP is funded by HUD and administered by Middle Tennessee State University (MTSU).

# Lower Level Floor Plan – 1705 Read Avenue, Chattanooga, TN

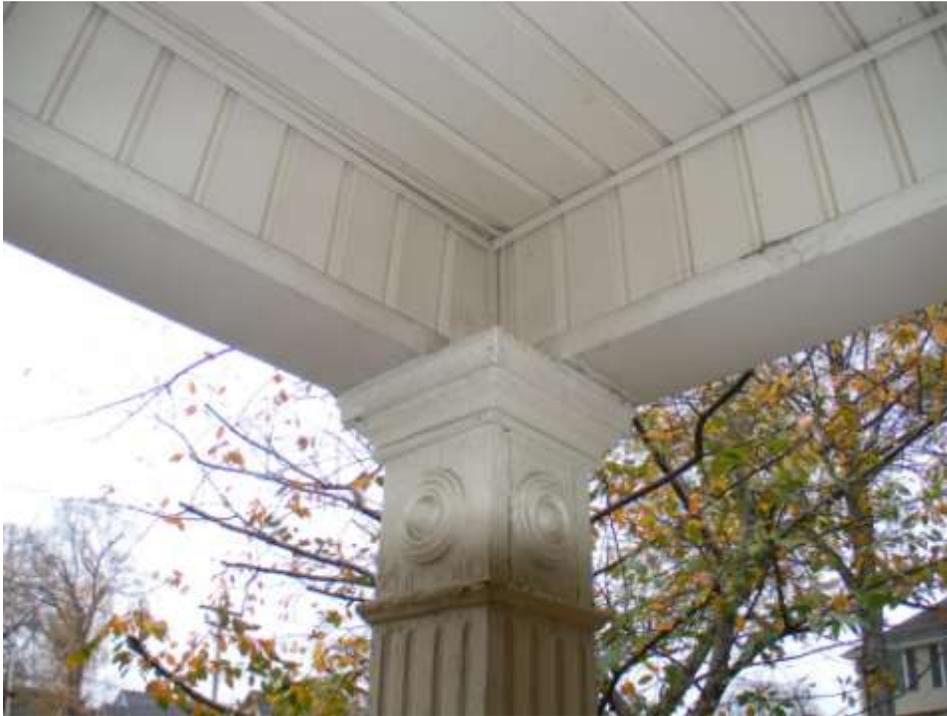
Lead-based paint in deteriorated condition was detected on several exterior painted components, including the Front Porch posts and the front door transom and frame. At the interior, several interior doors and their associated trim, several lower level baseboards, trim and railings at the stairway between levels, and several cased openings tested positive for Lead Based Paint via XRF examination, and have varying degrees of paint deterioration.

**Front Porch – Posts, Beams and Ceiling. Beam and ceiling are wrapped, but posts are POS for LBP.**

Seven interior rooms, the front porch, plus the exterior drip line and bare yard soils, will receive some degree of work during this rehabilitation to remove deteriorated Lead Based Paint, primarily at the Front Porch posts, the front door transom and frame, several interior doors and their associated trim, several lower level baseboards, the trim and railings at the stairway between levels, and several cased openings throughout the house.

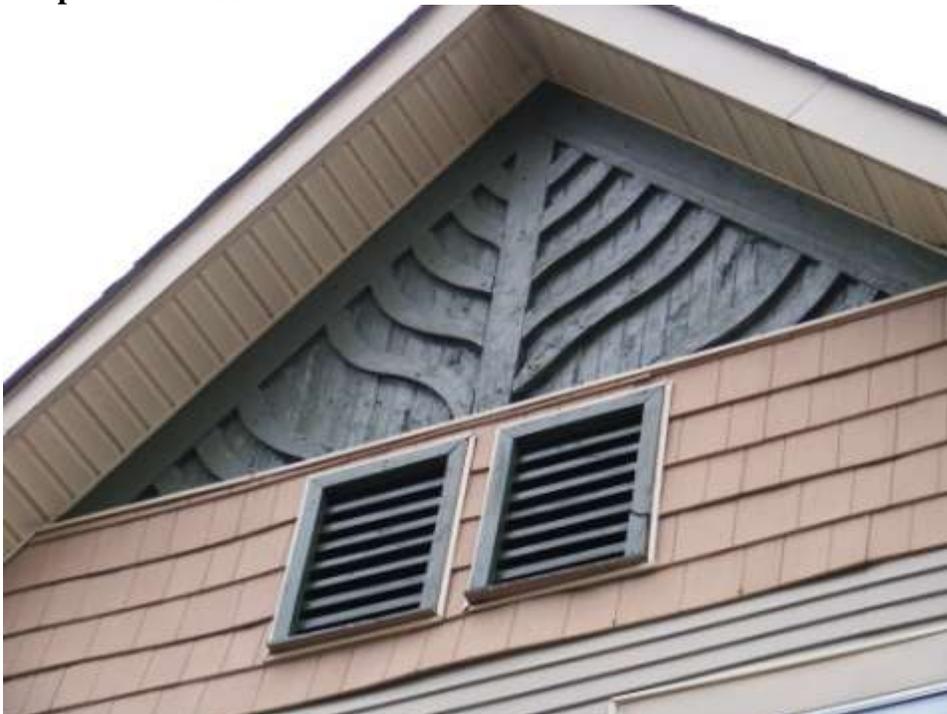
3. The wood shakes and exposed wood at each gable end at the second floor were not tested, and may be assumed to contain lead-based paint. However, the homeowner stated during the interview at the field inspection that these surfaces had been stabilized and repainted within the past year. A visual inspection of these surfaces showed them to indeed be in an intact condition (see picture in Appendix B of this Risk Assessment Report). However, these surfaces should be monitored into the future, and any deficiencies in the paint films on these components should be addressed immediately to prevent possible hazardous lead exposures.

**Gable end at Front (gable ends at right and left sides similar) – shakes and wood were not tested for LBP, as these members were stabilized and repainted within past year (per homeowner), and appear to be in an intact condition. Adjacent roof overhangs are wrapped.**

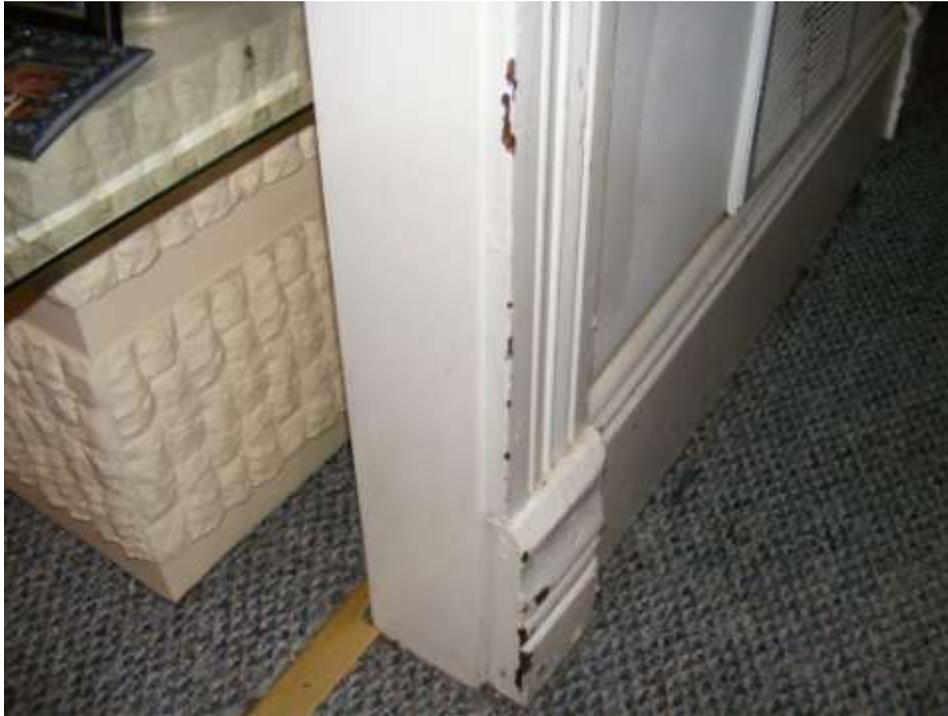
**Living Room/Foyer cased opening – POS for LBP**

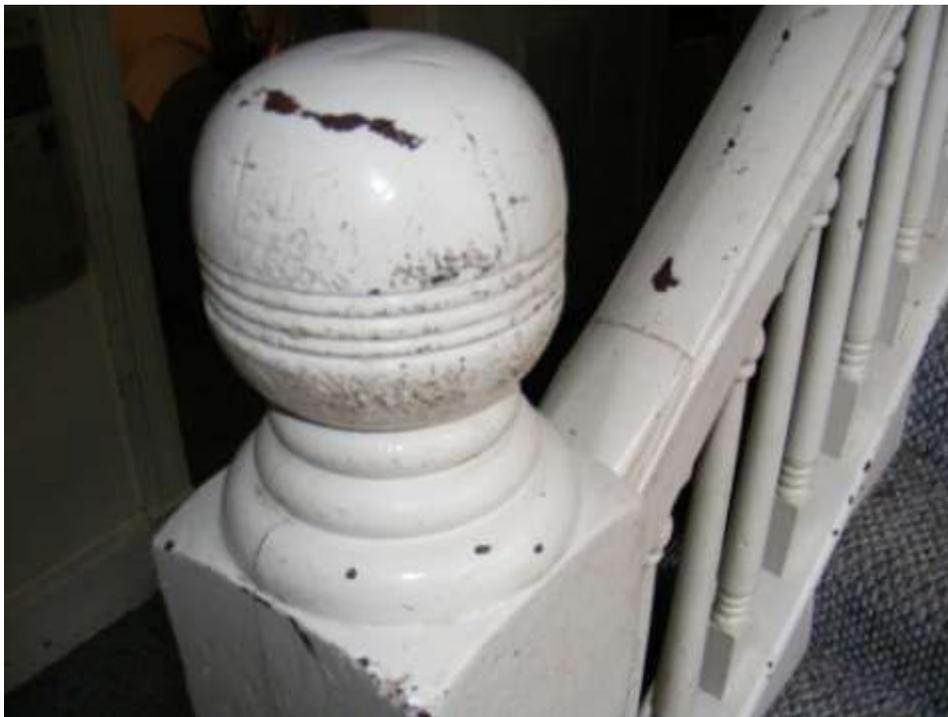
**Typical construction – Stair Post and railing at lower level entry foyer  
are POS for LBP**

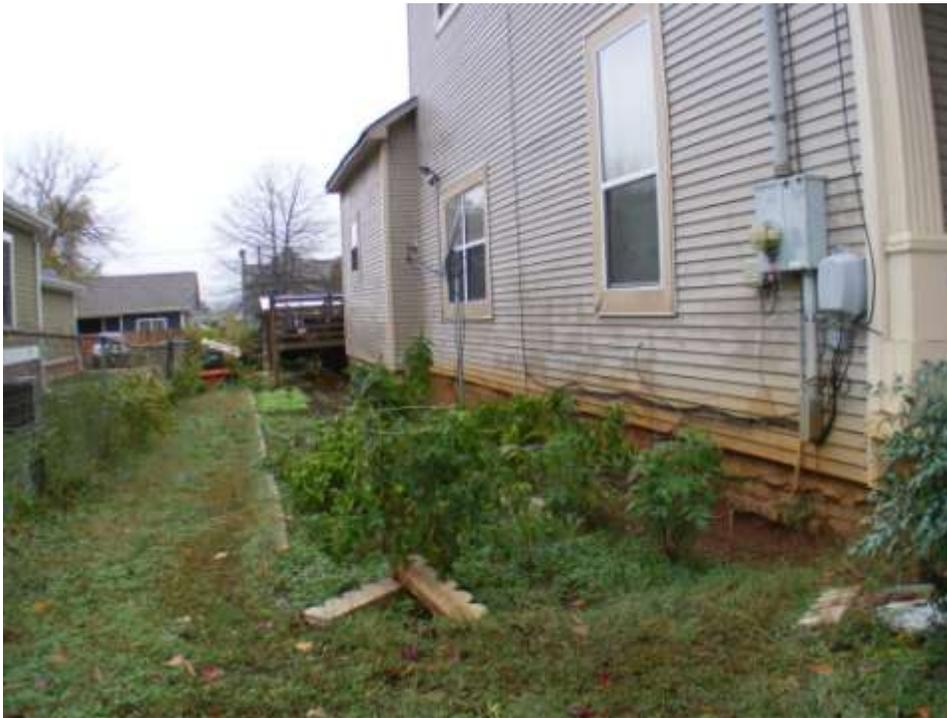
4. There are currently vegetable garden activities within the drip line areas at the rear, right, and left sides of the house; see pictures in Appendix B of this Risk Assessment Report. The soil samples taken within these areas returned hazardous lead levels at many times the allowable thresholds. These vegetable gardens are being destroyed and removed as a part of the work in Section Six above. After this remediation effort is completed, the homeowner is advised **NOT** to grow any vegetables or fruit within these areas, as the plant root systems, or the fruits/vegetables themselves (i.e., potatoes, beets, carrots) will extend below the levels where contaminated soil is replaced, and a lead hazard in ingested vegetables and/or fruit may exist.

**Vegetable Garden within Left Side Drip Line area – soil POS for LBP at many times the allowable threshold, contaminating plants/vegetables.**

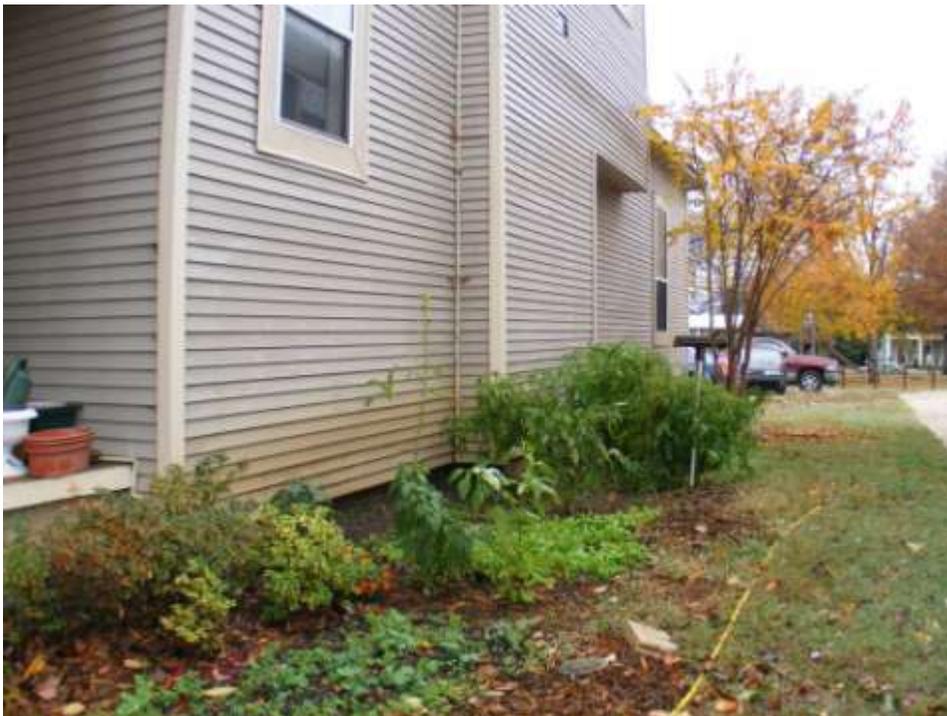
**Vegetable Garden within Right Side Drip Line area – soil POS for LBP at many times the allowable threshold, contaminating plants/vegetables.**

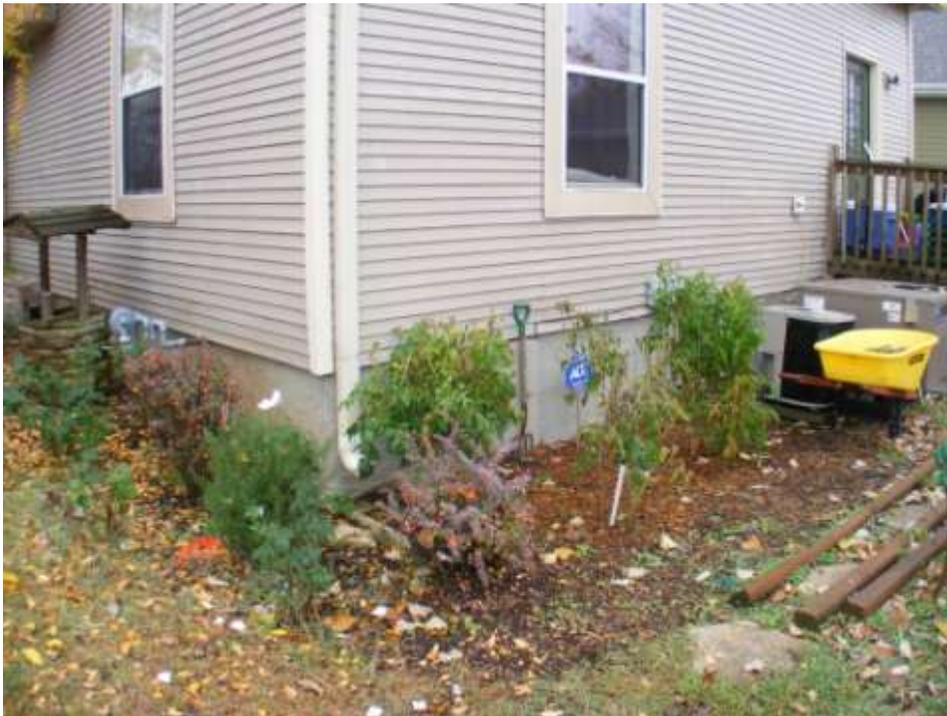
**Vegetable Garden within Rear Drip Line area – soil POS for LBP at many times the allowable threshold, contaminating plants/vegetables.**

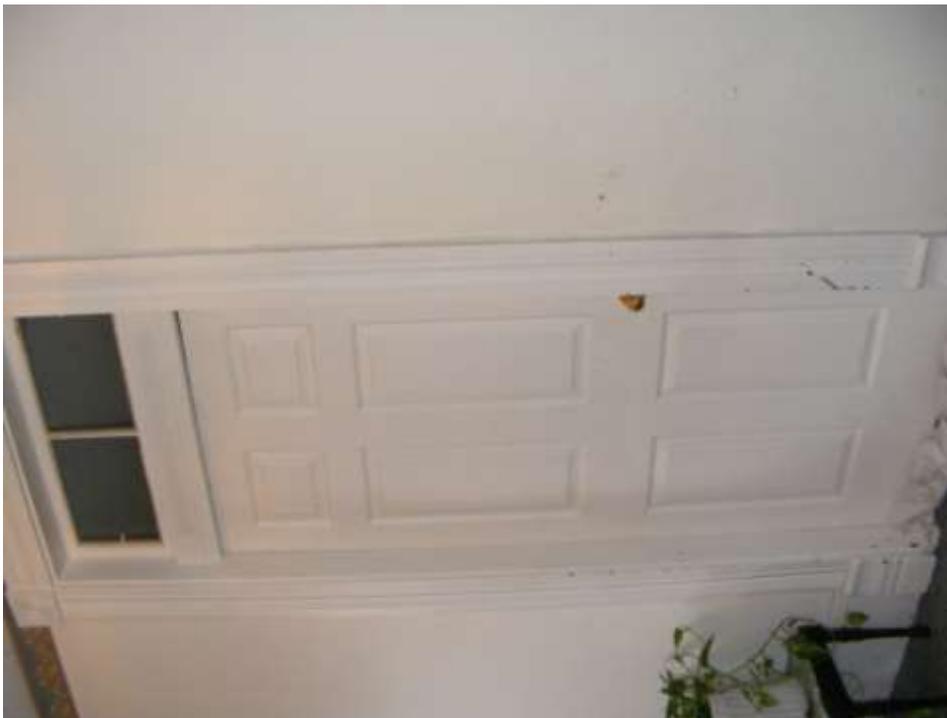
**Typical Upper Level door and transom – many components of these assemblies are POS for LBP, and opening shall receive rehabilitation.**
