**U.S. Environmental Protection Agency
Region II
Lawrence Aviation Industries Site
Old Mill Creek**

LANDSCAPE RESTORATION PLAN

Date : May 12, 2010

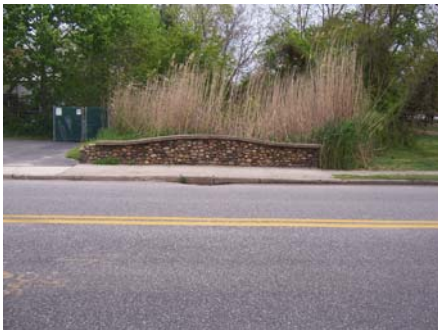
View of the vegetation on the east side of Barnum Avenue prior to removal activities.

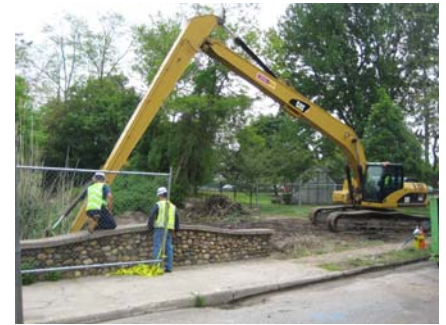
On the east side of Barnum Avenue, one (1) Honey Locust tree and a variety of reeds, vines, and brambles were removed from the creek bank. The area cleared of vegetation was approximately 40ft east of the culvert and approximately 45ft up the south bank and onto the level grade. This area was cleared to create a working platform for the excavator that as used to remove the sediment from the creek.

Heavy equipment was used in removing sediments and debris along Old Mill Creek.

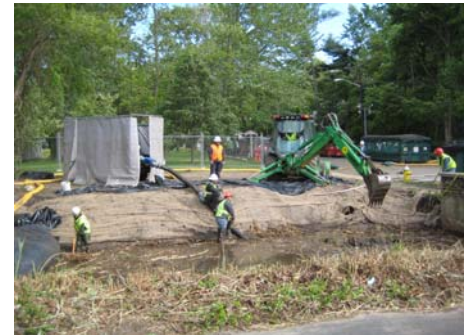
Erosion mat placed on the bank of Old Mill Creek.

For the most immediate and effective erosion control on the creek bank we will apply a bio-degradable erosion matting to the exposed soil from the waterline to approximately two feet beyond the top edge of the bank. This matting will be held in place by six inch steel staples installed on 18" centers. Two options are proposed for the creek bank.

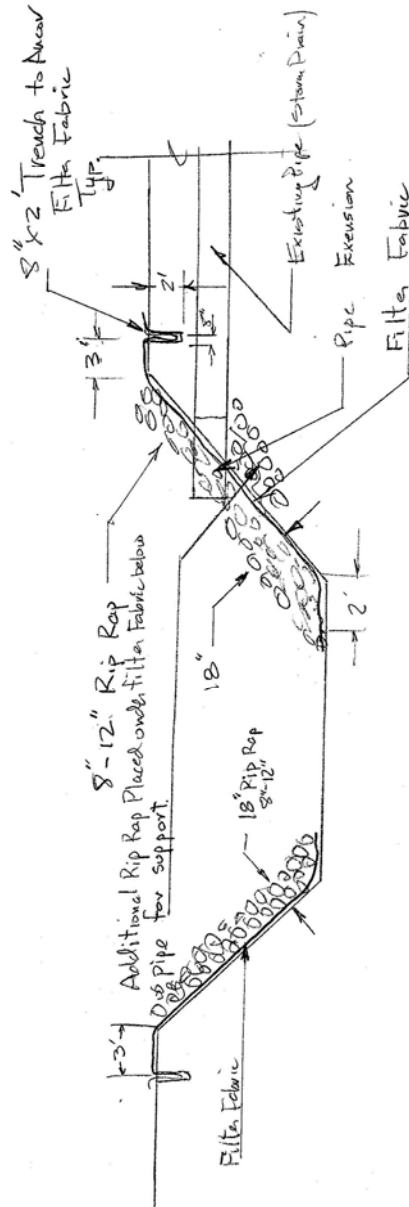
Proposed Landscape Restoration Design Option 2

Note : Although represented in the above diagram as having rip rap placed on the northern creek bank, this may not occur.

Option 1 will have the matting over-seeded with shade tolerant native marsh grass mix. This will allow for a more natural look with local reeds eventually taking over the area. Option 2 is to have rip rap (concrete blocks) placed along the creek bank. This will prevent and limit the amount of phragmites and other grasses and reeds from growing along the bank.
