# **Incident Action Plan**

## ***Millard Anhydrous Ammonia Release***

**06/09/2014**

**Richland, Mississippi**

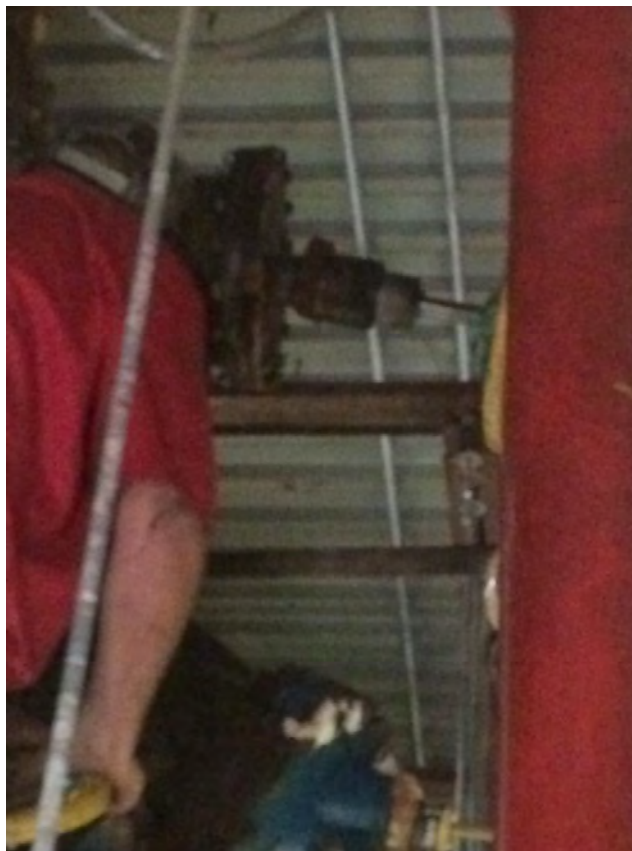
Siera Type	Event (Observation)	
Primary ID	Former leak location	
Secondary ID	Motor room	
Location	Motor room; Leak 32.26358413696289, -90.15679931640625	
Initials	Bailey Williams	
Comments	Workers will be cutting and capping off pipes. Picture taken on top of tank.

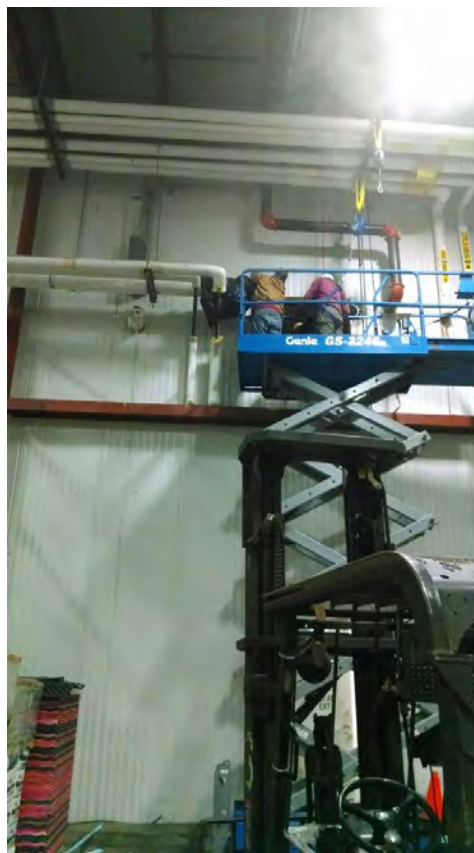
Date Time	2014/06/11 13:22
Siera Type	Safety (Observation)
Primary ID	Freezer 6
Secondary ID	
Location	Freezer 6 at pipe repair site ,
Initials	Andrew Henault
Comments	Crew cutting and removing damaged pipe

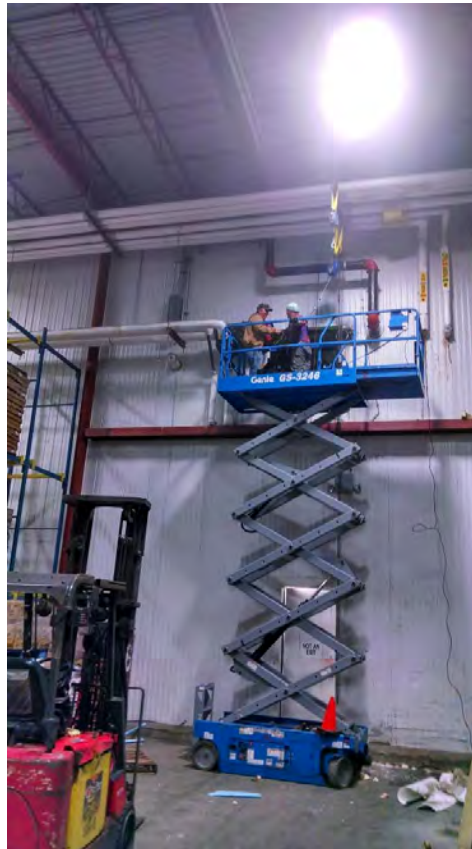
Continued - Photo 2

Date Time	2014/06/11 13:22
Siera Type	Safety (Observation)
Primary ID	Freezer 6
Secondary ID	
Location	Freezer 6 at pipe repair site ,
Initials	Andrew Henault
Comments	Crew cutting and removing damaged pipe
