IDAHO
CLEARWATER COUNTY
2015 SITE RESTORATION REPAIRS
OROFINO, CLEARWATER COUNTY, IDAHO
SITE CONTOUR AND
ASPHALT REPAIR DETAILS

RECORD
DRAWING

Sheet
reference
number:
C-5
SHEET 5 OF 6

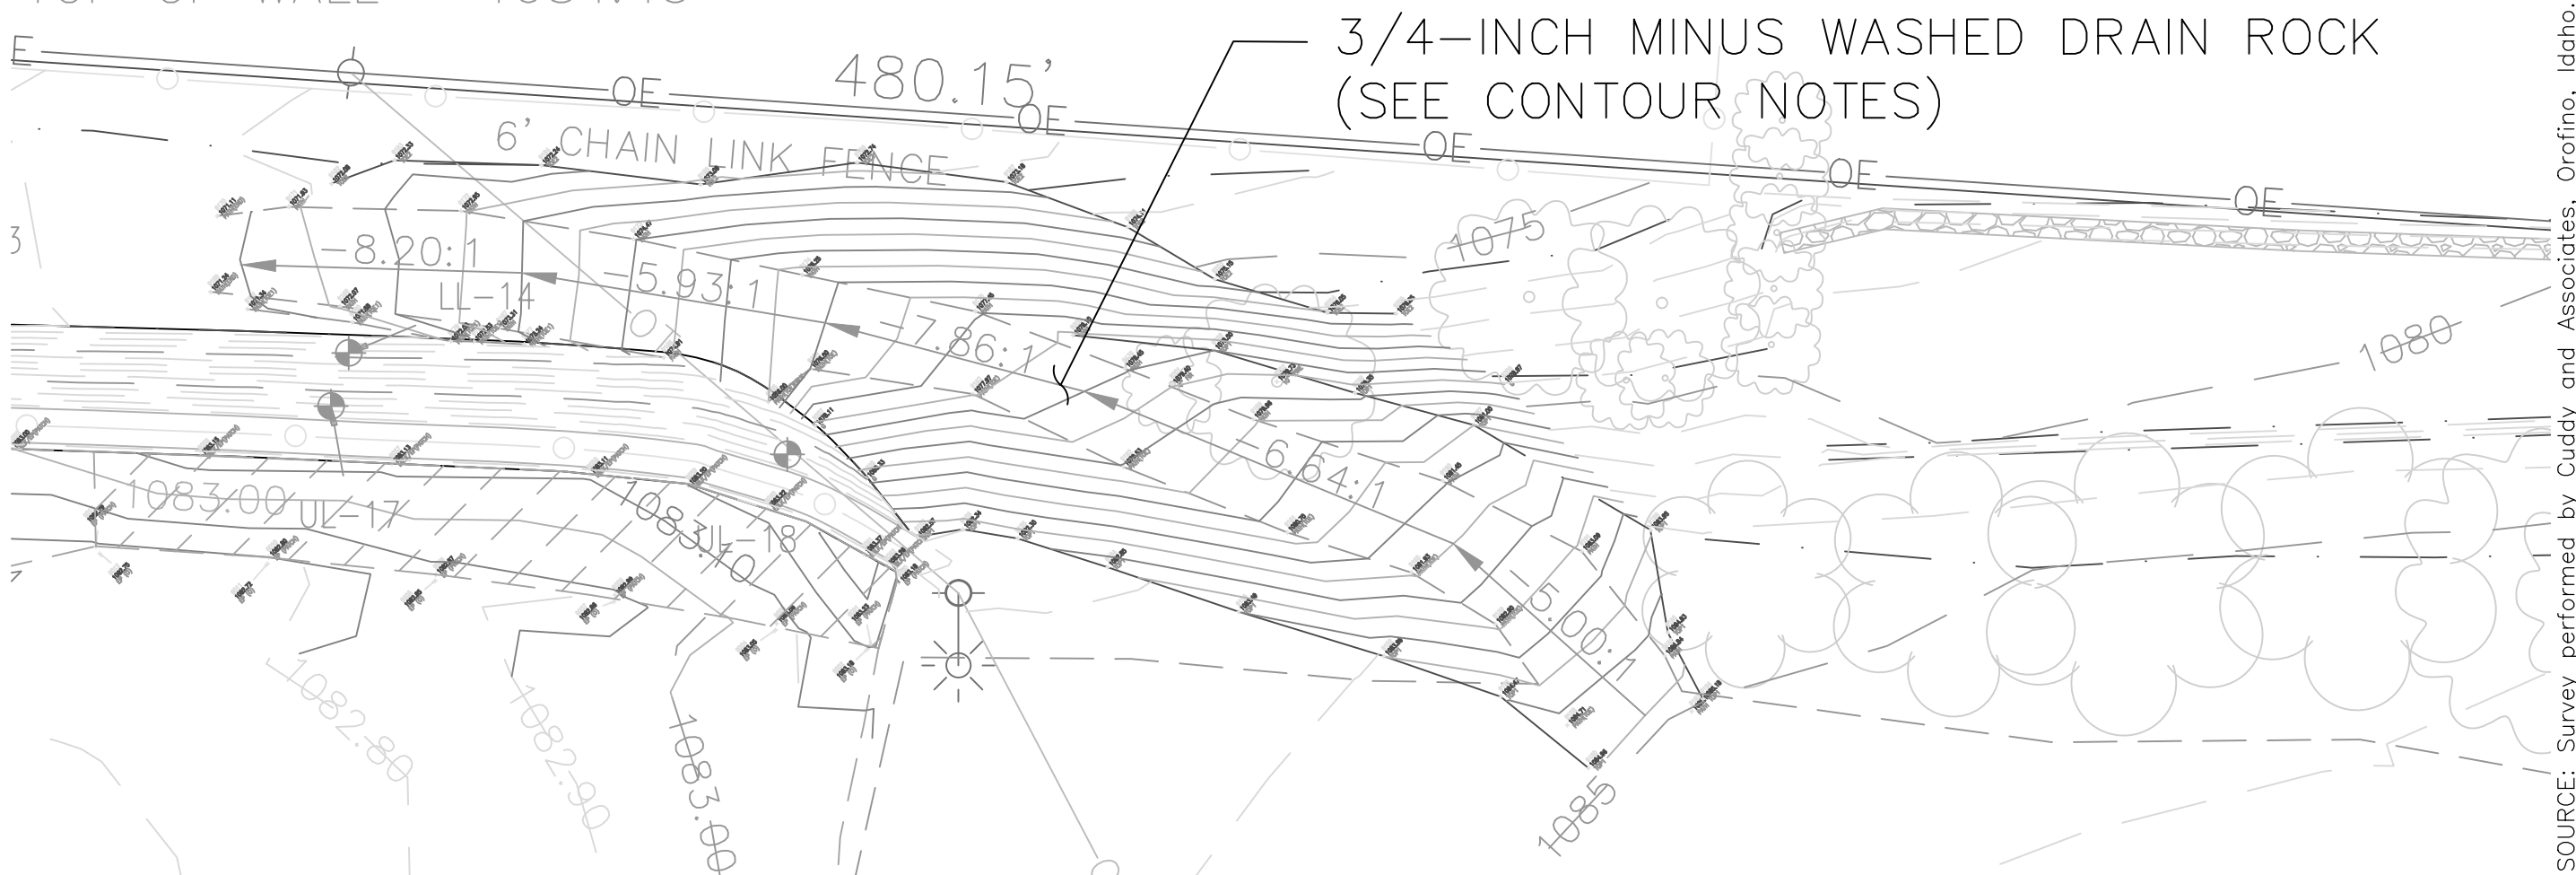
1 LOWER WALL RAMP
C-2 CONTOUR LINES SHOWN AT 1 FOOT INTERVALS

1. THE LOWER WALL RAMP MAXIMUM SLOPE IS 20% (11.3 degrees).

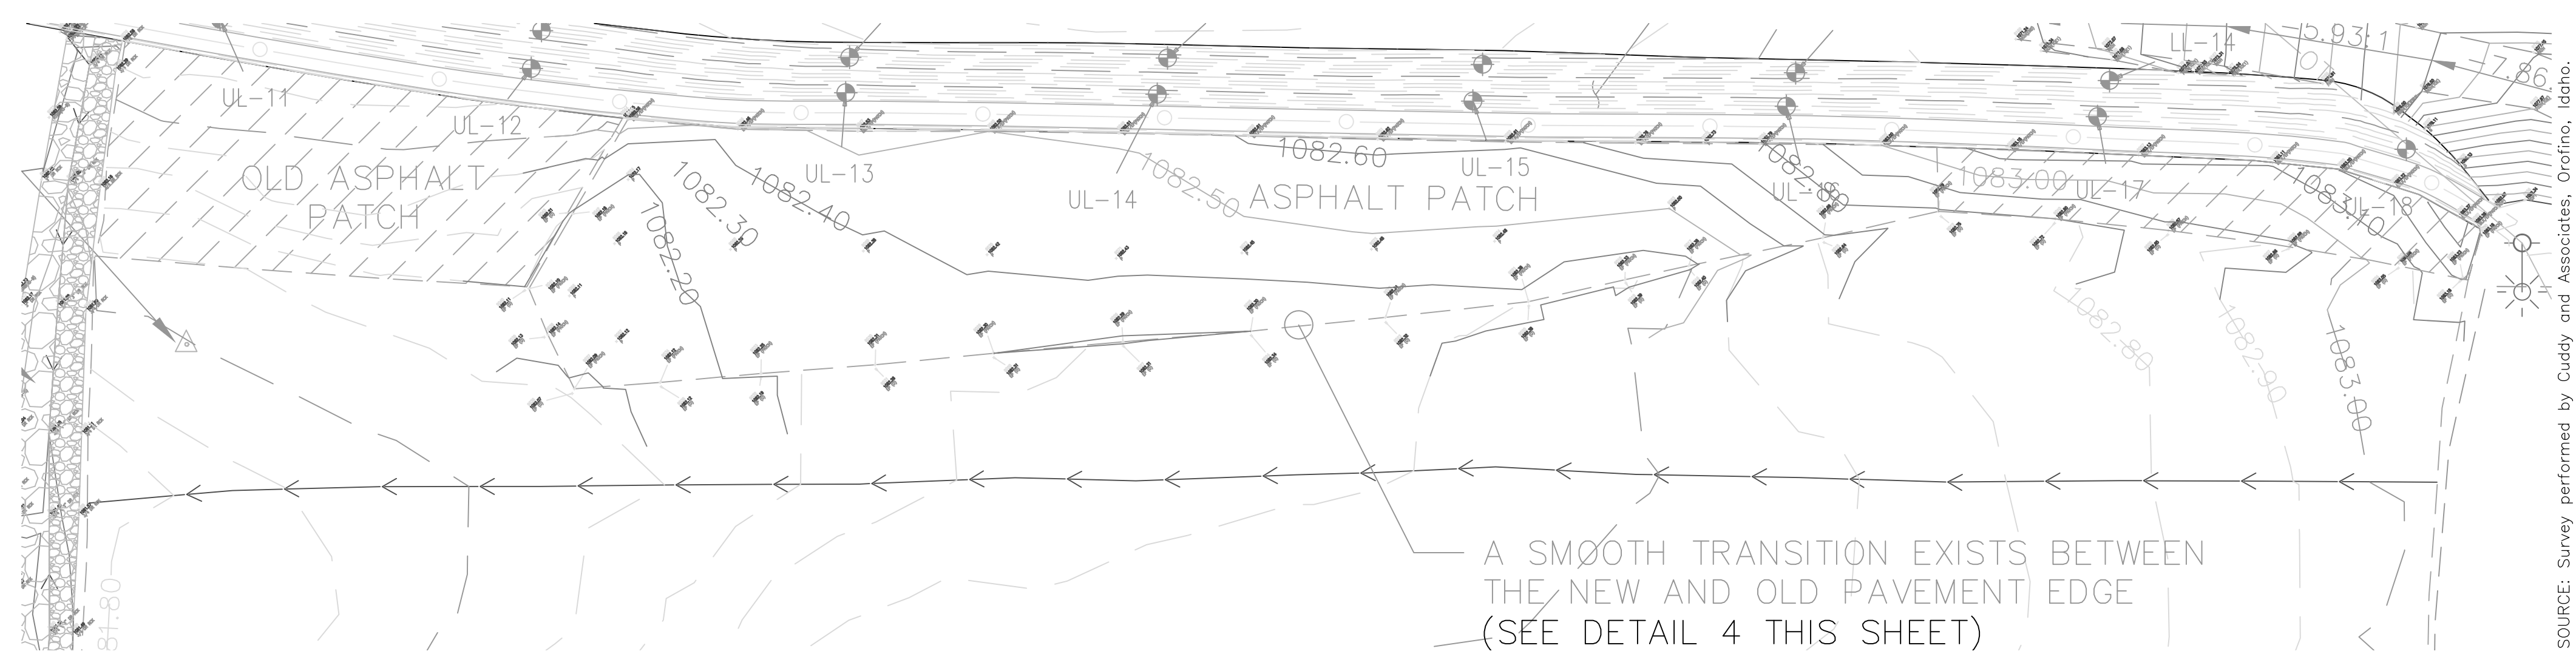
3 ASPHALT REPAIR AREA
C-2 CONTOUR LINES SHOWN AT 0.5 FOOT INTERVALS

A SMOOTH TRANSITION EXISTS BETWEEN
THE NEW AND OLD PAVEMENT EDGE
(SEE DETAIL 4 THIS SHEET)
