Lane Plating Removal Action

Perimeter Air Monitoring Daily Report (4/20/2023)

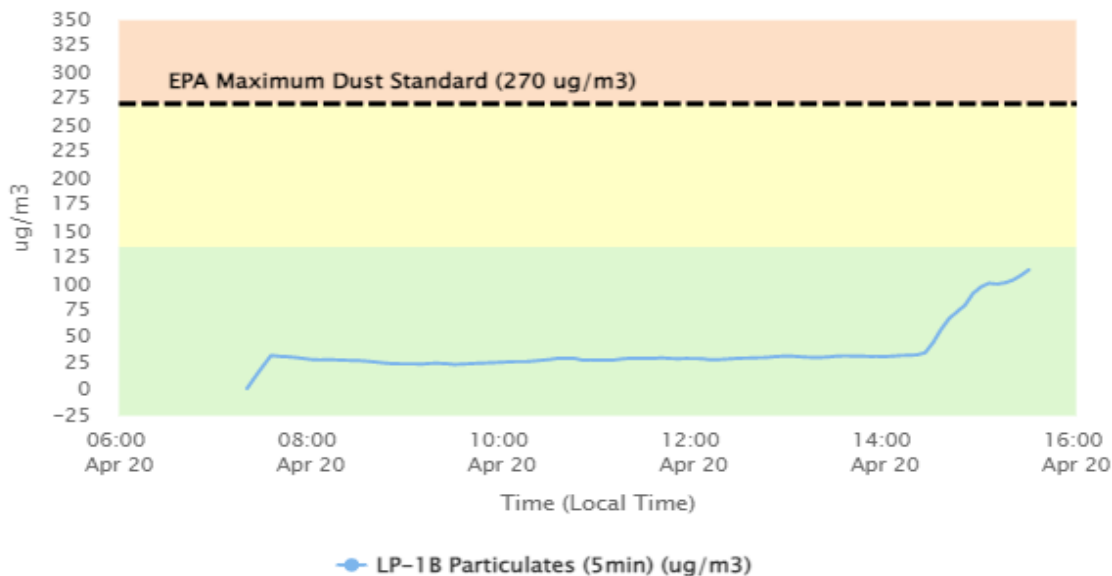
Stat	Reading (ug/m3)	Time Occurred
Min	0.142	8:20:20 AM
Max	107.2	4:25:20 PM
Avg	34.36	4/20/2023
N/A

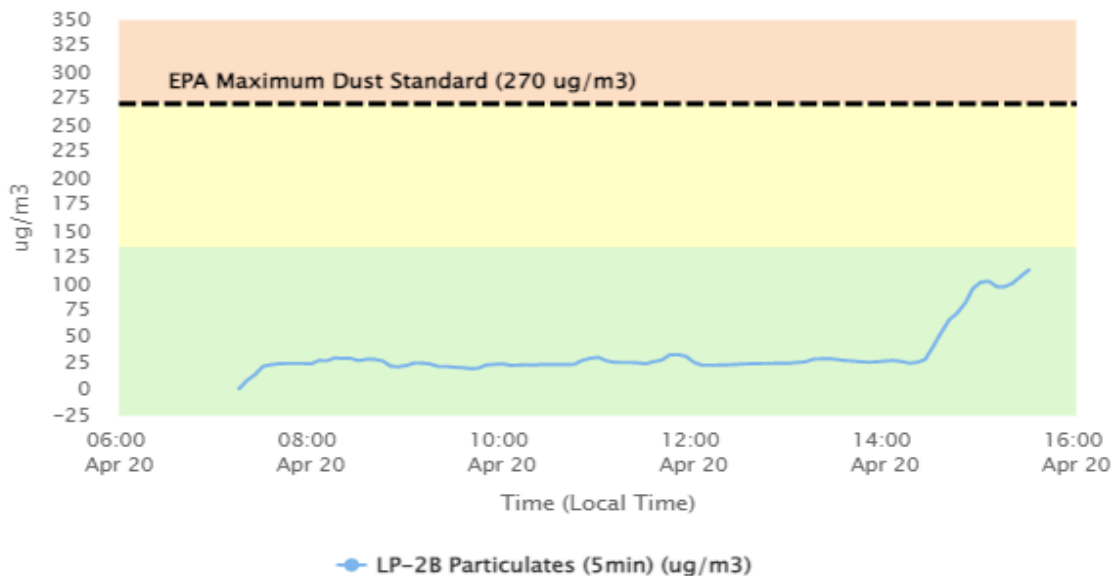
Stat	Reading (ug/m3)	Time Occurred
Min	0	8:15:20 AM
Max	106.5	4:25:20 PM
Avg	31.23	4/20/2023
N/A

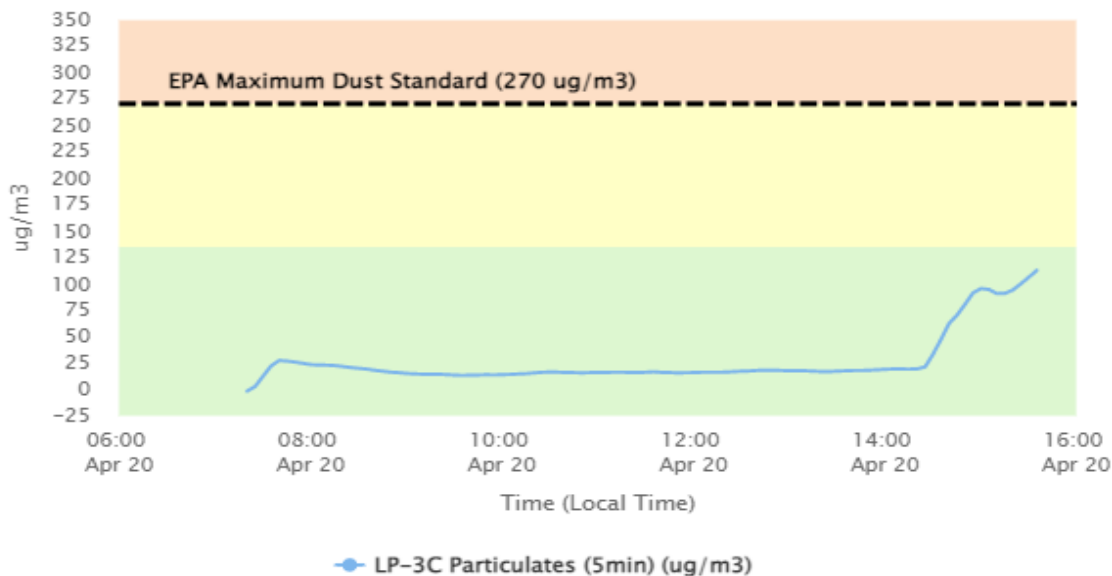
Stat	Reading (ug/m3)	Time Occurred
Min	0	8:20:20 AM
Max	105.5	4:30:20 PM
Avg	24.67	4/20/2023
N/A
