Lane Plating Removal Action

Perimeter Air Monitoring Daily Report (6/21/2023)

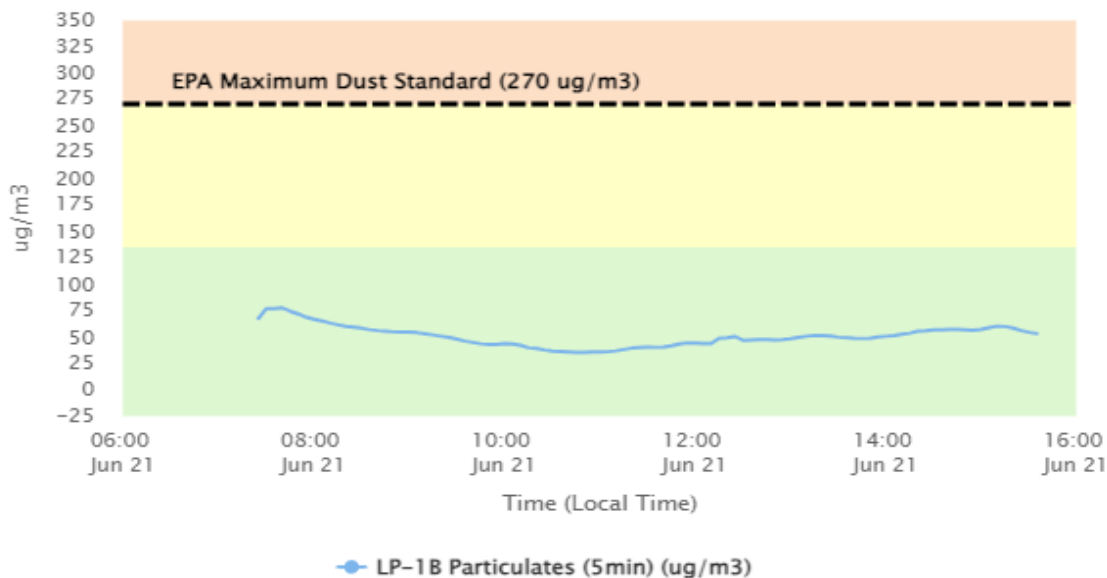
For Location LP-1

Stat	Reading (ug/m3)	Time Occurred
Min	34.52	11:50:20 AM
Max	76.85	8:40:20 AM
Avg	49.98	6/21/2023
N/A

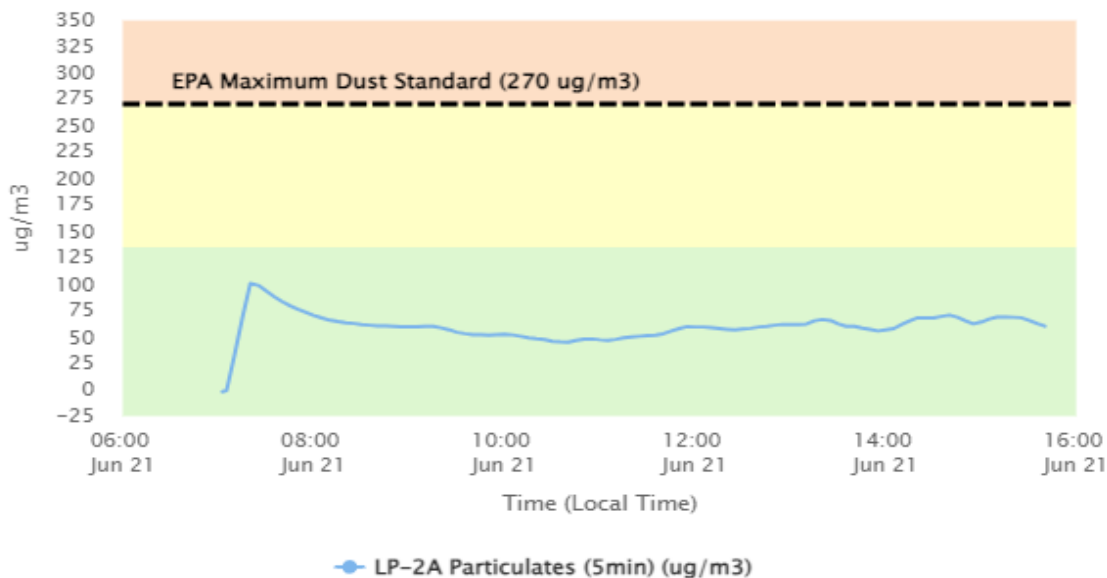
For Location LP-2

Stat	Reading (ug/m3)	Time Occurred
Min	0	8:02:40 AM
Max	100.1	8:20:20 AM
Avg	58.66	6/21/2023
N/A

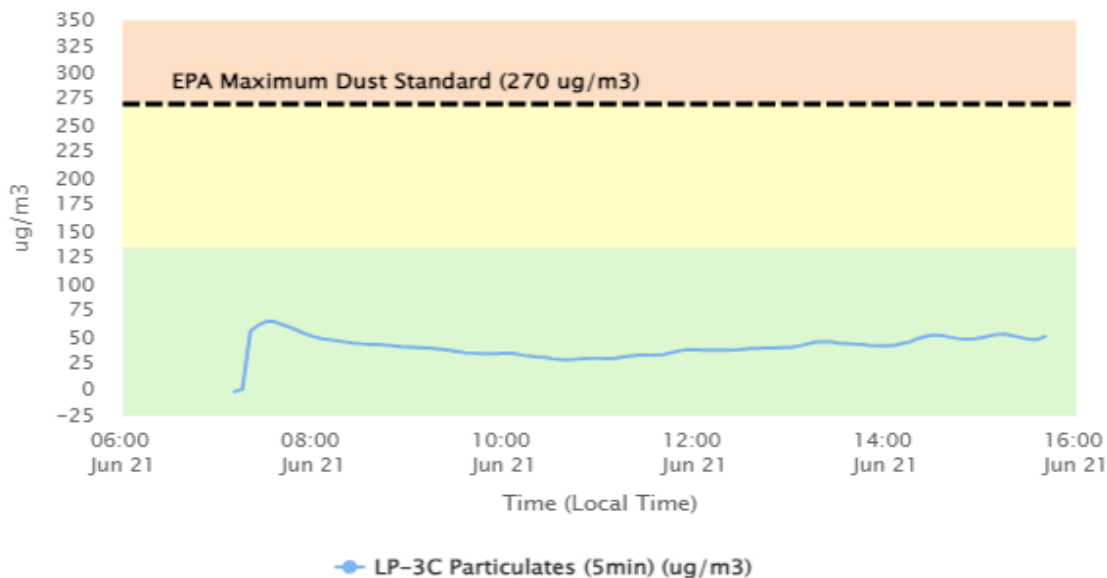
For Location LP-3

Stat	Reading (ug/m3)	Time Occurred
Min	0	8:10:20 AM
Max	63.8	8:35:20 AM
Avg	40.04	6/21/2023
N/A

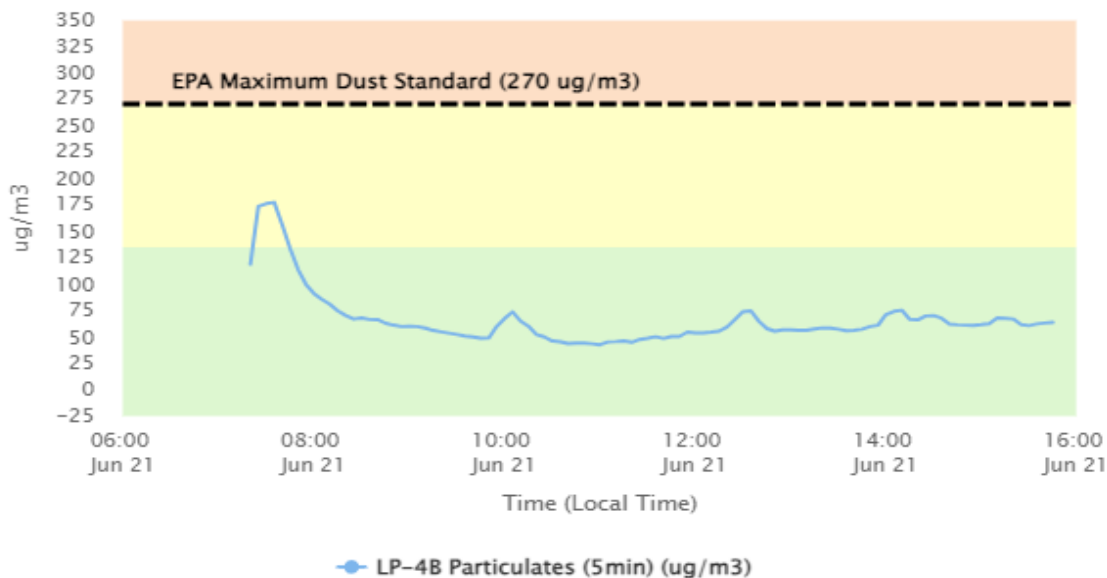
For Location LP-4

Stat	Reading (ug/m3)	Time Occurred
Min	41.75	12:00:20 PM
Max	176.8	8:35:20 AM
Avg	65.26	6/21/2023

From 07:20 am to 07:45 am, DustTrak LP-4B experienced elevated particulate levels due to an on-site vehicle's exhaust.
