**REMOVAL PROGRAM
PRELIMINARY ASSESSMENT/
SITE INVESTIGATION REPORT
FOR THE
MARINO PROPERTY SITE
MIDDLETOWN, MIDDLESEX COUNTY, CONNECTICUT
21 April 2009, 11-14 May 2009, 19 May 2009, 4 June 2009,
11 June 2009, 23-24 June 2009, 25-28 August 2009, and
25 September 2009**

U.S. Environmental Protection Agency
Region I
Emergency Planning and Response Branch
1 Congress Street, Suite 1100
Boston, MA 02114-2023

Weston Solutions, Inc.
Region I
Superfund Technical Assessment and Response Team (START)
3 Riverside Drive
Andover, MA 01810

January 2010

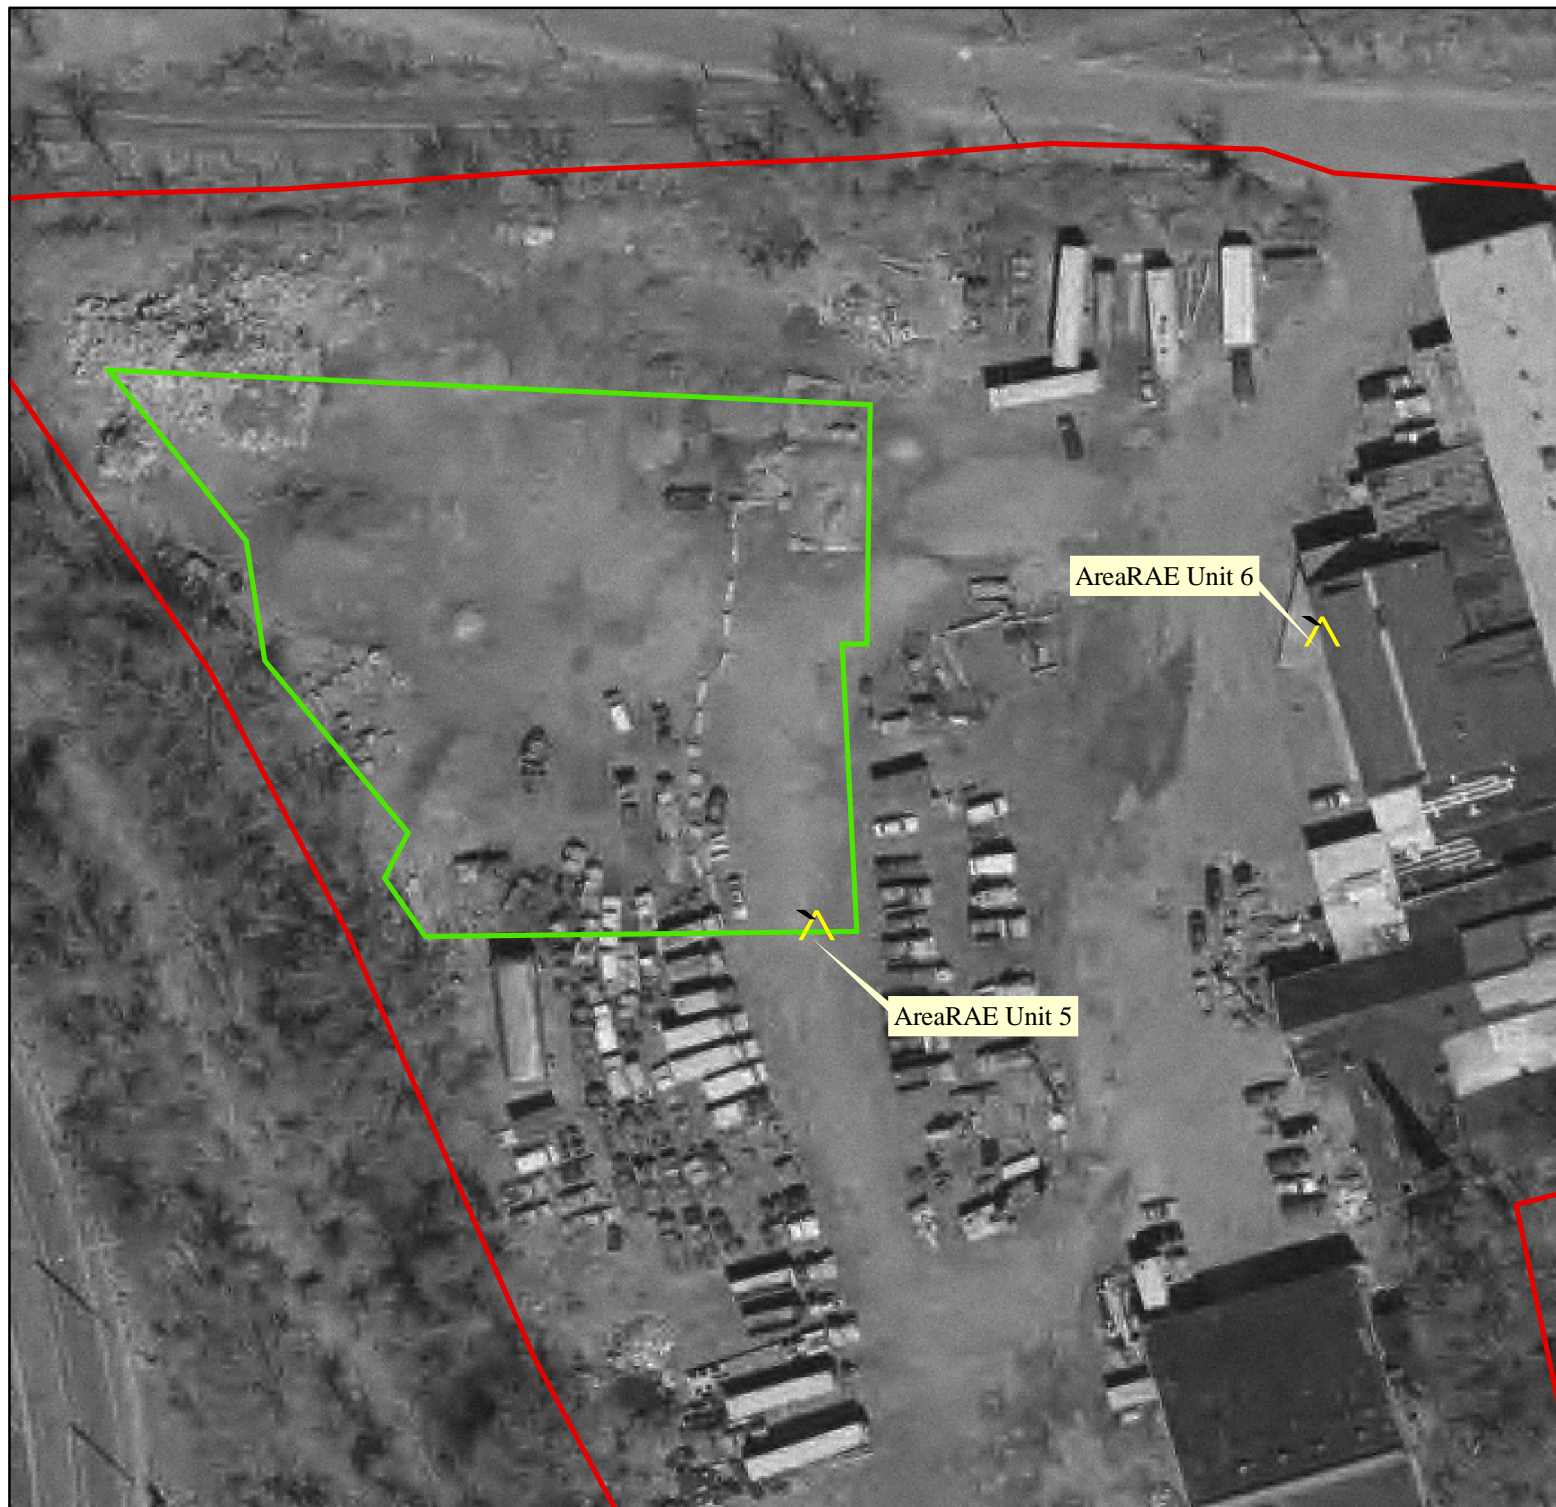
Figure 5

**Air Monitoring Station Locations
(August 2009 Test Pit Excavations)**

START personnel established two AreaRAE base stations. One station (AreaRAE Unit 6) was established to the east of the EZ, along the west side of Building No. 1, at a height of approximately 5 feet above ground surface. The second station (AreaRAE Unit 5) was established to the southeast of the EZ, on a concrete barrier, approximately 4 ft above ground surface. Continuous ambient air monitoring was conducted at the two AreaRAE base stations while excavation activities were being conducted on site (see Appendix A, Figure 5) [2].

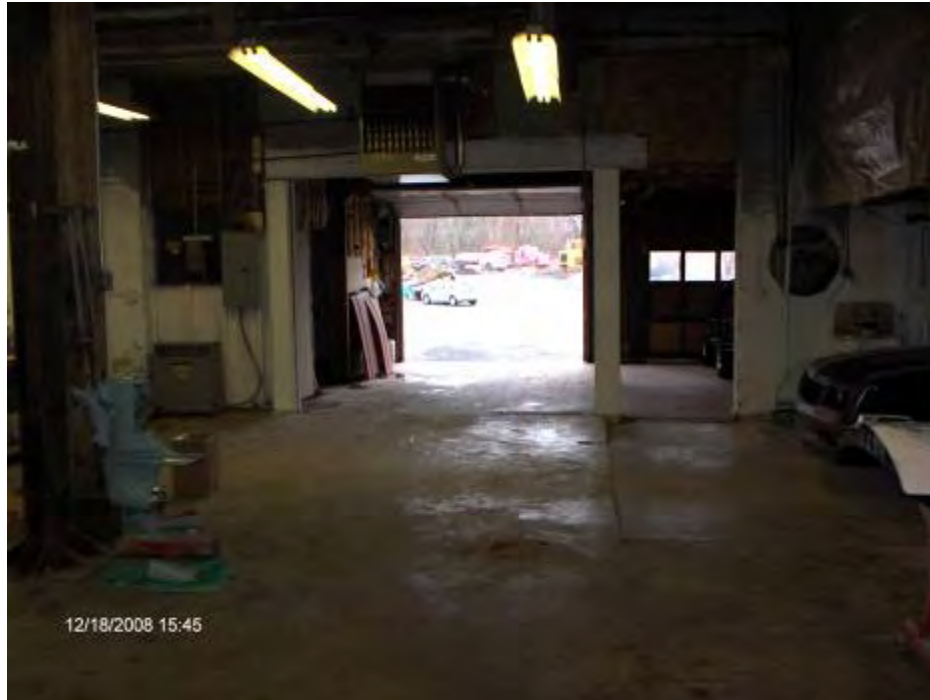
SCENE: View of the auto body shop area within the northern interior portion of Building No. 1 located on the northeastern portion of the Marino Property Site. Note: Date and time stamp on the photograph are incorrect.

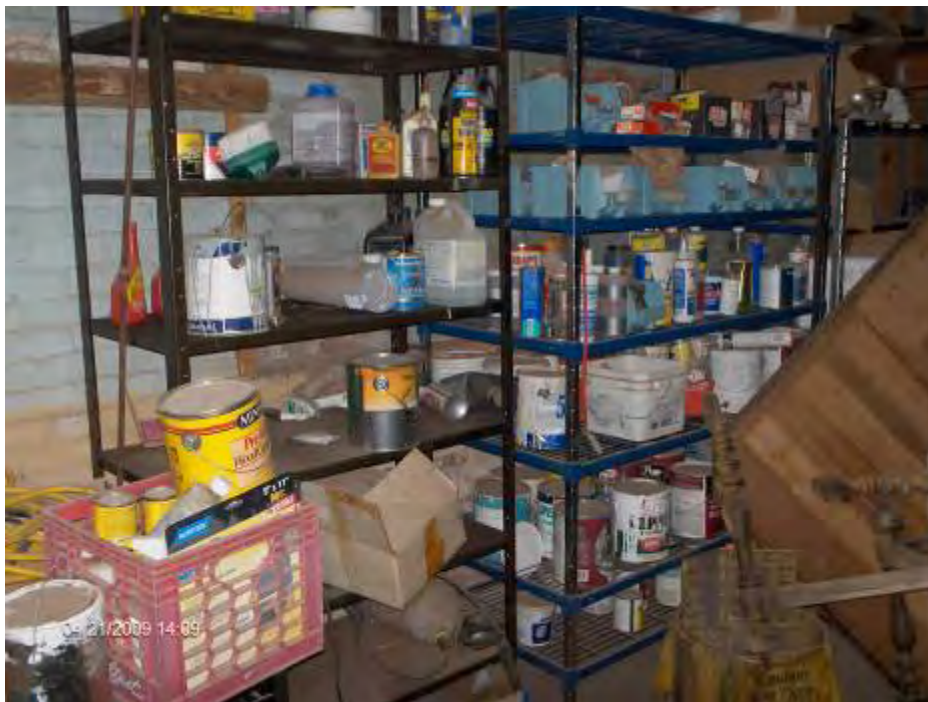
SCENE: View of paints and chemicals stored within the central interior portion of Building No. 1 located on the northeastern portion of the Marino Property Site.

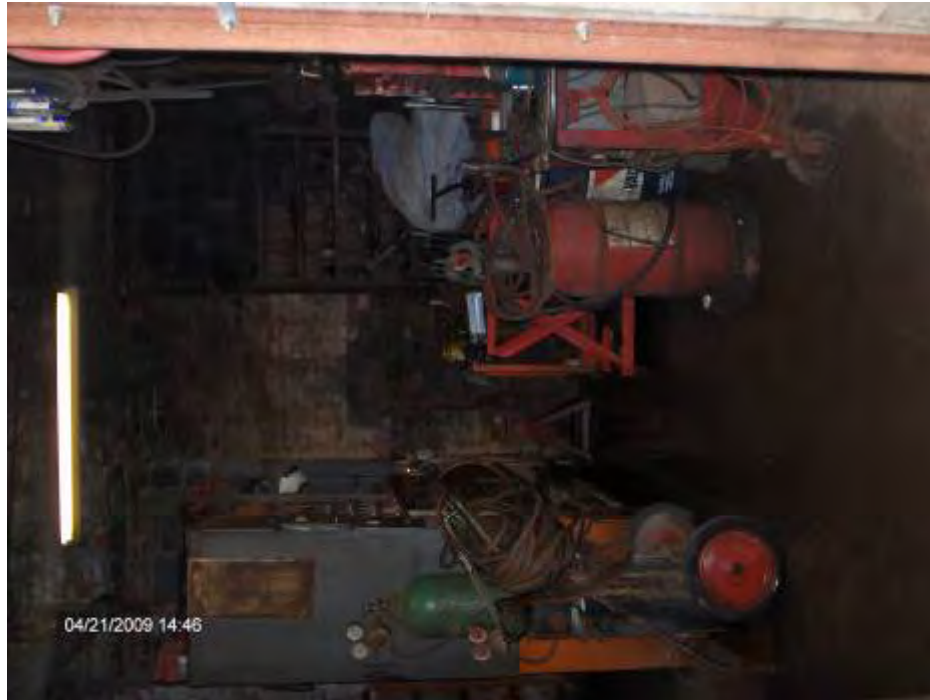
SCENE: View of a storage area operated by American Contractors within the southern portion of Building No. 1 located on the northeastern portion of the Marino Property Site.

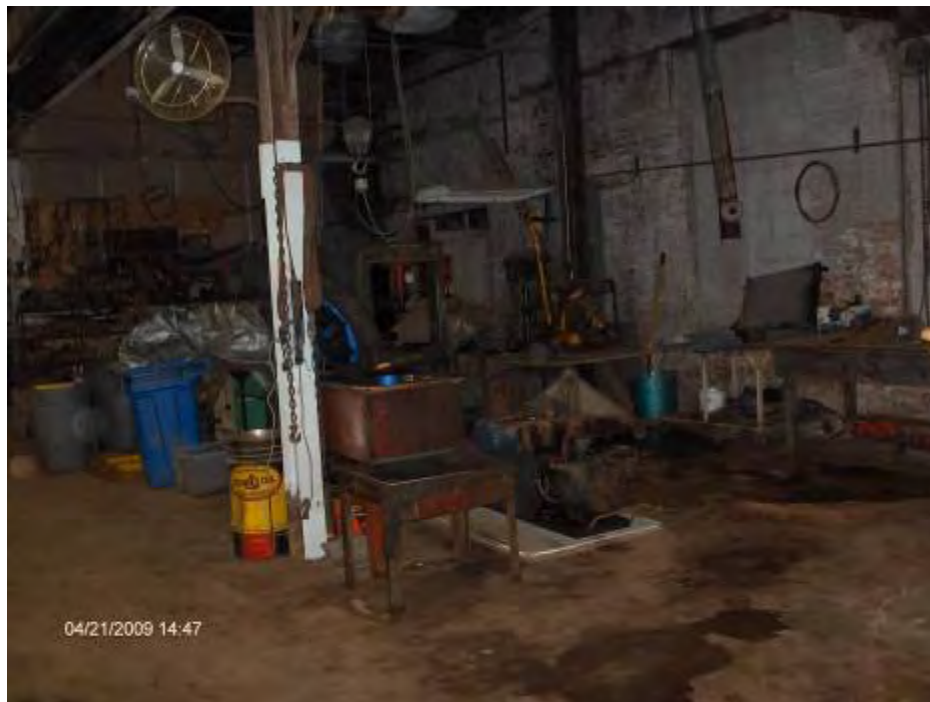
SCENE: View of a work area operated by American Contractors within the southern portion of Building No. 1 located on the northeastern portion of the Marino Property Site. Note the petroleum stains on the floor surface.

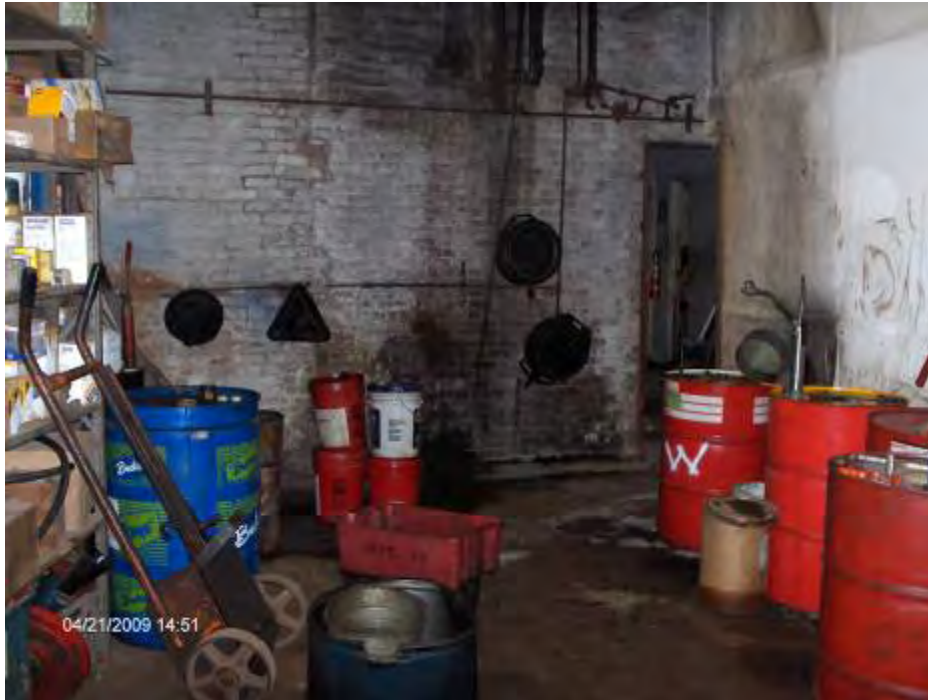
SCENE: View of an oil storage area operated by American Contractors within the southern portion of Building No. 1 located on the northeastern portion of the Marino Property Site.

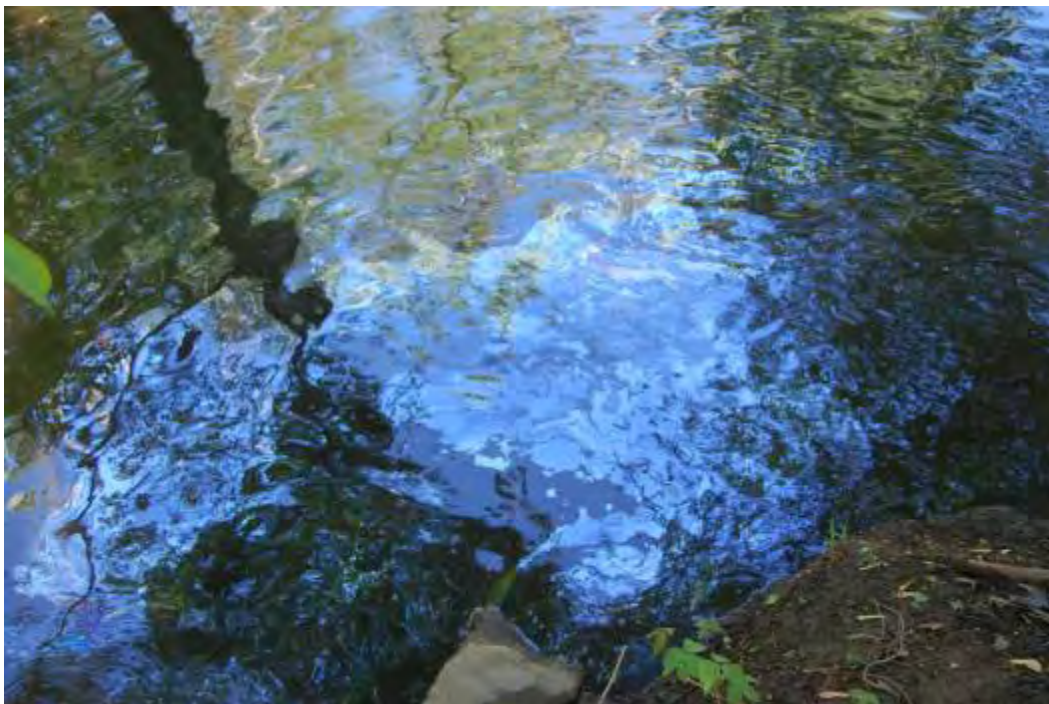
SCENE: View of a sheen observed within the northern portion of the drainage ditch located west of the Marino Property Site.

<u>Parameter</u>	<u>Quantities/Extent</u>
(X) Sheens:	A petroleum sheen was observed at the bottom of test pit TP-06 during August 2009 test-pitting activities. A sample of the material was collected for Total Petroleum Hydrocarbon (TPH) analysis. Analytical results revealed 4.65 milligrams per liter (mg/L) of TPH. During the installation of a piezometer (DD-01) within the drainage ditch located west of the Site, and during sediment sampling activities, petroleum sheens were observed along the drainage ditch and its confluence with Sumner Brook.
() Stressed Vegetation:

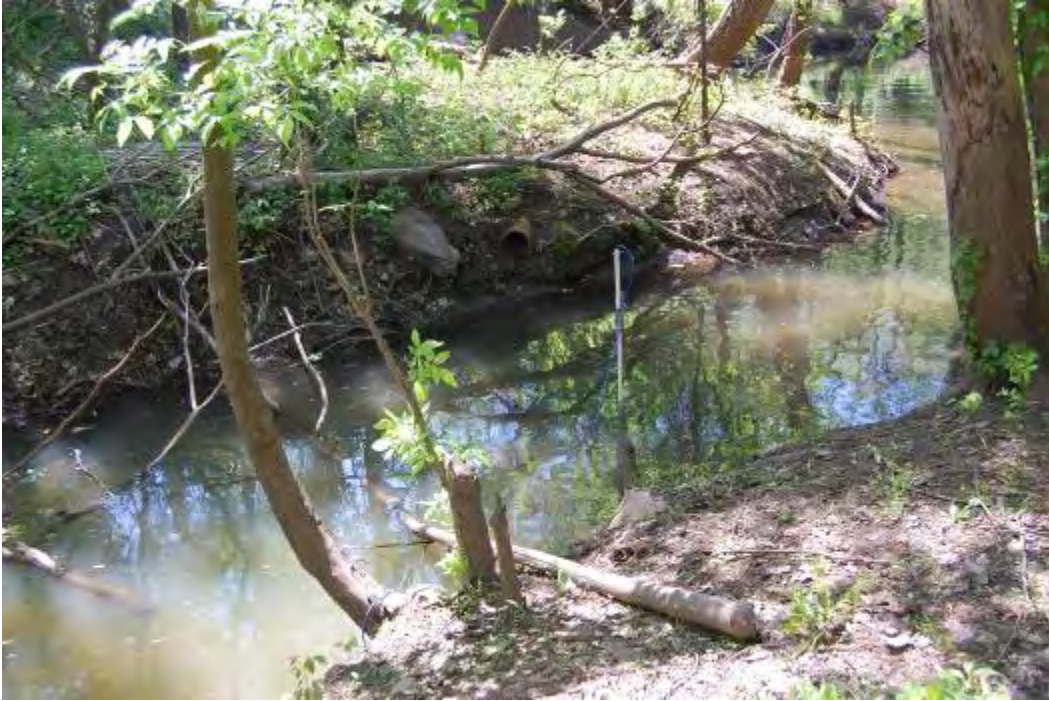
SCENE: View of transducer DD-01 located in the piezometer that was installed in the northern portion of the drainage ditch located west of the Marino Property Site. Photograph taken facing northwest.

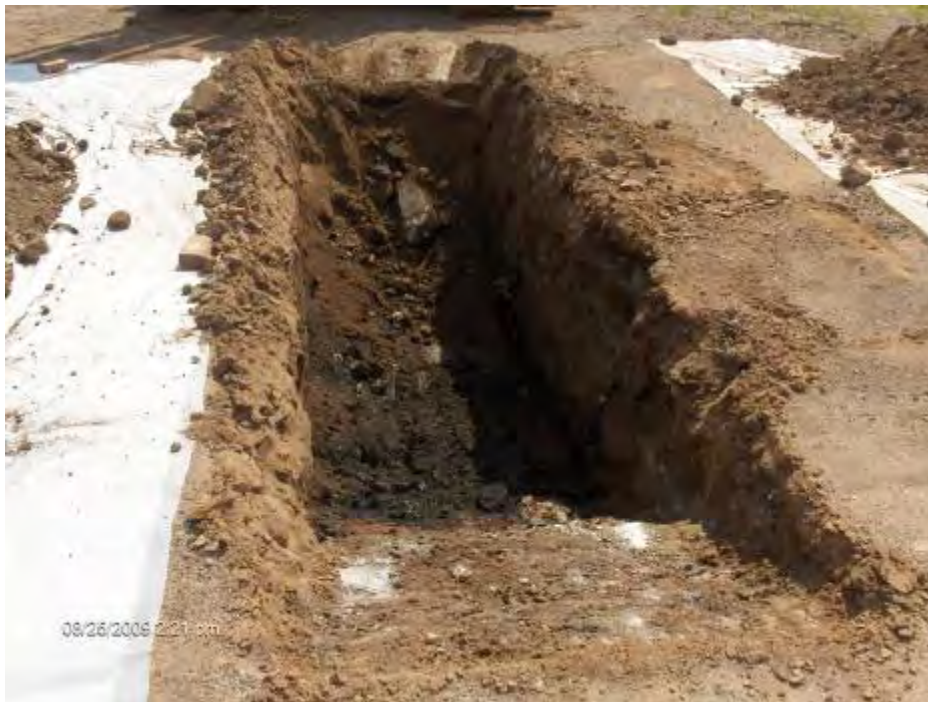
SCENE: View of the top 2 feet of test pit TP-09 located in the central portion of the Area of Investigation No. 1. Photograph taken facing west.

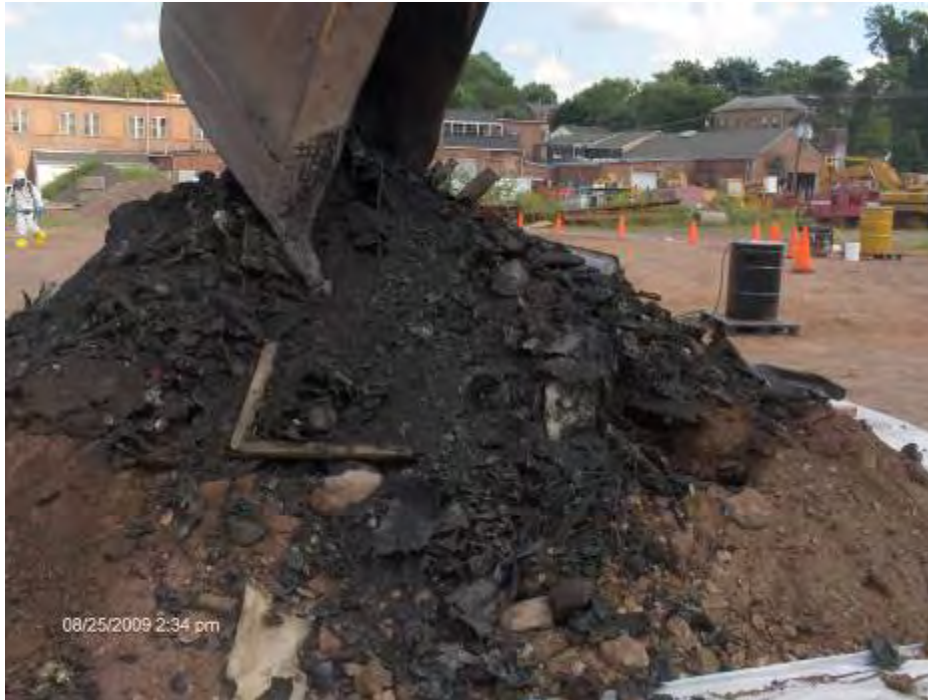
SCENE: View of material (including ash, wood, metal, glass, and plastic) excavated from test pit TP-09 located in the central portion of the Area of Investigation No. 1. Photograph taken facing southeast.

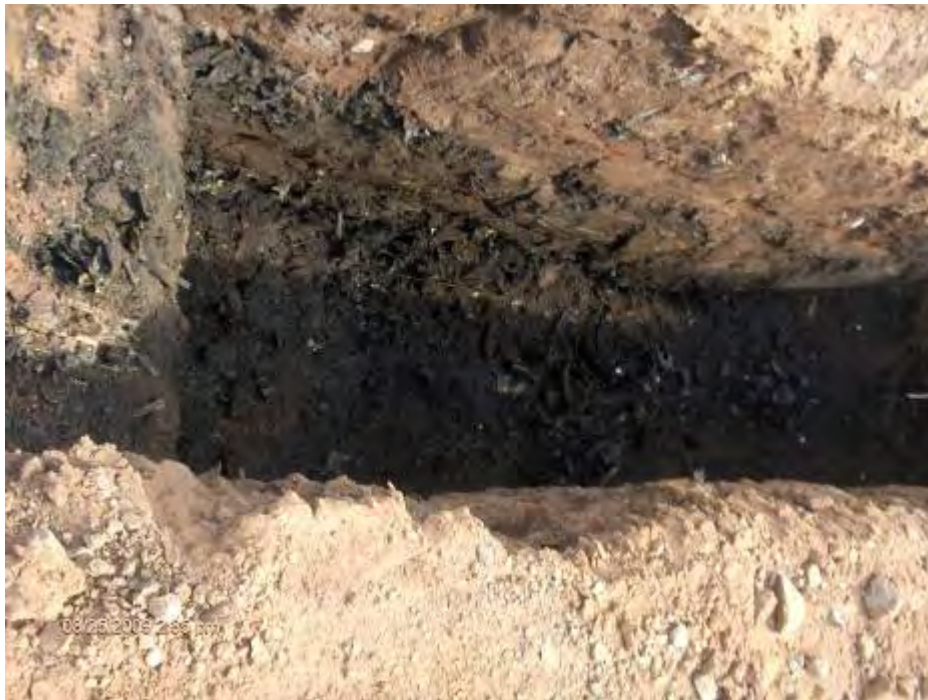
SCENE: View of test pit TP-09 located in the central portion of the Area of Investigation No. 1. Note incinerator ash throughout the excavation.

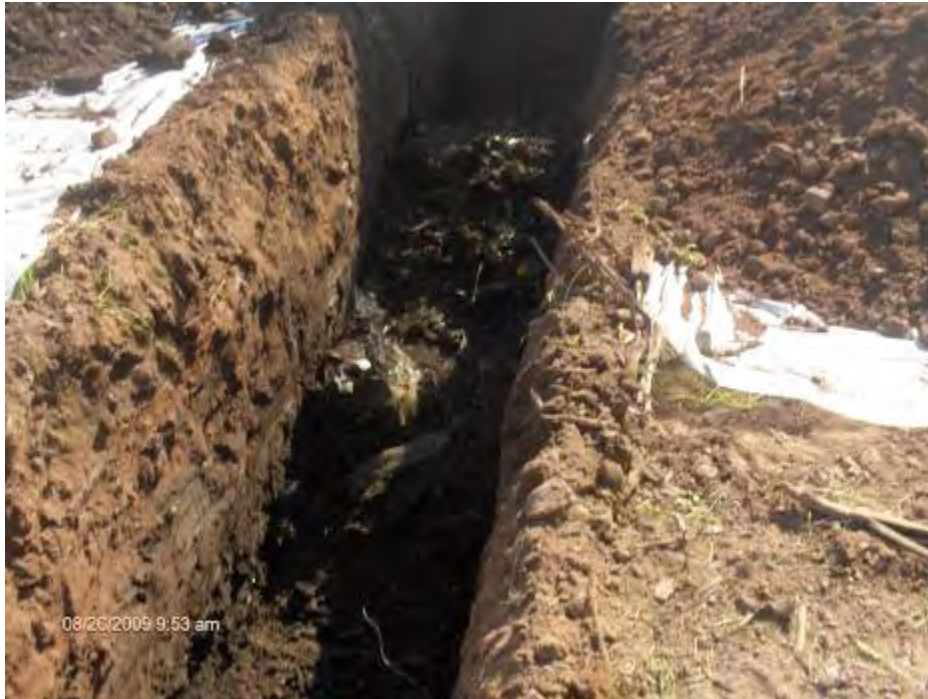
SCENE: View of test pit TP-05/10 located in the western-central portion of the Area of Investigation No. 1. Photograph taken facing east.

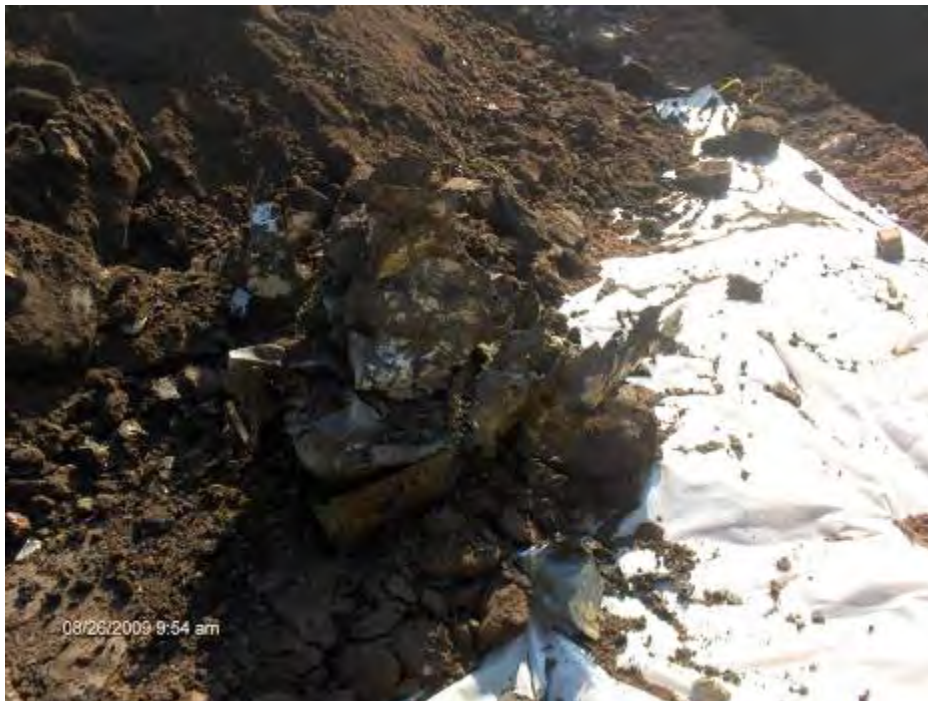
SCENE: View of metal debris excavated from test pit TP-05/10 located in the western-central portion of the Area of Investigation No. 1.

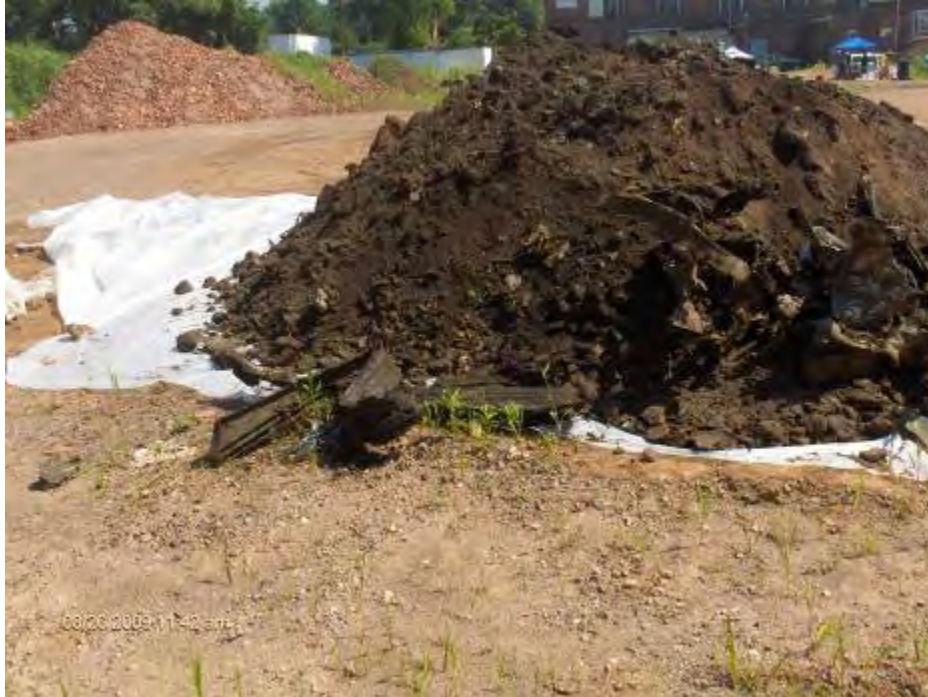
SCENE: View of material (including ash, metal, and glass) excavated from test pit TP-05/10 located in the western-central portion of the Area of Investigation No. 1. Photograph taken facing east.

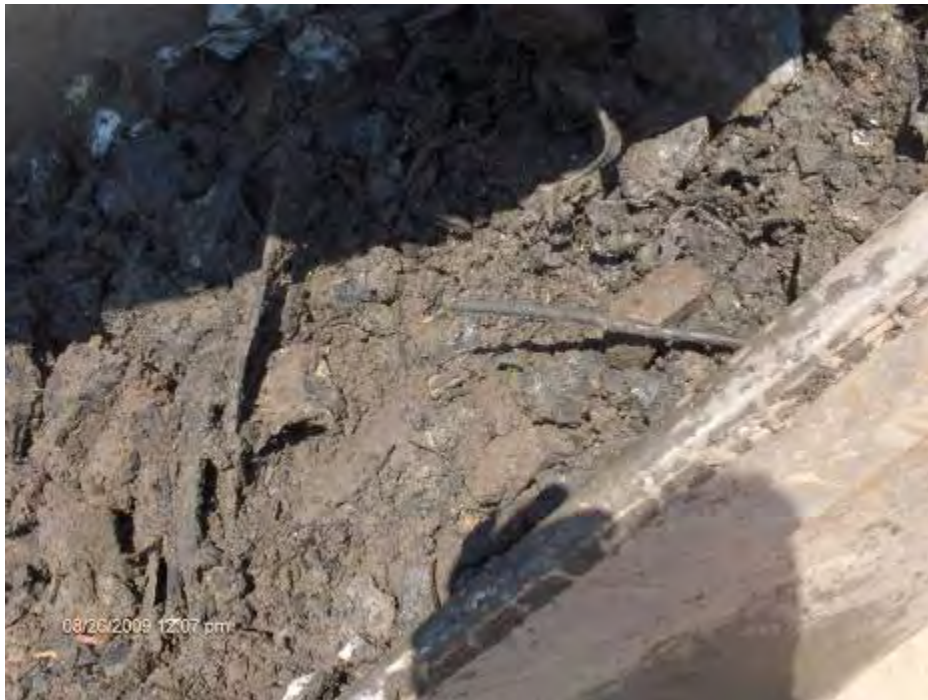
SCENE: View of material (including ash, metal, and glass) excavated from test pit TP-05/10 located in the western-central portion of the Area of Investigation No. 1. Material was sampled as location TP-05/10 (14).

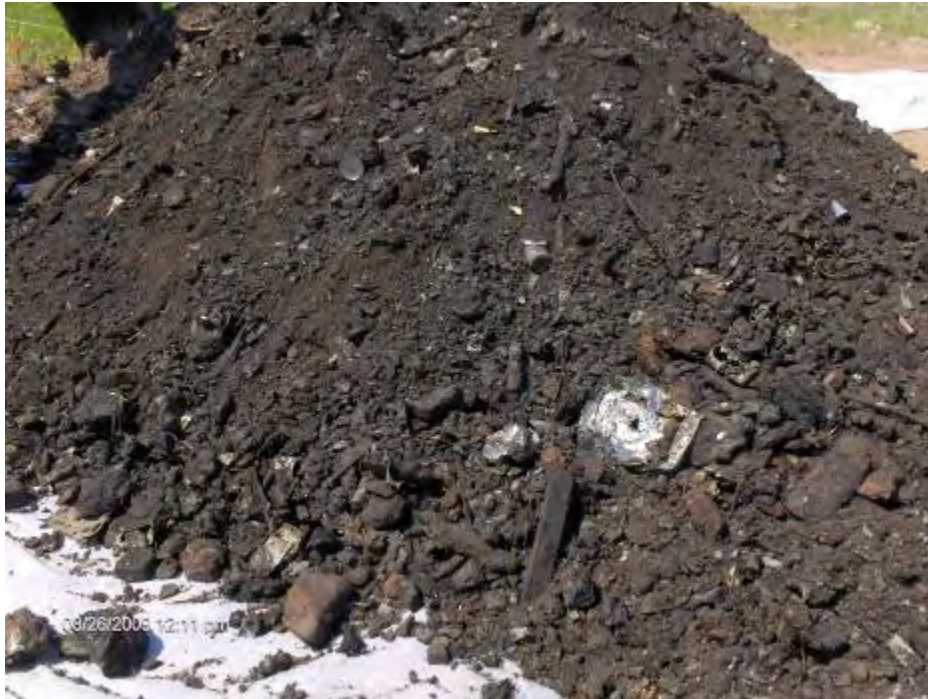
SCENE: View of material (including ash, metal, glass, and wood) excavated from test pit TP-05/10 located in the western-central portion of the Area of Investigation No. 1. Photograph taken facing north.

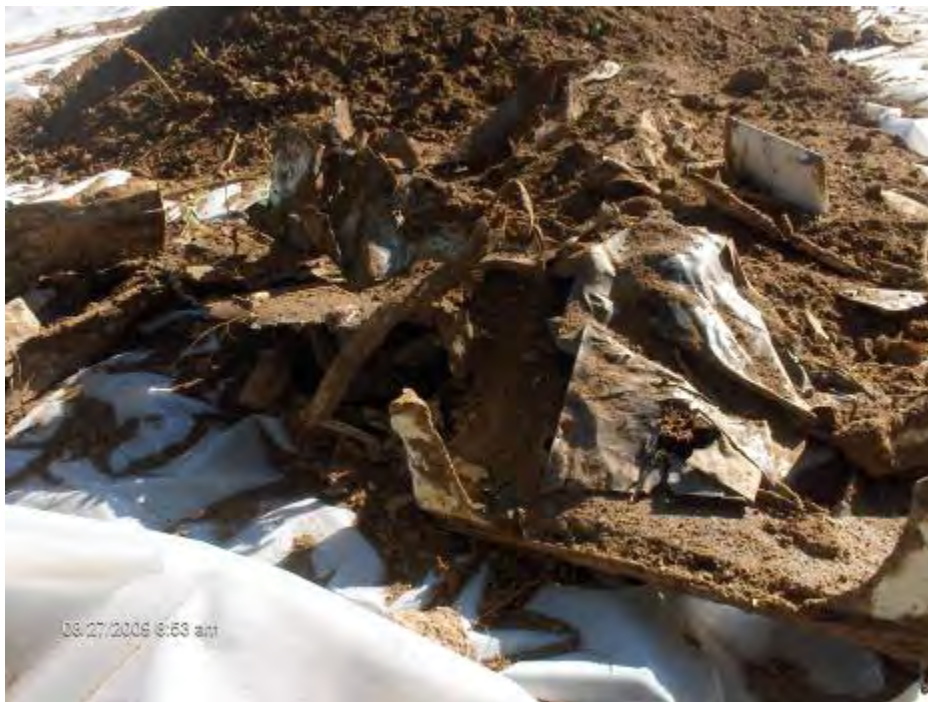
SCENE: View of material (including metal and plastic) excavated from test pit TP-01 located in the southwestern portion of the Area of Investigation No. 1. Photograph taken facing east.

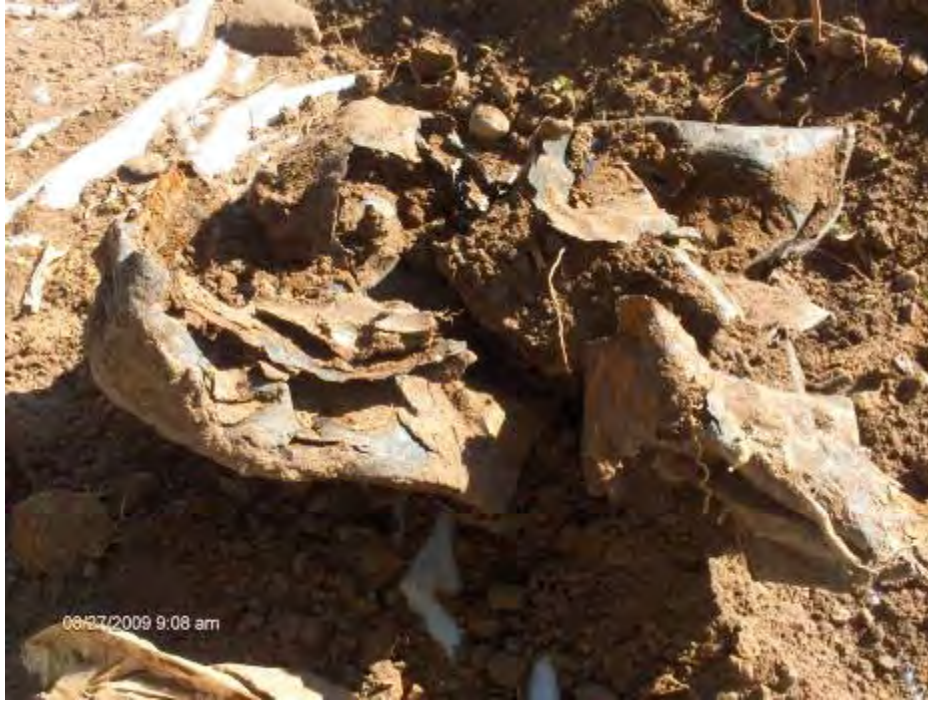
SCENE: View of a crushed 55-gallon steel drum excavated from test pit TP-01 located in the southwestern portion of the Area of Investigation No. 1. Material within the drum was sampled as DR-01 (1), and appeared to be soil.

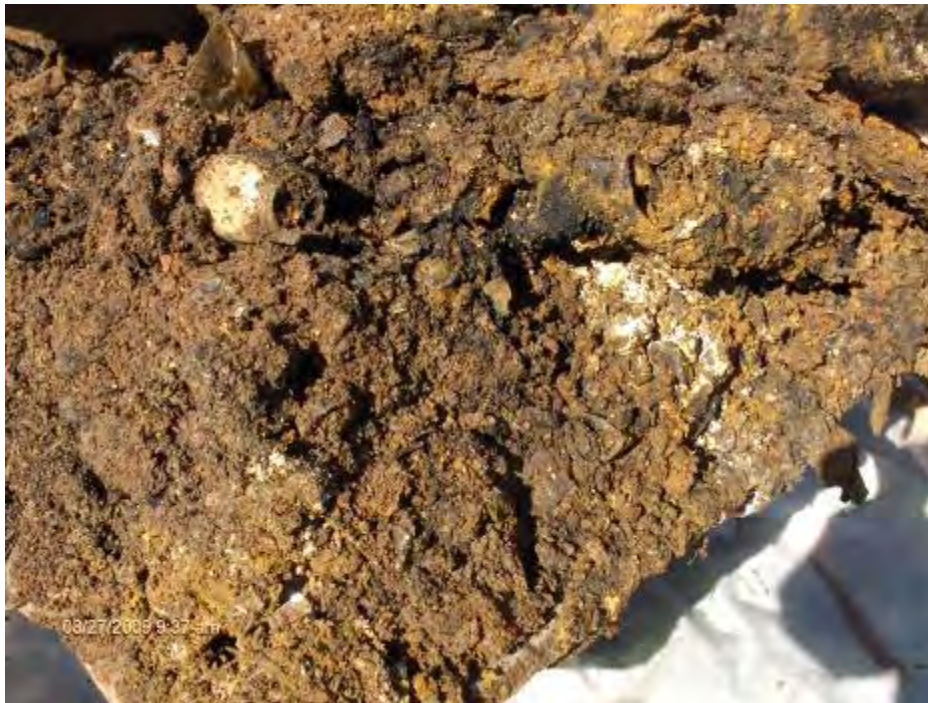
SCENE: View of material (including glass, plastic, and metal) excavated from test pit TP-01 located in the southwestern portion of the Area of Investigation No. 1. Material was sampled as TP-01 (8).

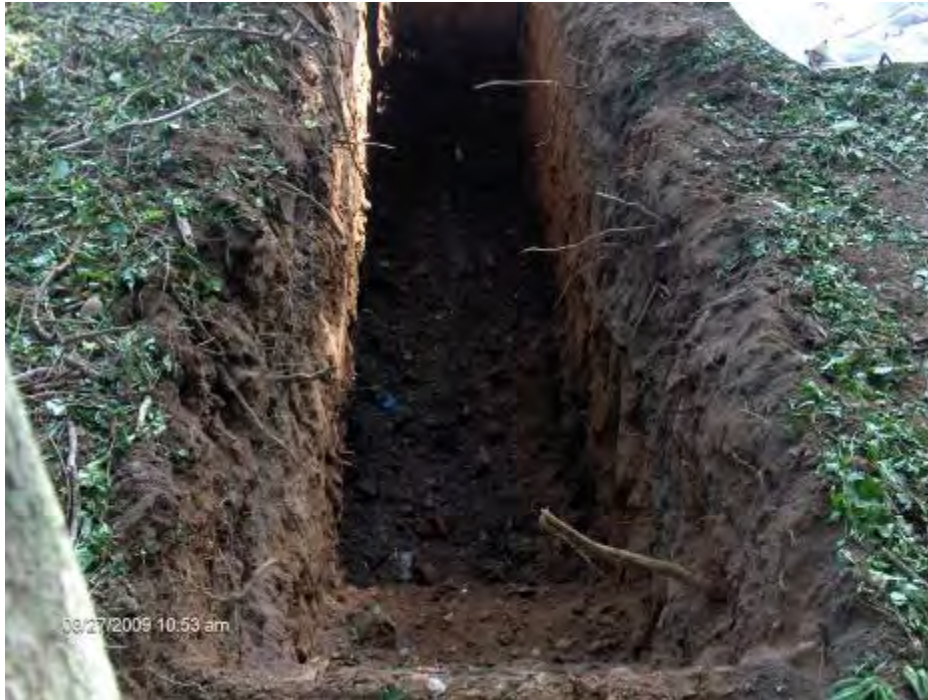
SCENE: View of the western portion of test pit TP-01 located in the southwestern portion of the Area of Investigation No. 1. Photograph taken facing east.

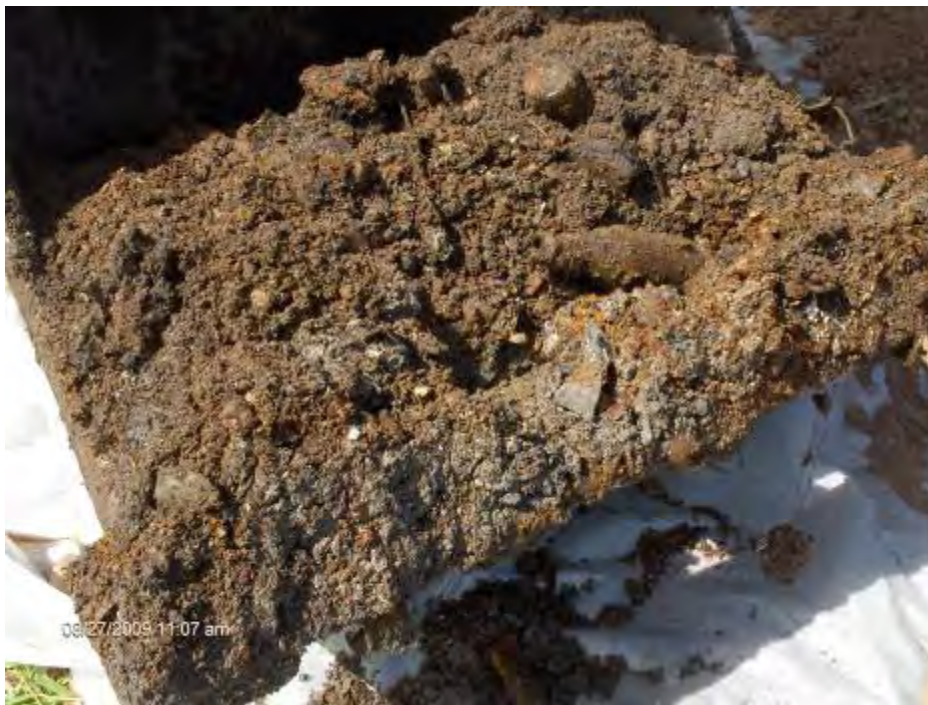
SCENE: View of material (including glass and metal) excavated from test pit TP-01 located in the southwestern portion of the Area of Investigation No. 1. Material was sampled as TP-01 (12).

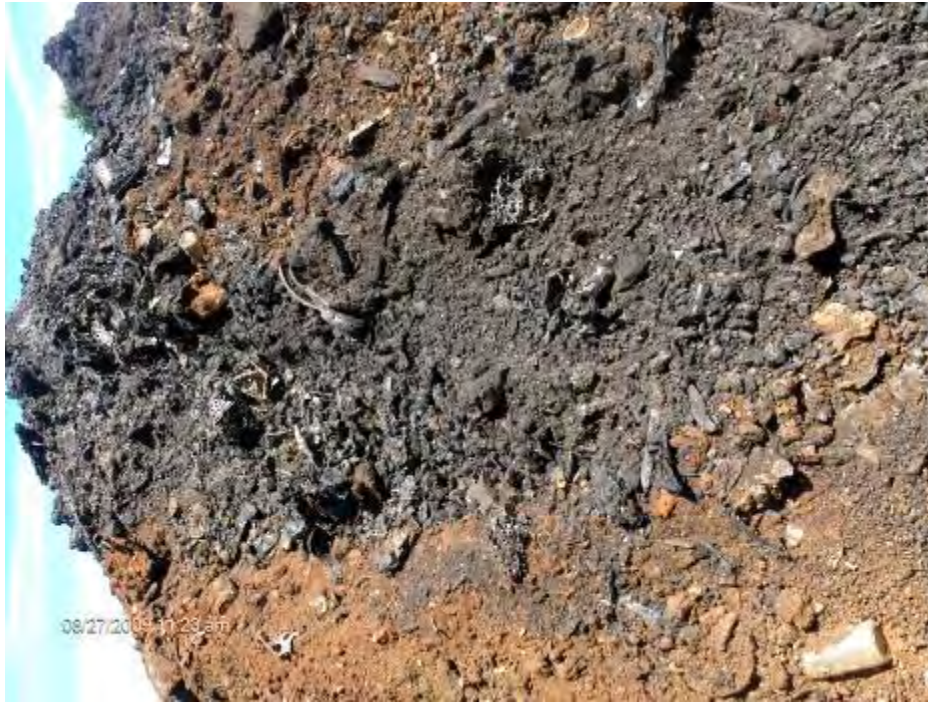
SCENE: View of material (including ash, metal, glass, wood, and plastic) excavated from test pit TP-01 located in the southwestern portion of the Area of Investigation No. 1. Photograph taken facing west.

(X) Landfill:	During site activities, evidence of former landfilling activities was observed on the Site. Site background information indicates that incinerator ash was buried throughout the Site as part of City of Middletown municipal landfill operations. Ash material was observed during test-pitting activities at a depth of approximately 1 to 16 feet below ground surface (bgs). In addition to ash material, various containers with waste product material were noted in one test pit (TP-02/04) excavated in August 2009. In addition, ash material and debris (glass, brick, metal, fabric, <i>etc.</i>) were noted in all five test pits excavated in August 2009.

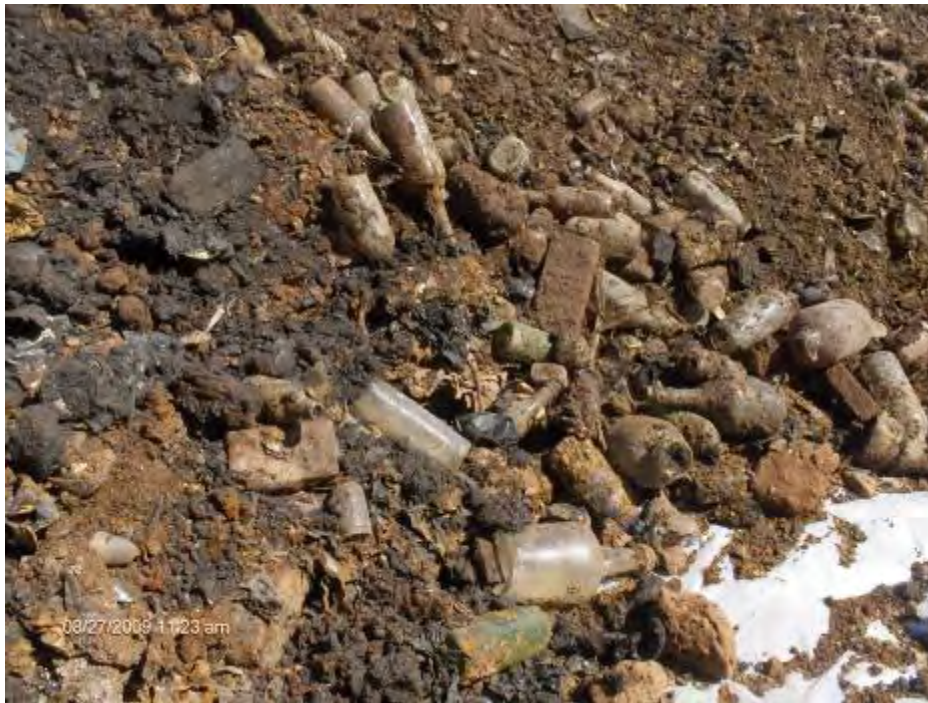
SCENE: View of material (including glass, ash, and metal) excavated from test pit TP-01 located in the southwestern portion of the Area of Investigation No. 1. Photograph taken facing west.

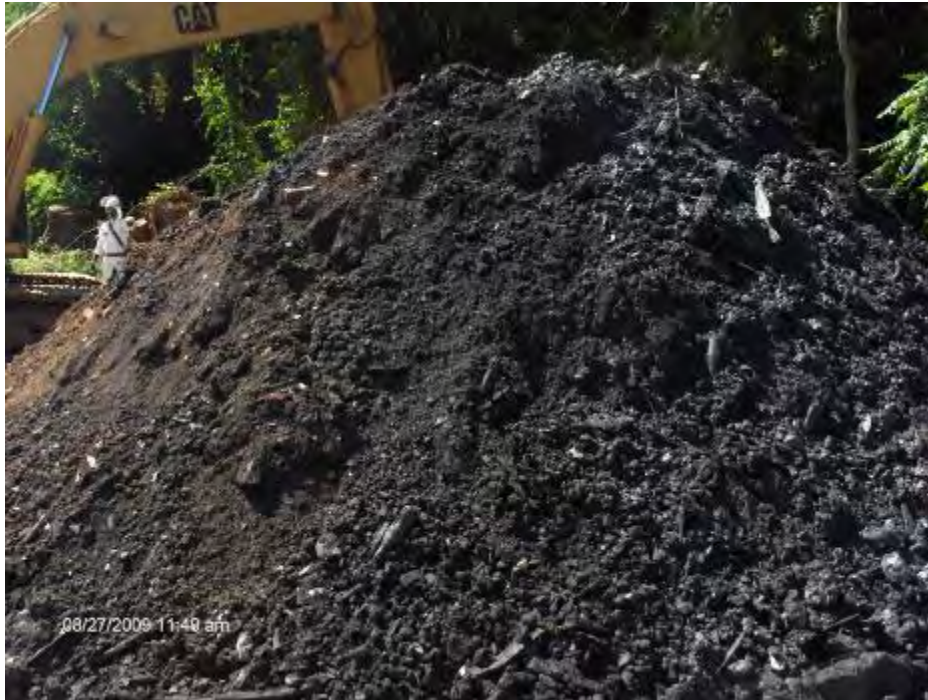
SCENE: View of material (including ash and plastic) excavated from test pit TP-01 located in the southwestern portion of the Area of Investigation No. 1. Photograph taken facing southwest.

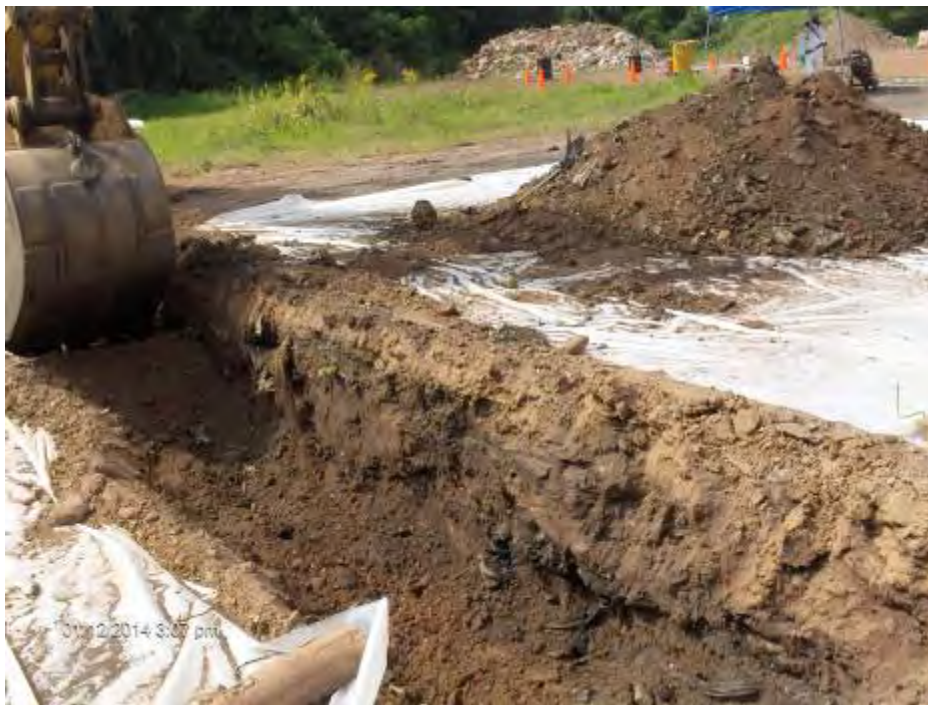
SCENE: View of test pit TP-06 located in the southeastern portion of the Area of Investigation No. 1. Metal debris is noted in the wall of the test pit. Photograph taken facing northwest. Note: Date and time stamp are incorrect.

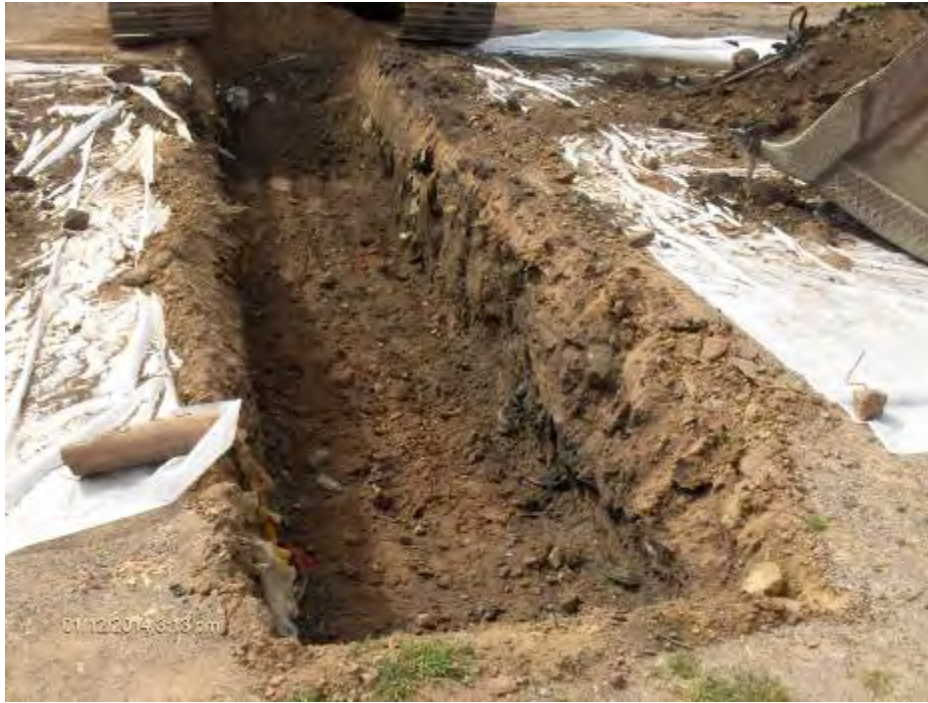
SCENE: View of test pit TP-06 located in the southeastern portion of the Area of Investigation No. 1. Photograph taken facing west. Note: Date and time stamp are incorrect.

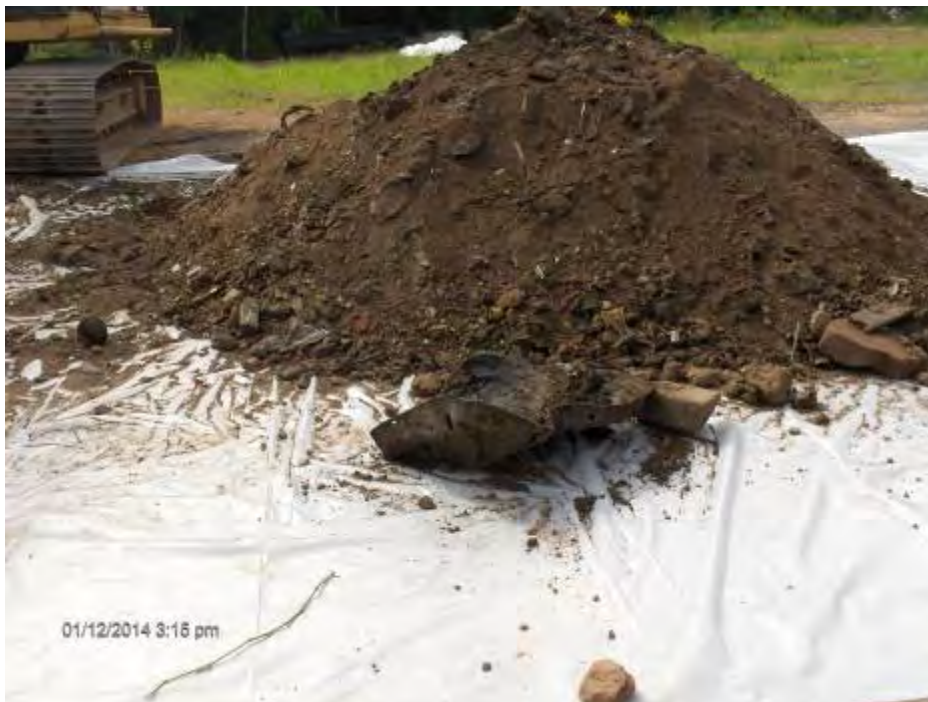
SCENE: View of material (including metal and glass) excavated from test pit TP-06 located in the southeastern portion of the Area of Investigation No. 1. Photograph taken facing west. Note: Date and time stamp are incorrect.

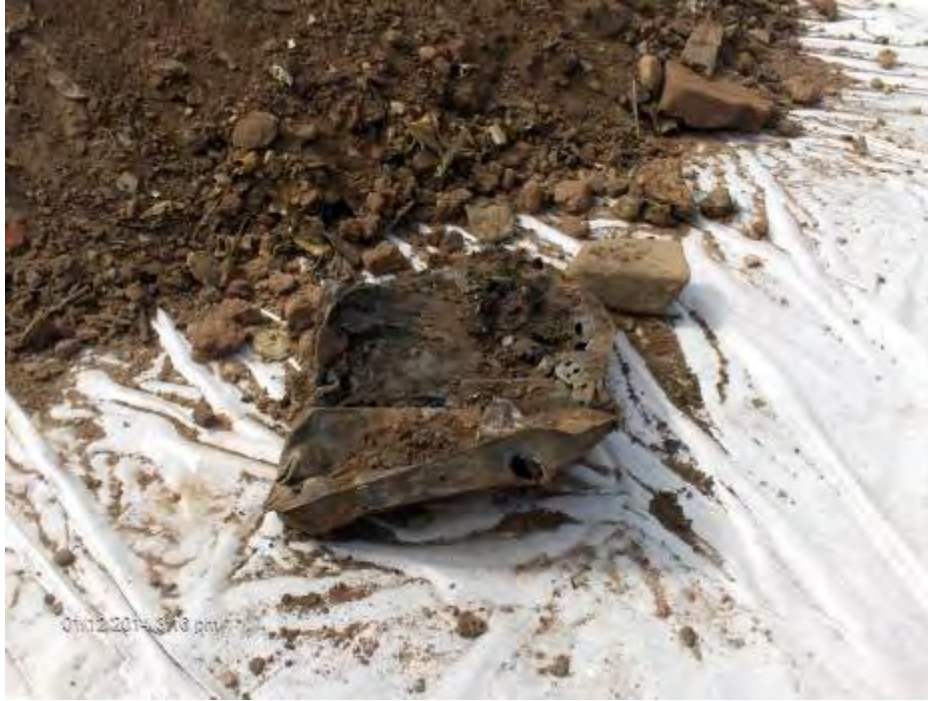
SCENE: View of an automobile gas tank excavated from test pit TP-06 located in the southeastern portion of the Area of Investigation No. 1. Photograph taken facing west. Note: Date and time stamp are incorrect.

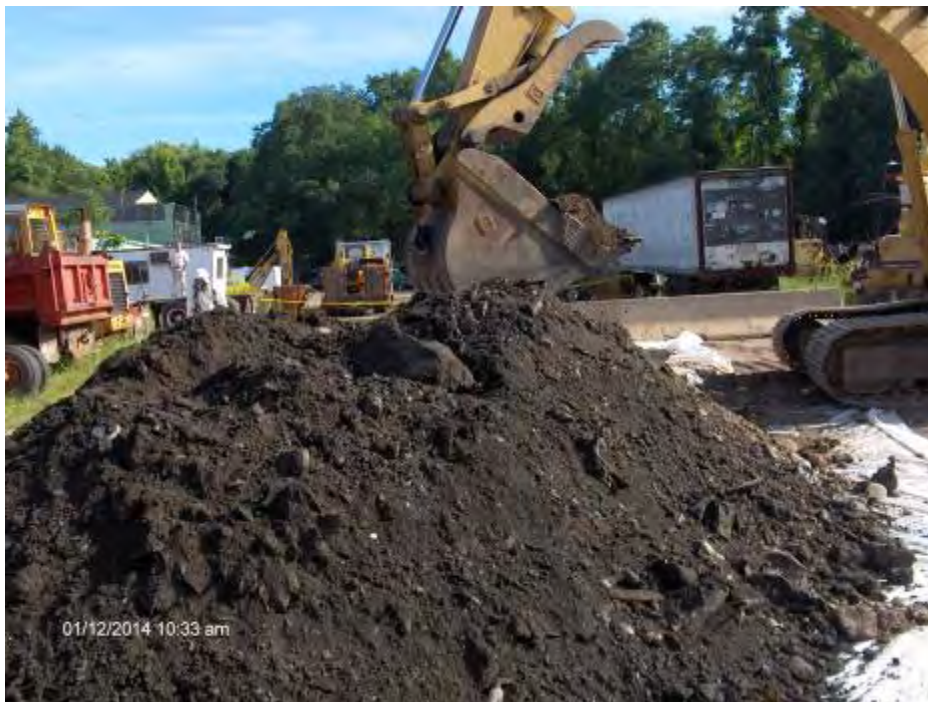
SCENE: View of material (including ash, metal, and glass) excavated from test pit TP-06 located in the southeastern portion of the Area of Investigation No. 1. Photograph taken facing south. Note: Date and time stamp are incorrect.
