**REMOVAL PROGRAM
PRELIMINARY ASSESSMENT/
SITE INVESTIGATION REPORT
FOR THE
MARINO PROPERTY SITE
MIDDLETOWN, MIDDLESEX COUNTY, CONNECTICUT
21 April 2009, 11-14 May 2009, 19 May 2009, 4 June 2009,
11 June 2009, 23-24 June 2009, 25-28 August 2009, and
25 September 2009**

U.S. Environmental Protection Agency
Region I
Emergency Planning and Response Branch
1 Congress Street, Suite 1100
Boston, MA 02114-2023

Weston Solutions, Inc.
Region I
Superfund Technical Assessment and Response Team (START)
3 Riverside Drive
Andover, MA 01810

January 2010

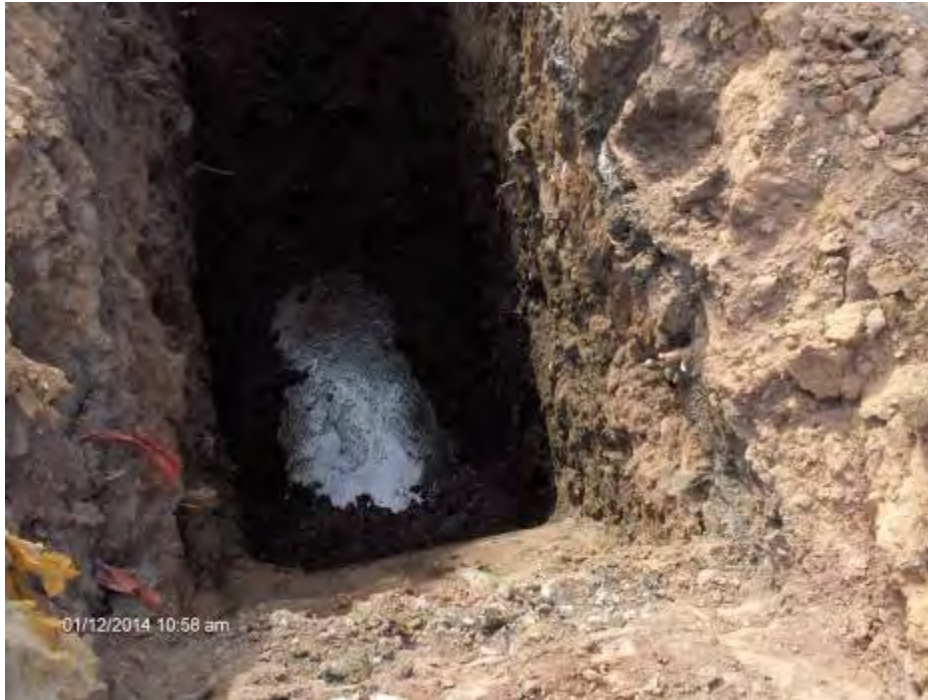
SCENE: View of a petroleum sheen on groundwater seeping into test pit TP-06 located on the southeastern portion of the Area of Investigation No. 1. Material was sampled as TP-06 (Water for Oil Identifications). Note: Date and time stamp are incorrect.

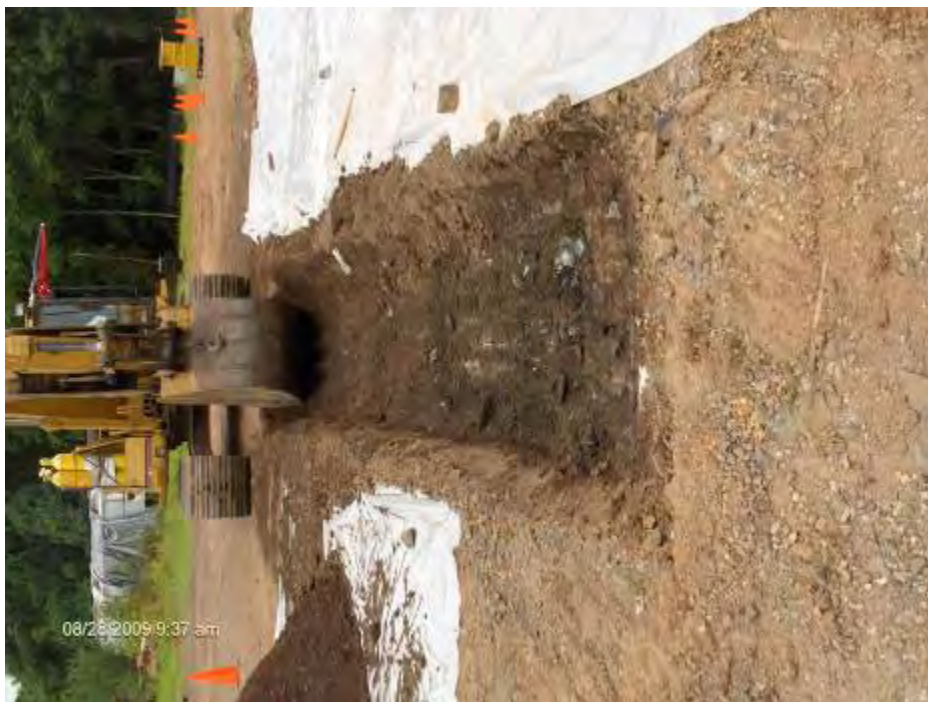
SCENE: View of test pit TP-02/04 located in the northeastern portion of the Area of Investigation No. 1. Photograph taken facing west.

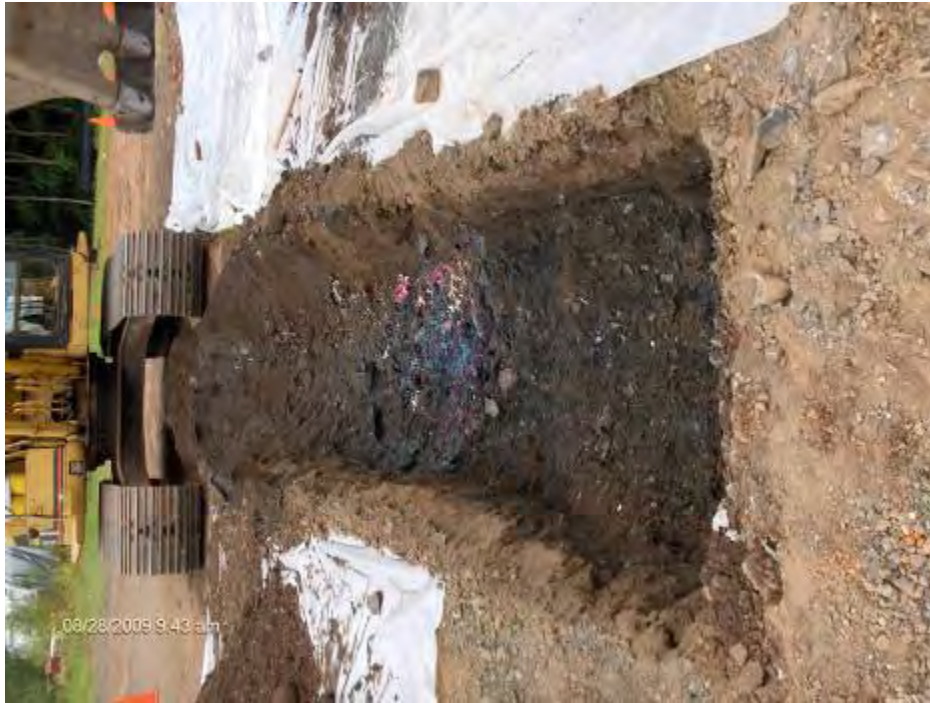
SCENE: View of test pit TP-02/04 located in the northeastern portion of the Area of Investigation No. 1. Note rubber-like material at less than 2 feet below the ground surface. Photograph taken facing west.

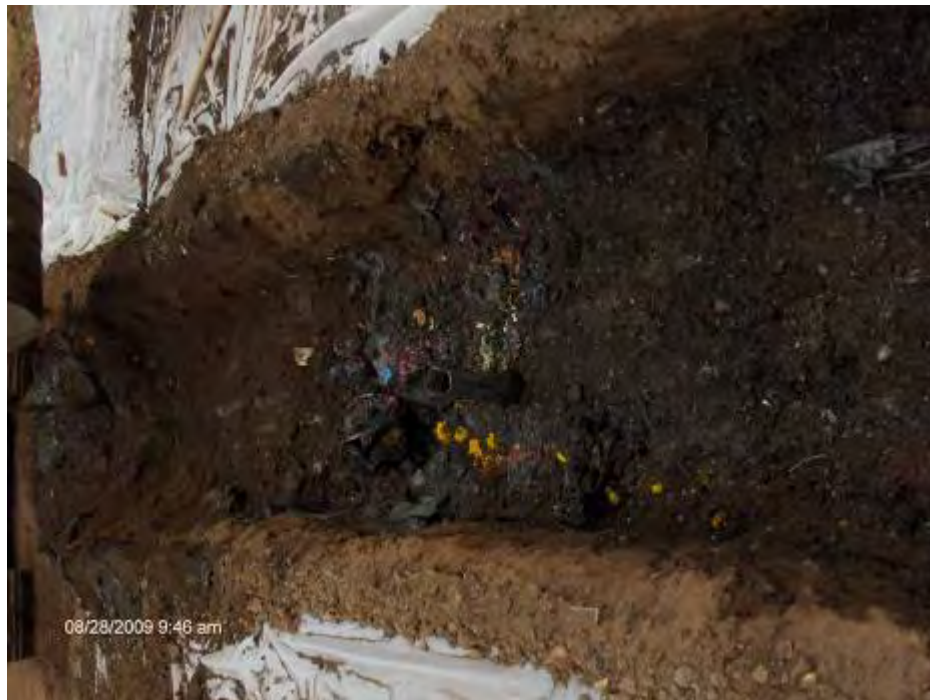
SCENE: View of test pit TP-02/04 located in the northeastern portion of the Area of Investigation No. 1. Note rubber-like material and what appears to be a vertical polyvinylchloride pipe. Photograph taken facing west.

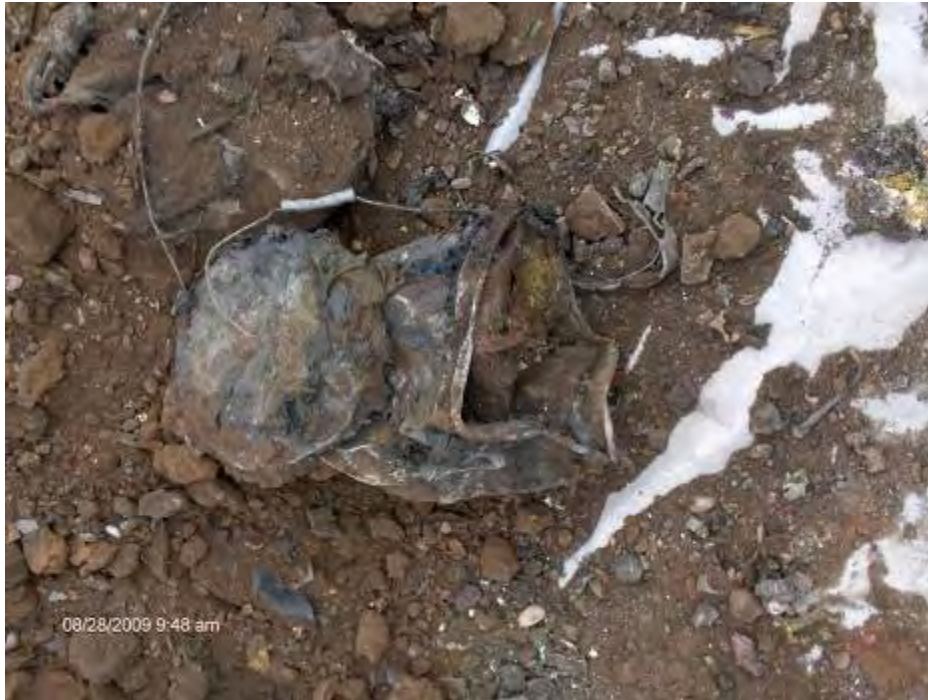
SCENE: View of a pail and product material excavated from test pit TP-02/04 located in the northeastern portion of the Area of Investigation No. 1.

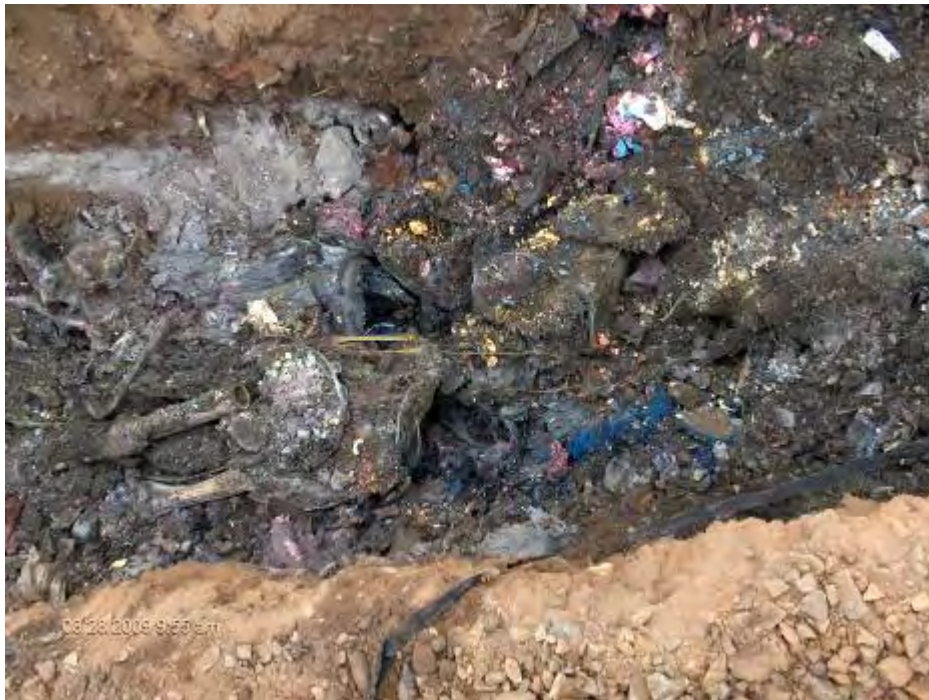
SCENE: View of product material encountered during the excavation of test pit TP-02/04 located in the northeastern portion of the Area of Investigation No. 1.

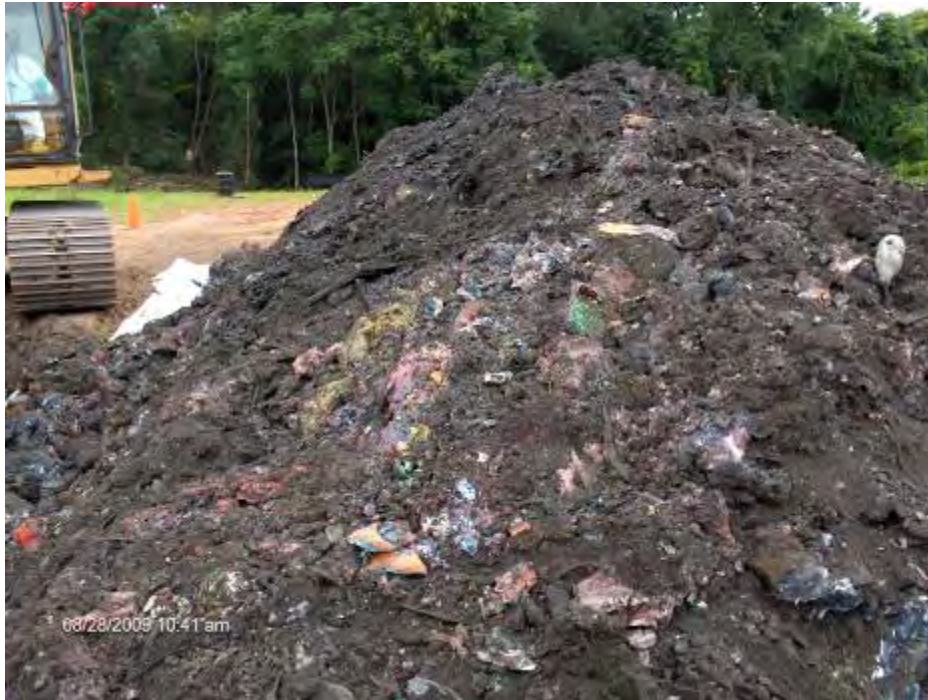
SCENE: View of material (including rubber-like material and soil) excavated from test pit TP-02/04 located in the northeastern portion of the Area of Investigation No. 1. Material was sampled as part of test pit TP-02/04 (SPC-01), TP-02/04 (SPG-01), and TP-02/04 (SPG-02). Photograph taken facing west.

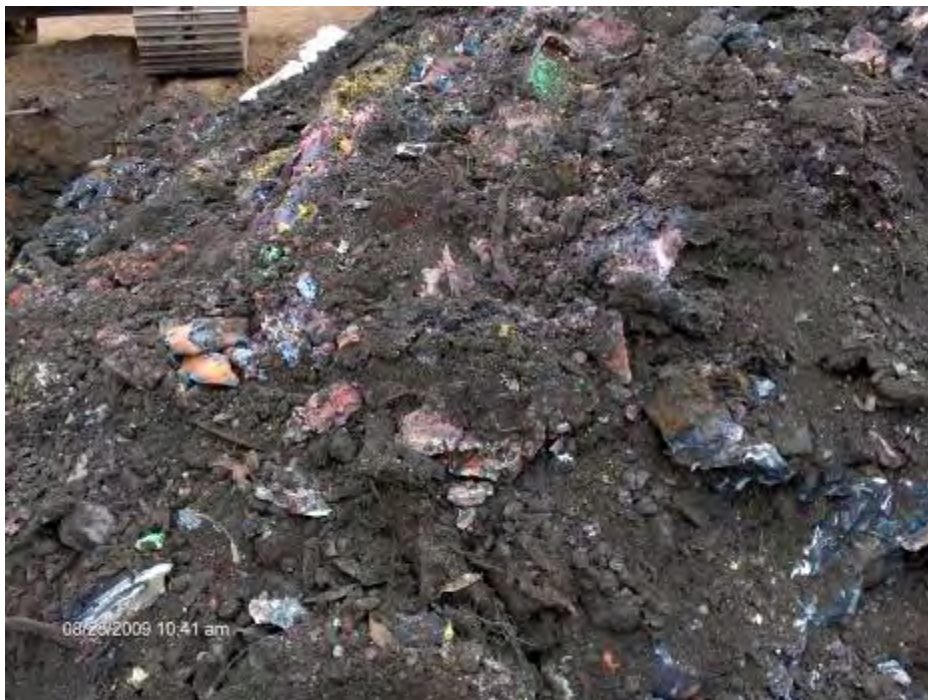
SCENE: View of material (including rubber-like material and soil) excavated from test pit TP-02/04 located in the northeastern portion of the Area of Investigation No. 1. Material was sampled as part of test pit TP-02/04 (SPC-01), TP-02/04 (SPG-01), and TP-02/04 (SPG-02). Photograph taken facing west.

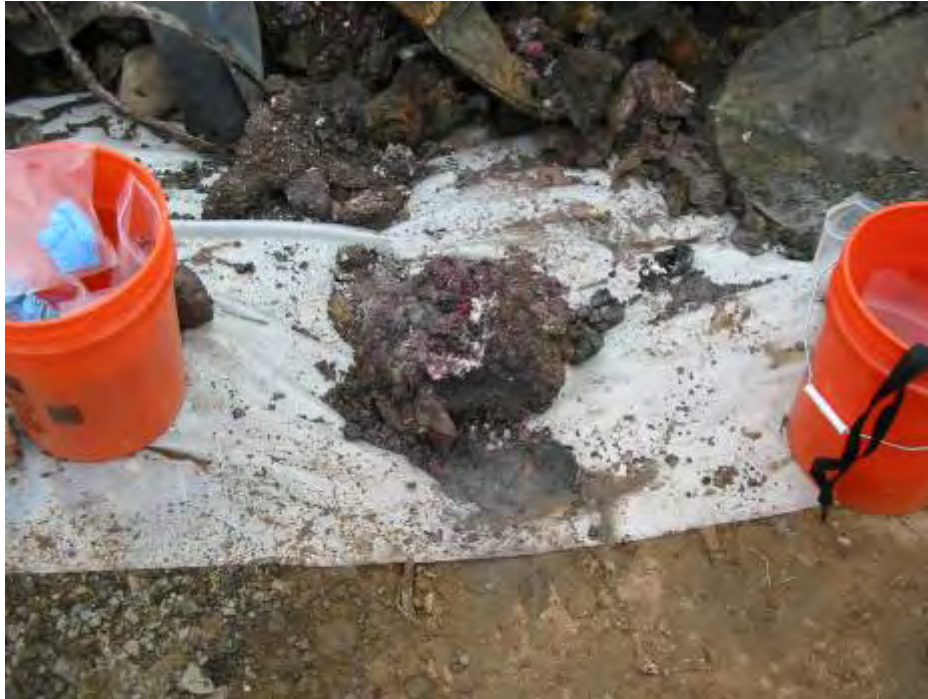
SCENE: View of material excavated from test pit TP-02/04 located in the northeastern portion of the Area of Investigation No. 1. Material was sampled as part of test pit TP-02/04 (Pail-01).

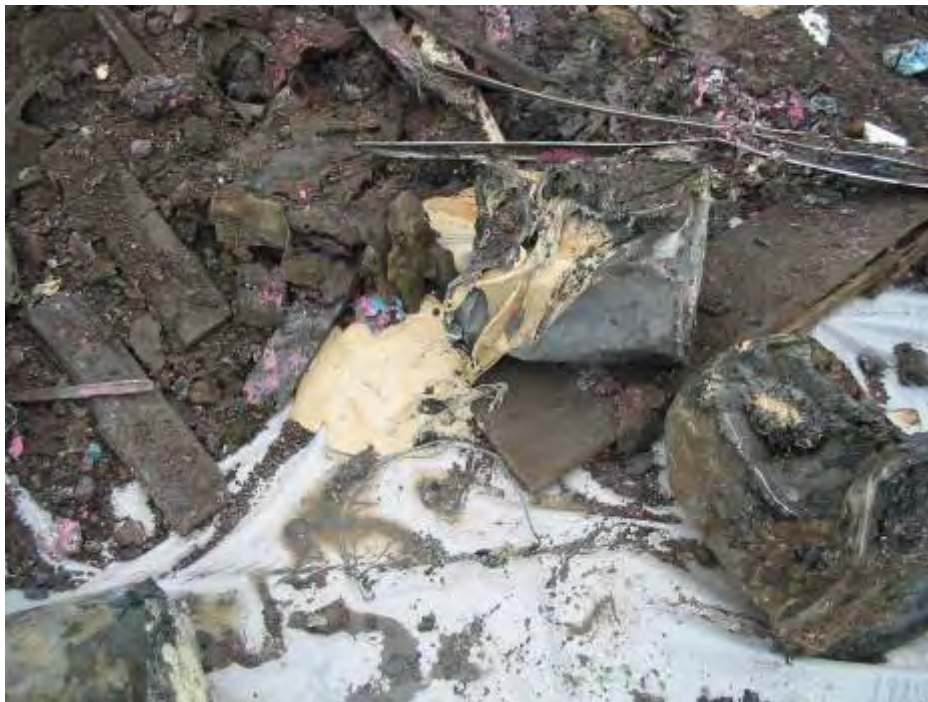
SCENE: View of material excavated from test pit TP-02/04 located in the northeastern portion of the Area of Investigation No. 1. Material was sampled as part of TP-02/04 (Pail-02).

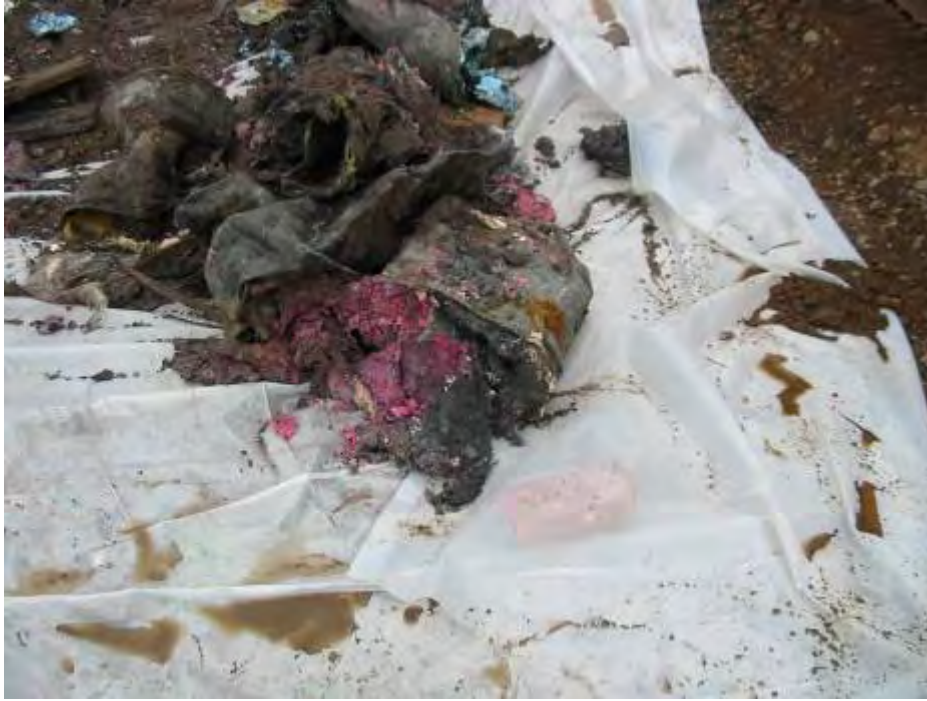
SCENE: View of material excavated from test pit TP-02/04 located in the northeastern portion of the Area of Investigation No. 1. Material was sampled as part of test pit TP-02/04 (Pail-02).

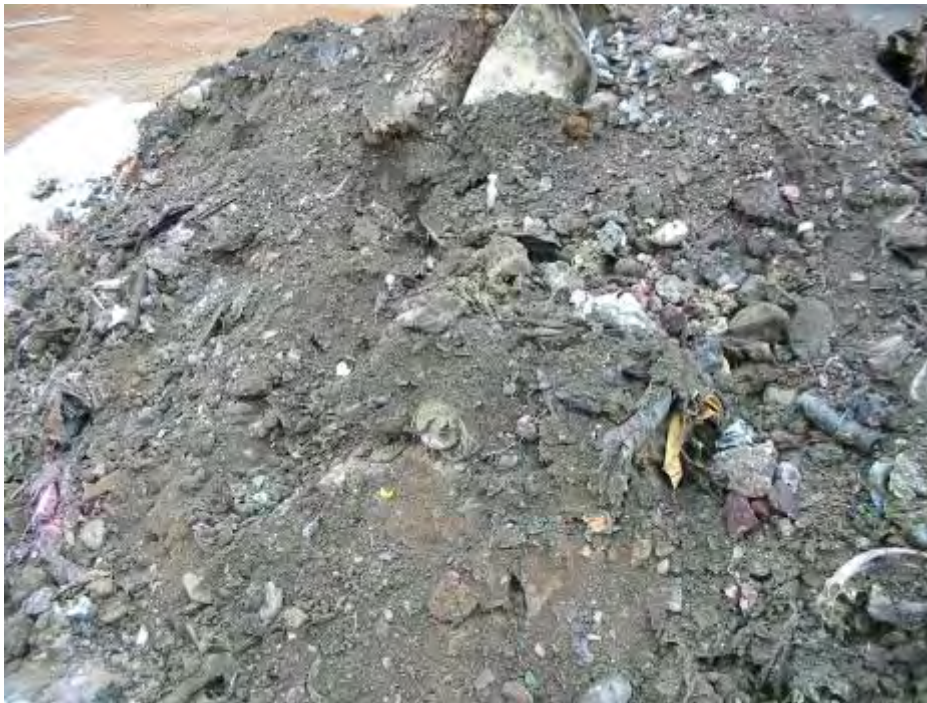
SCENE: View of material (including rubber-like material and soil) excavated from test pit TP-02/04 located in the northeastern portion of the Area of Investigation No. 1. Material was sampled as part of test pit TP-02/04 (SPG-01).

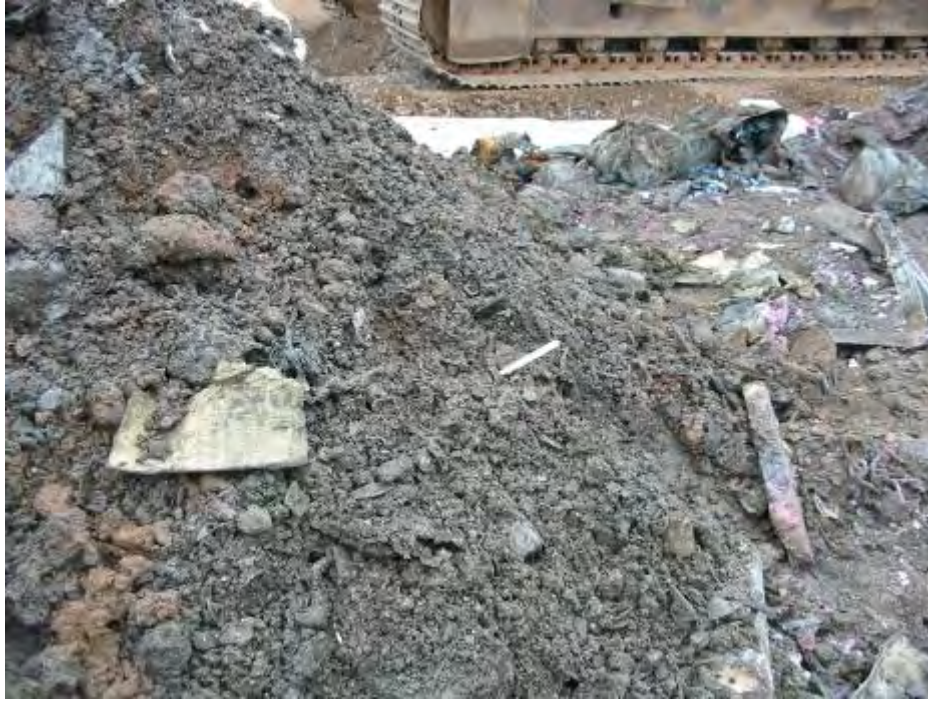
SCENE: View of material (including rubber-like material and soil) excavated from test pit TP-02/04 located in the northeastern portion of the Area of Investigation No. 1. Material was sampled as part of test pit TP-02/04 (SPG-02). Photograph taken facing south.

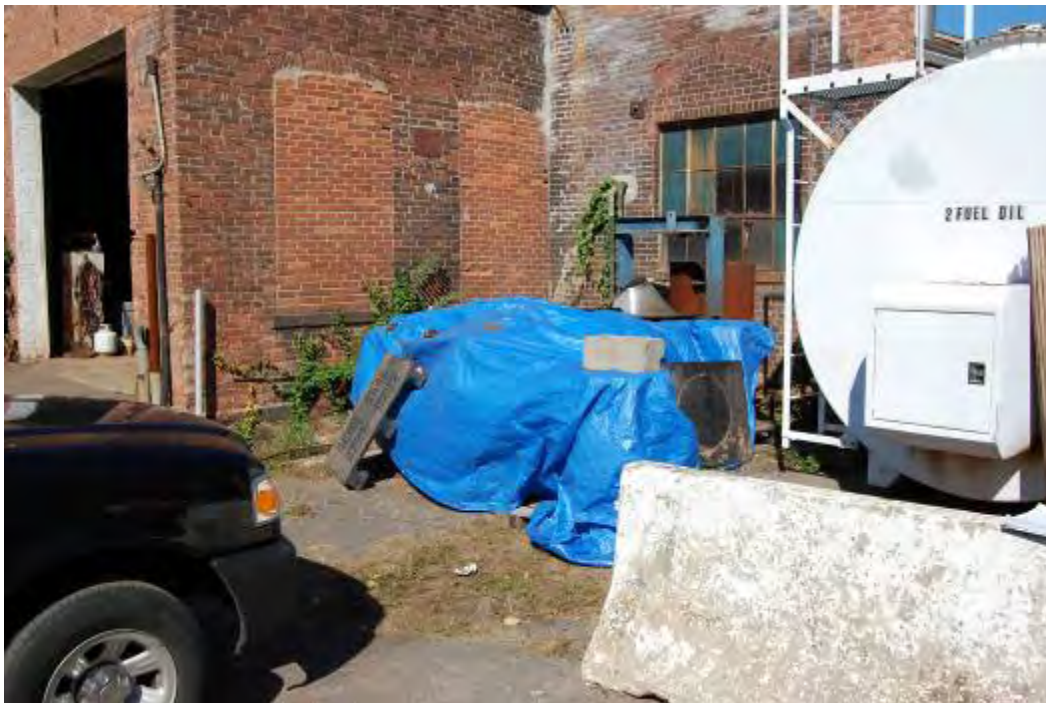
SCENE: View of staged drums containing overpacked material excavated from test pit TP-02/04. Drum staging area is located adjacent to the southwestern portion of Building No. 1. Photograph taken facing northeast.

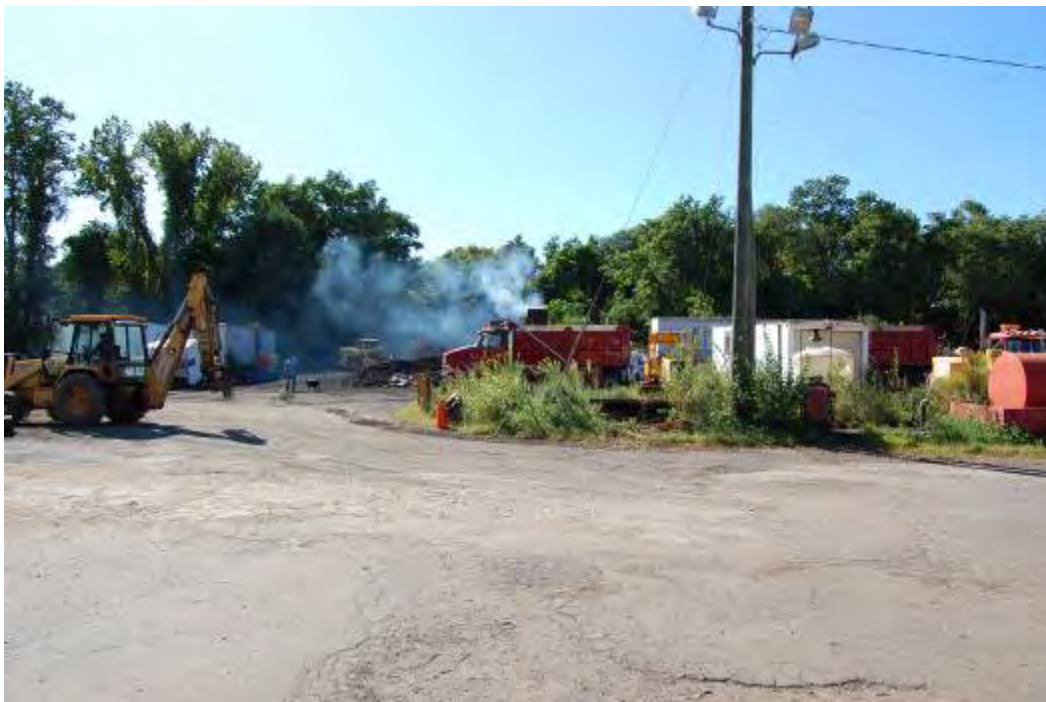
SCENE: View of the western-central portion of the Marino Property Site. Note the asphalt recycling operations on the western property boundary. Photograph taken facing west.

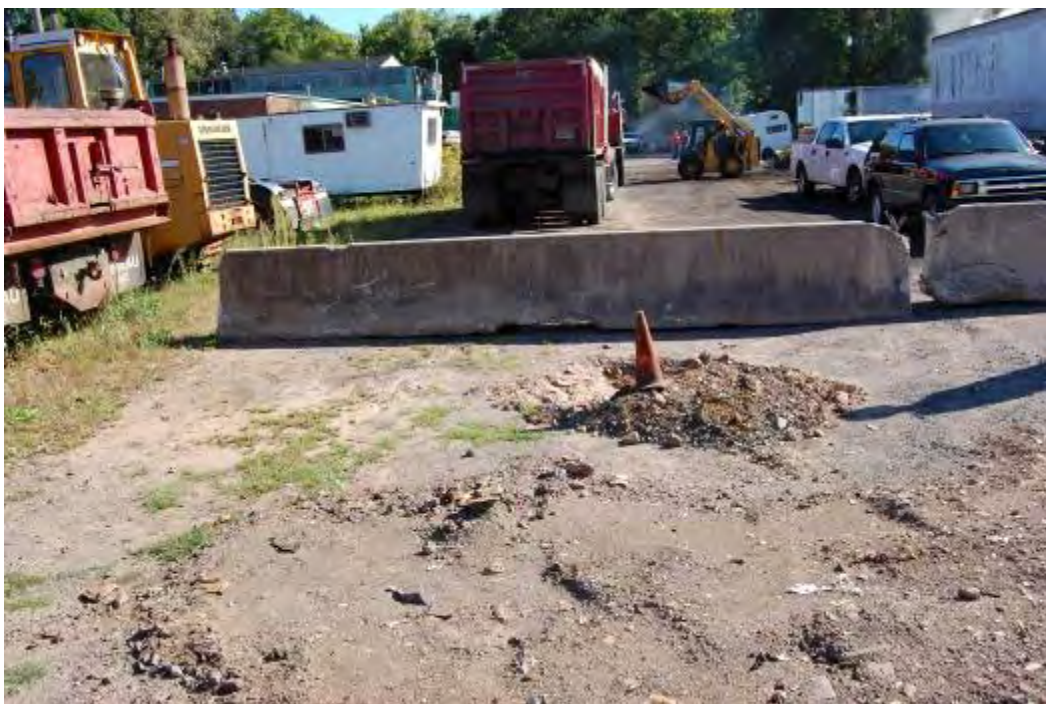
SCENE: View of surface soil sample location SS-21. Photograph taken facing south.

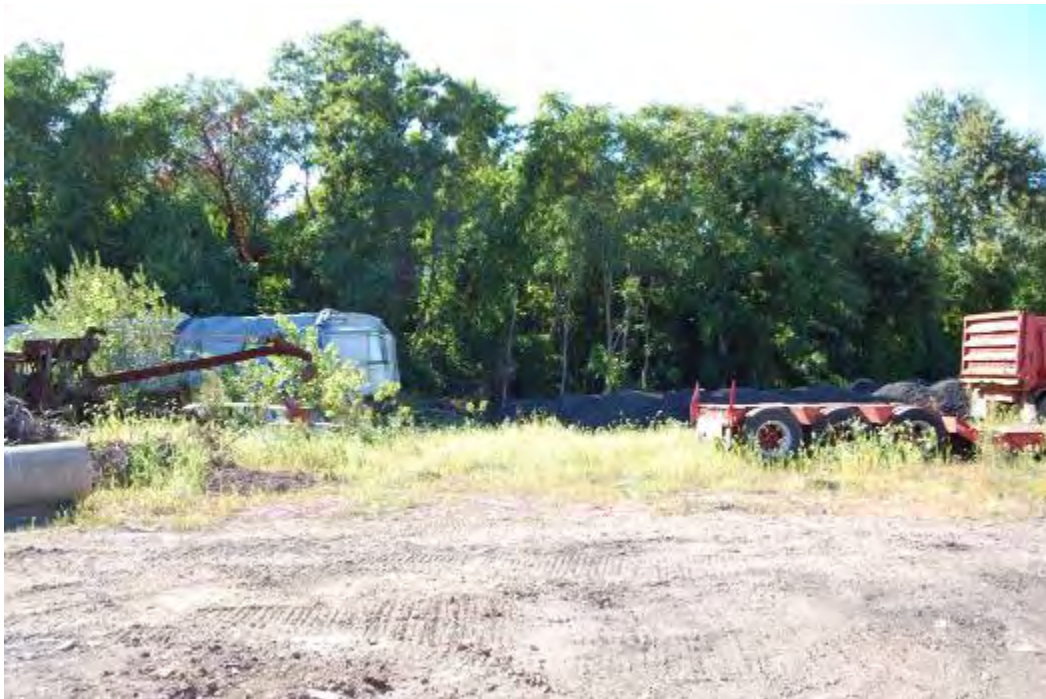
SCENE: View of staged asphalt material located on the southern portion of the Area of Investigation No. 1. Photograph taken facing west.

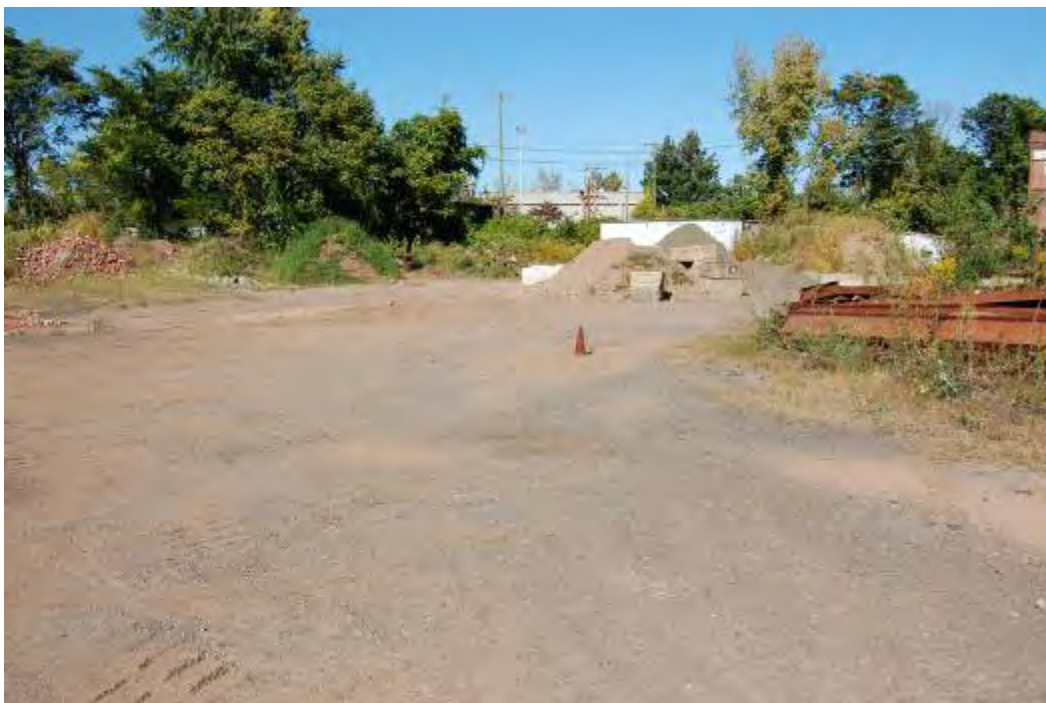
SCENE: View of surface soil sample location SS-12. Photograph taken facing north.

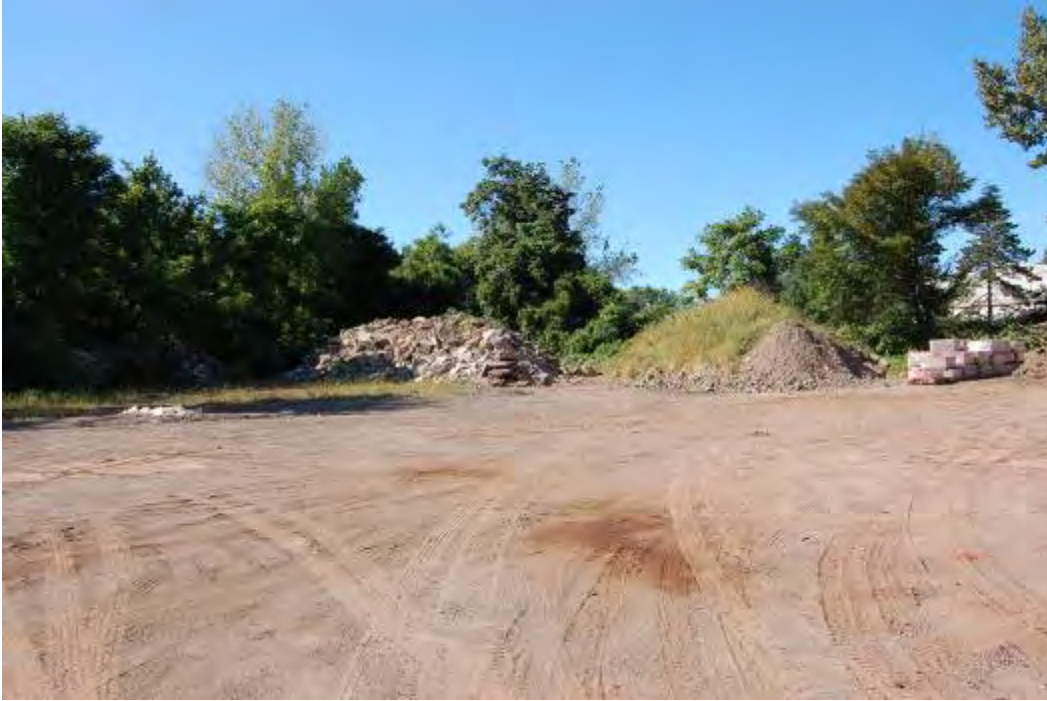
SCENE: View of the central and northern portion of the Area of Investigation No. 1. Photograph taken facing northwest.

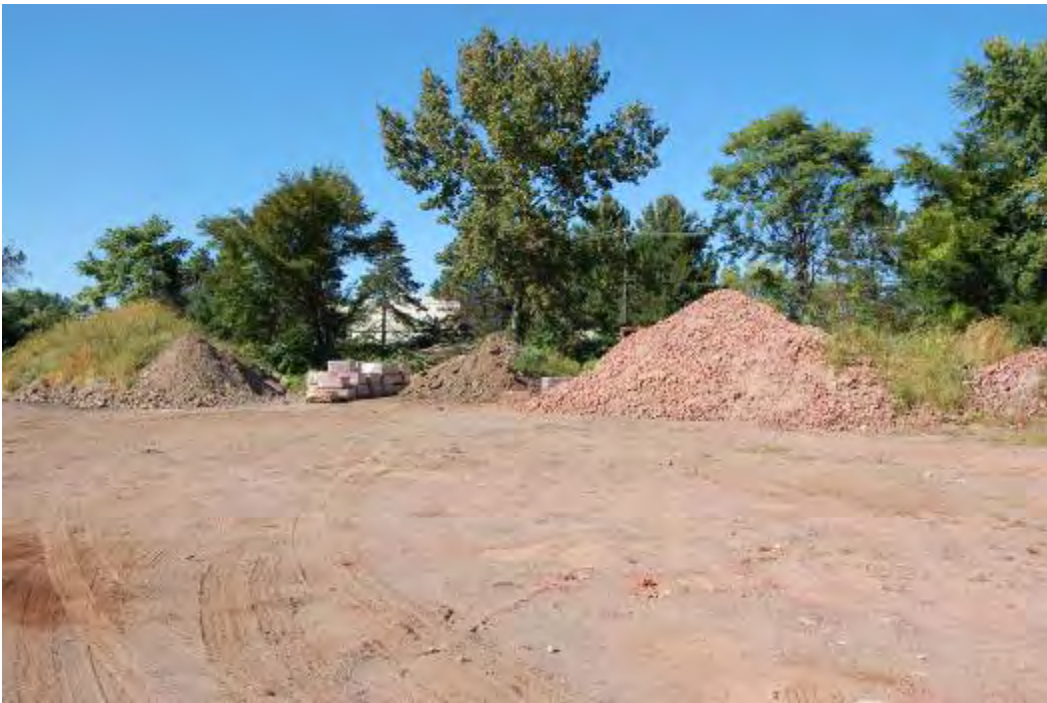
SCENE: View of the northern portion of the Area of Investigation No. 1. Photograph taken facing north.

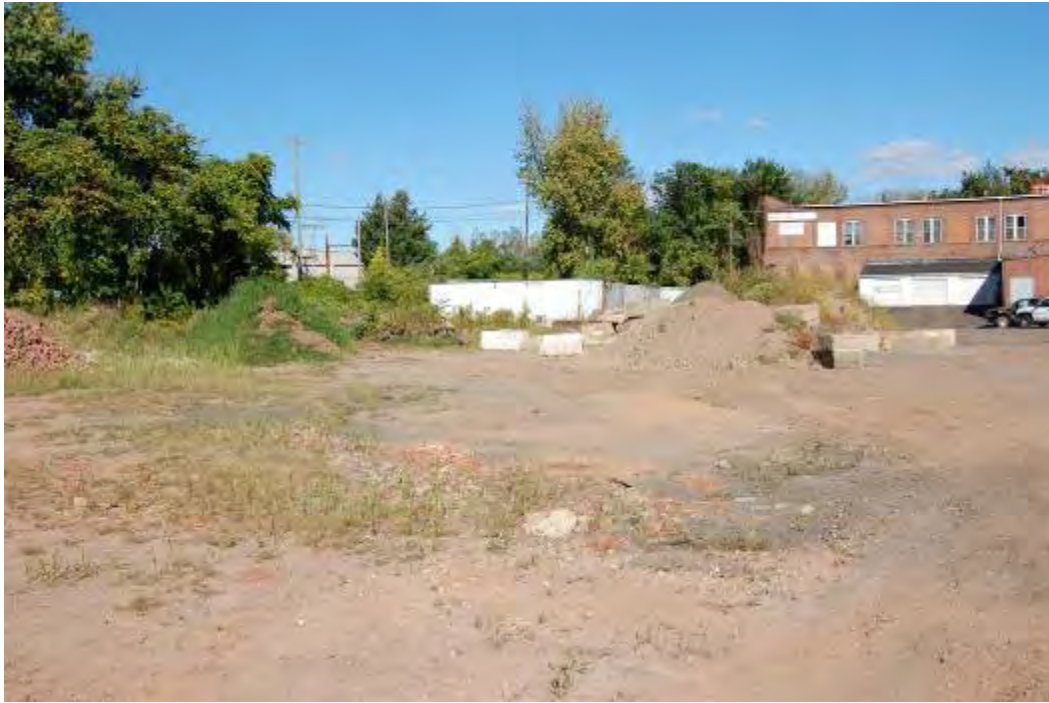
SCENE: View of the northeastern portion of the Area of Investigation No. 1 and the location of test pit TP-02/04. Photograph taken facing northeast.

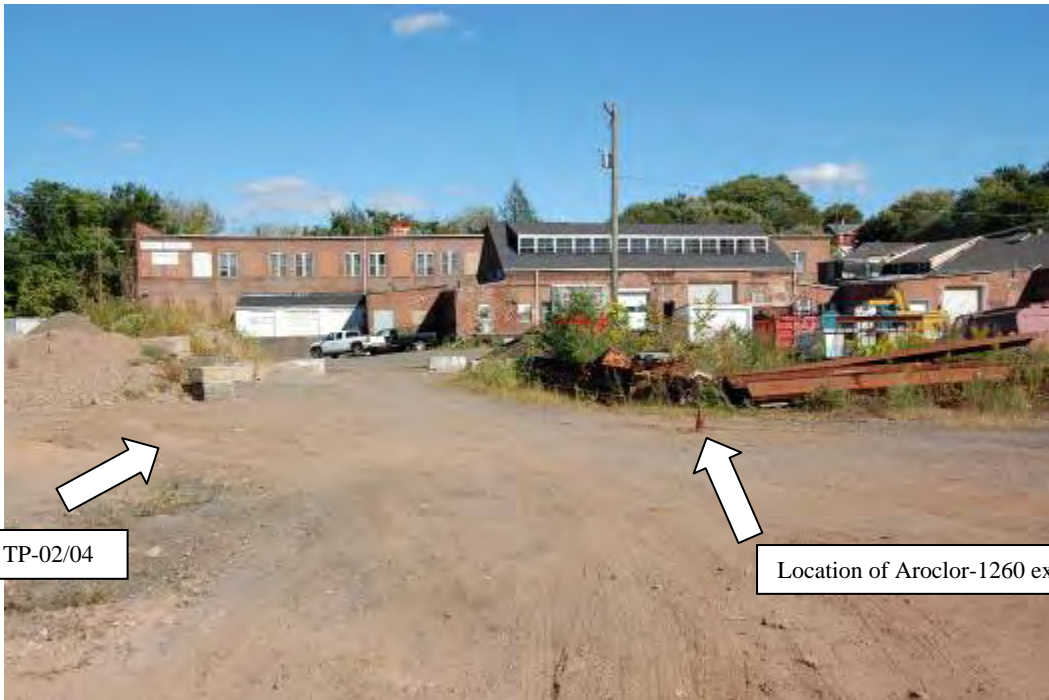
SCENE: View of the eastern-central portion of the Area of Investigation No. 1. Photograph taken facing east.

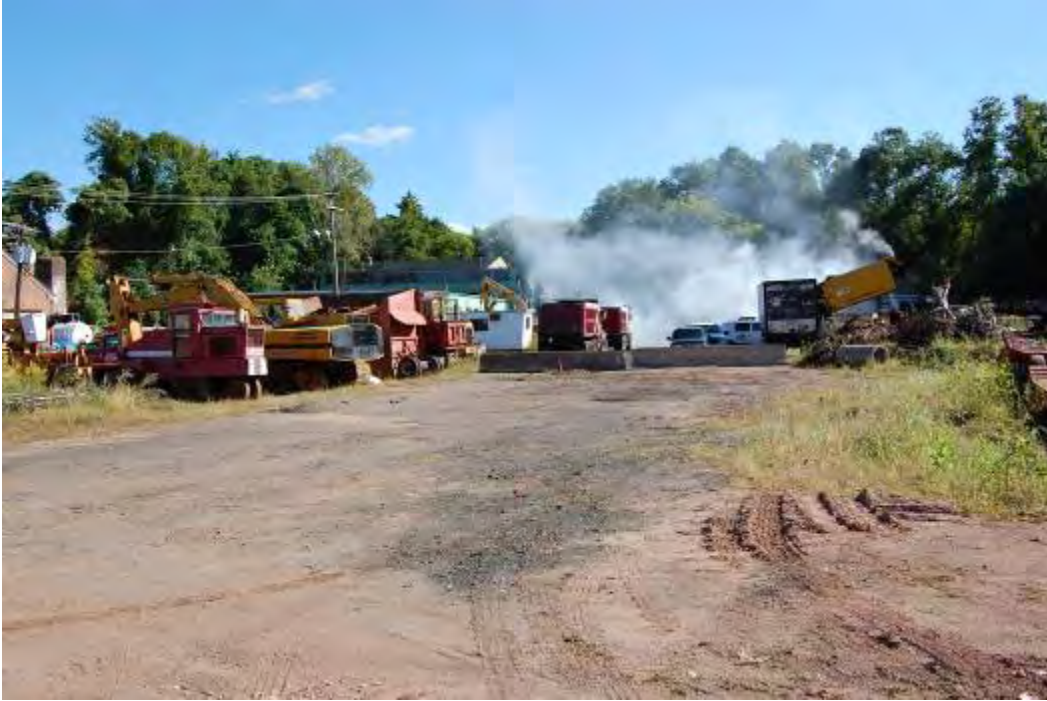
SCENE: View of the southeastern portion of the Area of Investigation No. 1. Note asphalt recycling operations on the western property boundary. Photograph taken facing south.

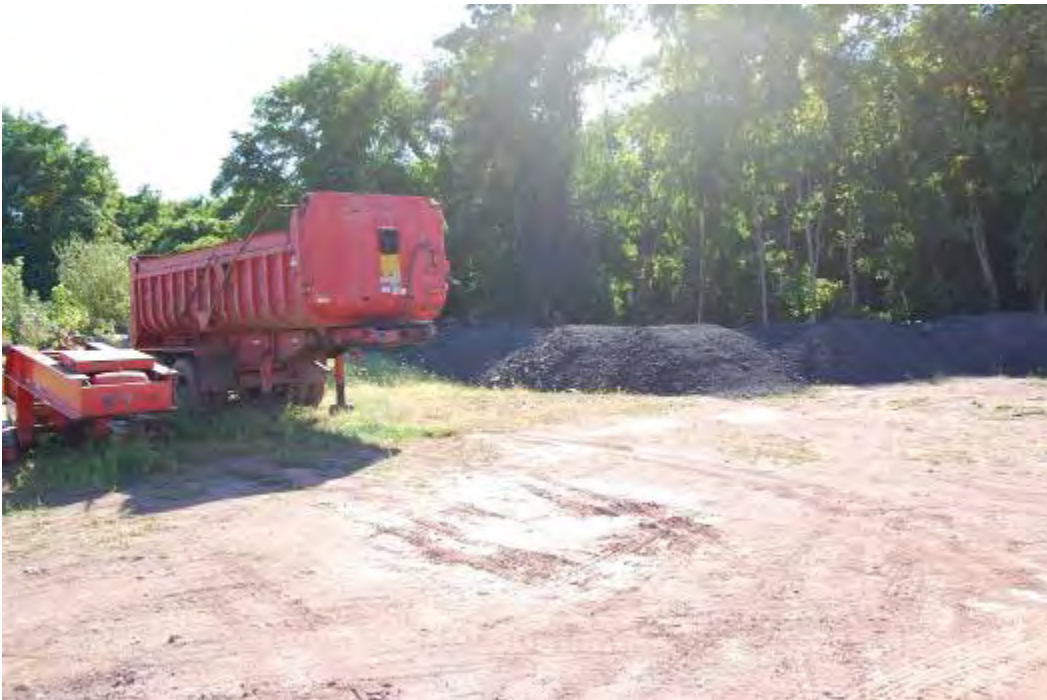
SCENE: View of the southern portion of the Area of Investigation No. 1. Note the piles of staged asphalt. Photograph taken facing southwest.

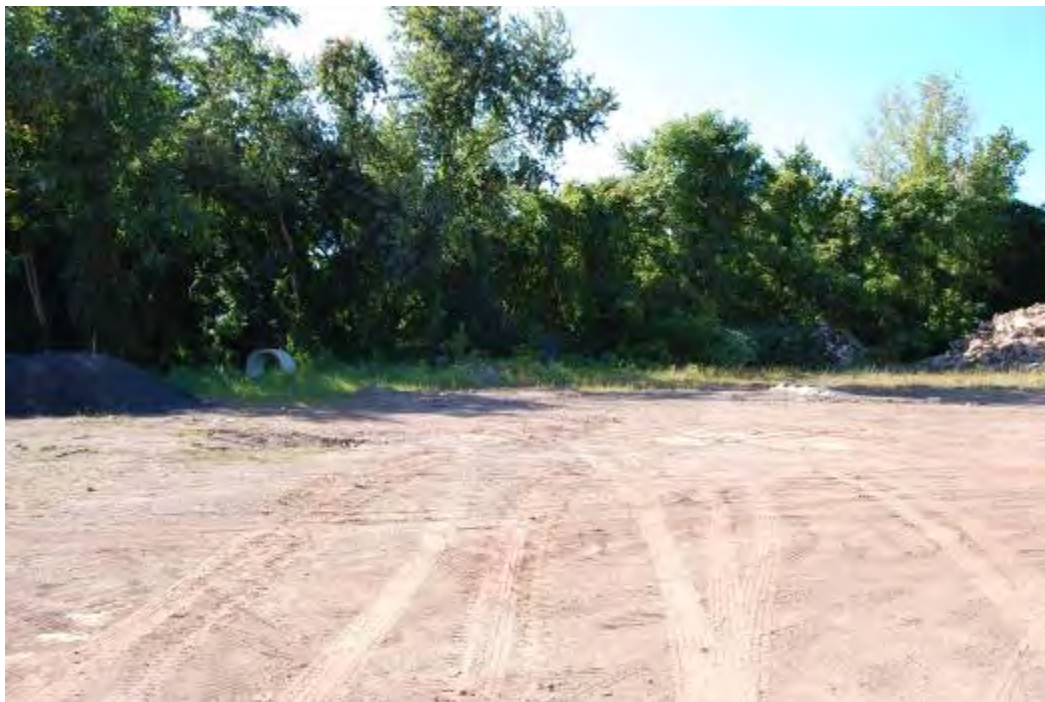
SCENE: View of the western central portion of the Area of Investigation No. 1. Photograph taken facing northwest.

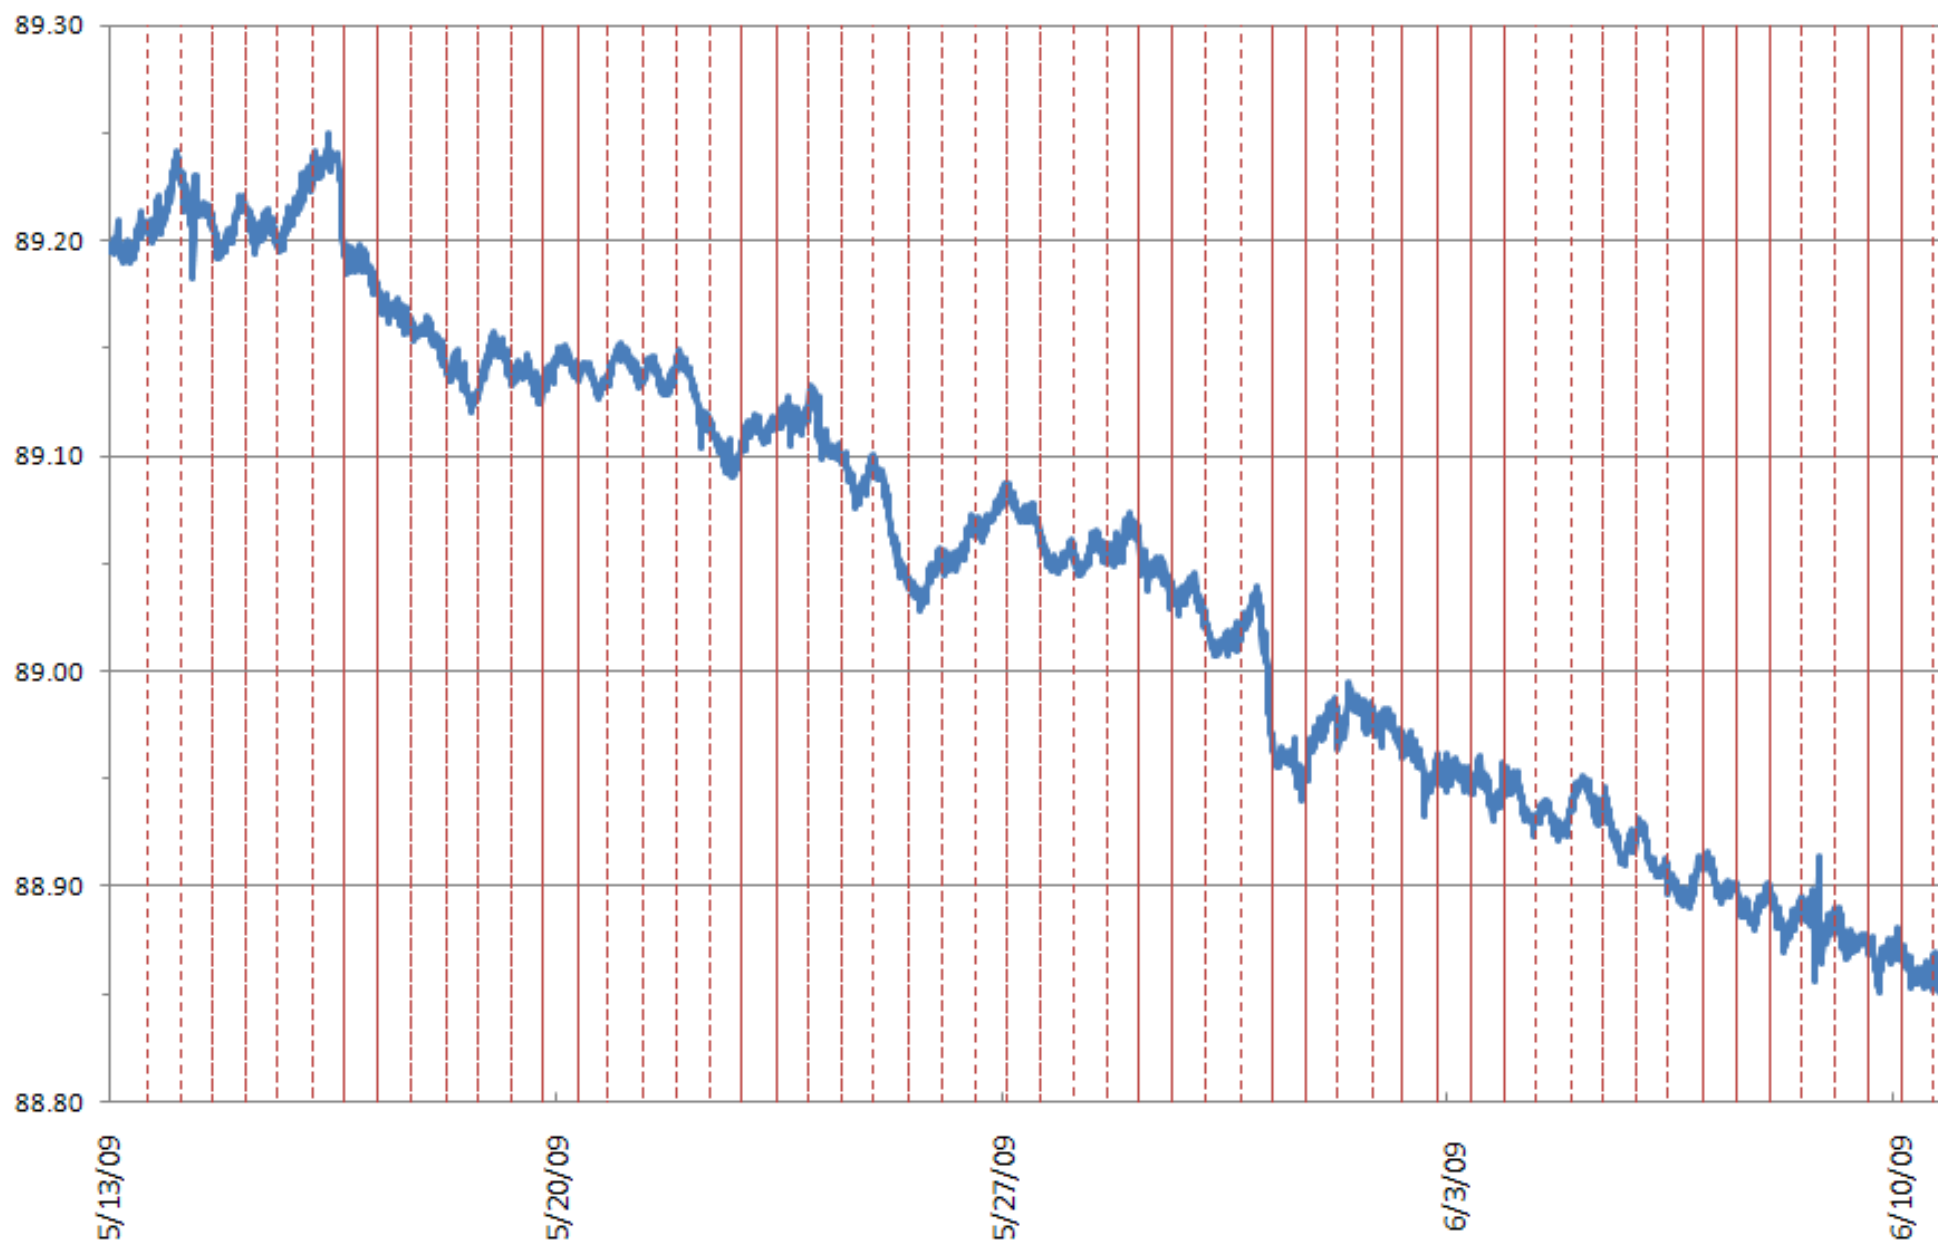
ERT-3

Note: Elevations are based on arbitrary 100 foot elevation line.
Vertical dashed lines indicate approximate high tide.
