**Subject: Final Comprehensive Environmental Response, Compensation, and Liability Act
(CERCLA) Removal Action Report
Industrial Metal Alloys
Winston-Salem, Forsyth County, North Carolina
EPA Contract No. EP-W-05-054
TDD No. TTEMI-05-001-0039**

FINAL
CERCLA REMOVAL ACTION REPORT
INDUSTRIAL METAL ALLOYS
WINSTON-SALEM, FORSYTH COUNTY, NORTH CAROLINA
EPA CONTRACT NO. EP-W-05-054
TDD NO. TTEMI-05-001-0039

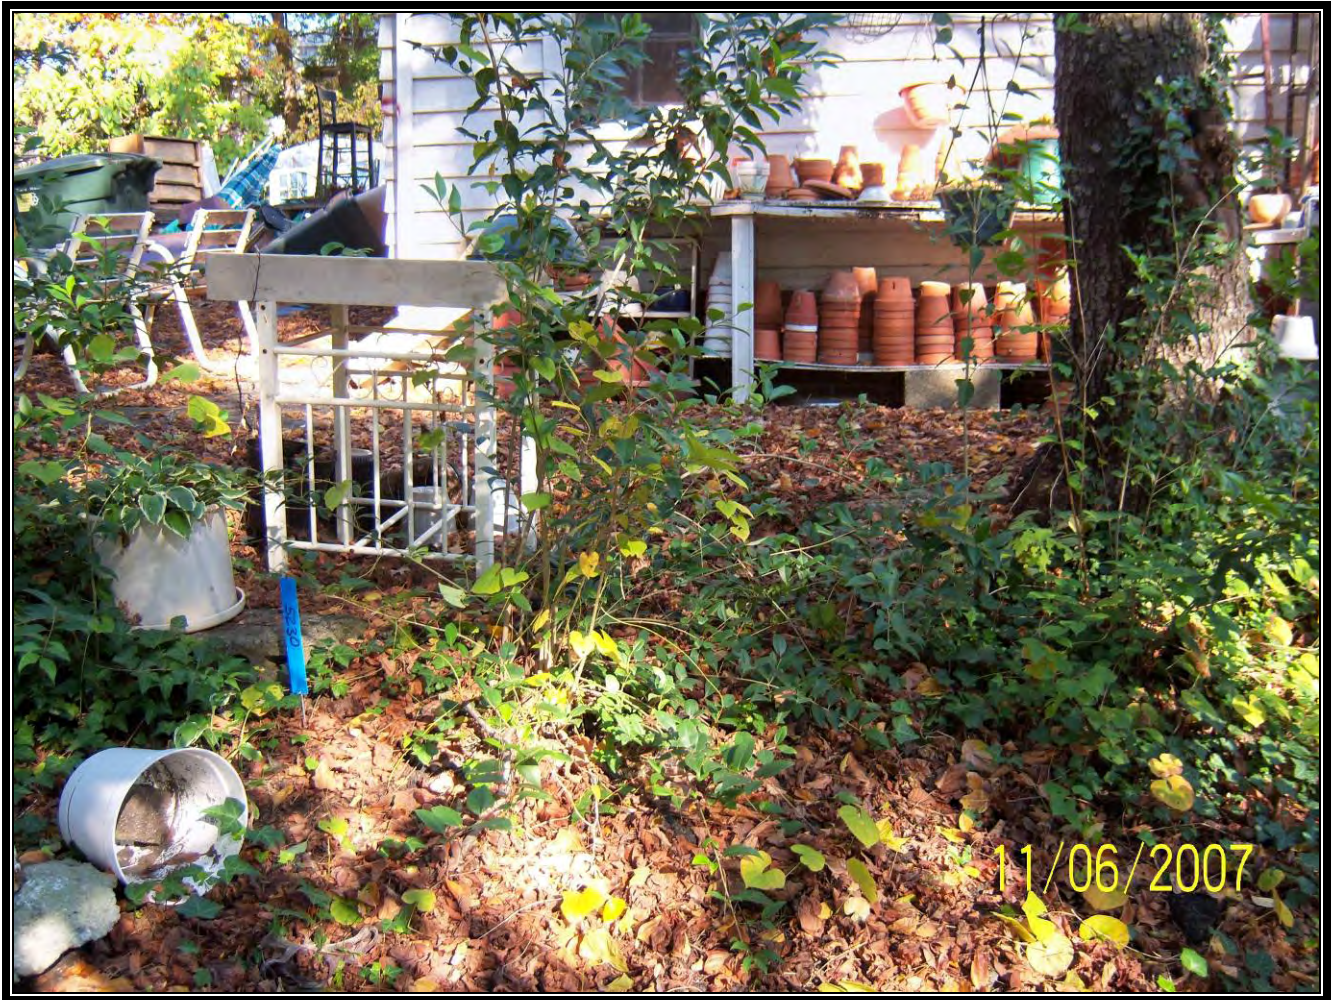
OFFICIAL PHOTOGRAPH NO. 1
U.S. ENVIRONMENTAL PROTECTION AGENCY

Subject: Pre-existing conditions of grid L5 prior to excavation activities at 2117 Main Street (V's Treasures).

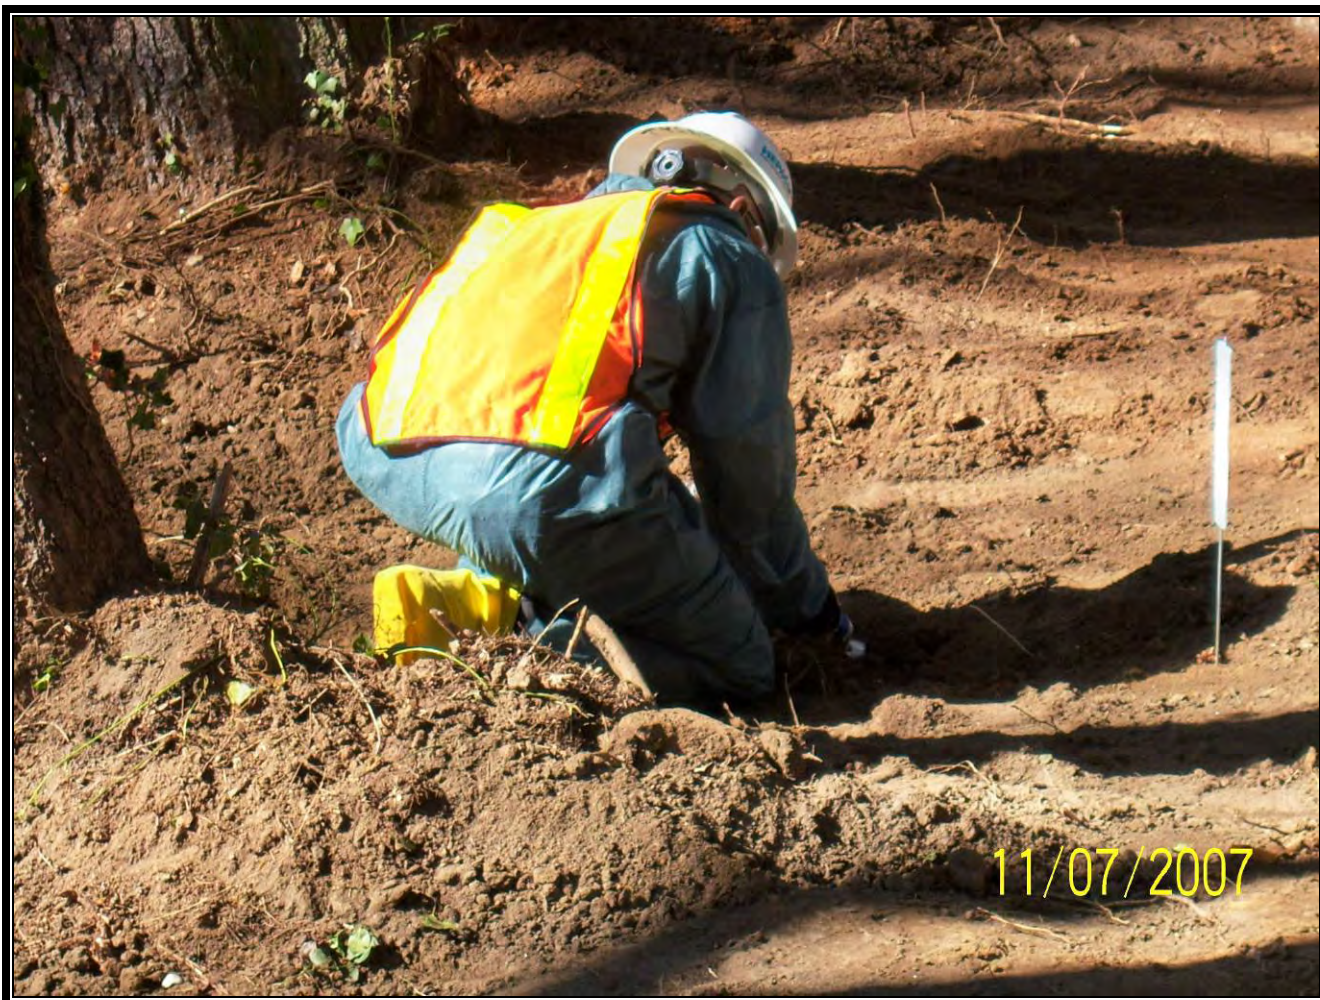
OFFICIAL PHOTOGRAPH NO. 4
U.S. ENVIRONMENTAL PROTECTION AGENCY

TDD Number: TTEMI-05-001-0039 **Location:** Industrial Metal Alloys
Orientation: West **Date:** November 7, 2007
Photographer: Brian Malone, Tetra Tech **Witness:** HEPACO
Subject: HEPACO obtaining composite sample of grid N4 at a depth of 6 inches.

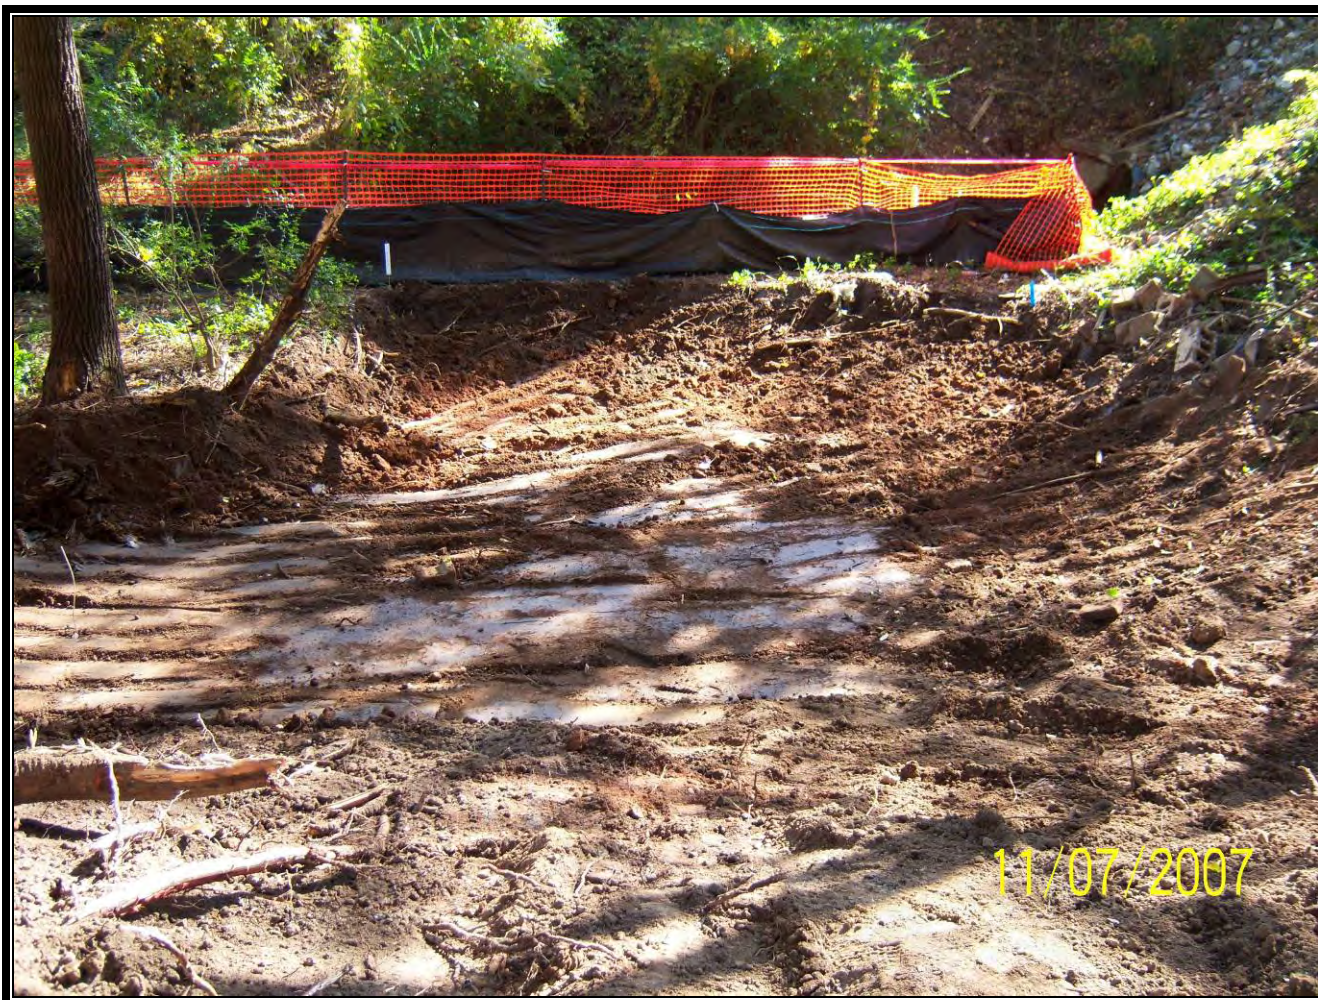
OFFICIAL PHOTOGRAPH NO. 5
U.S. ENVIRONMENTAL PROTECTION AGENCY

TDD Number:	TTEMI-05-001-0039	Location:	Industrial Metal Alloys
Orientation:	South	Date:	November 7, 2007
Photographer:	Brian Malone, Tetra Tech	Witness:	None
Subject:	Completed excavation of grid O5 at a depth of 12 inches bgs.

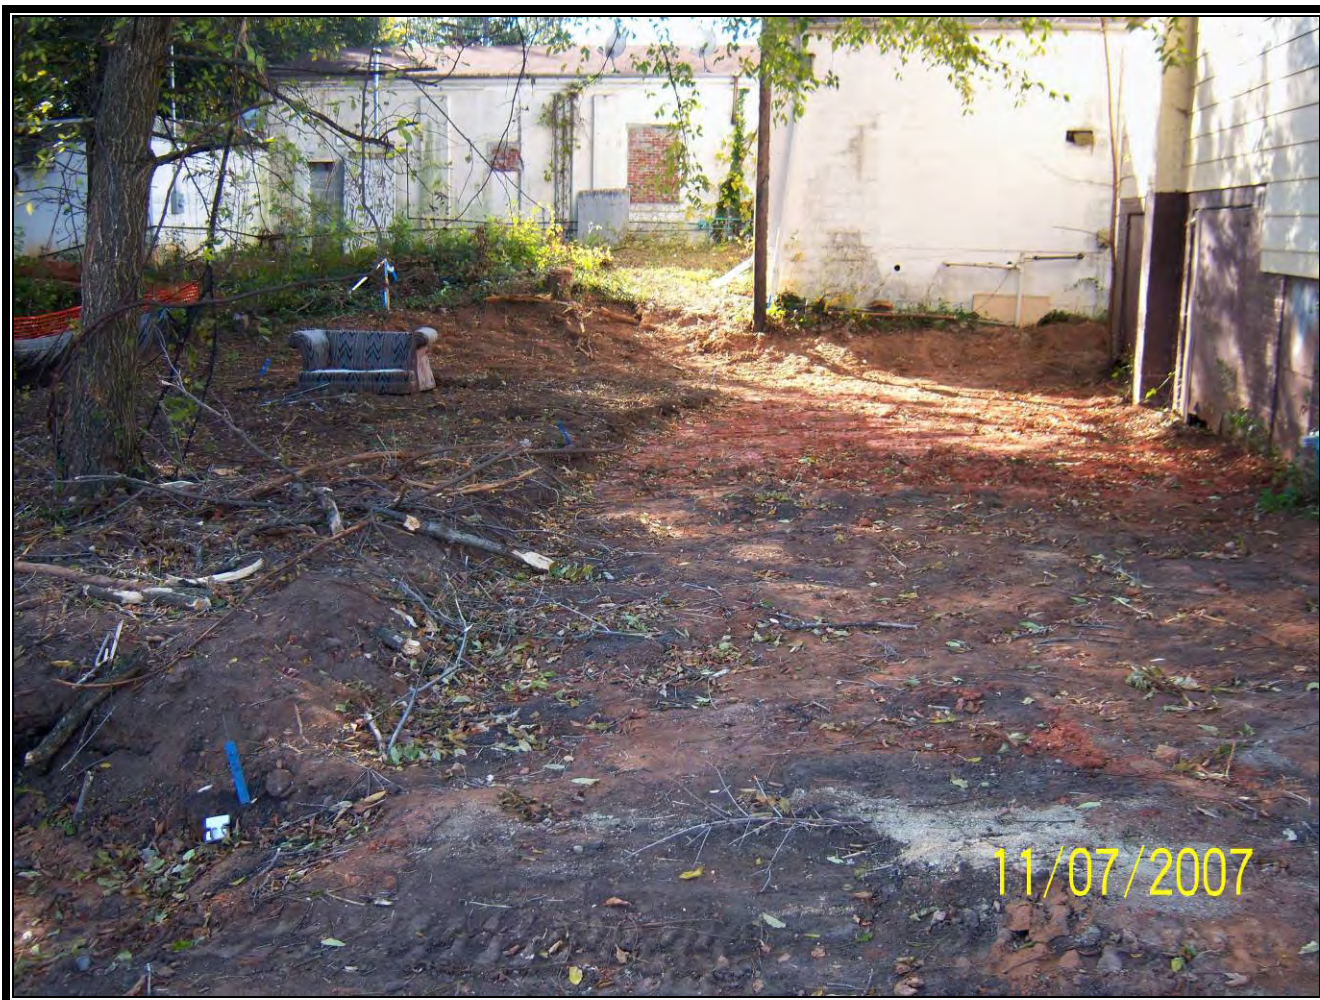
OFFICIAL PHOTOGRAPH NO. 7
U.S. ENVIRONMENTAL PROTECTION AGENCY

TDD Number:	TTEMI-05-001-0039	Location:	Industrial Metal Alloys
Orientation:	West	Date:	November 7, 2007
Photographer:	Brian Malone, Tetra Tech	Witness:	None
Subject:	Completed excavation of grids C8, C7, C6 and D6.

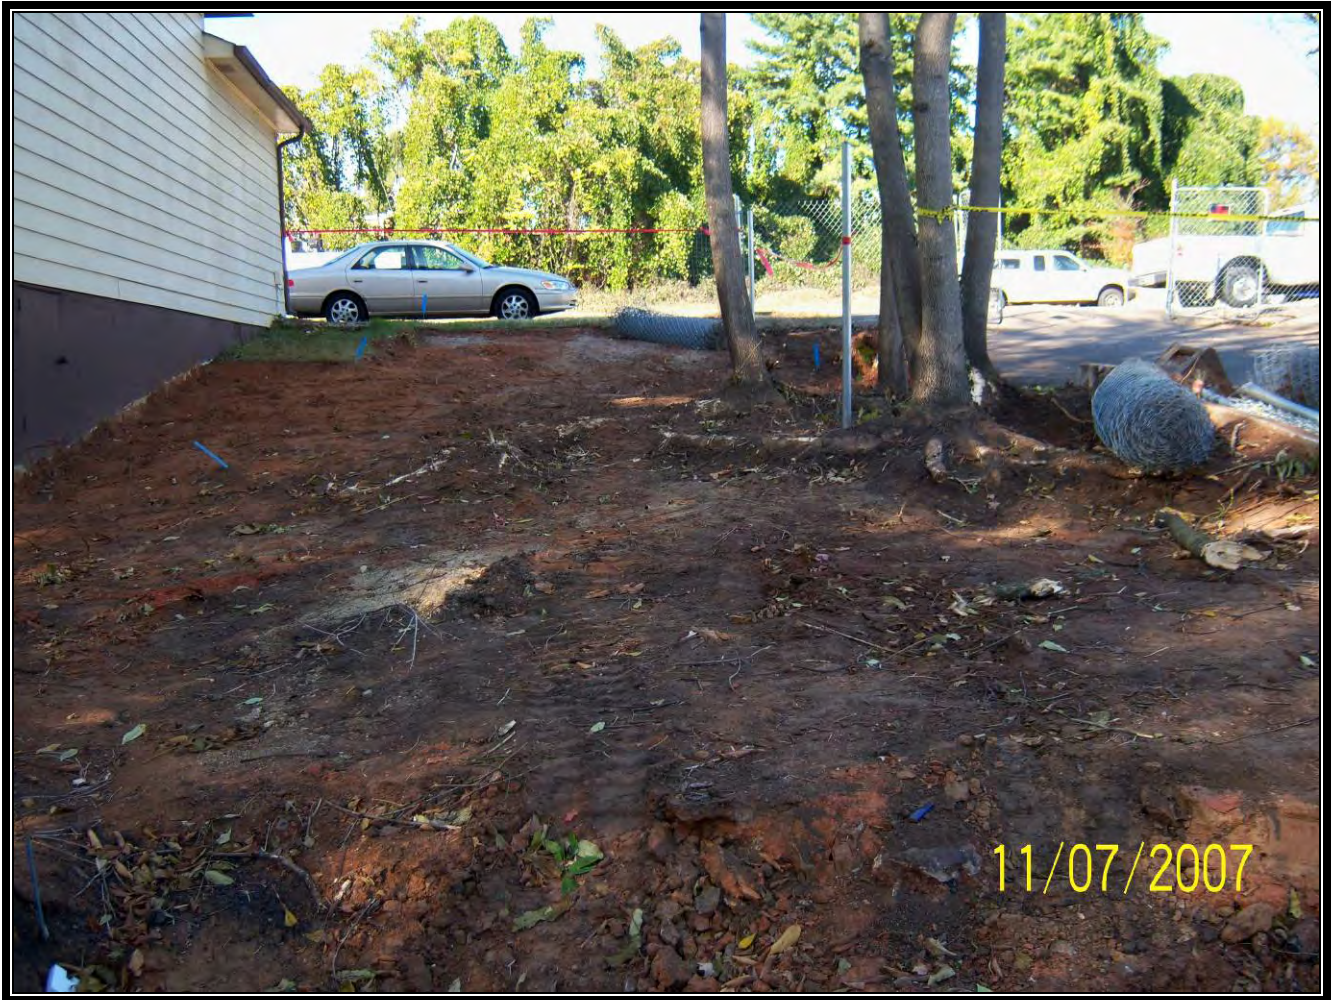
OFFICIAL PHOTOGRAPH NO. 8
U.S. ENVIRONMENTAL PROTECTION AGENCY

TDD Number:	TTEMI-05-001-0039	Location:	Industrial Metal Alloys
Orientation:	North	Date:	November 7, 2007
Photographer:	Brian Malone, Tetra Tech	Witness:	None
Subject:	Completed excavation of grids D9-A9 respectively.

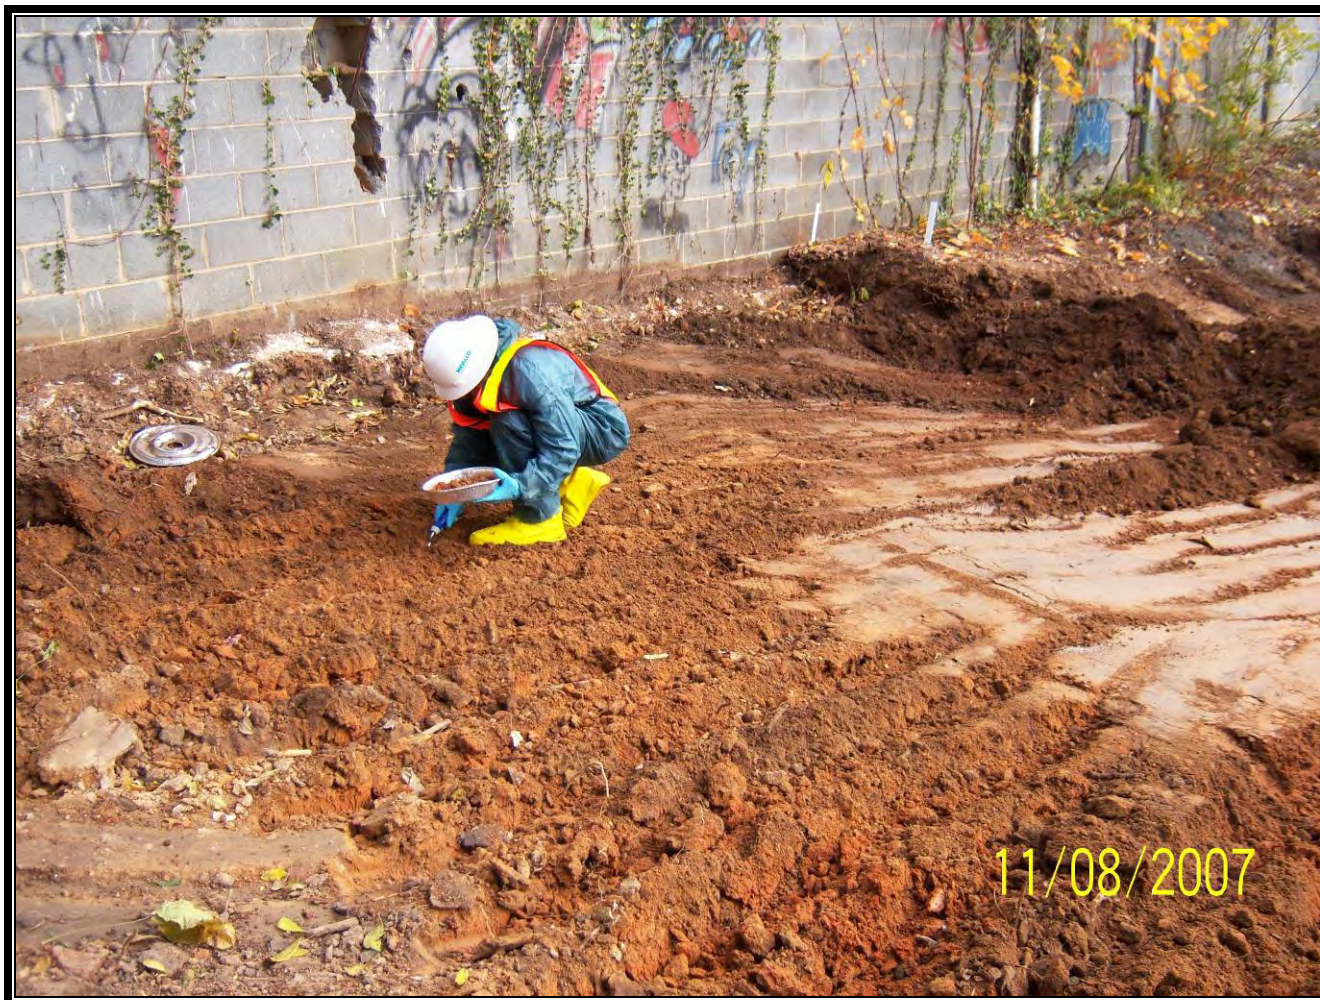
OFFICIAL PHOTOGRAPH NO. 9
U.S. ENVIRONMENTAL PROTECTION AGENCY

TDD Number: TTEMI-05-001-0039 **Location:** Industrial Metal Alloys
Orientation: Northeast **Date:** November 8, 2007
Photographer: Brian Malone, Tetra Tech **Witness:** HEPACO
Subject: HEPACO obtaining composite sample of grid I10 at a depth of 12 inches.

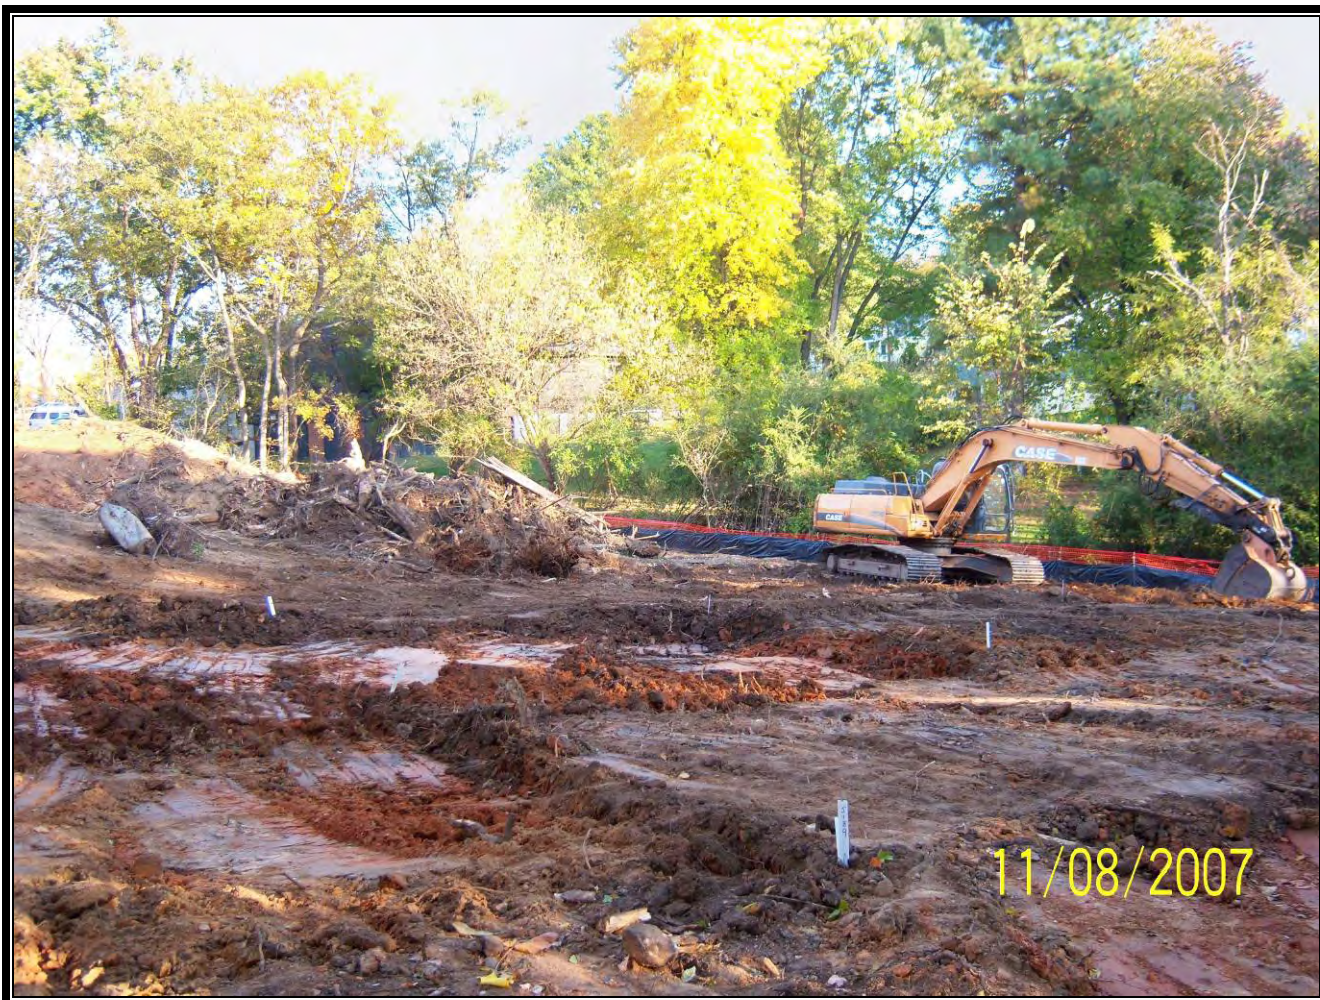
OFFICIAL PHOTOGRAPH NO. 12
U.S. ENVIRONMENTAL PROTECTION AGENCY

TDD Number:	TTEMI-05-001-0039	Location:	Industrial Metal Alloys
Orientation:	Southeast	Date:	November 8, 2007
Photographer:	Brian Malone, Tetra Tech	Witness:	None
Subject:	Excavation of grid rows 10 and 11.

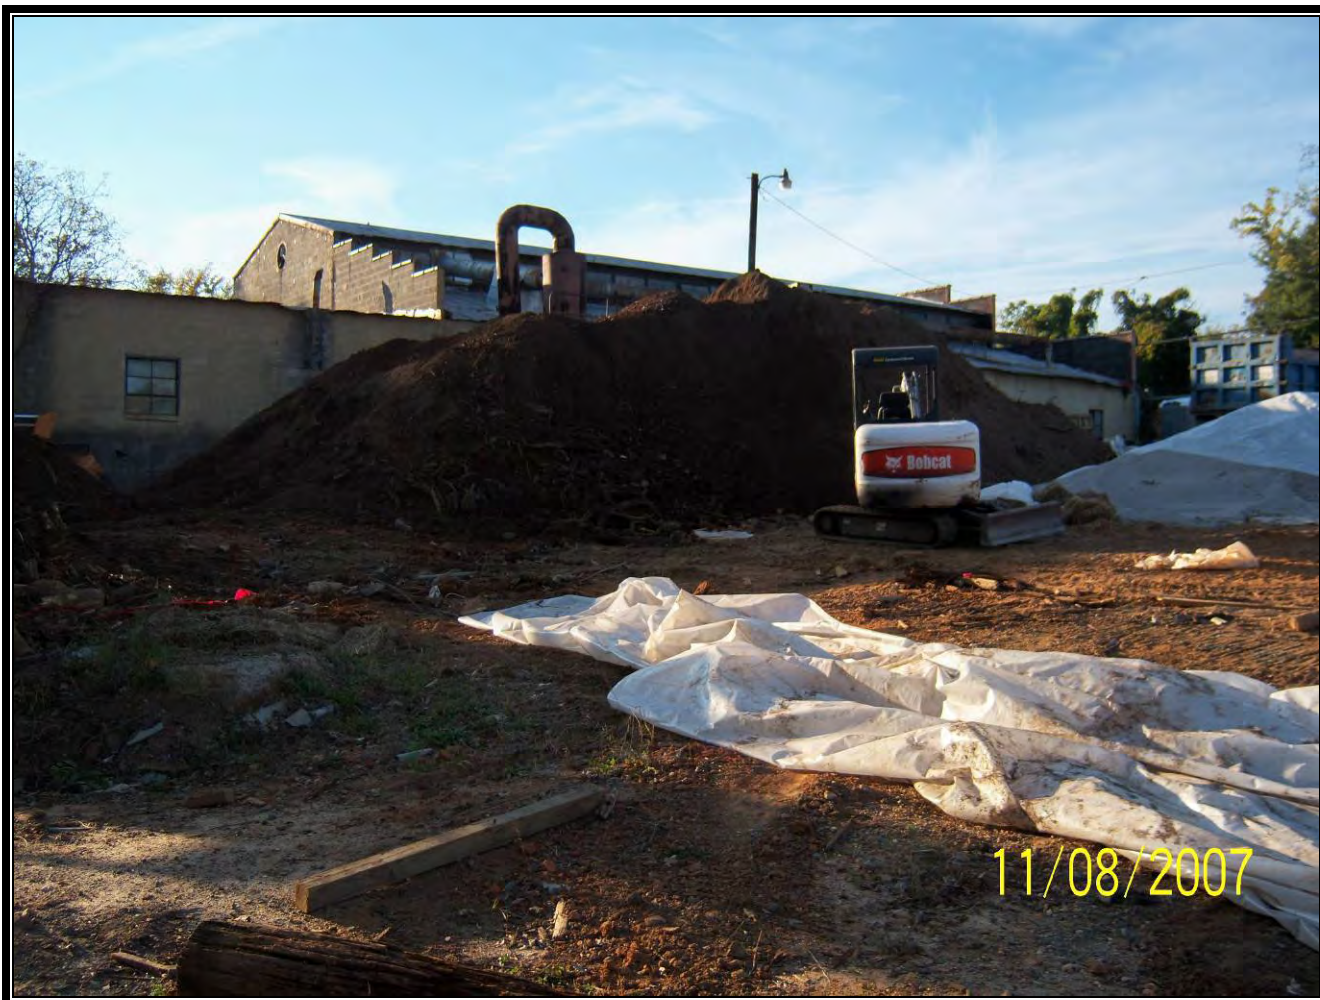
OFFICIAL PHOTOGRAPH NO. 13
U.S. ENVIRONMENTAL PROTECTION AGENCY

TDD Number:	TTEMI-05-001-0039	Location:	Industrial Metal Alloys
Orientation:	West	Date:	November 8, 2007
Photographer:	Brian Malone, Tetra Tech	Witness:	None
Subject:	Contaminated soil stockpile located on the east side of the building.

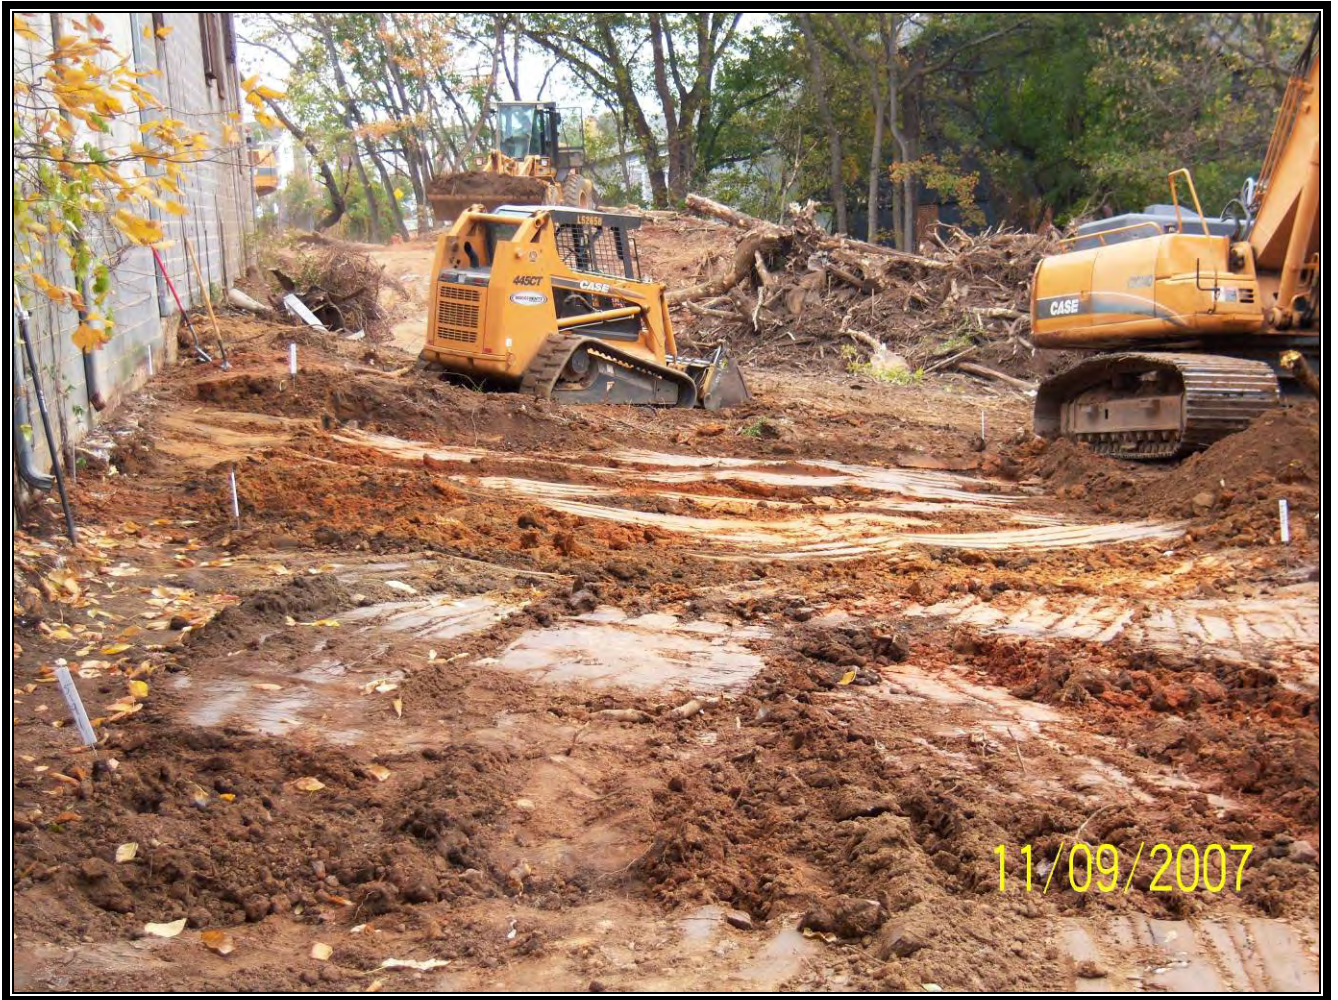
OFFICIAL PHOTOGRAPH NO. 14
U.S. ENVIRONMENTAL PROTECTION AGENCY

TDD Number: TTEMI-05-001-0039 **Location:** Industrial Metal Alloys
Orientation: East **Date:** November 9, 2007
Photographer: Brian Malone, Tetra Tech **Witness:** None
Subject: Extent of excavation in grids I12, H12 at 12 inches bgs.

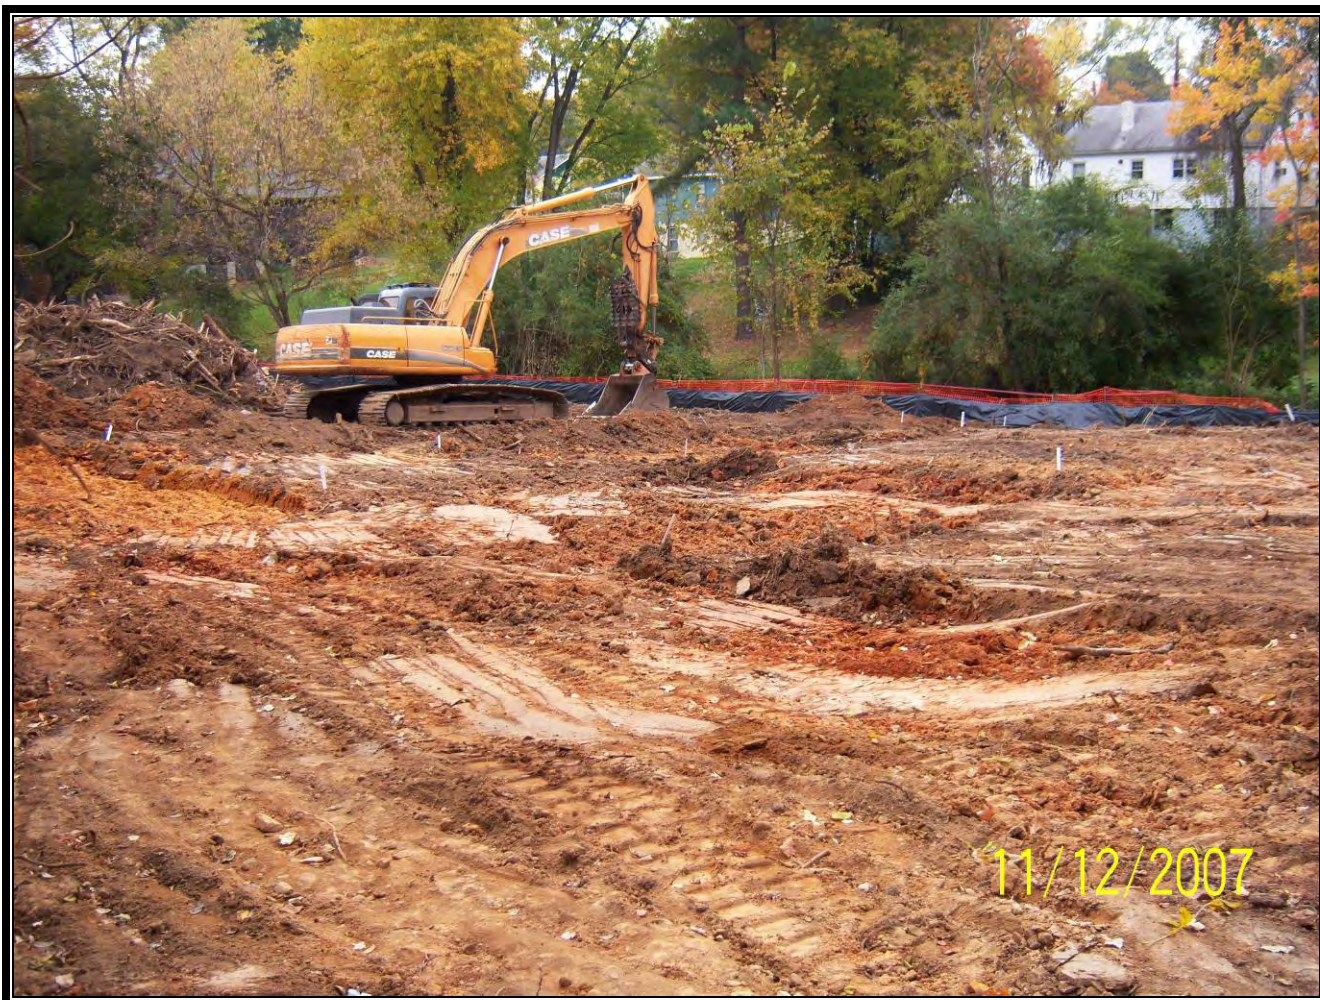
OFFICIAL PHOTOGRAPH NO. 16
U.S. ENVIRONMENTAL PROTECTION AGENCY

TDD Number:	TTEMI-05-001-0039	Location:	Industrial Metal Alloys
Orientation:	Southeast	Date:	November 12, 2007
Photographer:	Brian Malone, Tetra Tech	Witness:	None
Subject:	Extent of excavation in row 12.

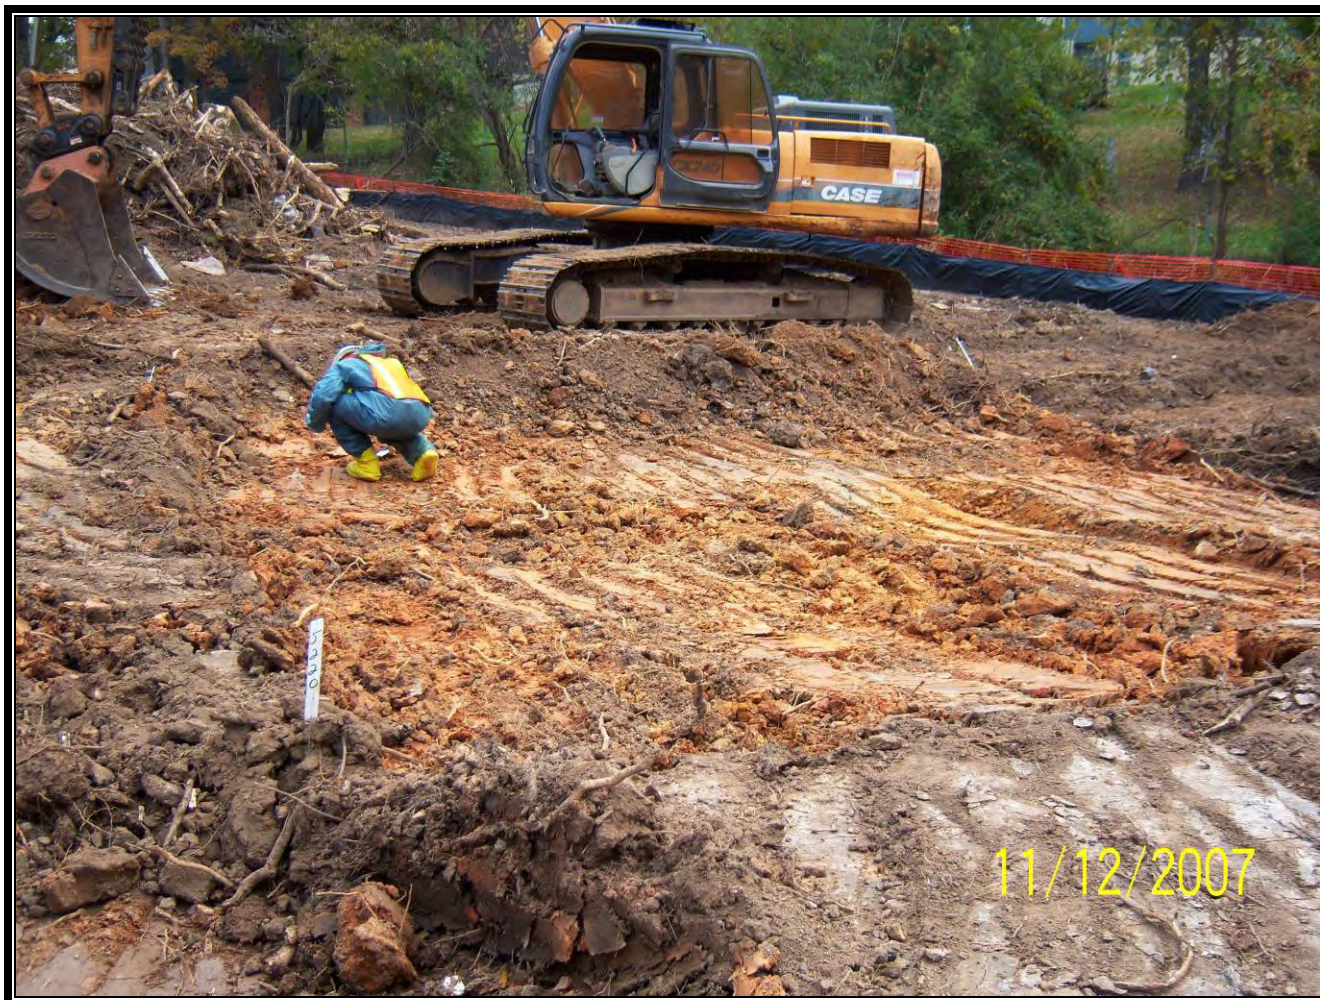
OFFICIAL PHOTOGRAPH NO. 18
U.S. ENVIRONMENTAL PROTECTION AGENCY

TDD Number:	TTEMI-05-001-0039	Location:	Industrial Metal Alloys
Orientation:	Southeast	Date:	November 12, 2007
Photographer:	Brian Malone, Tetra Tech	Witness:	HEPACO
Subject:	HEPACO obtaining five point composite sample from grid K12 at 12 inches bgs.

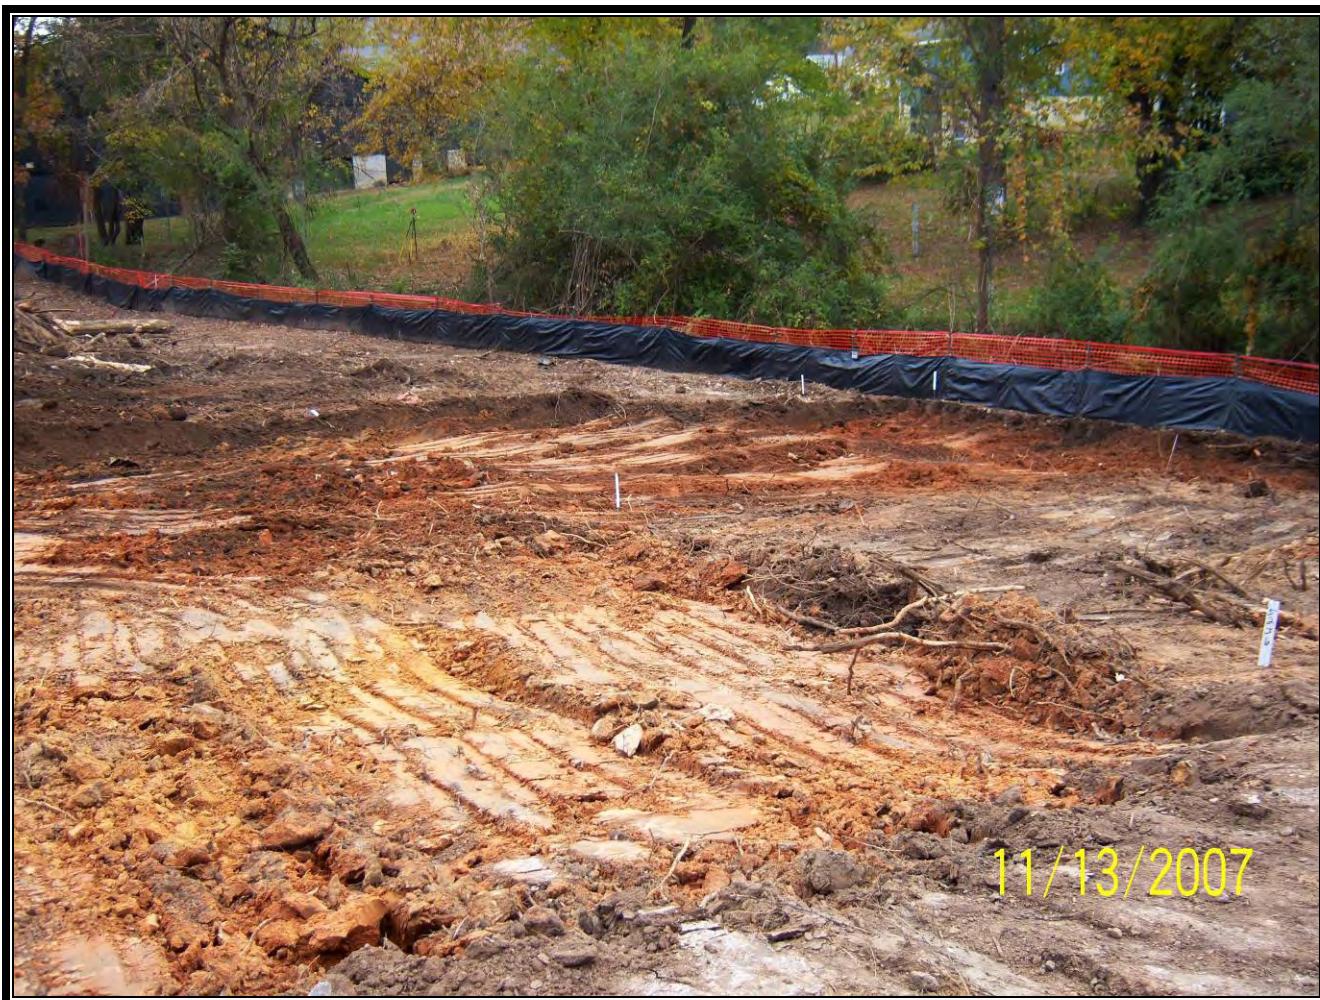
OFFICIAL PHOTOGRAPH NO. 19
U.S. ENVIRONMENTAL PROTECTION AGENCY

TDD Number:	TTEMI-05-001-0039	Location:	Industrial Metal Alloys
Orientation:	Southeast	Date:	November 13, 2007
Photographer:	Brian Malone, Tetra Tech	Witness:	None
Subject:	Extent of excavation in grids L13 and M13.

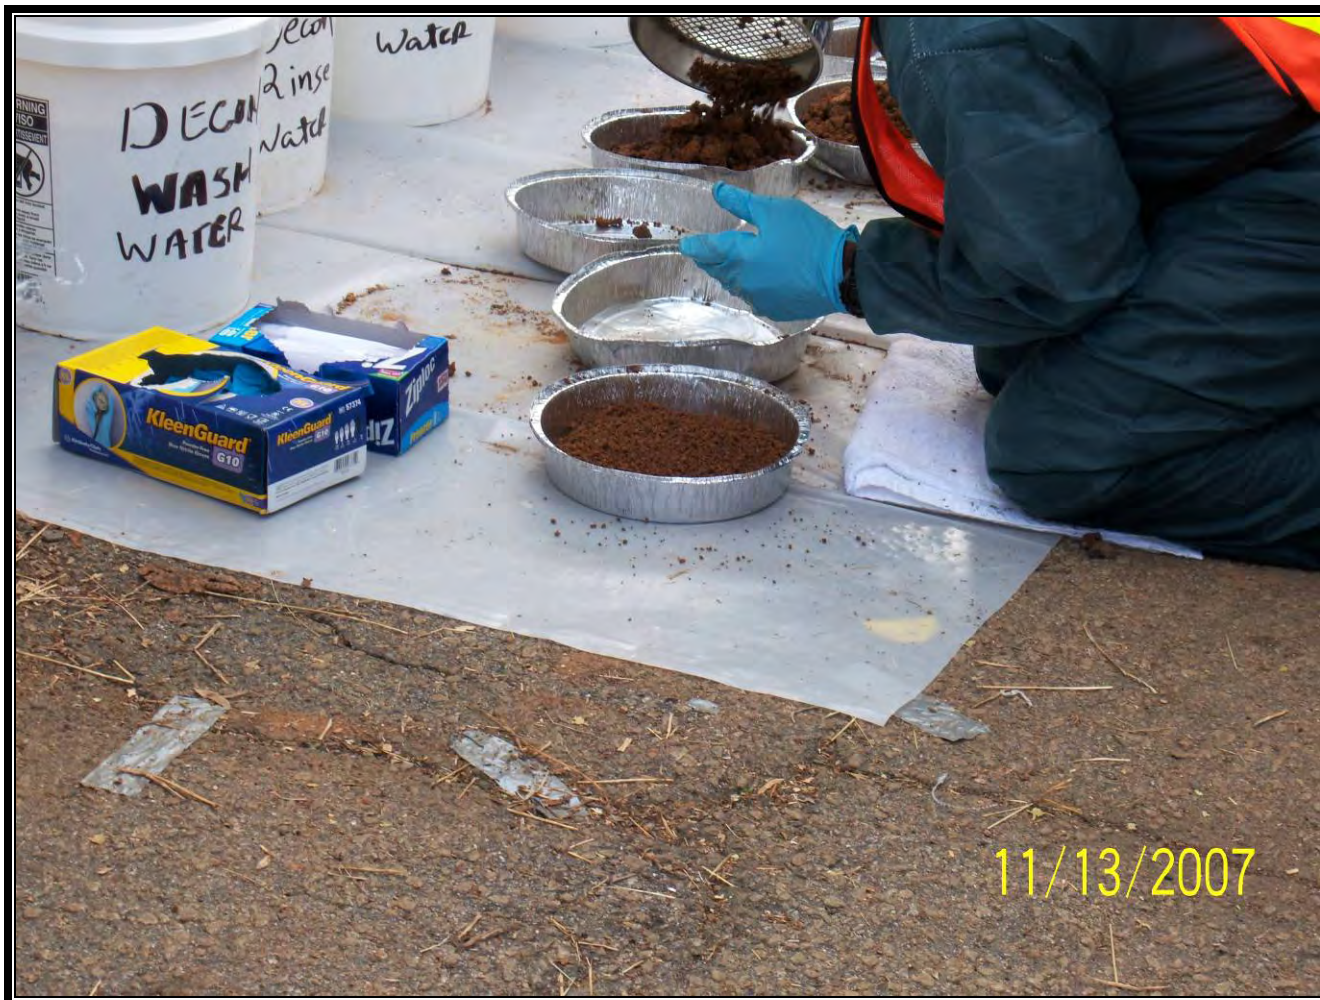
OFFICIAL PHOTOGRAPH NO. 20
U.S. ENVIRONMENTAL PROTECTION AGENCY

TDD Number: TTEMI-05-001-0039 **Location:** Industrial Metal Alloys
Orientation: South **Date:** November 13, 2007
Photographer: Brian Malone, Tetra Tech **Witness:** HEPACO
Subject: HEPACO processing composite sample for XRF screening.

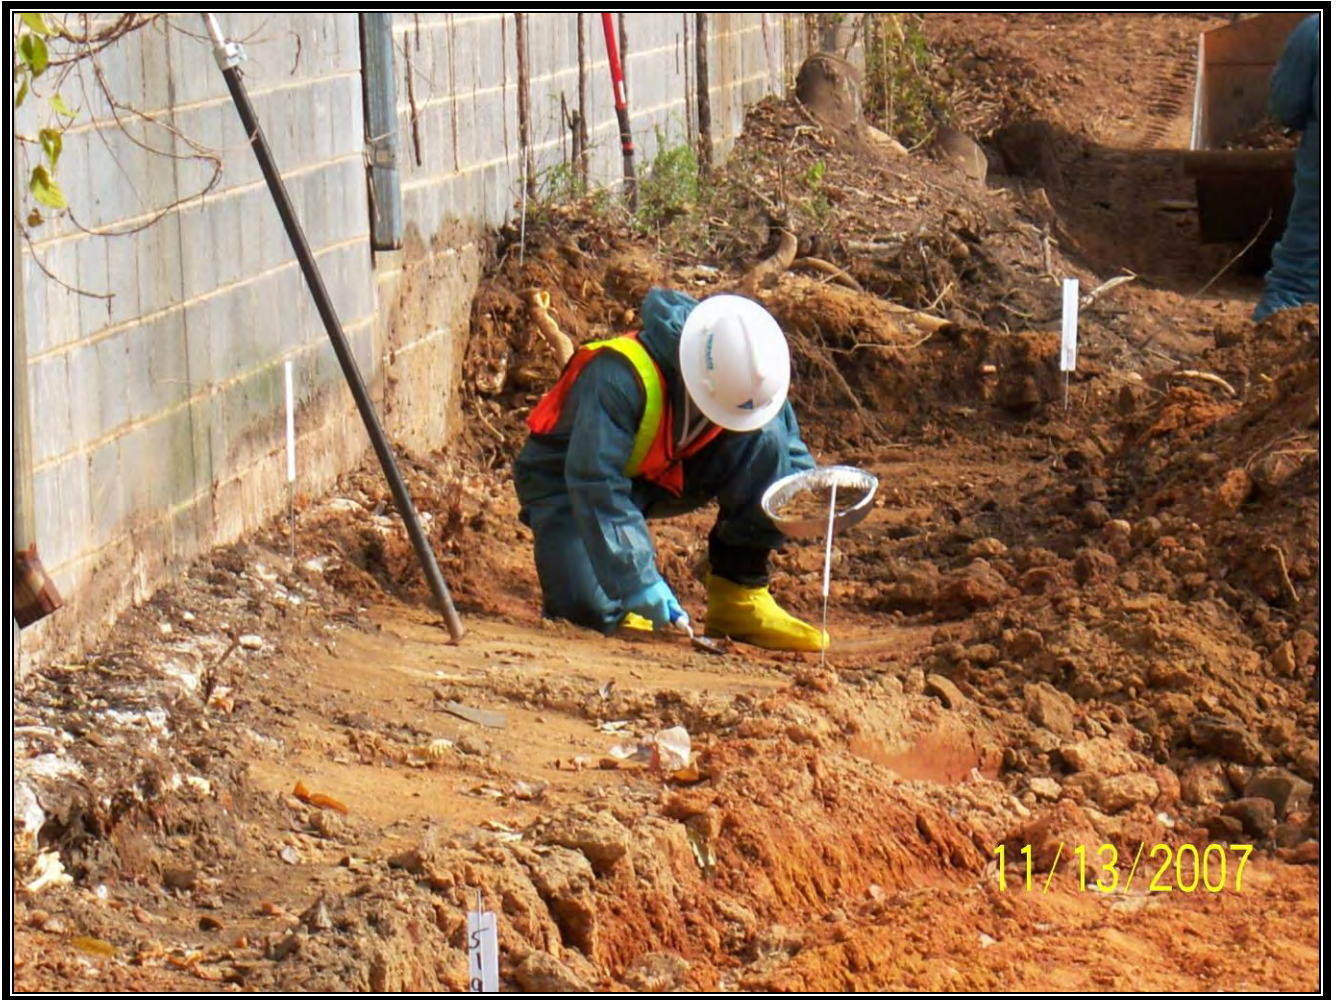
OFFICIAL PHOTOGRAPH NO. 21
U.S. ENVIRONMENTAL PROTECTION AGENCY

TDD Number:	TTEMI-05-001-0039	Location:	Industrial Metal Alloys
Orientation:	East	Date:	November 13, 2007
Photographer:	Brian Malone, Tetra Tech	Witness:	HEPACO
Subject:	HEPACO obtaining five point composite sample from grid H13.

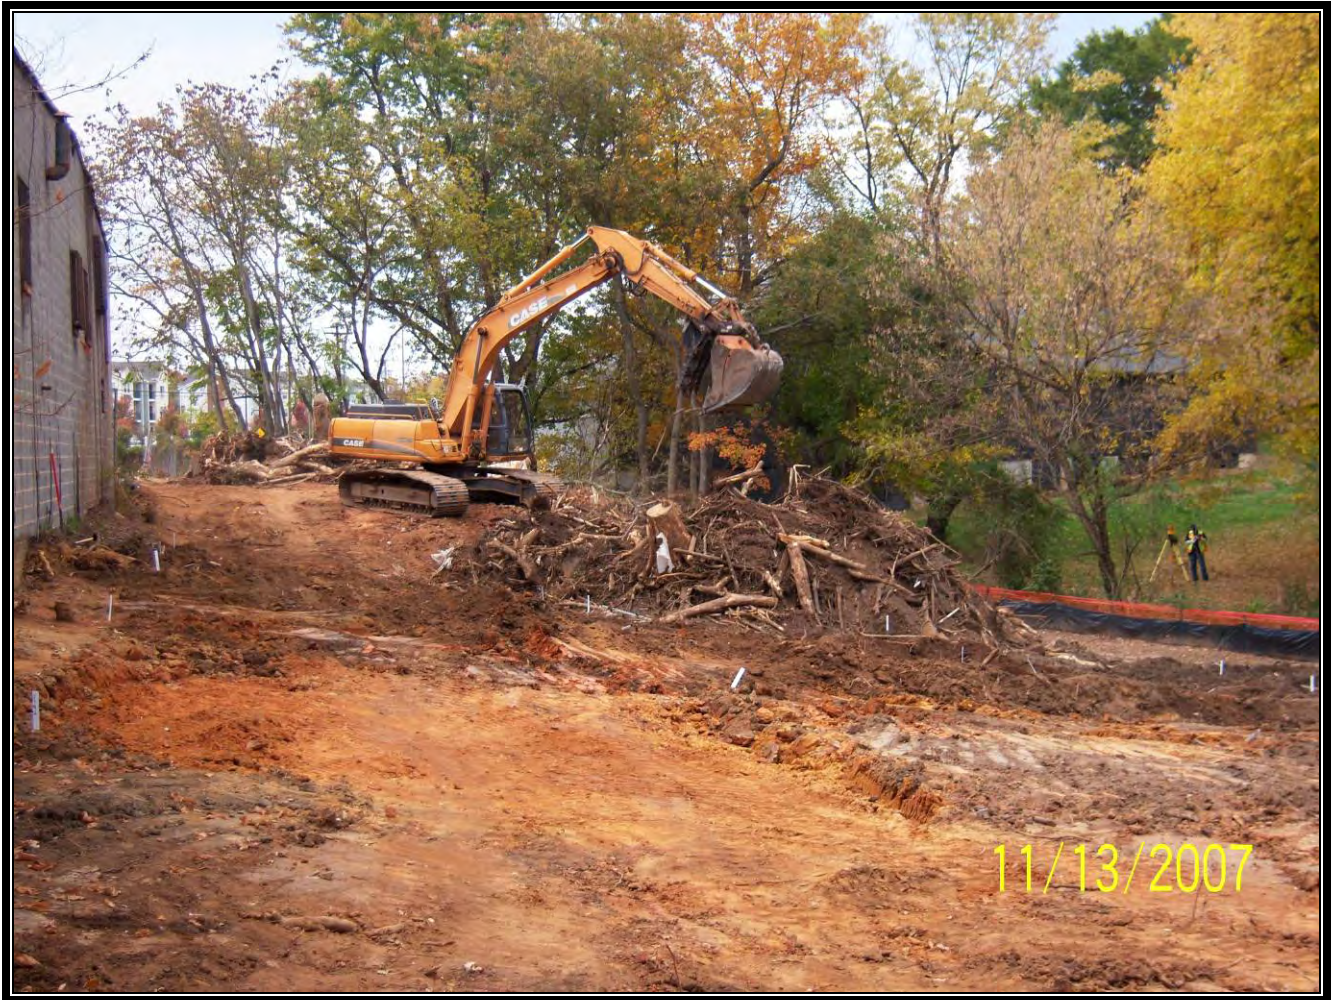
OFFICIAL PHOTOGRAPH NO. 22
U.S. ENVIRONMENTAL PROTECTION AGENCY

TDD Number:	TTEMI-05-001-0039	Location:	Industrial Metal Alloys
Orientation:	East	Date:	November 13, 2007
Photographer:	Brian Malone, Tetra Tech	Witness:	None
Subject:	HEPACO segregating woody debris and soil with excavator.

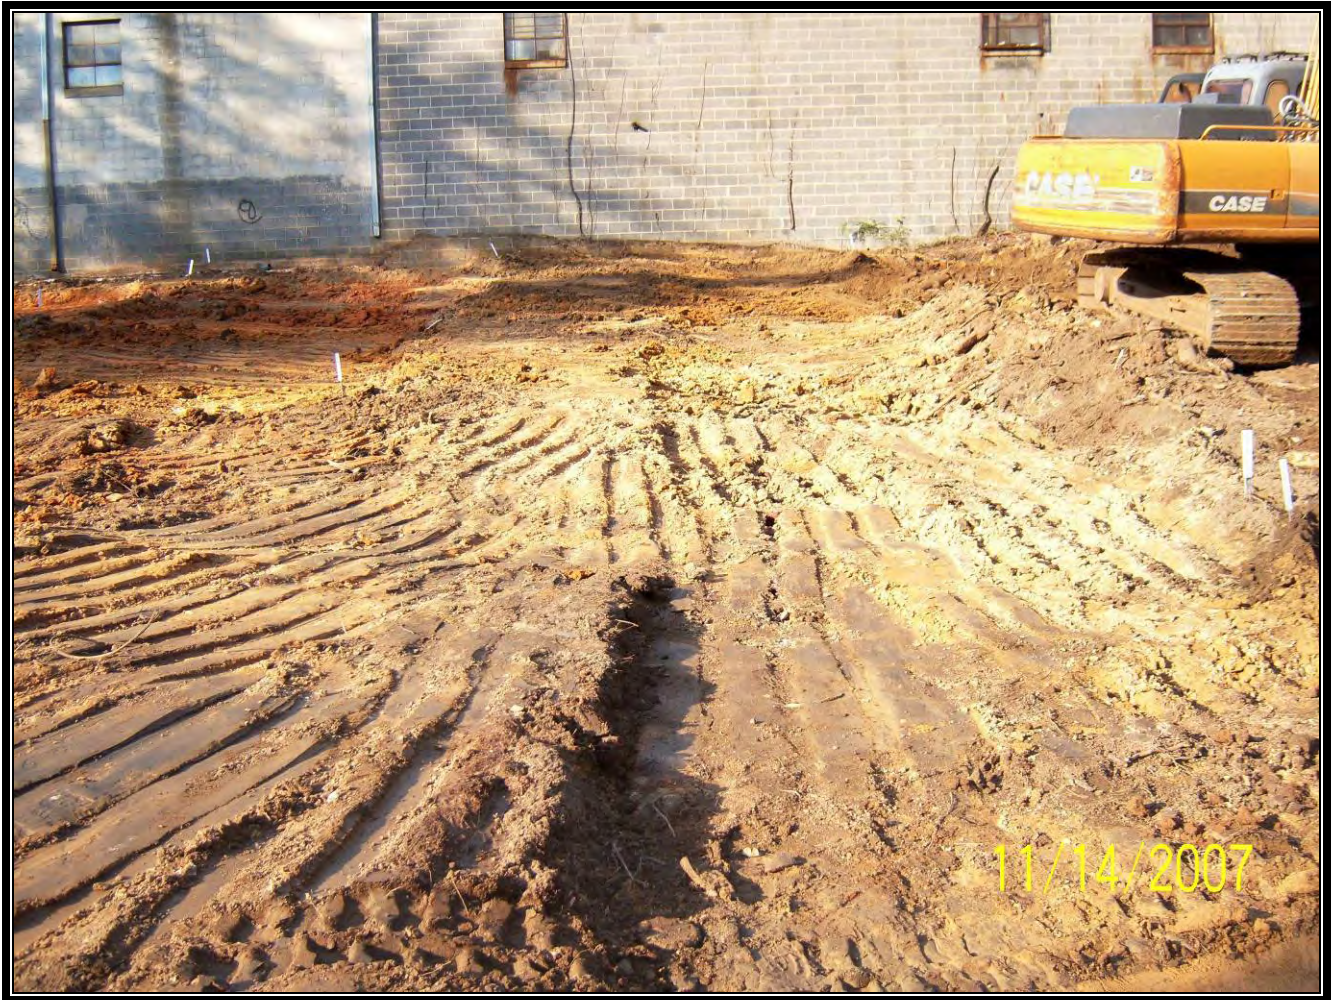
OFFICIAL PHOTOGRAPH NO. 23
U.S. ENVIRONMENTAL PROTECTION AGENCY

TDD Number:	TTEMI-05-001-0039	Location:	Industrial Metal Alloys
Orientation:	North	Date:	November 14, 2007
Photographer:	Brian Malone, Tetra Tech	Witness:	None
Subject:	Extent of excavation in grid row 14. Row was separated into a and b grids with beginning depths of 6 inches and 12 inches respectively.
