**Subject: Final Comprehensive Environmental Response, Compensation, and Liability Act
(CERCLA) Removal Action Report
Industrial Metal Alloys
Winston-Salem, Forsyth County, North Carolina
EPA Contract No. EP-W-05-054
TDD No. TTEMI-05-001-0039**

FINAL
CERCLA REMOVAL ACTION REPORT
INDUSTRIAL METAL ALLOYS
WINSTON-SALEM, FORSYTH COUNTY, NORTH CAROLINA
EPA CONTRACT NO. EP-W-05-054
TDD NO. TTEMI-05-001-0039

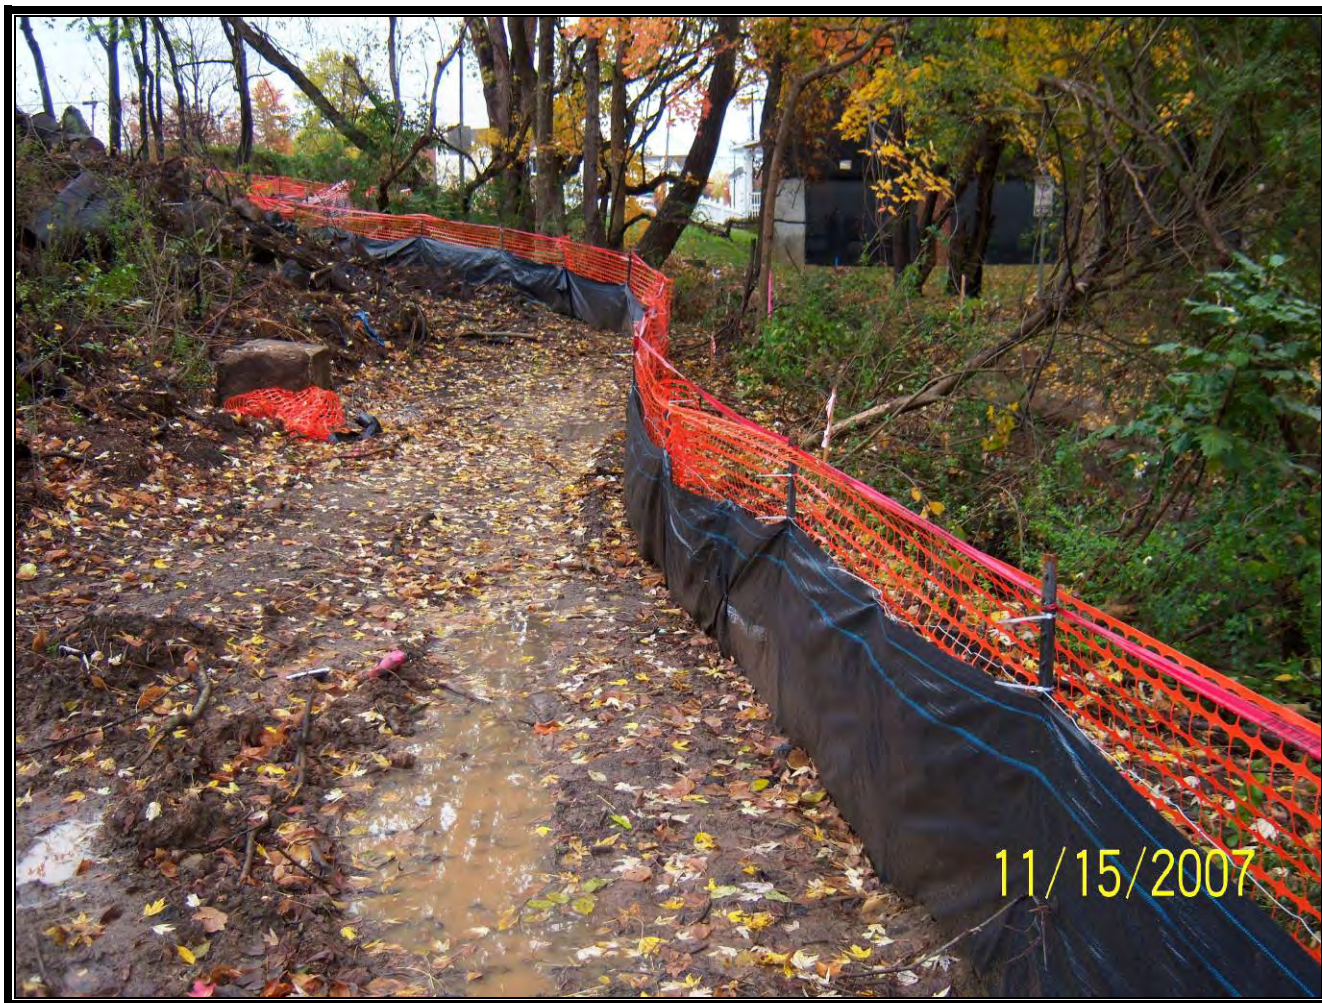
OFFICIAL PHOTOGRAPH NO. 24
U.S. ENVIRONMENTAL PROTECTION AGENCY

TDD Number:	TTEMI-05-001-0039	Location:	Industrial Metal Alloys
Orientation:	East	Date:	November 15, 2007
Photographer:	Brian Malone, Tetra Tech	Witness:	None
Subject:	Silt fence condition during storm event.

0900 START and Hepaco walk the silt fence to check for damage or break through. Fence is in good condition. One area near grid M13. Hepaco conducted repairs. — BM

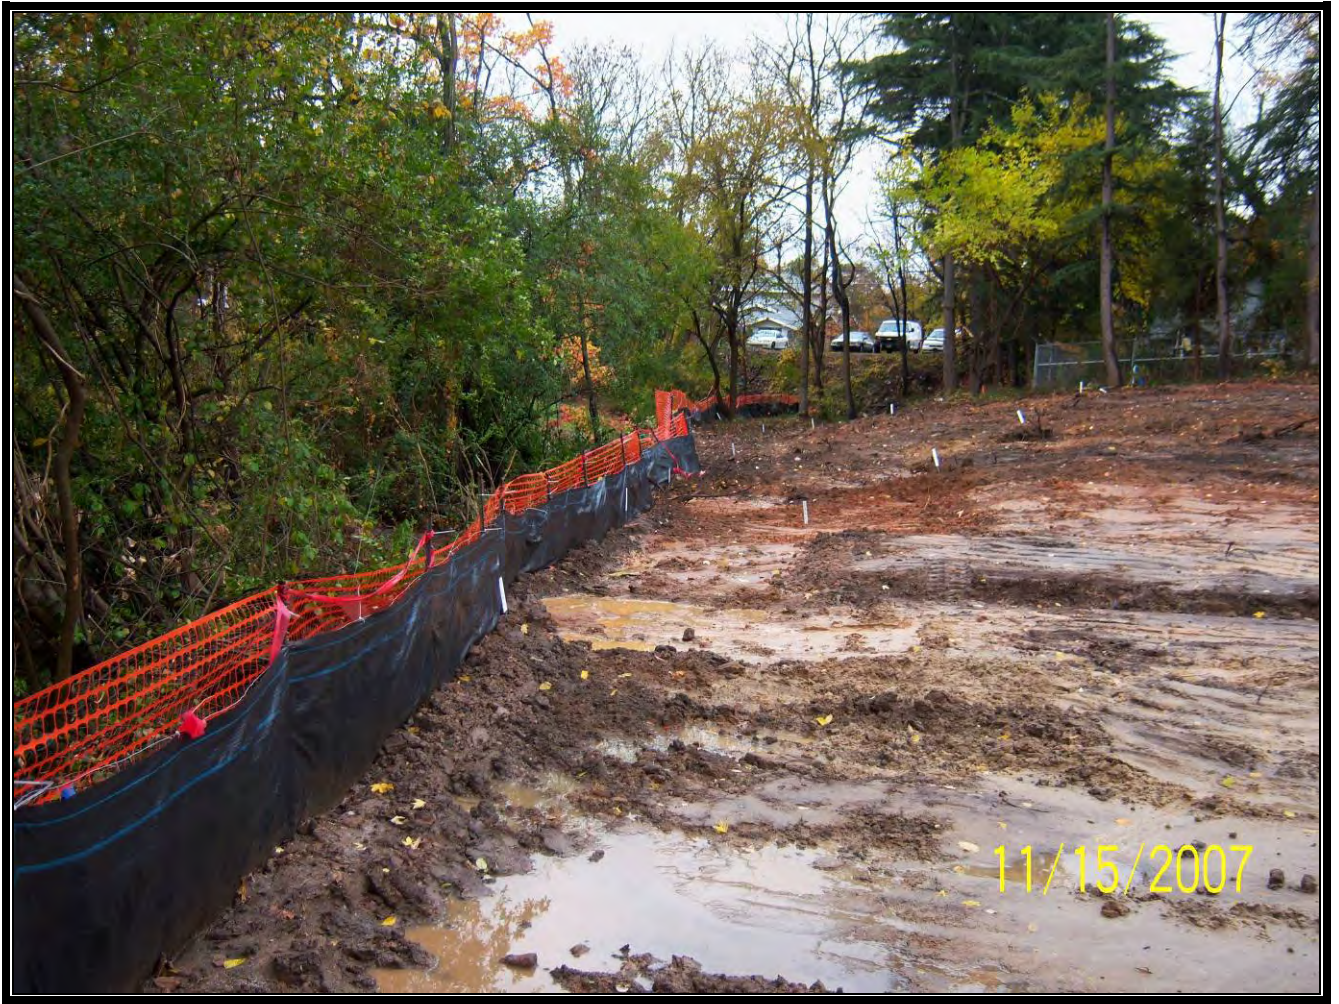
OFFICIAL PHOTOGRAPH NO. 25
U.S. ENVIRONMENTAL PROTECTION AGENCY

TDD Number:	TTEMI-05-001-0039	Location:	Industrial Metal Alloys
Orientation:	West	Date:	November 15, 2007
Photographer:	Brian Malone, Tetra Tech	Witness:	None
Subject:	Silt fence condition during storm event. Small area of breakthrough in foreground.

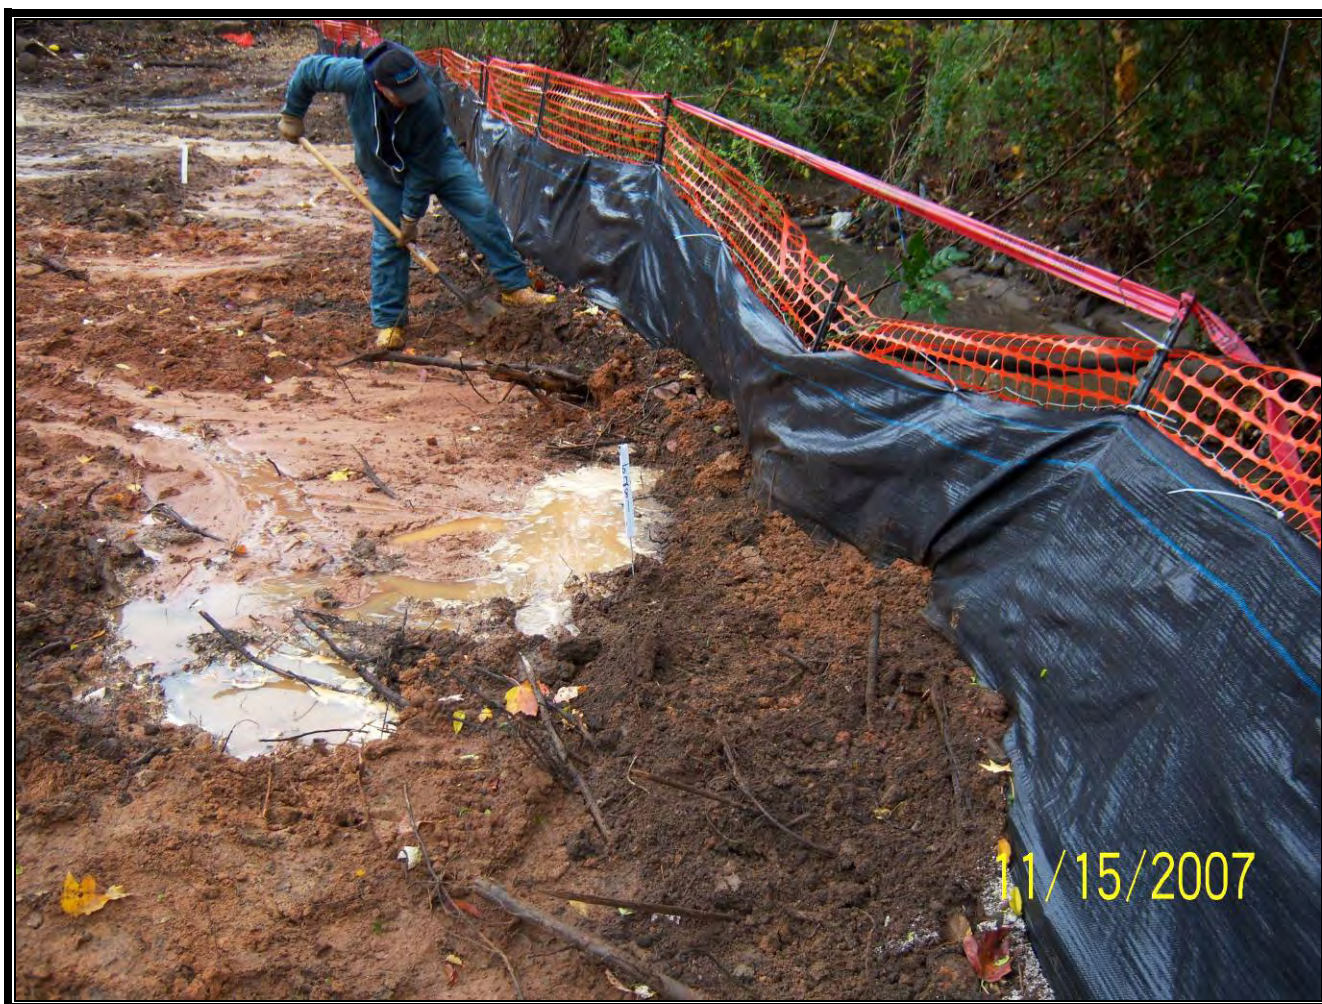
OFFICIAL PHOTOGRAPH NO. 26
U.S. ENVIRONMENTAL PROTECTION AGENCY

Subject: HEPACO repairing the silt fence where breakthrough occurred.

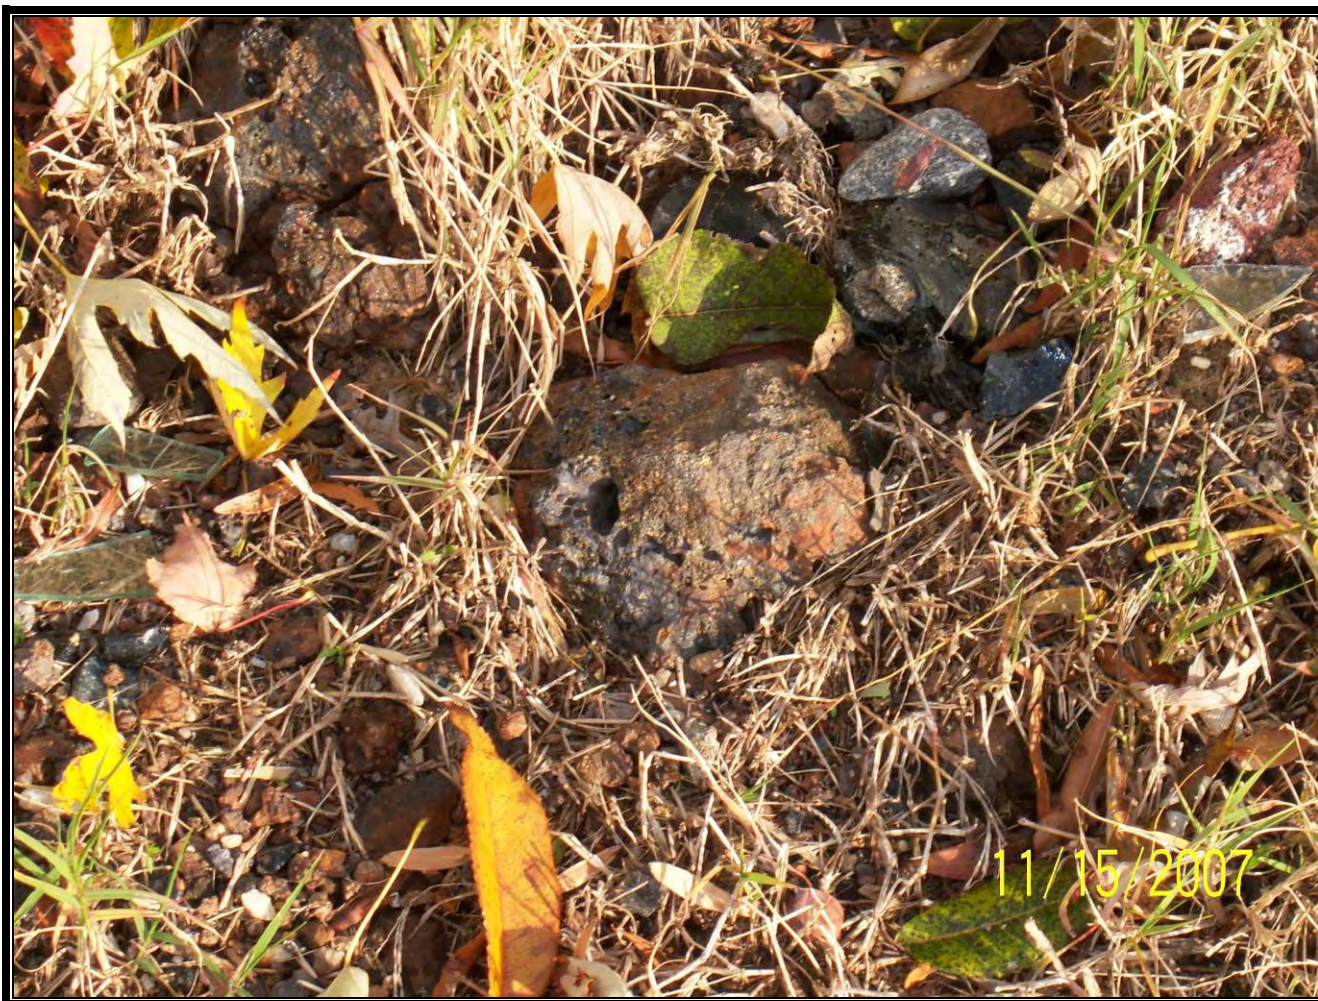
OFFICIAL PHOTOGRAPH NO. 28
U.S. ENVIRONMENTAL PROTECTION AGENCY

TDD Number:	TTEMI-05-001-0039	Location:	Industrial Metal Alloys
Orientation:	East, downward	Date:	November 15, 2007
Photographer:	Brian Malone, Tetra Tech	Witness:	None
Subject:	Slag observed at southwest corner of neighboring GMAC building.

0900 START documented conditions on SW corner GMAC building and south side of building. Visible slag still ordered and photographed. Additional removal will be conducted. — BM

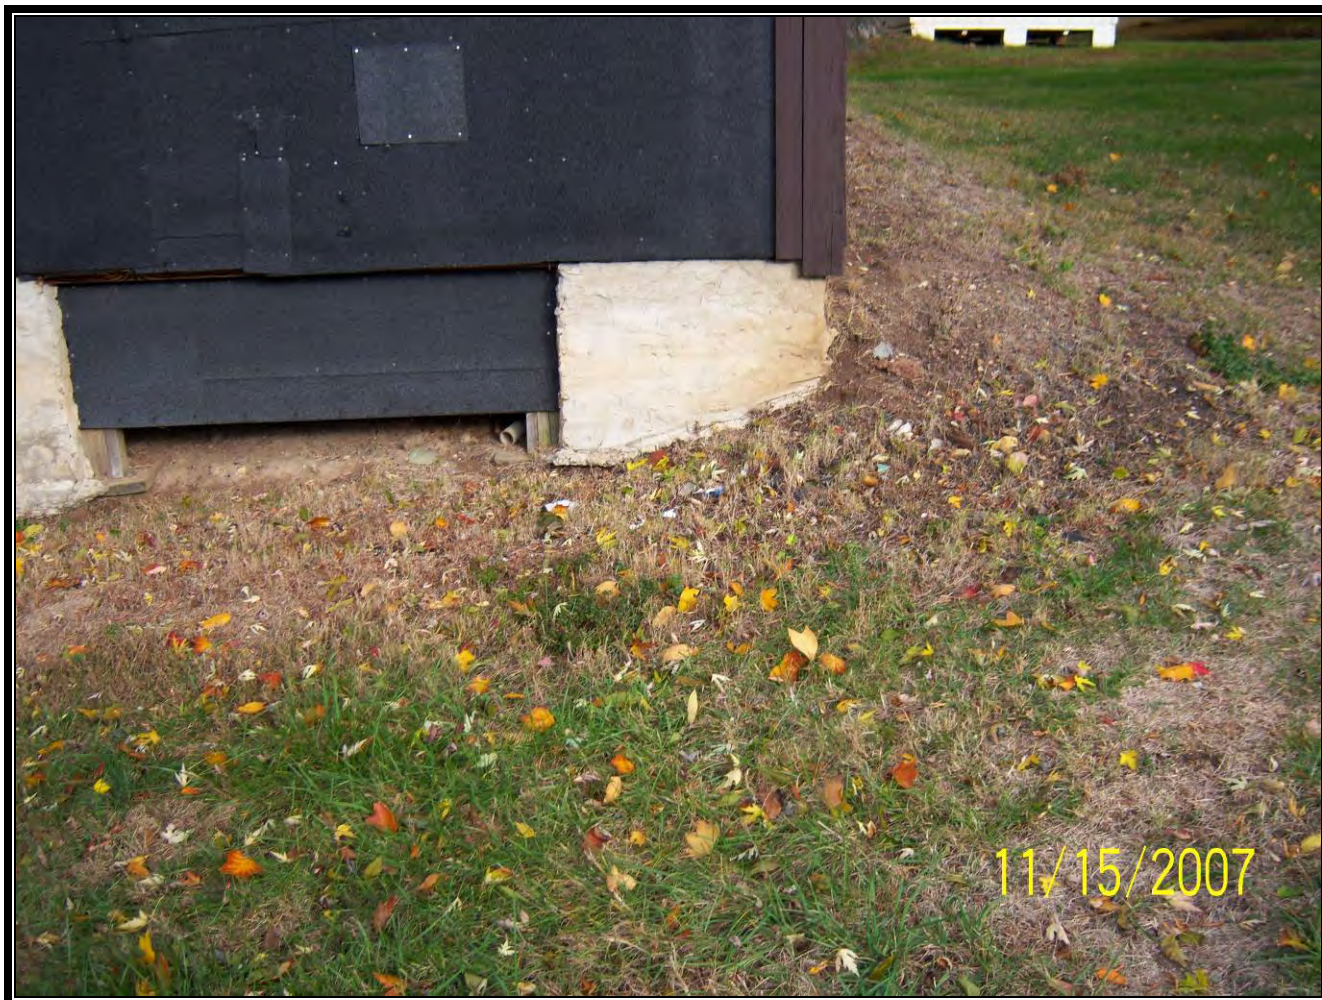
OFFICIAL PHOTOGRAPH NO. 29
U.S. ENVIRONMENTAL PROTECTION AGENCY

TDD Number:	TTEMI-05-001-0039	Location:	Industrial Metal Alloys
Orientation:	West	Date:	November 15, 2007
Photographer:	Brian Malone, Tetra Tech	Witness:	None
Subject:	Location of visible slag along the south side and southwest corner of the GMAC building.

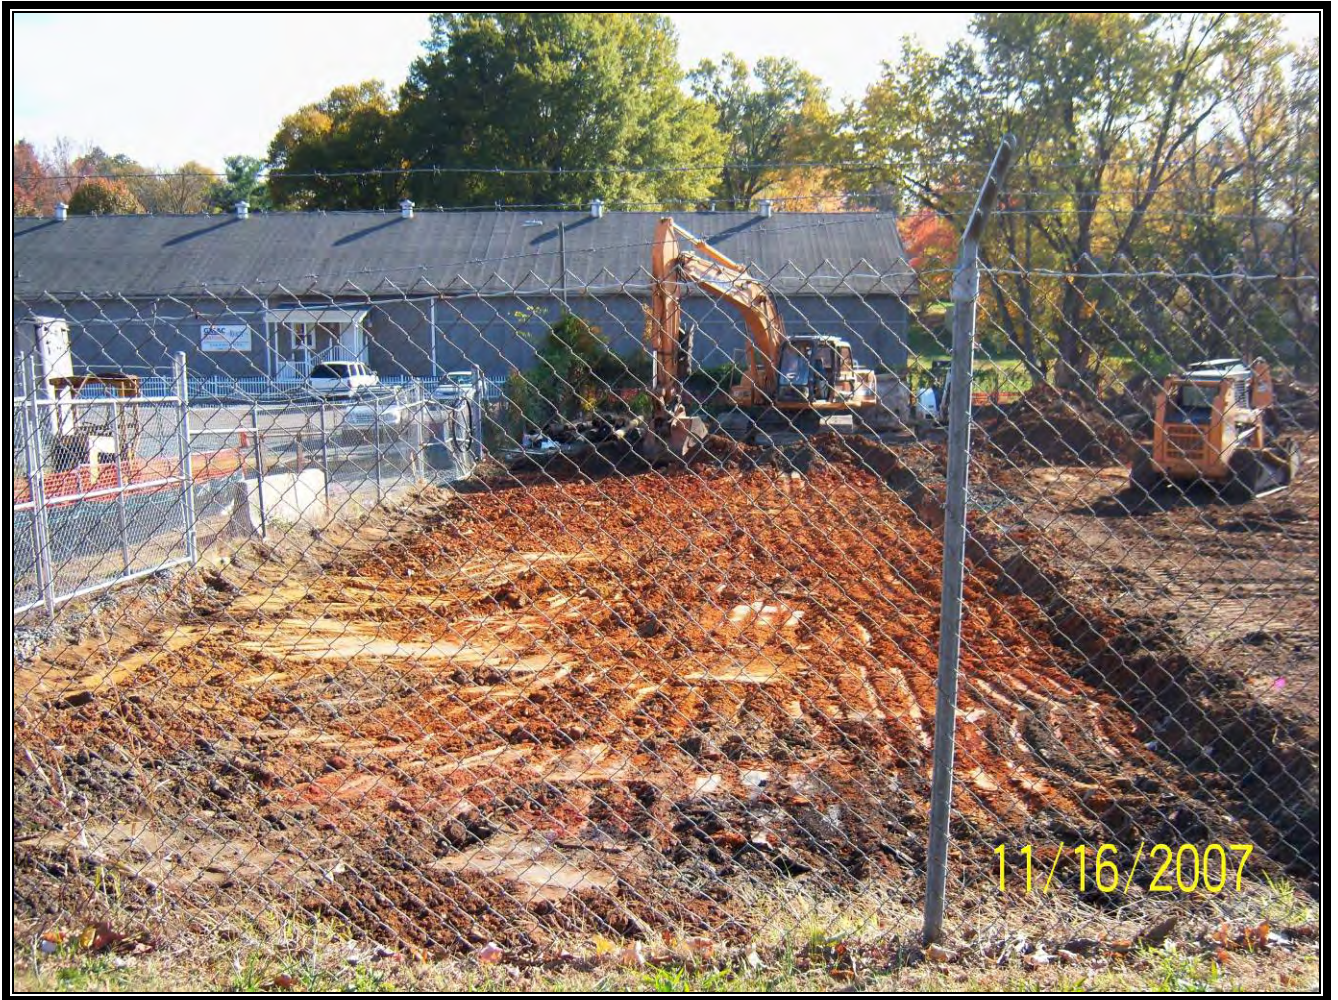
OFFICIAL PHOTOGRAPH NO. 30
U.S. ENVIRONMENTAL PROTECTION AGENCY

TDD Number:	TTEMI-05-001-0039	Location:	Industrial Metal Alloys
Orientation:	South	Date:	November 16, 2007
Photographer:	Brian Malone, Tetra Tech	Witness:	None
Subject:	Initial excavation of grid rows 24 and 25.

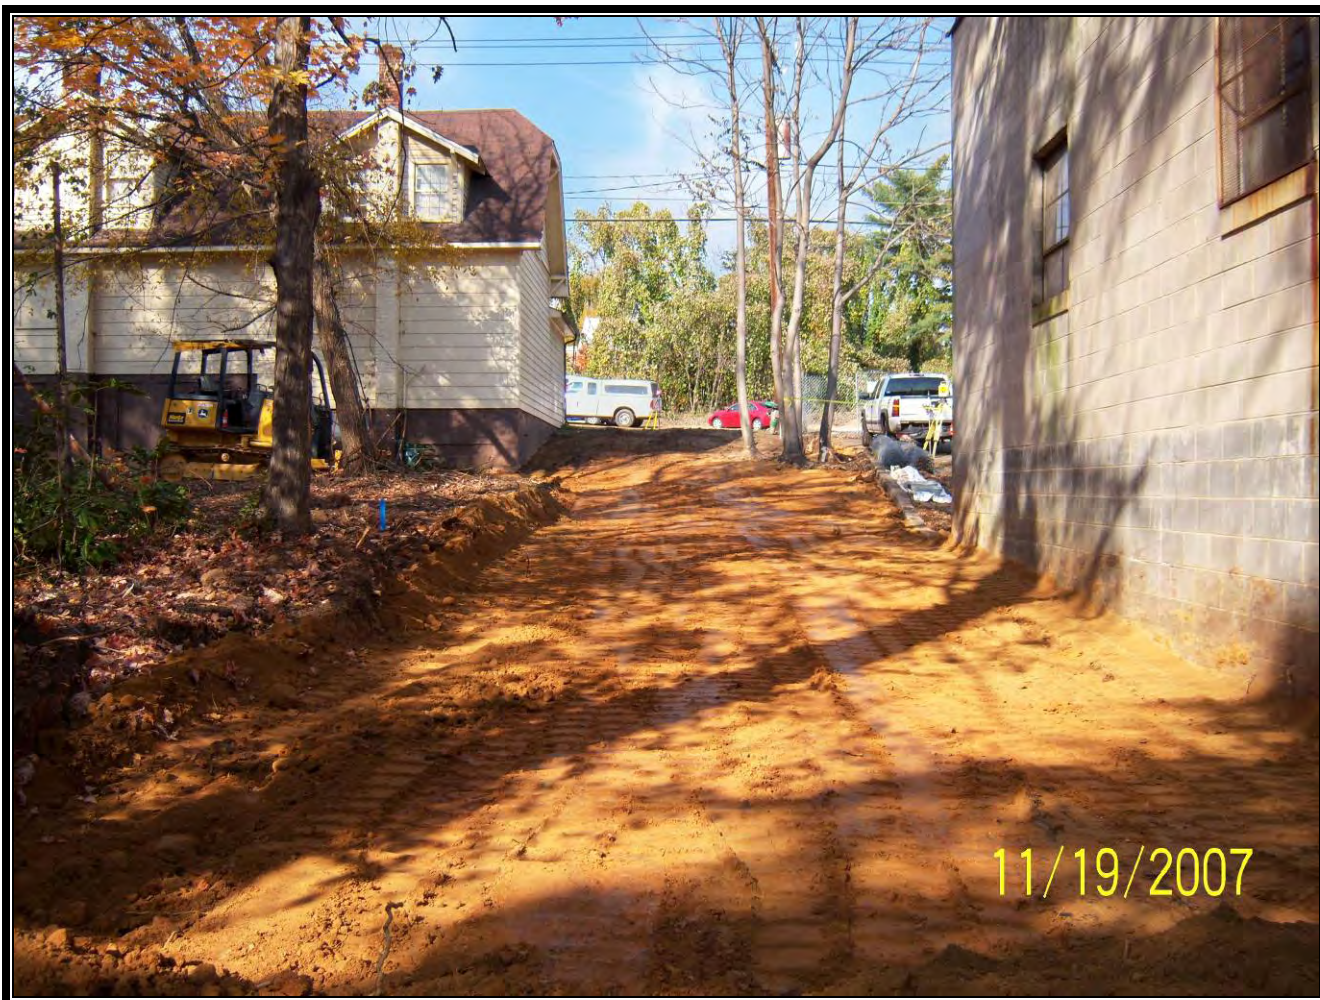
OFFICIAL PHOTOGRAPH NO. 31
U.S. ENVIRONMENTAL PROTECTION AGENCY

TDD Number:	TTEMI-05-001-0039	Location:	Industrial Metal Alloys
Orientation:	North	Date:	November 19, 2007
Photographer:	Brian Malone, Tetra Tech	Witness:	None
Subject:	Initial lifts of backfill placed in grid row 9.

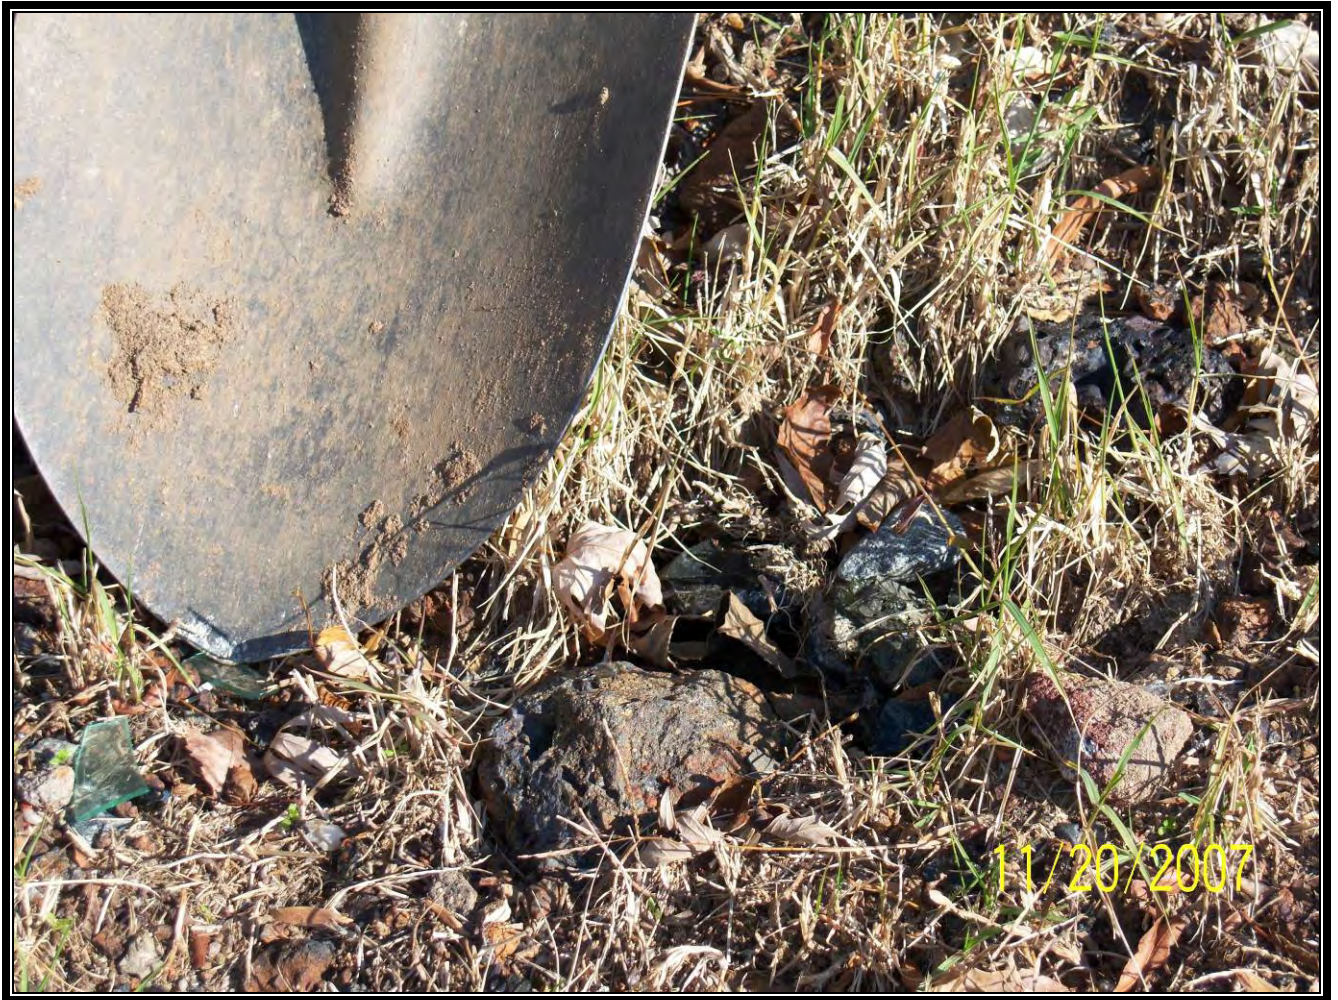
OFFICIAL PHOTOGRAPH NO. 32
U.S. ENVIRONMENTAL PROTECTION AGENCY

TDD Number:	TTEMI-05-001-0039	Location:	Industrial Metal Alloys
Orientation:	West, downward	Date:	November 20, 2007
Photographer:	Brian Malone, Tetra Tech	Witness:	None
Subject:	Pieces of slag observed at southwest corner of neighboring GMAC building.

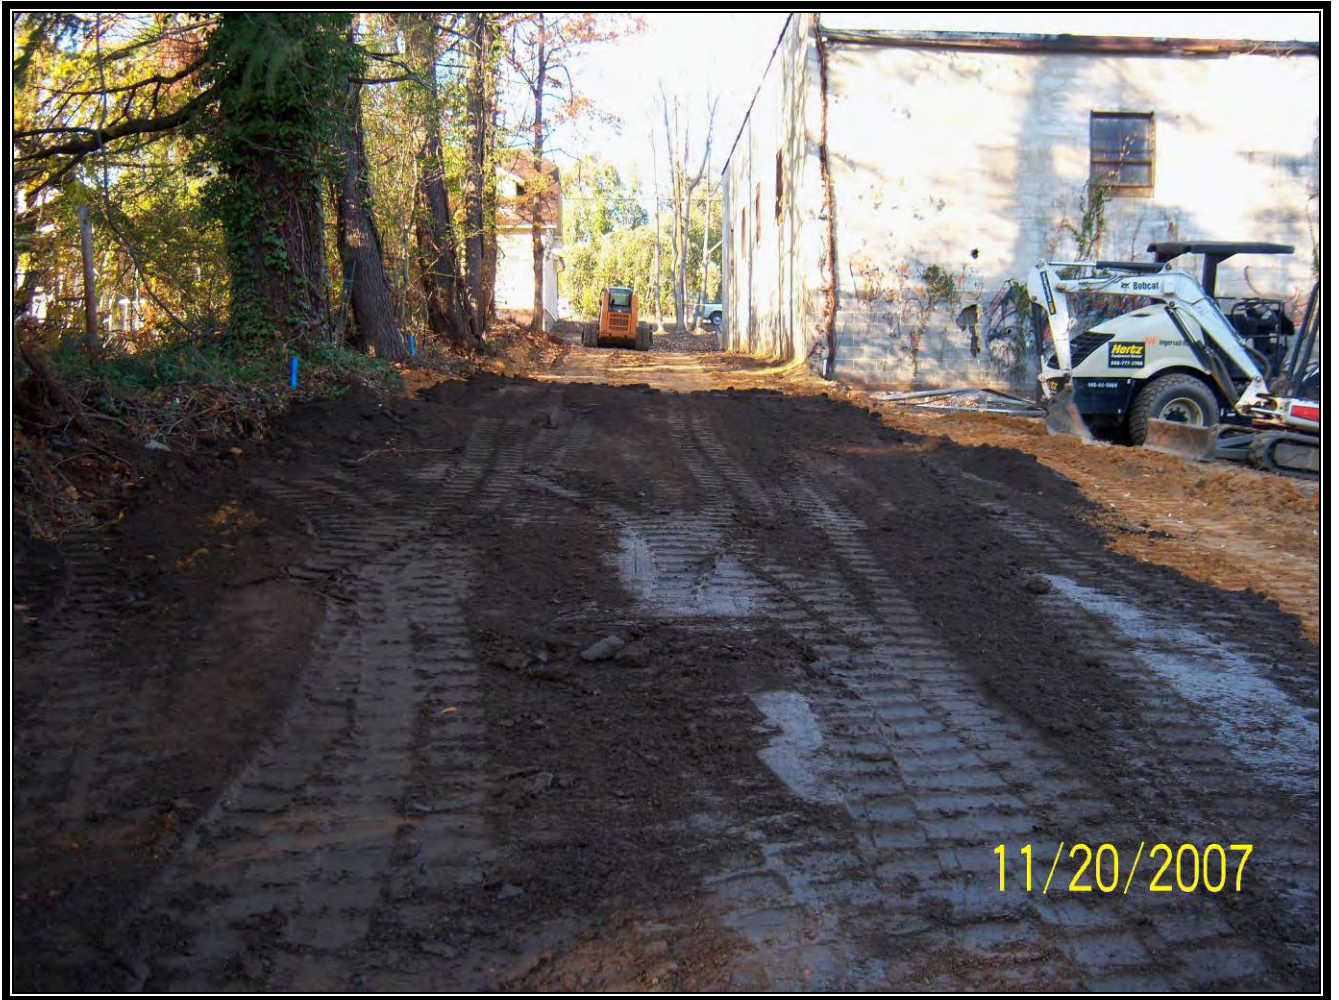
OFFICIAL PHOTOGRAPH NO. 35
U.S. ENVIRONMENTAL PROTECTION AGENCY

TDD Number:	TTEMI-05-001-0039	Location:	Industrial Metal Alloys
Orientation:	North	Date:	November 20, 2007
Photographer:	Brian Malone, Tetra Tech	Witness:	None
Subject:	Completed compaction of backfill material in grid row 9, prior to placement of topsoil

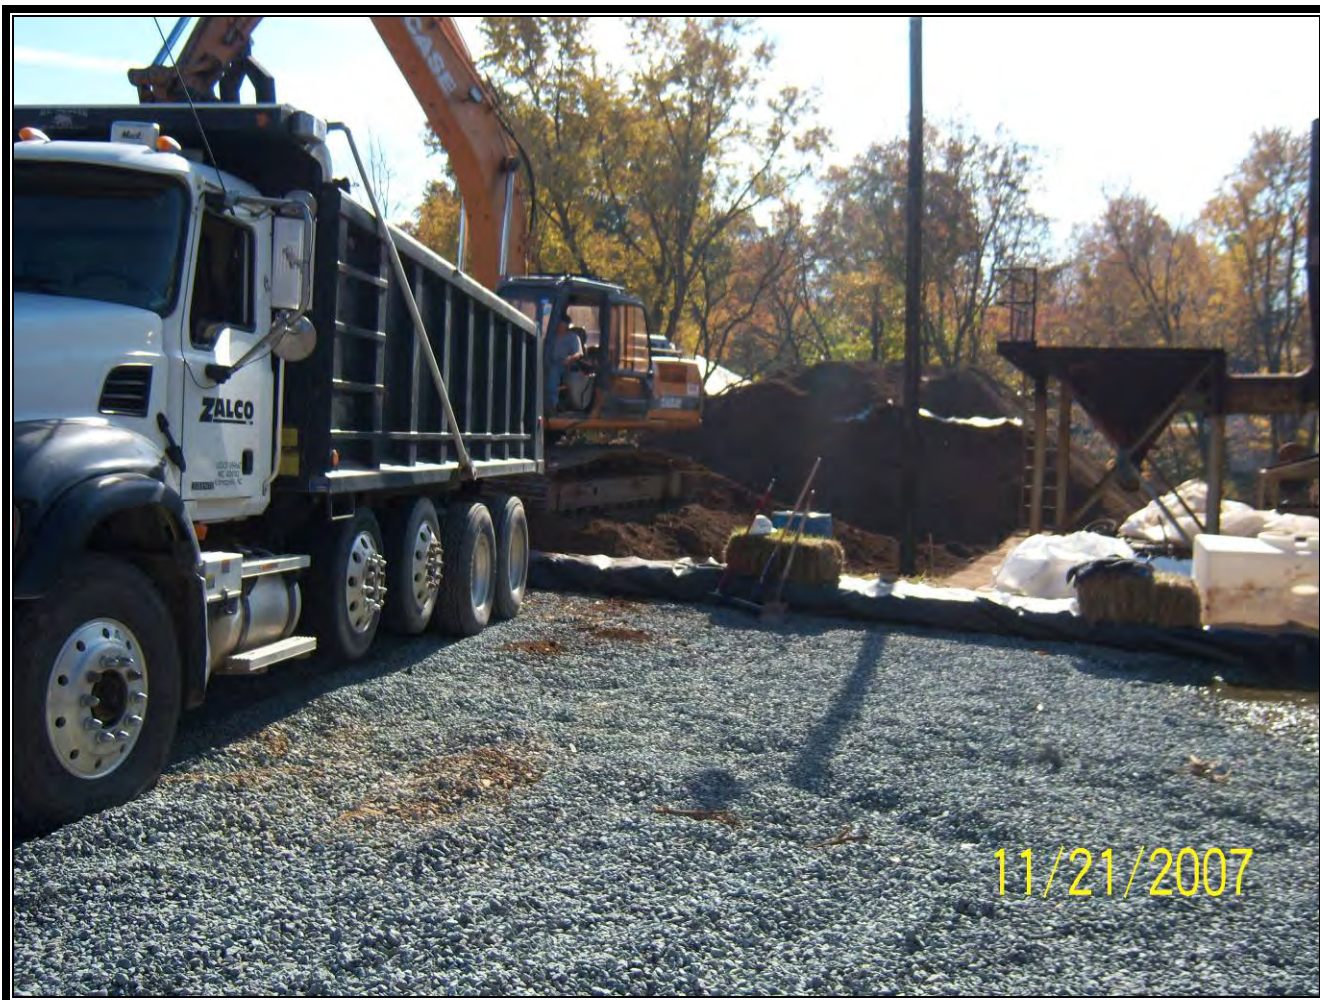
OFFICIAL PHOTOGRAPH NO. 36
U.S. ENVIRONMENTAL PROTECTION AGENCY

Subject: Loading of stockpile material for transport to disposal facility.

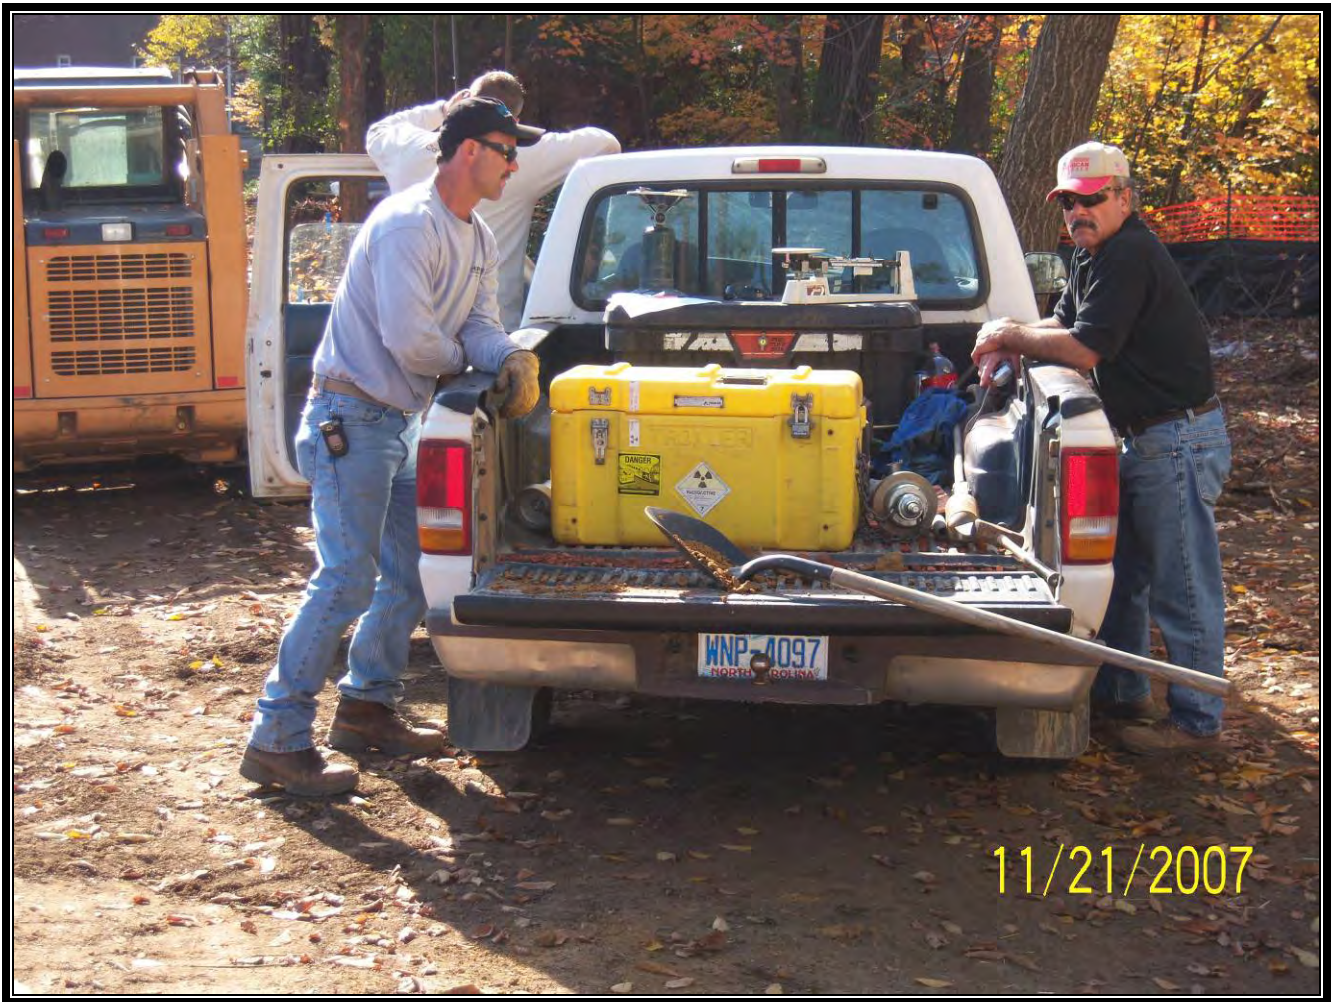
OFFICIAL PHOTOGRAPH NO. 37
U.S. ENVIRONMENTAL PROTECTION AGENCY

Subject: Geo-technical representative at Site to conduct testing to determine moisture density proctor value and conduct compaction testing with Troxler nuclear gauge.

completed. Compaction to 95% proctor value required for excavation replacement beyond 6" bgs. ———— BM

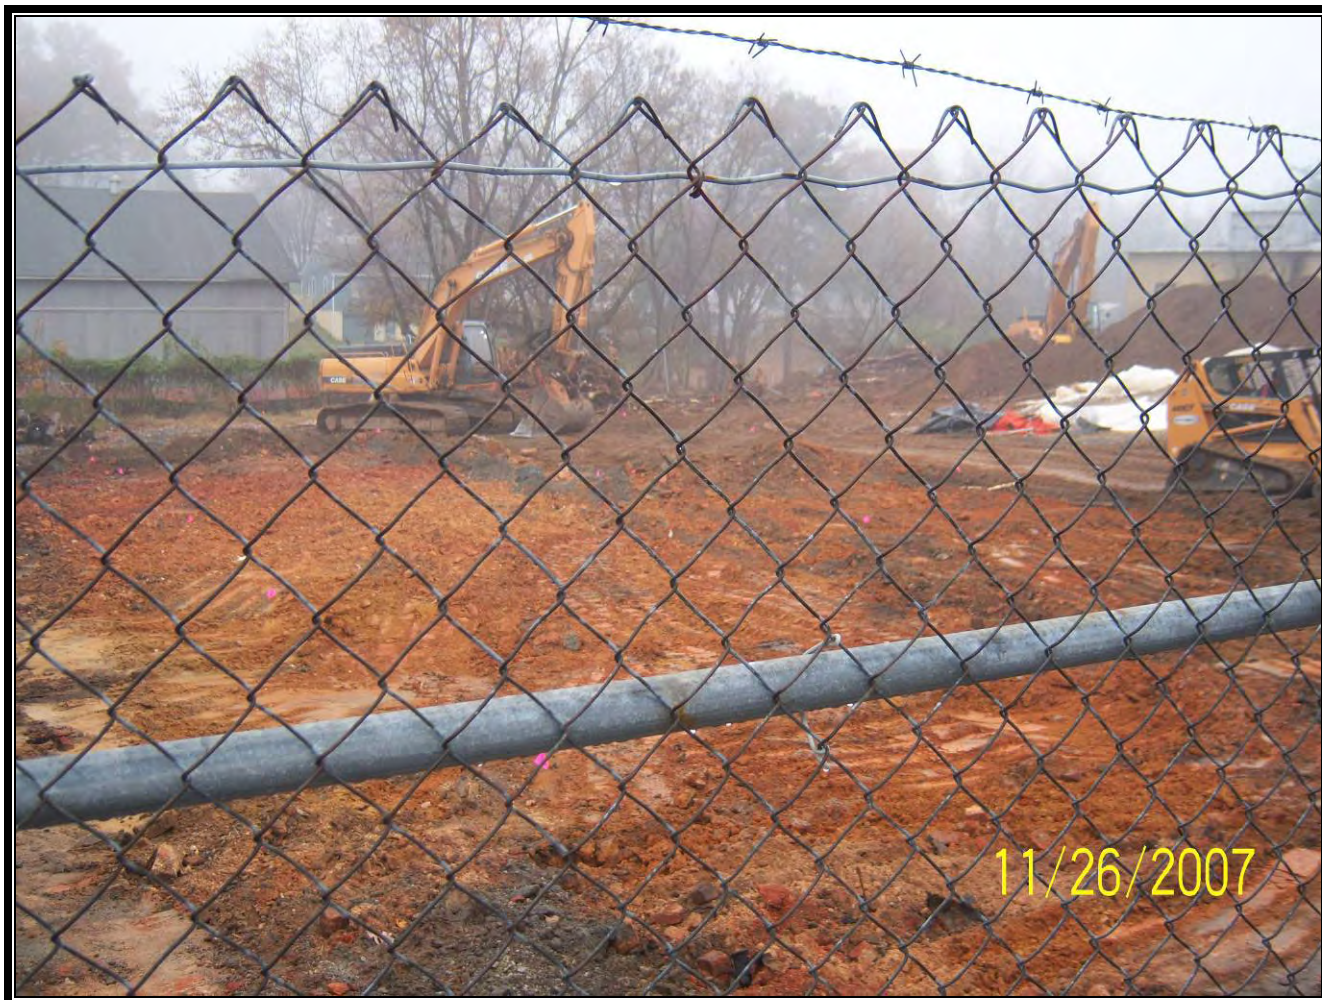
OFFICIAL PHOTOGRAPH NO. 38
U.S. ENVIRONMENTAL PROTECTION AGENCY

TDD Number:	TTEMI-05-001-0039	Location:	Industrial Metal Alloys
Orientation:	South	Date:	November 26, 2007
Photographer:	Brian Malone, Tetra Tech	Witness:	None
Subject:	Extent of excavation in the northeast portion of the site.

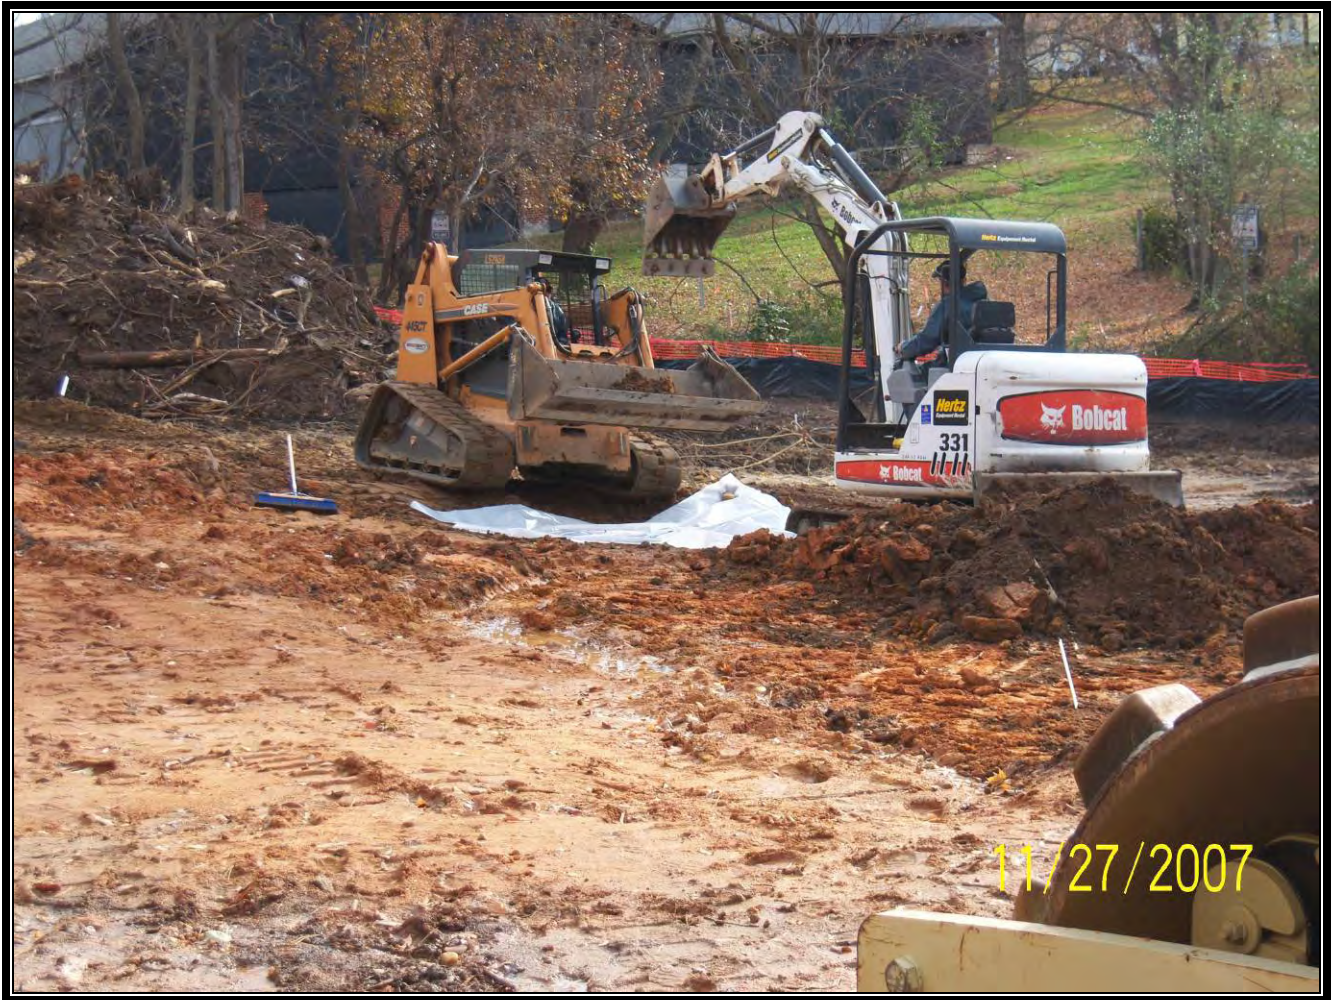
OFFICIAL PHOTOGRAPH NO. 39
U.S. ENVIRONMENTAL PROTECTION AGENCY

TDD Number:	TTEMI-05-001-0039	Location:	Industrial Metal Alloys
Orientation:	West	Date:	November 27, 2007
Photographer:	Brian Malone, Tetra Tech	Witness:	None
Subject:	HEPACO conducting additional excavation of grid J12 due to analytical results above the SSCS.

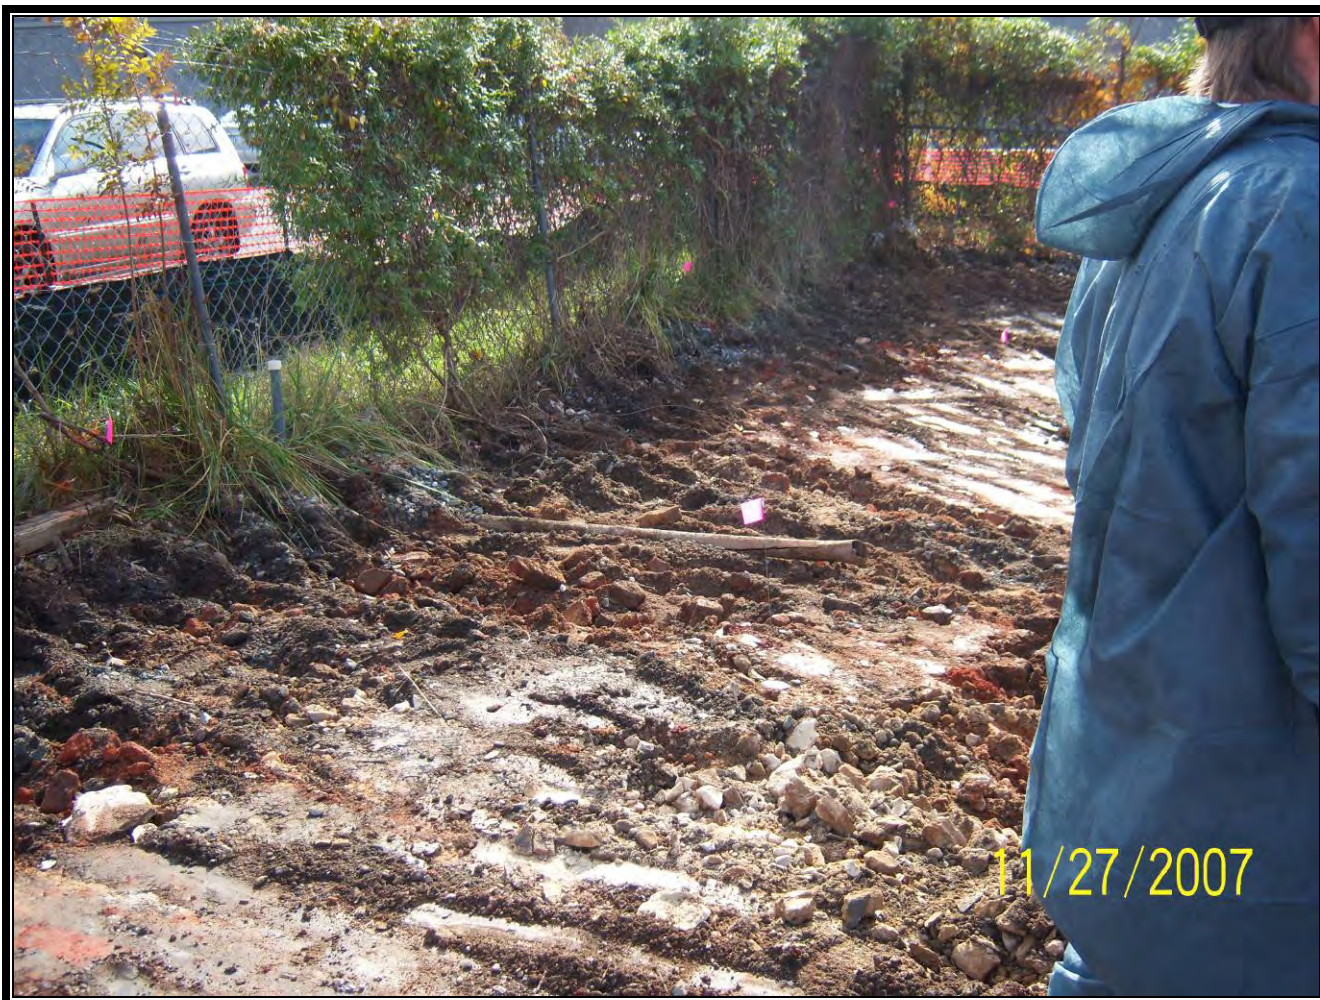
OFFICIAL PHOTOGRAPH NO. 40
U.S. ENVIRONMENTAL PROTECTION AGENCY

TDD Number:	TTEMI-05-001-0039	Location:	Industrial Metal Alloys
Orientation:	South	Date:	November 27, 2007
Photographer:	Brian Malone, Tetra Tech	Witness:	HEPACO
Subject:	Pipe observed running east and west in the Colter storage yard.

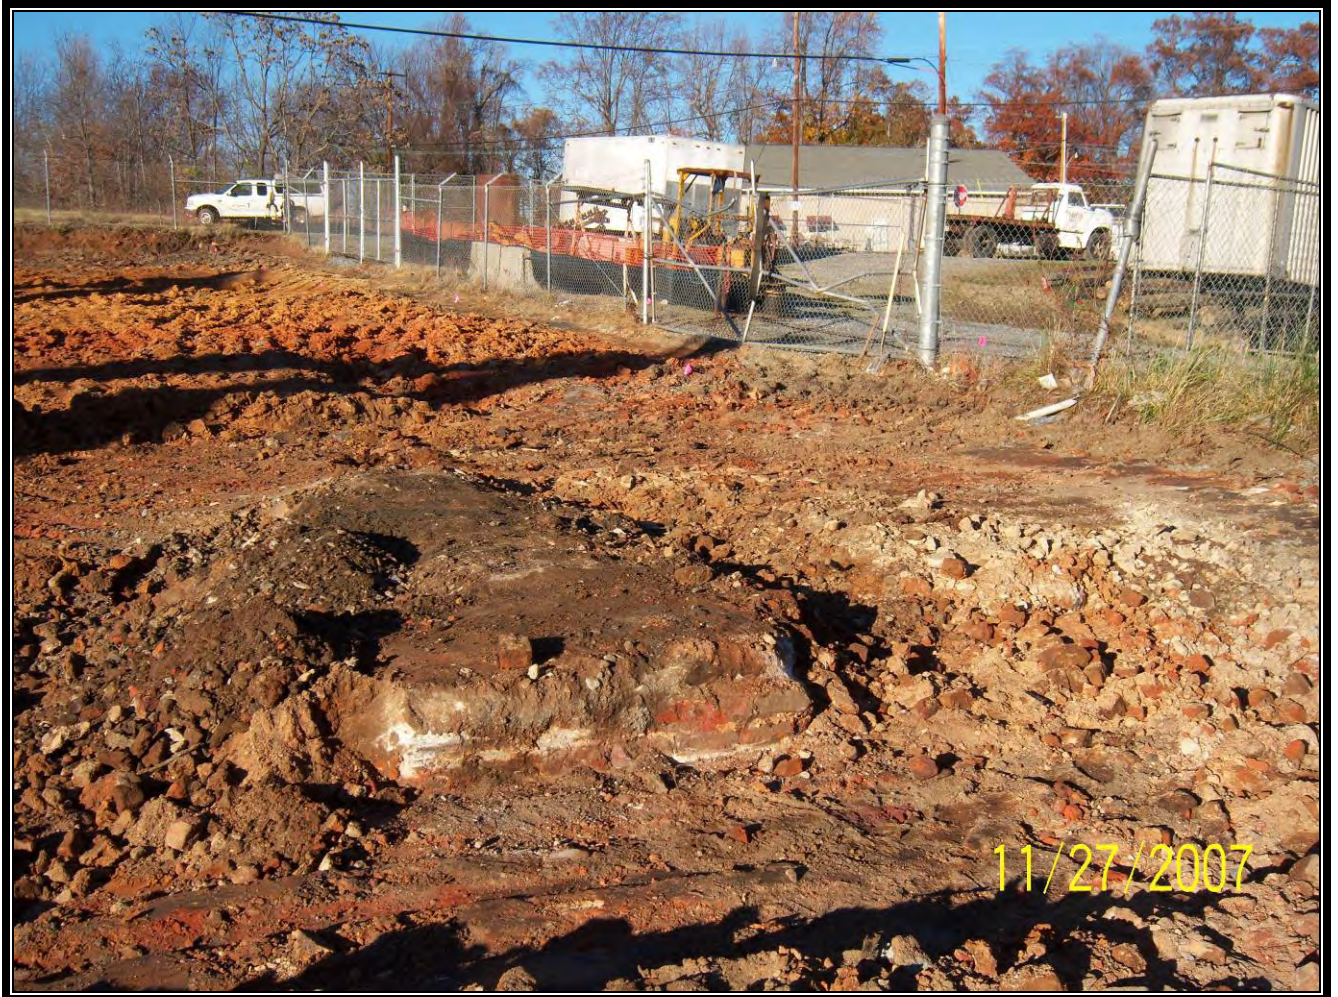
OFFICIAL PHOTOGRAPH NO. 42
U.S. ENVIRONMENTAL PROTECTION AGENCY

1100 Contacted by Hepaco excavator. In areas of G24 & J25 excavation uncovered soil with solvent like odor. START investigated area and identified two concrete structures and numerous steel lines similar to product lines in the area. Odor was strong in area of excavation. Area was evaluated and excavator moved to area of grid A23. Contacted OEC Analyser to discuss findings and recommended contacting property owner and getting A23/F10 onsite to conduct H&S level screening at a minimum.

TDD Number:	TTEMI-05-001-0039	Location:	Industrial Metal Alloys
Orientation:	North	Date:	November 27, 2007
Photographer:	Brian Malone, Tetra Tech	Witness:	None
Subject:	Concrete and brick below ground structure similar to small building footer and slab were uncovered during the excavation of grid G24/25 and F24/25.

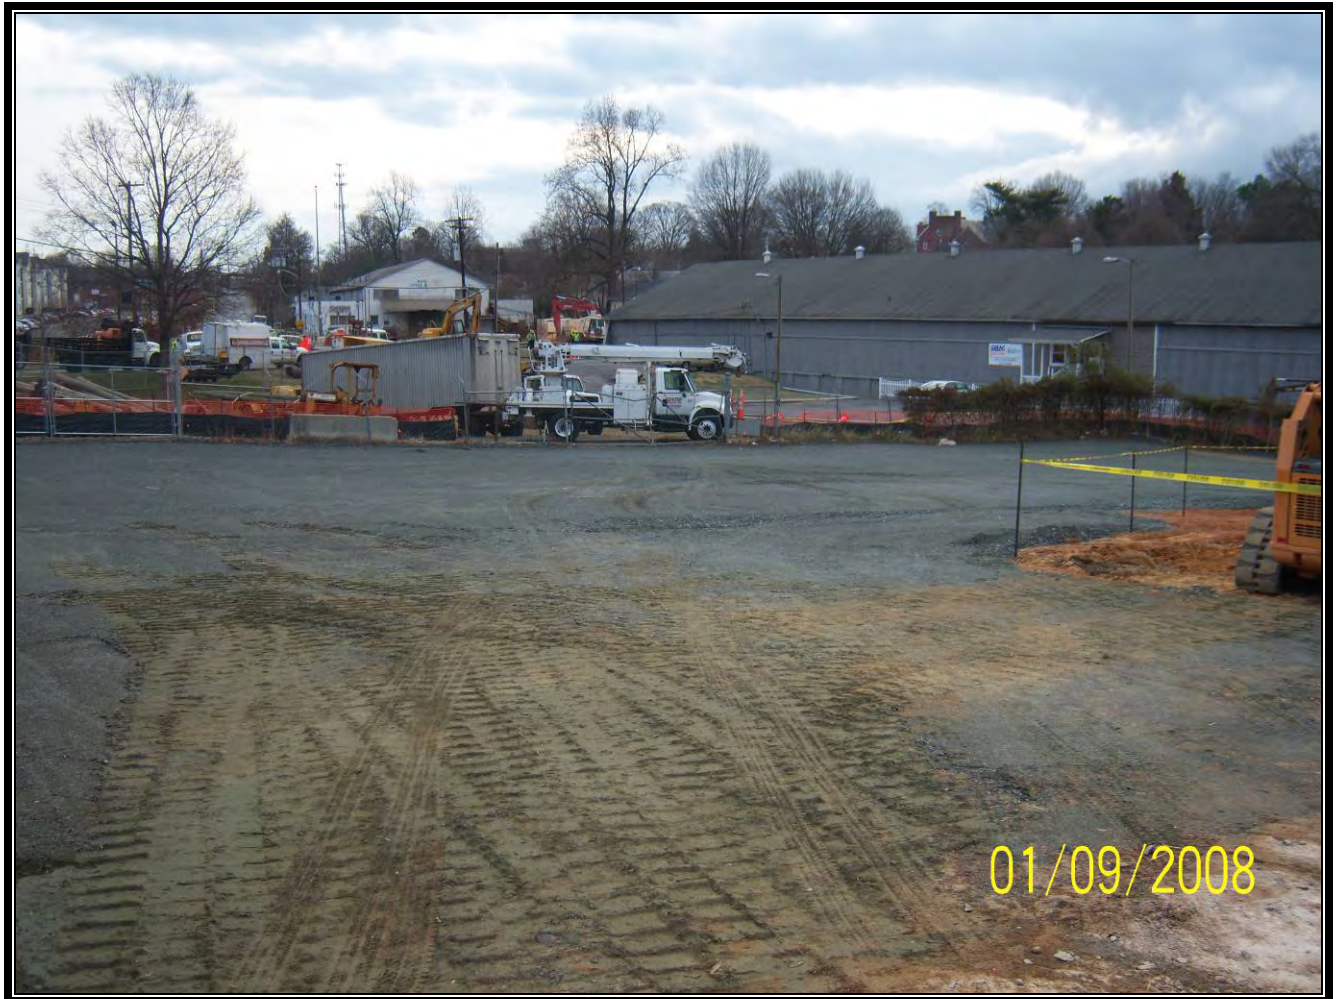
OFFICIAL PHOTOGRAPH NO. 45
U.S. ENVIRONMENTAL PROTECTION AGENCY

TDD Number: TTEMI-05-001-0039 **Location:** Industrial Metal Alloys
Orientation: East **Date:** January 9, 2008
Photographer: Brian Malone, Tetra Tech **Witness:** None
Subject: Completed backfill and compaction of grid rows 25, 24 and portions of 23 and 22.
