**Subject: Final Comprehensive Environmental Response, Compensation, and Liability Act
(CERCLA) Removal Action Report
Industrial Metal Alloys
Winston-Salem, Forsyth County, North Carolina
EPA Contract No. EP-W-05-054
TDD No. TTEMI-05-001-0039**

FINAL
CERCLA REMOVAL ACTION REPORT
INDUSTRIAL METAL ALLOYS
WINSTON-SALEM, FORSYTH COUNTY, NORTH CAROLINA
EPA CONTRACT NO. EP-W-05-054
TDD NO. TTEMI-05-001-0039

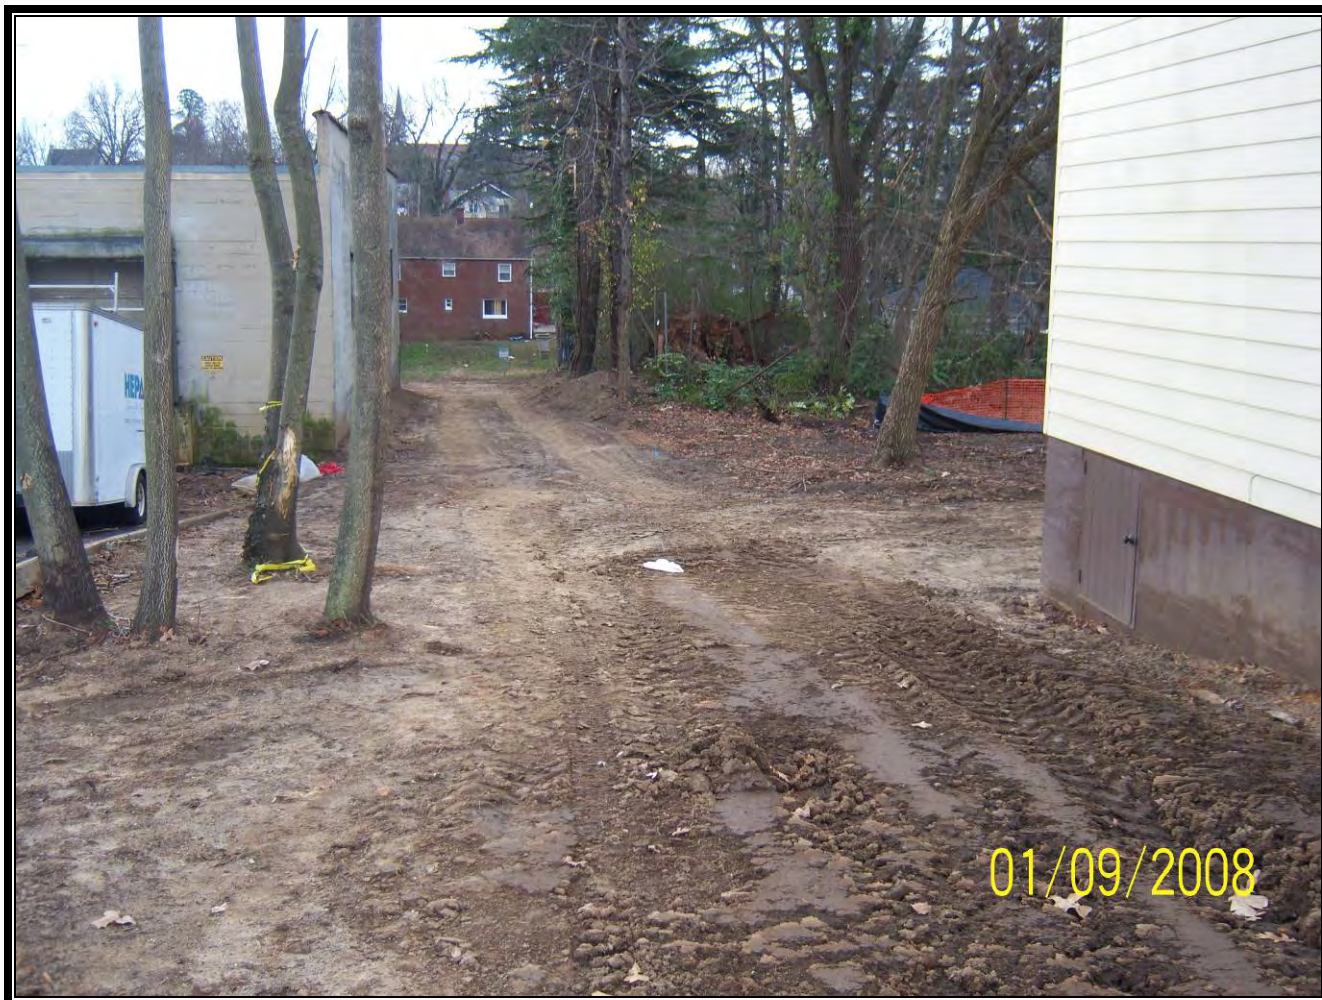
OFFICIAL PHOTOGRAPH NO. 46
U.S. ENVIRONMENTAL PROTECTION AGENCY

TDD Number:	TTEMI-05-001-0039	Location:	Industrial Metal Alloys
Orientation:	South	Date:	January 9, 2008
Photographer:	Brian Malone, Tetra Tech	Witness:	None
Subject:	Topsoil placement completed in grid row 9.

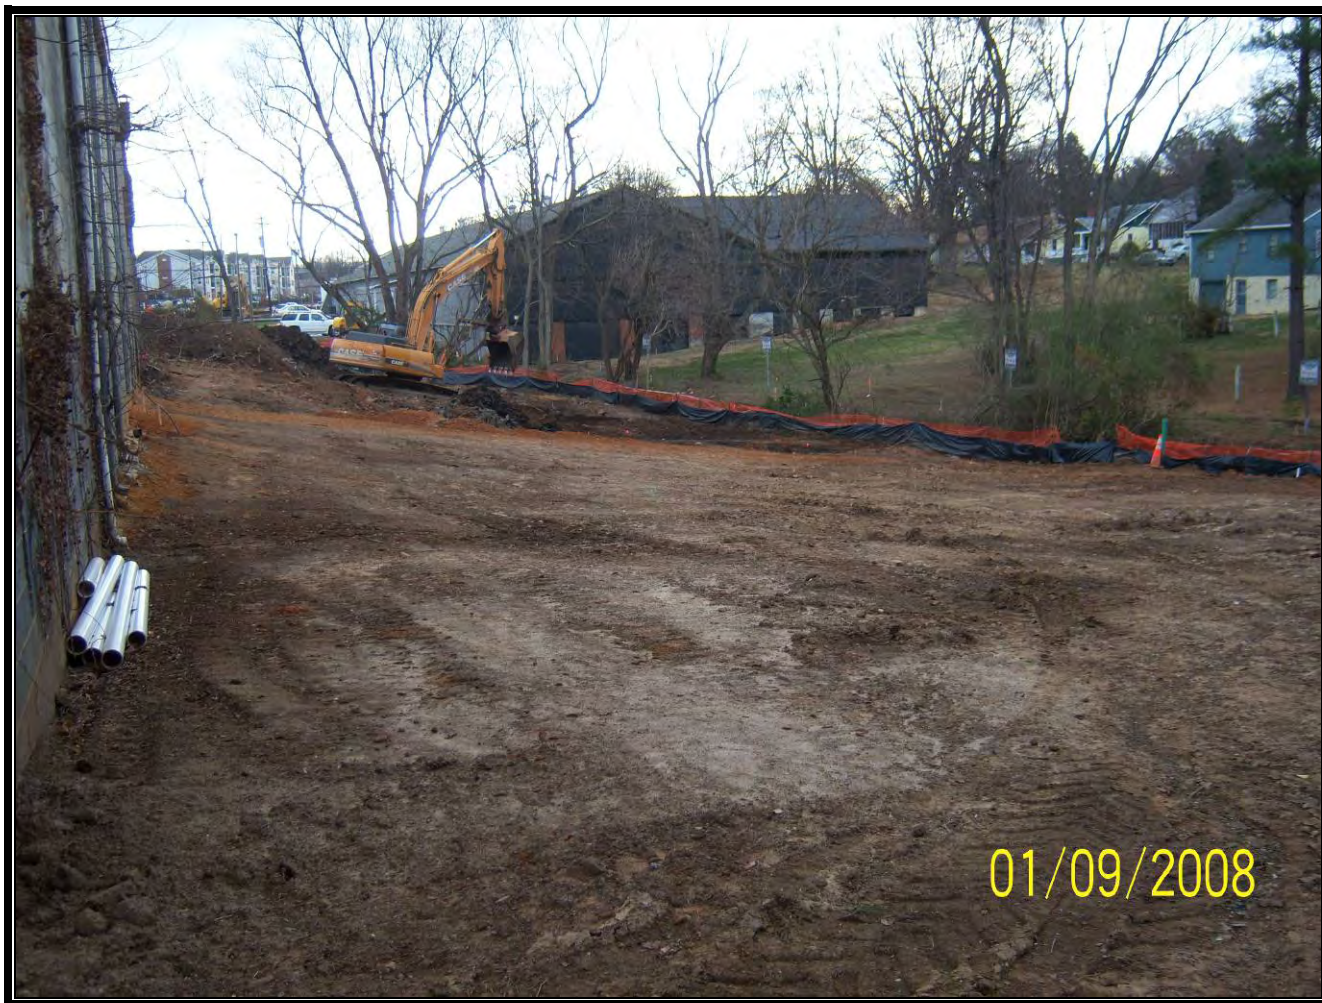
OFFICIAL PHOTOGRAPH NO. 47
U.S. ENVIRONMENTAL PROTECTION AGENCY

TDD Number:	TTEMI-05-001-0039	Location:	Industrial Metal Alloys
Orientation:	East	Date:	January 9, 2008
Photographer:	Brian Malone, Tetra Tech	Witness:	None
Subject:	Topsoil placement completed in grid rows 10,11,12,13 and 14.

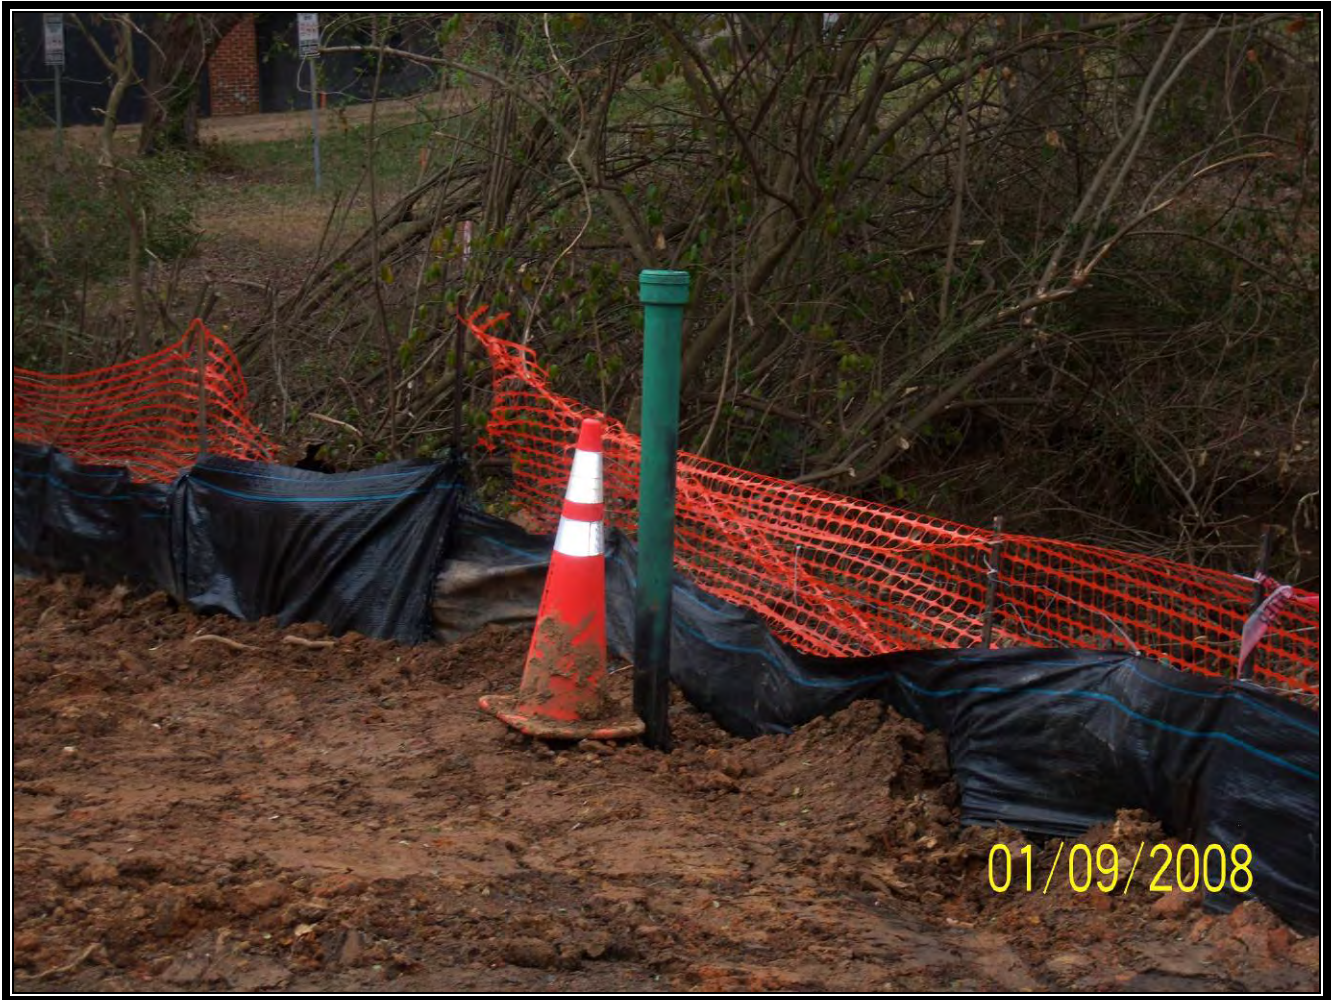
OFFICIAL PHOTOGRAPH NO. 49
U.S. ENVIRONMENTAL PROTECTION AGENCY

1320 Hepaco sampling grid M14. Grid split.
 to 6" on west side and 12" on
 west side. Clay pipe exists bisecting
 14 row which connects to a cleanout
 in 13 row. Pipe damaged throughout
 row. — BM

Subject: Repaired sewer drain line damaged during excavation with a clean out located in grid M14.

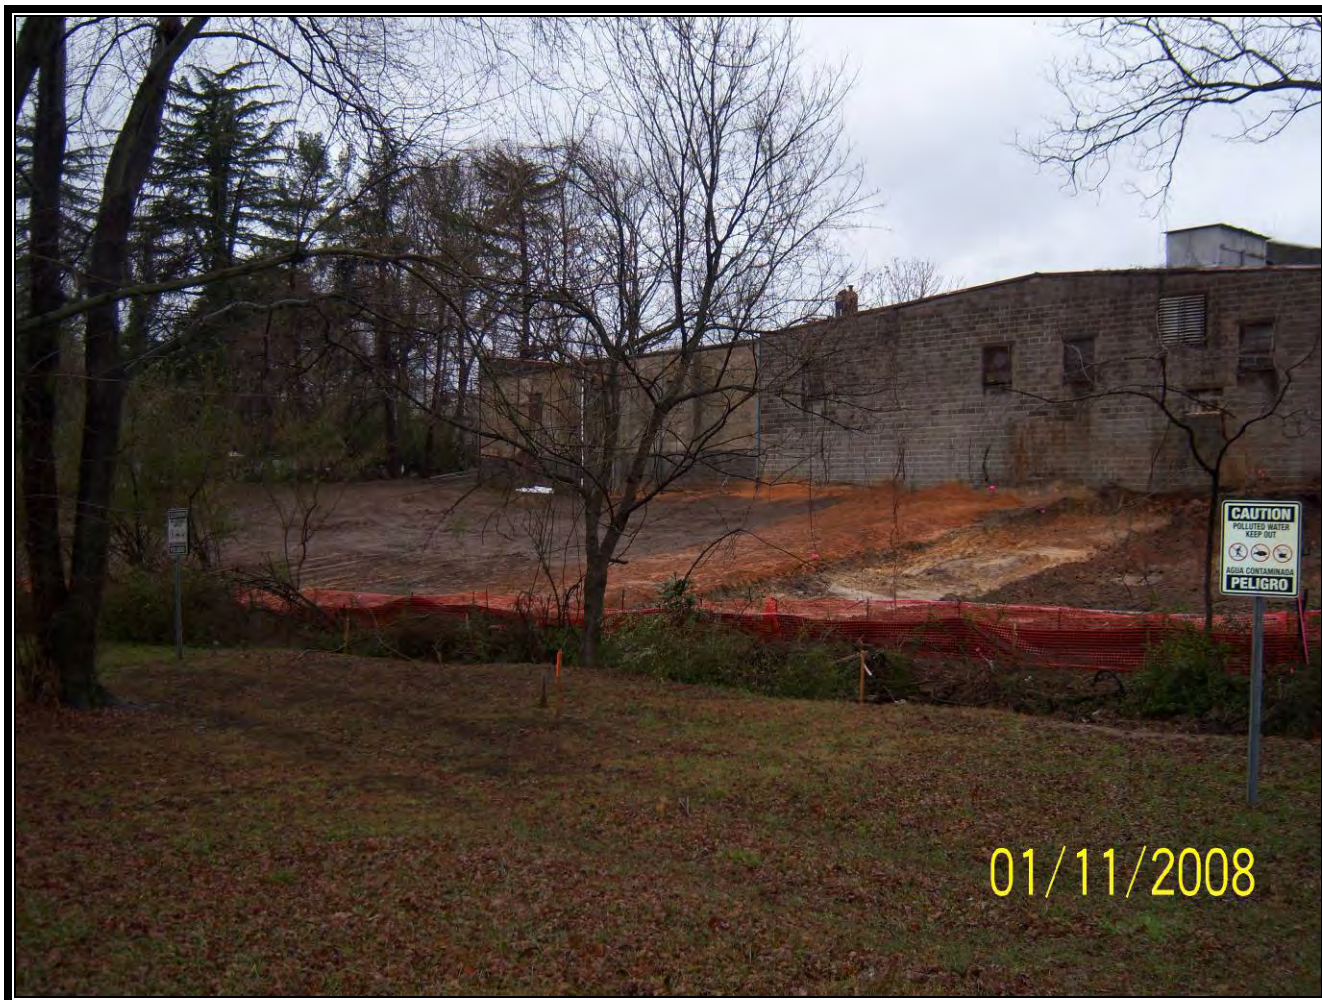
OFFICIAL PHOTOGRAPH NO. 52
U.S. ENVIRONMENTAL PROTECTION AGENCY

TDD Number:	TTEMI-05-001-0039	Location:	Industrial Metal Alloys
Orientation:	Southeast	Date:	January 11, 2008
Photographer:	Brian Malone, Tetra Tech	Witness:	None
Subject:	Extent of excavation at the IMACO site.

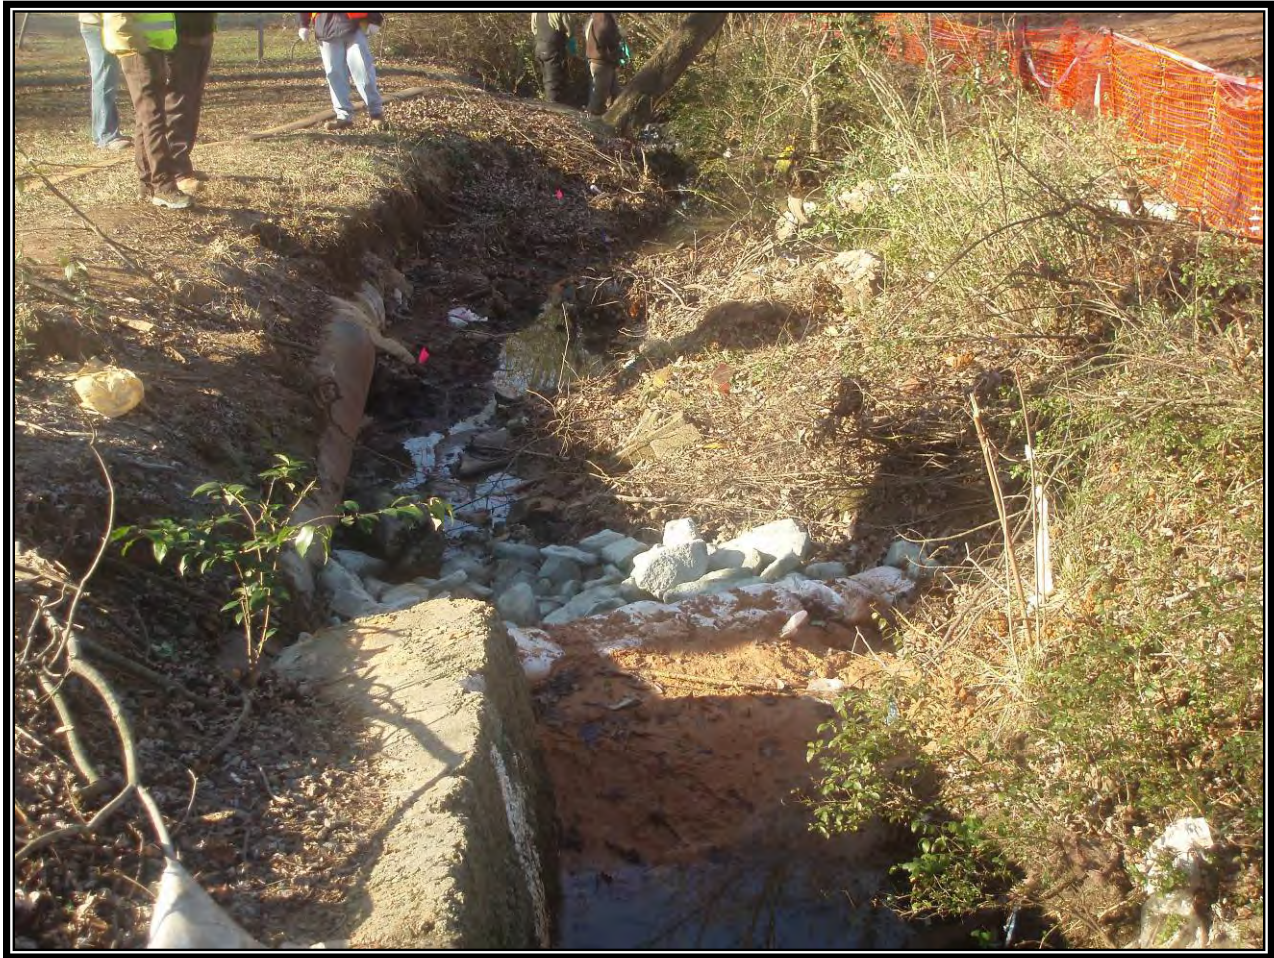
OFFICIAL PHOTOGRAPH NO. 53
U.S. ENVIRONMENTAL PROTECTION AGENCY

Subject: Dam constructed to hold back water during sediment excavation activities in the surface water stream on the south side of the site. Notice the active sewer line exposed in the left slope.

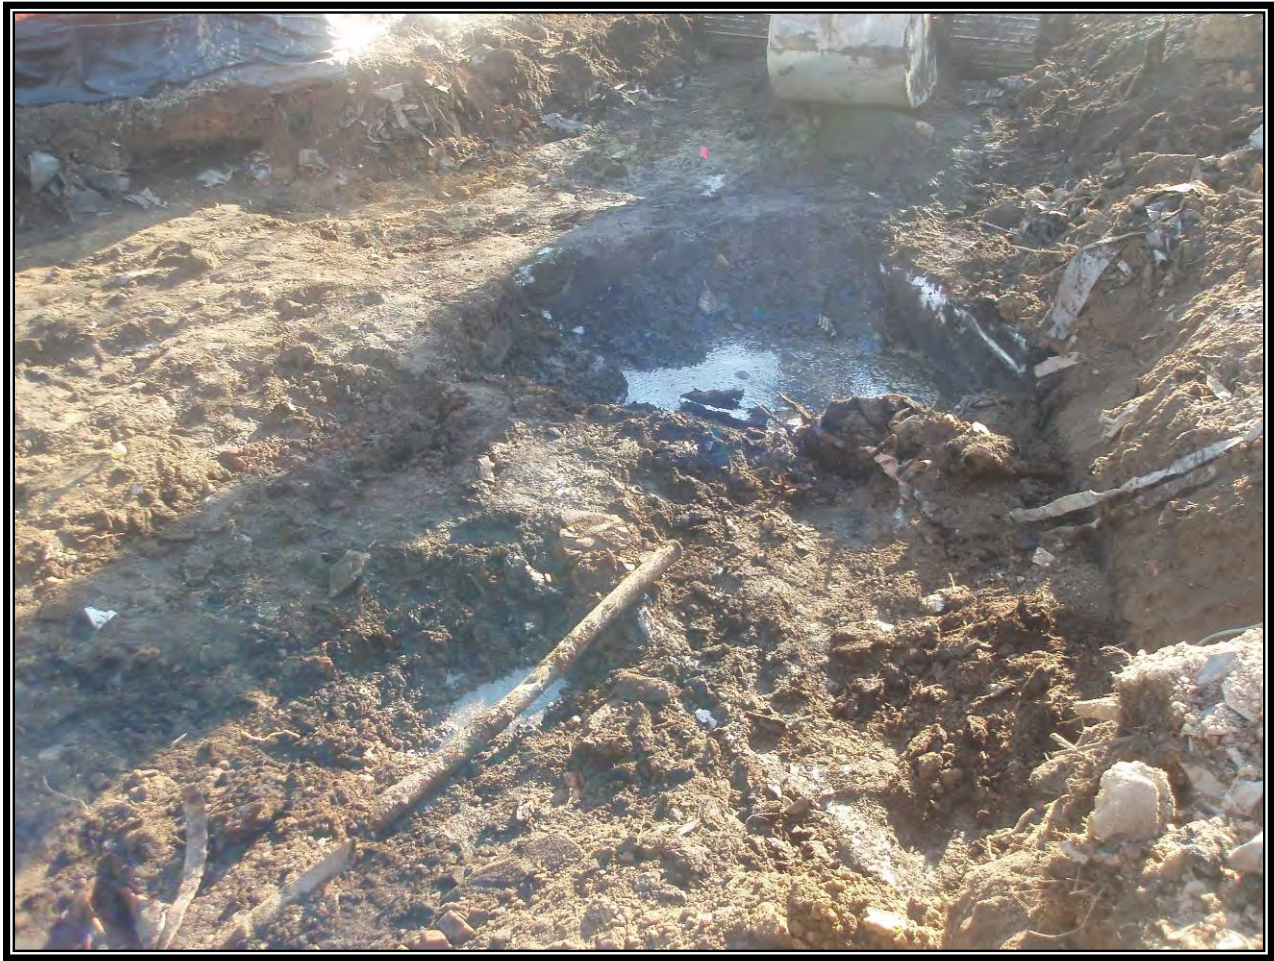
OFFICIAL PHOTOGRAPH NO. 54
U.S. ENVIRONMENTAL PROTECTION AGENCY

1500 HEPACO came across a buried concrete pit approximate 15' by 15' with 1 divider wall and a pipe that 90° down at the NW corner. The pit had an odor and the left or west side was filled with stained soil. The east side was filled with soil not stained. A sample (soil & water) sample was collected by B & C for analysis. The location was surveyed for final record reports. The pit was found in ~~the~~ I 20 grid.

Subject: Uncovered buried concrete two chamber vault located in grid I20. Samples were collected of the material found in the vault to determine the characteristics. The material was determined to be non-hazardous and will be backfilled with 2 feet of cover.

1050 Contacted OSC Hyzer to discuss Imaco site activities. OSC Hyzer indicated he had spoken with Hepaco and B&C and the analytical results of the waste identified in the concrete vault were all non-detected except for PCB result which required re-analysis due to equipment failure. Analysis of split indicated PCB were non-detected as well. OSC Hyzer also authorized the crushing of Kettle bottoms in lieu of recycling as recycling facility could not be identified. Stockpiles would be mixed with crushed material, re-sampled, analyzed and shipped as previous waste soil requirements. OSC Hyzer indicated START would document final site restoration activities and de-mob as previously discussed.

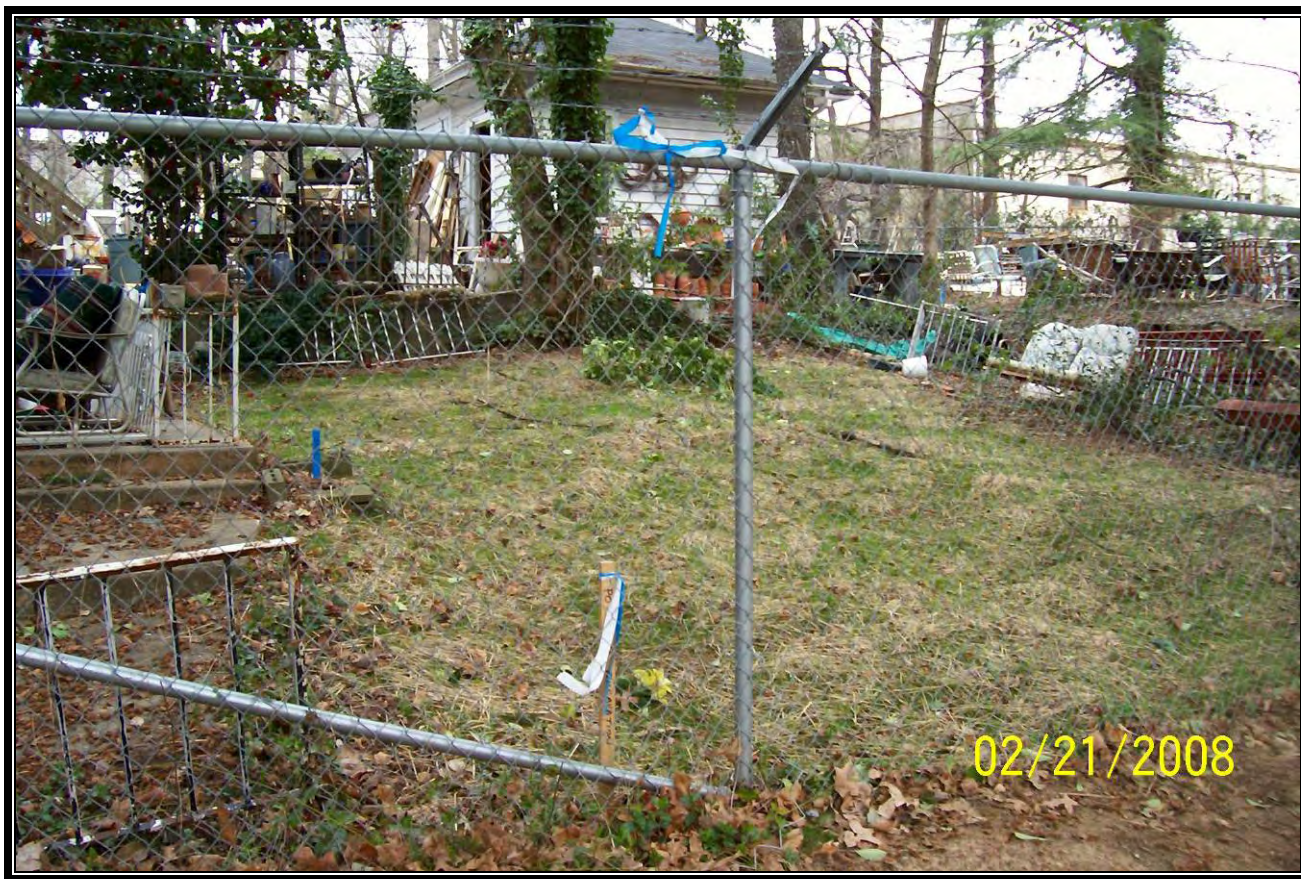
OFFICIAL PHOTOGRAPH NO. 55
U.S. ENVIRONMENTAL PROTECTION AGENCY

Subject: Restored condition of grid L5 located at 2117 Main Street (V's Treasures) .

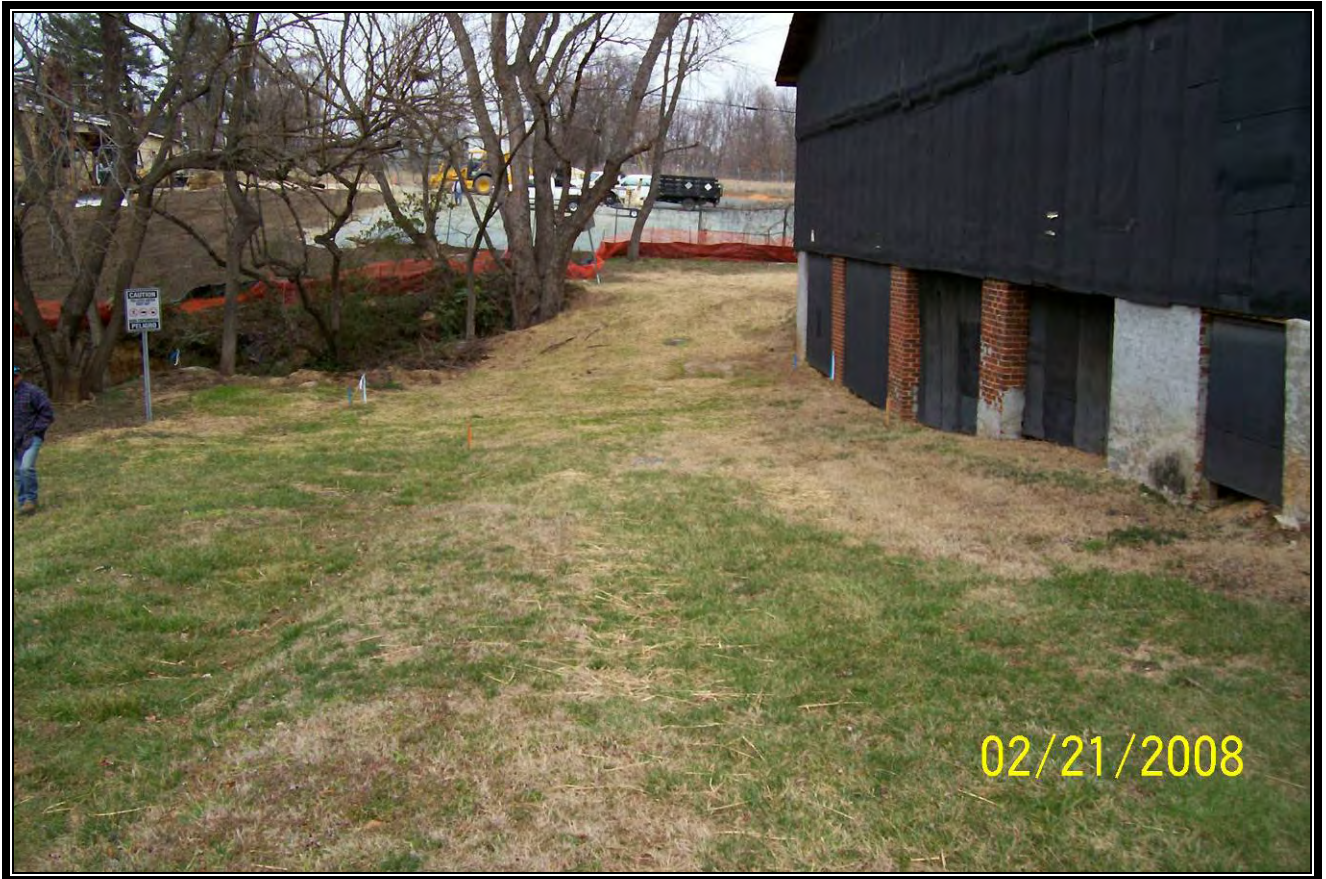
OFFICIAL PHOTOGRAPH NO. 56
U.S. ENVIRONMENTAL PROTECTION AGENCY

TDD Number:	TTEMI-05-001-0039	Location:	Industrial Metal Alloys
Orientation:	North	Date:	February 21, 2008
Photographer:	Shana Davis, Tetra Tech	Witness:	HEPACO
Subject:	Restored condition of grid L22 and K22, south of the GMAC building.

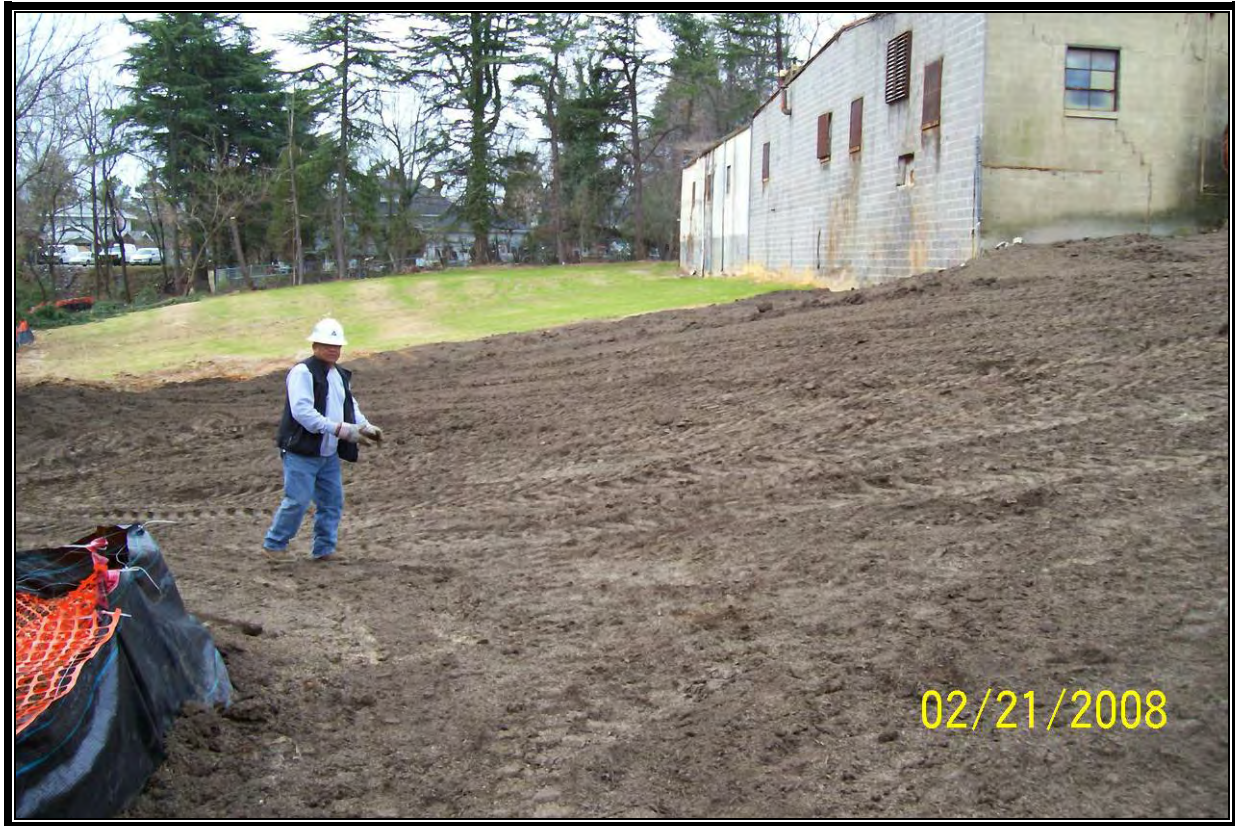
OFFICIAL PHOTOGRAPH NO. 58
U.S. ENVIRONMENTAL PROTECTION AGENCY

TDD Number:	TTEMI-05-001-0039	Location:	Industrial Metal Alloys
Orientation:	Southwest	Date:	February 21, 2008
Photographer:	Shana Davis, Tetra Tech	Witness:	HEPACO
Subject:	HEPACO conducting restoration of grids southeast of the IMACO building.

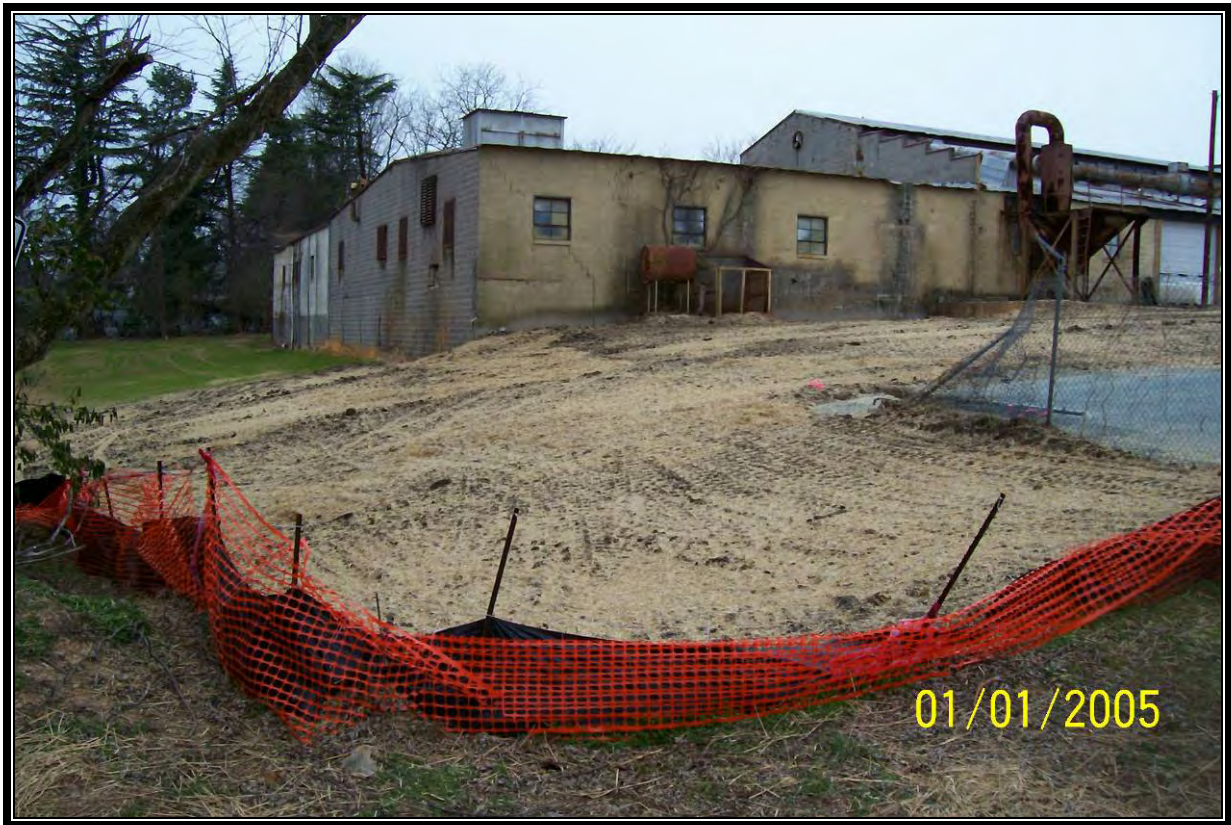
OFFICIAL PHOTOGRAPH NO. 60
U.S. ENVIRONMENTAL PROTECTION AGENCY

Subject: Final restoration of grids located on the northeast portion of the IMACO Site.

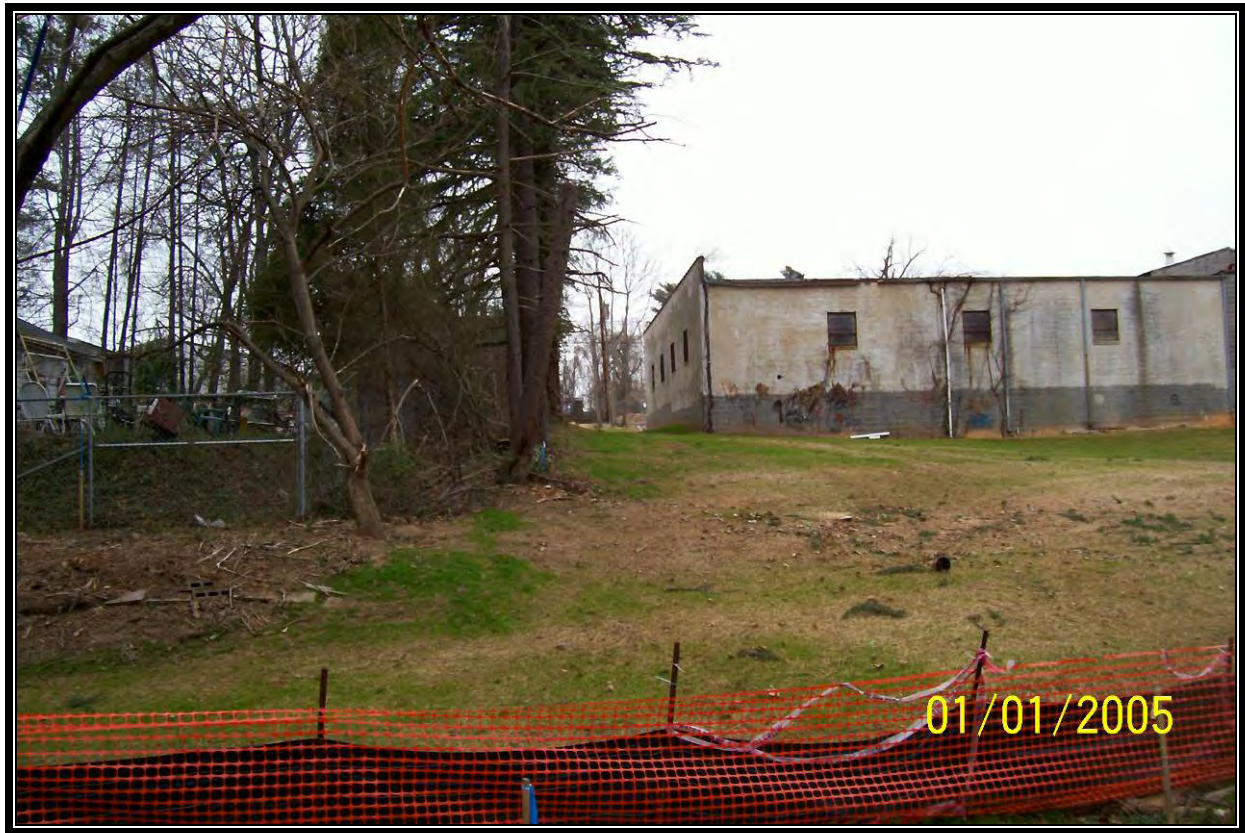
OFFICIAL PHOTOGRAPH NO. 64
U.S. ENVIRONMENTAL PROTECTION AGENCY

Subject: Final restoration of property north of the IMACO Site across E. Acadia Ave.

1010 Hepaco re-excavating grid CB. Photo 64.

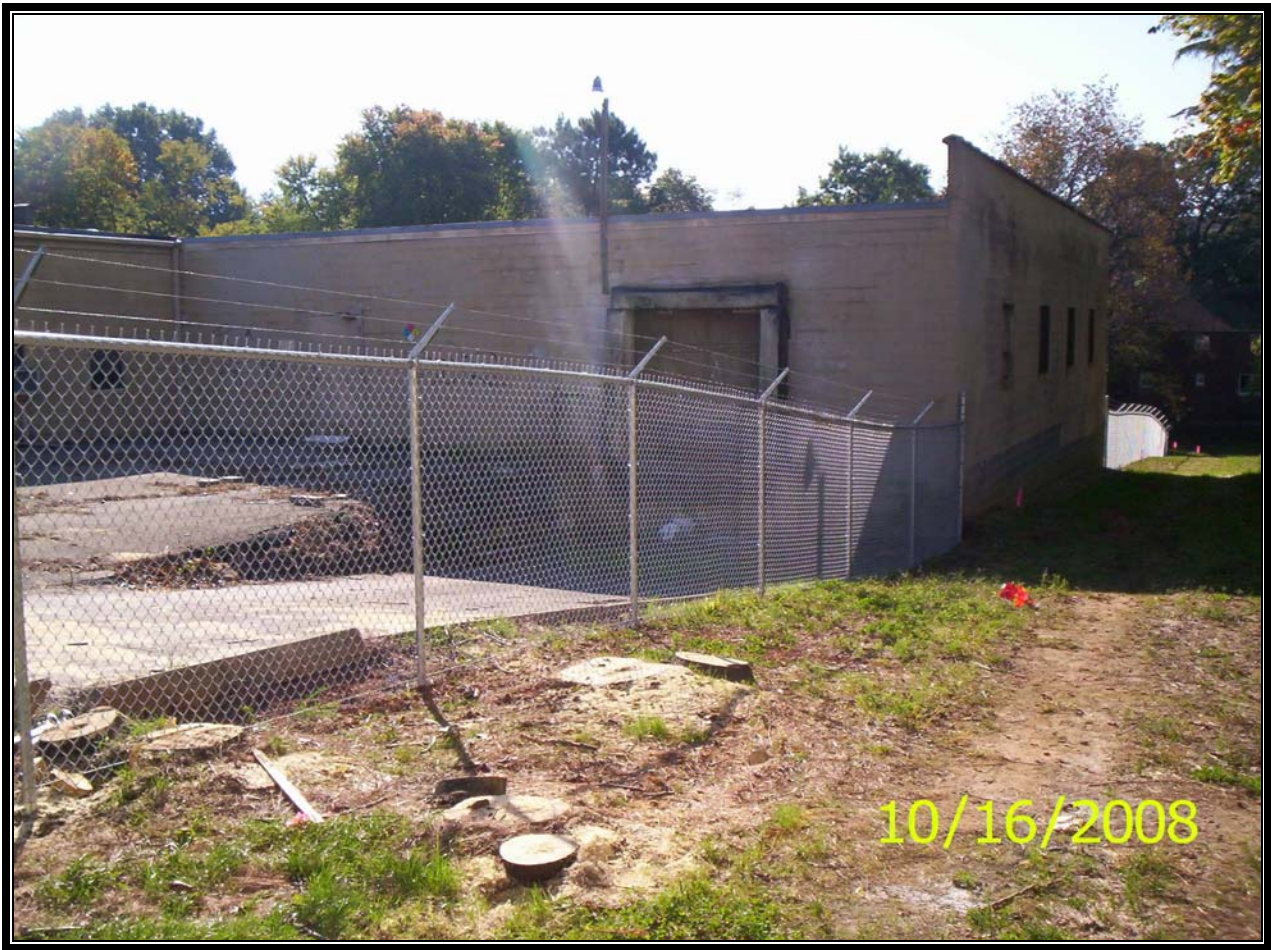
OFFICIAL PHOTOGRAPH NO. 67
U.S. ENVIRONMENTAL PROTECTION AGENCY

Subject: Installation of site perimeter security fencing; northwest gate.

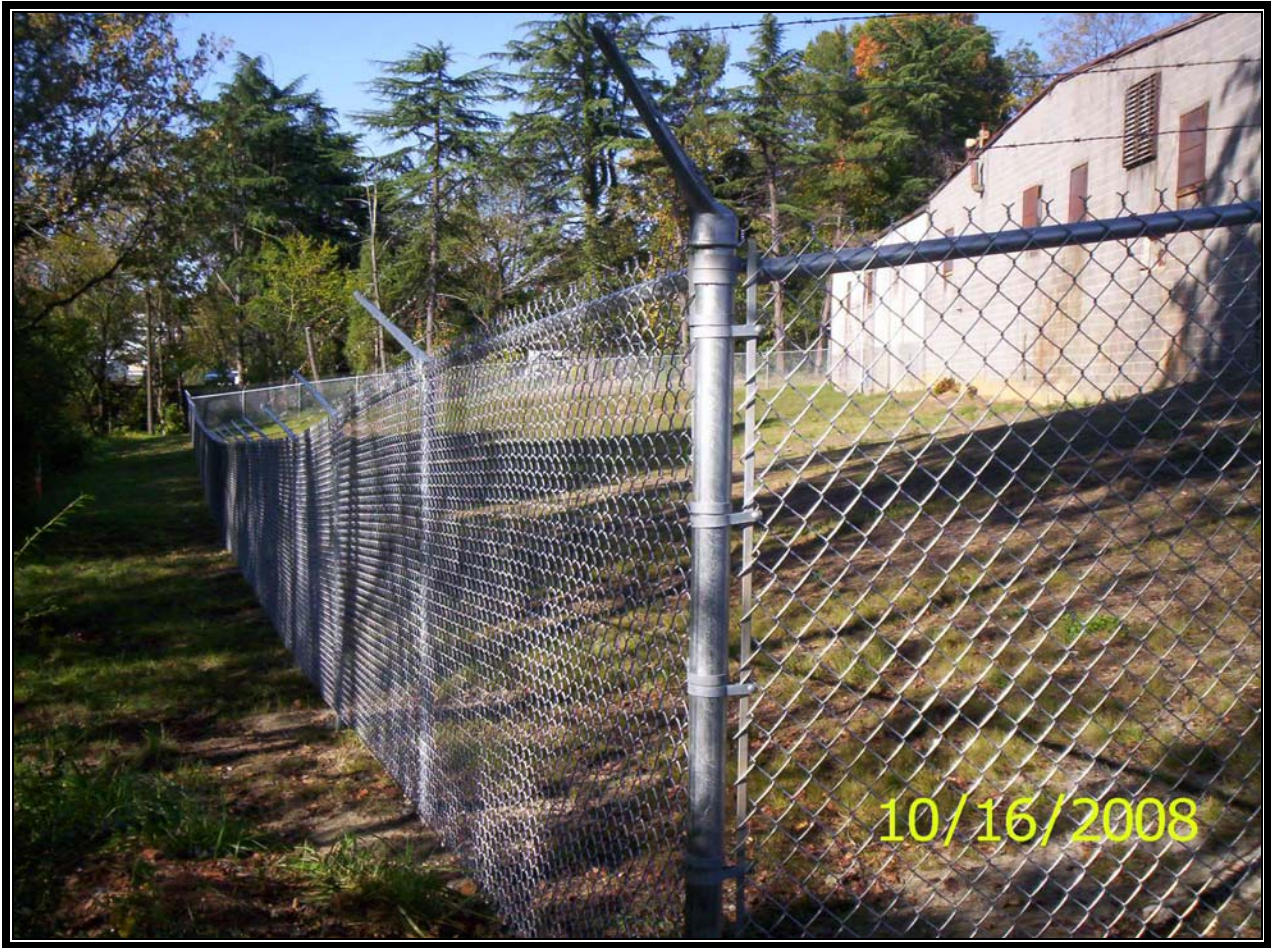
OFFICIAL PHOTOGRAPH NO. 68
U.S. ENVIRONMENTAL PROTECTION AGENCY

TDD Number:	TTEMI-05-001-0039	Location:	Industrial Metal Alloys
Orientation:	Southwest	Date:	October 16, 2008
Photographer:	James Kessler, HEPACO	Witness:	Fencing contractor
Subject:	Southern side of property with installed perimeter security fencing.
