**ON SCENE COORDINATOR REPORT  
FORMER INDUSTRIAL METAL ALLOY COMPANY SITE  
20 EAST ACADIA AVENUE  
WINSTON-SALEM, FORSYTH COUNTY, NORTH CAROLINA**

**HEPACO, Inc.  
2711 Burch Drive  
Charlotte, NC 28269**

**May 19, 2008**

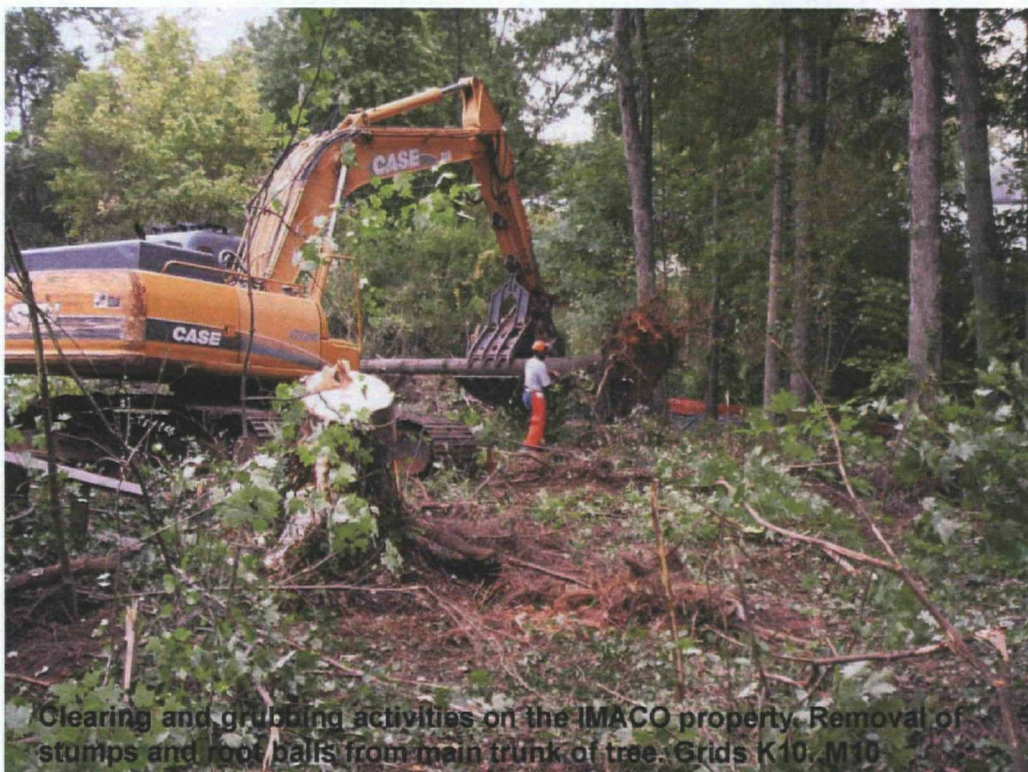
Photograph 5

Clearing and grubbing activities on the IMACO property. Removal of stumps and root balls from main trunk of tree. Grids K10, M10

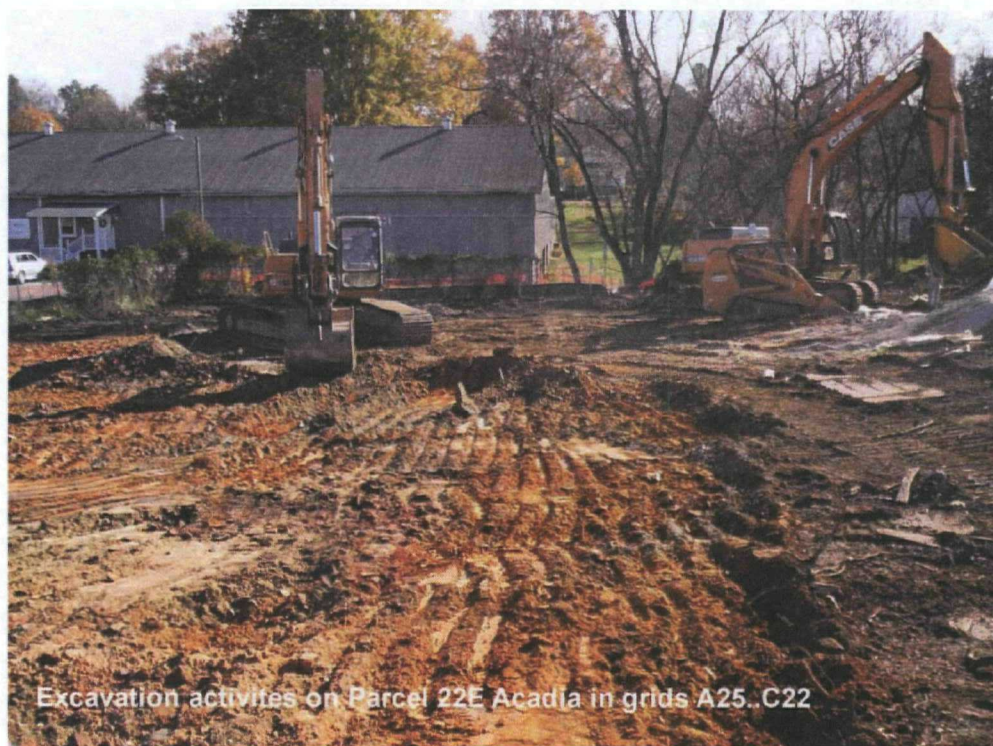
Photograph 6

Excavation activities on Parcel 22E Acadia in grids A25, C22
