**Subject: Final Emergency Response Letter Report  
Robinson Foundry  
Alexander City, Tallapoosa County, Alabama  
EPA Contract No. EP-W-05-054  
TDD No. TTEMI-05-001-0100**

The Tetra Tech Superfund Technical Assessment and Response Team (START) is submitting this letter report summarizing the emergency response activities conducted from June 8 through 11, 2009, at the Robinson Foundry in Alexander City, Tallapoosa County, Alabama. Appendix A provides figures that show the site location and layout of the facility. Appendix B is a photographic log of emergency response activities. Appendix C provides a container log and summary of waste volumes. Appendix D presents a copy of Tetra Tech's field logbook notes. Appendix E contains a Table of Witnesses.

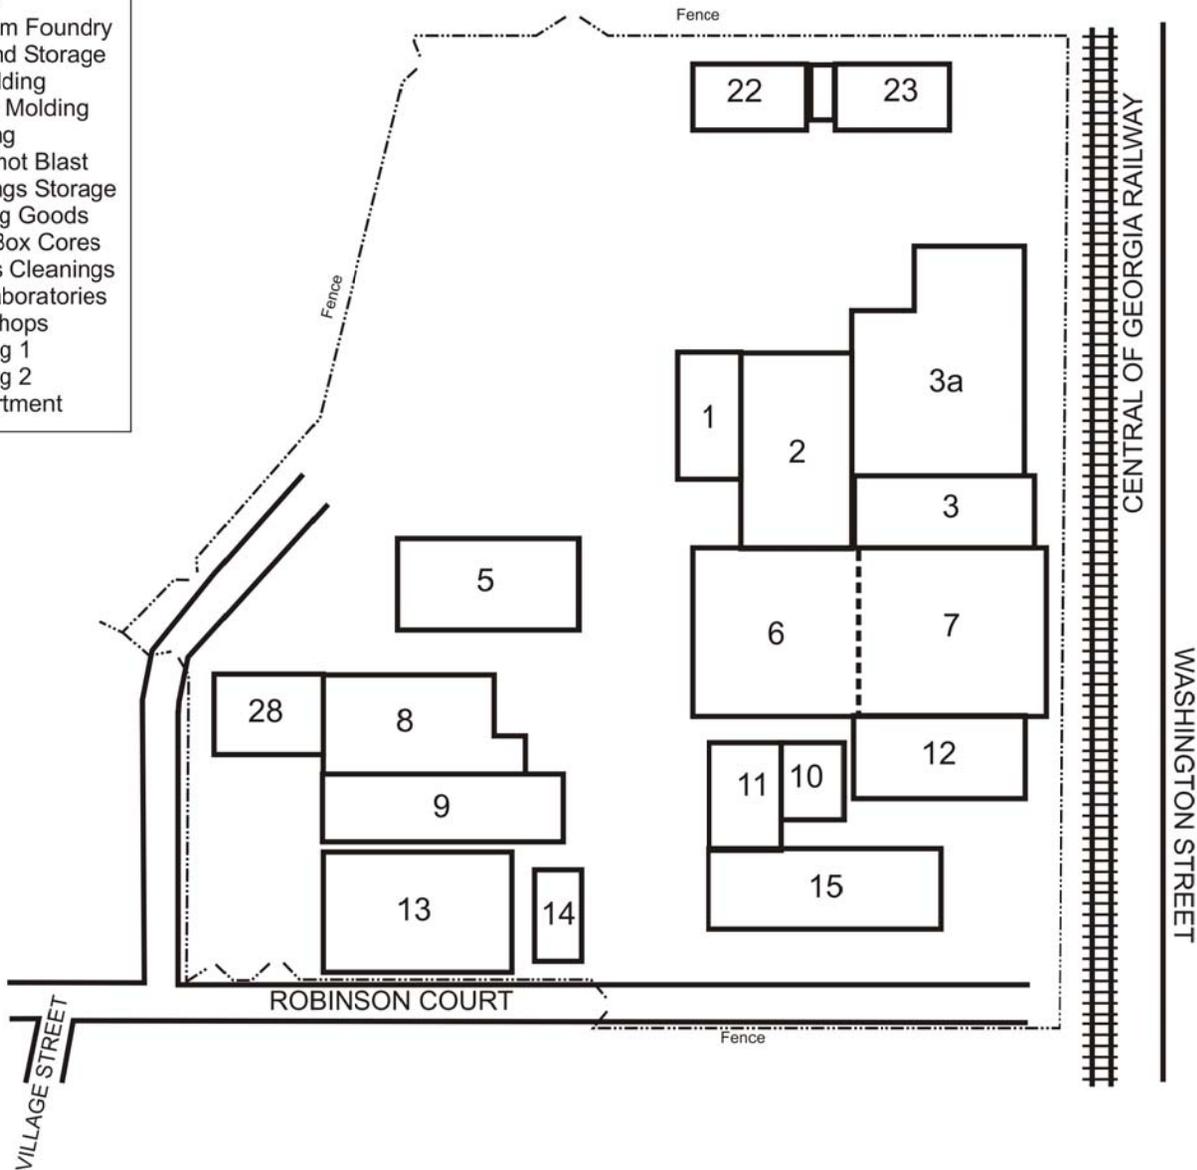
**FIGURE 2**  
**SITE DIAGRAM**

Building nomenclature adopted from the facility response plan. Some buildings were sold during bankruptcy and were not covered under the scope for this response. Thus, building numbering is not consecutive.

On June 9, EPA, START, and ERRS returned to the site and began moving drums and other small containers into Building 3a; one of the large empty buildings located on site (see Figure 2). A skid-steer was used to move the drums from building to building. Once the drums were brought into the staging area, START numbered them sequentially and developed a drum log. Containers too large to move with the skid-steer were numbered and sampled in place. Three tanks and 135 drums, totes, and small containers were identified as requiring sampling.

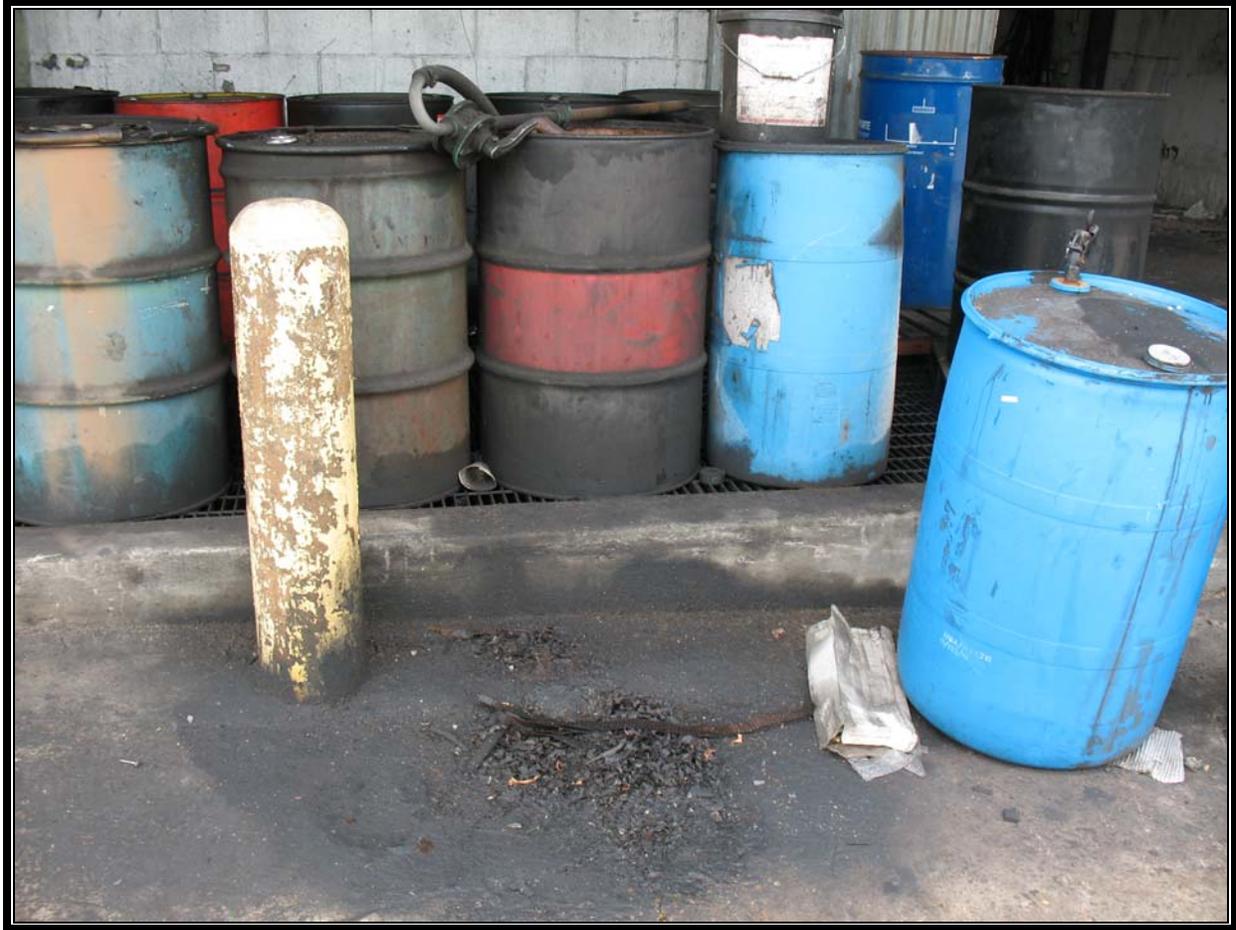
**OFFICIAL PHOTOGRAPH NO. 1**  
**U.S. ENVIRONMENTAL PROTECTION AGENCY**

**Subject:** Drums found outside warehouse upon arrival. Note staining on the ground indicating historical spills.

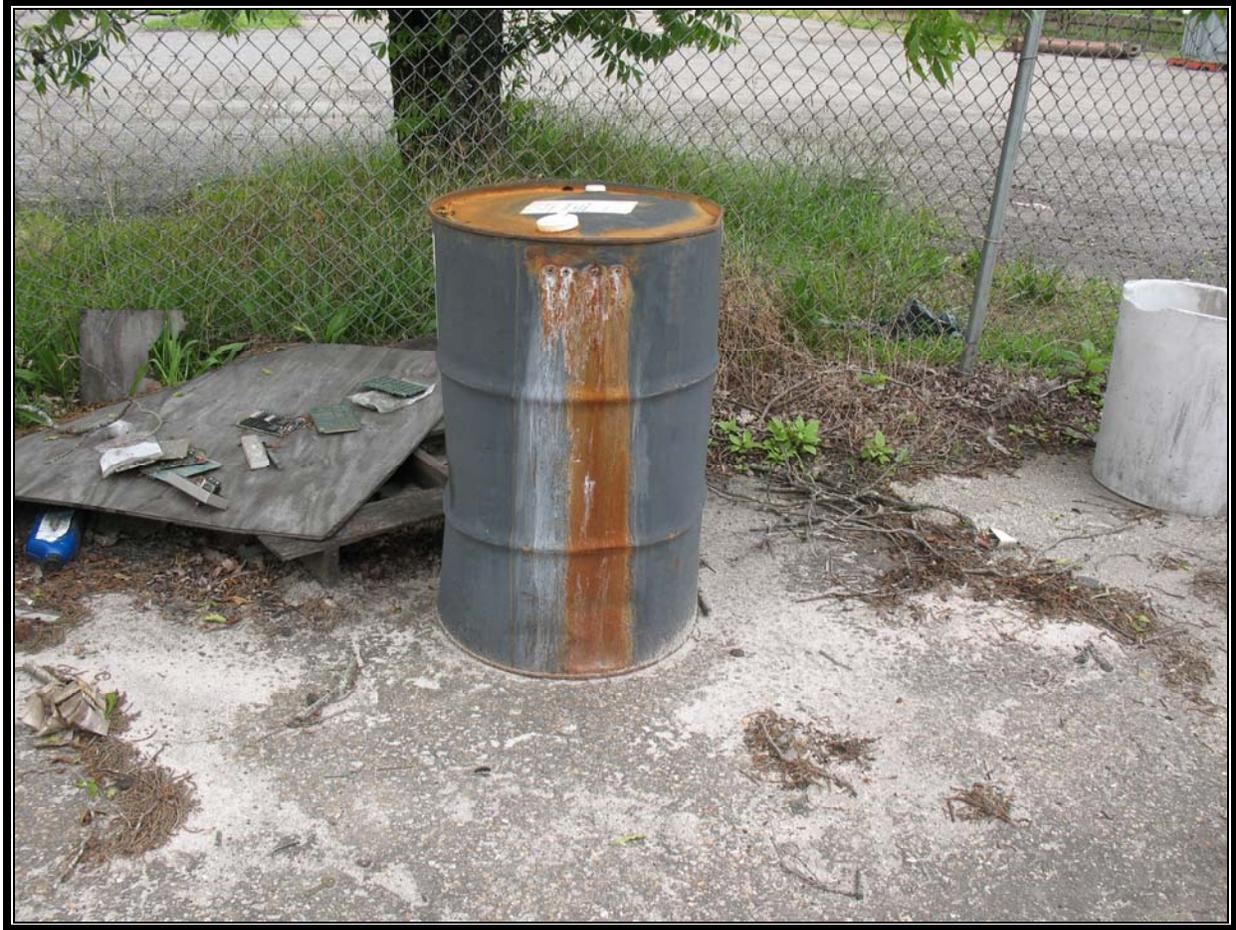
**OFFICIAL PHOTOGRAPH NO. 2**  
**U.S. ENVIRONMENTAL PROTECTION AGENCY**

**Subject:** Drum discovered during initial site walk-through. Note the pinhole leaks.

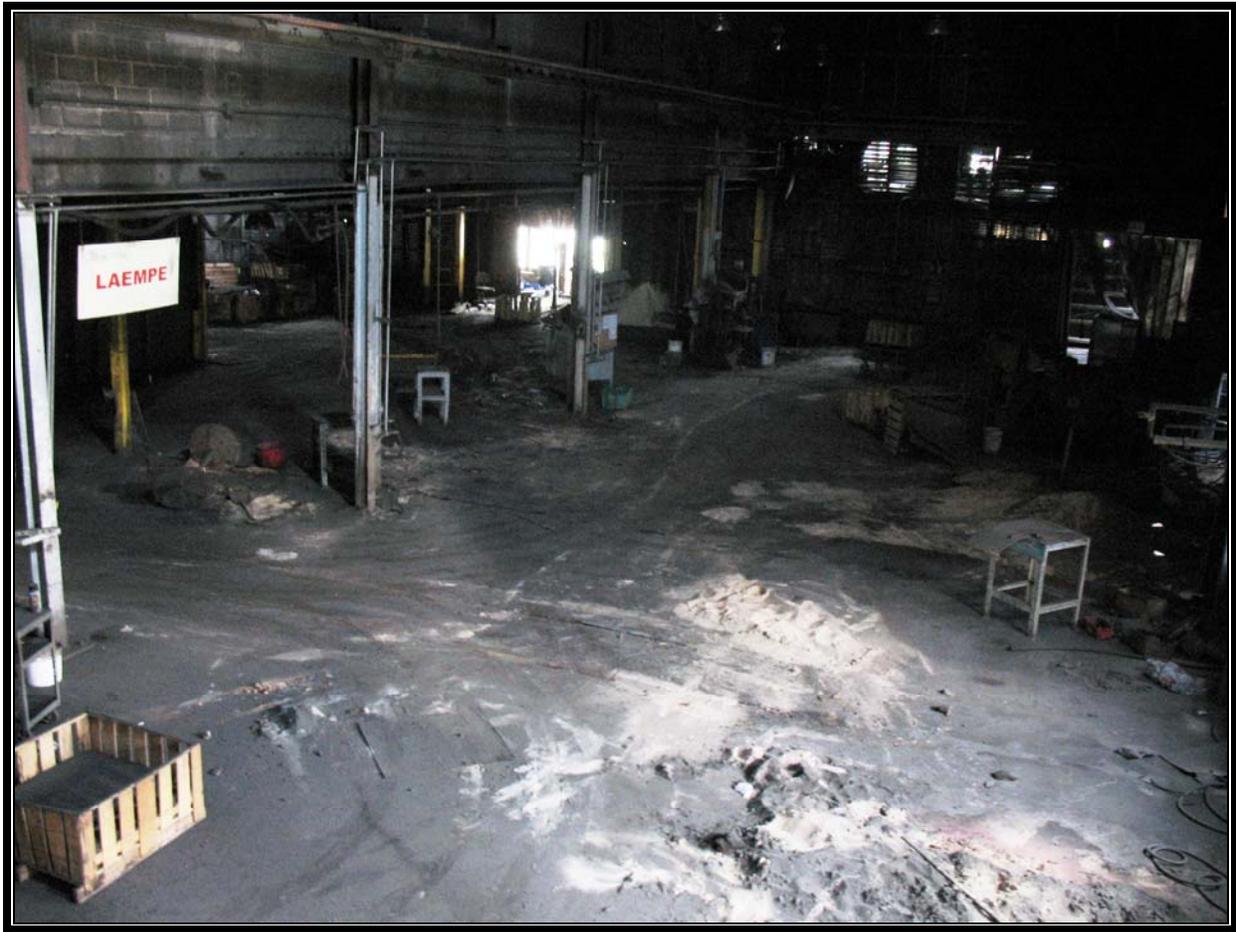
**OFFICIAL PHOTOGRAPH NO. 3**  
**U.S. ENVIRONMENTAL PROTECTION AGENCY**

**Subject:** Inside of Buildings 10, 11, and 12. Note the foundry dust and sand on the floor. XRF screening indicated no pervasive heavy metal contamination in the dust or sand.

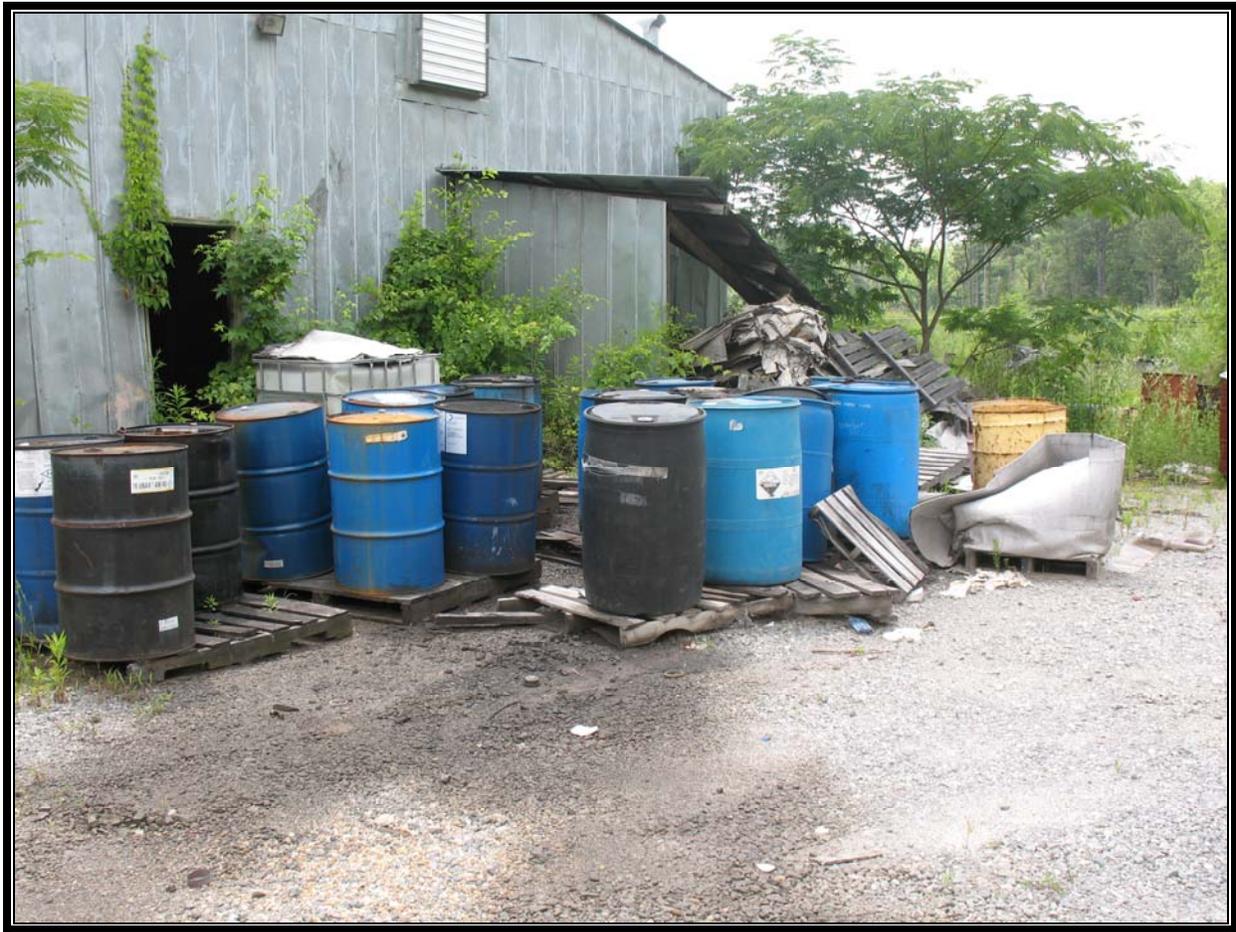
**OFFICIAL PHOTOGRAPH NO. 4  
U.S. ENVIRONMENTAL PROTECTION AGENCY**

**Subject:** Drums stored outside of Building 23. Note the staining of the ground.

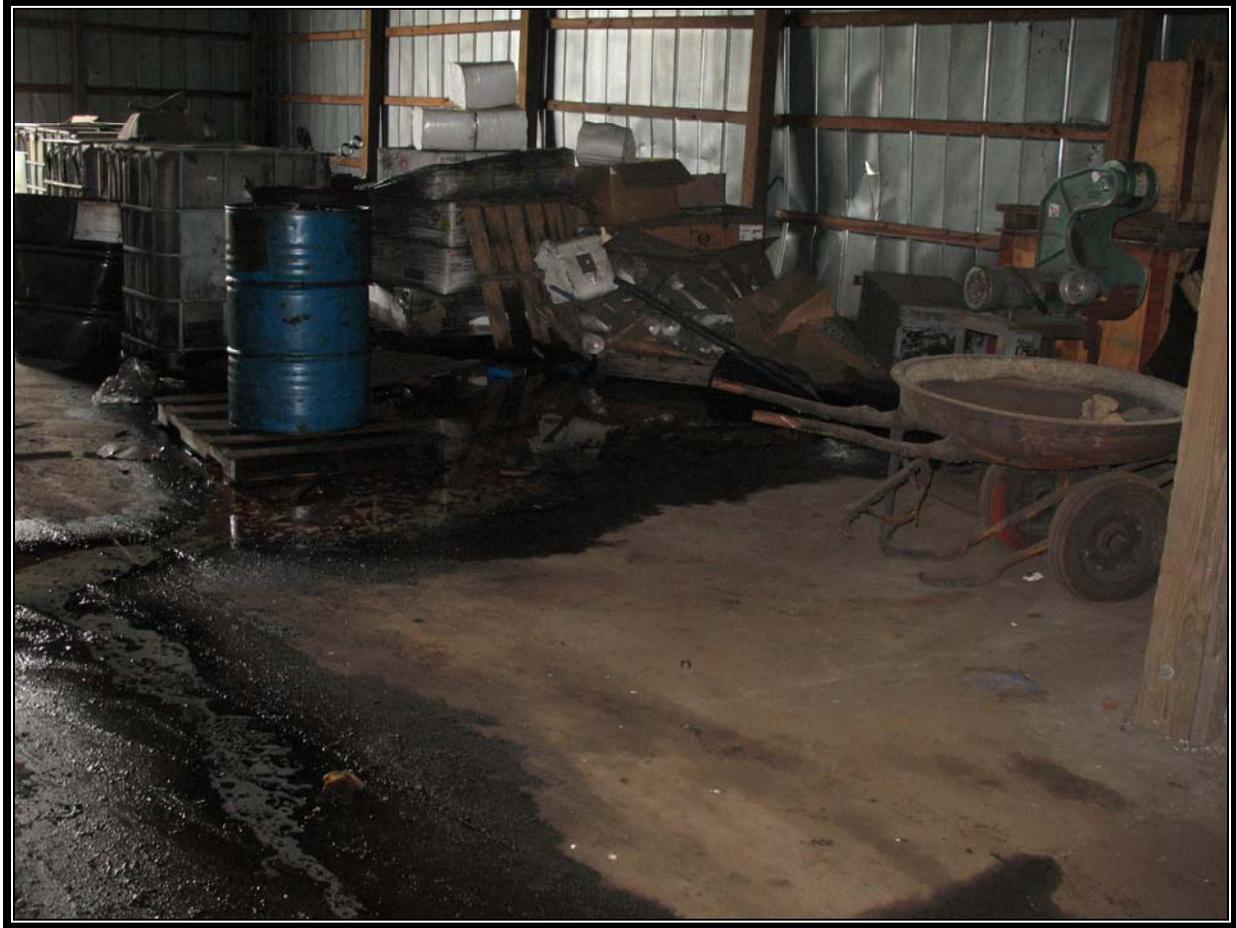
**OFFICIAL PHOTOGRAPH NO. 5**  
**U.S. ENVIRONMENTAL PROTECTION AGENCY**

**Subject:** Oil leaking from damaged containers in Building 22.

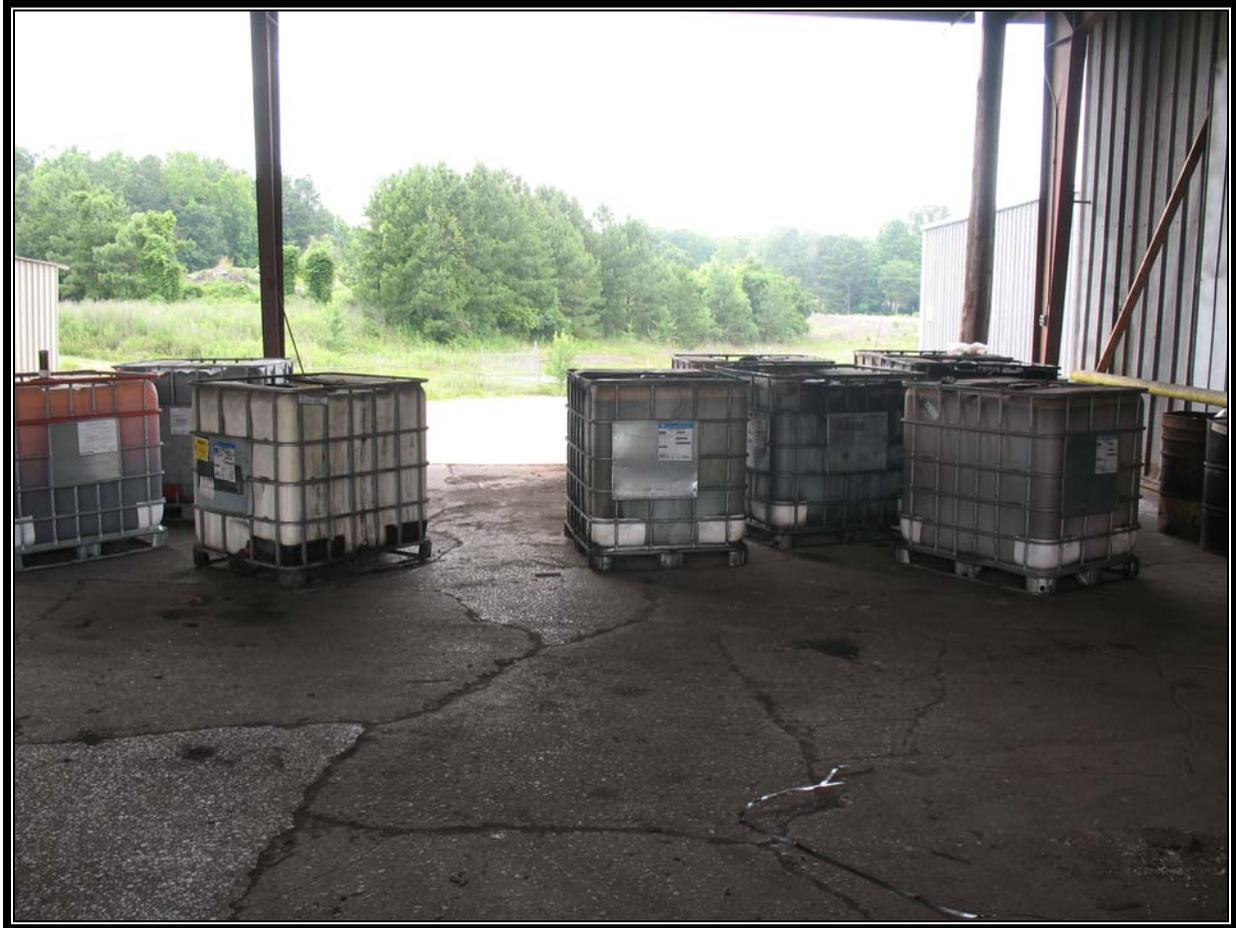
**OFFICIAL PHOTOGRAPH NO. 6**  
**U.S. ENVIRONMENTAL PROTECTION AGENCY**

**Subject:** Tote containers located on the loading dock in Building 28.

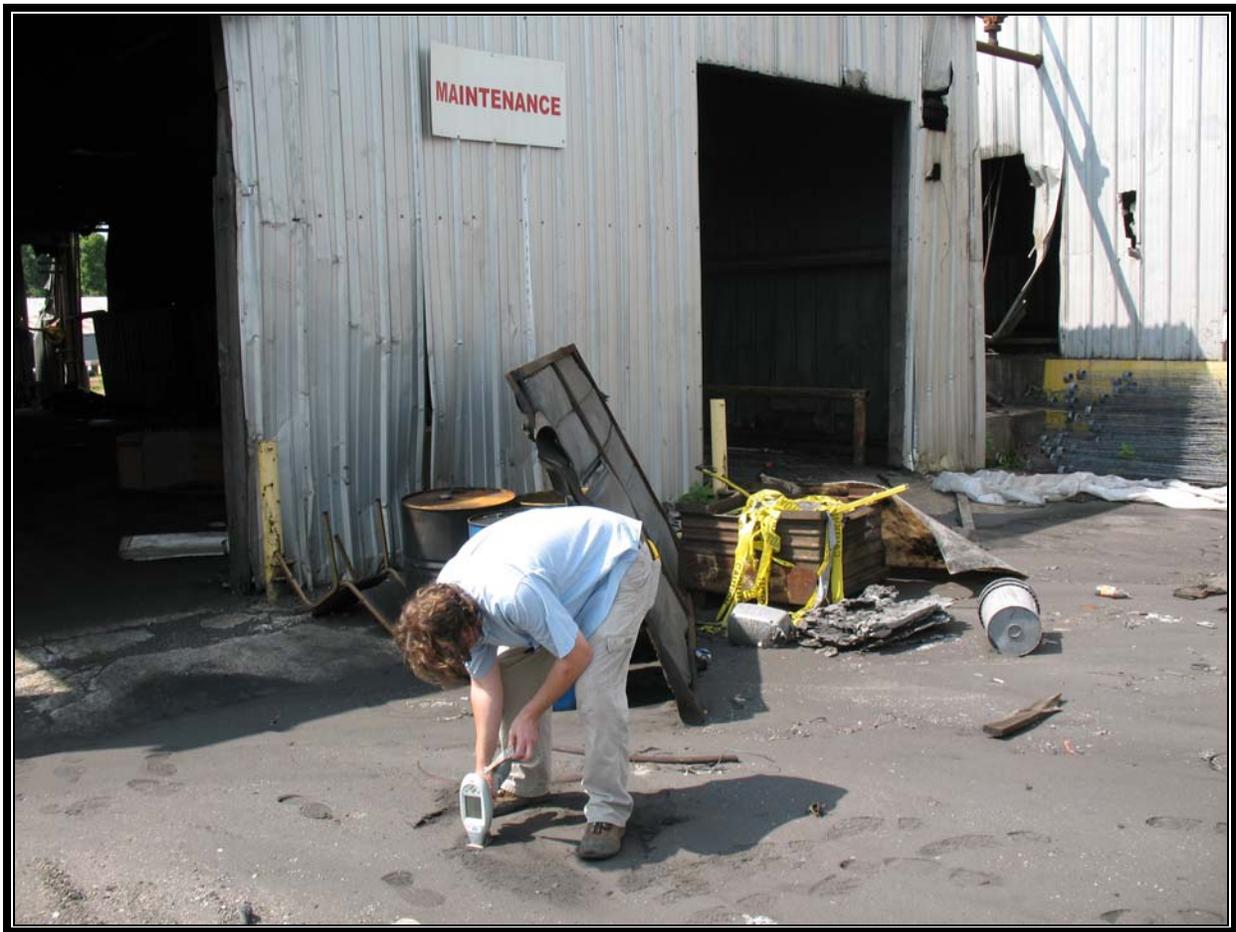
**OFFICIAL PHOTOGRAPH NO. 7**  
**U.S. ENVIRONMENTAL PROTECTION AGENCY**

**Subject:** START screening with XRF device to determine metal concentrations on site.

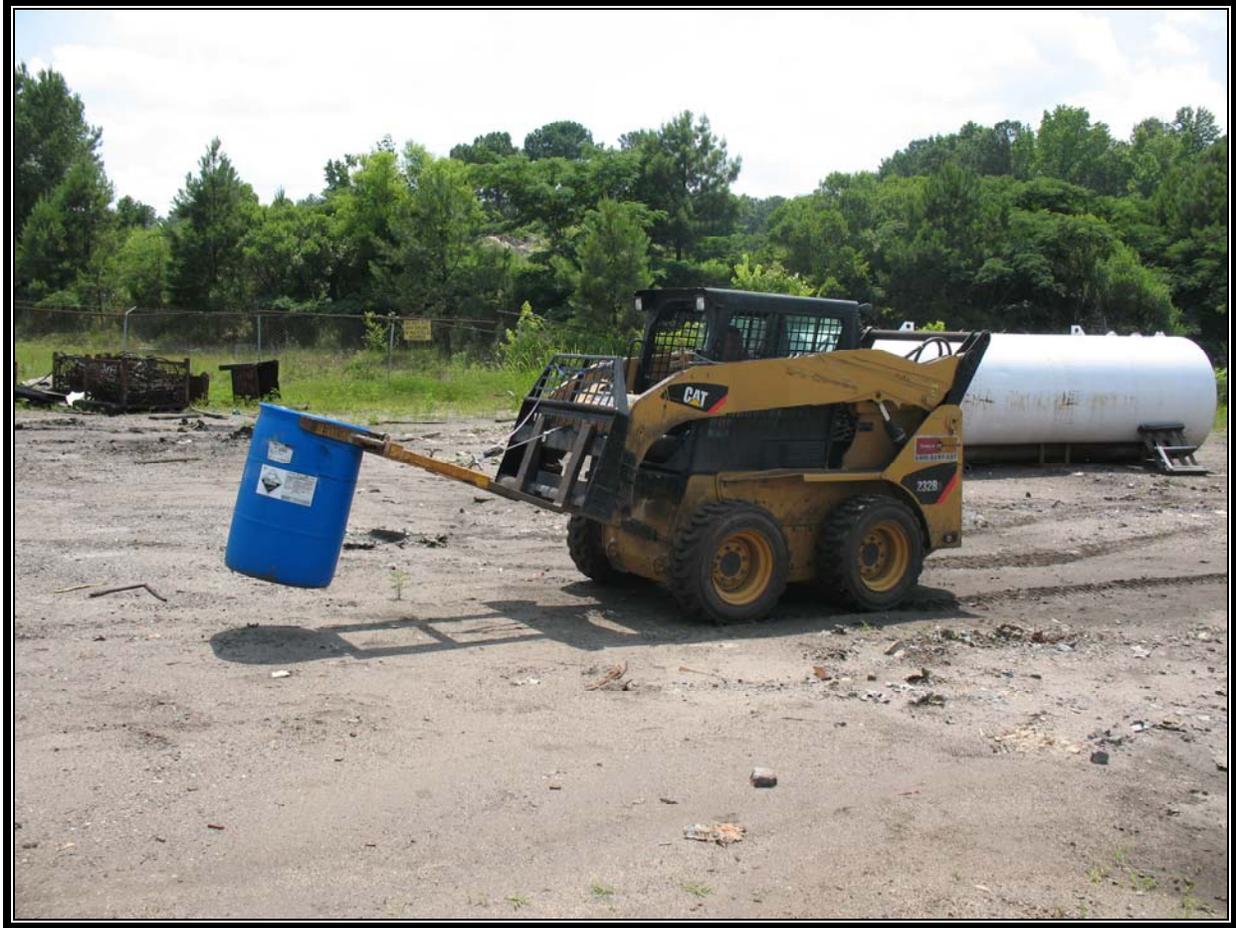
**OFFICIAL PHOTOGRAPH NO. 8  
U.S. ENVIRONMENTAL PROTECTION AGENCY**

**Subject:** Drums were collected from around the site and moved to a staging area for sampling.

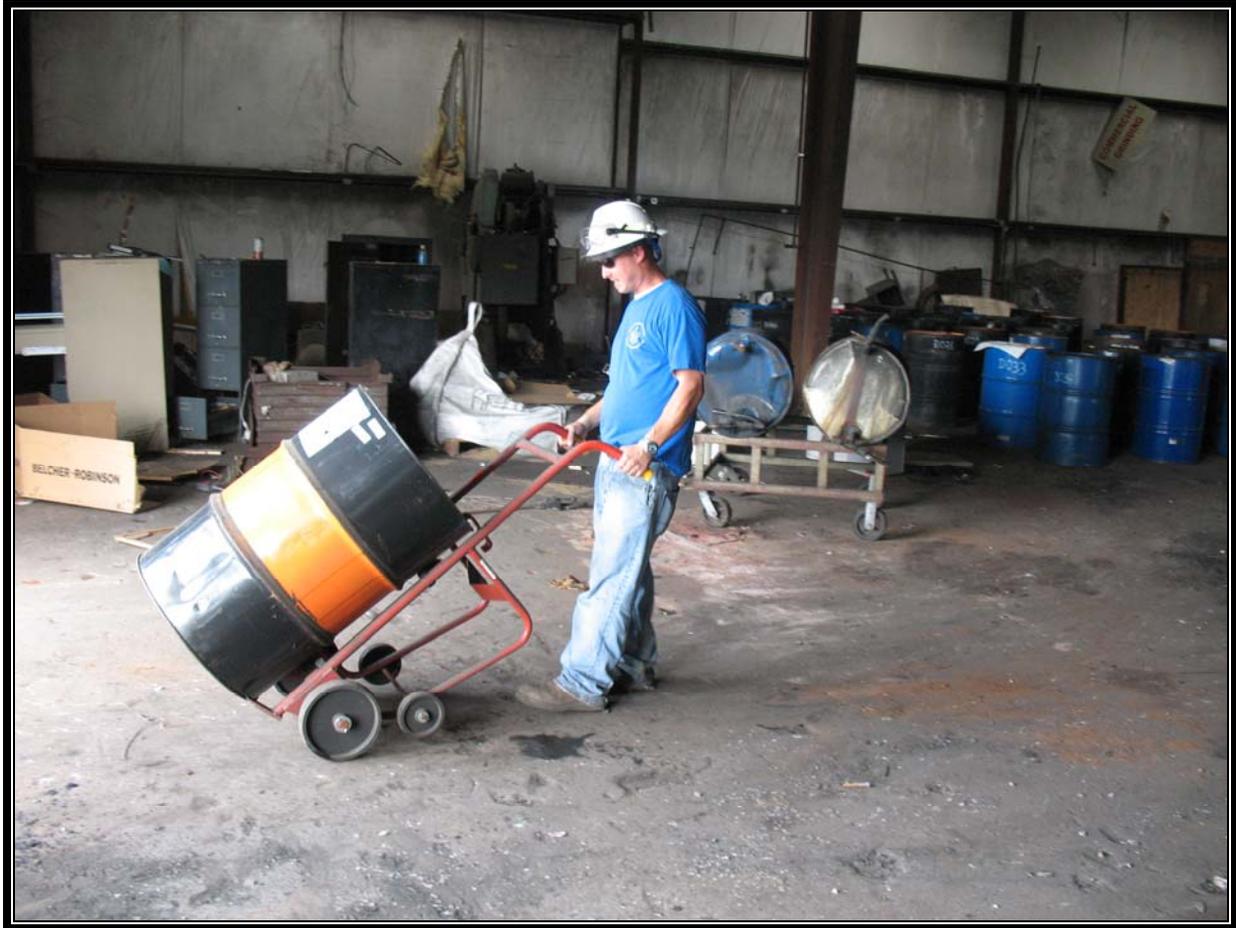
**OFFICIAL PHOTOGRAPH NO. 9**  
**U.S. ENVIRONMENTAL PROTECTION AGENCY**

**Subject:** Once moved by equipment to the staging area, ERRS crews segregated drums based on suspected contents in order to group similar material for future storage.

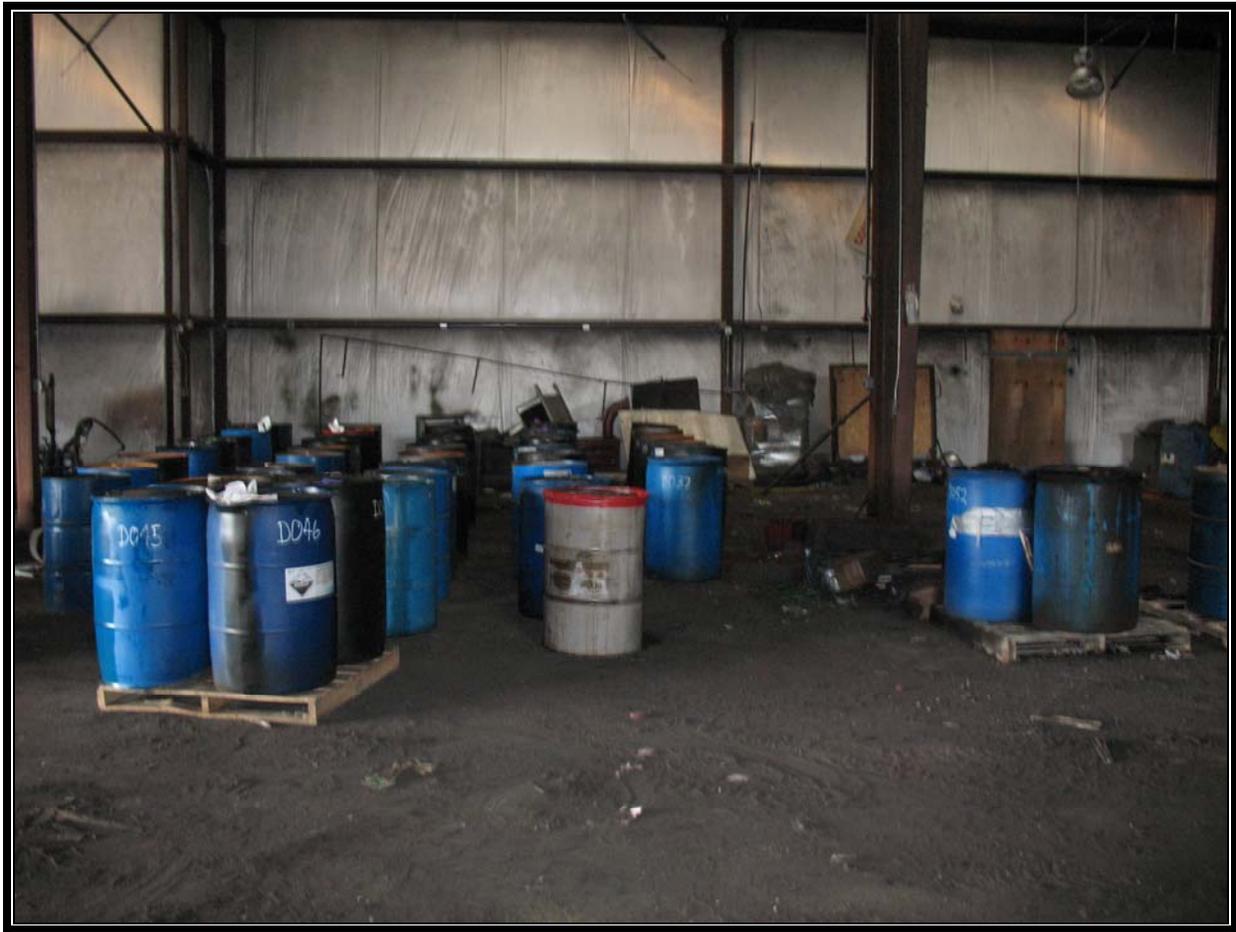
**OFFICIAL PHOTOGRAPH NO. 10**  
**U.S. ENVIRONMENTAL PROTECTION AGENCY**

**Subject:** Drums were numbered and placed in staging area to await sampling.

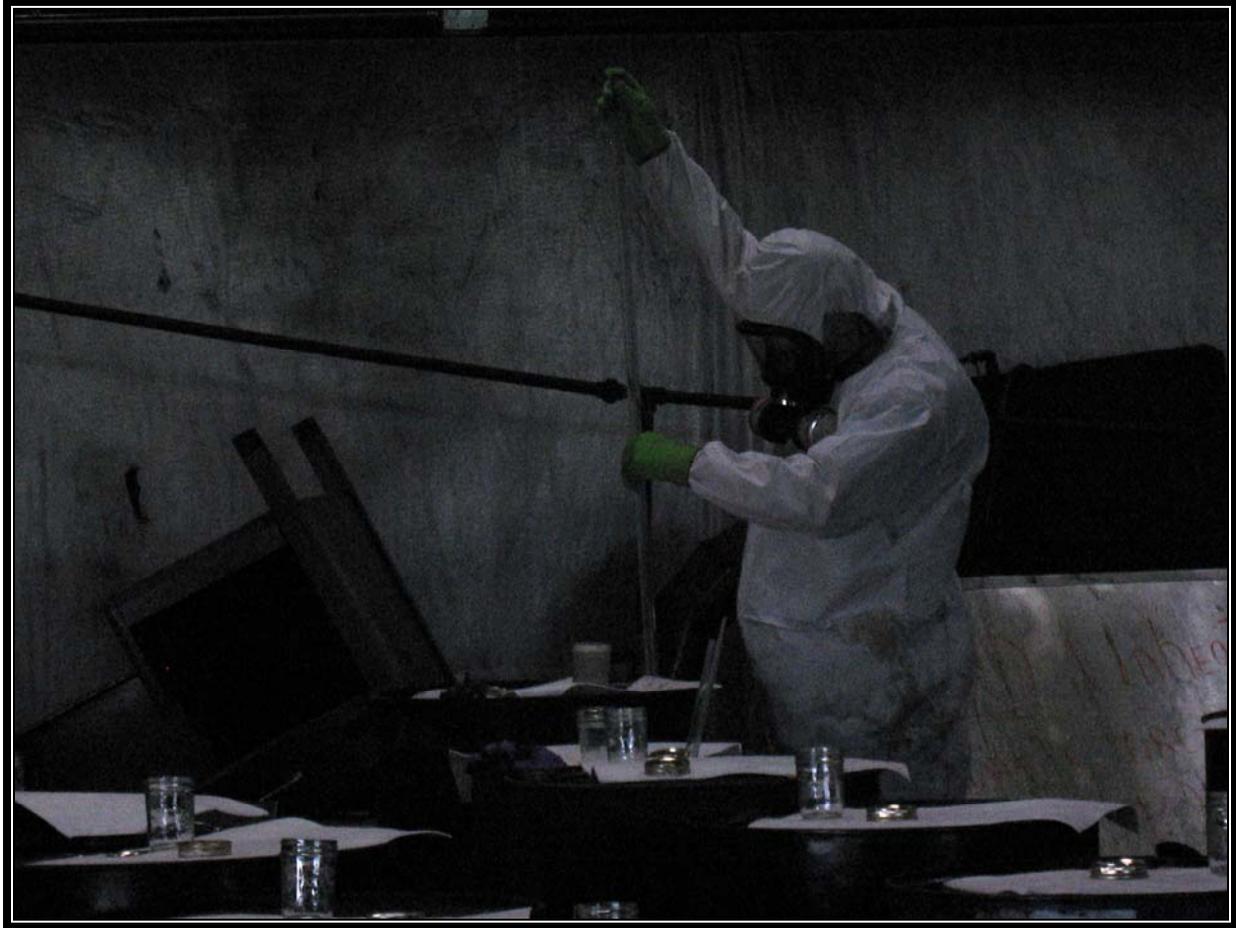
**OFFICIAL PHOTOGRAPH NO. 11  
U.S. ENVIRONMENTAL PROTECTION AGENCY**

**Subject:** Samples were collected from each drum. Additionally, information about each drum—including its volume, percent full, and any layering—was recorded during the sampling event

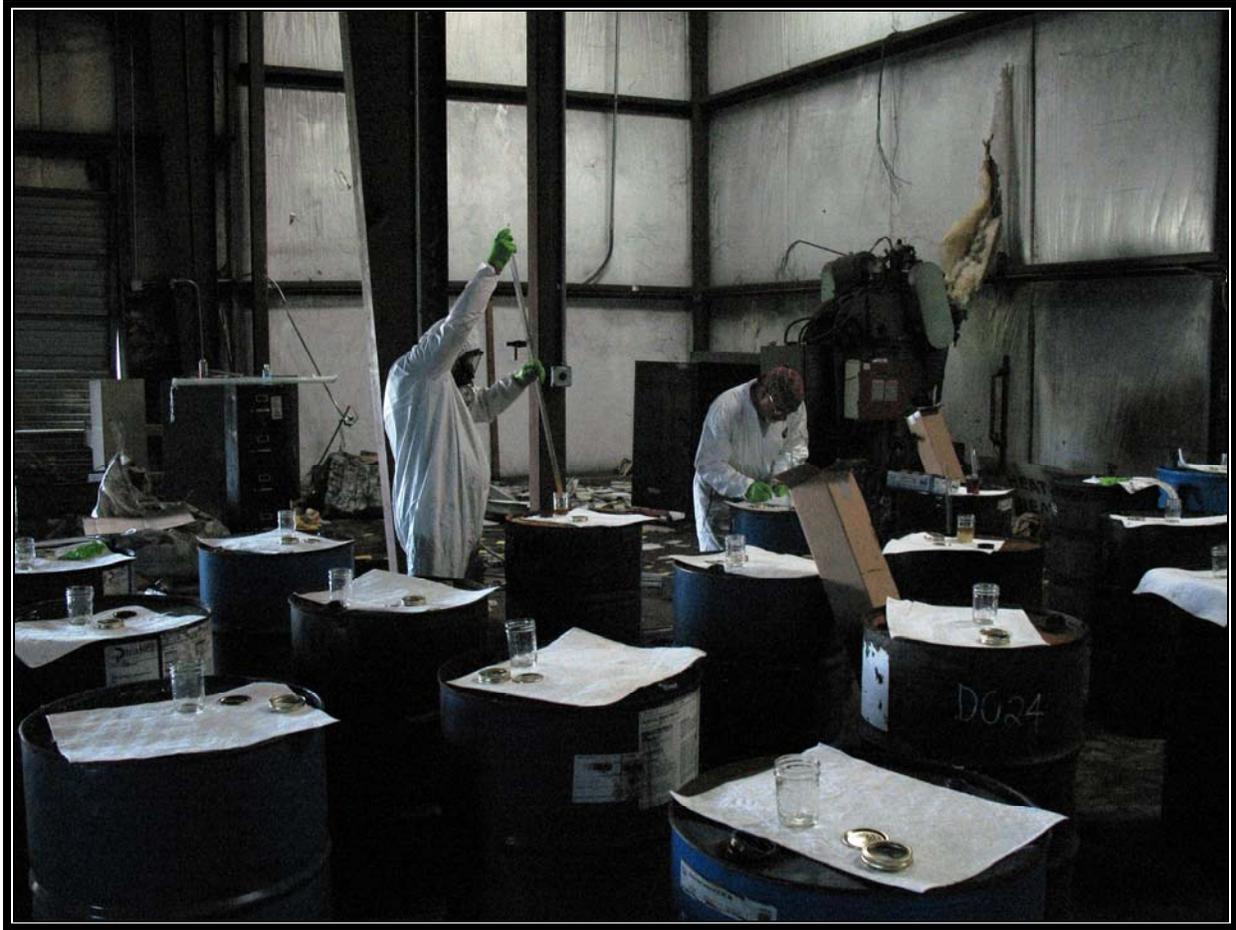
**OFFICIAL PHOTOGRAPH NO. 12**  
**U.S. ENVIRONMENTAL PROTECTION AGENCY**

**Subject:** START collecting samples from containers. Sampling equipment was pre-staged for each container to speed the sampling process.

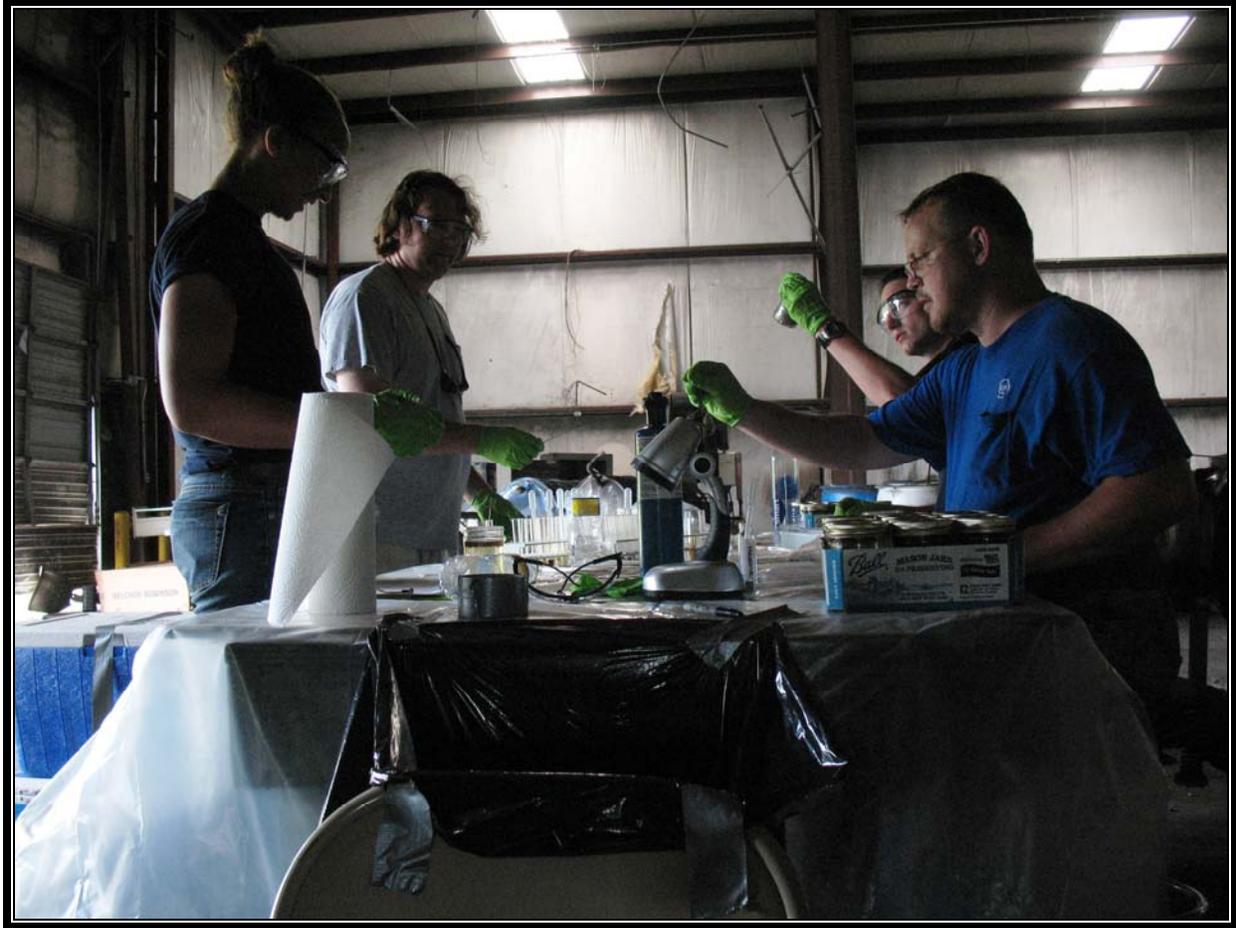
**OFFICIAL PHOTOGRAPH NO. 13  
U.S. ENVIRONMENTAL PROTECTION AGENCY**

**Subject:** Samples taken from drums were subjected to a series of field hazard categorization tests to determine their hazardous characteristics. Similar containers were then grouped into common waste streams, and composite samples of each waste stream were sent to a lab for disposal profile analysis.
