**Grandview and Josephine Mines
Removal Assessment Report
Metaline Falls, Washington
TDD: 03-05-0003**

**GRANDVIEW AND JOSEPHINE MINES
REMOVAL ASSESSMENT REPORT
METALINE FALLS, WASHINGTON**

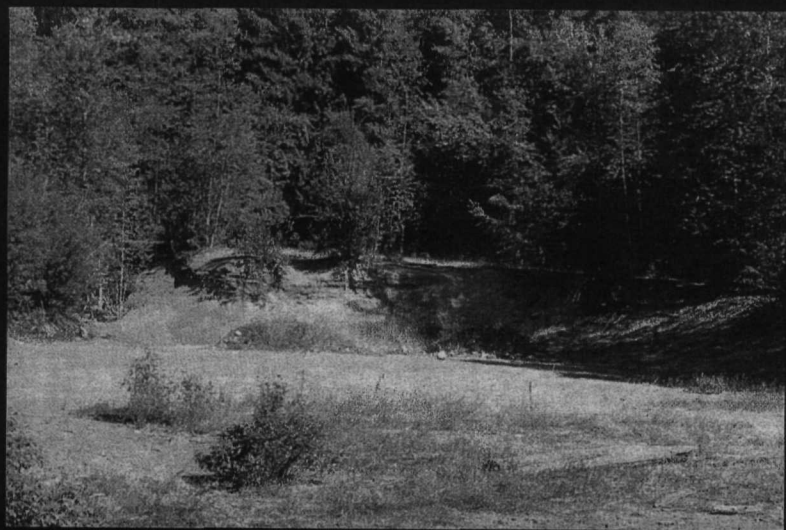
Photo 1.01

Photo No.	Date	By	Direction	Description
1.01	8/18/03	SD	E	A view of the Grandview Mine tailings deposit area located at the Pend Oreille Village.
1.02	8/18/03	SD	E	The area left of the tailings shown in Photograph 1.01.

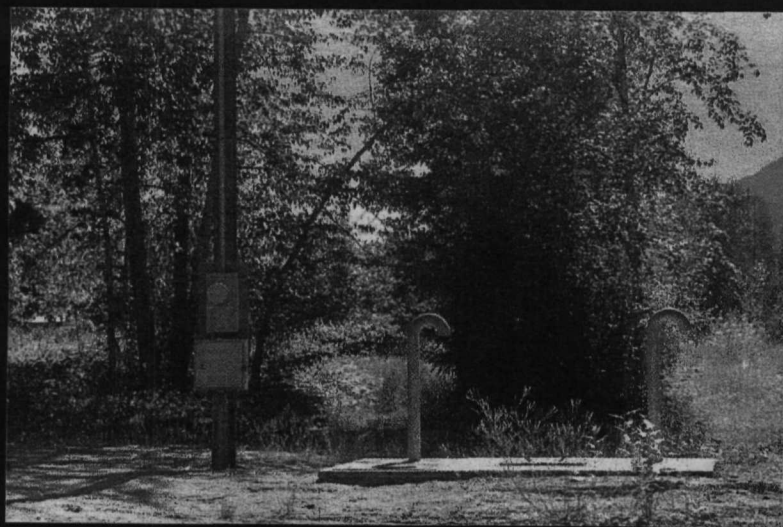
Photo 1.03

1.03	8/18/03	SD	W	A view of the access road to the tailings deposit area and a view of the Pend Oreille Village municipal water supply wells.
1.04	8/18/03	SD	E	Looking up at the Grandview Mine tailings deposit area from the drainage area below this area.

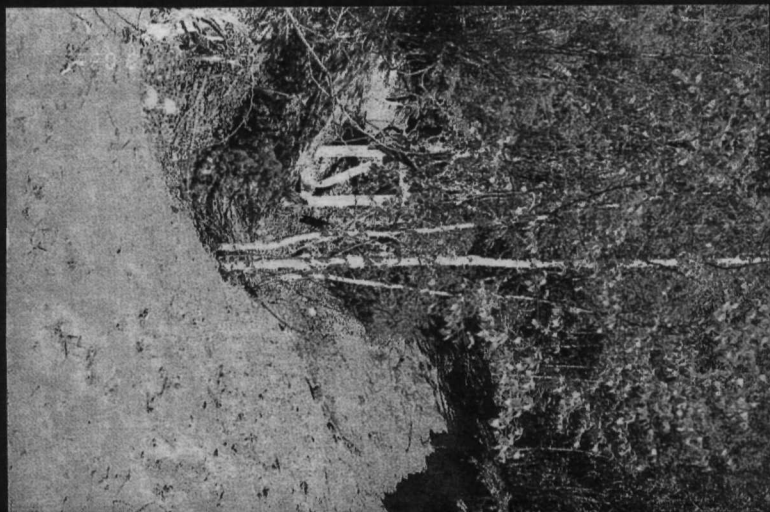
Photo 1.05

1.05	8/18/03	SD	E	A view of the drainage area just above the Grandview Mine tailings deposit area.
1.06	8/18/03	SD	E	Same as Photograph 1.05.
1.07	8/18/03	SD	W	A view of the Grandview Mine tailings deposit area as seen from the northeast corner of the area.

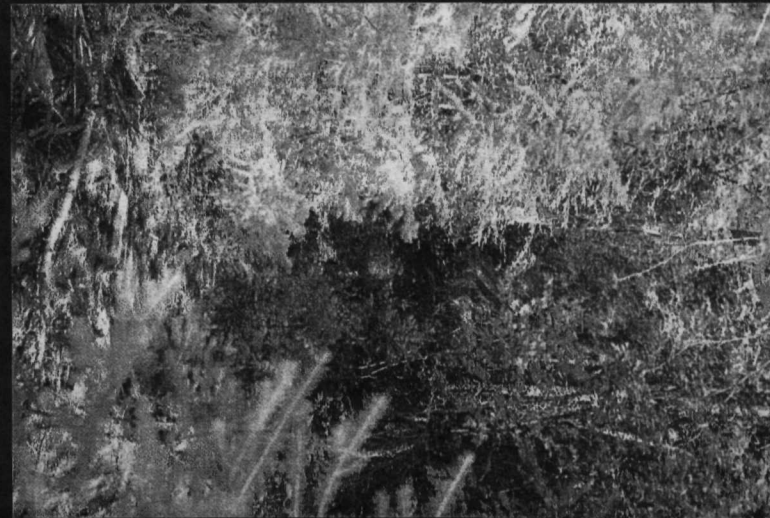
Photo 1.08

1.08	8/18/03	SD	E	The drainage area located above the tailings area, just east of the drainage pictured in Photograph 1.05.
1.09	8/18/03	SD	W	Remnants of the flume that was used to discharge mill tailings to the Grandview Mine tailings deposit area.

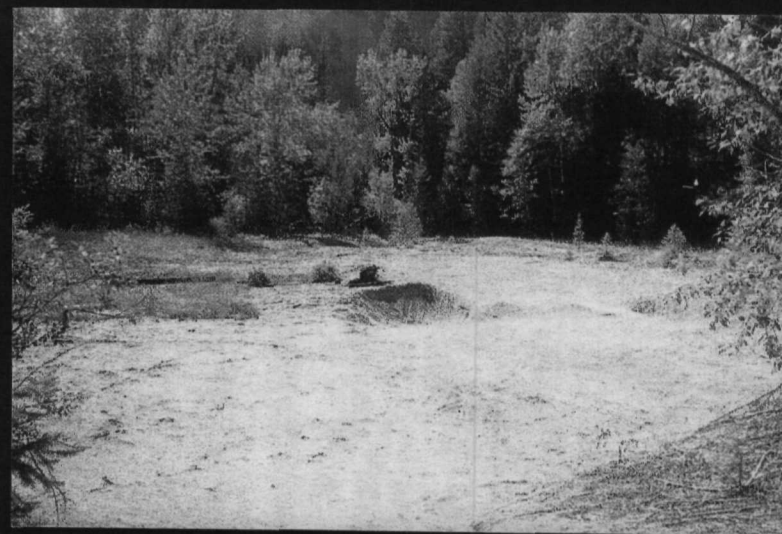
Photo 1.10

1.10	8/18/03	SD	W	Another view of the tailings deposit area as seen from where Photograph 1.09 was taken.
1.11	8/18/03	SD	W	Another view of the tailings deposit area just south of the area pictured in Photograph 1.10. Photograph 1 of a panoramic series of three photographs.

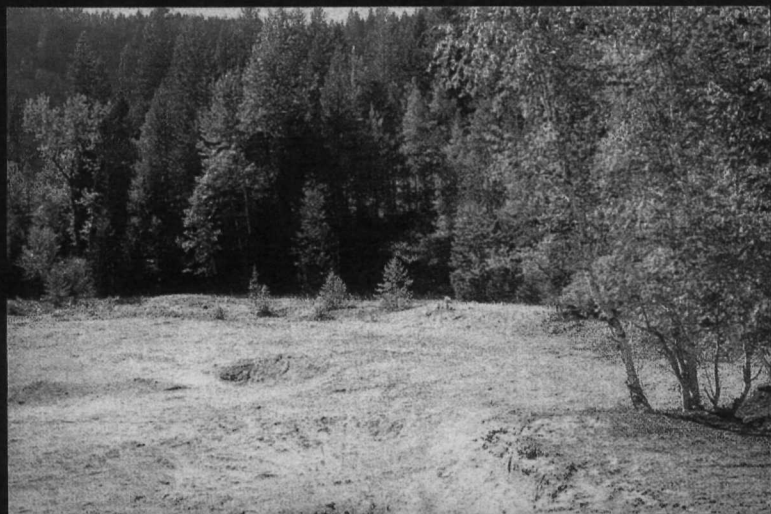
Photo 1.12

1.12	8/18/03	SD	W	Same as Photograph 1.10. Photograph 2 of a panoramic series of three photographs.
1.13	8/18/03	SD	W	Another view of the tailings deposit area just north of area pictured in Photograph 1.12. Photograph 3 in a panoramic series of three photographs.

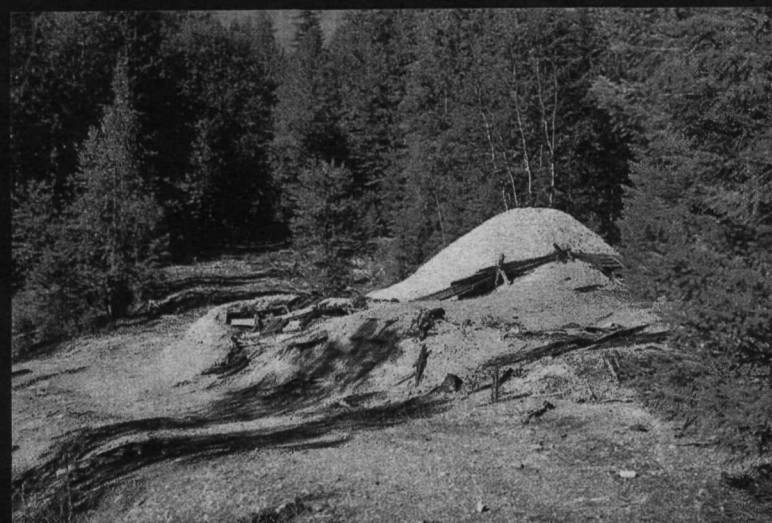
Photo 2.02

¹ Slopes of fifty percent are located in areas where tailings material is deposited in large piles (Photographs 2.02 and 2.06).

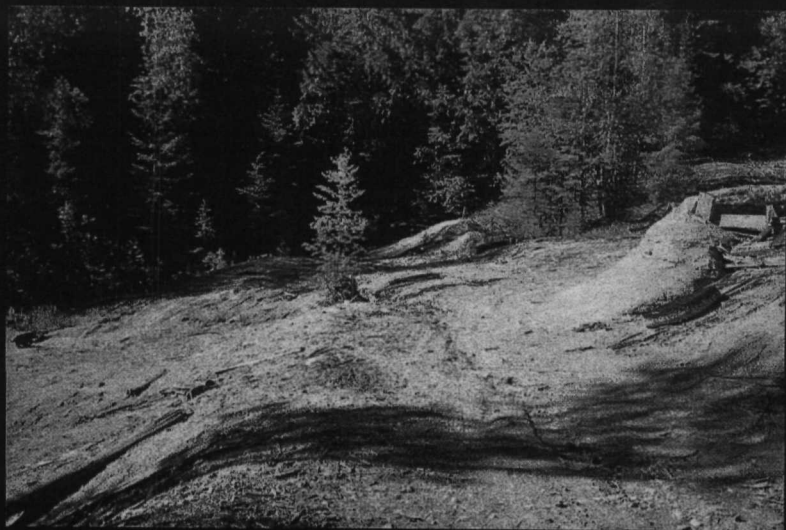
Photo 2.03

Photo No.	Date	By	Direction	Description
2.03	8/19/03	SD	S	A view of tailings adjacent to Flume Creek at the Old Mill Area of Josephine Mine.
2.04	8/19/03	SD	SW	Tailings west of the tailings pictured in Photograph 2.03.

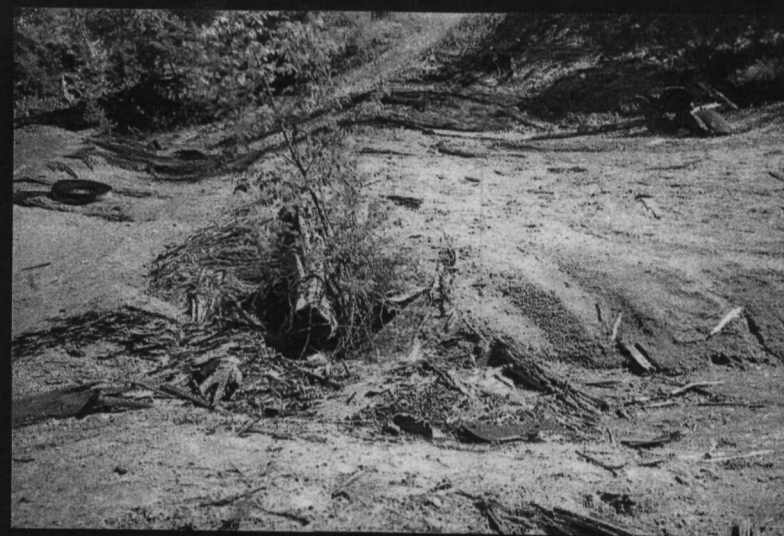
Photo 2.05

2.05	8/19/03	SD	N	Recent erosion in the tailings caused by runoff. Tailings in the photograph are located in the Old Mill Area of Josephine Mine.
2.06	8/19/03	SD	E	Tailings located east of the tailings pictured in Photograph 2.03.

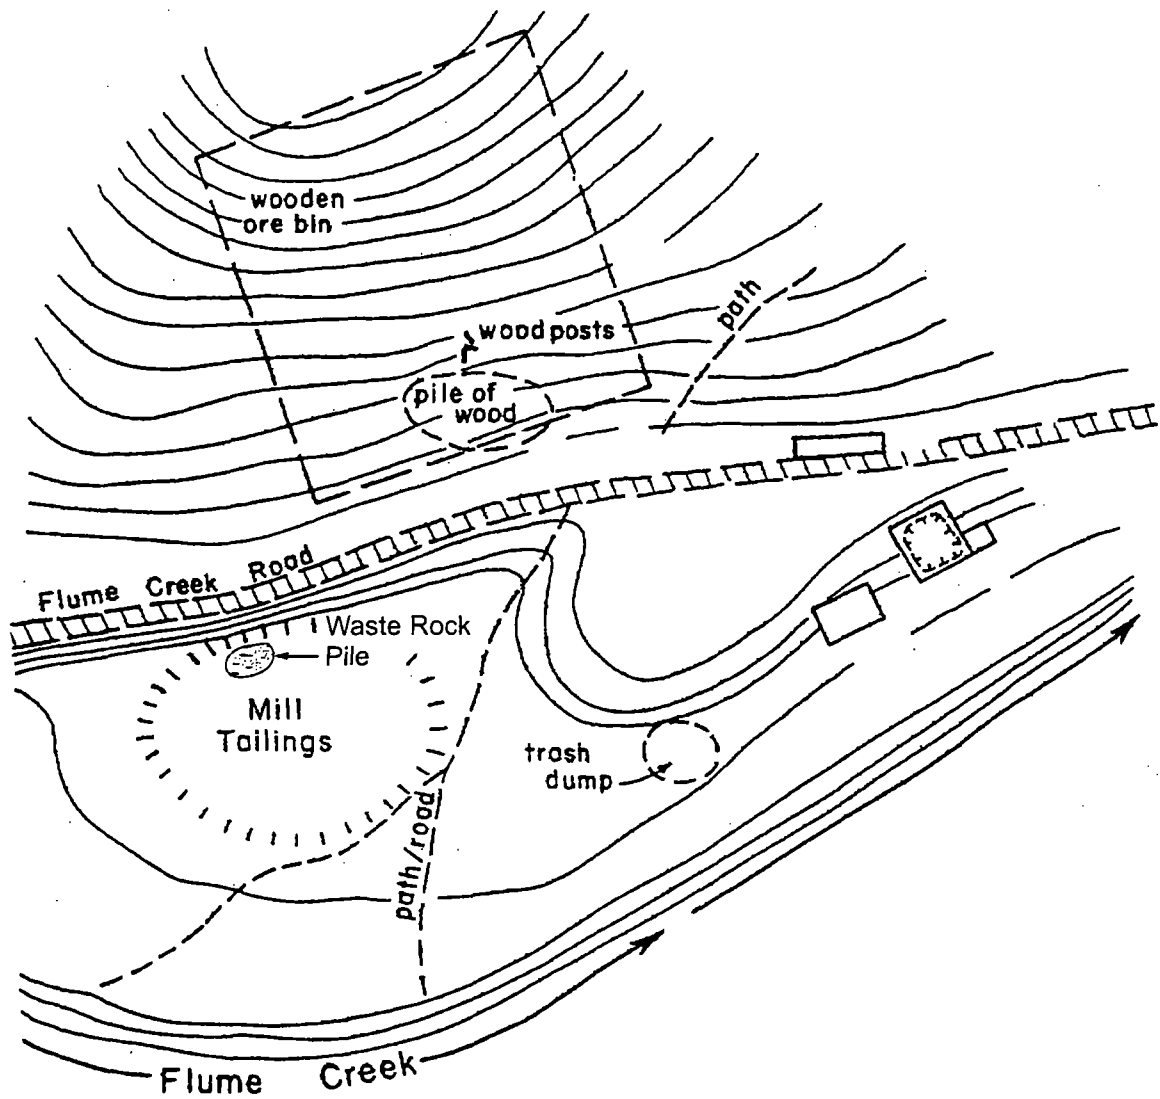
10:START-2\03050003\fig 1-3

There are two mill areas referred to as the Old Josephine Mill (Figure 1-3) and the New Josephine Mill (Figure 1-4). The Old Josephine Mill is located 0.25 miles east of Boundary Dam Road on Flume Creek Road and encompasses 5.3 acres. Access to the site is unrestricted. The Old Josephine Mill consists of a waste rock pile, tailings piles, and remnants of the old mill building. Tailings material covers about 2.5 acres in the area south of the site access road and extends down to the north bank of Flume Creek. The terrain at the Old Josephine Mill on the north side of the site access road consists of steep, rocky hills. South of the site access road, the slope varies between five and fifty percent¹. Waste rock and unprocessed ore has been mixed into the tailings material adjacent to the site access road. Flume Creek runs along the toe of the tailings pile. The flow in Flume Creek is estimated by the START-2 to be greater than 10 cubic feet per second. (E & E 2002)

The Old Josephine Mill area is located about 0.2 miles off of Boundary Dam Road and is the first area of the mine to be encountered by the site access road. At the Old Josephine Mill area, the START-2 photographed the tailings pile and collected a sample of the tailings. Photographs of the Josephine Mine site are provided as Appendix A.

The tailings in this area are tan in color and consist of fine-grained sandy soil. Tailings are deposited adjacent to the site access road and extend down to the north bank of Flume Creek. Roughly 25 feet from the north bank of Flume Creek on the east and west sides of the main tailings area, are large piles of tailings. Very little vegetation was observed in the areas where tailings are present. Erosion resulting from surface water runoff is visible throughout the primary tailings pile area. Also situated in the tailings pile area adjacent to the site access road is a large pile of unprocessed ore/waste rock.

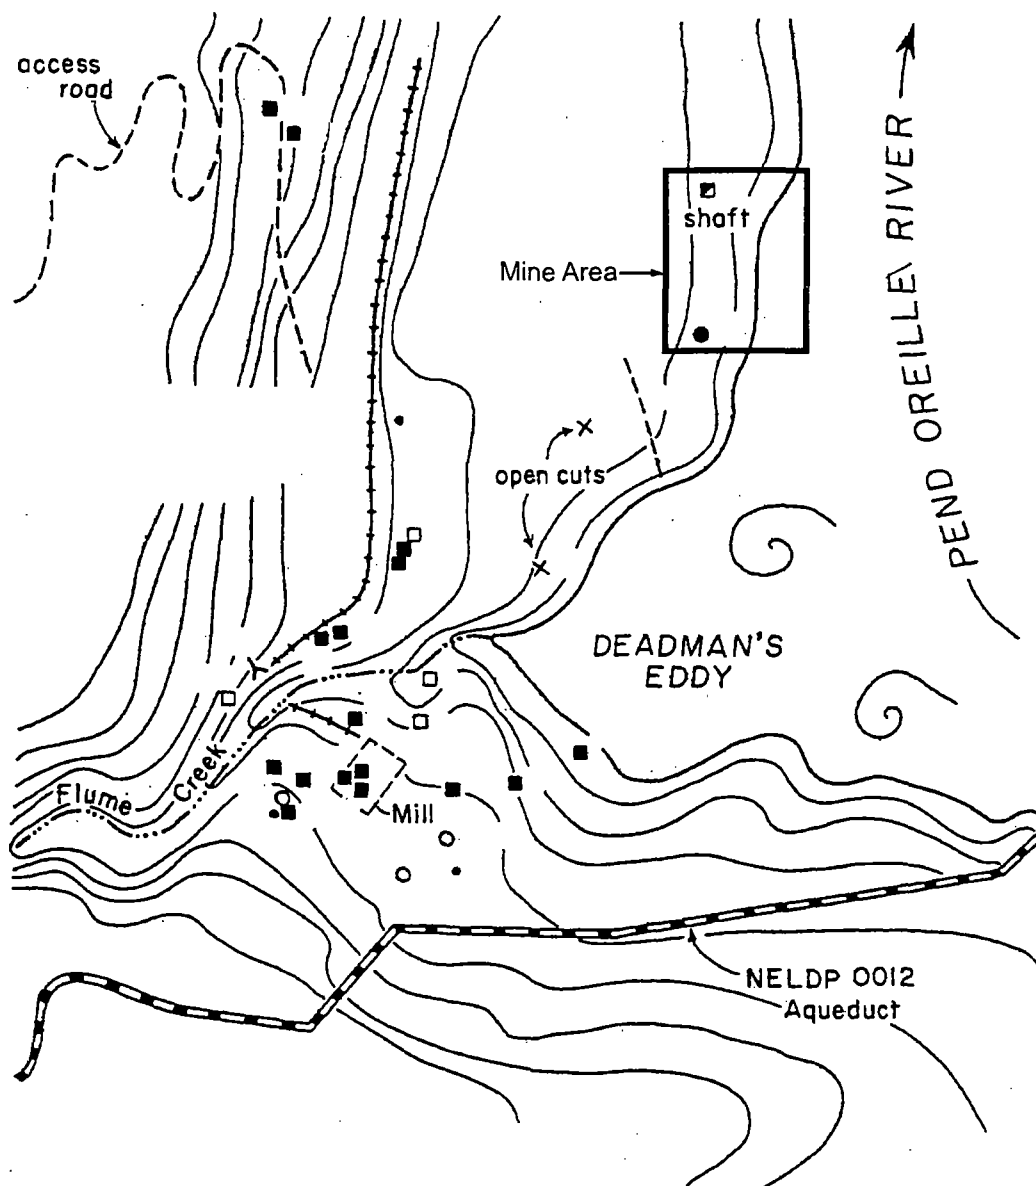
10:START-2\03050003\fig 1-4

The New Josephine Mill is located 0.7 miles east of Boundary Dam Road, towards the Pend Oreille River (E & E 2002). The New Josephine Mill site encompasses 38.5 acres and straddles Flume Creek (E & E 2002). Two waste rock piles and some remnant mill buildings are present at this site (BLM n.d.). Remnants of a tailings flume are present throughout Flume Creek and at its mouth (BLM n.d.). The terrain is flat in the area where the mill buildings are situated, however, the rest of the New Josephine Mill site, including the waste rock piles, slopes steeply down to Flume Creek (E & E 2002).

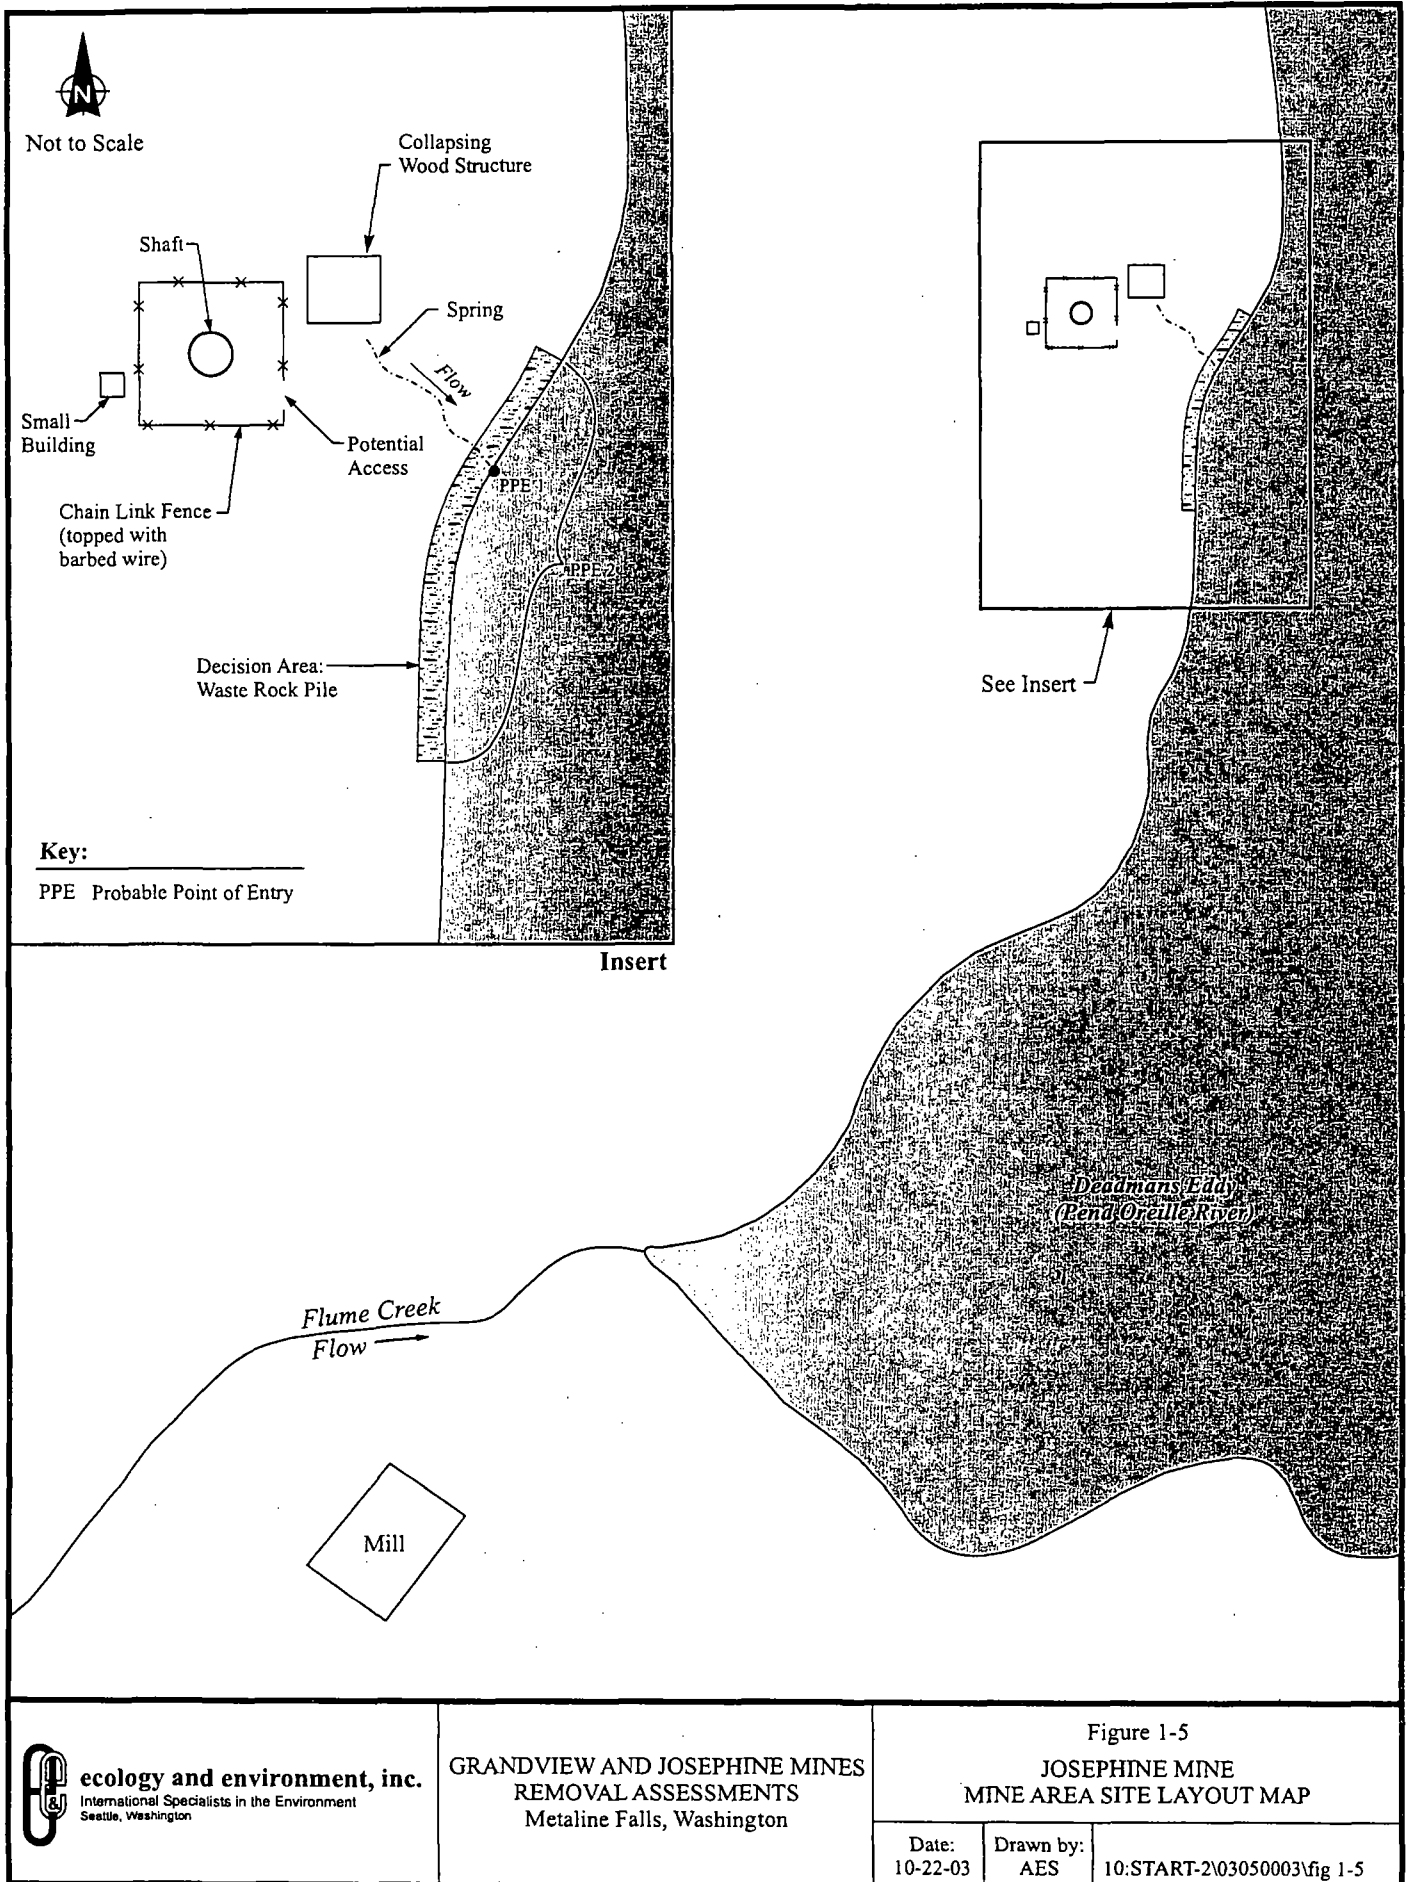
Figure 1-5

The mine area consists of a shaft, a waste rock pile, a small building, and a collapsing wood structure and is located directly across the Pend Oreille River from the waste rock at the Pend Oreille Mine/Mill (Figure 1-5). The shaft is surrounded by an 8-foot, barbed-wire-topped, chain-link fence. The shaft is filled with water up to approximately 25 feet from the surface. Approximately 2 feet southwest of the collapsing wood structure is a spring. The spring is estimated to flow at rates between 2 to 3 gallons per minute. The waste rock pile measures 60 feet long by 10 feet wide by 2 feet deep. The waste rock pile extends into the Pend Oreille River forming part of the bank of the river. A shop building and a

The mine area of the Josephine Mine site is located on the west bank of the Pend Oreille River and is not accessible by road. The mine area is only accessible by boat or by foot. An attempt was made to hike to the mine area along the bank of the Pend Oreille River south of Flume Creek's confluence with the river. The terrain along the bank of the Pend Oreille River at this location was rugged, and the EPA OSC decided that the effort required to access the site on foot would not be necessary. A boat will likely be necessary if access to this area is required in the future.
