Table 1
XRF and Corresponding Laboratory Results for Surfacing Material
Grandview Mine/Mill Site Reconnaissance
September 2008
Metaline Falls, WA

Table 2
Lower Level Mill Area XRF and Corresponding Laboratory Results for Tailings Material
Grandview Mine/Mill Site Reconnaissance
September 2008
Metaline Falls, WA

ENTACT <small>Leading the Nation in Customer Care</small>	Grandview Mine/Mill Property Metaline Falls, Washington
<p>Figure 1 General Site Location</p>

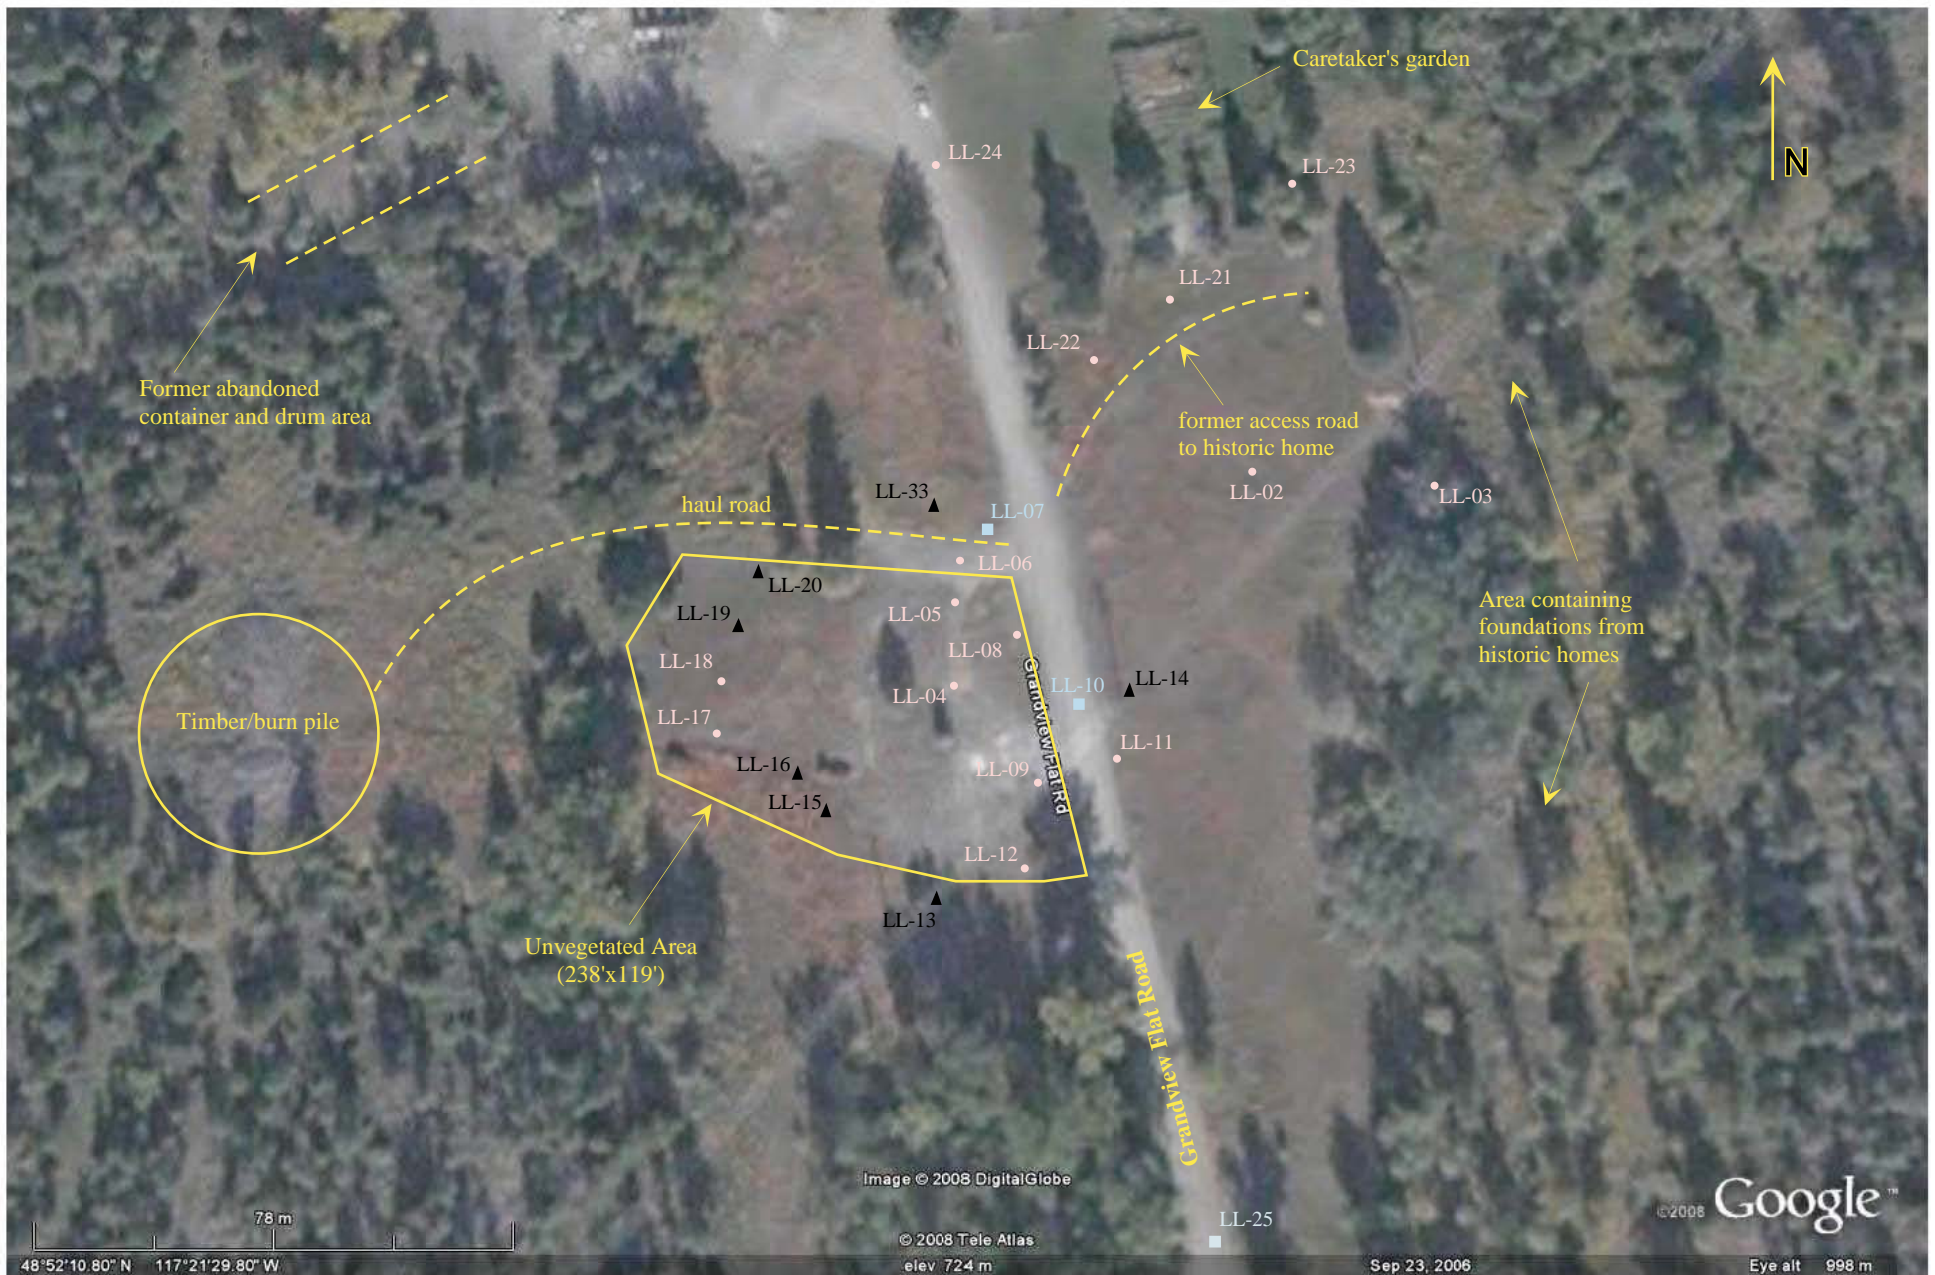
Figure 3
Lower Level Mill Area Sampling - Unvegetated Area and Homesite Area
Site Reconnaissance, September 2008

- ▲ XRF results below MTCA Method A cleanup levels
- XRF results above MTCA Method A cleanup levels for unrestricted land uses
- XRF results above MTCA Method A cleanup levels for industrial properties

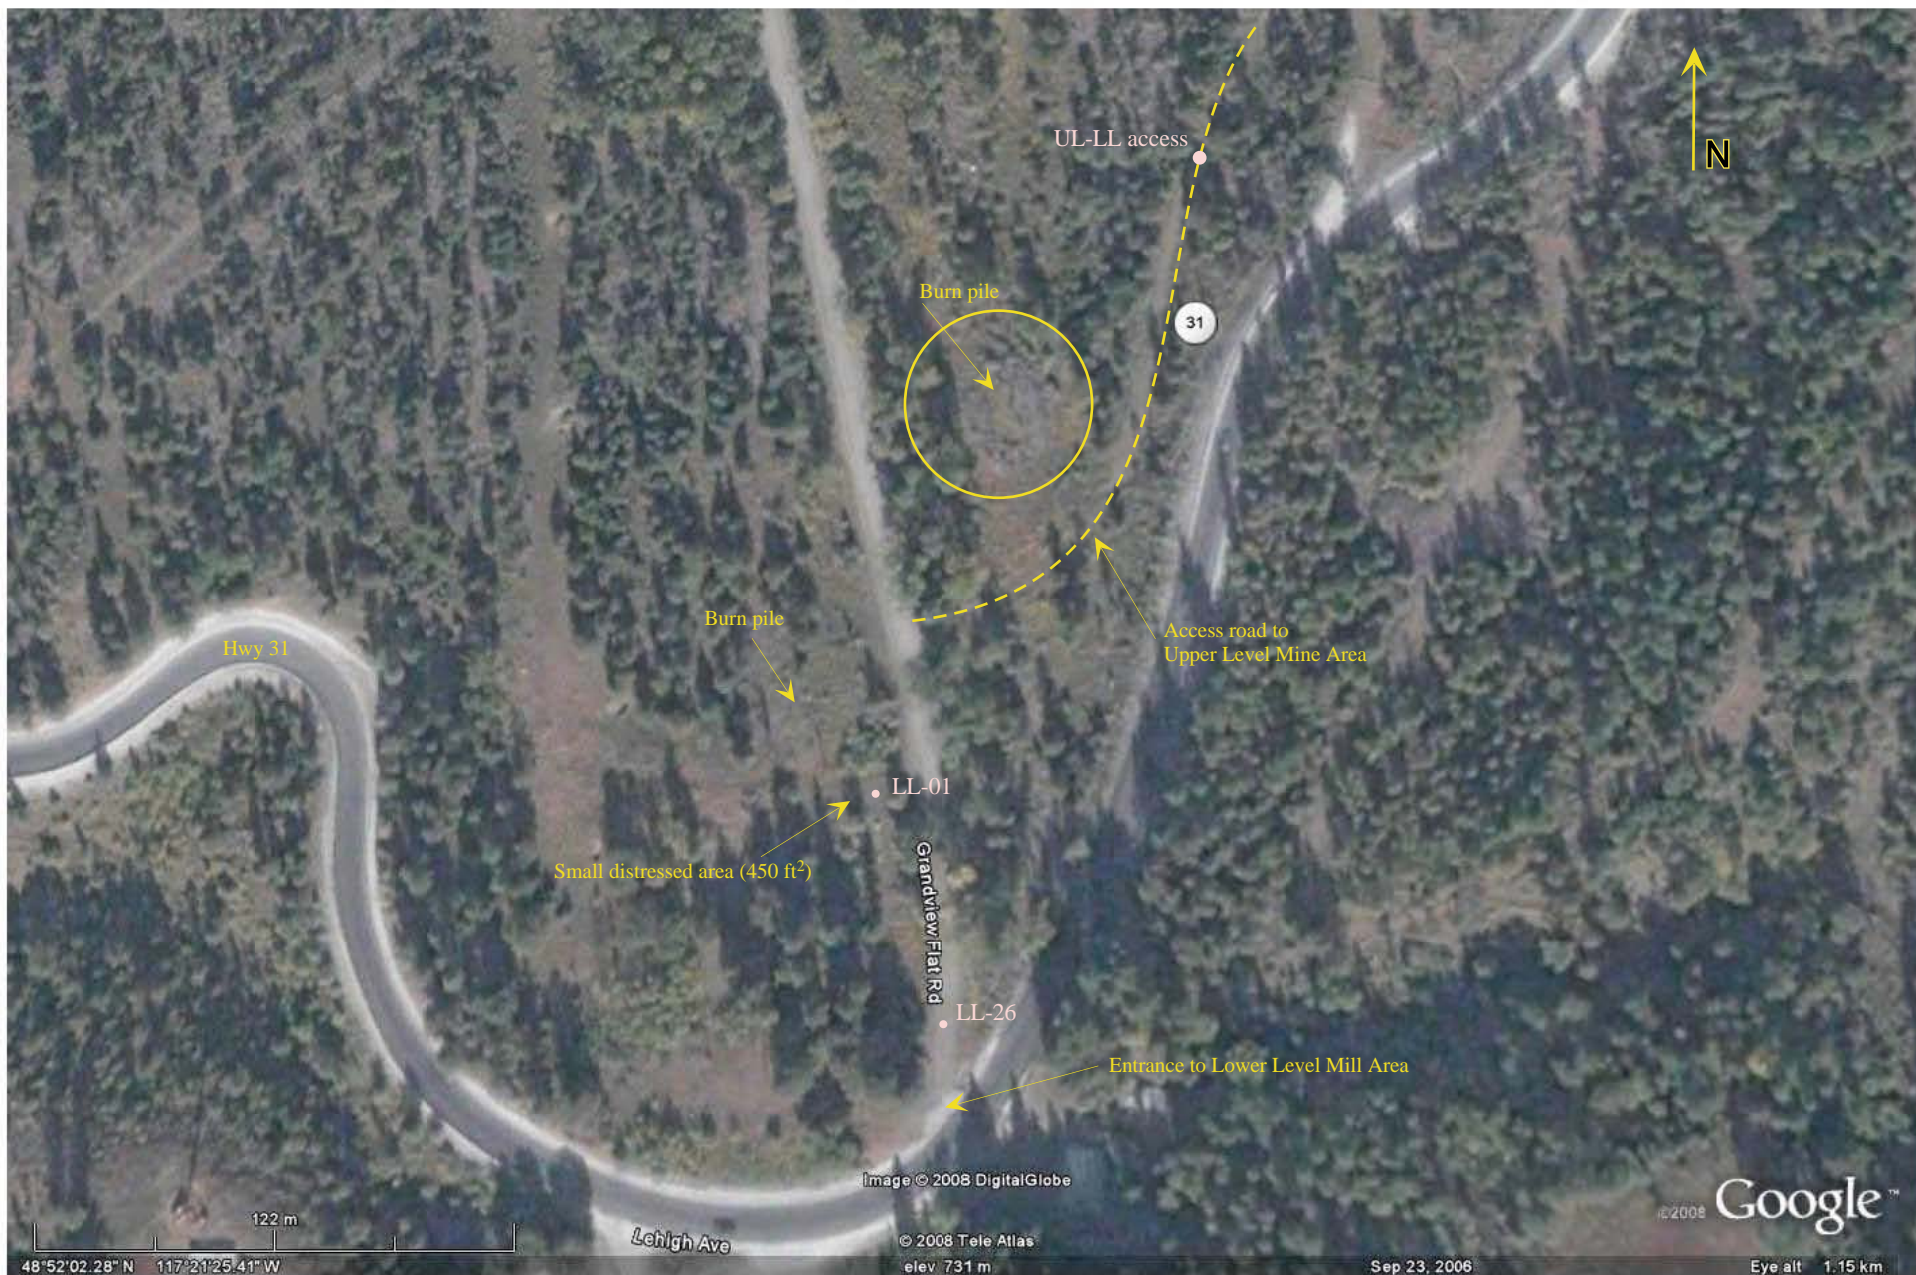
ENTACT Leading the Nation in Customer Care	Grandview Mine/Mill Property Metaline Falls, Washington
<p>Figure 4 Lower Level Mill Area Sampling along Grandview Flat Road Site Reconnaissance, September 2008</p>

- XRF results above MTCA Method A cleanup levels for industrial properties

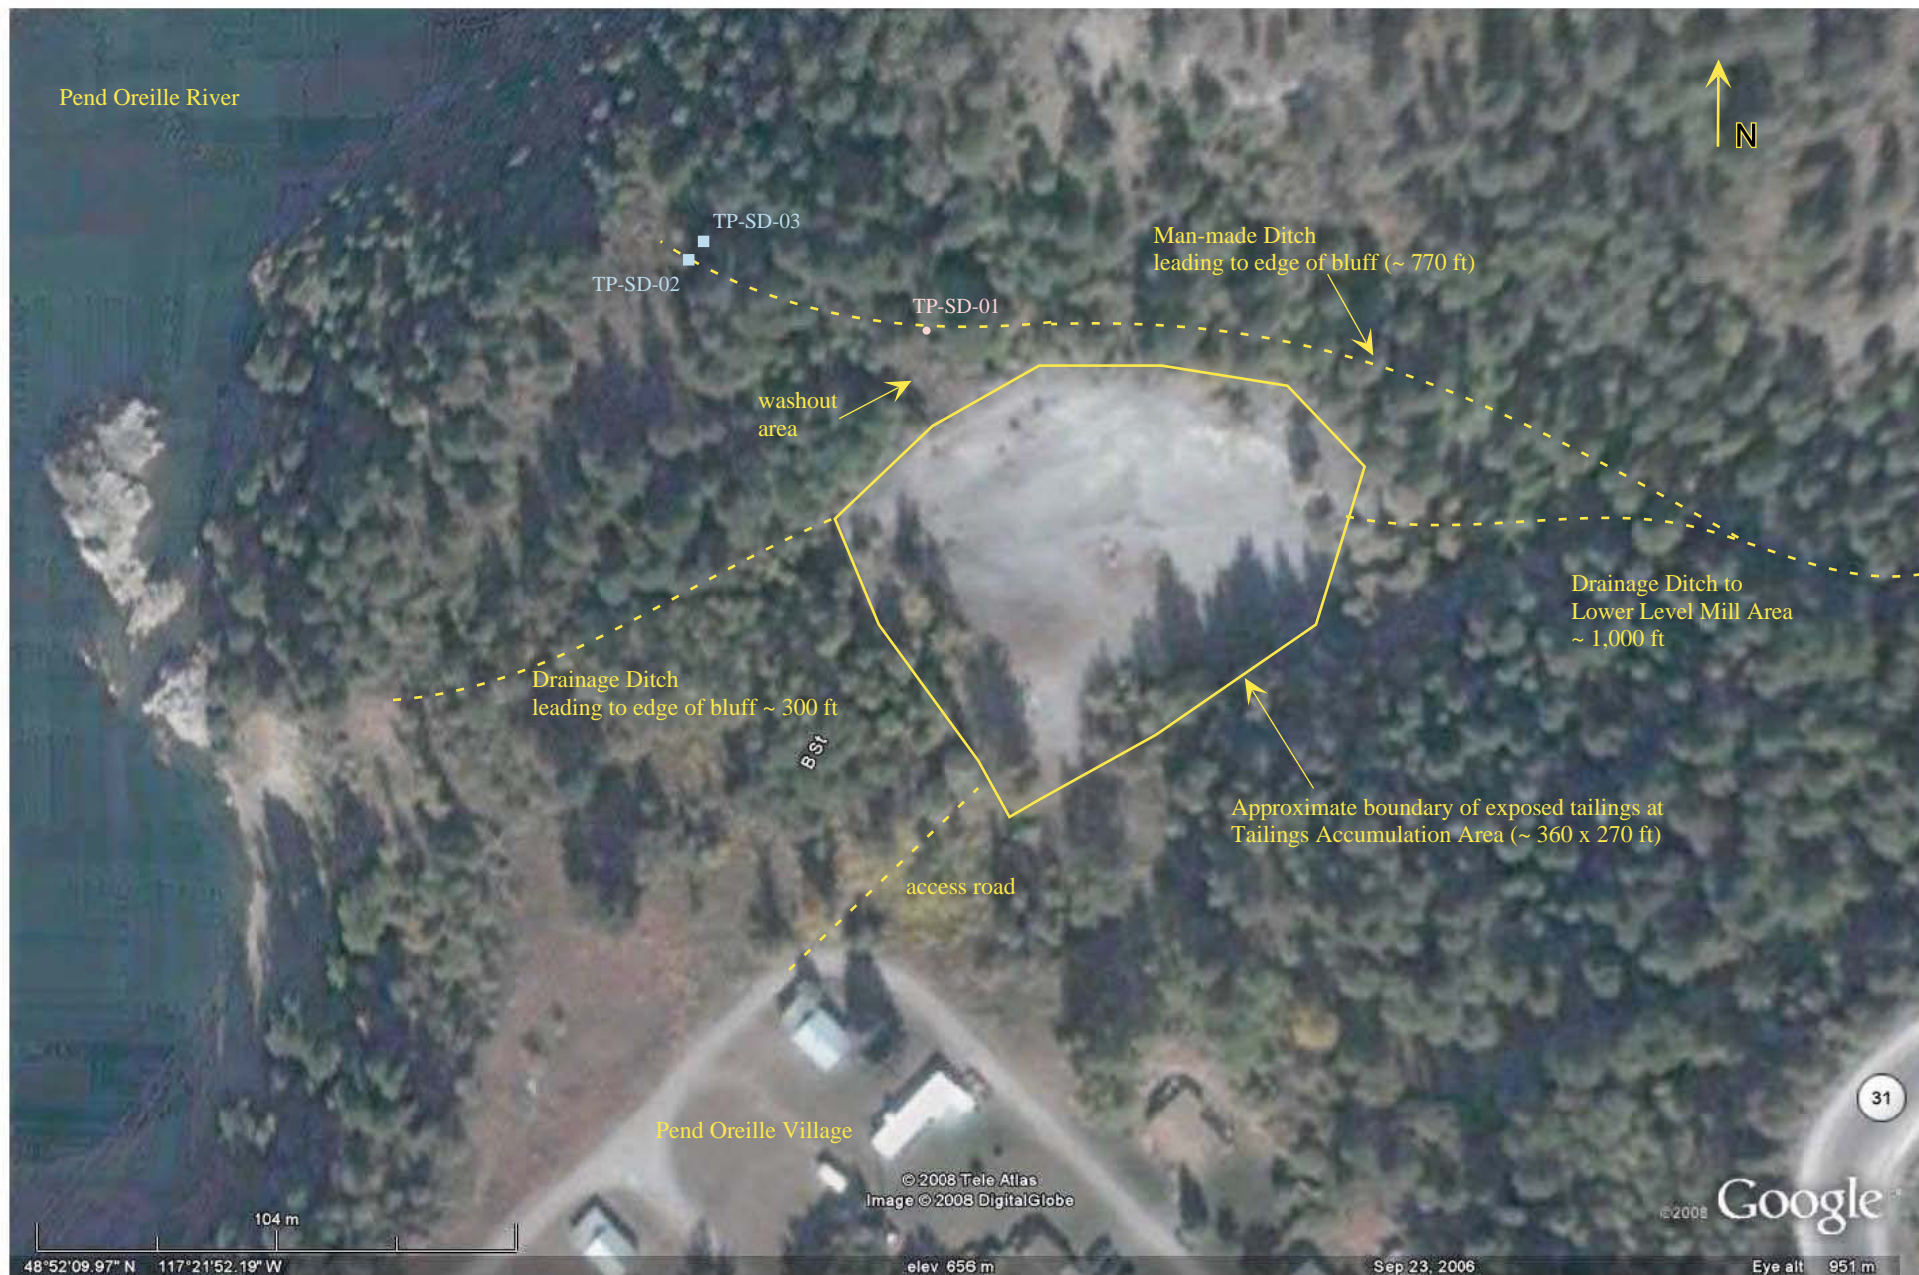
ENTACT Leading the Nation in Customer Care	Grandview Mine/Mill Property Metaline Falls, Washington
<p align="center"> Figure 5 Tailings Accumulation Area and Drainage Ditches Site Reconnaissance, September 2008 </p>

- XRF results above MTCA Method A cleanup levels for unrestricted land uses
- XRF results above MTCA Method A cleanup levels for industrial properties

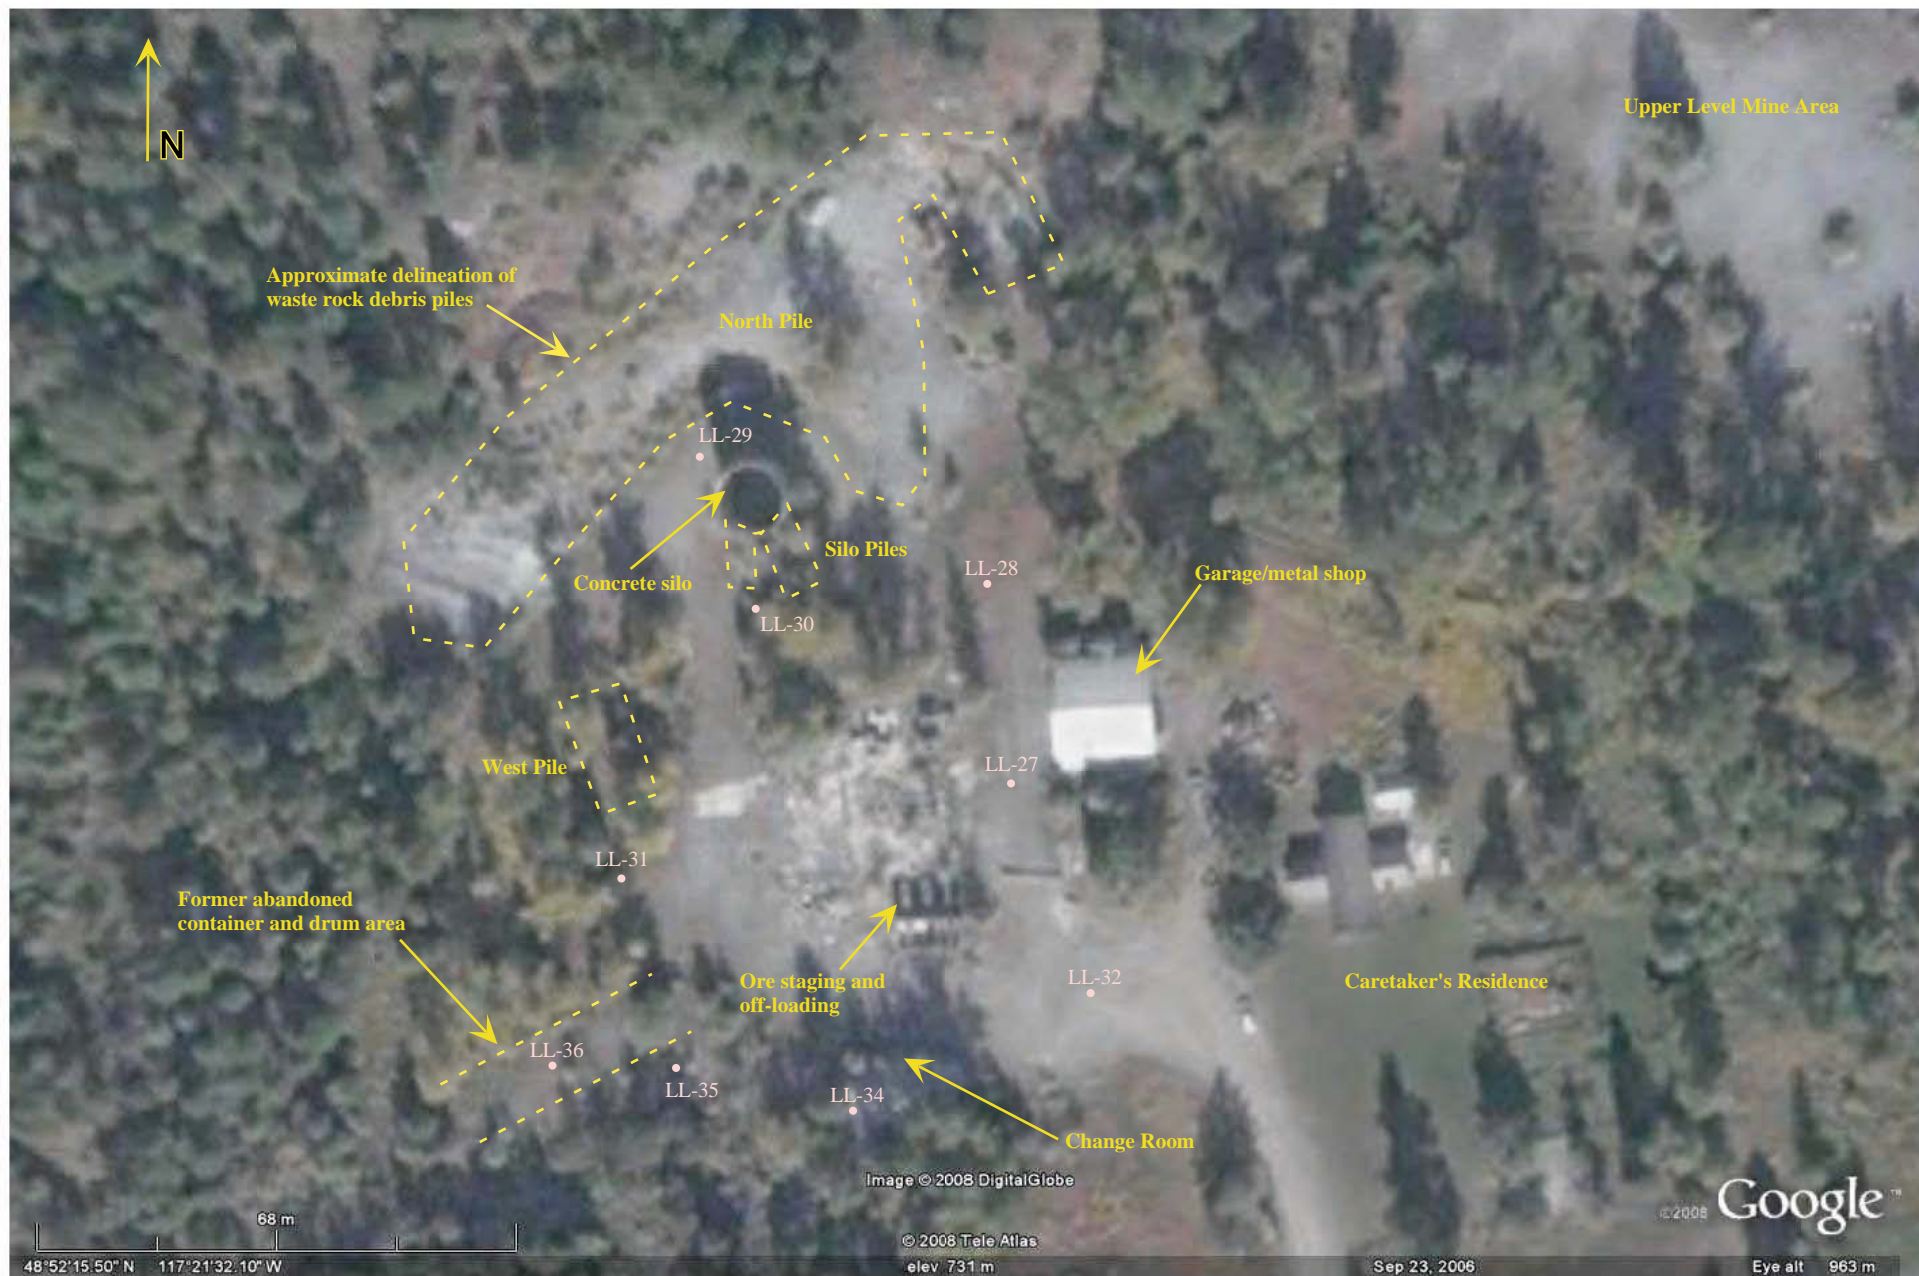
Figure 7
Lower Level Mill Area Sampling
Site Reconnaissance, September 2008

- XRF results above MTCA Method A cleanup levels for industrial properties
