FINAL DRAFT
Site Characterization Report
Grandview Tailings
Pend Oreille Village, Washington

URS Corporation
920 North Argonne, Suite 300
Spokane, Washington 99212

URS Project No. 36298195

January 31, 2007

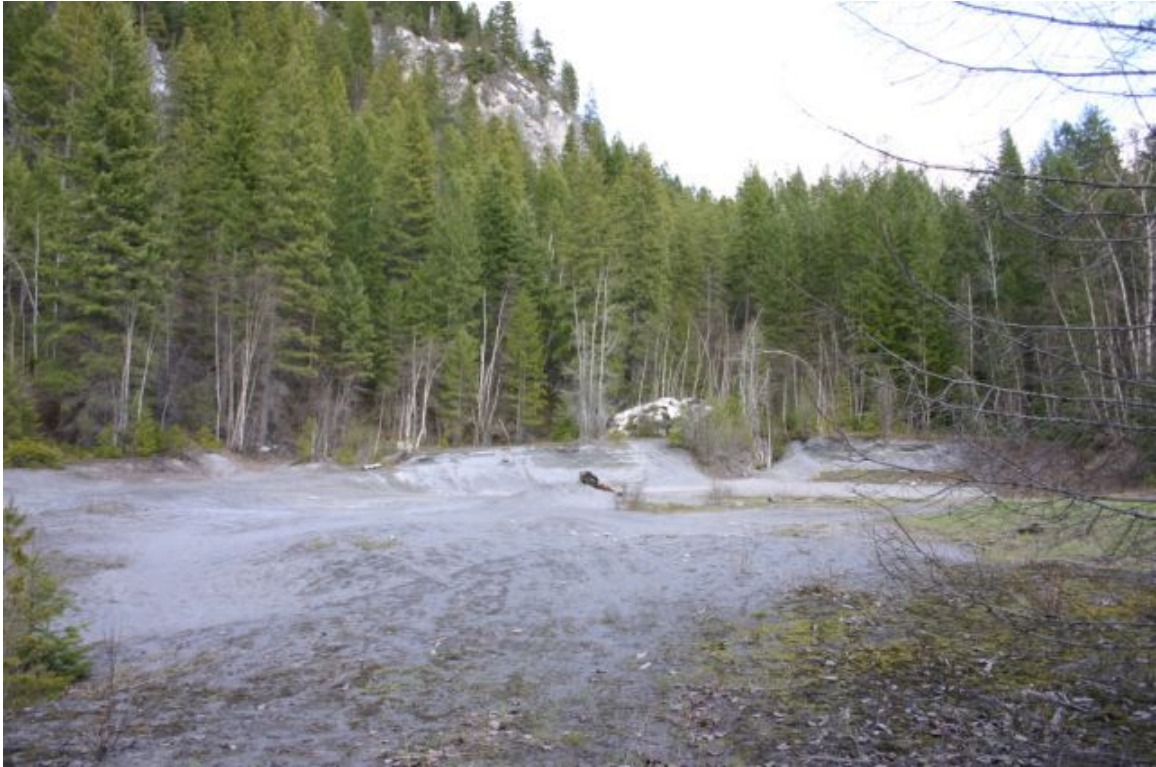
Photograph 1: Grandview mine tailings, view toward the east.

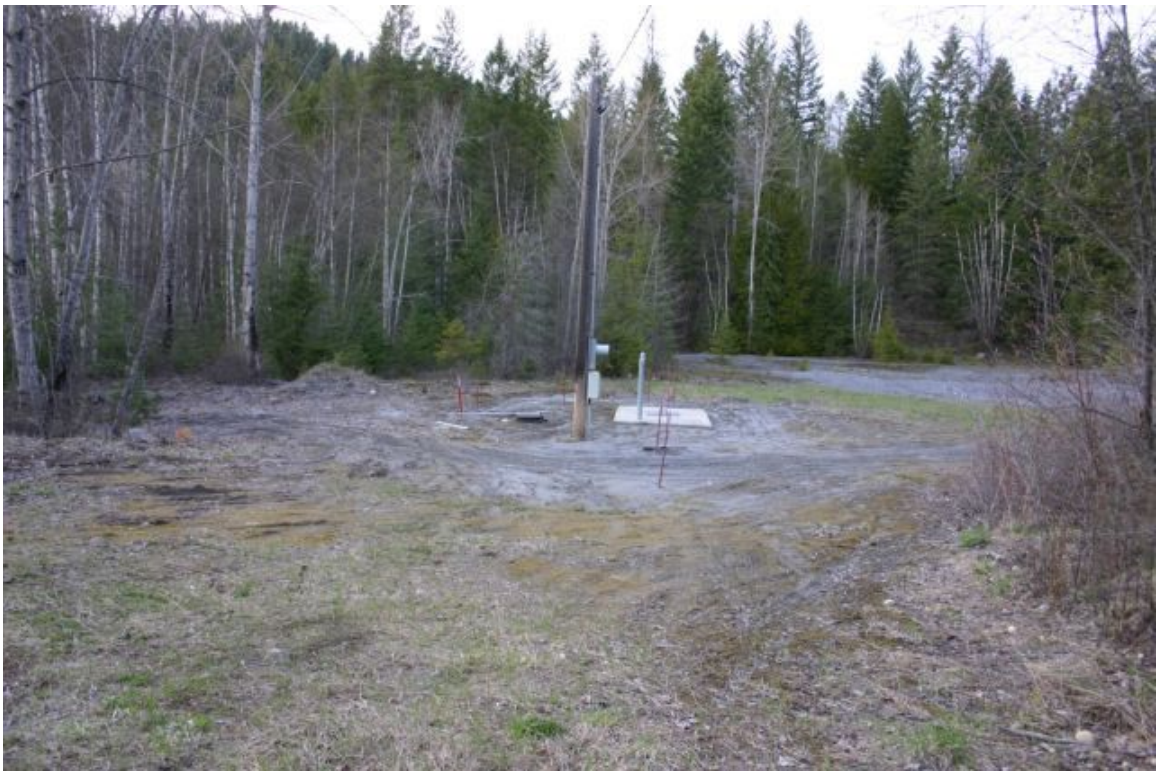
Photograph 2: View of Pend Oreille County Public Utility District's water booster station pressure reducing valve (PRV) and power pole. Note Grandview Mine tailings deposits in background. View to the northwest.

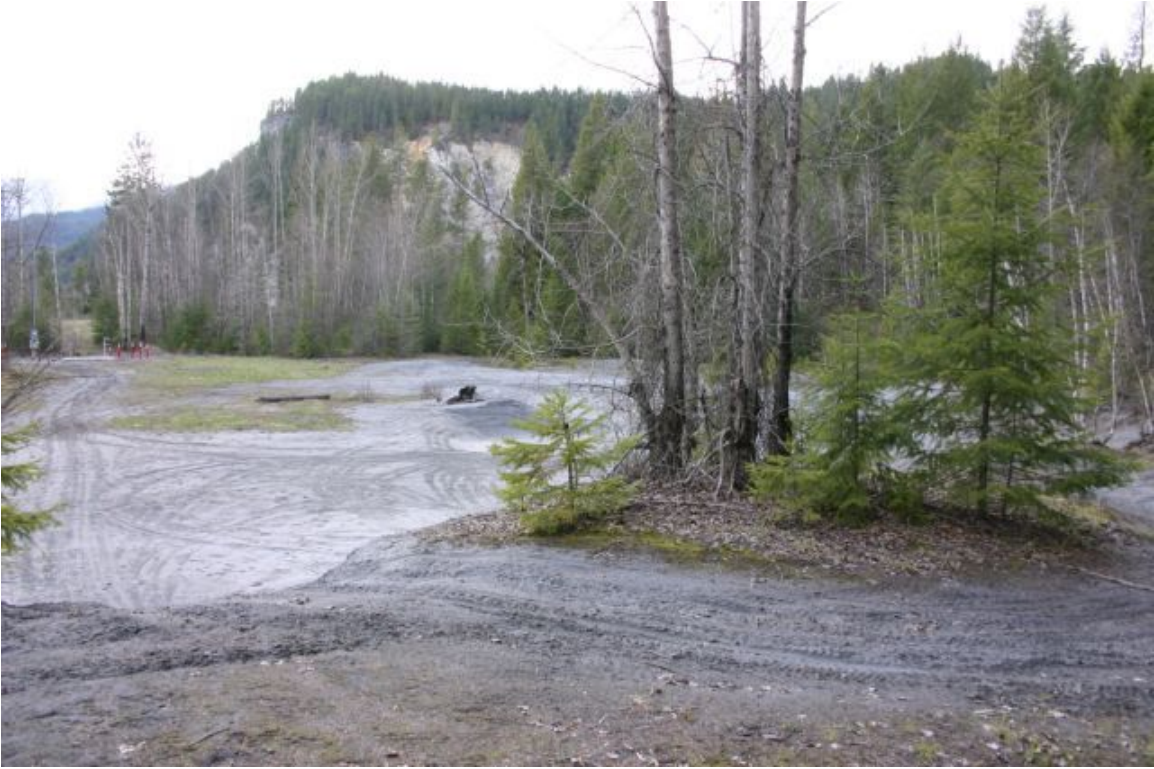
Photograph 3: View of Grandview Mine tailings to the west. Note the Pend Oreille County booster station PRV in upper left.

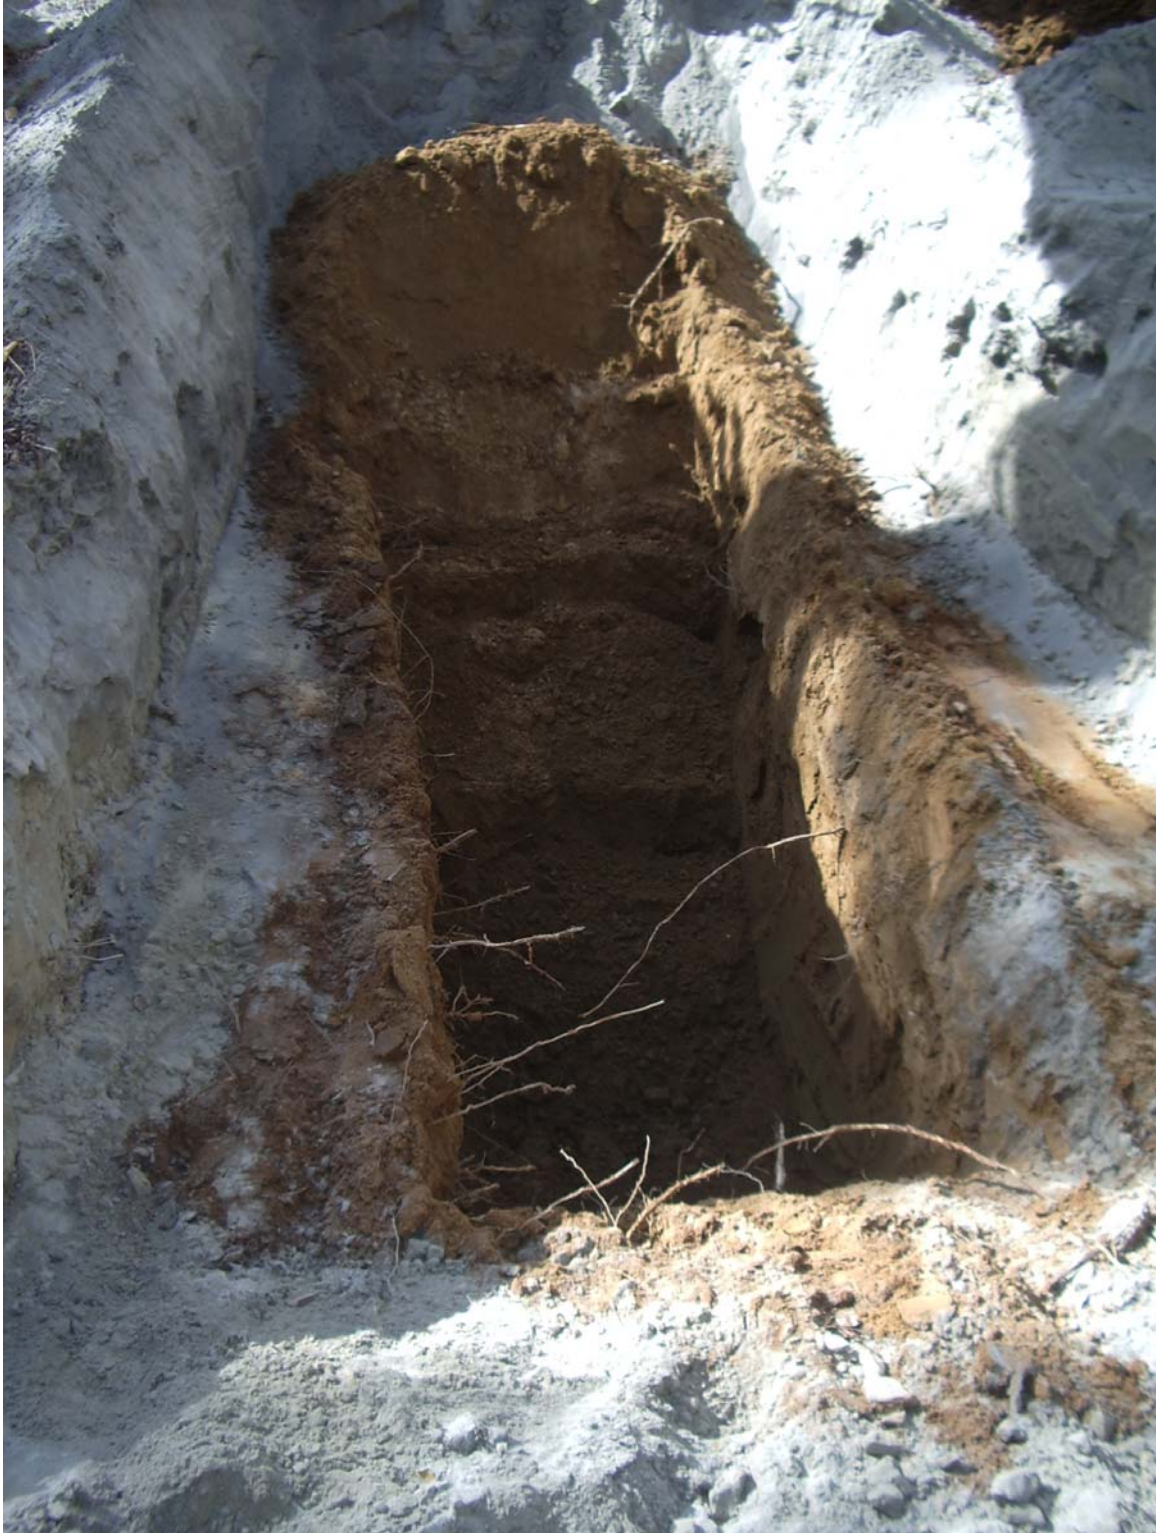
Photograph 4: Photograph of Test Pit TP-07. Note color difference between soil and tailings.

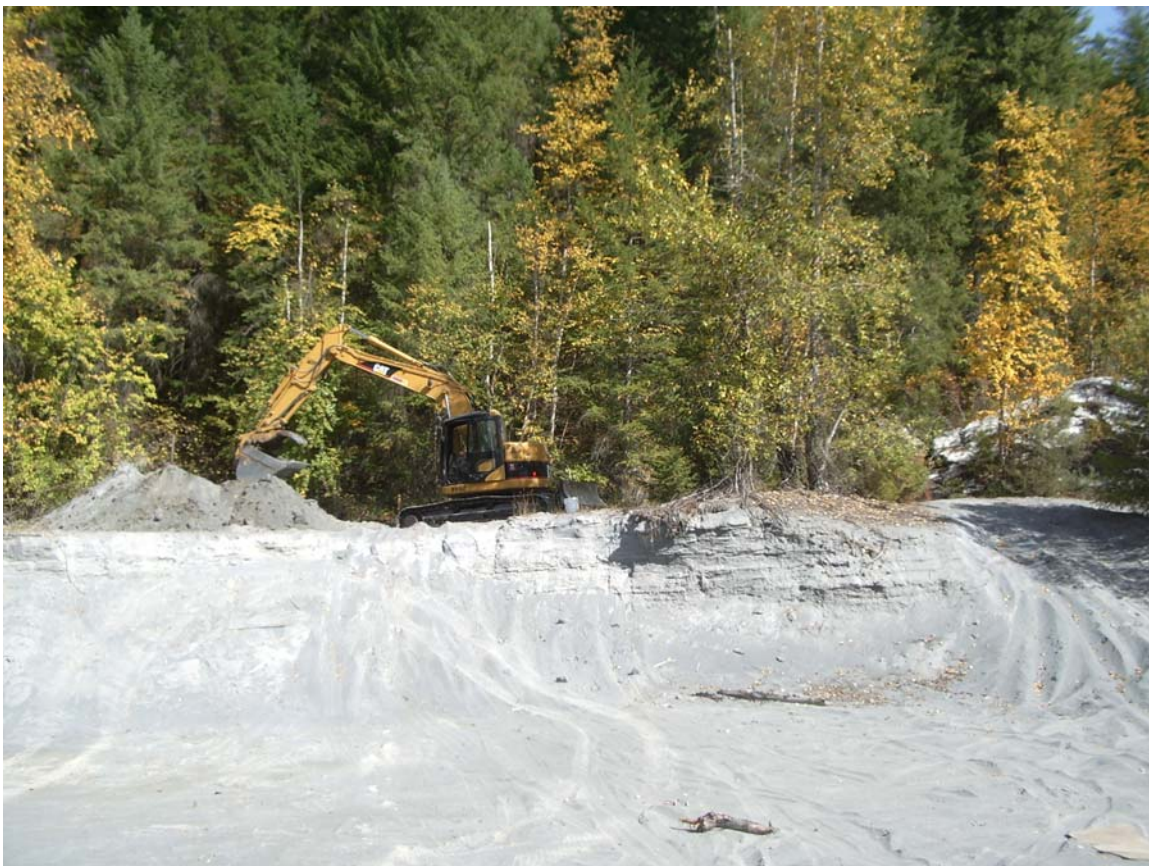
Photograph 5: Photograph of the excavation of Test Pit TP-06. View to the east.
