Title of Report: Cultural Resources Survey of the Grandview Mine and Mill, Pend Oreille County, Washington

Cultural Resources Survey of the Grandview Mine and Mill Site, Pend Oreille County, Washington

Short Report 1046
Archaeological and Historical Services
Eastern Washington University

December 2009

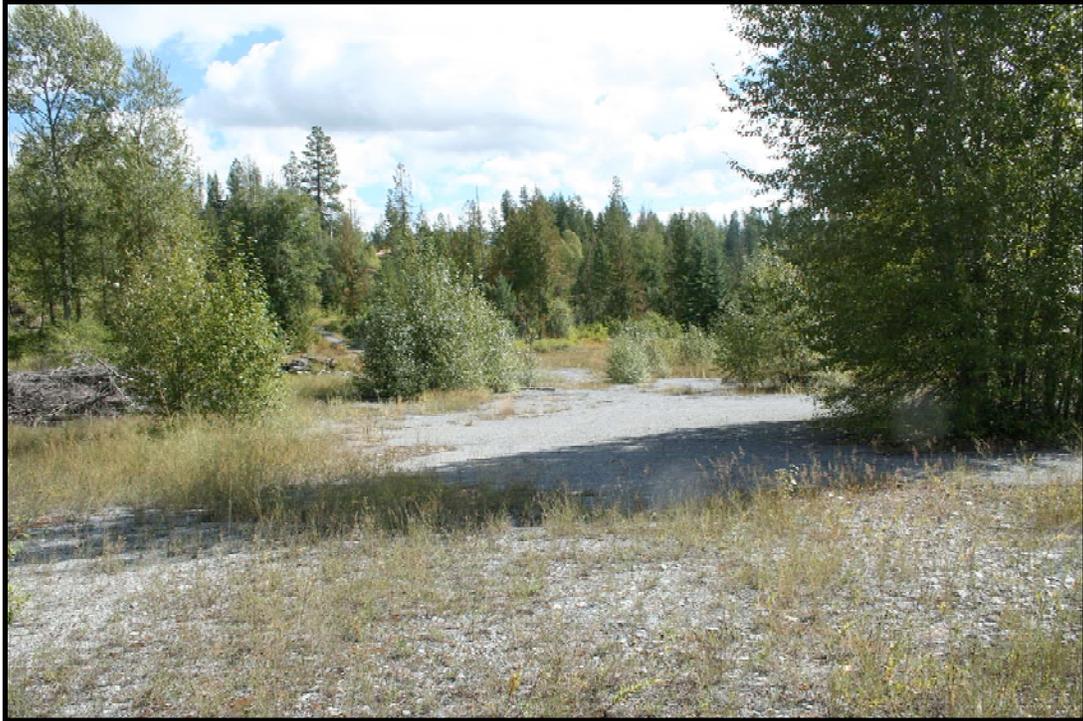
Ground Surface Conditions: Ground surface visibility was excellent throughout most of the project APE; 100 percent in some particularly disturbed places (Figure 3). Some areas along the periphery of the project APE were thickly vegetated, lowering visibility to 10 percent (Figure 4). Average ground surface visibility was about 80 percent. The sparse vegetation is due to several factors, including disturbance due to construction, excavation, and other mine activities and, presumably, due to the deleterious effects of the presence of metals, especially lead.

Figure 3. Upper terrace flat, view to the southeast.

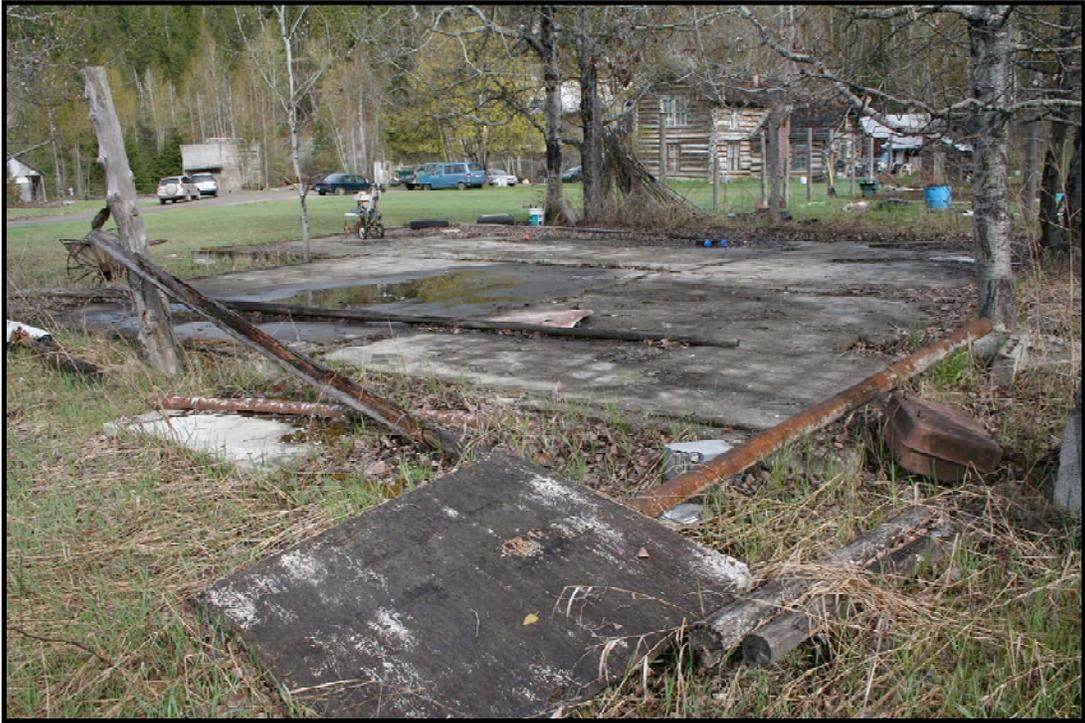
GV-8, House foundation: This foundation appears to be domestic in nature and was probably associated with the small community of mining employees that formed at Grandview Flats (Figure 11). All that remains of this house are the poured concrete platform, some stem walls, and some plumbing pipe remnants.

Figure 11. House foundation, view to the northwest.

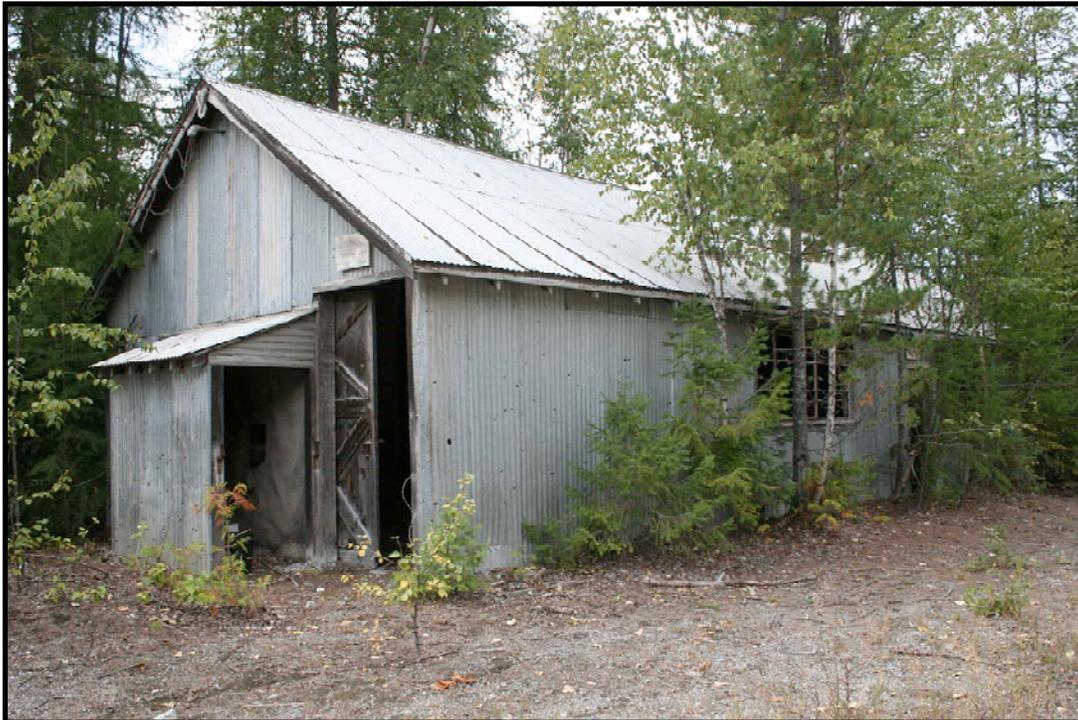
GV-9, Assay shed/wash house: This abandoned building is a gabled wood frame structure (16 feet by 50 ft) (Figure 12). The roof has moderately overhanging eaves with exposed rafter ends. Both the roof and exterior walls are clad with corrugated metal sheeting. The floor and foundation are poured concrete. A small shed-roofed addition is attached to the east side and may have served as a wood shed. Two wood sash double-hung windows, broken, are located on the east end of the south elevation and a square window opening, missing the sash, is located on the west end of the building. The other windows, two on the north elevation and one on the south, are large multiple-pane metal sash units. A large wood plank sliding door is located on the east end of the building, while another wood panel door lies on the floor of the west room. The interior of the building is divided into two parts, with the eastern two-thirds occupied by the assay and test lab room, and the western third occupied by the wash room. The interior of the assay and test lab was provided with wall board coverings on the ceiling and walls, but most of this material has fallen to the floor, leaving the wood frame exposed. A wood shelf occupies most of the west wall of the room, and a poured concrete block, with mounting bolts, is visible at the northwest corner. In the adjacent washroom, the wall board is more intact (Figure 13). The room is partially filled with debris, including car parts. Metal and wood benches line the north and south walls (one of which is collapsed). Shelves and wood coat racks are mounted on the east wall. In the northwestern corner is a toilet room with a broken porcelain commode. At the center of the west wall is a half-circular terrazzo sink basin, with spray spigot above and foot control bar below. In the southwest corner is a shower room with broken pipes and linoleum on the walls.

Figure 12. Assay shed/wash house, view to the southwest.

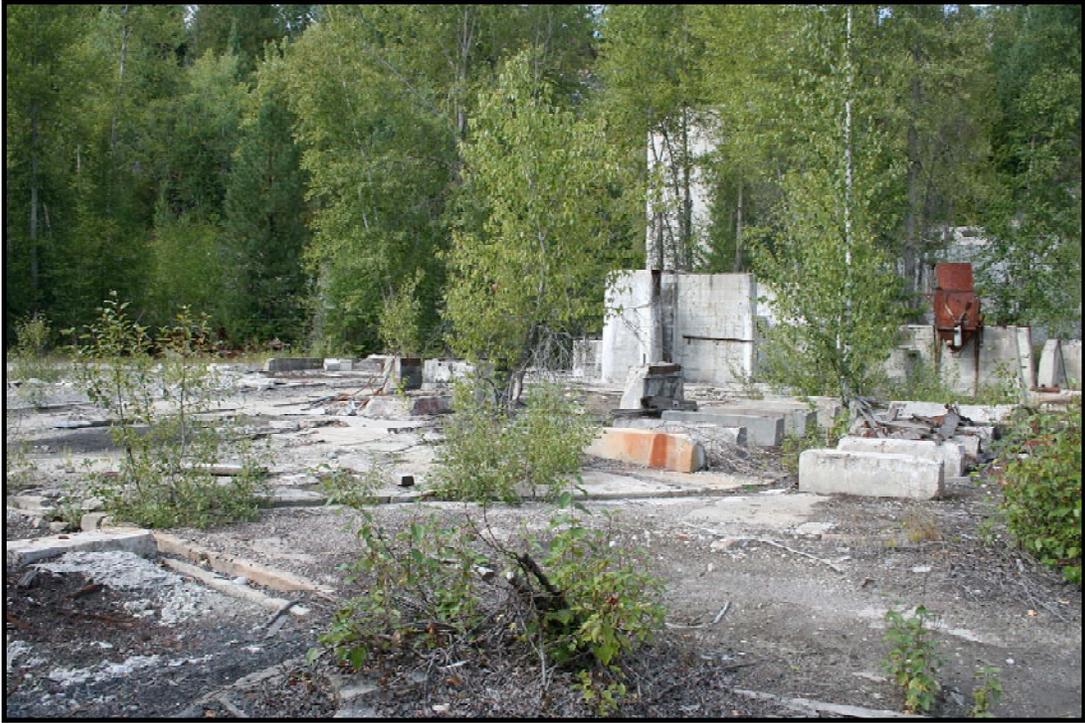
GV-10, Mill foundation: The mill ruins occupy a roughly 100 foot by 100 foot space. Concrete remnants include the concrete floor, foundation, stem walls, and equipment mounting blocks which tend to rise higher toward the back (north) end of the facility due to the tiered nature of the flotation process (Figure 14). The equipment mounts are massive, often in the shape of truncated obelisks. Some have machine mounting bolts projecting from the top flat surfaces. Rusting metal components are scattered about, including a hopper. The most intact portion of the mill is at the south end, where trucks were filled with ore from overhead bins (Figure 15).

Figure 14. Mill foundation, view to the northwest.

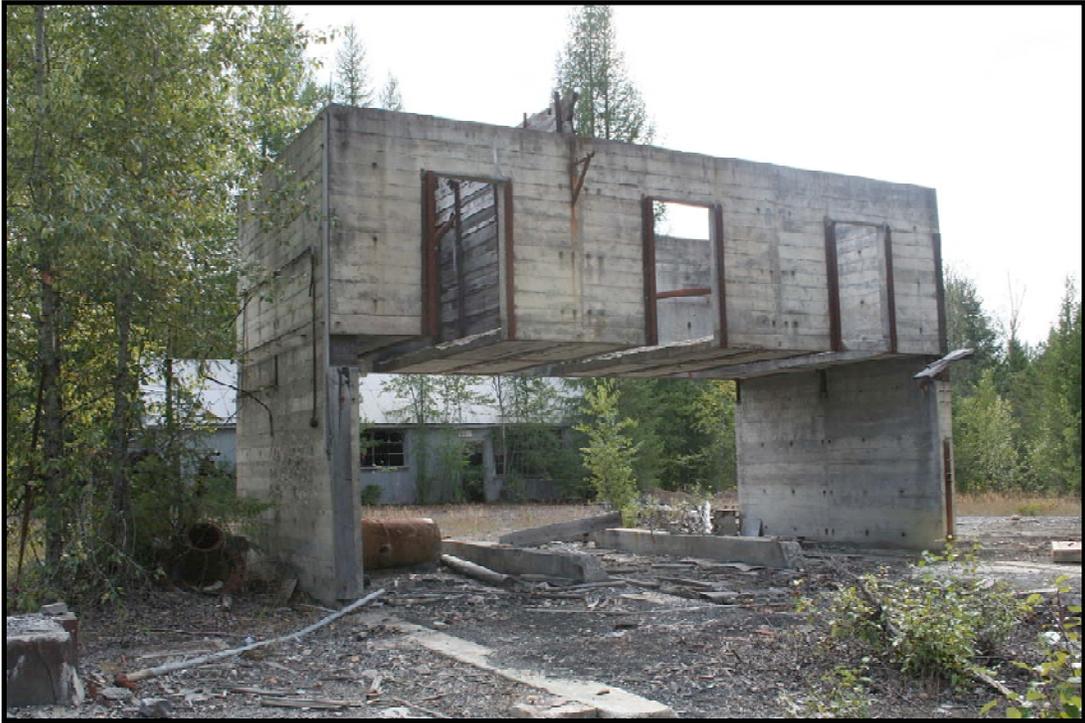
Figure 15. Mill foundation, truck loading bins, view to the southwest.

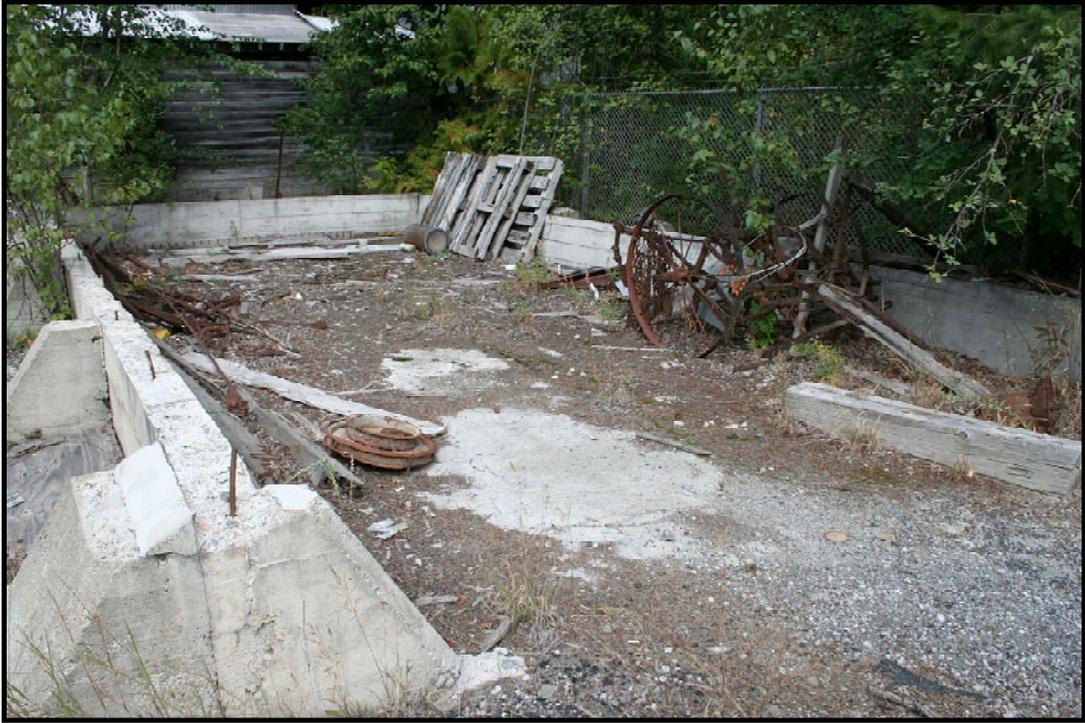
GV-11, Unidentified concrete building foundation No. 1: This small foundation (about 20 feet by 12 feet) may have been a vehicle garage (Figure 16). Remnants include the concrete floor and stem walls.

Figure 16. Unidentified concrete building foundation No. 1, view to the northeast.

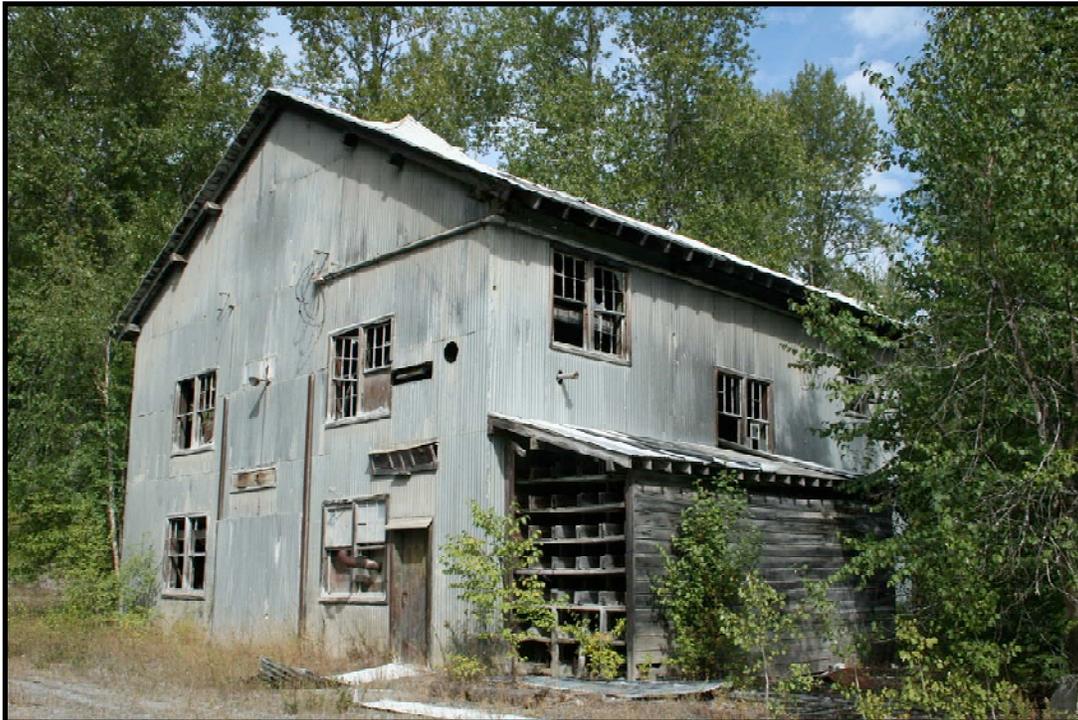
GV-13, Generator House: This abandoned building is a two-story wood frame rectangular structure, with a shed-roofed addition on the south side (Figure 18). The gabled roof is clad with corrugated metal sheeting and has exposed rafter ends. The exterior walls are clad with corrugated metal as well. The windows are multiple-pane wood sash double-hung units, mostly broken. A metal-clad lift up vehicle door is situated in the center of the east wall. The foundation and interior floor are poured concrete. The building has a timber beam superstructure with timber trusses supporting the roof. The interior walls are lined with corrugated metal, similar to that of the exterior walls. Inside are several mounted shelves and scattered miscellaneous debris (Figure 19).

Figure 18. Generator house, view to the northeast.

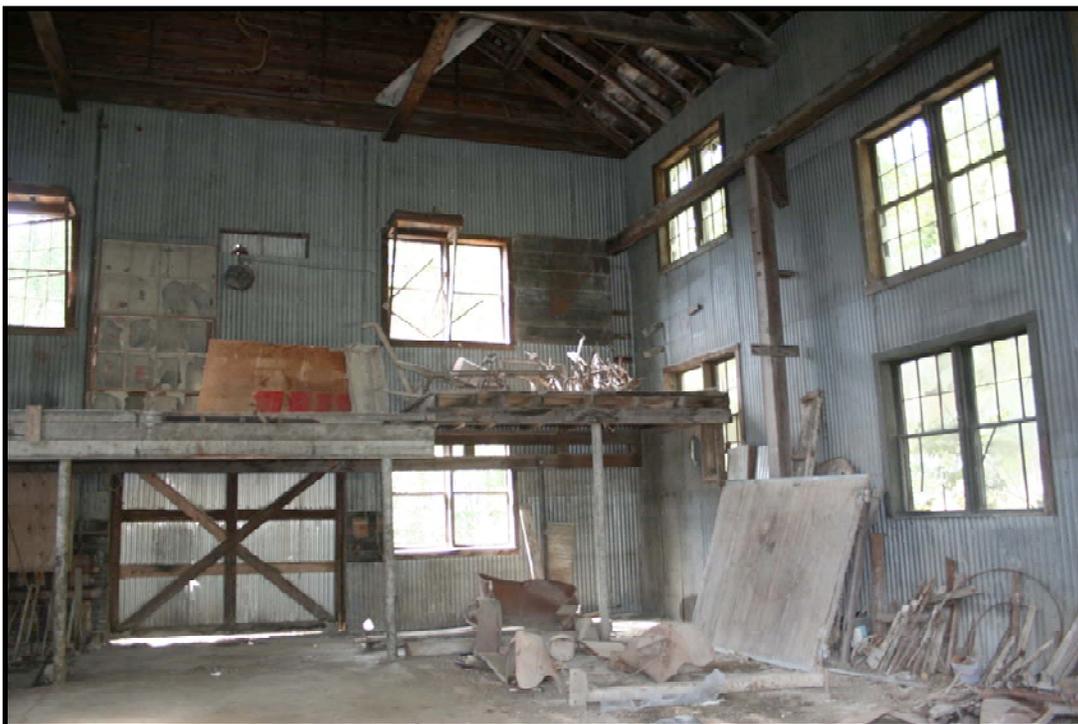
Figure 19. Generator house, interior, view to the northwest.

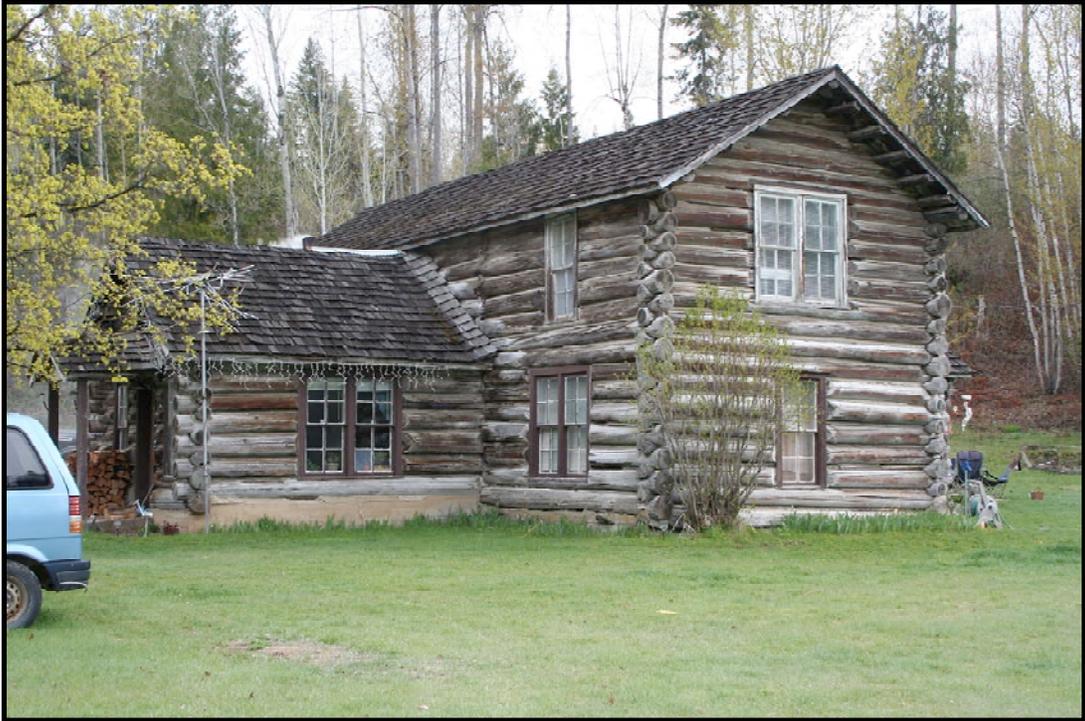
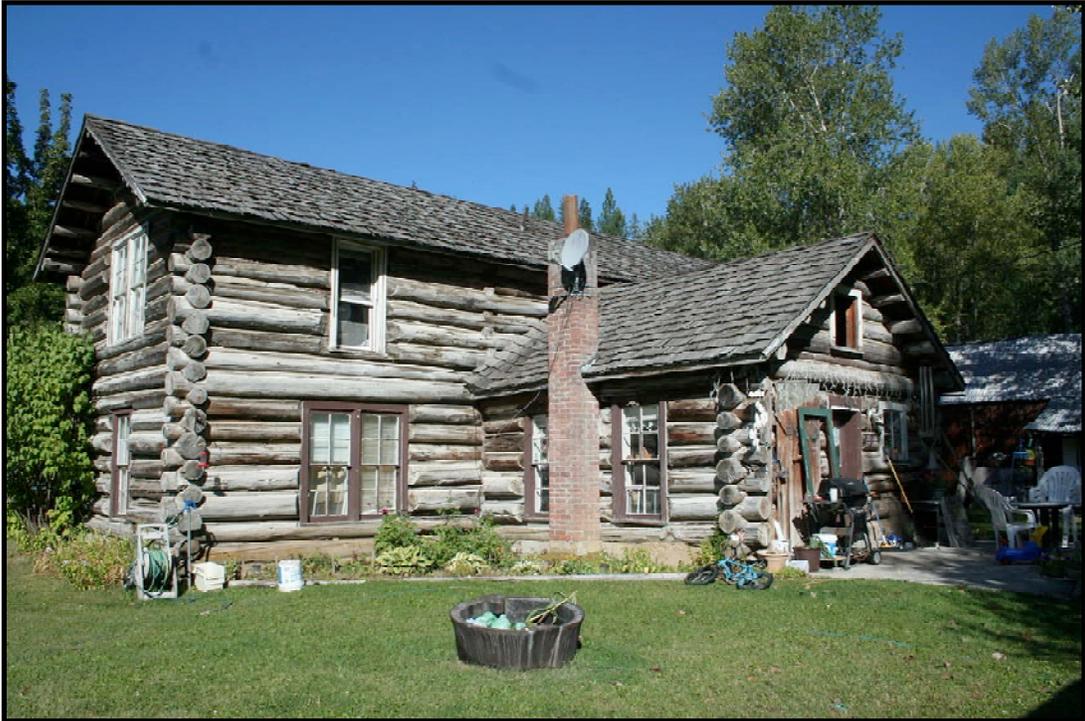
GV-14, Log Cabin: This building is a log structure with a cruciform plan consisting of a two-story side-gabled main section and one-story gabled extensions to the front (west) and rear (east) (Figures 20 and 21). The cabin is constructed of peeled un-milled logs of varying diameter. Chinking consists of split log lengths and plaster. The corners are secured with hand hewn V-notch construction (Figure 22). The house rests upon a poured concrete foundation. The roof is covered with wood shingles and has moderately-wide eaves with exposed log purlins in the gables. A stove pipe emerges from the north slope of the west wing roof. A full-height exterior brick chimney is attached to the south side of the east wing. Windows are multiple-pane wood sash double-hung units. The front entry contains a wood panel door beneath a simple gabled canopy supported by two square posts. Above the canopy is a square opening with no window. A similar opening is in the gable above the rear entry, which contains a wood panel door with a window.

Figure 20. Log cabin, view to the northeast.

Figure 21. Log cabin, view to the northwest.

The interior of the log cabin (Field No. GV-14) has been altered several times as part of the expected and normal course of modernization, but the exterior retains excellent integrity of its historic appearance and original construction materials. The cabin is a good example of state-of-the-art log cabin construction techniques of the period and, as such, is eligible for listing in the NRHP under Criterion C. Other buildings, structures, ruins, and objects within the project area are in an advanced state of deterioration and provide only an incomplete picture of the history of hard rock mining in northeastern Washington. Most of the structural remnants date to the mid-1950s, when the mill and other components were improved. Photographs of the mill site from the 1930s indicate that, except for the log cabin, all structures have been replaced by later modifications. Therefore, surviving remnants at the Grandview mine and mill are representative of only the later developments in hard rock mining technology. They lack sufficient integrity to warrant NRHP eligibility.

The cultural resources survey of the Grandview Mine project APE resulted in identification of one resource, the log cabin, eligible for listing in the NRHP. The log cabin is not included within the scope of the EE/CA process. It is recommended that clean up activities avoid the log cabin and leave it intact. Otherwise, the project may proceed as proposed with respect to cultural resources. In the event that potentially significant cultural resources are identified during construction activities, work should be halted in the immediate vicinity of the find and a professional archaeologist notified to assess the resource. This document should be submitted by Formation Environmental to the appropriate review agencies, including the DAHP, and other interested parties for review and comment prior to the initiation of any land altering activities.

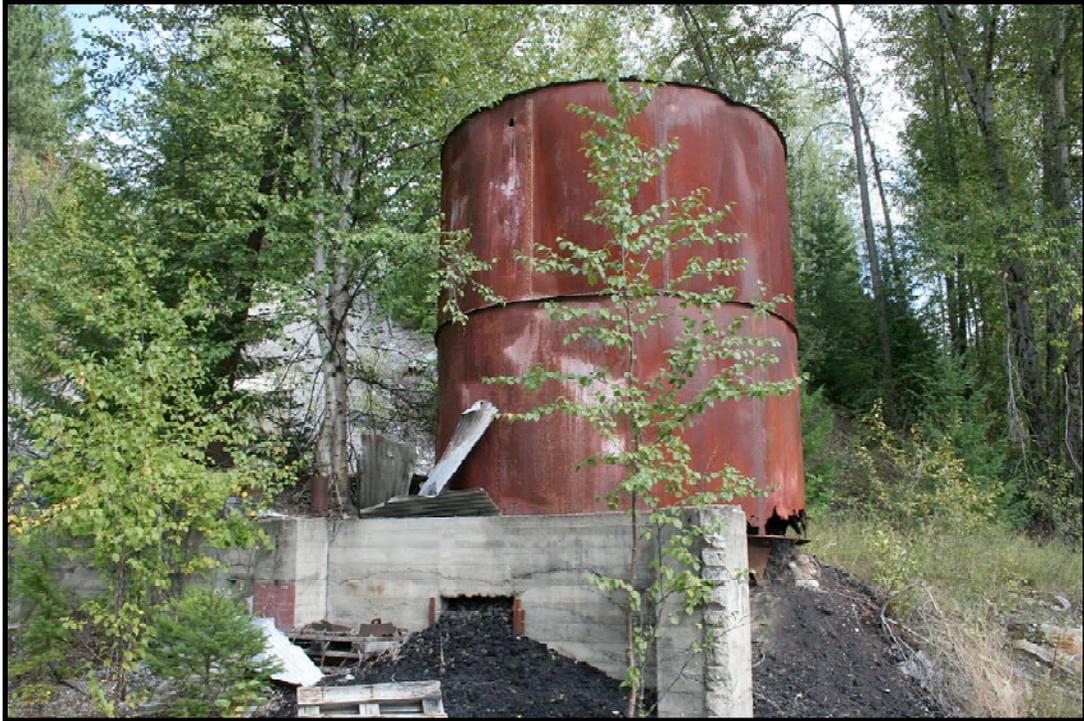
GV-20, Coal storage bin: This over-sized metal barrel, like a large oil drum, contains some coal that was never burned (Figure 30). The coal descended from the barrel into a concrete bin, from where it was shoveled into the burner of a boiler that has been removed.

Figure 30. Coal storage bin, view to the northeast.

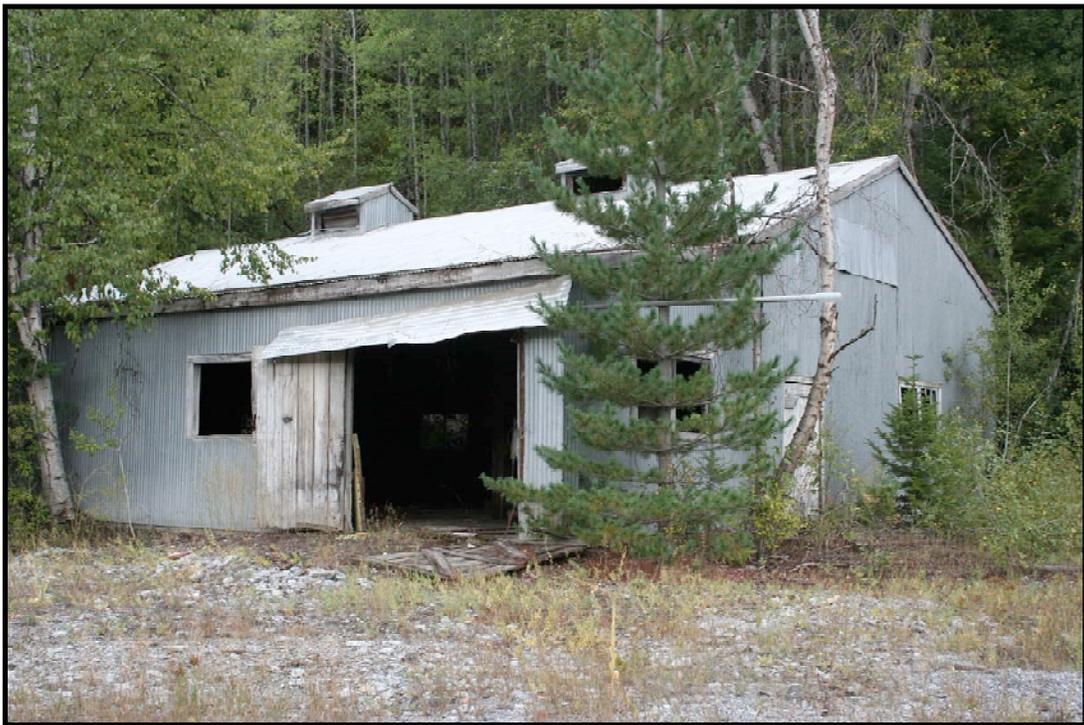
CV-23, Compressor house: This abandoned building is a 1-story wood frame structure (60 feet by 48 feet) with a main gabled section and a shed roof extension along the long south side (Figure 33). The short eaves are demarcated by fascia boards. The roof is covered with corrugated metal sheeting, as are the exterior walls. Two gabled and metal-clad ventilation cupolas are situated on the roof crest. The floor and foundation are poured concrete. Fenestration includes sliding wood sash windows, a wood panel pedestrian door on the east end, and swinging wood plank vehicle entry doors on the east end of the south wall. The structural wood frame work is visible in the interior. Square upright beams support the roof at the juncture of the gabled and shed roof portions of the building. The interior is one large room that contains an assortment of debris, shelving, electrical conduit, pipes, and machinery and equipment remnants. Poured concrete mounts and grooves in the floor accommodated the various machine installations. In the southwest quadrant are the mounts for two large compressors, one of which remains (Figure 34). This consists of an iron compressor housing and a large steel wheel/pulley that was turned by a belt attached to an engine, perhaps steam, that has been removed. Words stamped into the housing read “Ingersol Rand. Co., New York, U.S.A., Imperial Type 10.” Another notable item in the compressor house is a large iron boiler exhibiting tubes for water circulation in the upper chamber and a coal combustion chamber below. Stamped on the boiler are the words “Kewanee Boiler Corporation, Kewanee, Illinois, Type C Boiler.” The Kewanee Boiler Corporation remained in production until 2002. Another notable piece of equipment in this building is what appears to be an electrical dynamo.

Figure 33. Compressor house, view to the northwest.

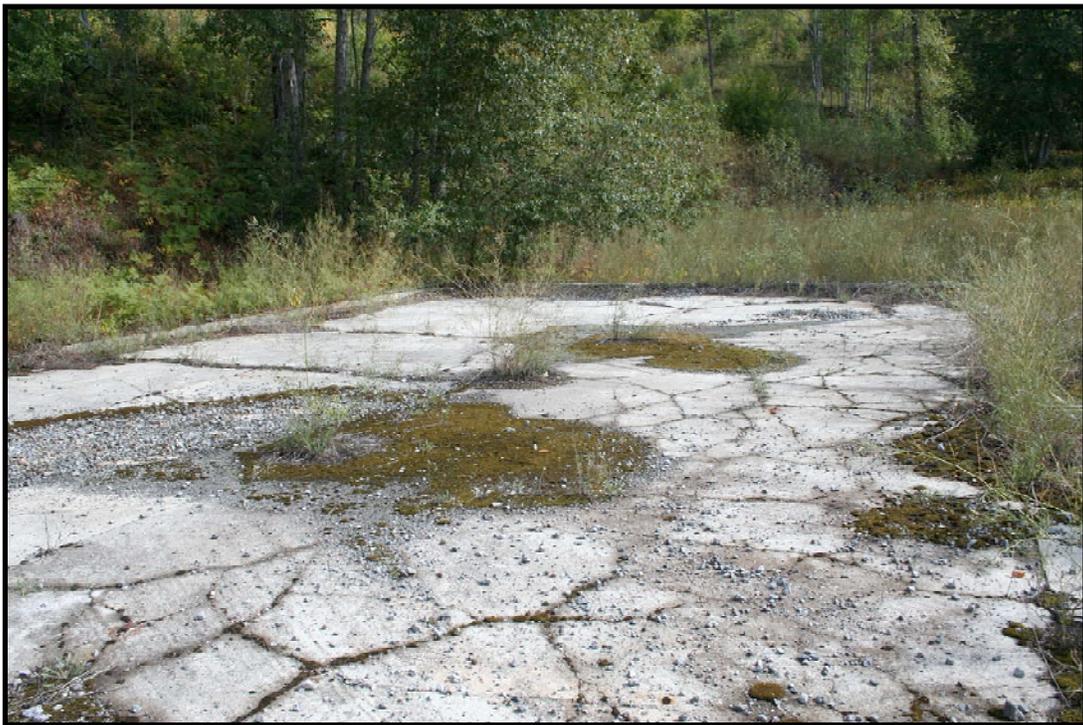
CV-31, Unidentified concrete building foundation No. 2: This structural ruin consists of a poured concrete floor (45 feet by 60 feet), stem walls with metal mud sills, and underground pipe remnants (Figure 41). Its former function has not been identified.

Figure 41. Unidentified concrete building foundation No. 2, view to the east.

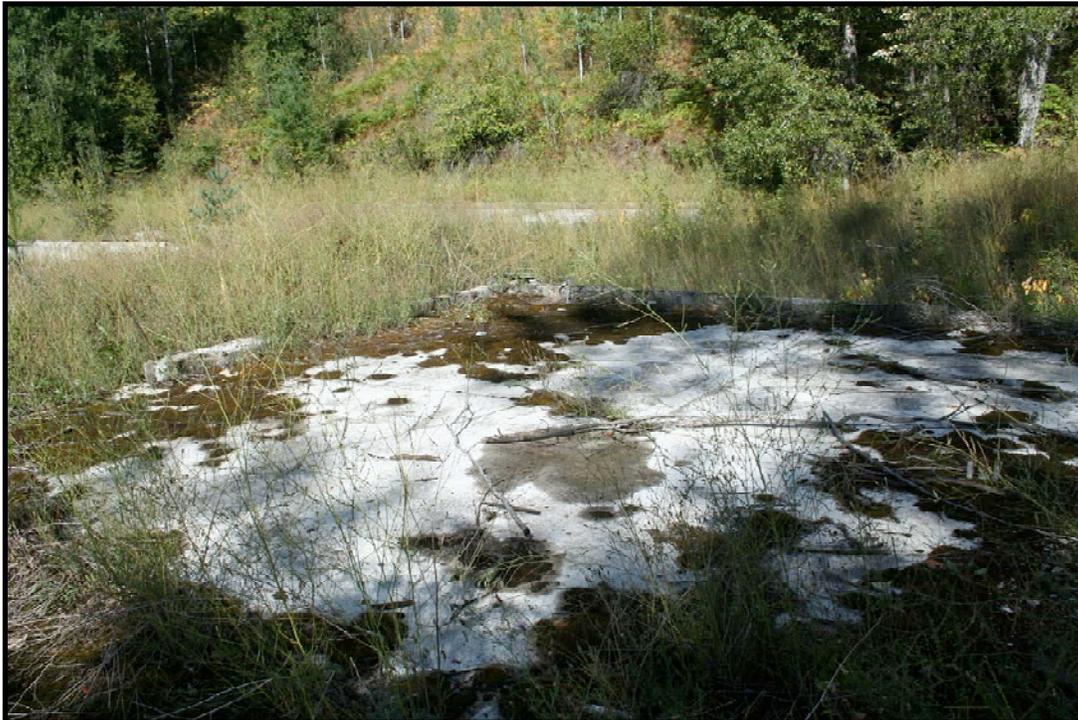
CV-32, Unidentified concrete building foundation No. 3: This structural ruin consists of a poured concrete floor (30 feet by 24 feet), stem walls, water and drain pipes, electrical conduit, and marks on the concrete floor made by interior wood framing (Figure 42). Its former function has not been identified.

Figure 42. Unidentified concrete building foundation No. 3, view to the southeast.

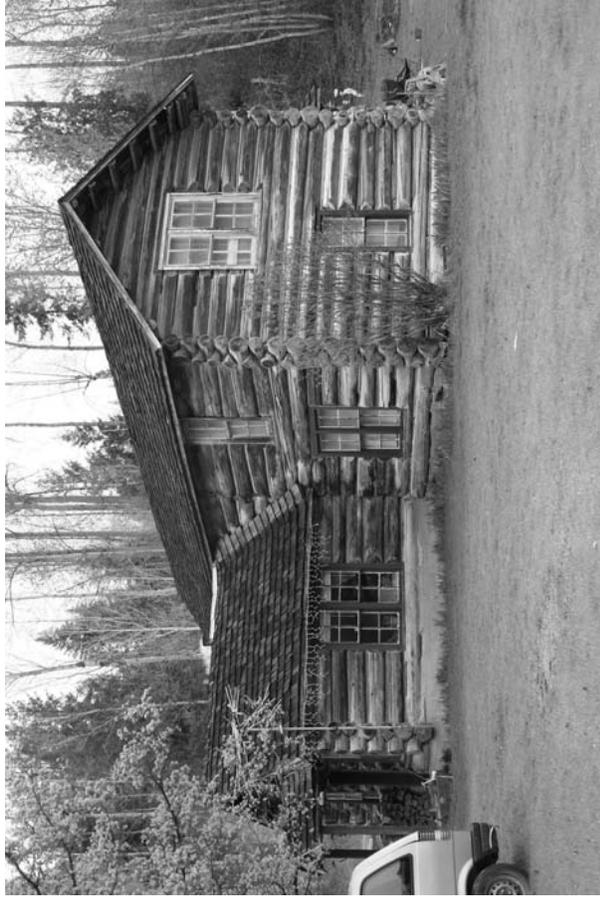
Photography Neg. No (Roll No./Frame No.): GMMM-1a

View of West (front) and south elevations taken 9/9/2009

This building is a log structure with a cruciform plan consisting of a two-story side-gabled main section and one-story gabled extensions to the front (west) and rear (east). The cabin is constructed of peeled un-milled logs of varying diameter. Chinking consists of split log lengths and plaster. The corners are secured with hand hewn V-notch construction. The house rests upon a poured concrete foundation. The roof is covered with wood shingles and has moderately-wide eaves with exposed log purlins in the gables. A stove pipe emerges from the north slope of the west wing roof. A full-height exterior brick chimney is attached to the south side of the east wing. Windows are multiple-pane wood sash double-hung units. The front entry contains a wood panel door beneath a simple gabled canopy that is supported by two square posts. Above the canopy is a square opening with no window. A similar opening is placed in the gable above the rear entry, which contains a wood panel door with a window. The interior of the cabin has a quite modern appearance, having undergone remodeling probably several times. The latest renovations may date to the 1960s, judging from the appearance of the kitchen cupboards. From the inside one would not know that the house was a log cabin. The walls and ceilings are sheet rock that obscures any clue of the nature of the log construction. Open passage ways are rounded at the corners. A living room, kitchen, master bedroom, and den are located on the first floor, while more bedrooms occupy the upper level.
