Subject: **Letter Report of Geophysical Investigation
Mills Gap Road Groundwater Contamination Site
MACTEC Project 6690-03-9450
CERCLA Docket No. CER-04-2004-3755**

Re: Geophysical Investigation of Potential Buried Material, CTS Site, Mills Gap Road, Arden, North Carolina

GEOPHYSICAL SURVEY
CTS-MILLS GAP ROAD
ARDEN, NC

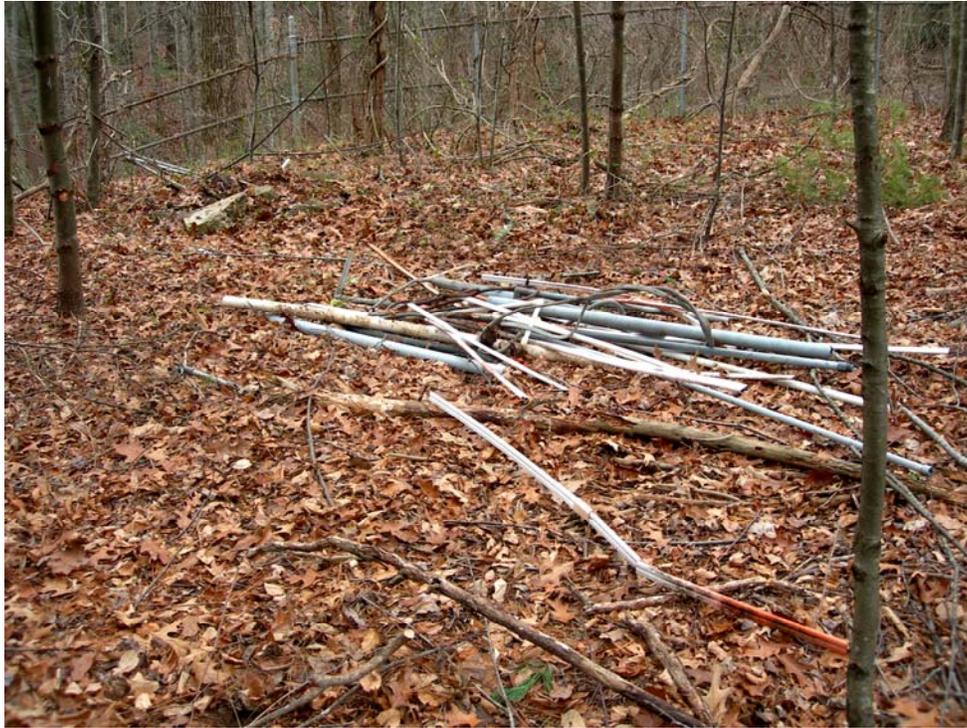
Photograph 1: View of surficial metal and plastic debris cleared from geophysical investigation area prior to implementing geophysical survey.

Prior to conducting the geophysical investigation, MACTEC personnel cleared debris located on the ground in the vicinity of the proposed activities (Photograph 1), as metallic debris would interfere with the survey results and non-metallic/vegetative debris would hamper access. On December 7, 2010, Geo Solutions, Ltd. (Geo Solutions) mobilized to the Site to perform the geophysical investigation under the direction of MACTEC personnel. Also present at the Site were personnel from EPA's Environmental Response Team and an EPA Superfund Technical Assessment & Response Team (START) contractor. As noted in the Work Plan for Geophysical Investigation, two areas of surface debris containing concrete/bricks and floor tiles were excluded from the investigation area.

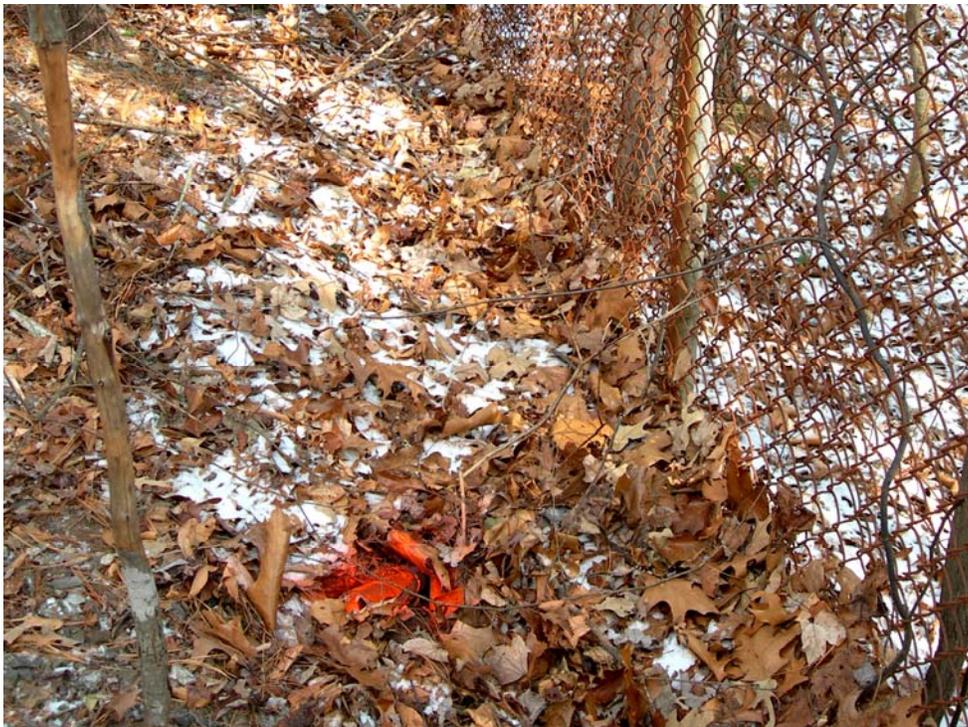
Photograph 2: View of surficial metal debris identified during EM profiling.

The EM survey identified several anomalies adjacent to the fence located along the eastern and southern property boundary. The anomalies were further investigated using a magnetometer, and several pieces of metal debris were identified on the ground surface and determined to be the source of the anomalies (Photograph 2). The EM survey did not identify anomalies or indications of buried debris at distances greater than approximately five feet inside the fence. The elevated readings along the property boundary are attributed to the adjacent metal fence.

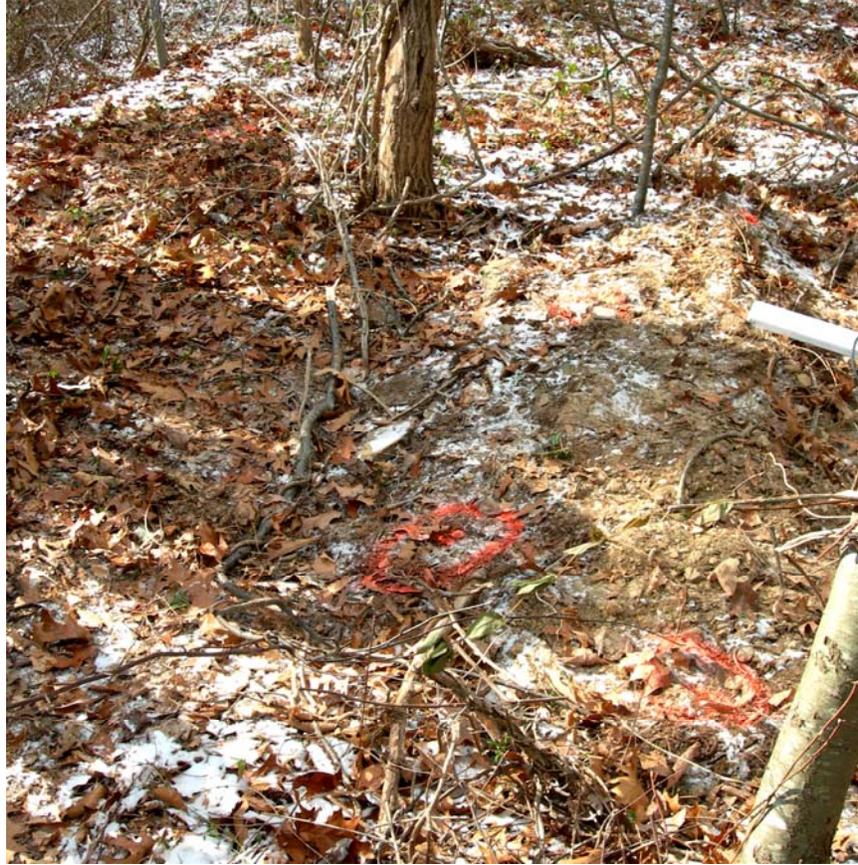
Photograph 3: View of surficial metal debris identified during EM profiling.

Upon completion of the EM survey and review of the data in the field, the GPR survey was configured and conducted. The GPR survey consisted of five arrays: two arrays across the central portion of the area toward the southeast corner, one array to the north along the western portion of the area, and two arrays in the vicinity of the previously-identified polyethylene barrels/drums. The GPR survey identified additional minor metal debris on the ground surface (Photograph 3); however, the GPR survey did not indicate buried debris in the surveyed areas.

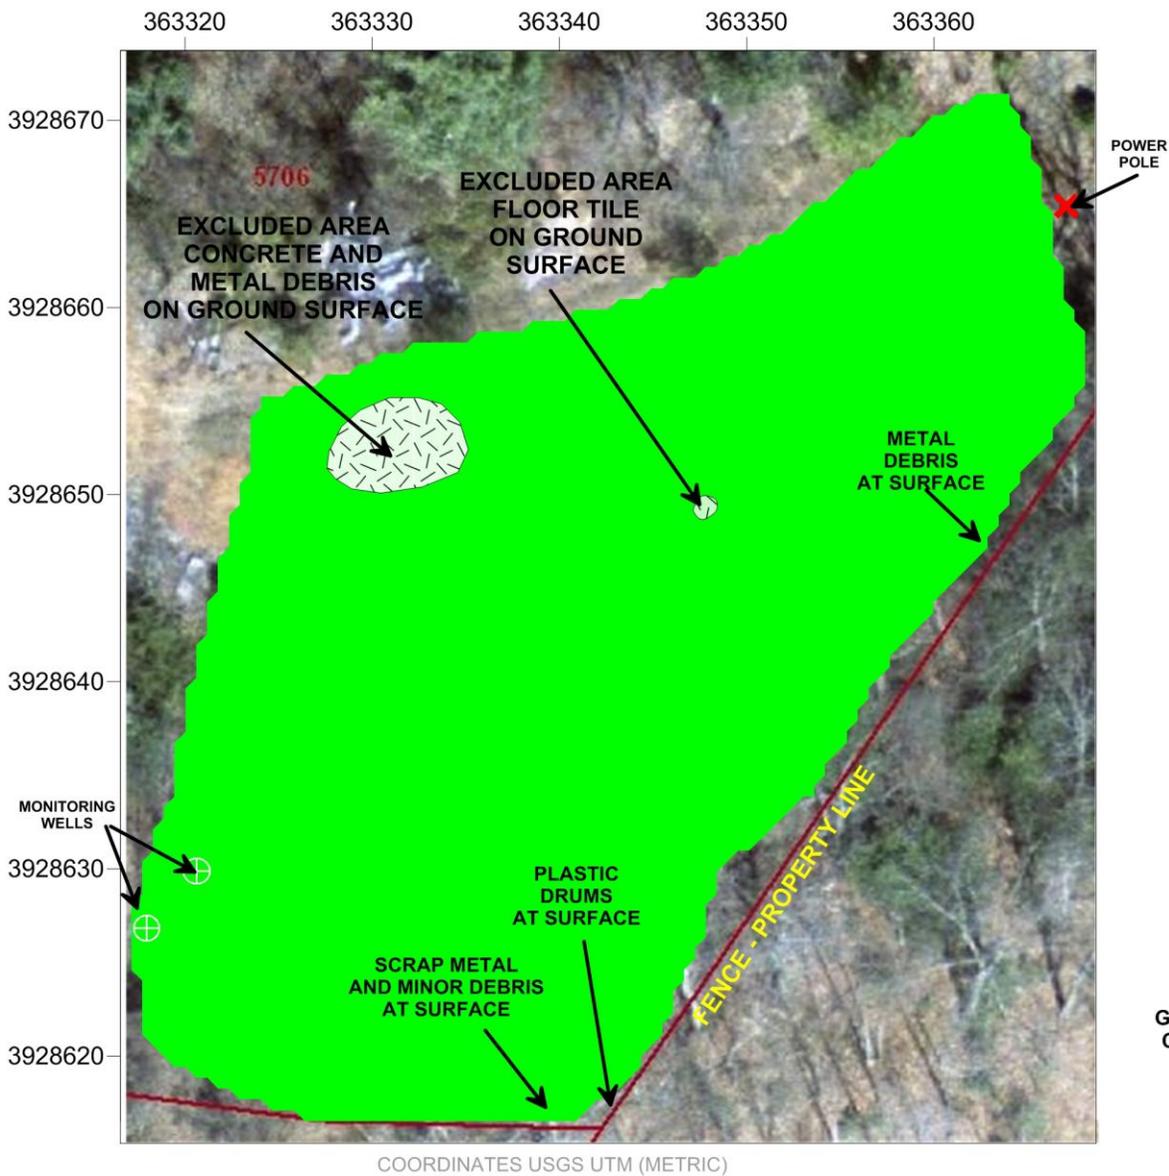
FIGURE 2

SITE LOCATION MAP AND GENERAL MAP ILLUSTRATING THE LOCATION OF FEATURES WITHIN THE GEOPHYSICAL SURVEY AREA

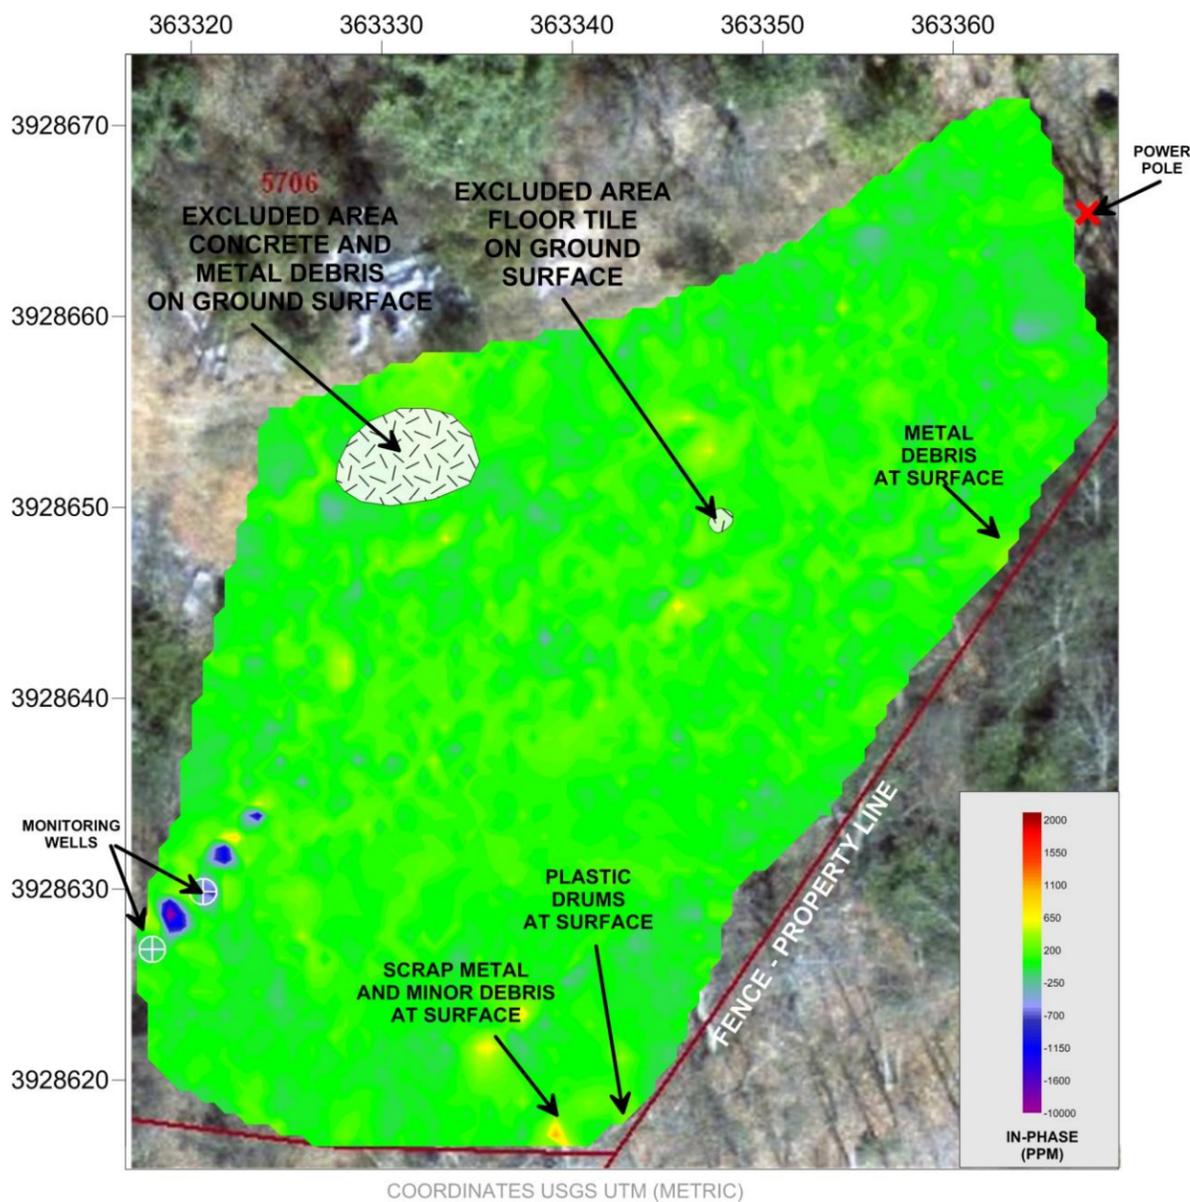
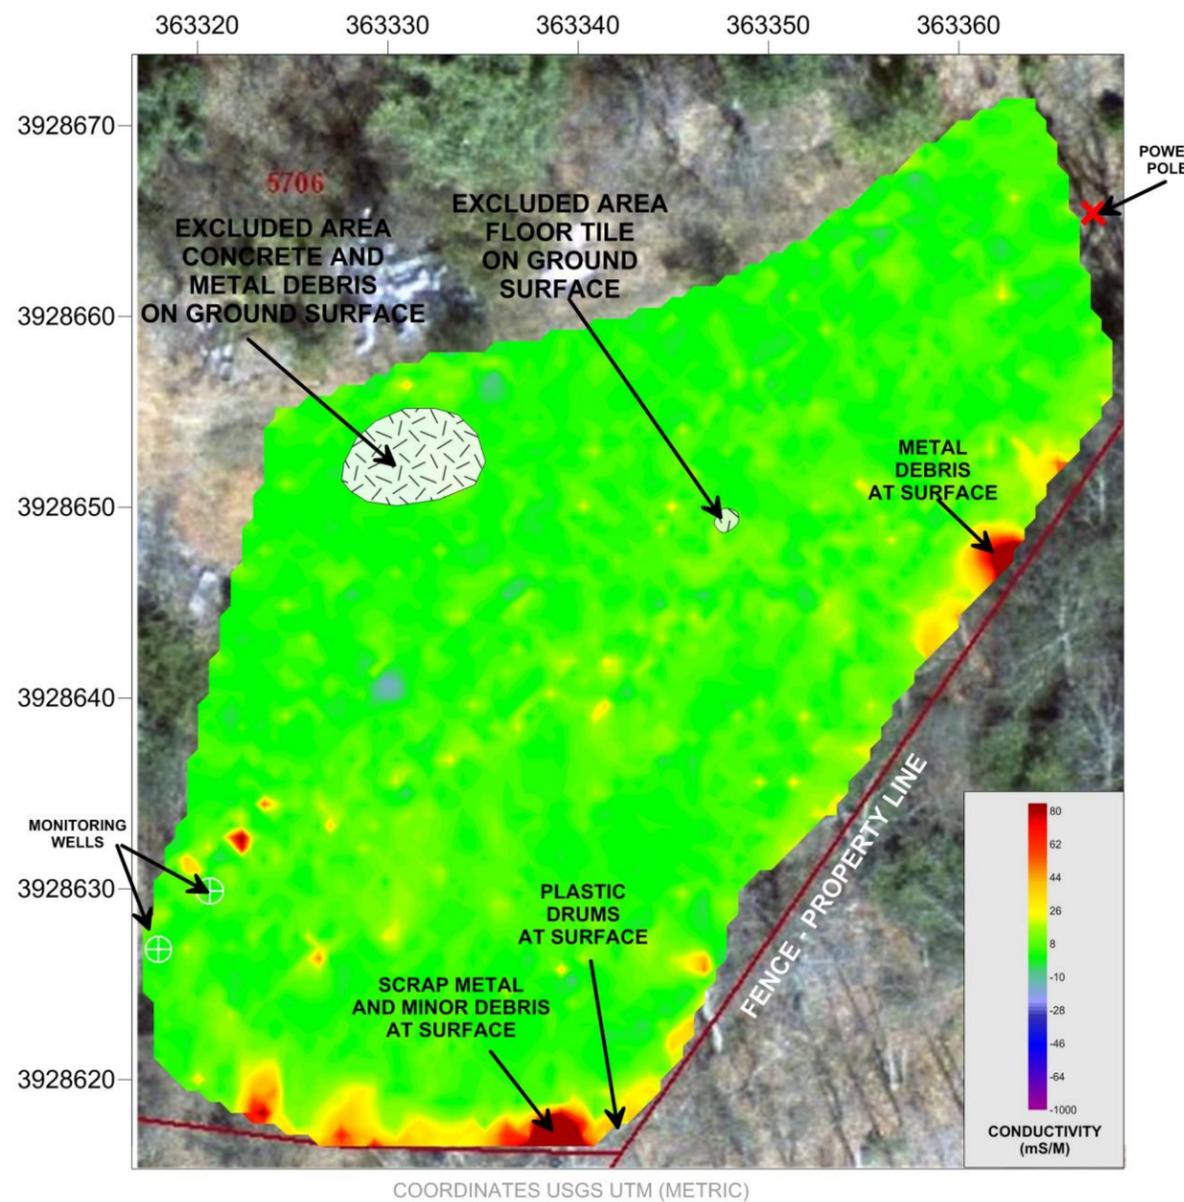
FIGURE 3

EM DATA
3870 Hz IN-PHASE DATA (METAL DETECTION MODE)

EM DATA
3870 Hz CONDUCTIVITY MODE

**RESULTS OF MULTIFREQUENCY
ELECTROMAGNETIC
GEOPHYSICAL SURVEY
3870 Hz FREQUENCY**

In general, Figures 2 through 4 illustrates the results of the 3870 Hz, 11070 Hz, and 90030 Hz in-phase and conductivity data. This information is generally used to indicate the location of buried metal material and the presence of potentially conductive soils or scattered debris. This would include but not limited to: buried concrete with metal

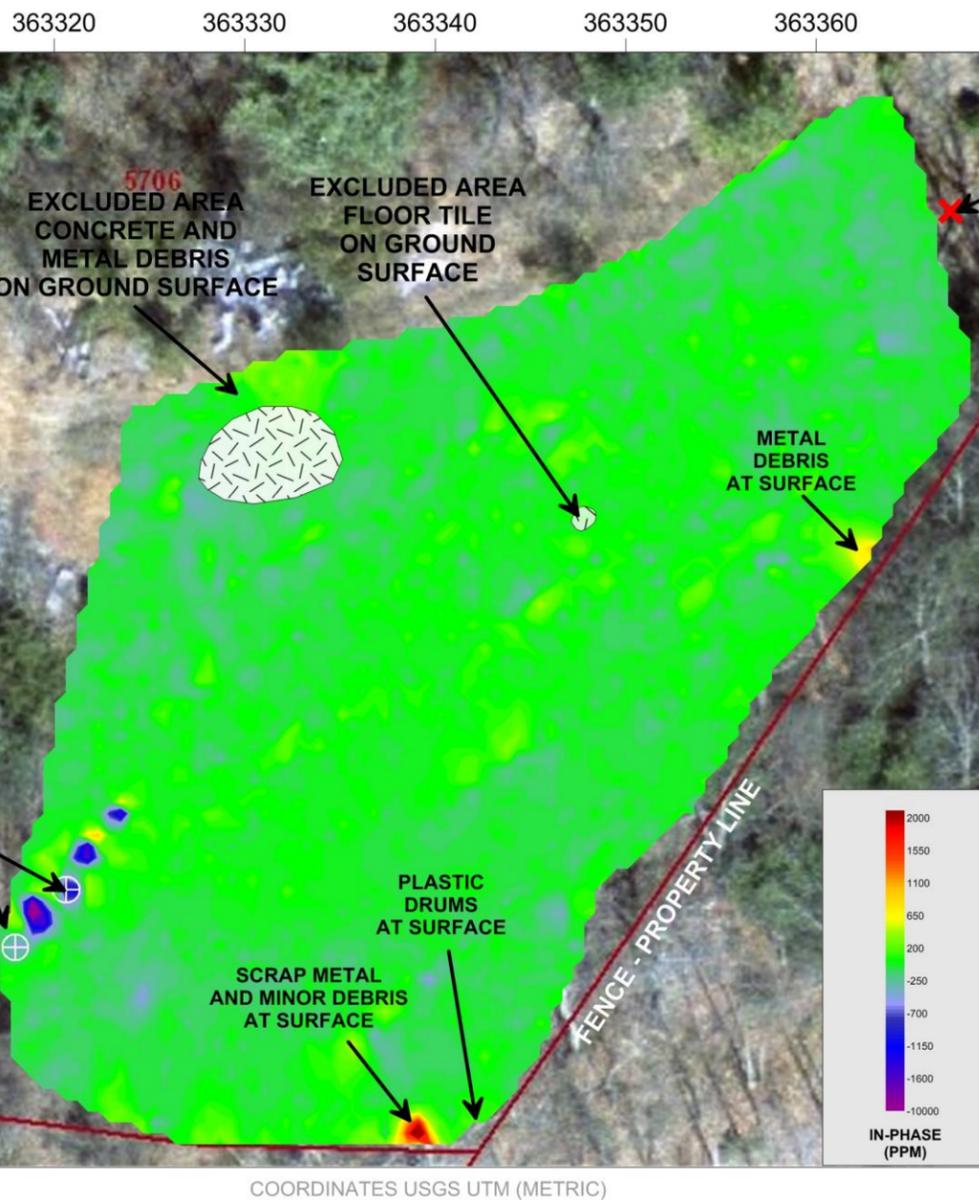
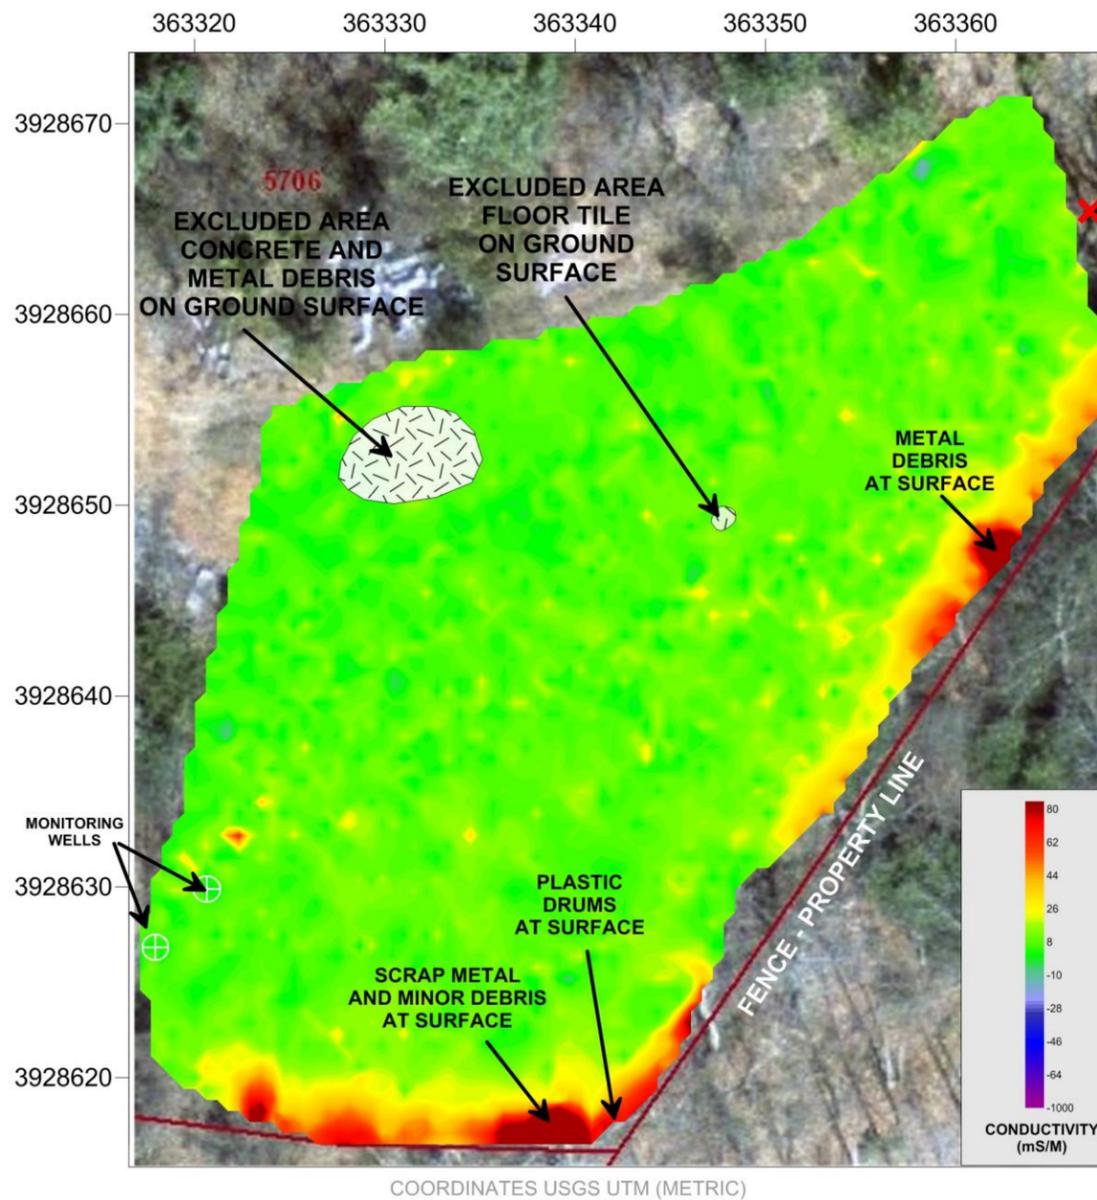
FIGURE 4

EM DATA
11070 Hz IN-PHASE DATA (METAL DETECTION MODE)

EM DATA
11070 Hz CONDUCTIVITY MODE

**RESULTS OF MULTIFREQUENCY
ELECTROMAGNETIC
GEOPHYSICAL SURVEY
11070 Hz FREQUENCY**

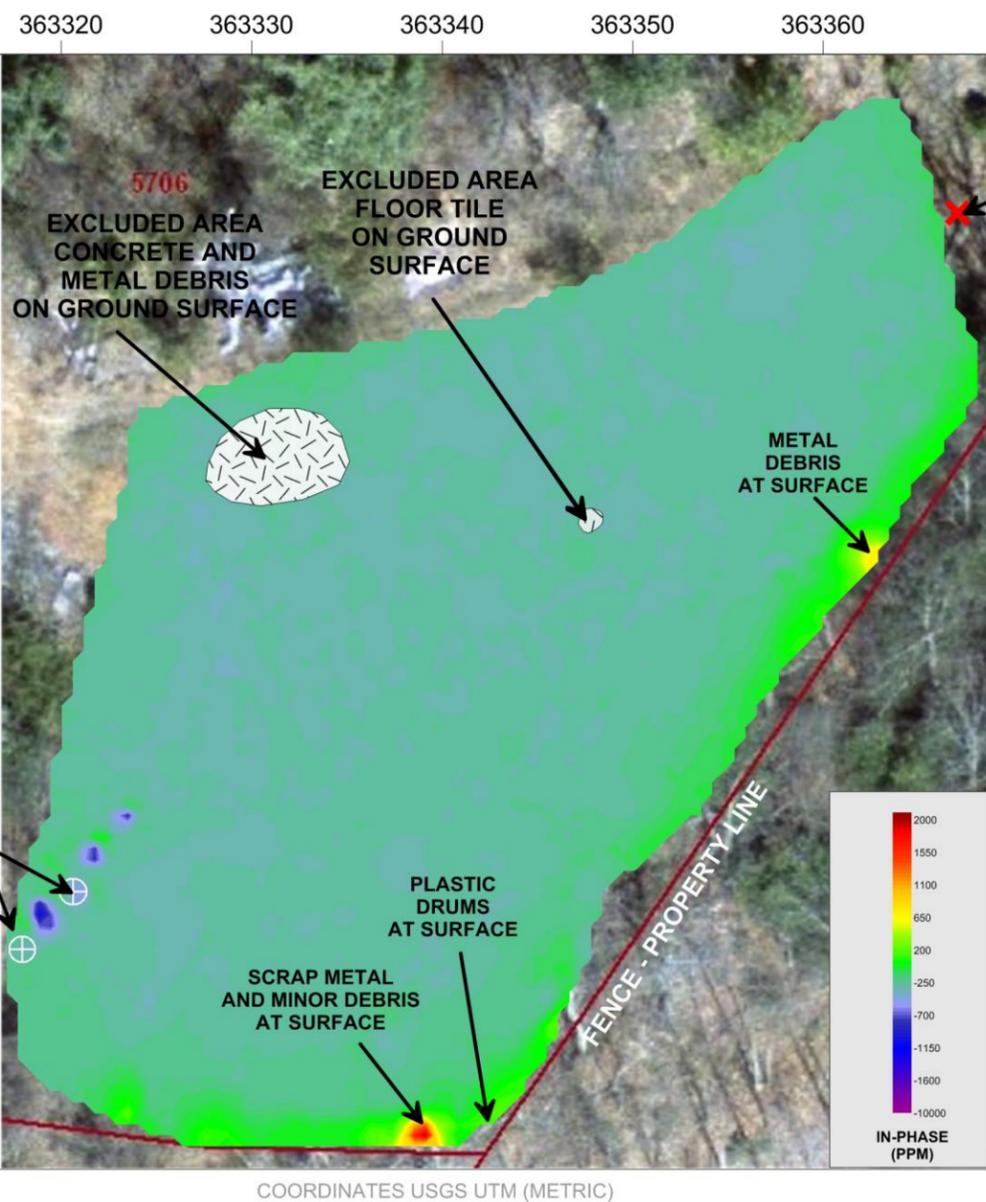
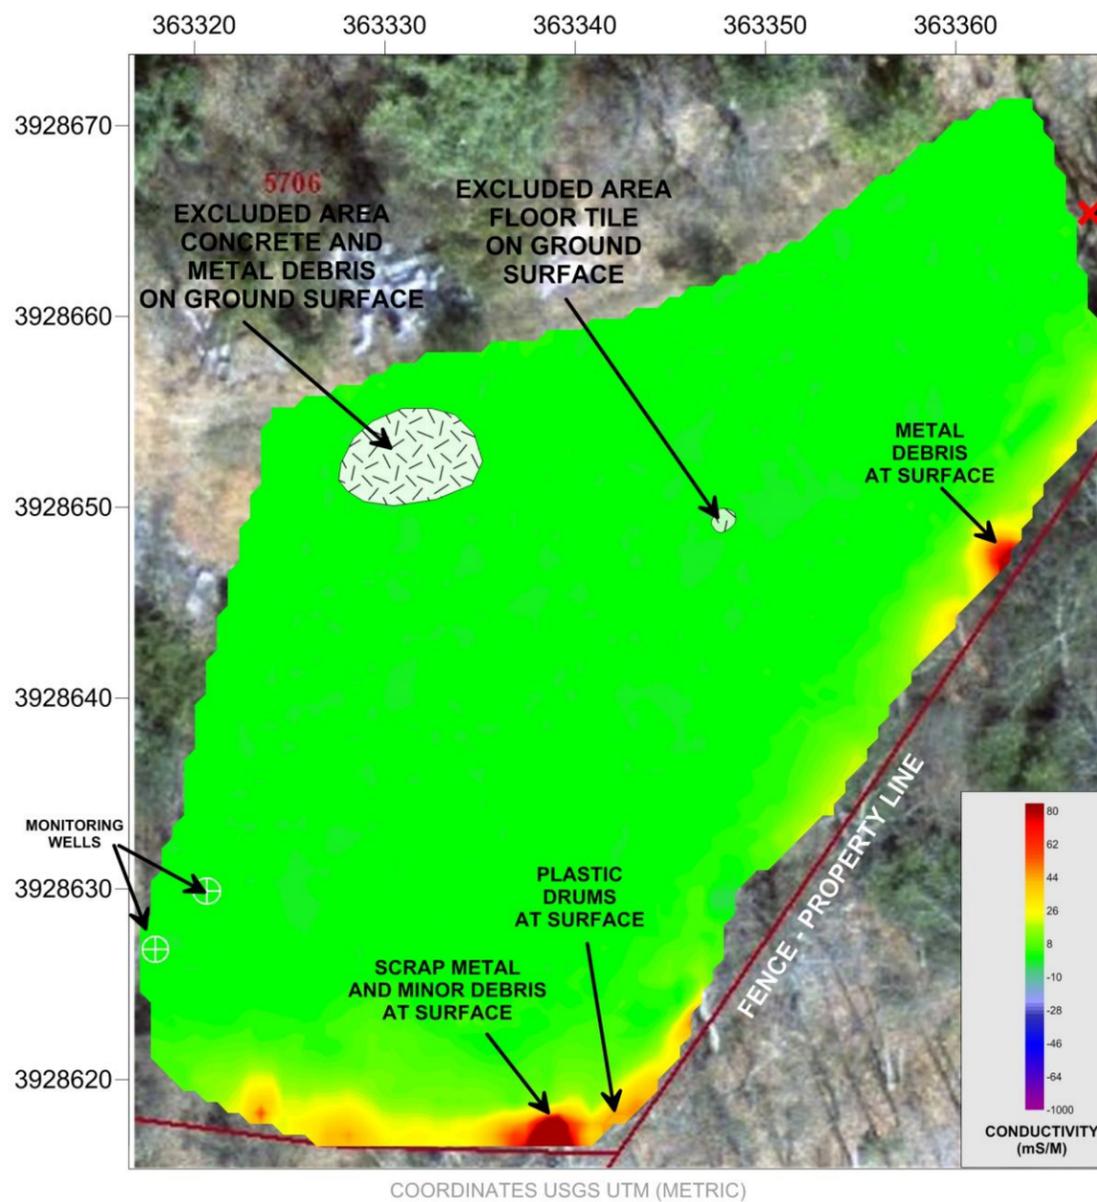
FIGURE 5

EM DATA
90030 Hz IN-PHASE DATA (METAL DETECTION MODE)

EM DATA
90030 Hz CONDUCTIVITY MODE

**RESULTS OF MULTIFREQUENCY
ELECTROMAGNETIC
GEOPHYSICAL SURVEY
90030 Hz FREQUENCY**

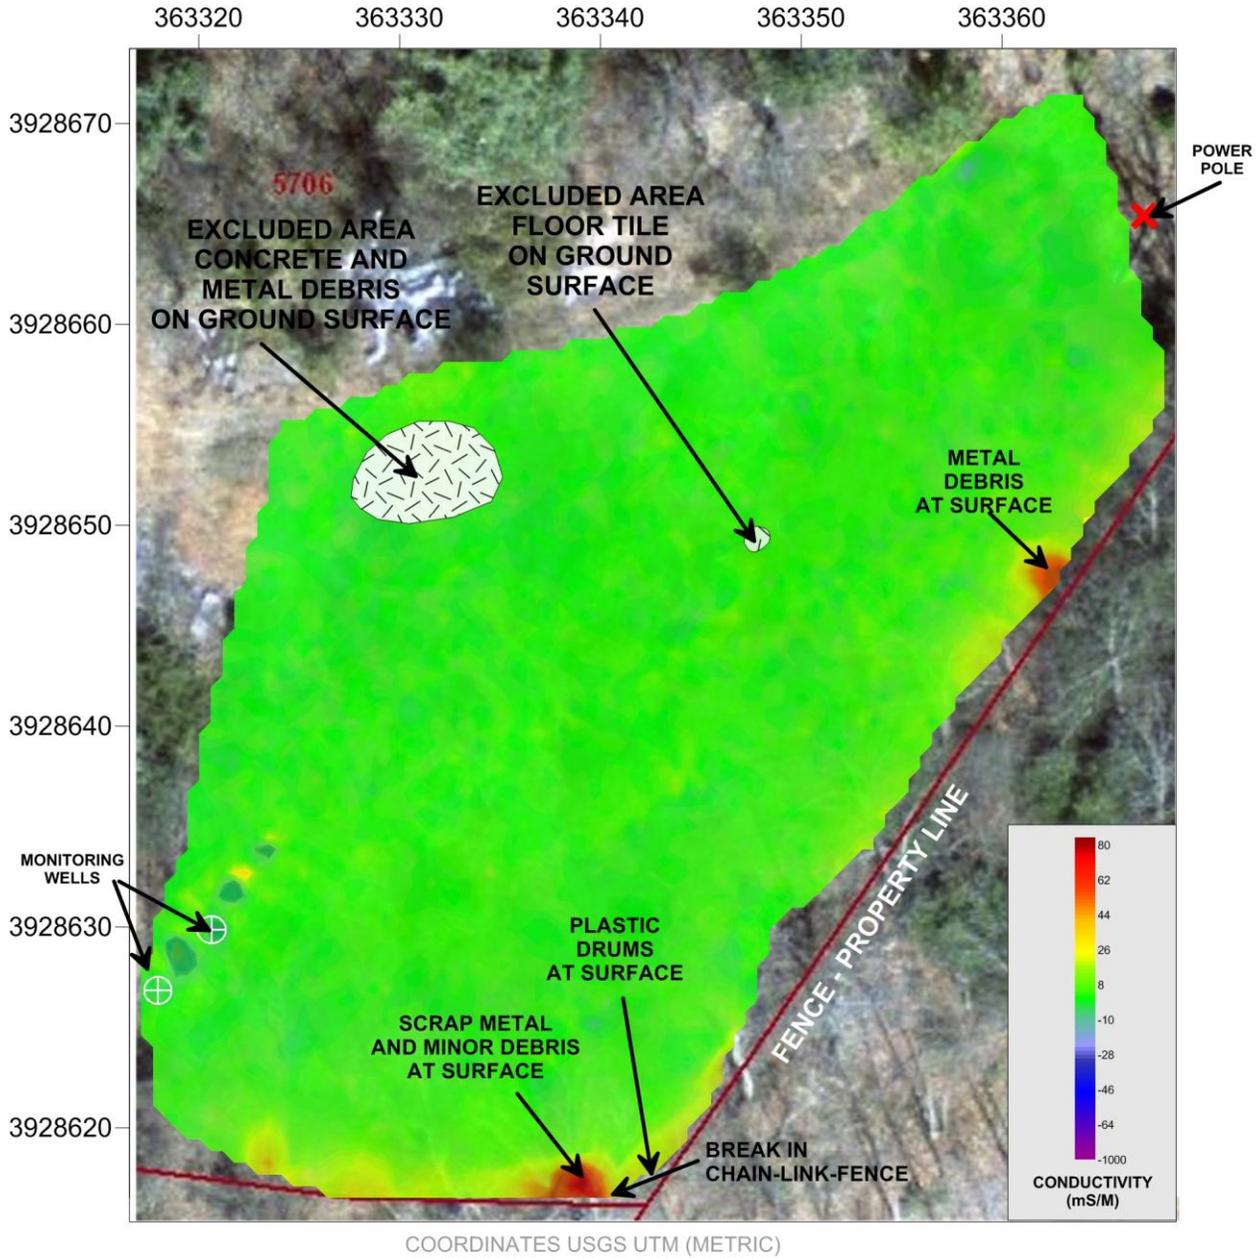
- An area with a strong EM anomaly coincided with the presence of several large (0.5 to 1 ft) metal objects located along the east side of the site and along a chain-link fence.
- A small area represented by a positive anomaly located along the southeast side of the site where several plastic drums were noted. This is also the site where the removal of surface debris had taken place. Geo Solutions discovered a small quantity of metal wire that was likely the source of the EM anomaly. Geo Solutions also noted a break in the chain-link fence. Typically, discontinuity in fencing can account for EM anomalies.

SUMMARY OF EM ANOMALIES

A summary figure (Figure 5) illustrates the location of the above anomalies.

Geo Solutions has completed a limited geophysical evaluation of the CTS Site Property. Here, we found evidence for the presence of limited surface debris. Furthermore, the results of the EM evaluation indicate broad areas of the site that show no evidence of any debris, surface or buried. We conclude that the site has not been used as a site for burial of debris. A summary of the identified surface features is presented in Figure 5.

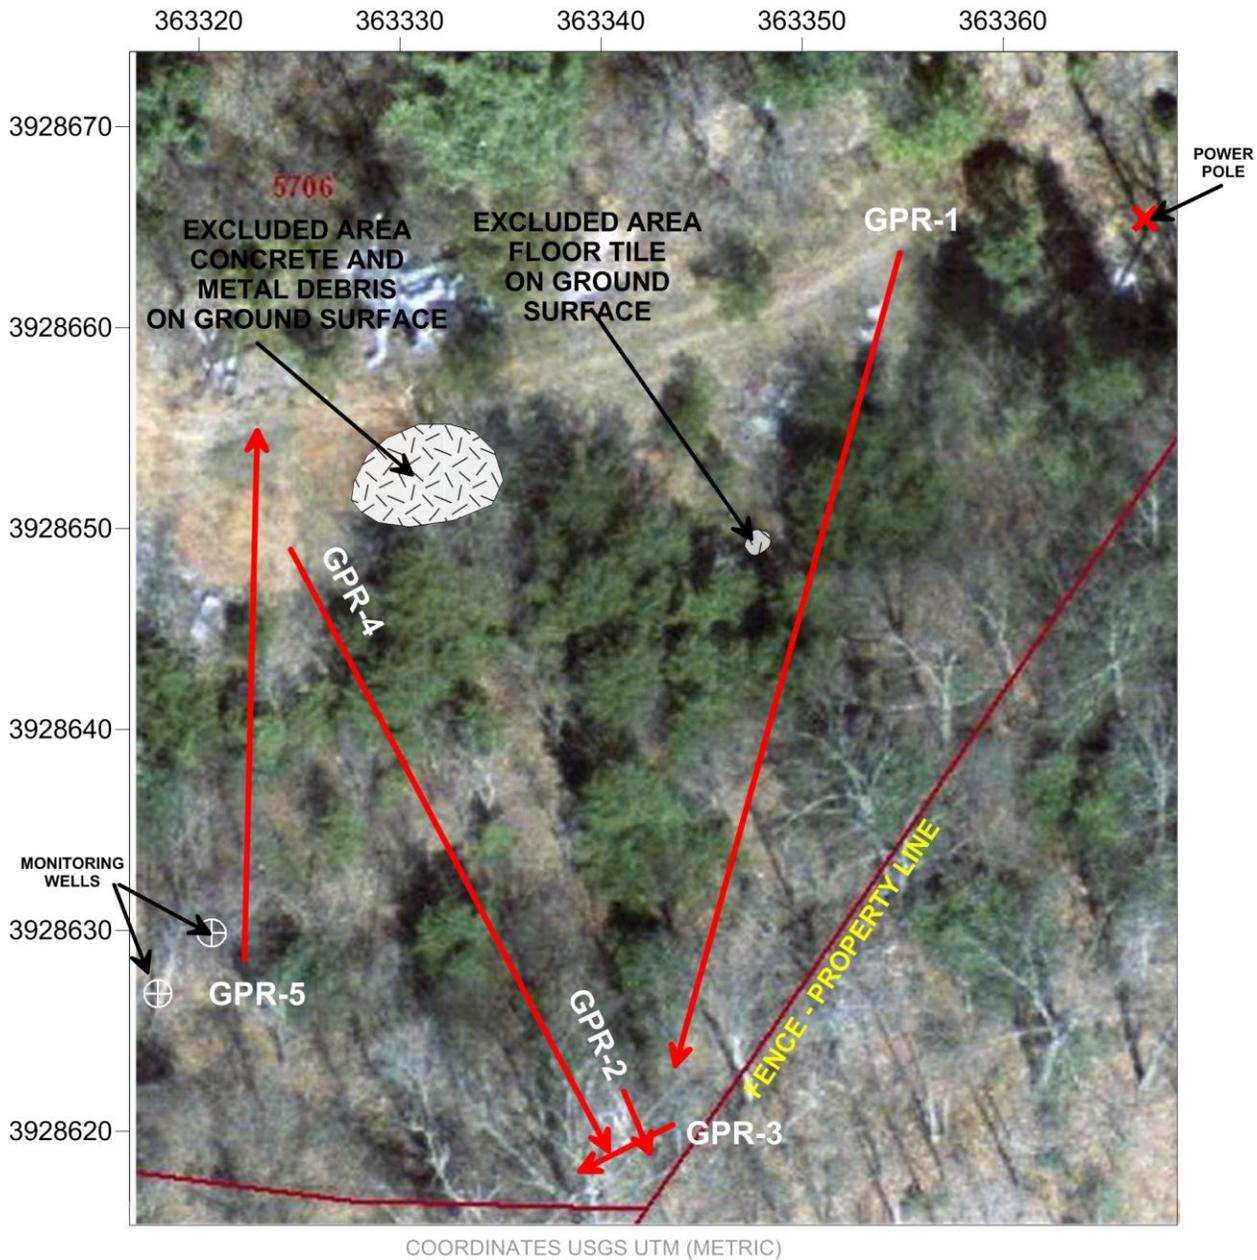
FIGURE 6

LOCATION OF GROUND-PENETRATING RADAR PROFILE LINES

A total of 5 GPR records are presented in this evaluation. The location of the GPR profiles is presented in Figure 6 and the GPR profiles are presented in Figure 7. Most notable in these records is the presence of steeply dipping bedding structures probably associated with the bedrock or saprolite soils. Here, the soils appear to be undisturbed below a depth of approximately 2 to 3 feet.

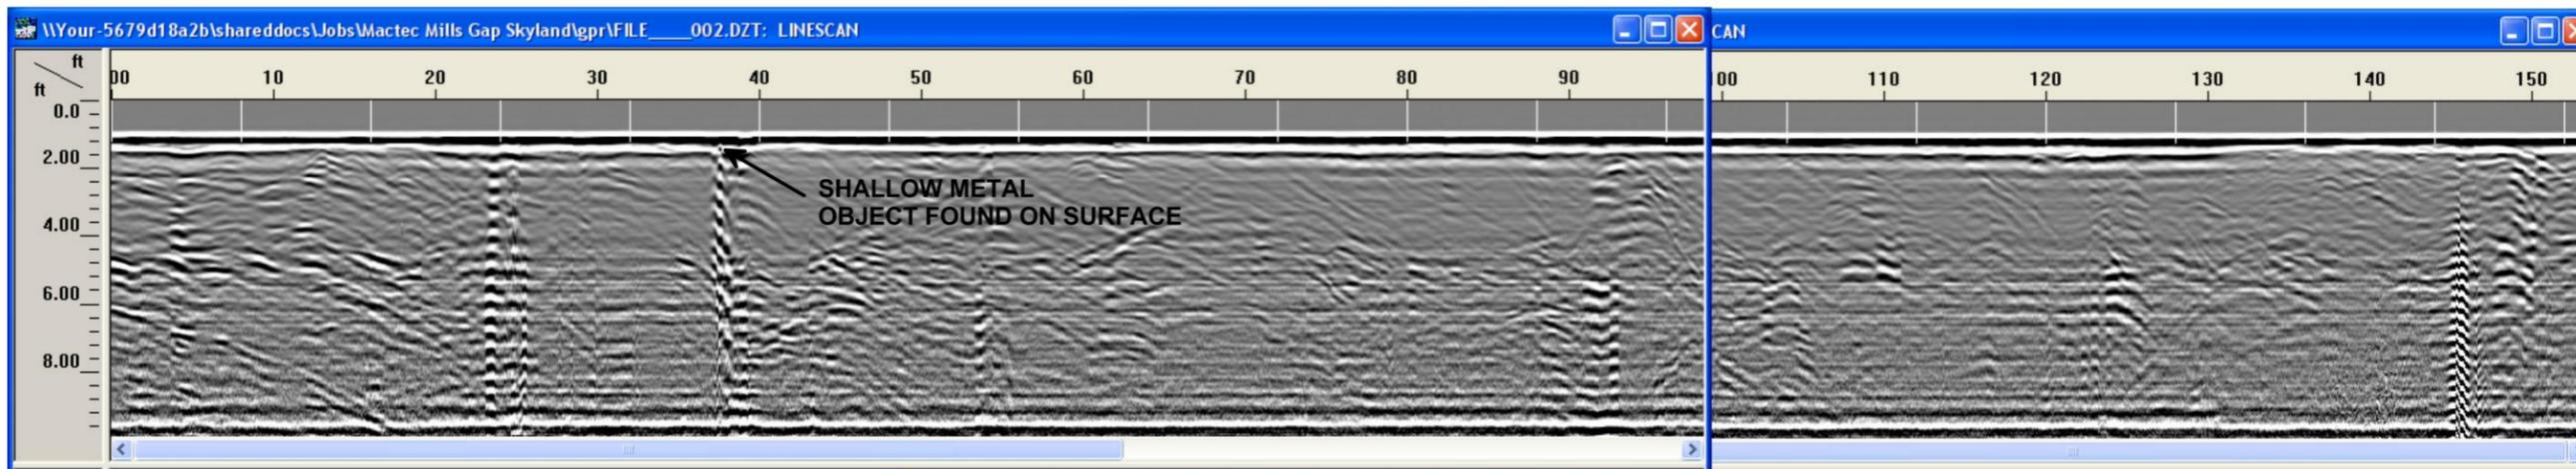
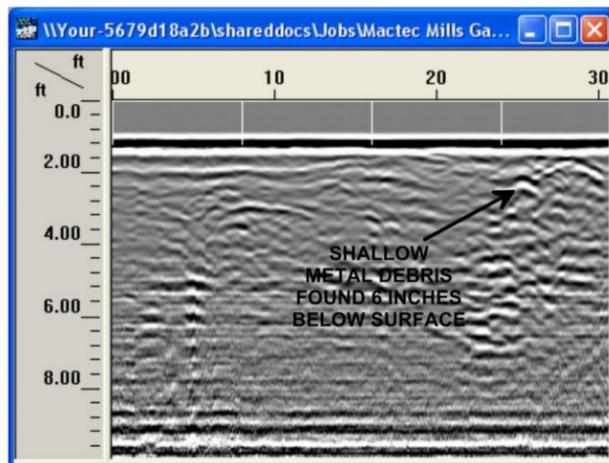
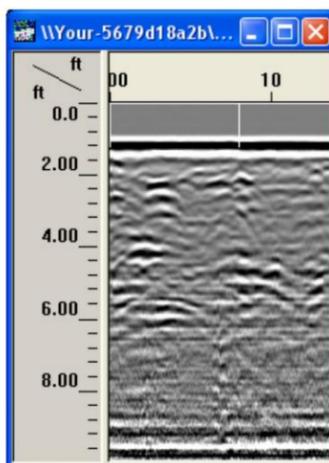
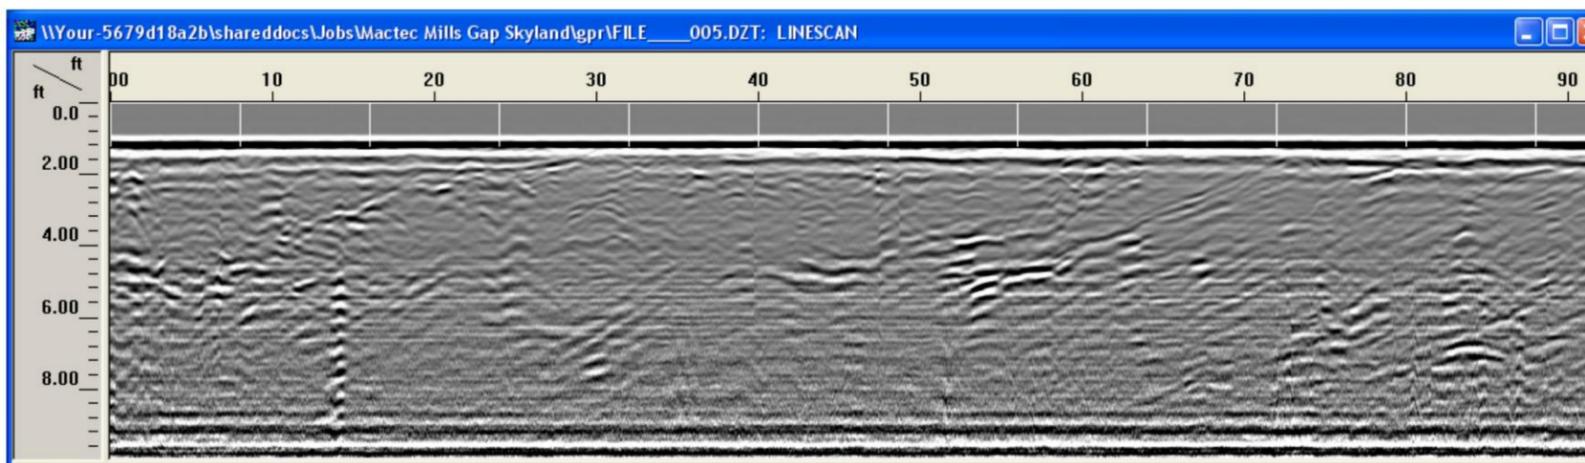
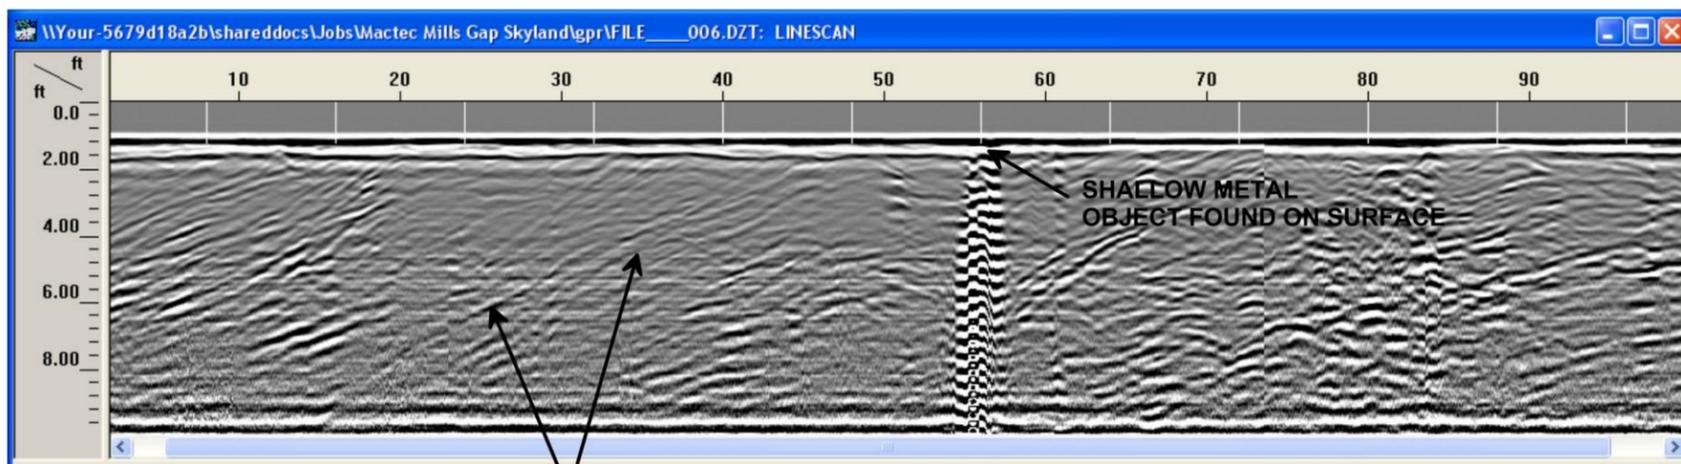
FIGURE 7

BEDDING STRUCTURES IN BEDROCK/SAPROLITE

RESULTS OF GROUND-PENETRATING RADAR EVALUATION

Additionally, using GPR, Geo Solutions discovered that the soil has not been disturbed below 2 to 3 feet below the land surface. As such, the site does not represent a disposal site where excavation and fill has occurred. Because of previous site cleanup by MACTEC was fairly thorough, very little surface debris was detected.
