**REMOVAL PROGRAM
AFTER ACTION REPORT
FOR THE
ROLNICK PROPERTY SITE
BREWER, PENOBSCOT COUNTY, MAINE
6 JULY 2009 THROUGH 18 JUNE 2010**

U.S. Environmental Protection Agency
Region I
Emergency Planning and Response Branch
5 Post Office Square, Suite 100
Boston, Massachusetts 02109-3912

Weston Solutions, Inc.
Superfund Technical Assessment and Response Team III (START)
3 Riverside Drive
Andover, Massachusetts 01810

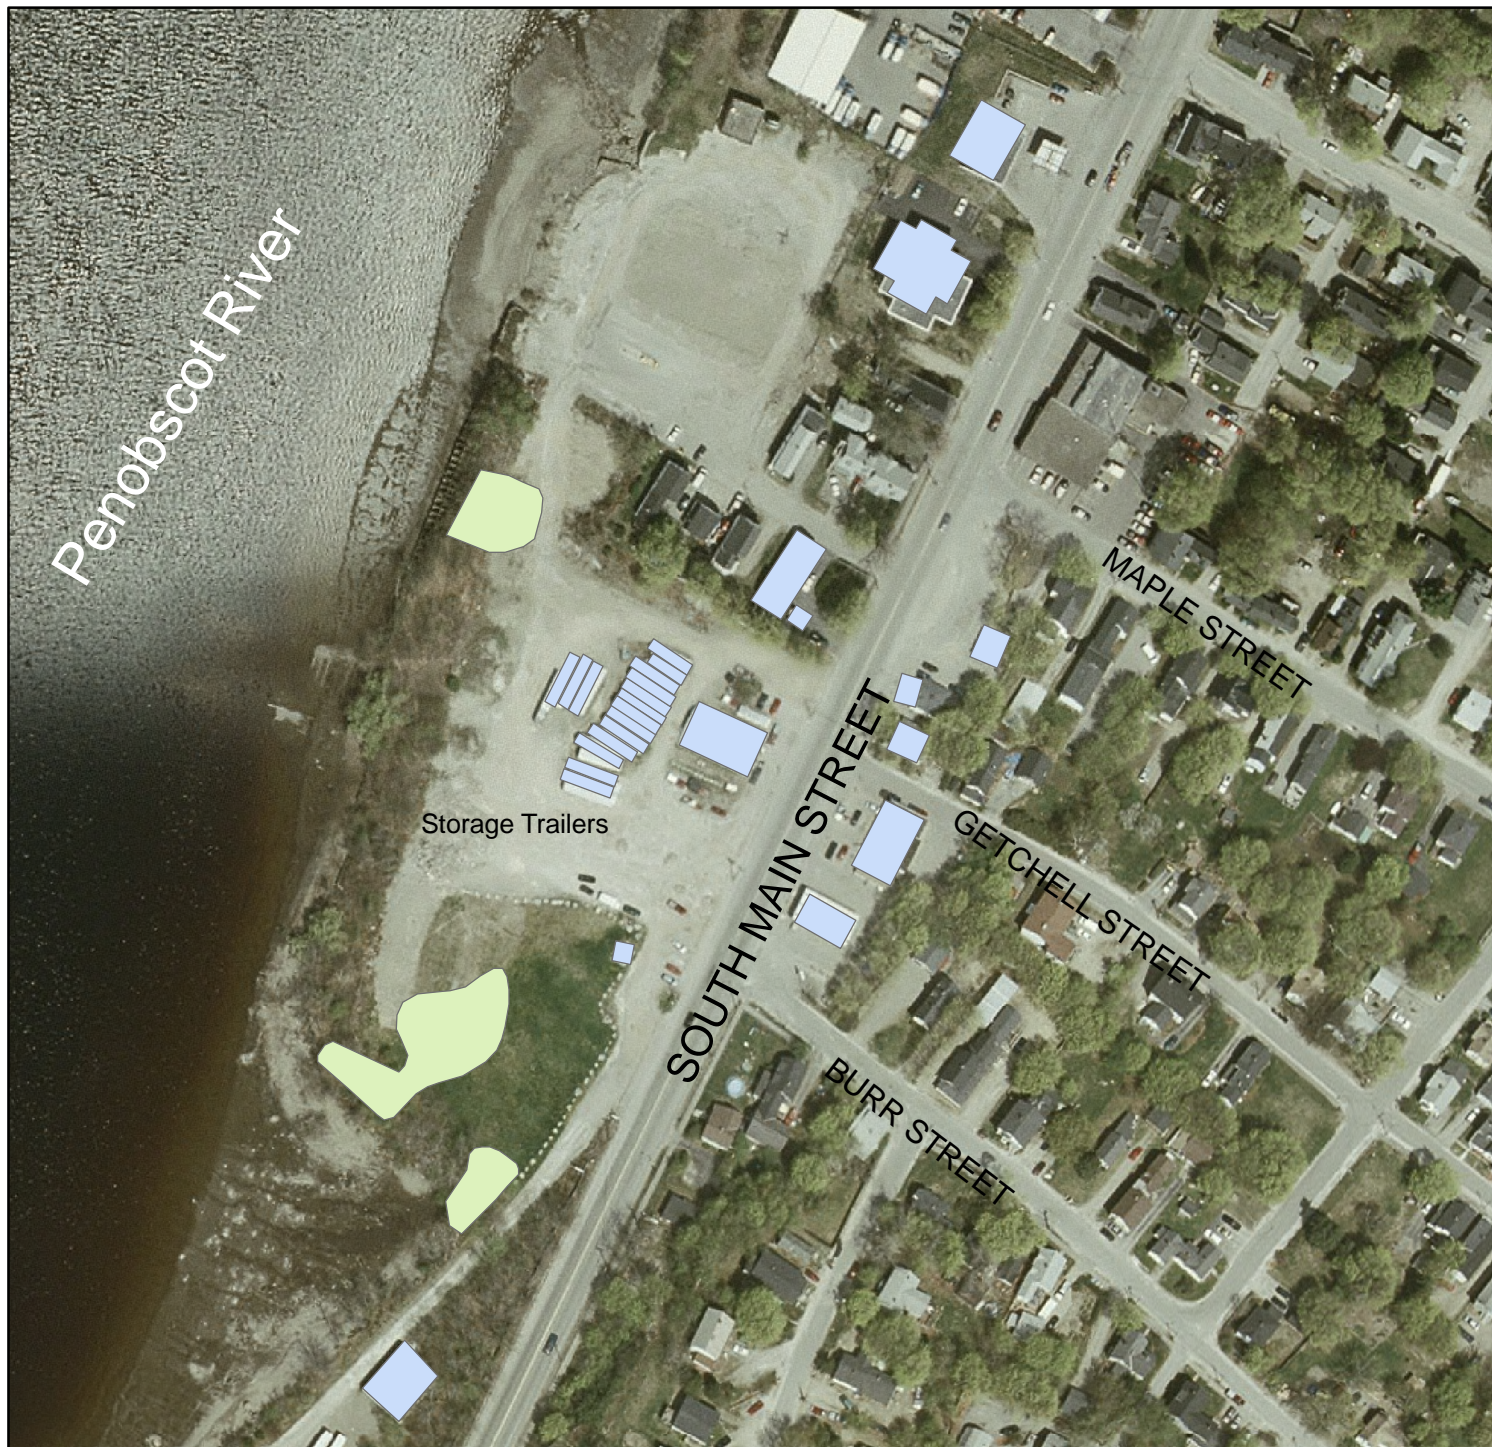
Figure 2

Site Diagram

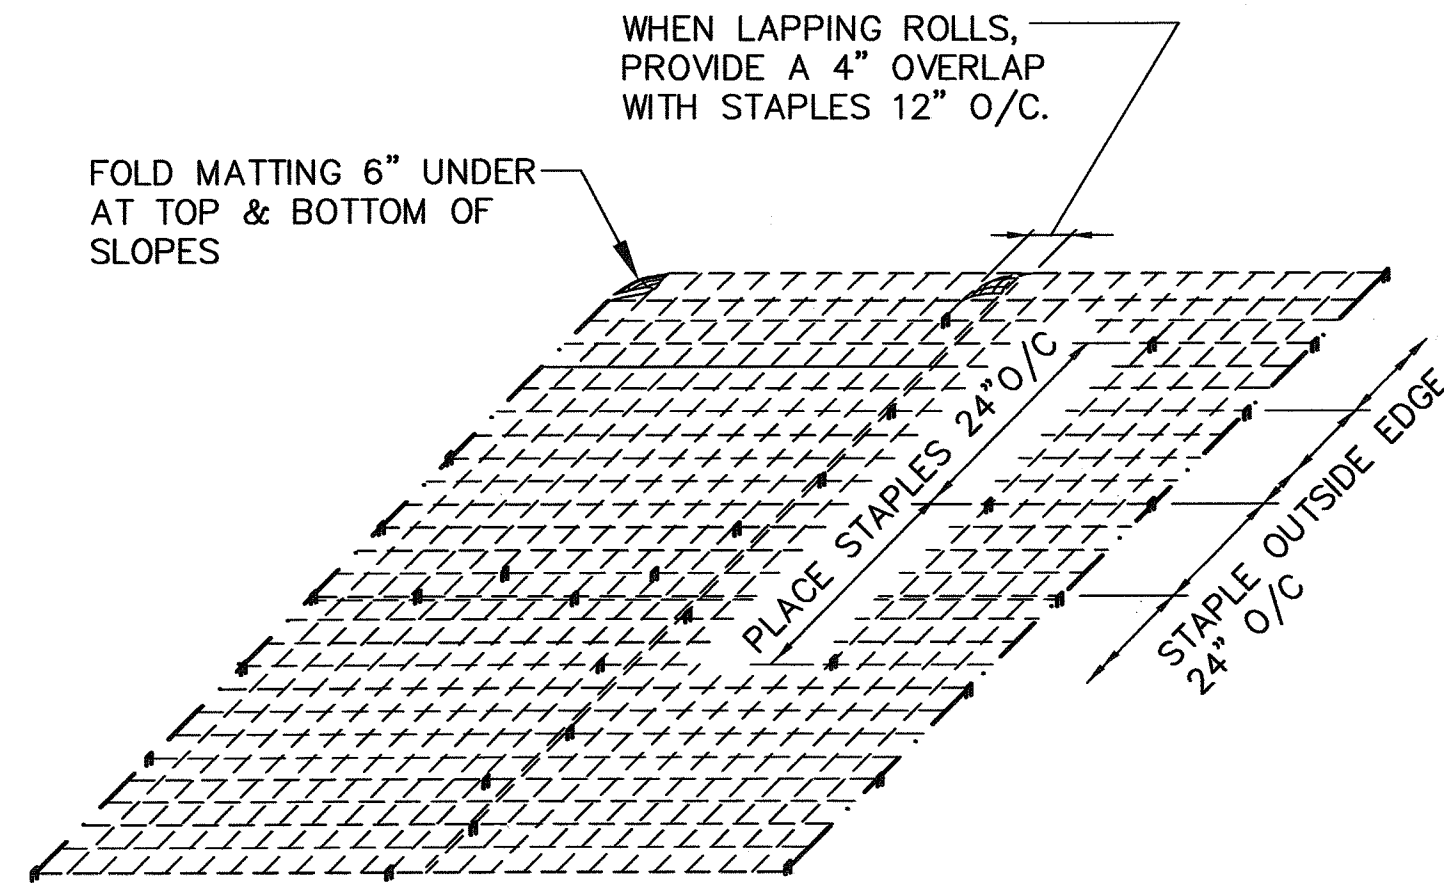
SLOPE STABILIZATION

EROSION CONTROL MATTING

1. BURY THE TOP END OF THE MATTING 6" OR MORE IN DEPTH. TAMP THE TRENCH FULL OF SOIL. SECURE WITH ROWS OF STAPLES, 12" SPACING, 6" DOWN FROM THE TRENCH. OVERLAP BURIED END WITH THE NEXT SUCCESSIVE MAT A MINIMUM OF 3".
2. ALL VEGETATIVE SLOPES 4:1 OR STEEPER TO RECEIVE EROSION CONTROL MATTING.
3. MATTING SHALL BE CURLED WOOD EXCELSIOR OR STRAW FIBER WITH BIODEGRADABLE MESH ON BOTH SIDES; NORTH AMERICAN GREEN S150BN, AMERICAN EXCELSIOR CO. CURLEX II FIBRENET, OR APPROVED EQUAL.

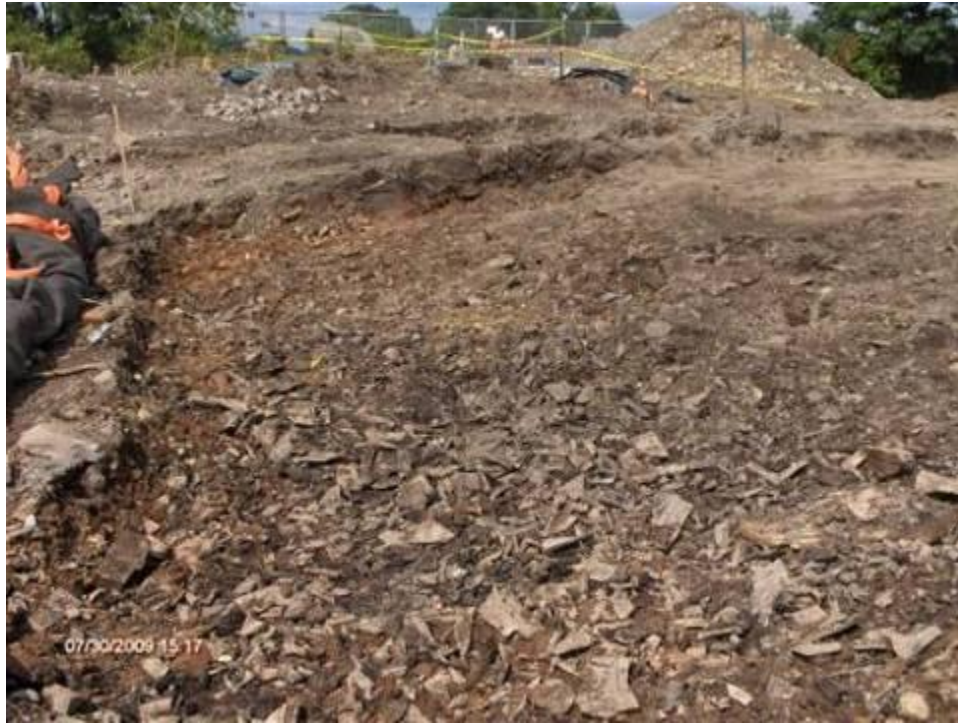
SCENE: View of battery casings found during excavation of top shelf segments E005 through E008. Photograph taken facing northeast.

During excavation of the Top Shelf, battery casings were observed in E006 through E008. The battery casings were excavated until the majority of the battery casings were removed. Segments E006 to E008 on the Top Shelf were excavated to approximately 10 feet.

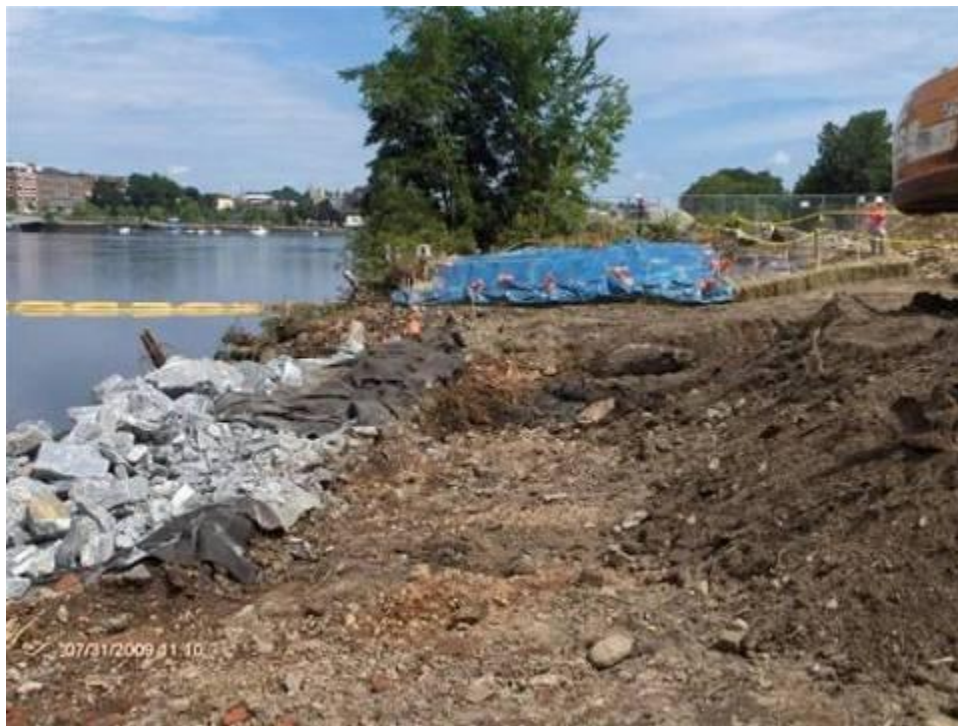
SCENE: View of the top shelf excavations of E005 through E008. Photograph taken facing north-northeast.

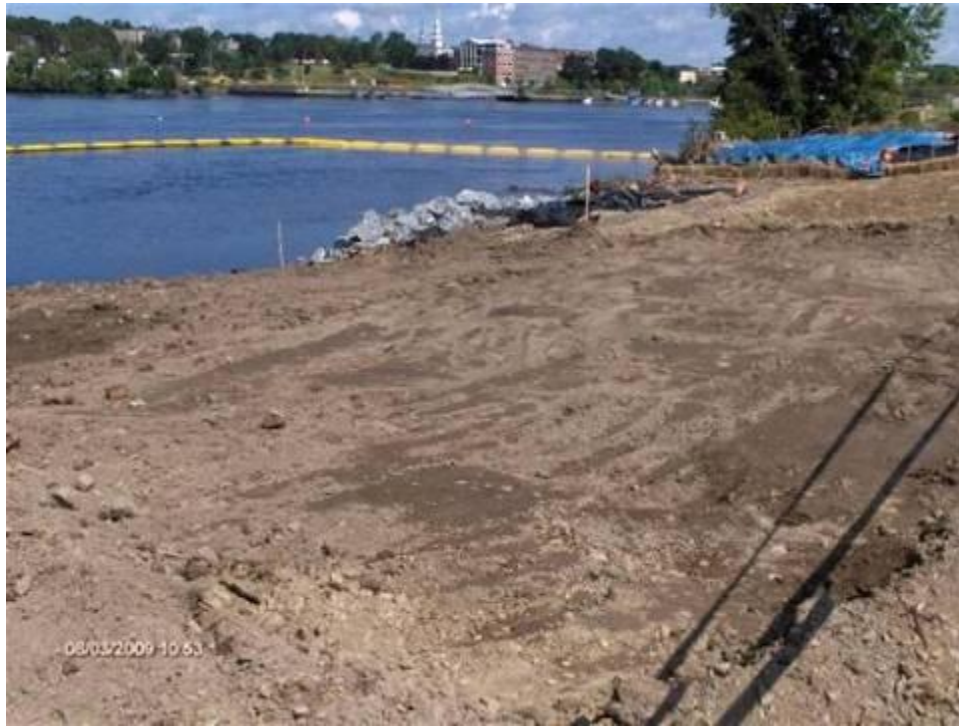
SCENE: View of the top shelf segments E005 to E008, backfilled with 'common' fill soil. Photograph taken facing north-northwest.

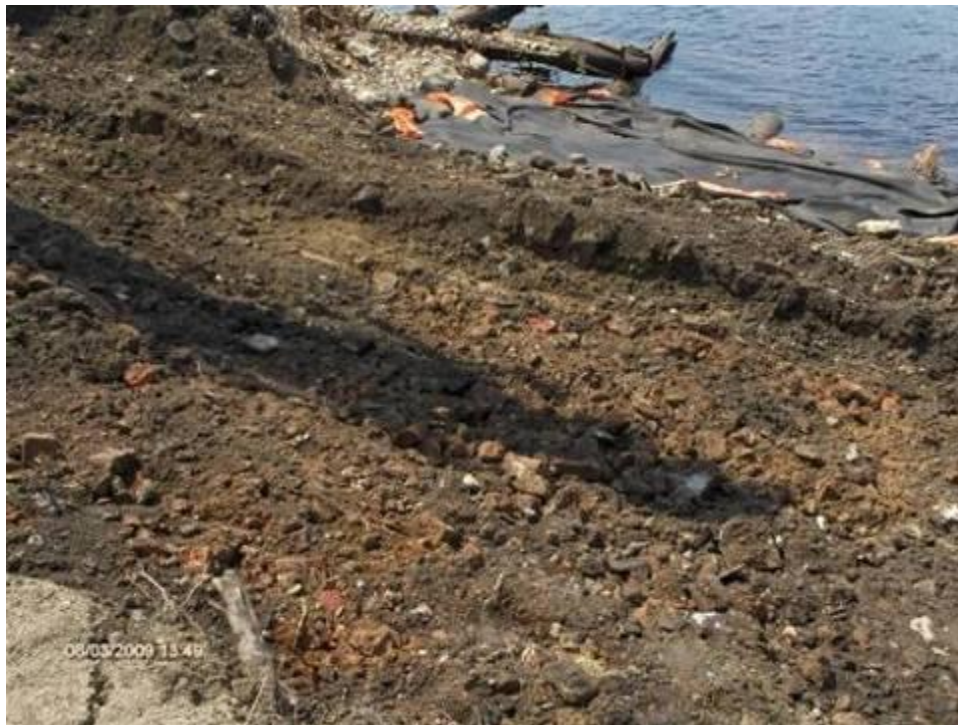
SCENE: View of battery casings and debris (brick) in the top shelf excavation of segment E009. Photograph taken facing west-northwest.

During Top Shelf excavation activities, battery casings were observed in E009-Z. Test pits were excavated at E010-X, E-011-X, E013-X, and E014-X to determine potential extent. Soil was not visibly contaminated at a depth of 3 feet.

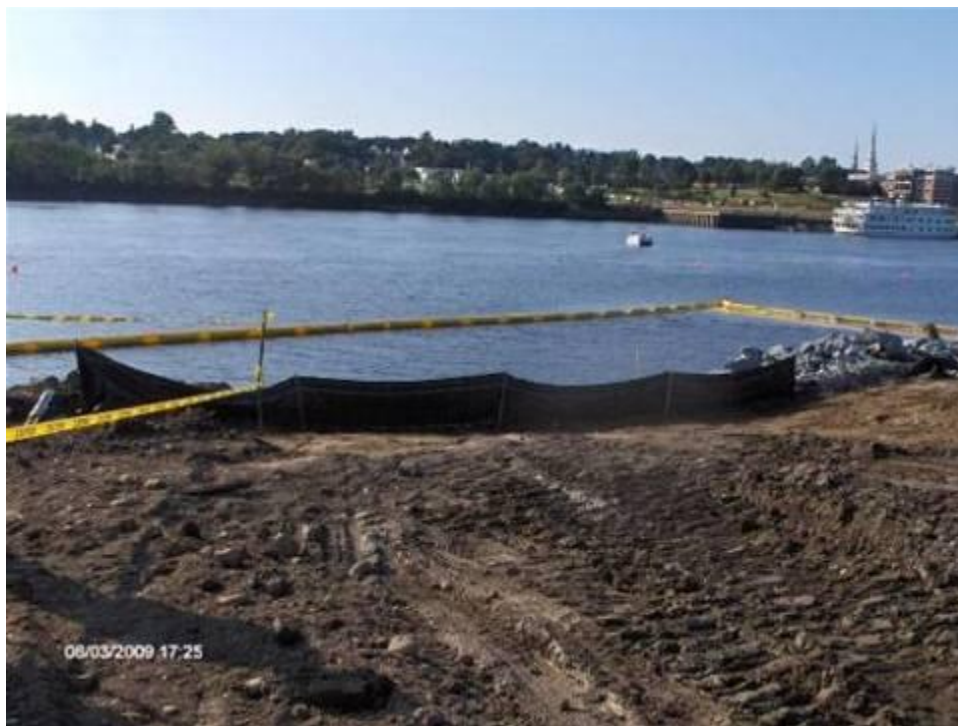
SCENE: View of the top shelf area E009 to E011, backfilled with clean soil. Photograph taken facing northwest.

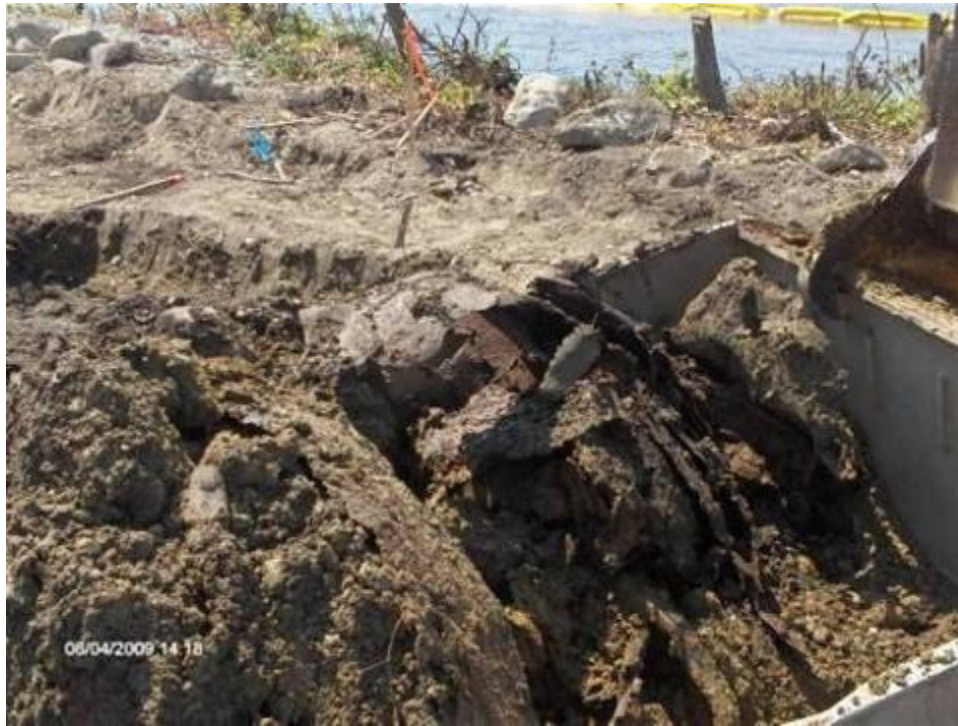
SCENE: View of metal automobile debris observed in the top shelf excavation of E012 and E013. Photograph taken facing west.

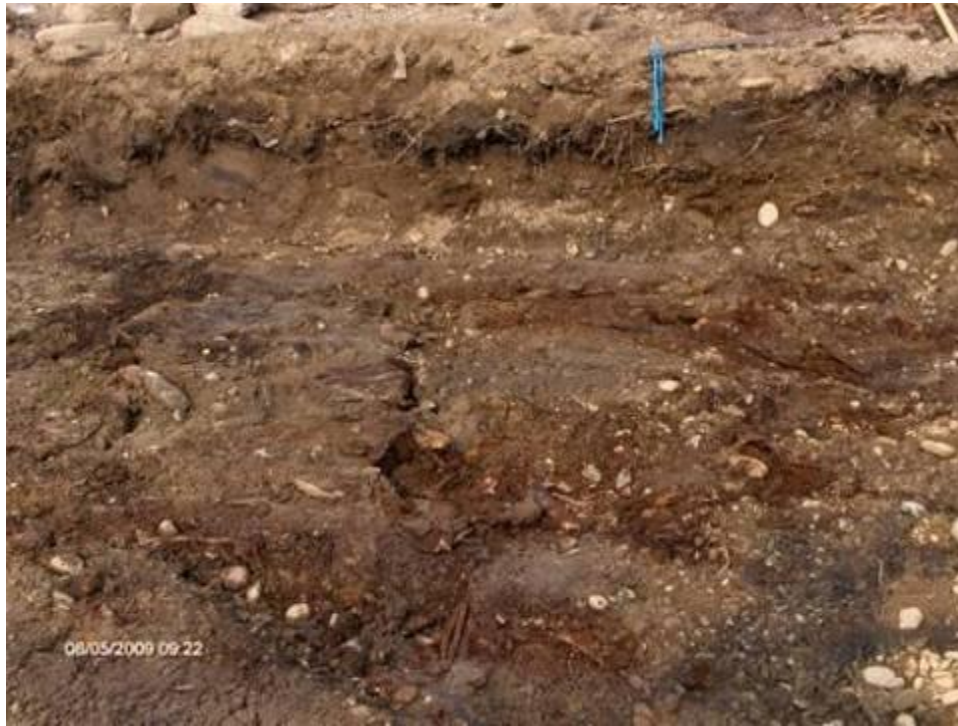
SCENE: View of metal debris in the excavation of top shelf segments E016-X. Photograph taken facing south-southwest.

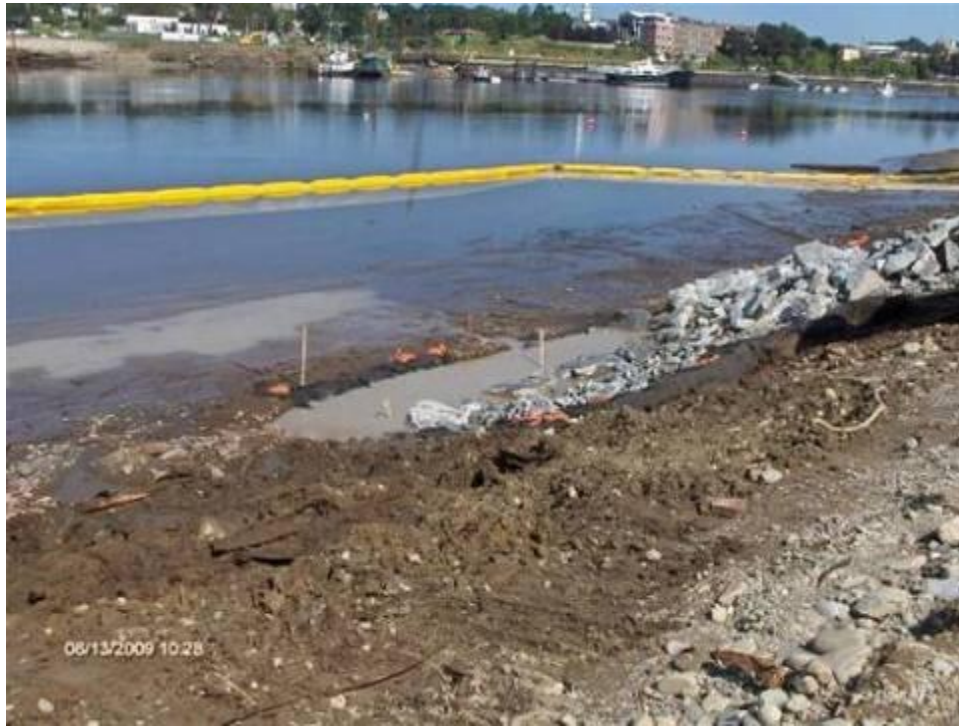
SCENE: View of bank segments E009 (with stone) to E013 (excavated) at low tide. Photograph taken facing northwest.

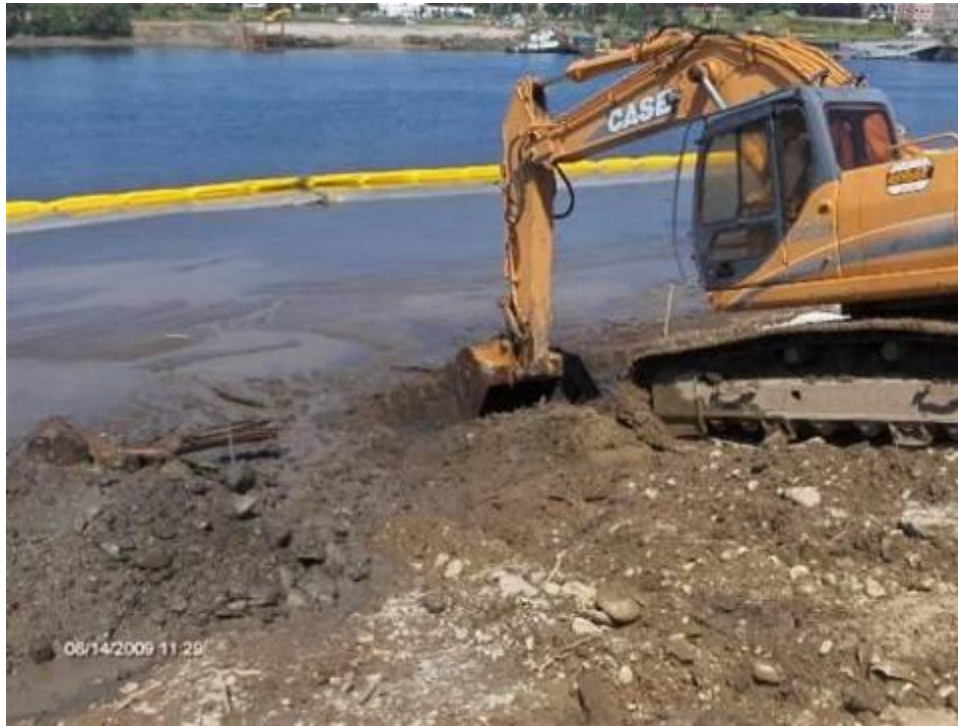
SCENE: View of the excavation of the toe trench of bank segments E011 and E013. Photograph taken facing west-northwest.

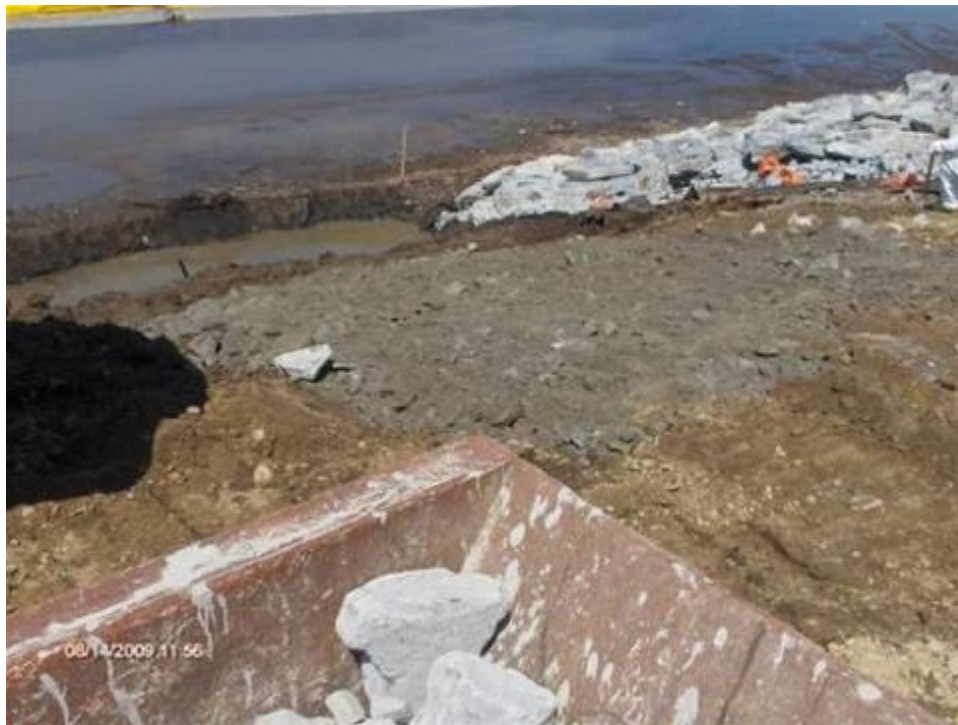
SCENE: View of riverbank stabilization using ground stone (fines) to allow for equipment access. Photograph taken facing northwest.

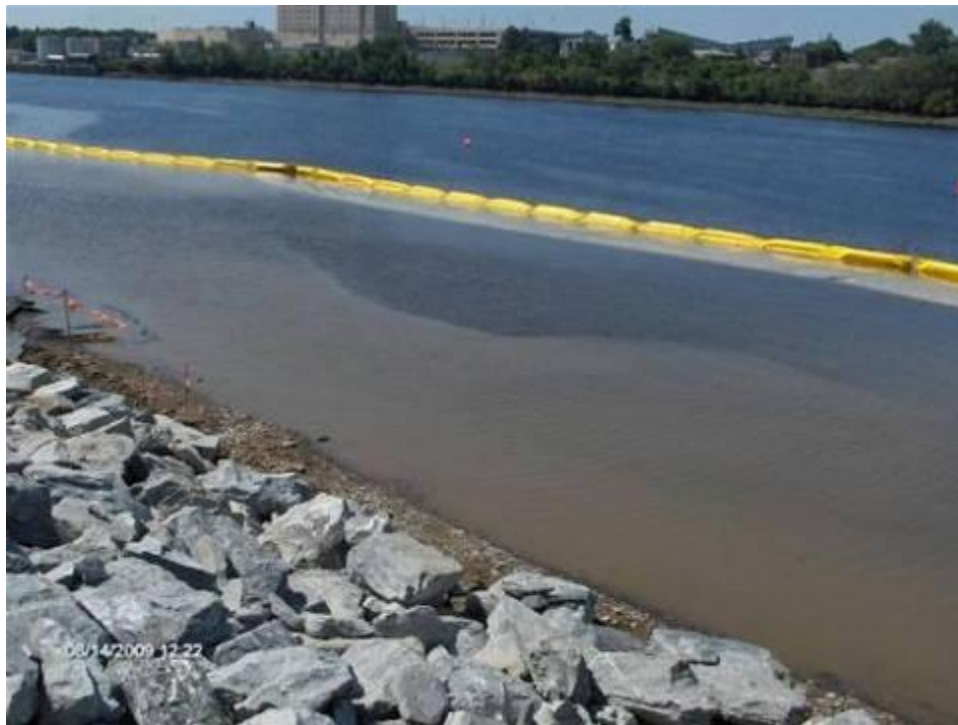
SCENE: View of siltation observed during incoming tide. Photograph taken facing west-southwest.

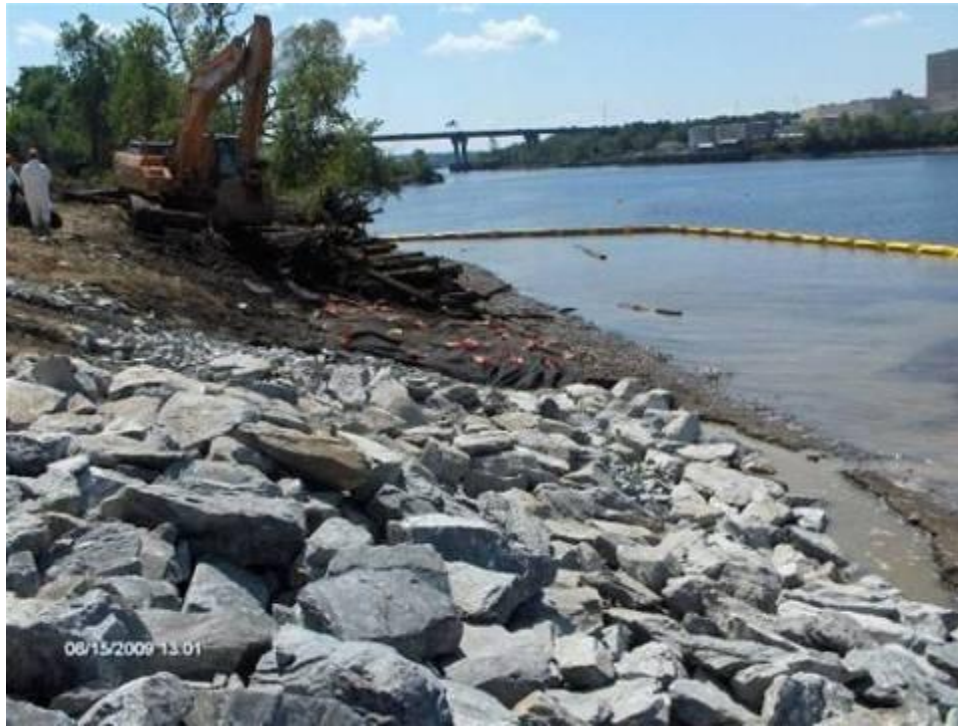
SCENE: View of bank segment E014 covered with Geotech fabric for the incoming tide. Photograph taken facing south-southwest.

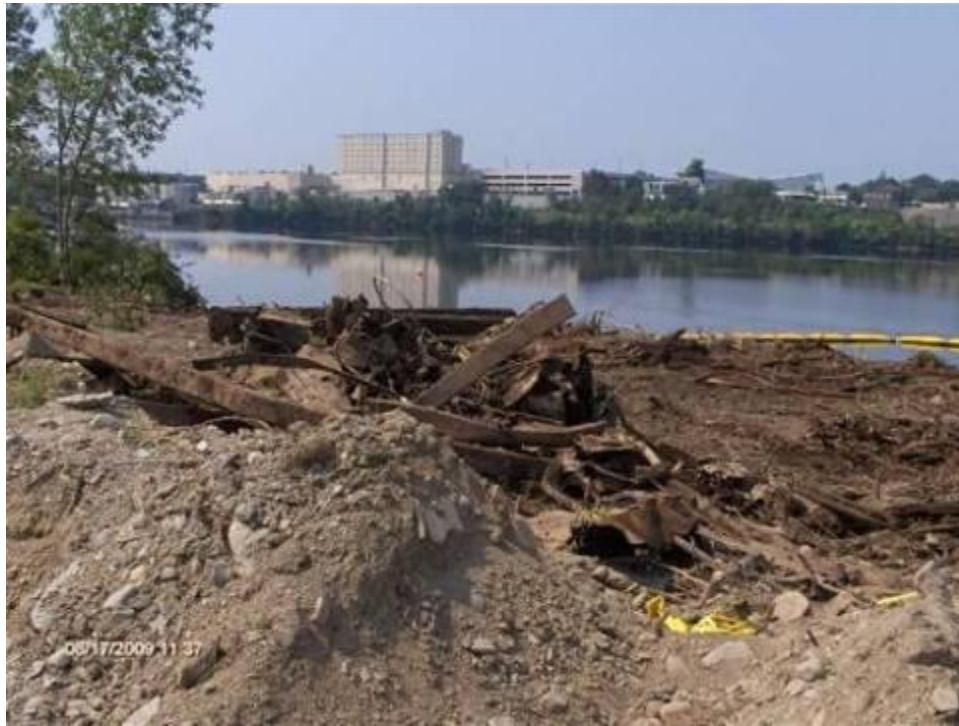
SCENE: View of metal debris from excavations, staged for decontamination at approximately E019. Photograph taken facing west.

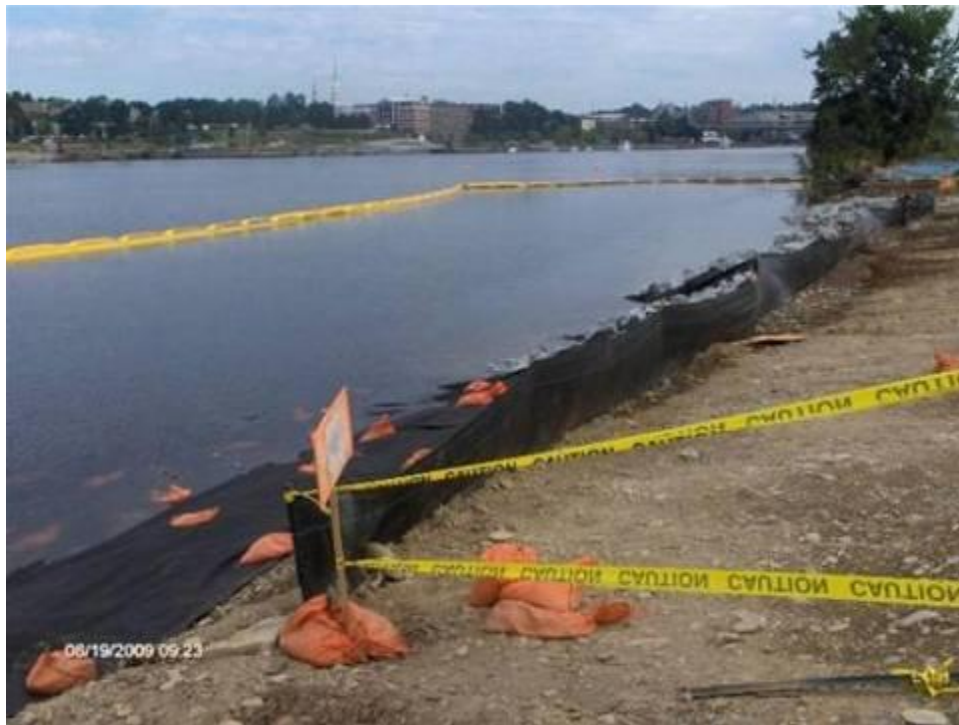
SCENE: View of Geotech fabric over bank segments E015 to E018 during high tide, and silt fence at the top of slope. Photograph taken facing northwest.

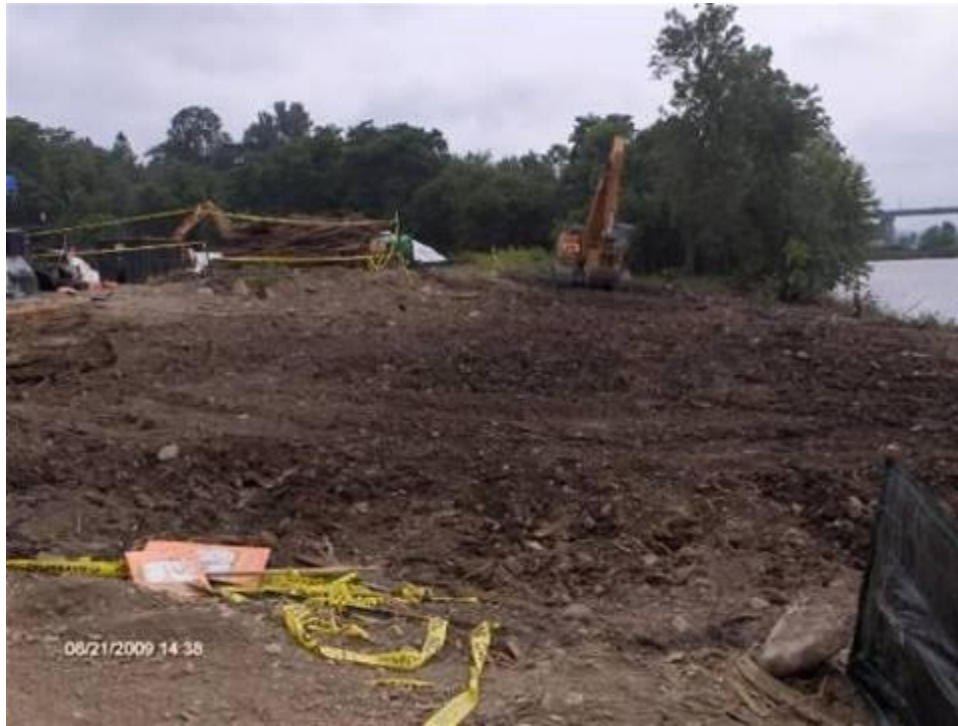
SCENE: View of the excavation of top shelf segments E021 and E022. Photograph taken facing south-southwest.

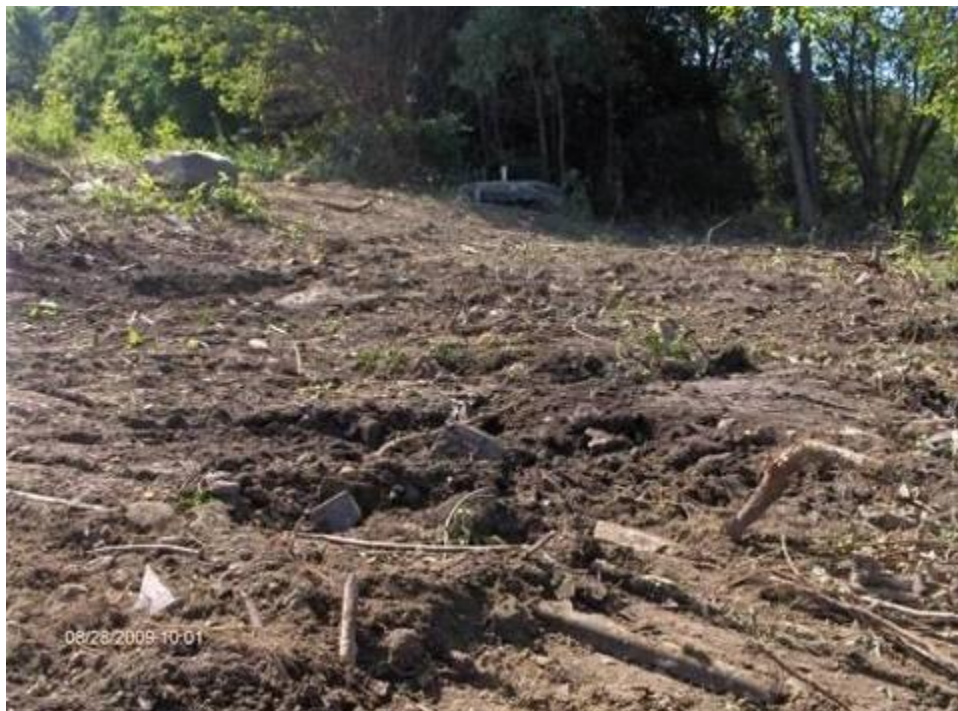
SCENE: View of battery casings, found in tree roots (tree removed). Photograph taken facing south.

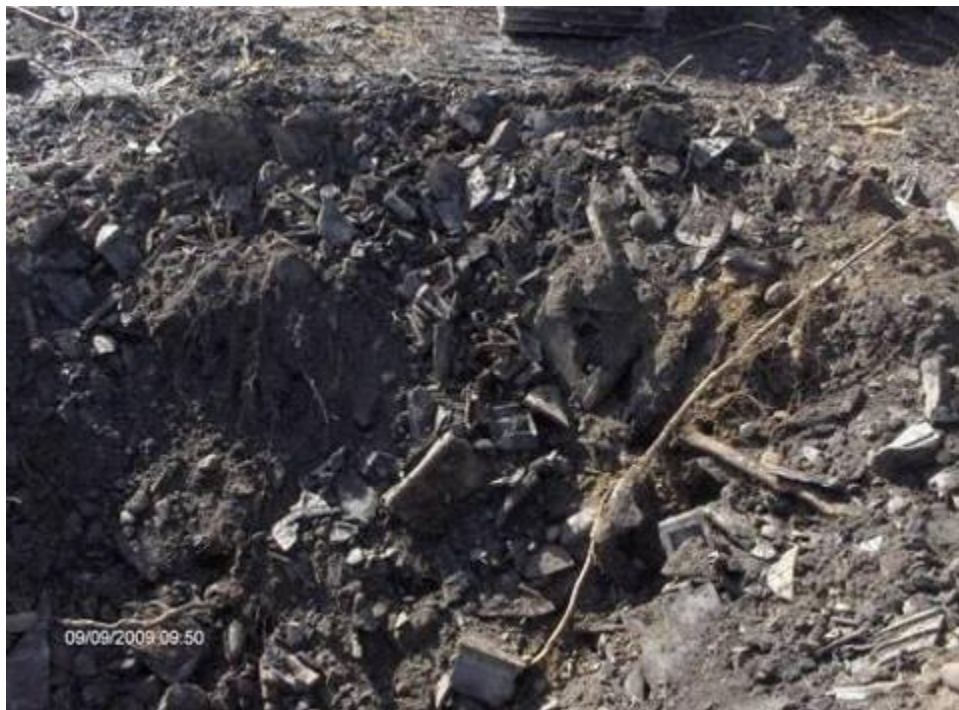
SCENE: View of test pit 6, excavated to approximately 3 feet, battery casings observed. Photograph taken facing south.

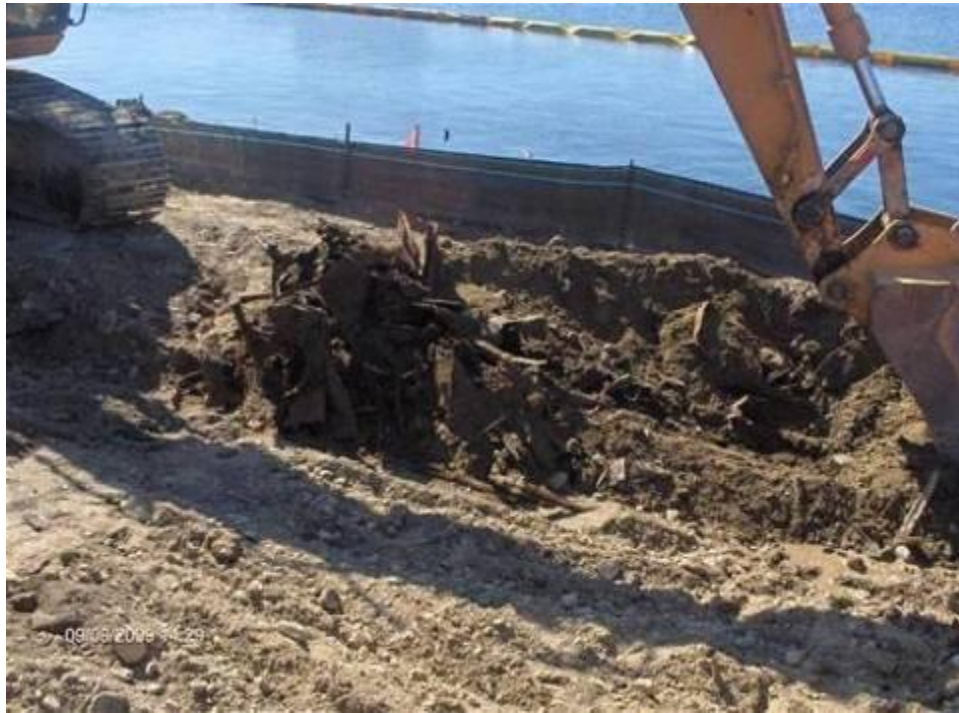
SCENE: View of the metal vehicle debris observed during the excavation of E027-X. Photograph taken facing west.

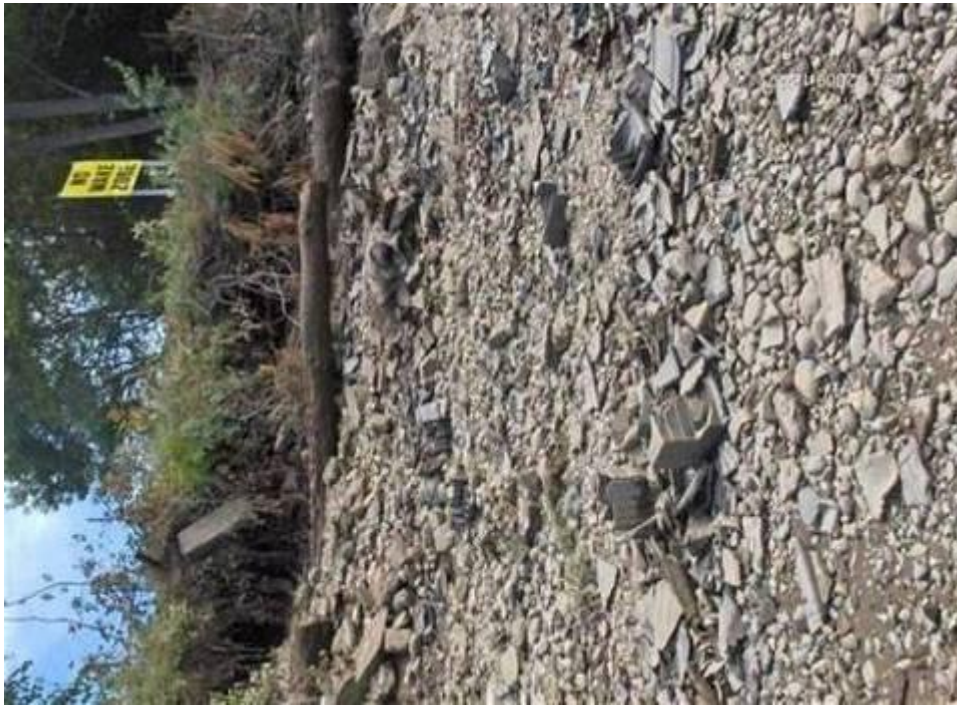
SCENE: View of the battery casings observed on the riverbed and in the riverbank wall at the southwest corner of the site. Photograph taken facing east.

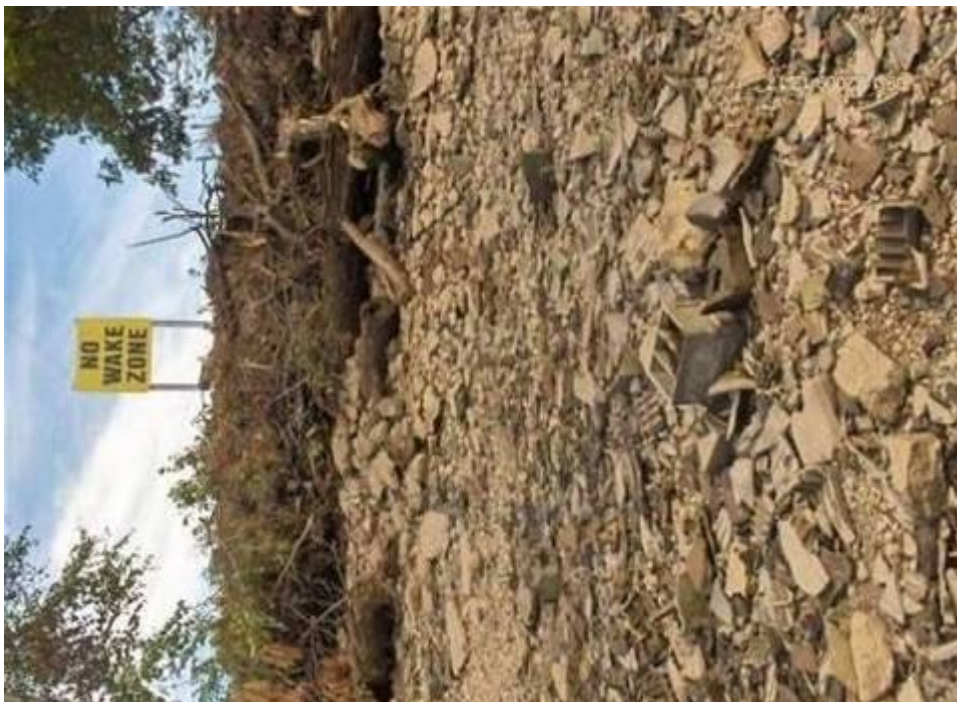
SCENE: View of the battery casings observed on the riverbed and in the riverbank wall at the southwest corner of the site. Photograph taken facing northeast.

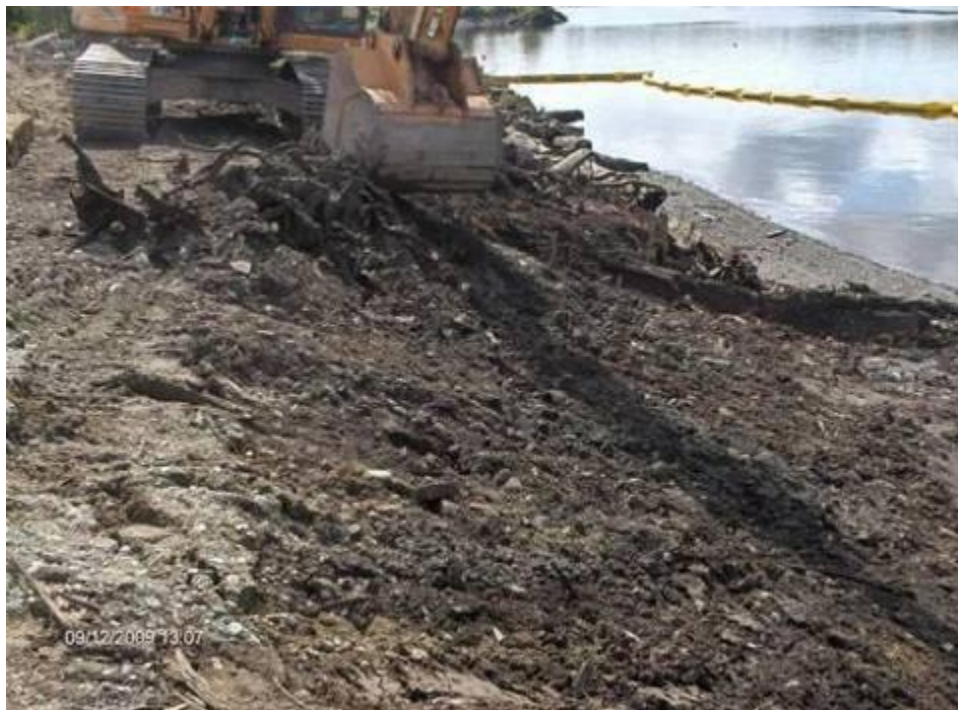
SCENE: View of the excavation of bank segment E030 and E031, battery casings observed. Photograph taken facing south-southwest.

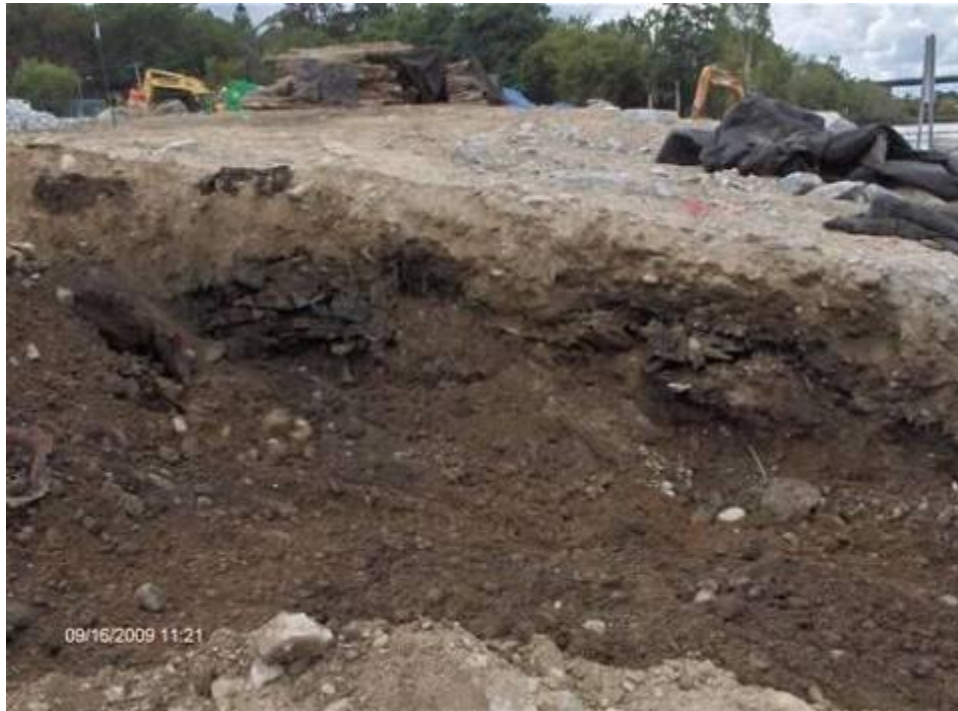
SCENE: View of the battery casings and metal auto debris in the south wall of E018, observed during re-excavation. Photograph taken facing south.

Beginning on 14 September 2009, START SL Dupree collected post-excavation samples after ERRS re-excavated Top Shelf segments E009 to E020 in areas previously excavated to less than 2 feet bgs. Battery casings were observed in several locations. Locations with battery casings were excavated to greater depths than 2 feet, based on XRF analytical results.

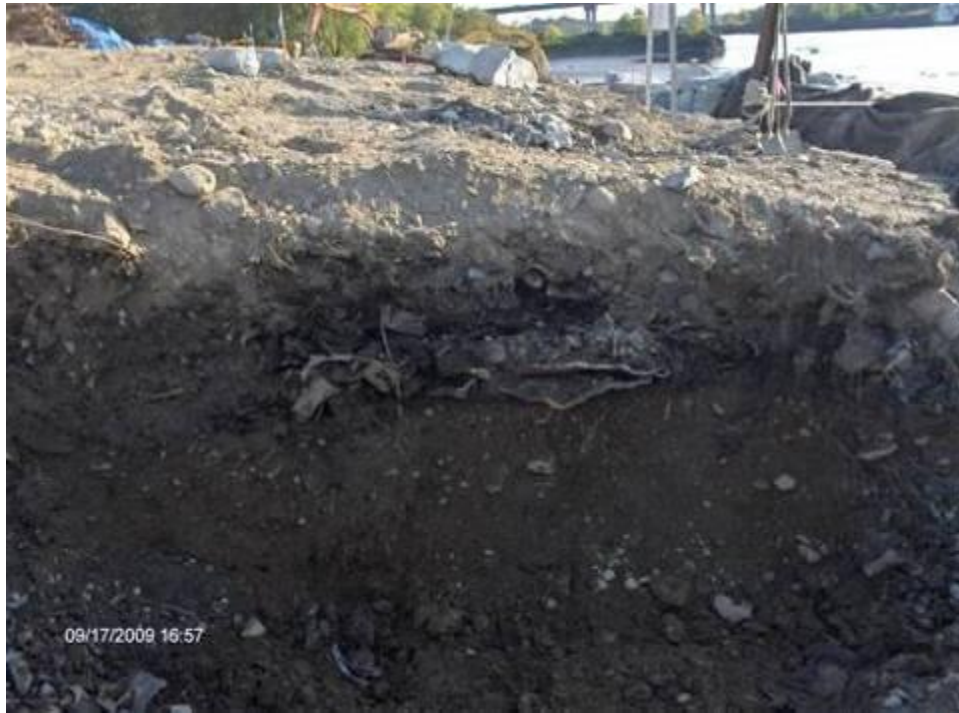
SCENE: View of the casings and auto debris observed in the south wall of top shelf segment E019 during re-excavation. Photograph taken facing southwest.

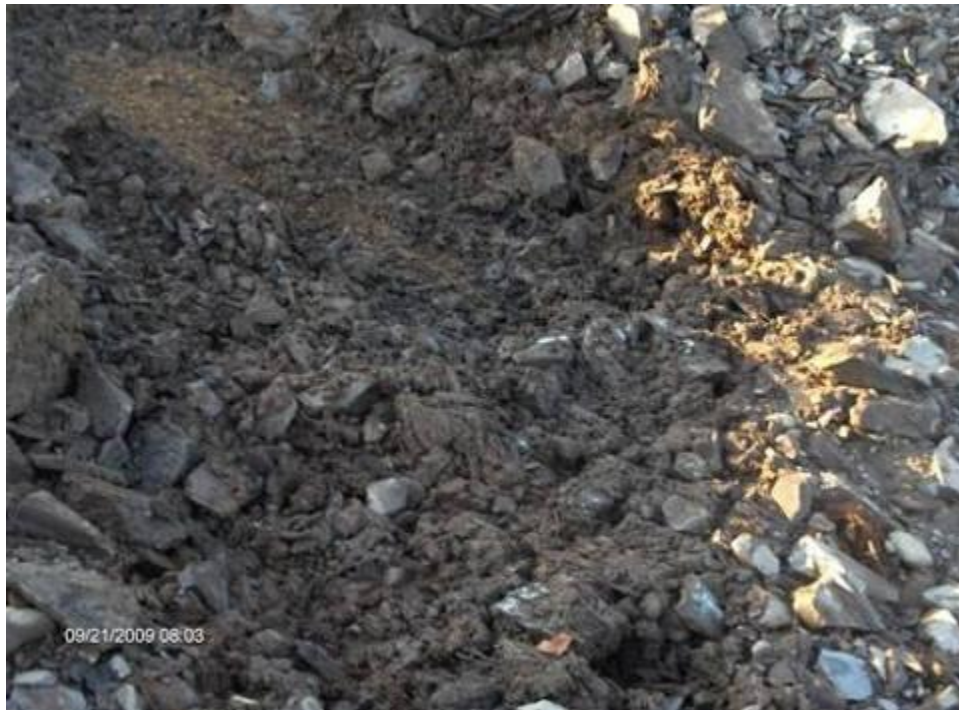
SCENE: View of the battery casings observed during excavation activities of bank segment E039. Photograph taken facing south.

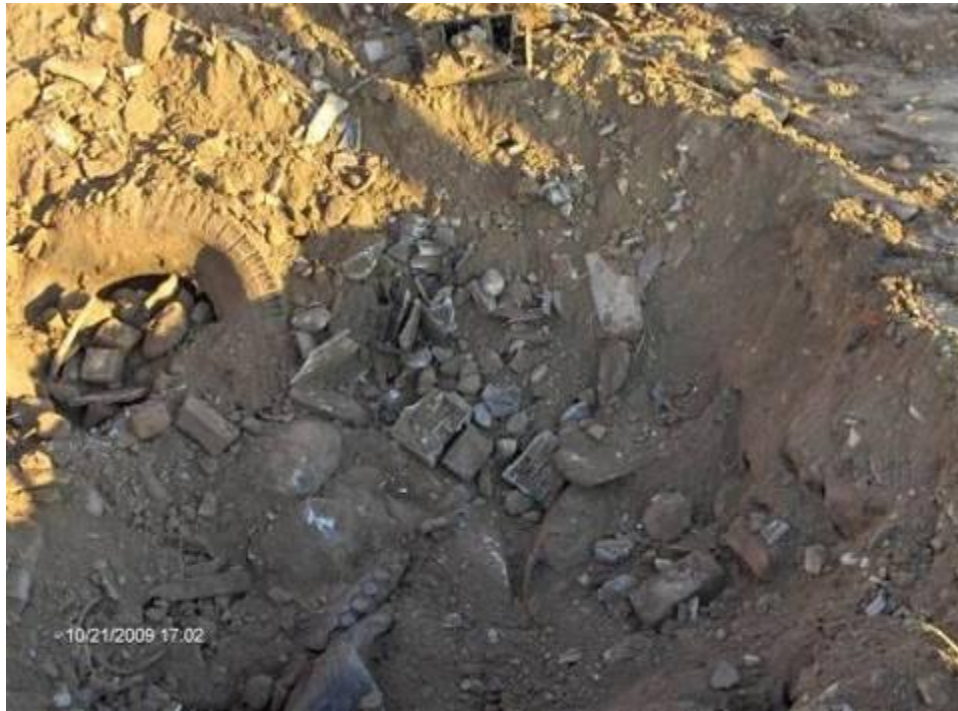
SCENE: View of battery casings observed during the test pit excavation in E053-F, located on the edge of the southern field. Photograph taken facing east.

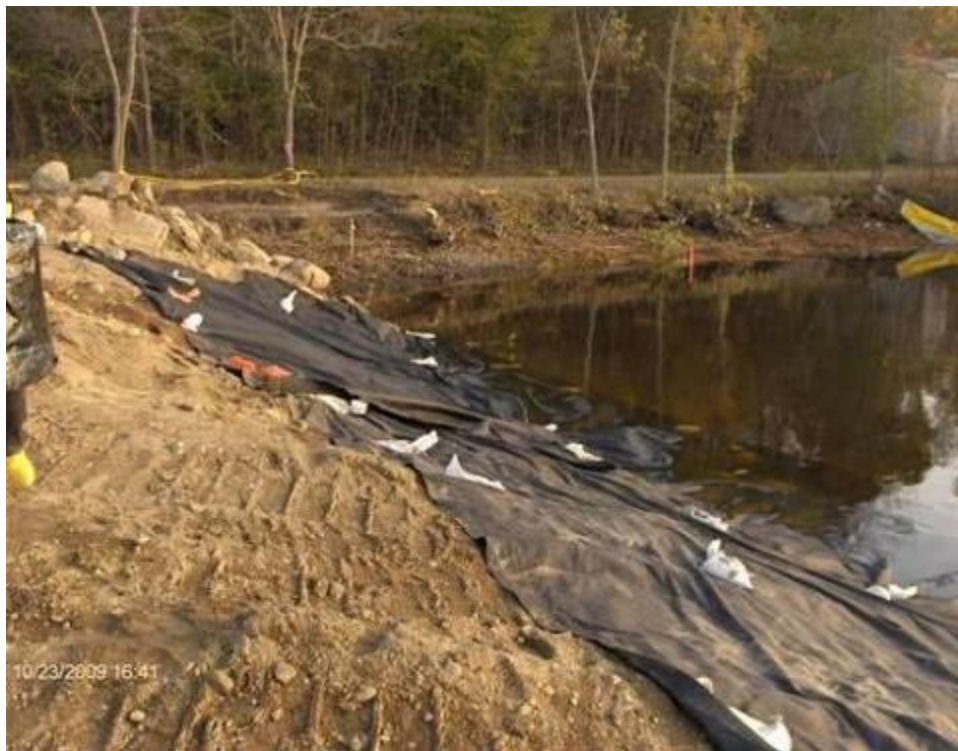
SCENE: View of the bank segments E053 to E057, covered with Geotech fabric. Photograph taken facing southeast.
