**REMOVAL PROGRAM
AFTER ACTION REPORT
FOR THE
ROLNICK PROPERTY SITE
BREWER, PENOBSCOT COUNTY, MAINE
6 JULY 2009 THROUGH 18 JUNE 2010**

U.S. Environmental Protection Agency
Region I
Emergency Planning and Response Branch
5 Post Office Square, Suite 100
Boston, Massachusetts 02109-3912

Weston Solutions, Inc.
Superfund Technical Assessment and Response Team III (START)
3 Riverside Drive
Andover, Massachusetts 01810

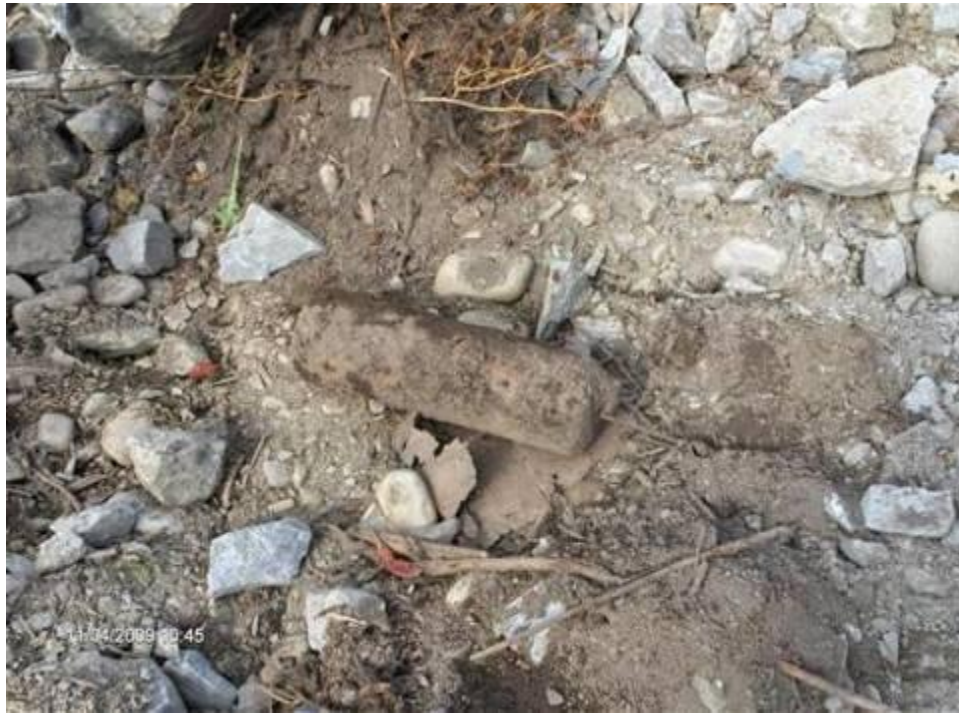
SCENE: View of a cylinder found during north end excavation activities. No label was observed, and the cylinder was punctured and empty.

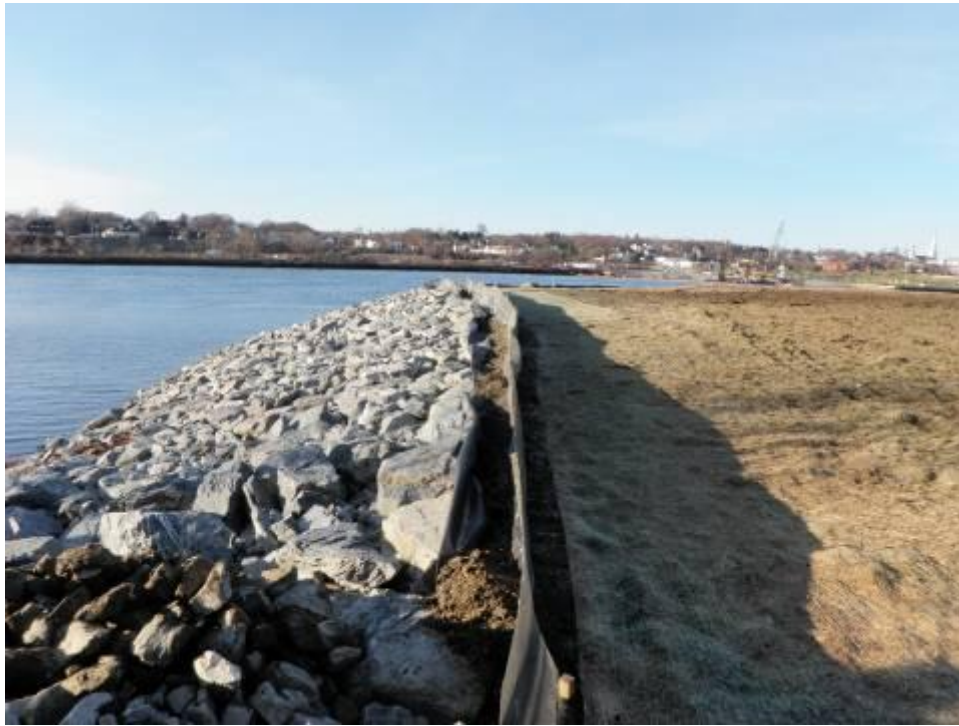
SCENE: View of the southern border of the site, at the top of the riprap slope; silt fence and erosion control matting installed. Photograph taken facing west-northwest.

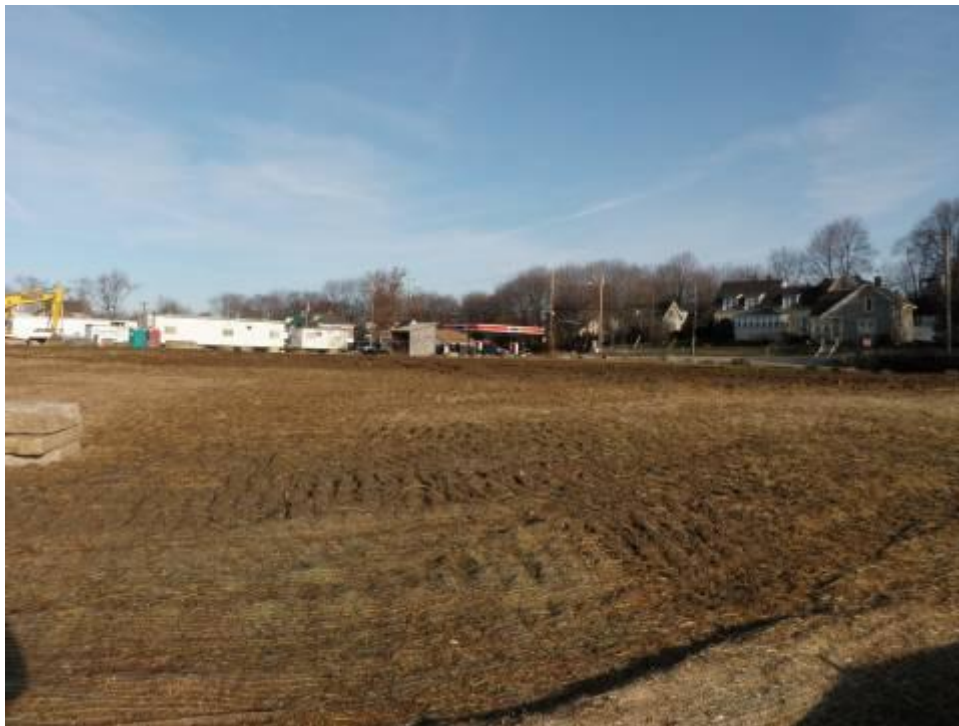
SCENE: View of the southern field with erosion control matting and hydroseed. Photograph taken facing northeast.

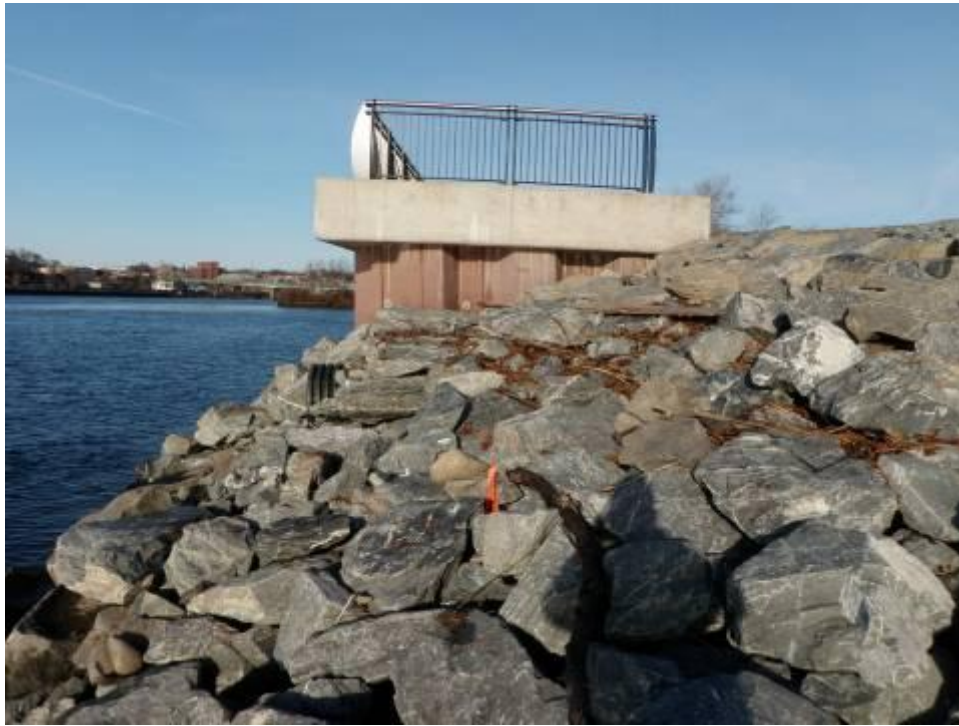
SCENE: View of the riprap wall abutting the adjacent town sea wall at the northern end of the site. Photograph taken facing north-northeast.
