**Subject: Removal Site Evaluation, Revision 0
Oak Haven Lead Investigation
EPA Contract No. EP-W-05-053
Technical Direction Document (TDD) No. TNA-05-003-0099**

REMOVAL SITE EVALUATION

OAK HAVEN LEAD INVESTIGATION SALISBURY, ROWAN COUNTY, NORTH CAROLINA

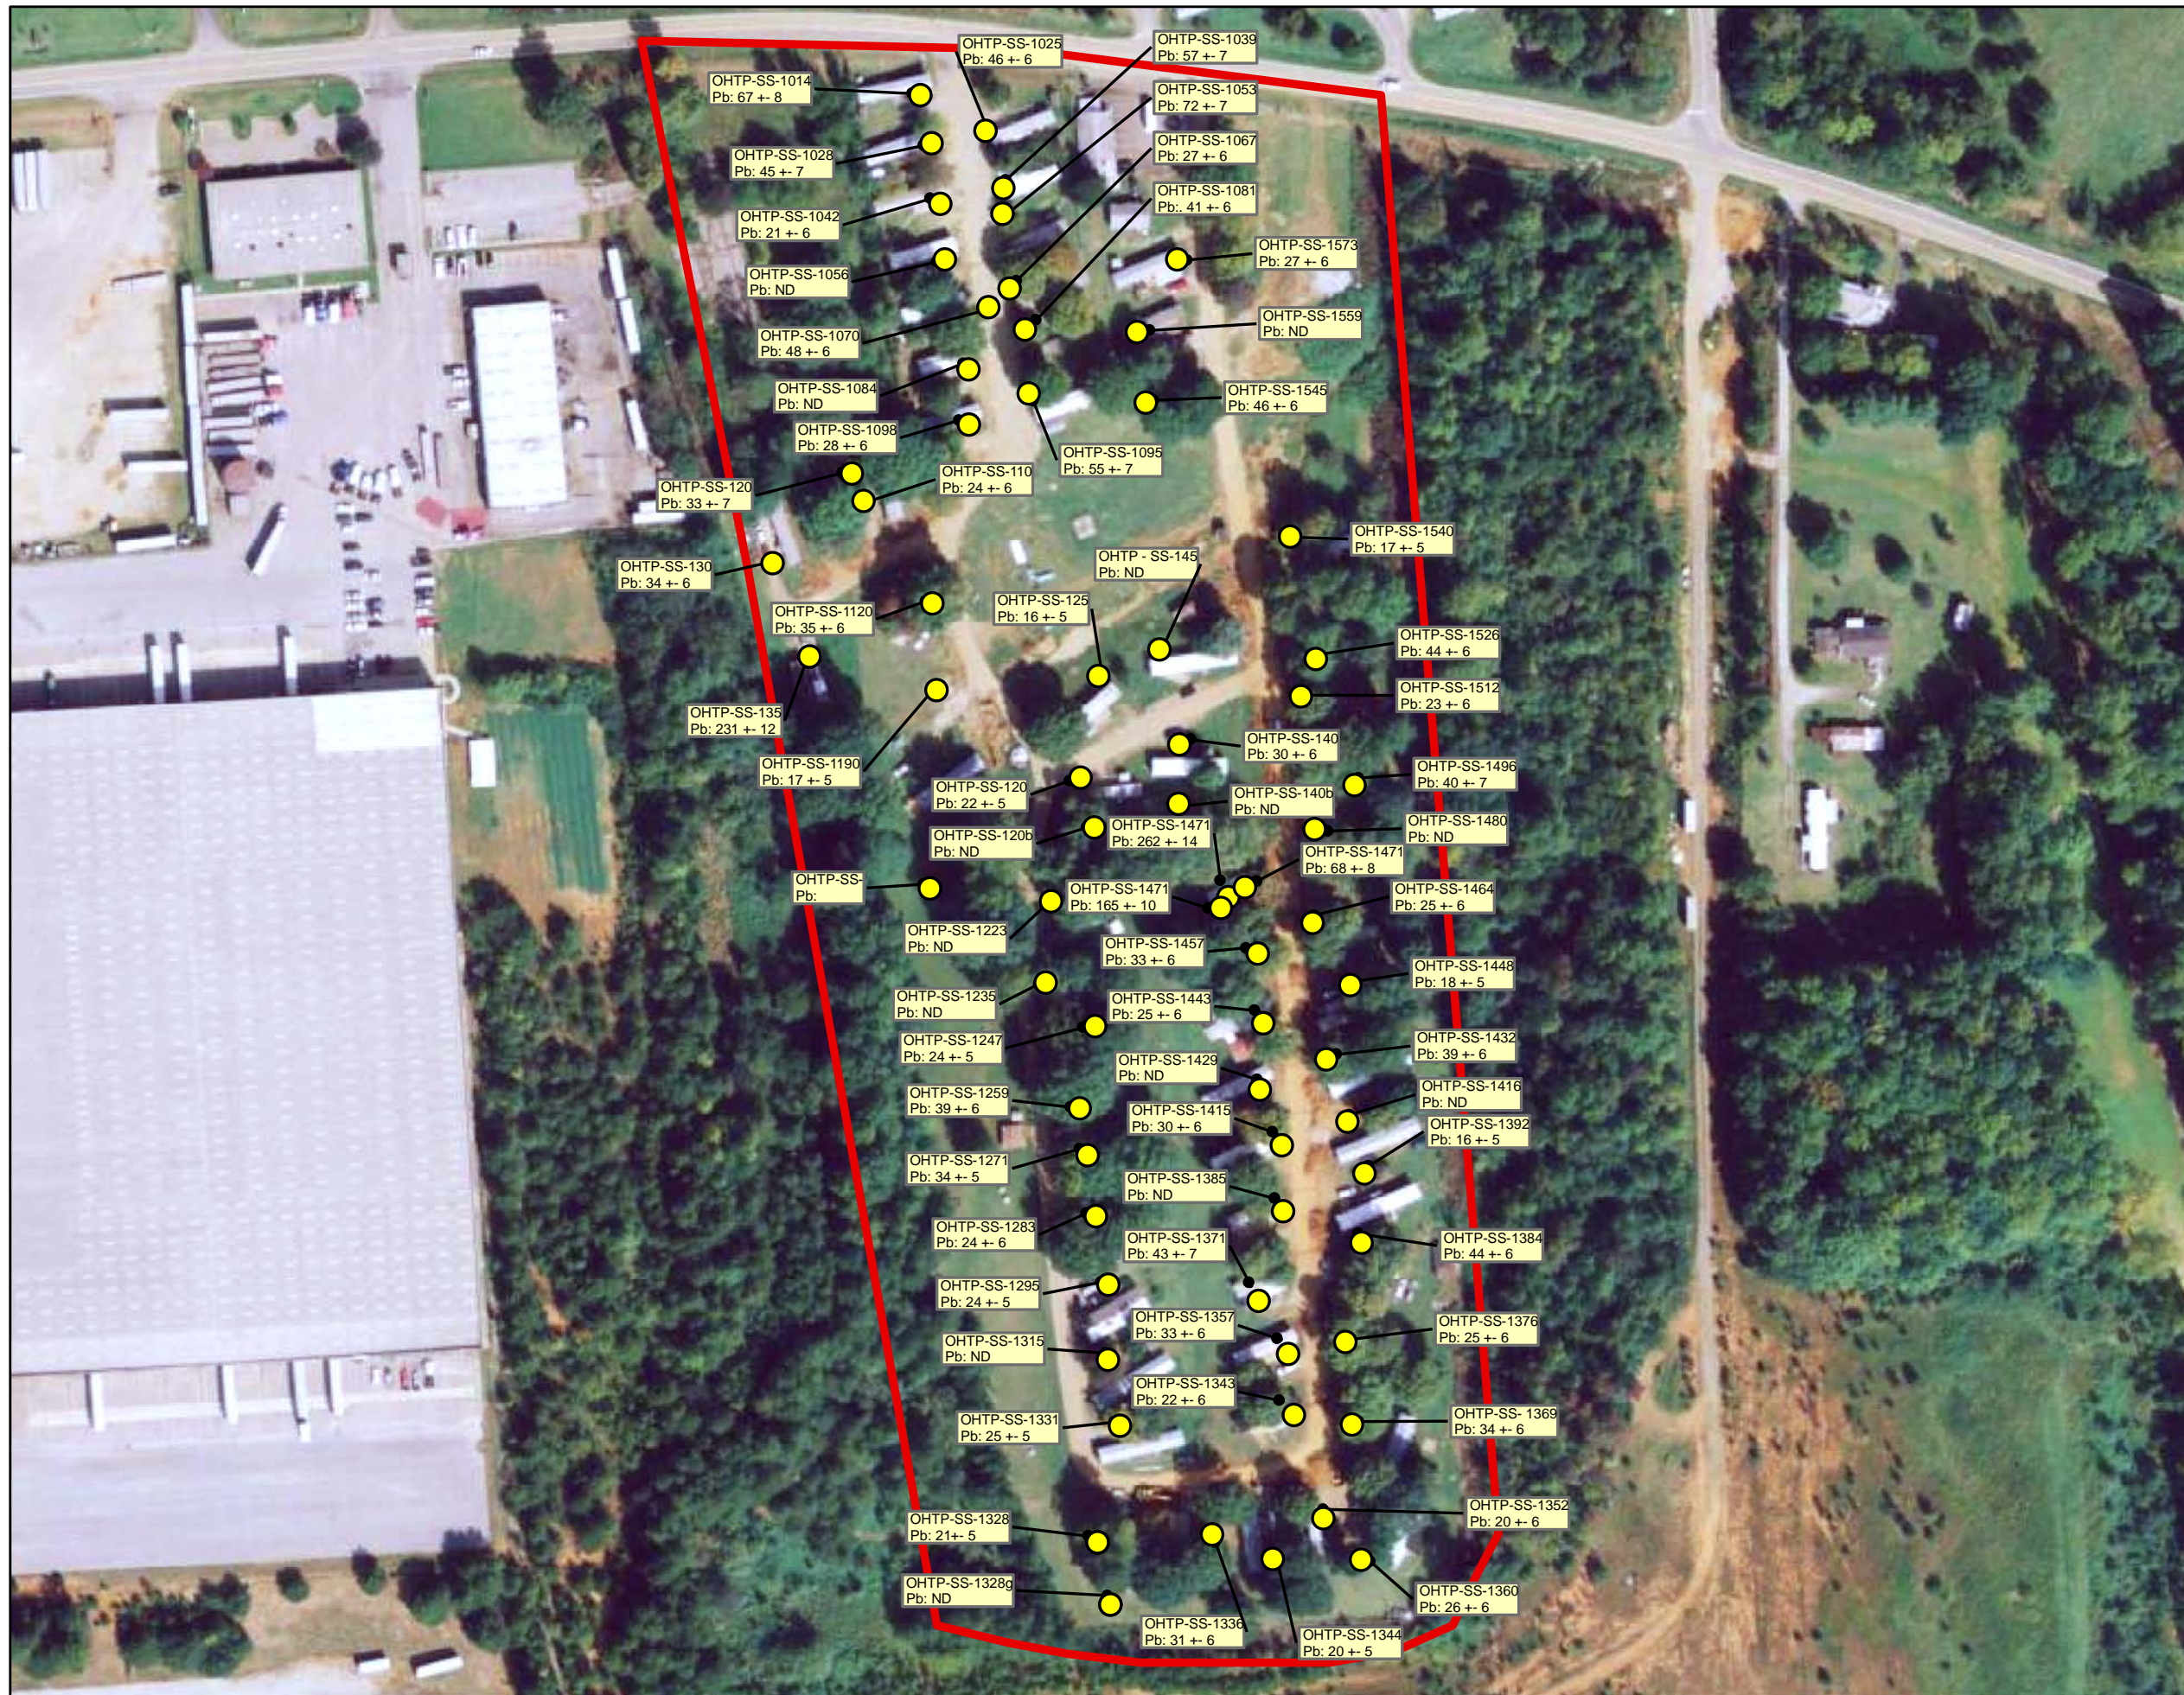
FIGURE 3
RESIDENTIAL SAMPLE LOCATIONS
SEPTEMBER 14-18, 2009

From September 14 to September 18, 2009, START conducted XRF screening of surface soils (0-6 inches bgs) at locations determined on-site by the EPA OSC in order to determine the type and distribution of impacts present at the site. A total of 236 locations (residences, the site perimeter, and general site areas) were collected and screened with the XRF for lead concentrations (Appendix B, Table 3). XRF results indicated 1 surface location with concentrations of lead above the residential RAL of 400 ppm. Surface XRF results for lead for residential sample locations are found in Appendix A, Figure 3; XRF results for perimeter sample locations are found in Appendix A, Figure 4; and XRF results for general site area sample locations are found in Appendix A, Figure 5.

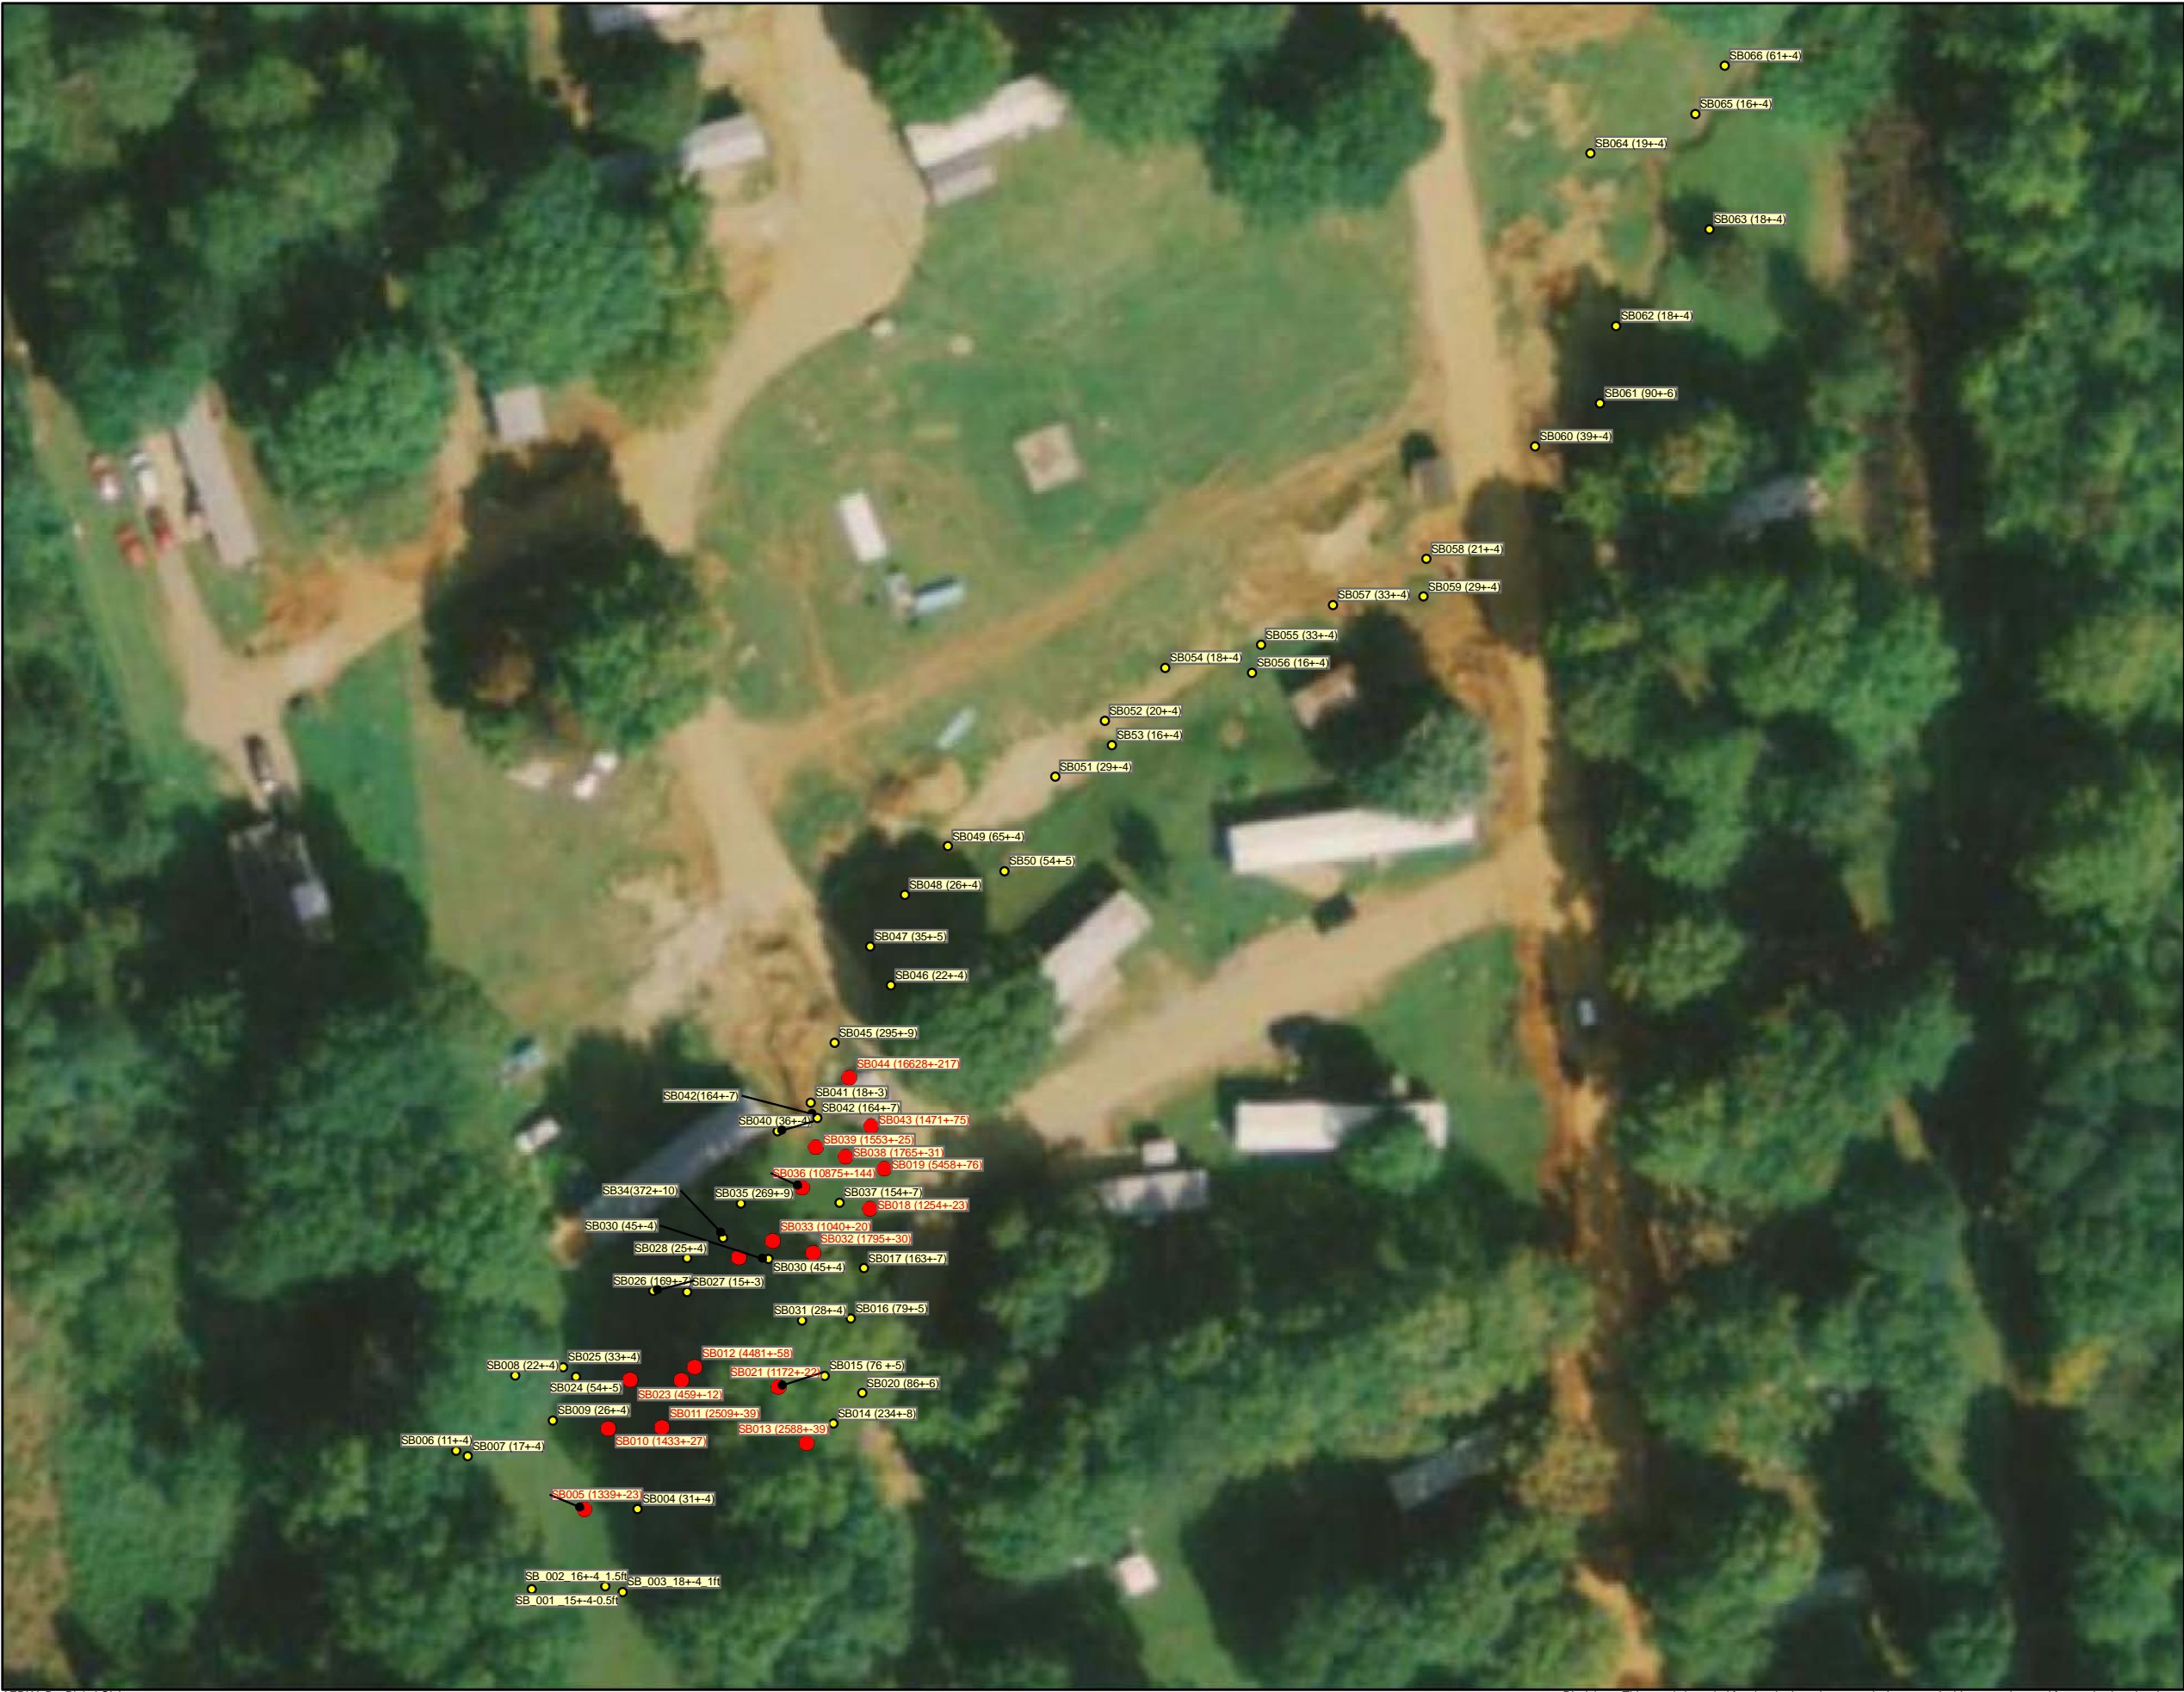
FIGURE 6
SUBSURFACE SAMPLE LOCATIONS
SEPTEMBER 22-25, 2009

From September 22 to September 25, 2009, EPA requested that START collect subsurface samples using hand augers from a depth of 6 inches bgs to 24 inches bgs. A total of 66 locations were collected and screened with the XRF for lead concentrations. XRF results indicated 18 subsurface locations with concentrations of lead above the residential RAL of 400 ppm, with values ranging from 459 ppm to 16,628 ppm. Based on the XRF results, areas were identified by the EPA OSC for the collection of confirmation soil samples to be submitted for laboratory analysis. A total of 25 soil samples plus one duplicate were collected by START for lead analysis by SW846 Method 6010B. Results of the analyses indicated that 16 subsurface soil samples exceeded the residential RAL for lead, with values ranging from 673 ppm to 23,200 ppm. Subsurface XRF results for lead at each sample location are found in Appendix A, Figure 6. In addition, a comparison between XRF results and laboratory results is located in Appendix B, Table 4.

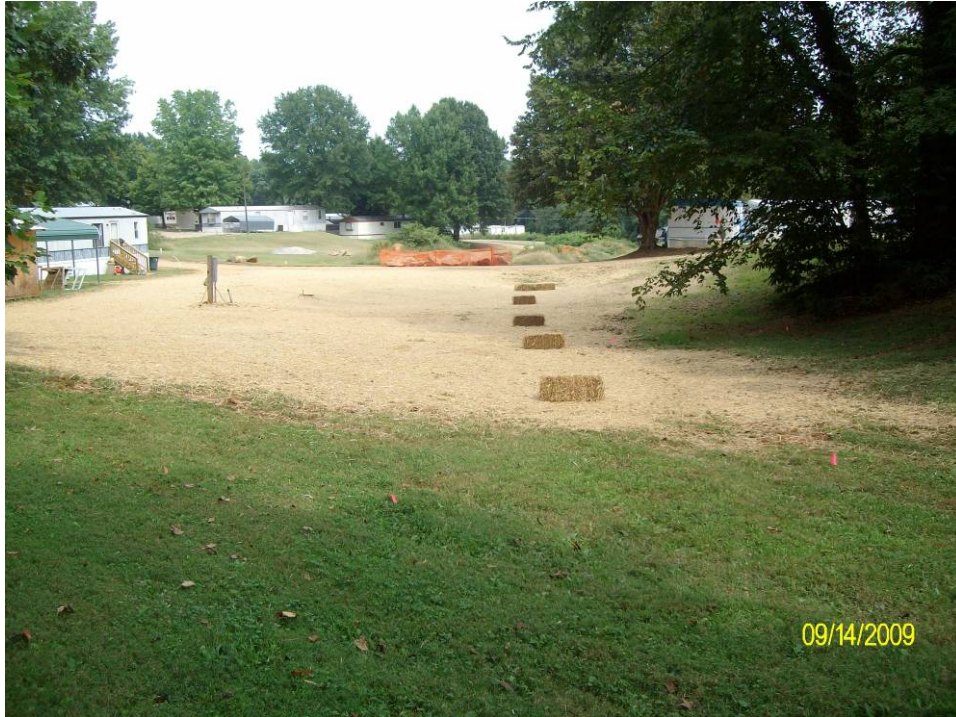
Official Photograph No. 1

Site Name:	Oak Haven Lead Investigation	Date:	September 14, 2009
Location:	Salisbury, Rowan County, NC	TDD No:	TNA-05-003-0099
Photographer:	Jorge Sanchez , START		
Subject:	Preexisting excavation backfill over stormwater line

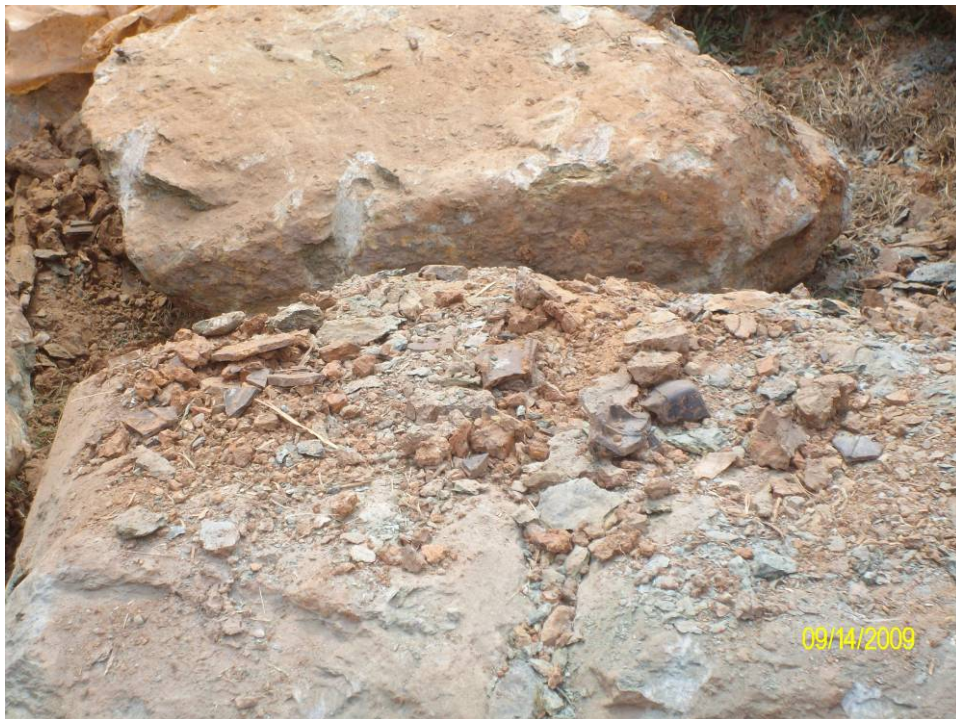
Official Photograph No. 2

Site Name:	Oak Haven Lead Investigation	Date:	September 14, 2009
Location:	Salisbury, Rowan County, NC	TDD No:	TNA-05-003-0099
Photographer:	Jorge Sanchez , START		
Subject:	Lead battery casings (black pieces) on boulders within orange fencing

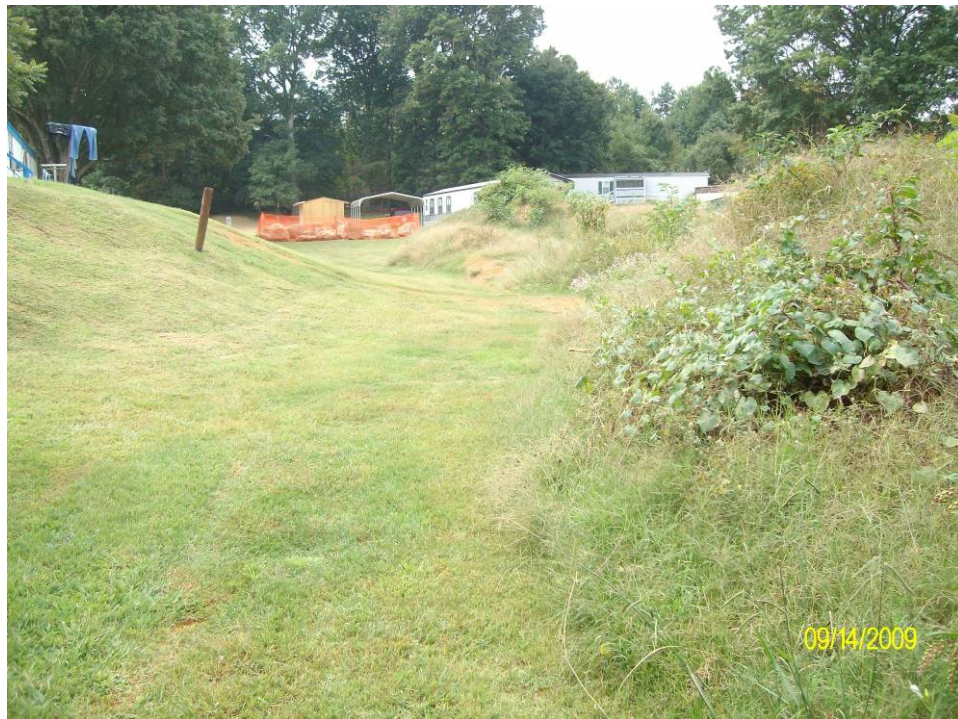
Official Photograph No. 3

Site Name:	Oak Haven Lead Investigation	Date:	September 14, 2009
Location:	Salisbury, Rowan County, NC	TDD No:	TNA-05-003-0099
Photographer:	Jorge Sanchez , START		
Subject:	Stormwater line runs along edge of spoil piles

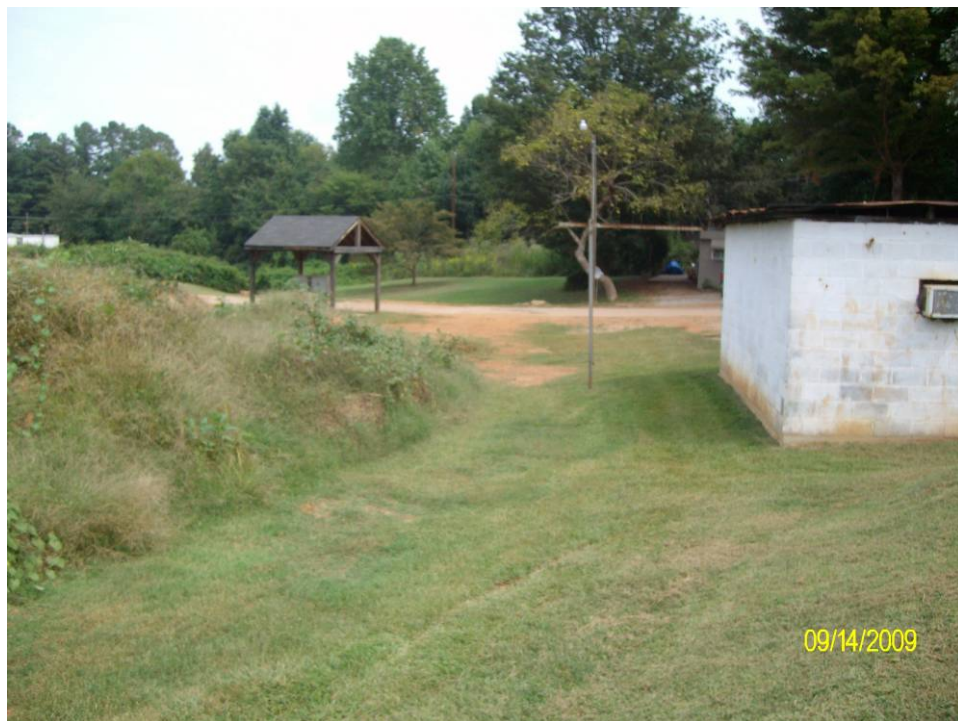
Official Photograph No. 4

Site Name:	Oak Haven Lead Investigation	Date:	September 14, 2009
Location:	Salisbury, Rowan County, NC	TDD No:	TNA-05-003-0099
Photographer:	Jorge Sanchez , START		
Subject:	Stormwater line runs along edge of spoil piles toward road

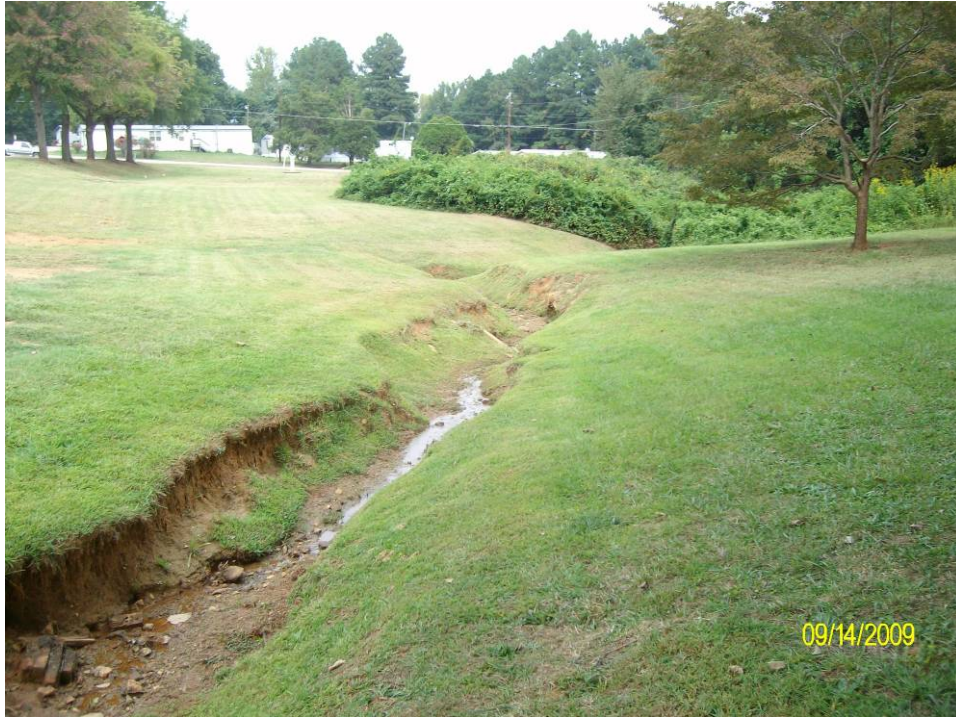
Official Photograph No. 5

Site Name: Oak Haven Lead Investigation
Location: Salisbury, Rowan County, NC
Photographer: Jorge Sanchez , START
Subject: Stormwater discharge into creek

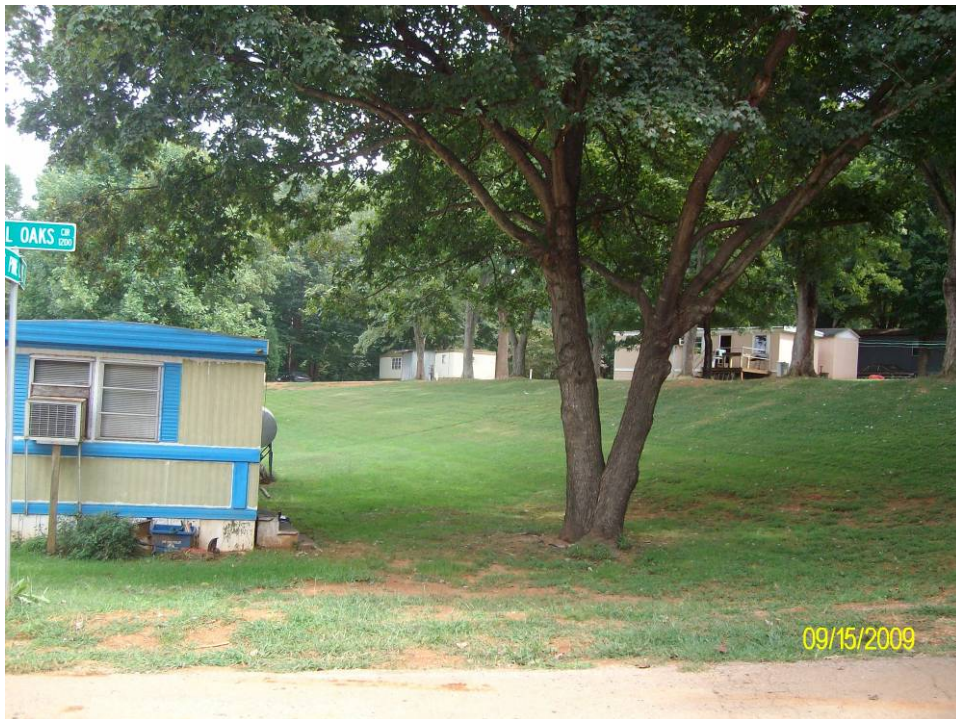
Official Photograph No. 6

Site Name: Oak Haven Lead Investigation
Location: Salisbury, Rowan County, NC
Photographer: Jorge Sanchez , START
Subject: Perimeter of jobsite outside of excavation area to the east

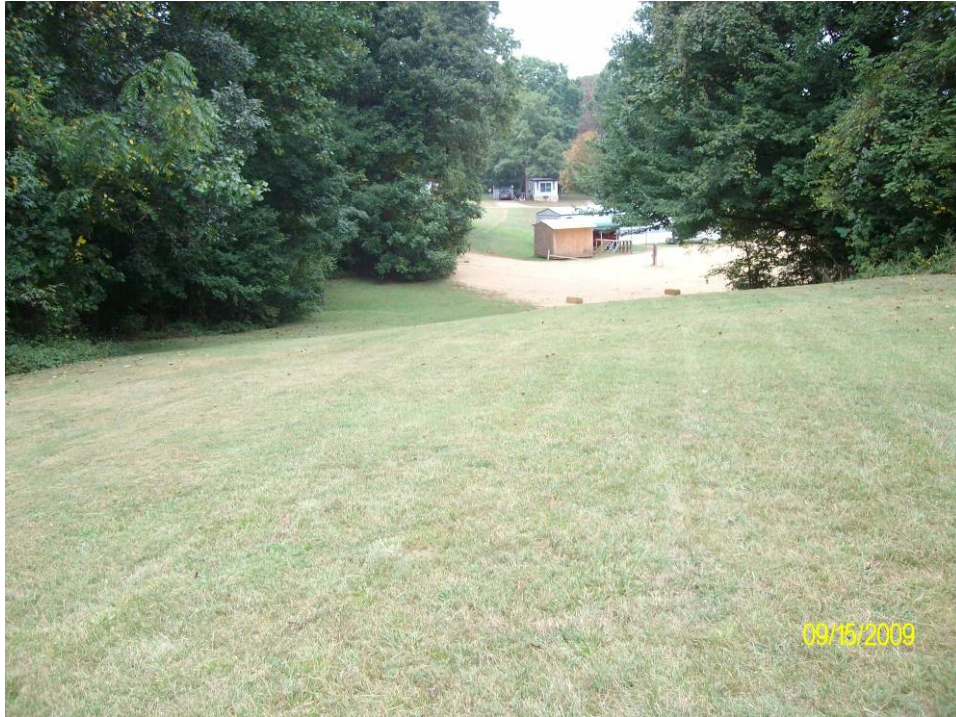
Official Photograph No. 7

Site Name:	Oak Haven Lead Investigation	Date:	September 15, 2009
Location:	Salisbury, Rowan County, NC	TDD No:	TNA-05-003-0099
Photographer:	Jorge Sanchez , START		
Subject:	Perimeter of jobsite outside of excavation area from the south

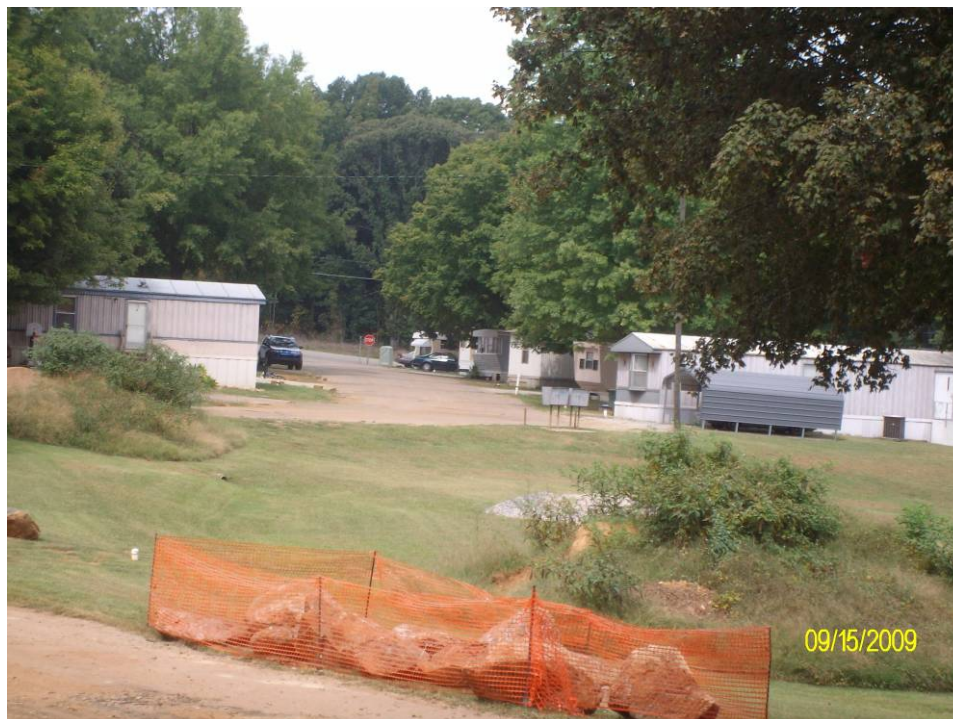
Official Photograph No. 9

Site Name:	Oak Haven Lead Investigation	Date:	September 15, 2009
Location:	Salisbury, Rowan County, NC	TDD No:	TNA-05-003-0099
Photographer:	Jorge Sanchez , START		
Subject:	Perimeter of jobsite outside of excavation area to the north

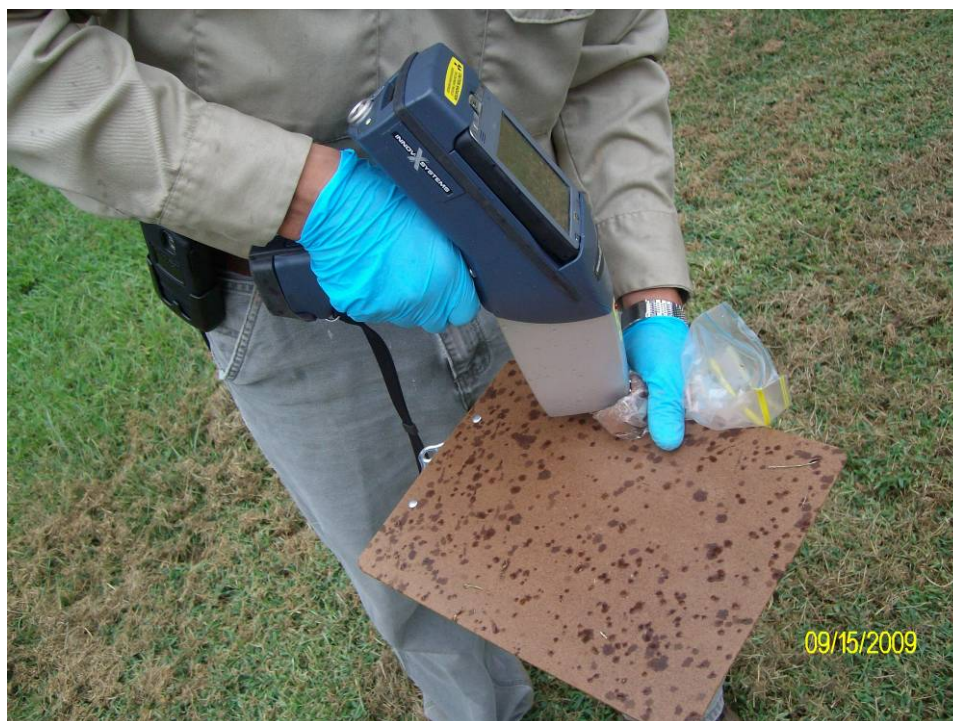
Official Photograph No. 10

Site Name:	Oak Haven Lead Investigation	Date:	September 15, 2009
Location:	Salisbury, Rowan County, NC	TDD No:	TNA-05-003-0099
Photographer:	Jorge Sanchez , START		
Subject:	Field screening of soil samples using XRF

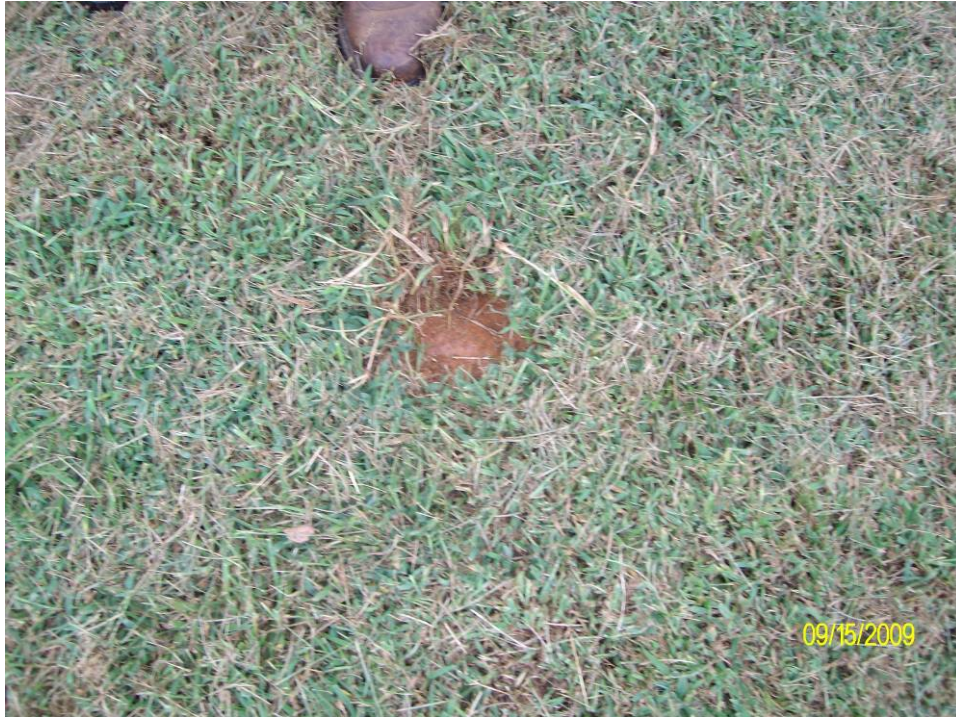
Official Photograph No. 11

Site Name:	Oak Haven Lead Investigation	Date:	September 15, 2009
Location:	Salisbury, Rowan County, NC	TDD No:	TNA-05-003-0099
Photographer:	Jorge Sanchez , START		
Subject:	Soil sample location; collected using SS spoons or hand augers

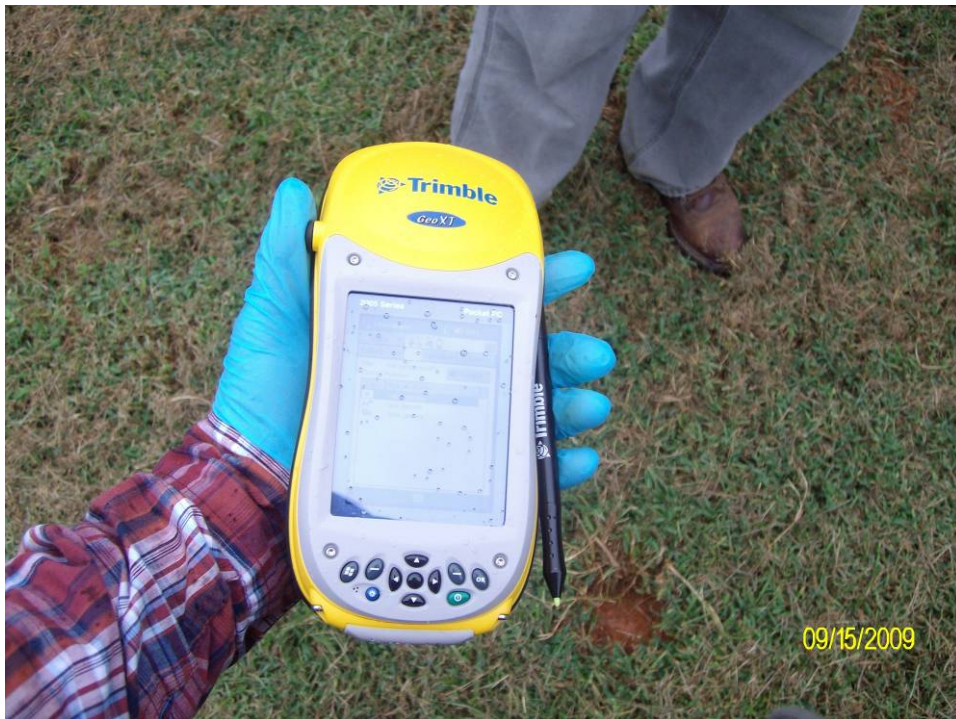
Official Photograph No. 12

Site Name:	Oak Haven Lead Investigation	Date:	September 15, 2009
Location:	Salisbury, Rowan County, NC	TDD No:	TNA-05-003-0099
Photographer:	Jorge Sanchez , START		
Subject:	Field surveying of soil sample location using GPS unit by Trimble

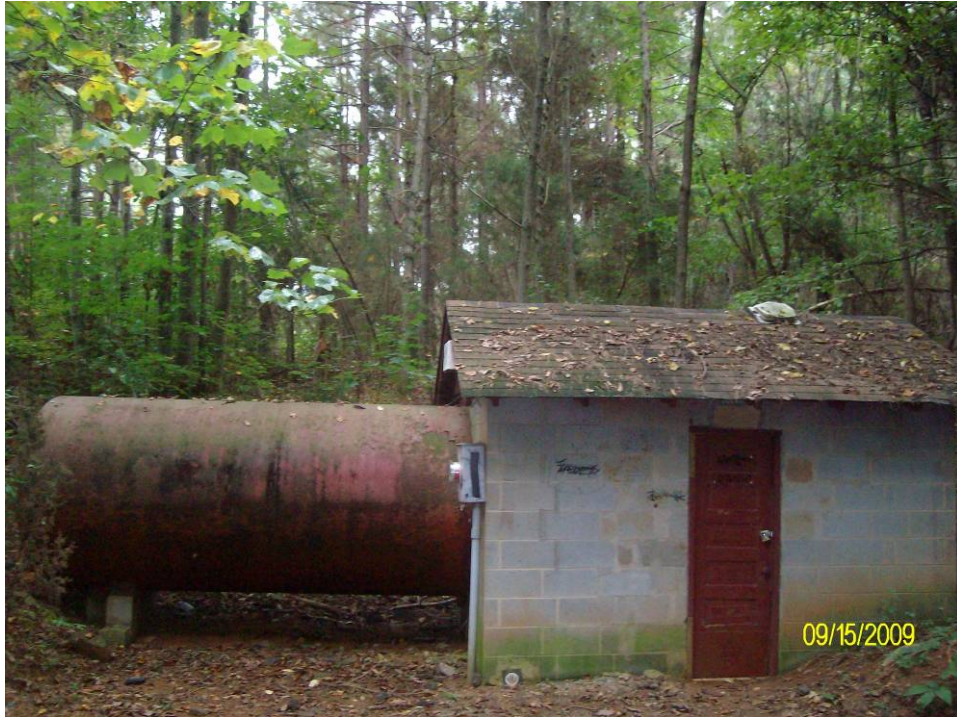
Official Photograph No. 13

Site Name:	Oak Haven Lead Investigation	Date:	September 15, 2009
Location:	Salisbury, Rowan County, NC	TDD No:	TNA-05-003-0099
Photographer:	Jorge Sanchez , START		
Subject:	Pump house in perimeter of jobsite outside of excavation area to the west
