HRS DOCUMENTATION RECORD COVER SHEET

Name of Facility: US Finishing/Cone Mills

EPA ID No. SCD003358744

Date Prepared: March 2011

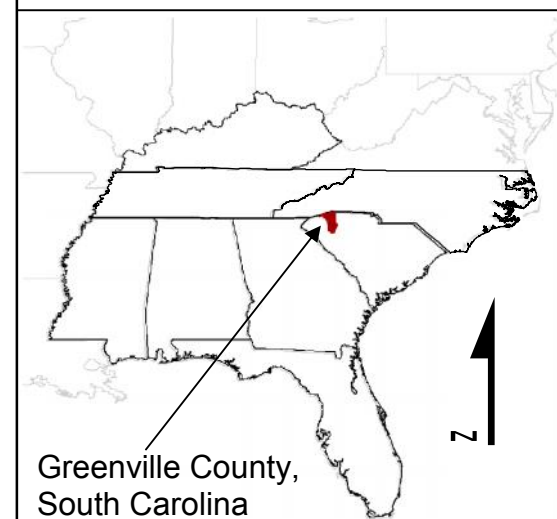
**FIGURE 3
SAMPLE LOCATION MAP**

Sources: 2010 Greenville Property Tax Maps (Ref. 4); 1991 GeoTrans Remedial Investigation/Feasibility Study (Ref. 8); 2006 SCDHEC ESI Update (Ref. 9); 2004 SCDHEC ESI (Ref. 10); 2005 MACTEC Site Assessment (Ref. 41); 2010 Google Earth (Image City of Greenville GIS) (Ref. 71)

The following samples were collected during the 2004 ESI conducted by SCDHEC. The samples were black, sandy sludge within the aeration lagoon (CM-019-SO) and black, silty soil along the dam of the aeration pond, in an area stained from repeated overflow (CM-020-SO) (Refs. 10, p. 9; 9, p. 547; 11, pp. 81-82). All samples were collected in accordance with the SCDHEC Bureau of Land and Waste Management Standard Operating Procedures (SOP) and the USEPA Region 4, Science and Ecosystem Support System (SESD) Environmental Investigations Standard Operating Procedures and Quality Assurance Manual (EISOPQAM) (Ref. 9, pp. 524, 544; 49). Samples were submitted to ChemTech Consulting Group, an EPA Contract Laboratory Program (CLP) laboratory, for analysis of EPA Target Compound List (TCL) and Target Analyte List (TAL) parameters (Ref. 10, pp. 31, 212-213). Quality Assurance and Quality Control (QA/QC) information for these samples is located in Reference 10, pp. 314-328. See Figure 3 this HRS documentation record for sample locations.

The following samples were collected during the 2004 ESI conducted by SCDHEC (Ref. 10, p. 15). Soil samples CM-035-SO and CM-037-SO were collected from the dump area and consist of dark, silty soil and black loose sandy soil, respectively; sample CM-037-SO contained small pieces of slag and ash as well (Ref. 9, p. 546; 10, p. 15; 11, pp. 67-68, 88). Background soil sample CM-018-SO was collected during the 2004 ESI from an area upgradient of the facility (Ref. 9, p. 547). All samples were collected in accordance with the SCDHEC Bureau of Land and Waste Management SOPs and the USEPA Region 4, SESD EISOPQAM, (Ref. 9, pp. 524, 544; 49). Samples were submitted to ChemTech Consulting Group, an EPA CLP laboratory, for EPA TCL and TAL parameters (Refs. 9, p. 544; 10, pp. 32-33, 226-228). QA/QC information for these samples is located in Reference 10, pp. 314-328. See Figure 3 of this HRS documentation record for sample locations.

The following sample was collected during the 2004 ESI conducted by SCDHEC (Ref. 10, p. 15). Sediment sample CM-006-SE was collected from the former Northern Reservoir near the influent pipe; a sludge-like layer was noted in the sample (Refs. 9, p. 546; 10, pp. 17, 24; 11, pp. 60, 61, 64). The source sample was compared to background soil sample CM-018-SO, collected in an area upgradient of the facility. The former Northern Reservoir was created with natural soil and is currently drained; therefore, background soil sample CM-018-SO represents conditions prior to filling the former Northern Reservoir (Refs. 3; 9, p. 7; 43, p. 14). All samples were collected in accordance with the SCDHEC Bureau of Land and Waste Management SOPs and the USEPA Region 4, SESD EISOPQAM, (Refs. 9, pp. 524, 544; 49). Samples were submitted to ChemTech Consulting Group, an EPA CLP laboratory, for EPA TCL and TAL parameters (Refs. 9, p. 544; 10, pp. 32-33). QA/QC information for these samples is located in Reference 10, pp. 314-328. See Figure 3 of this HRS documentation record for sample locations.

The samples below were collected during the February 2005 sampling event conducted by MACTEC for SCDHEC (Ref. 41). All samples below were collected from the former Northern Reservoir and compared to the Langston Creek sediment sample USF-001-SE. Although not collected from an impoundment, the intake in the impoundment on Langston Creek is the source of water for the former Northern Reservoir and the source of much of the sediment in the former Northern Reservoir, as evidenced by the presence of PCB-laden sediments (Refs. 10, p. 7). The emergency overflow allowed water and sediments to exit the former Northern Reservoir, which then flowed overland into Langston Creek downstream of USF-001-SE (Ref. 11, p. 10). No other streams feed into the former Northern Reservoir, which has a limited area of drainage (Refs. 3; 10, pp. 8, 17). The SCDHEC samples were collected in accordance with the EPA EISOPQAM dated May 1996 and the MACTEC samples were collected in accordance with the September 2001 EISOPQAM update (Refs. 9, p. 882; 41, pp. 7-9; 49). Sample locations are depicted in Figure 3 of this HRS documentation record.

SCDHEC personnel collected the following release samples during the ESI Update sampling event starting on June 20, 2005 (Ref. 9). All samples were collected in accordance with the SCDHEC Bureau of Land and Waste Management SOPs and the USEPA Region 4, SESD EISOPQAM (Ref. 9, pp. 524, 544). Samples were submitted to Bonner, an EPA CLP laboratory, for EPA TCL and TAL parameters (Refs. 9, p. 544; 50, pp. 2-4). QA/QC information for these samples is located in Reference 9, pages 931-941. See Figure 3 this HRS documentation record for sample locations.

* Sample locations are depicted on Figure 3 of this HRS documentation record.

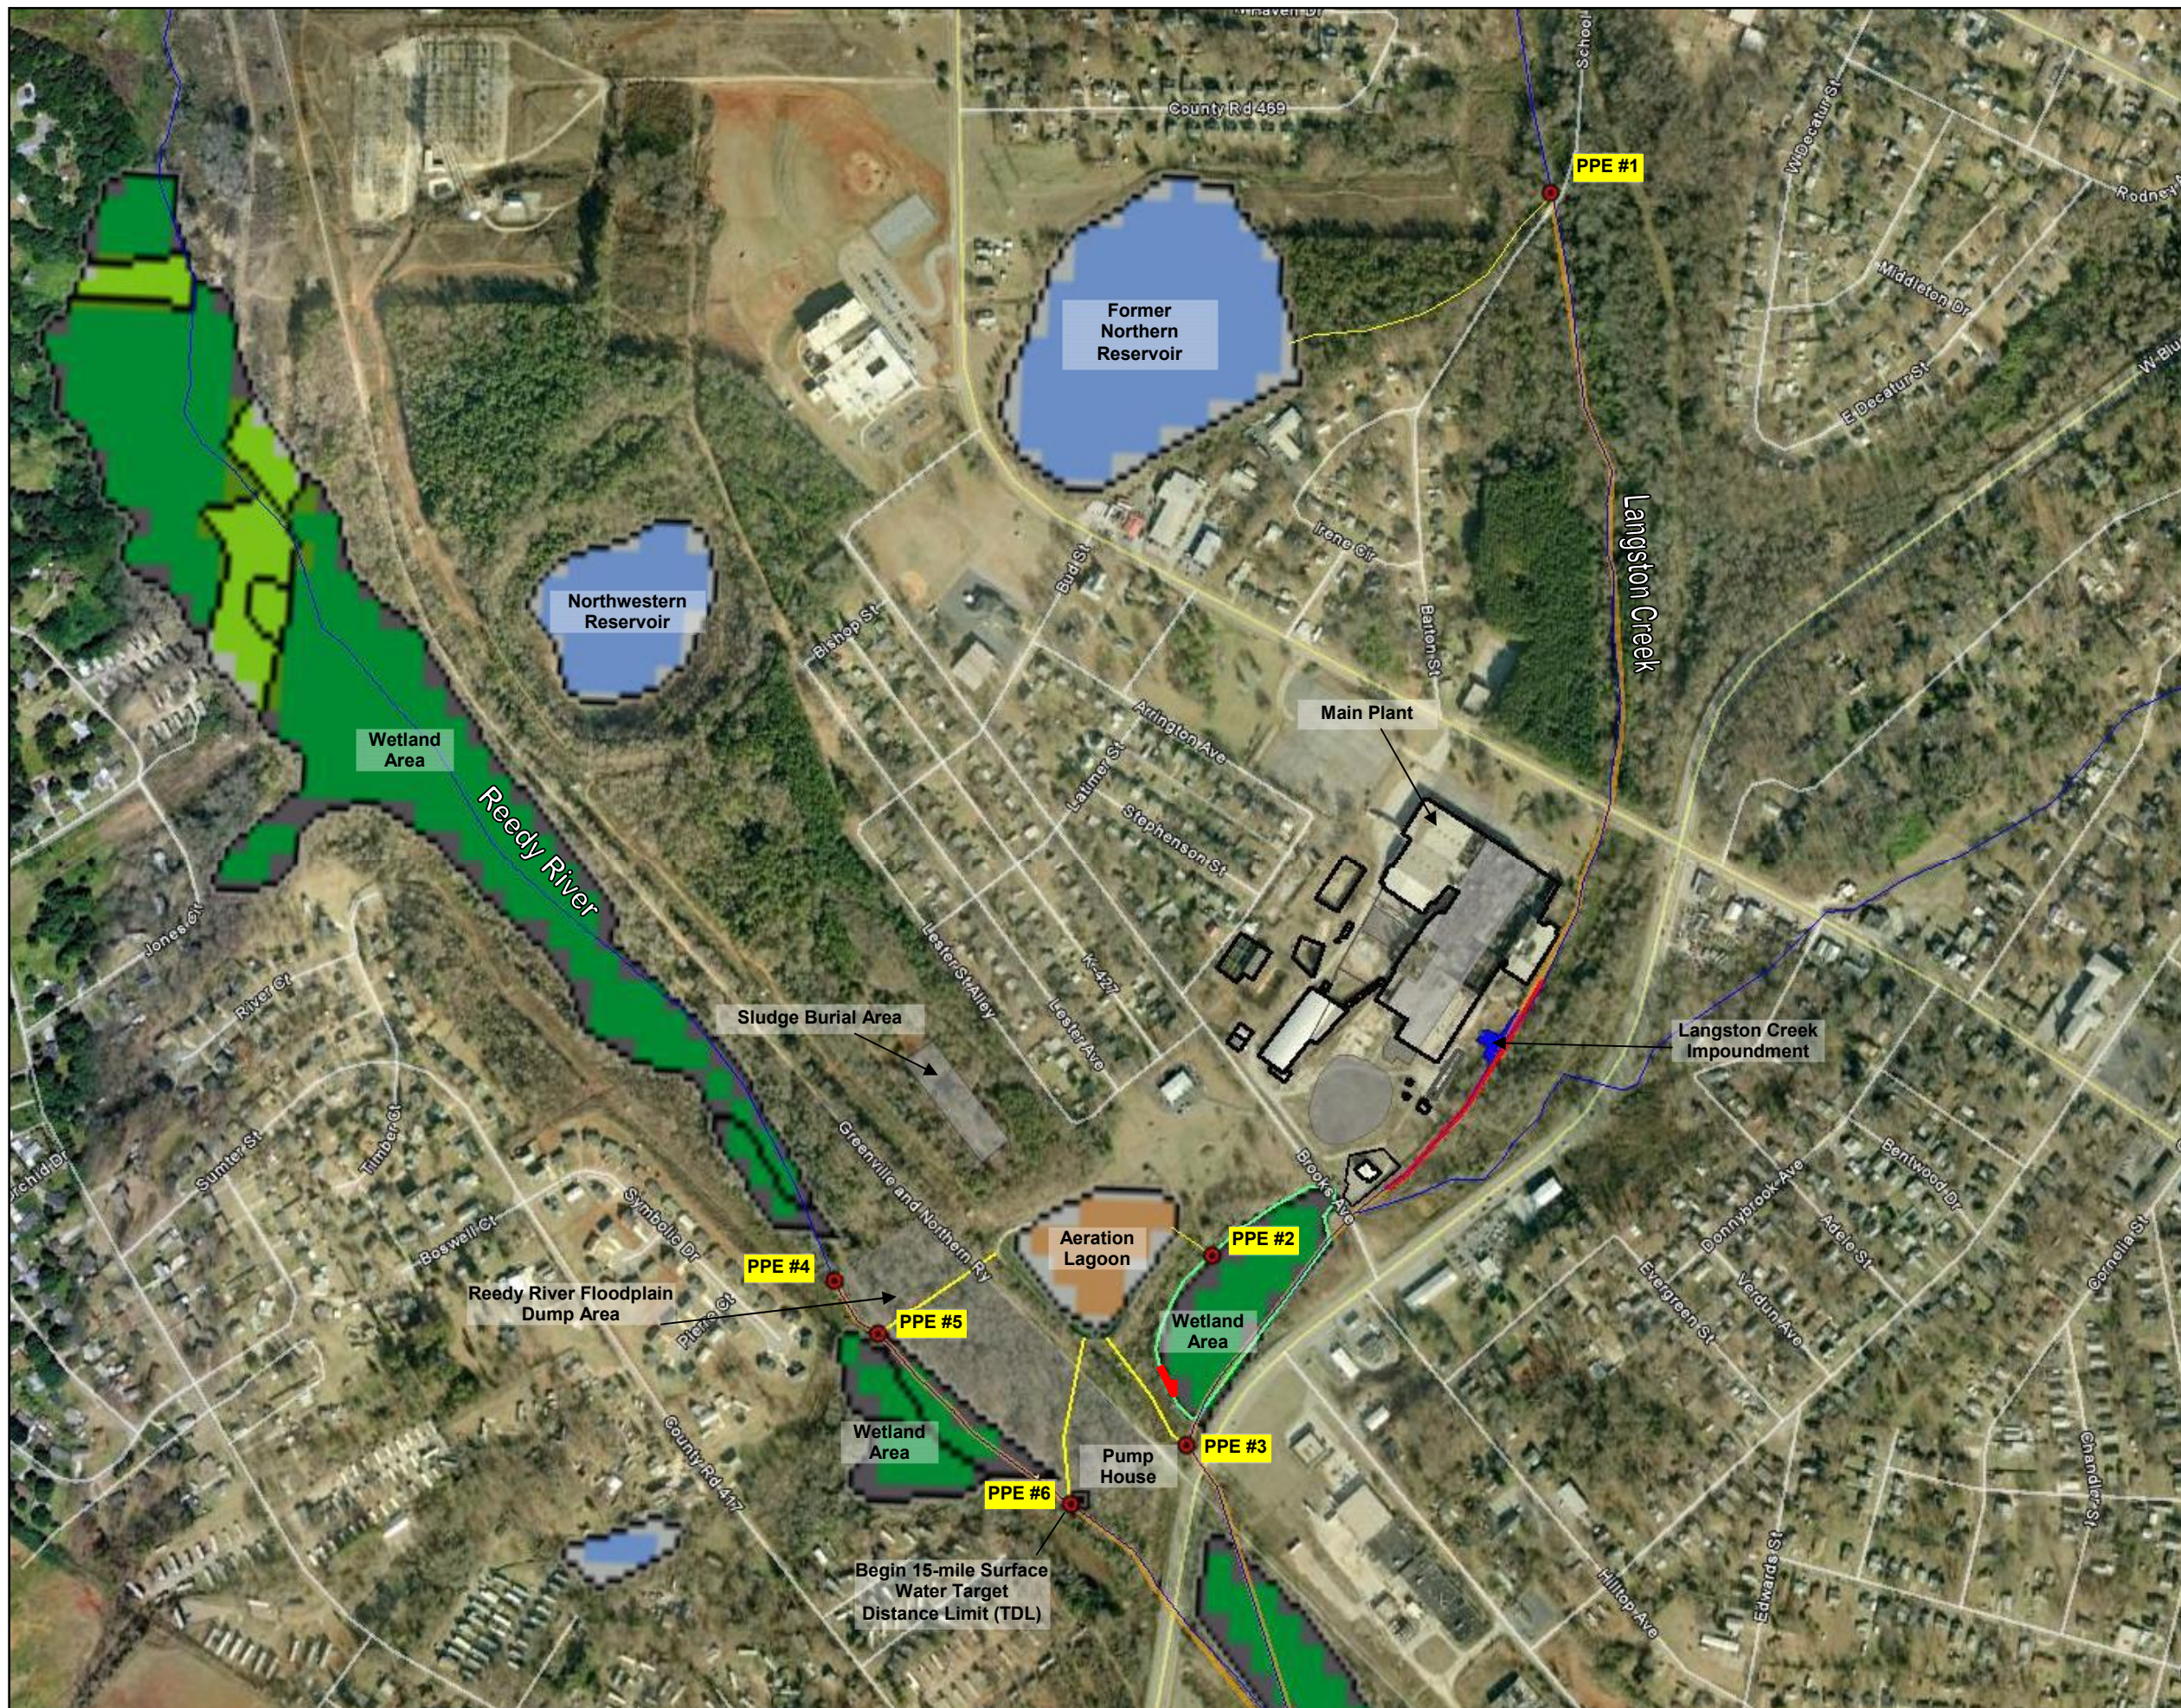
**FIGURE 4
PROBABLE POINT OF ENTRY
LOCATION MAP**

- Current property feature outline
- Former property feature outline
- Surface water pathway
- Overland flow from Sources
- Level II contamination
- Wetland perimeter for surface water pathway
- Probable Point of Entry (PPE)

For HRS scoring purposes, the US Finishing/Cone Mills site consists of three sources. Source 1 is the aeration lagoon (surface impoundment), Source 2 is the Reedy River floodplain dump (landfill), and Source 3 is the former northern reservoir (contaminated soil). Level II concentrations of site-related hazardous substances have been documented in Langston Creek, which is a fishery, and in wetlands adjacent to Langston Creek (see Figure 4 of this HRS documentation record).

In 1976, water from the aeration lagoon leaked into the Reedy River through an uncapped 15-inch pipeline ending at the pump house (Ref. 24, pp. 1-2). See Figure 4 for an illustration of the PPEs and surface water flow in the vicinity of the property.

The aeration lagoon (Source 1), located south of the main plant, was built in 1965 to contain wastewater prior to discharging to the Greenville Sewer system (Refs. 8, p. 36; 16, p. 3; 18, p. 1; 24, pp. 1-2; 45, pp. 1; see Figure 4 of this HRS documentation record). During the 2004 ESI, evidence of repeated overflow from the aeration lagoon was observed (Ref. 10, p. 9). Water from the lagoon flows either in a southeasterly direction towards the wetlands located east of the aeration lagoon, continuing to Langston Creek or in a southwesterly direction towards the Reedy River (Refs. 3; 8, p. 16). Wastewater placed into the aeration lagoon included spent liquor from the boil-out machines, the continuous bleaching machines, and the mercertizers; wastewater from the basement; and accumulated dye sludge cleaned out during the July 4th plant shutdowns (Refs. 8, pp. 14, 38; 9, pp. 181-184; 45, p. 2). Although chromium use at the facility ended in 1975, chromium-containing waste continued to enter the lagoon via stormwater, as chromium waste remained on the facility (Refs. 8, p. 38; 16, p. 3). On at least two occasions, ground water from chromium-contaminated wells W-2 or W-10 was pumped directly into the aeration lagoon (Ref. 8, p. 38). Sludge samples from the aeration lagoon were collected during multiple sampling events. Sludge samples collected in 1988, 1989, and 1990 indicated chromium concentrations at a range of 190 to 3,200 mg/kg (Ref. 8, p. 102). Arsenic, barium, cadmium, cobalt, copper, lead, mercury, nickel, silver and zinc were also detected during these sampling events (Ref. 8, p. 102). A composite sample from the aeration lagoon was collected during the 1991 RI/FS (Ref. 8, p. 101). Arsenic was detected at a concentration of 6.7 mg/kg; chromium was detected in the sludge at a concentration of 398 mg/kg (Ref. 8, p. 102).
