**Subject: HAMPTON FALLS** – Gruhn Engine Repair Site, 35 Weare Road,  
DES Site #198905073, Project #807

# **INDOOR AIR SOIL VAPOR INTRUSION STUDY REPORT**

**Gruhn Engine Repair Site  
Hampton Falls, NH**

**July 2010**

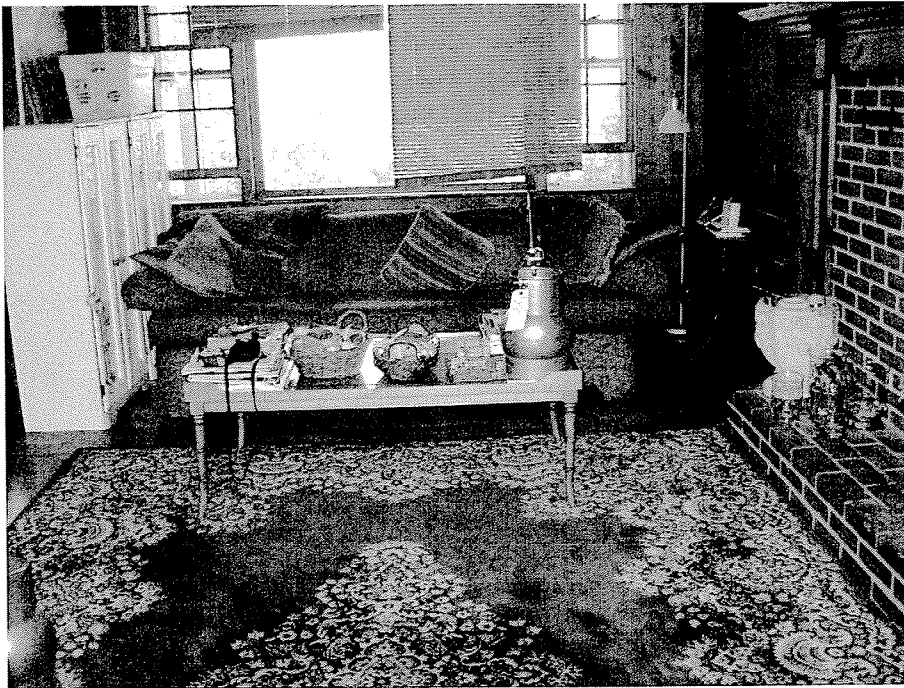
**Photograph Description:** View of the 24-hour indoor air canister on the first floor facing the west exterior wall.

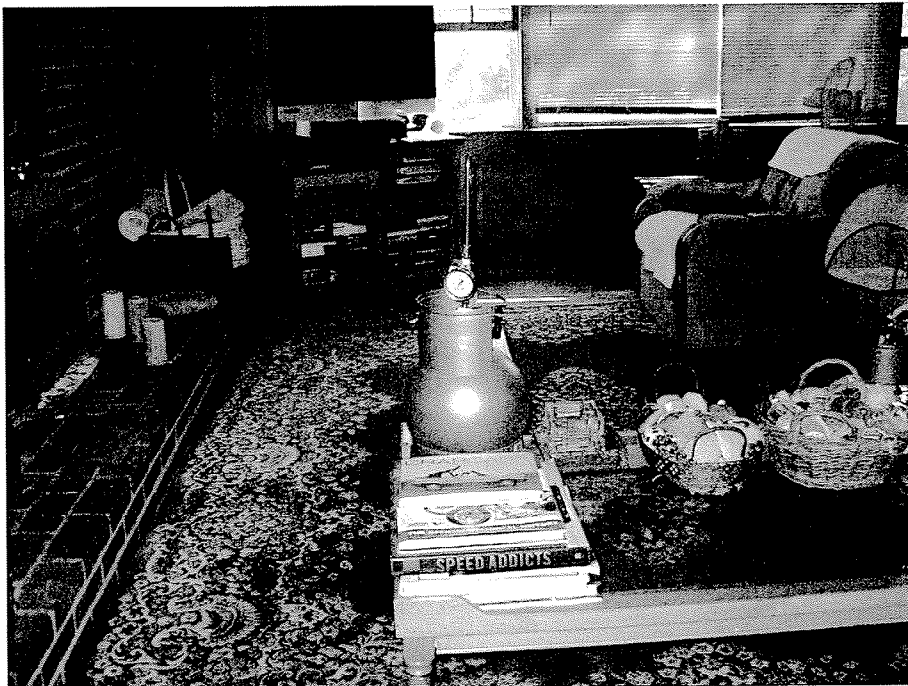
**Photograph Description:** View of the 24-hour indoor air canister on the first floor facing the east exterior wall.

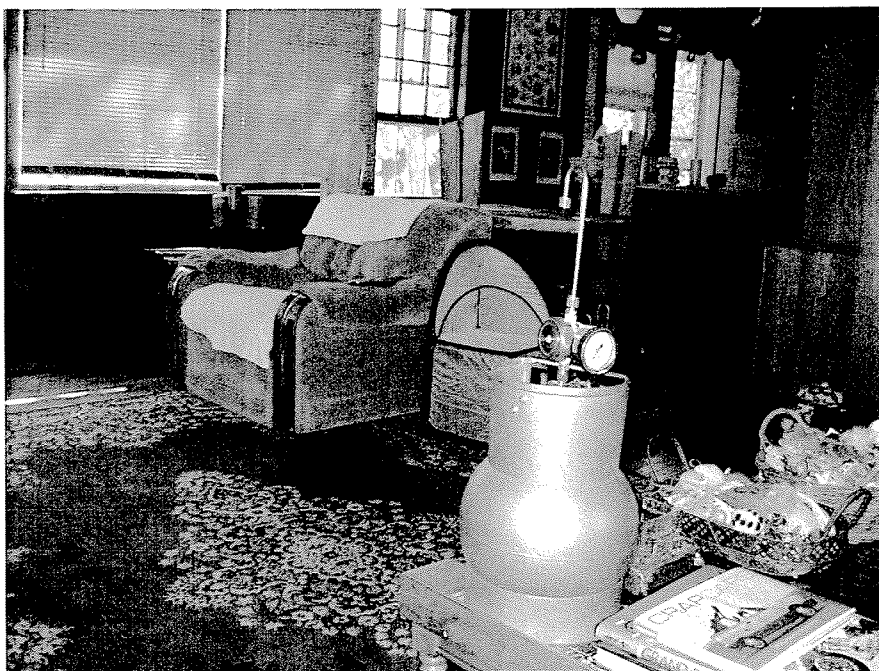
**Photograph Description:** View of the 24-hour indoor air canister on the first floor facing the east exterior wall.

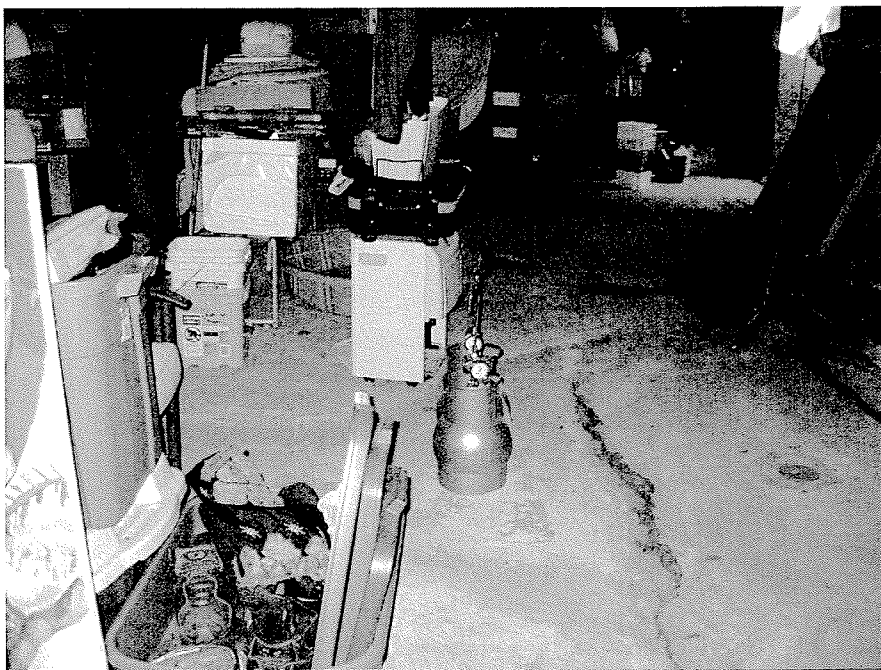
**Photograph Description:** View of the 24-hour indoor air canisters, including the duplicate, in the basement facing the north wall.

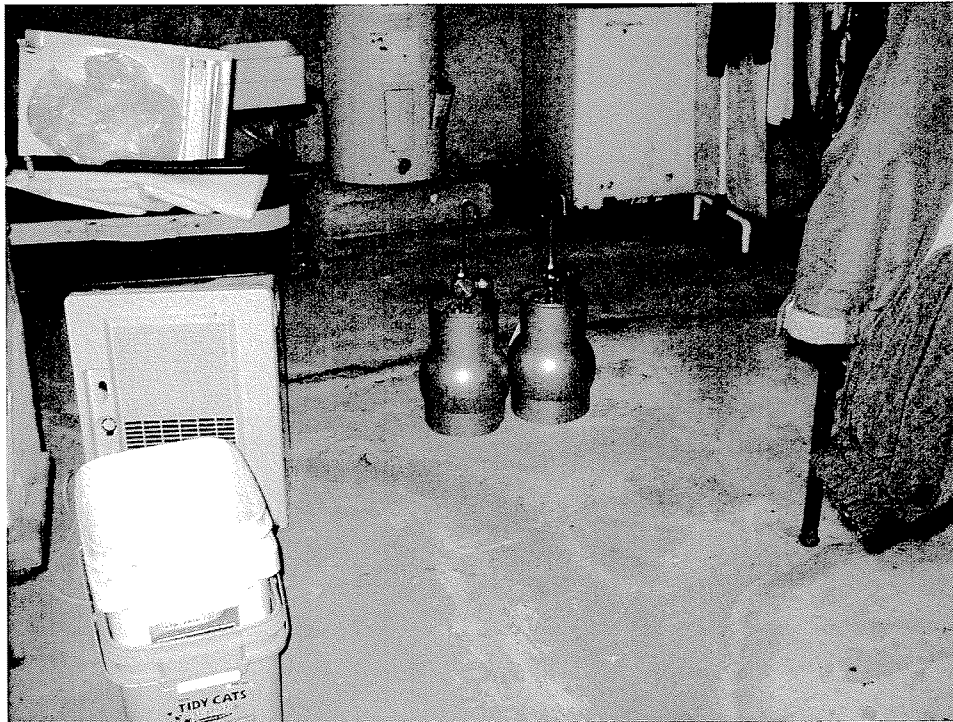
**Photograph Description:** View of the 24-hour indoor air canisters, including the duplicate, in the basement facing the east wall.

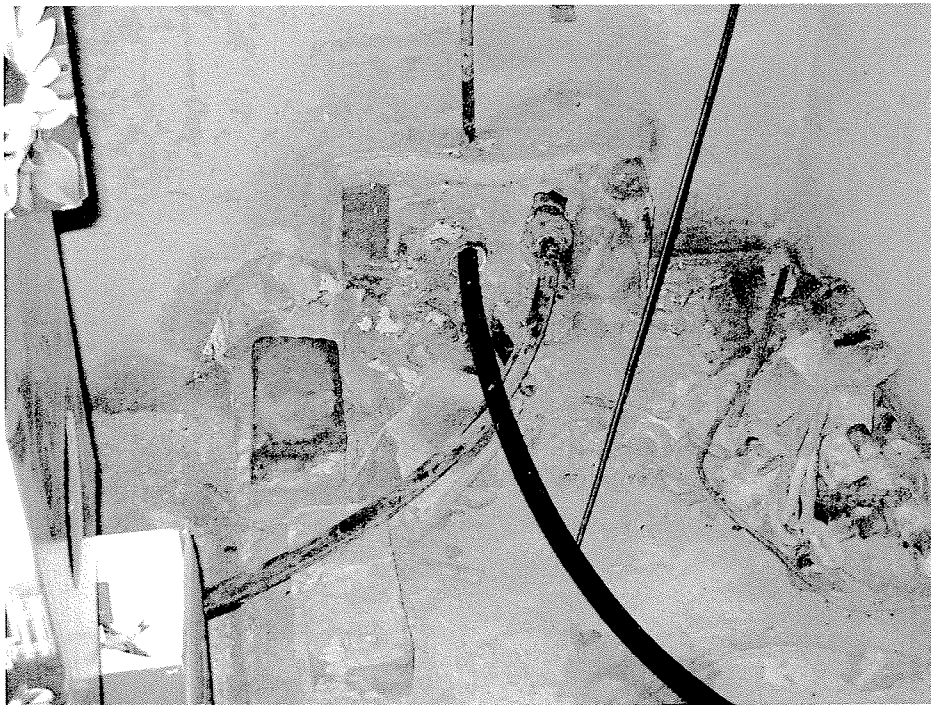
- a waterline that came through the west wall of the basement that was not well sealed and therefore could be a potential pathway for soil gas to enter the basement.
- a sump pump pit next to the bulk head entrance that had a pipe going to the concrete foundation that could also be a potential pathway.

**Photograph Description:** View of the water line entering the basement which was located at the west wall near the basement stairs which appeared not to be well sealed.

- Prior to initiating this sampling event, NHDES believes that it is in the best interest of the property owner to seal/plug any foundation cracks, conduits or sumps within the basement area as these openings may represent preferential pathways for vapor migration into the house. Of note are the waterline that comes through the west wall of the basement and the sump pump with a pipe going into the foundation.

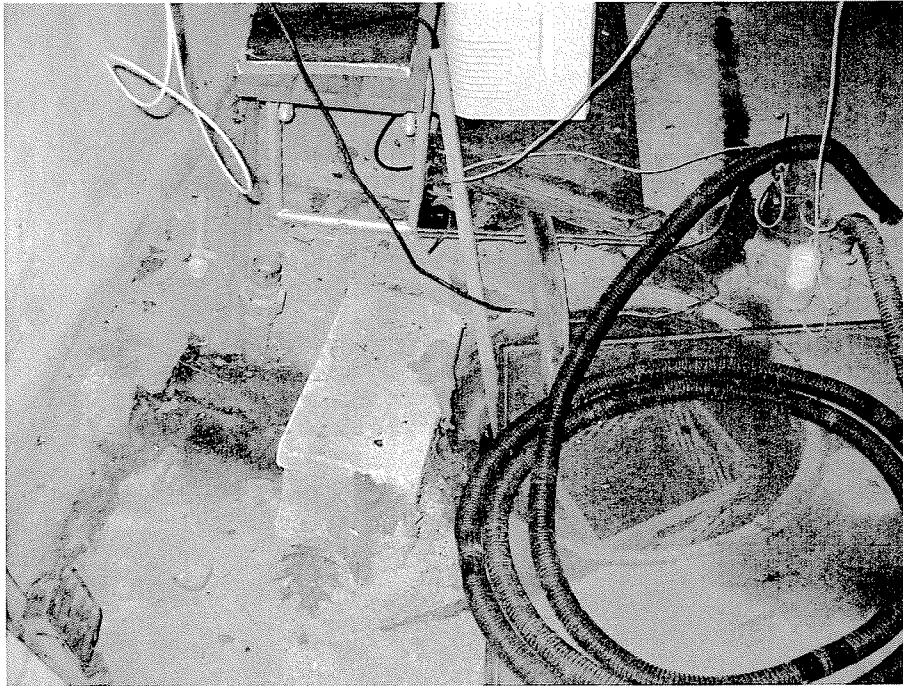
**Photograph Description:** View of the sump pump and pipe which was located along the east wall next to the bulk head entrance. The sump pump had a 25 inches diameter and there was some standing water observed. The pipe next to the sump pump was 1 foot from the east wall and goes into the concrete foundation.

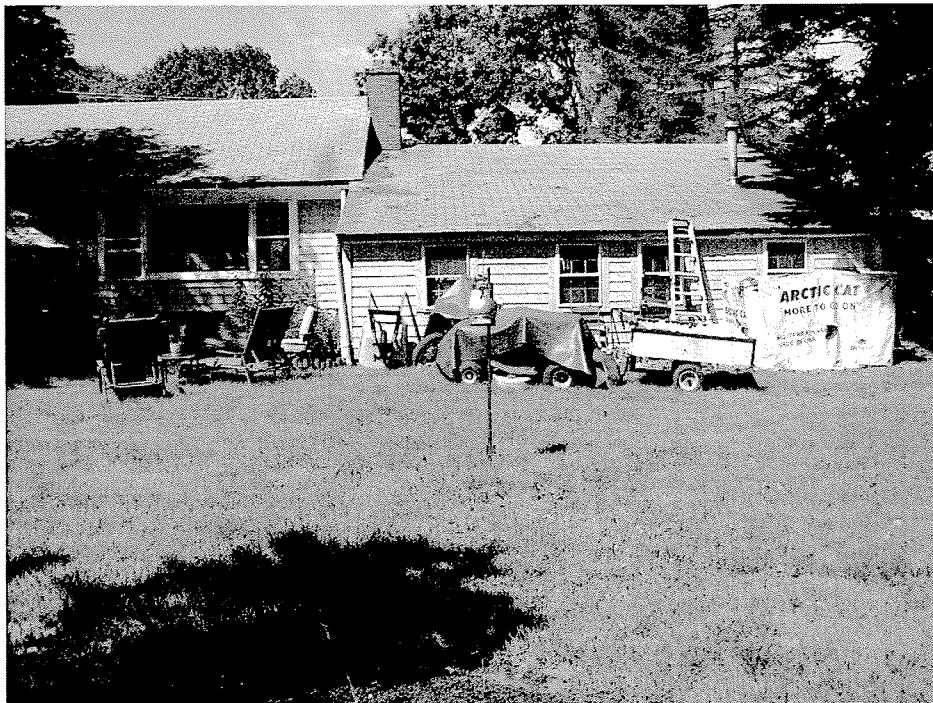
**Photograph Description:** View of the 24-hour ambient air canister facing west.
