**Subject: Final Emergency Response Letter Report
Maynard Terrace Methane Response
Atlanta, DeKalb County, Georgia
EPA Contract No. EP-W-05-054
TDD No. TTEMI-05-001-0136**

MAYNARD TERRACE
METHANE RESPONSE
ATLANTA,
DEKALB COUNTY,
GEORGIA

PHOTOGRAPHIC LOG

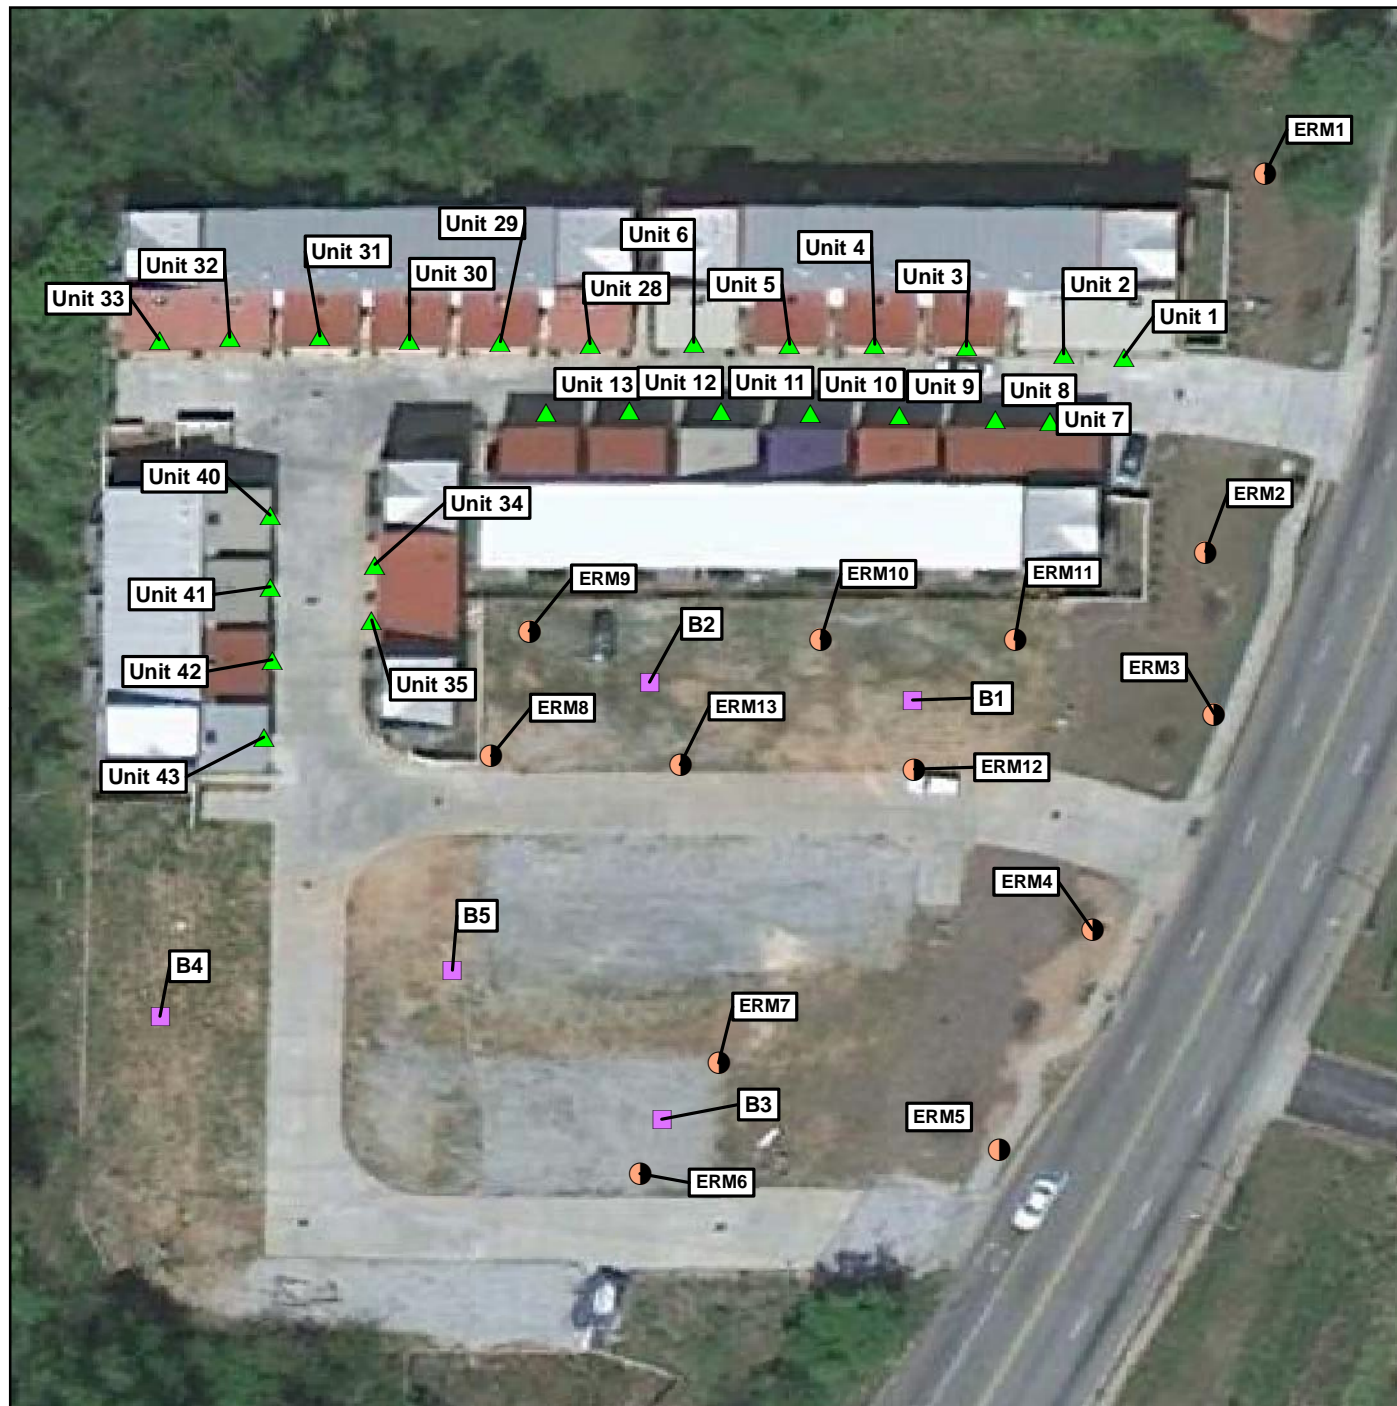
FIGURE 2
SITE LAYOUT WITH
SAMPLING LOCATIONS

- ▲ Water Meter Box Location (outside garage door)
- ERM Monitoring Location
- GeoProbe Location

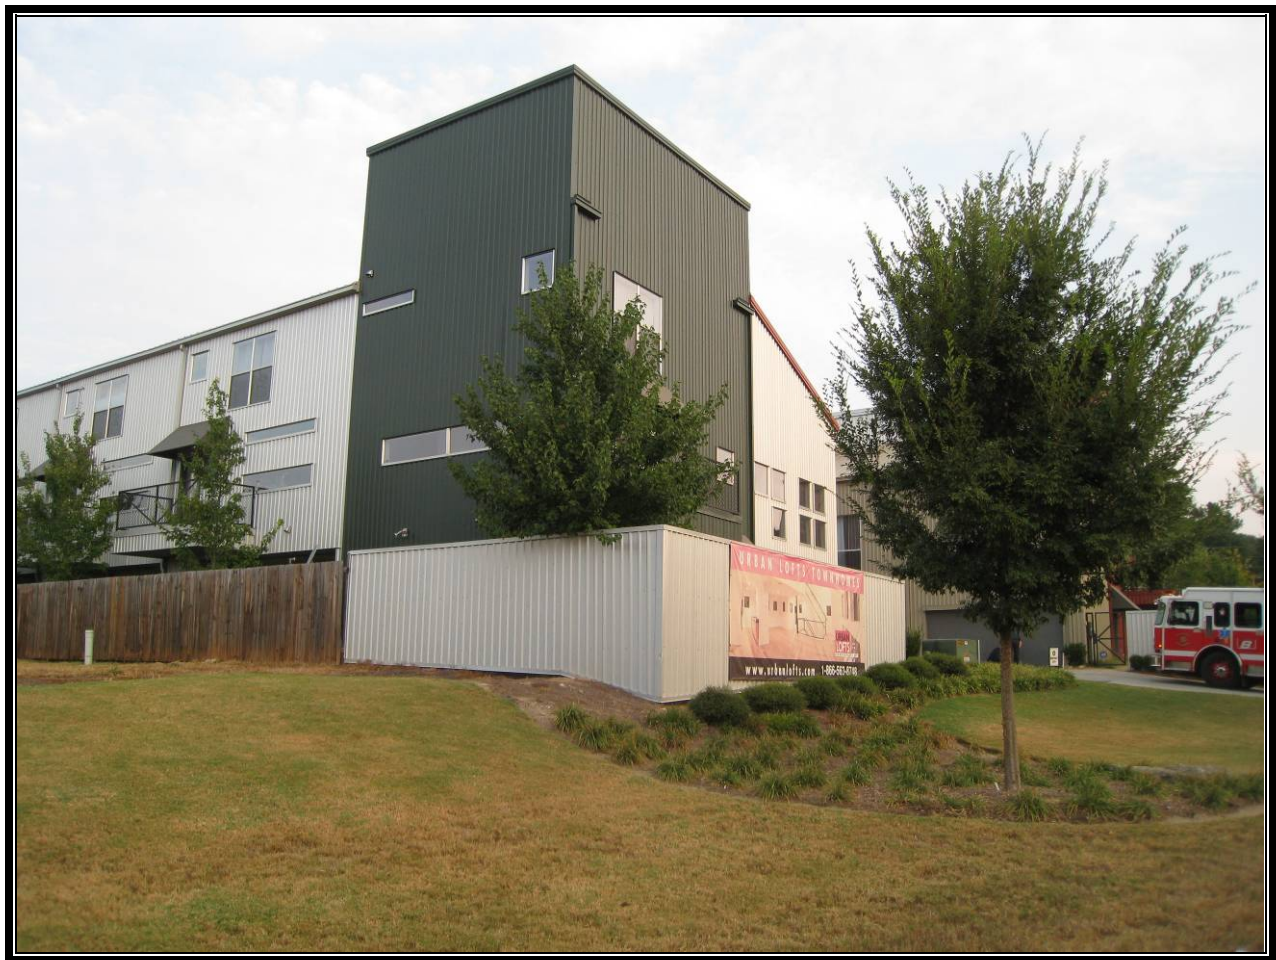
OFFICIAL PHOTOGRAPH NO. 1
U.S. ENVIRONMENTAL PROTECTION AGENCY

TDD Number:	TTEMI-05-001-0136	Location:	Maynard Terrace Methane Response
Orientation:	Northwest	Date:	September 22, 2010
Photographer:	Brian Croft, Tetra Tech	Witness:	Randy Mayer, Tetra Tech
Subject:	Northern portion of the site, where townhome units have already been constructed and occupied.

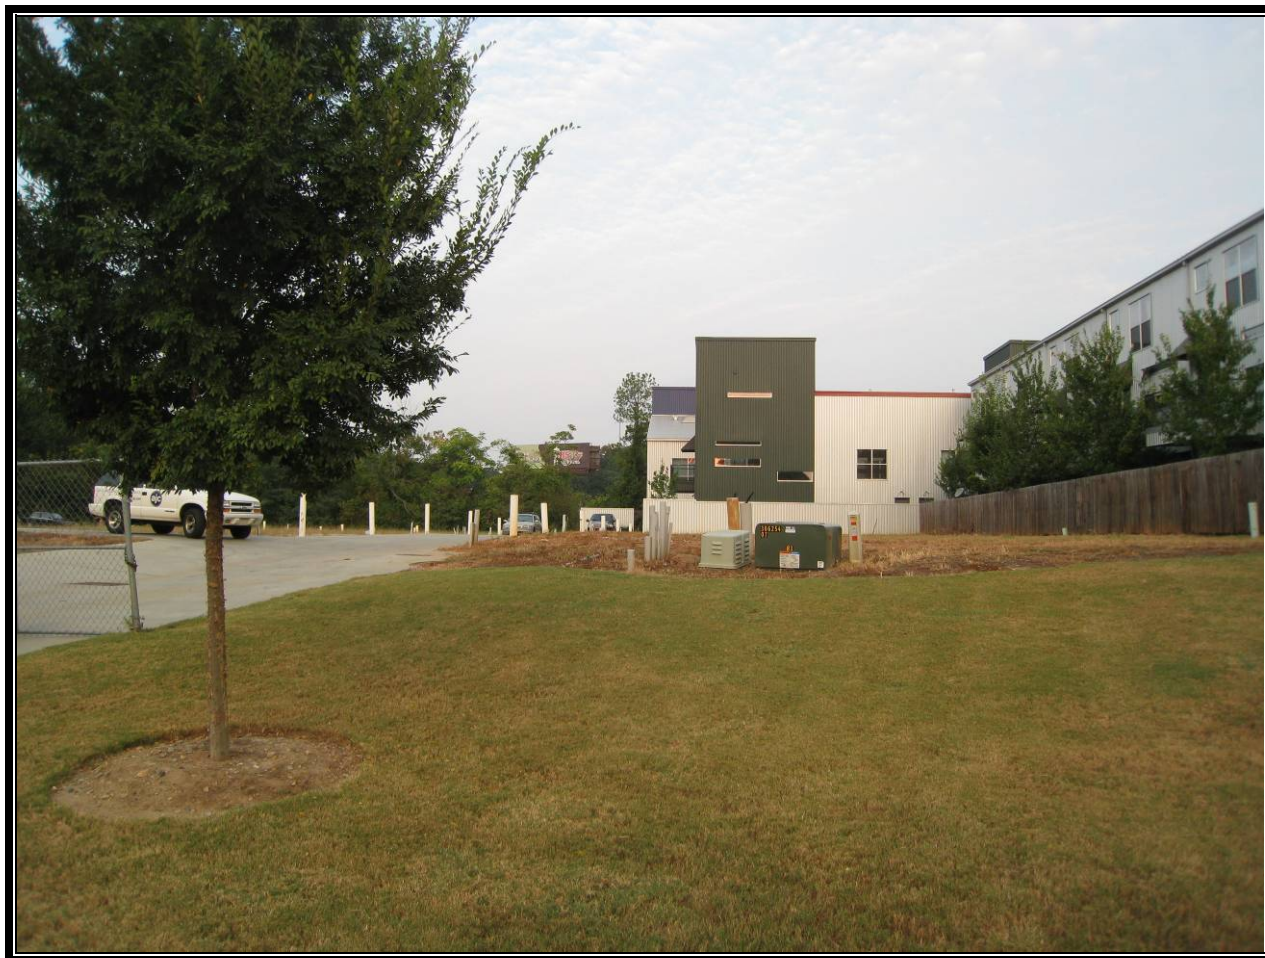
OFFICIAL PHOTOGRAPH NO. 2
U.S. ENVIRONMENTAL PROTECTION AGENCY

Subject: Central portion of the site.

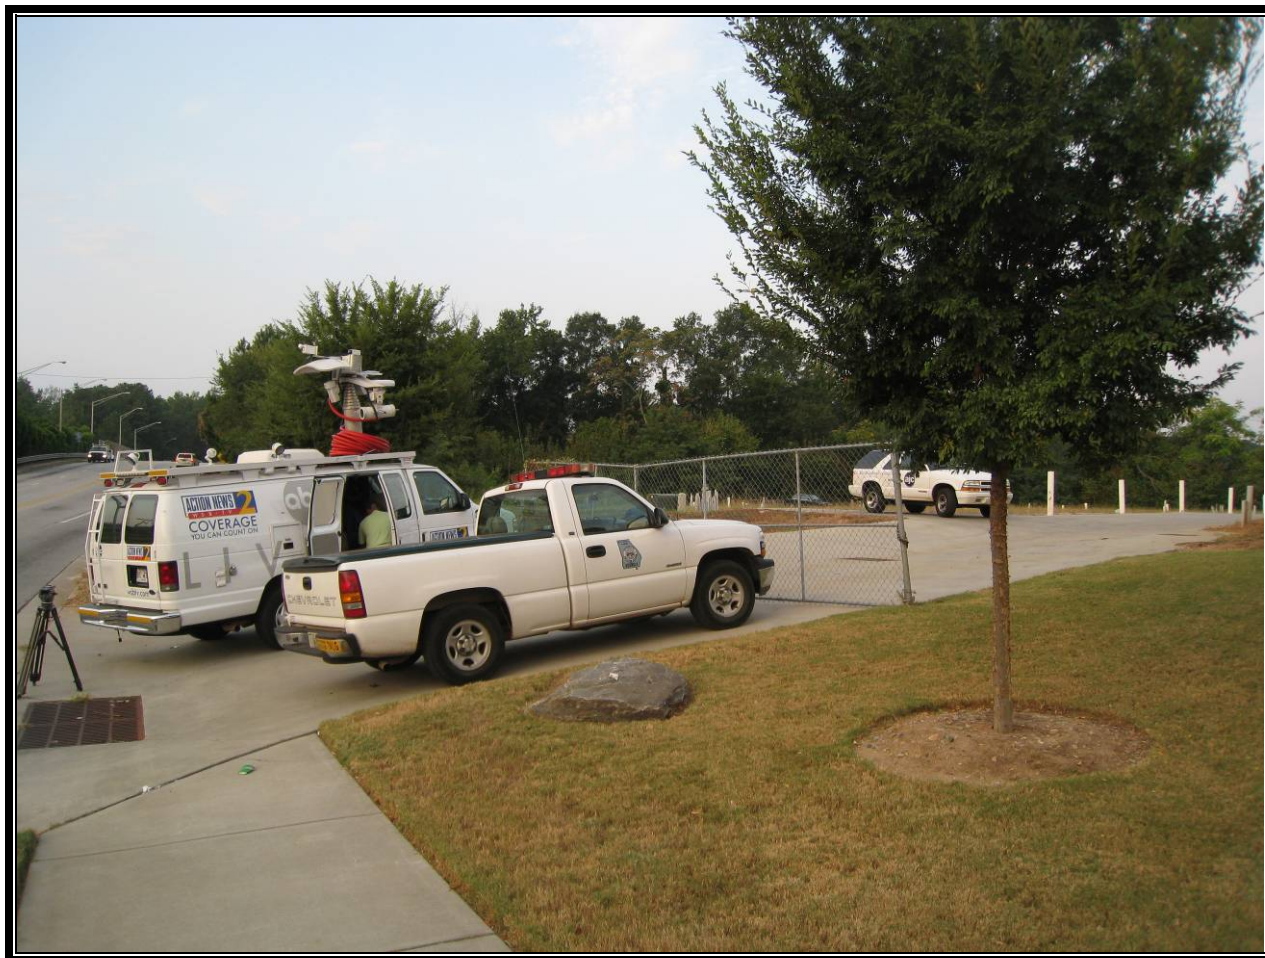
OFFICIAL PHOTOGRAPH NO. 3
U.S. ENVIRONMENTAL PROTECTION AGENCY

Subject: Southern portion of the site.

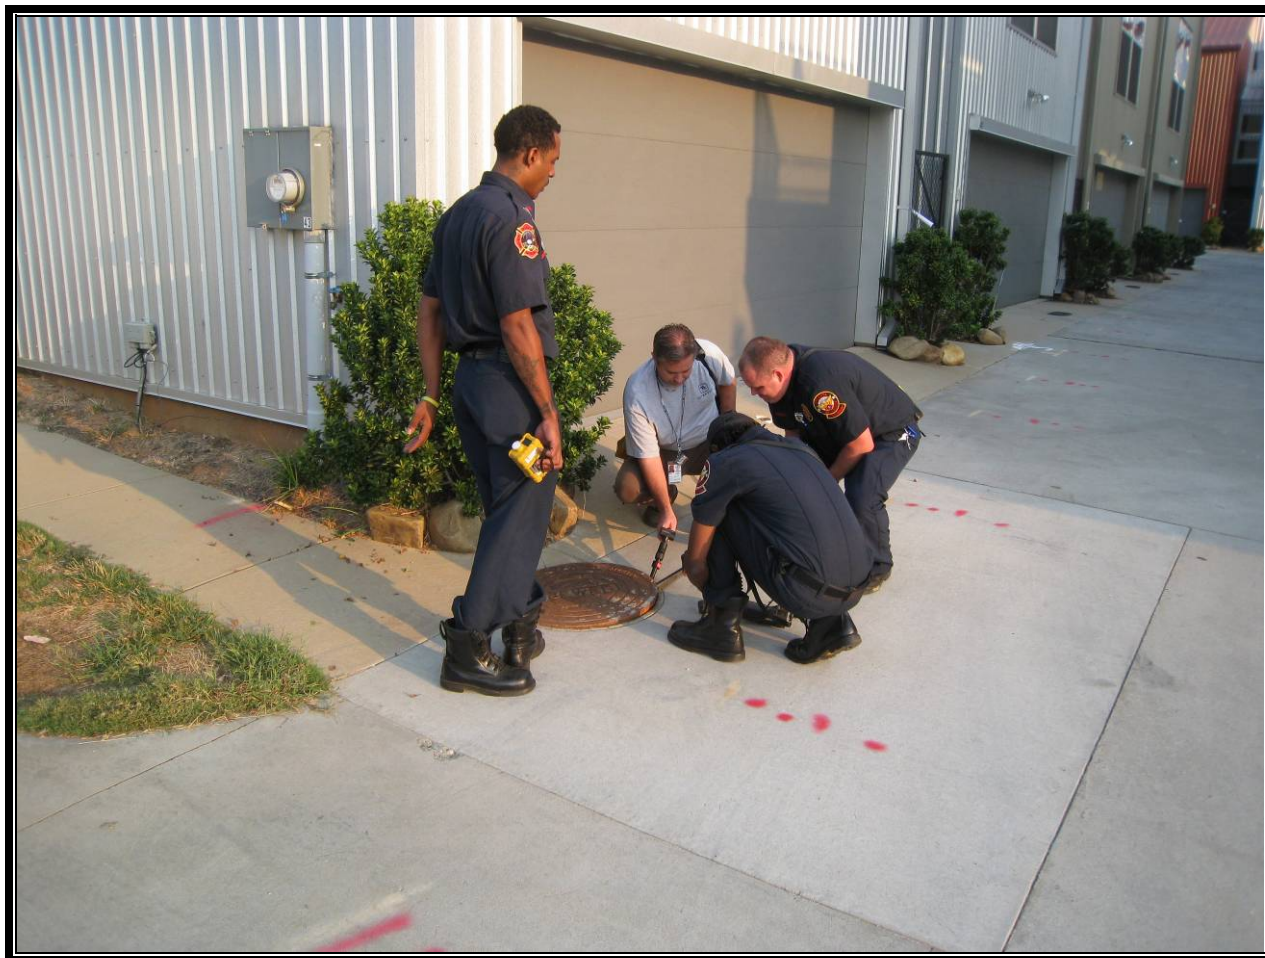
OFFICIAL PHOTOGRAPH NO. 5
U.S. ENVIRONMENTAL PROTECTION AGENCY

Subject: Tetra Tech and Atlanta Fire Department representatives conducting air monitoring of a sewer manhole located at the site.

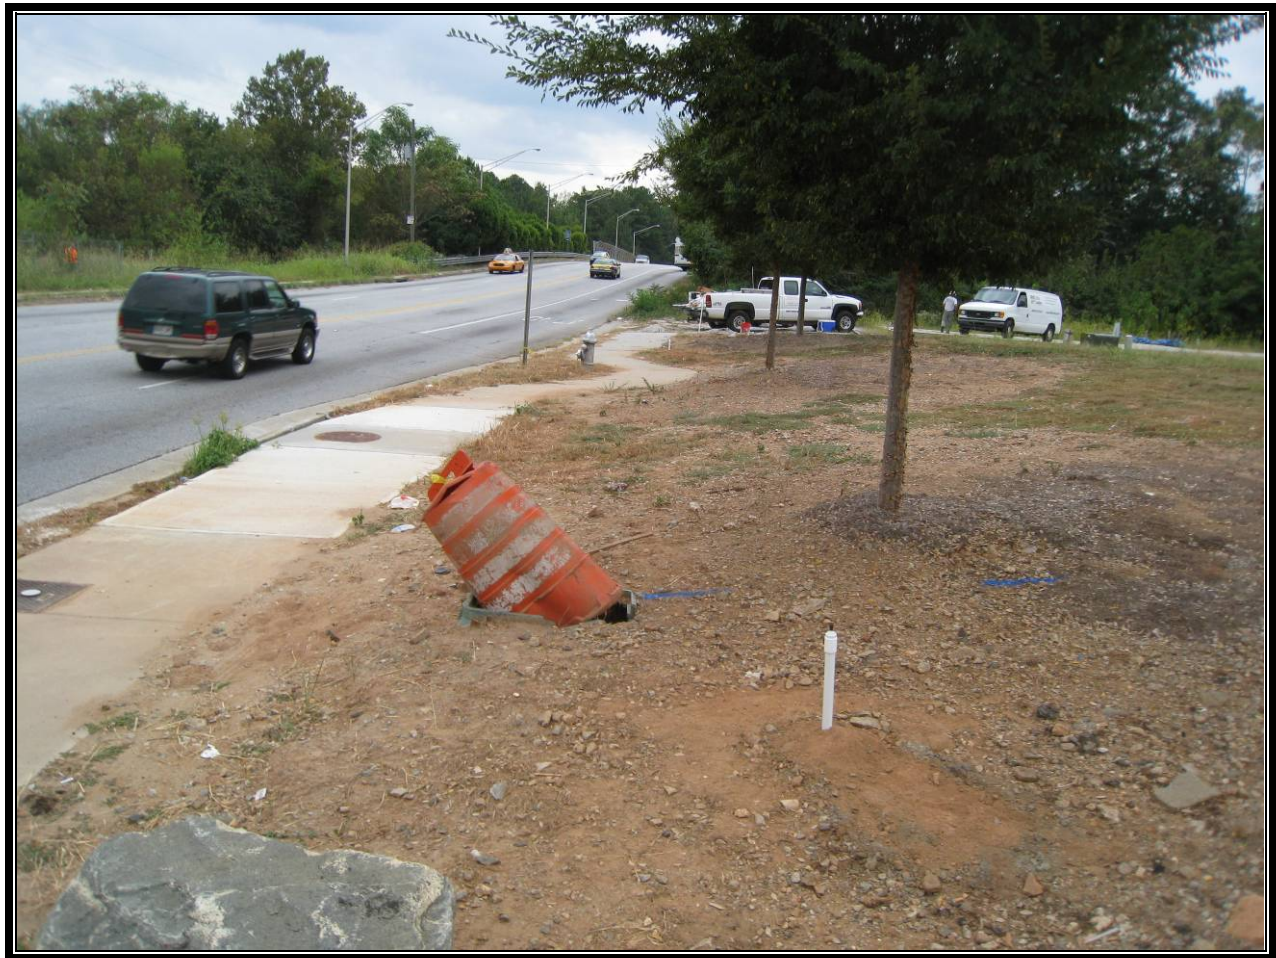
OFFICIAL PHOTOGRAPH NO. 8
U.S. ENVIRONMENTAL PROTECTION AGENCY

TDD Number:	TTEMI-05-001-0136	Location:	Maynard Terrace Methane Response
Orientation:	Southwest	Date:	September 23, 2010
Photographer:	Brian Croft, Tetra Tech	Witness:	Didi Fung, Tetra Tech
Subject:	Piezometer installed by ERM representatives as an air monitoring location.

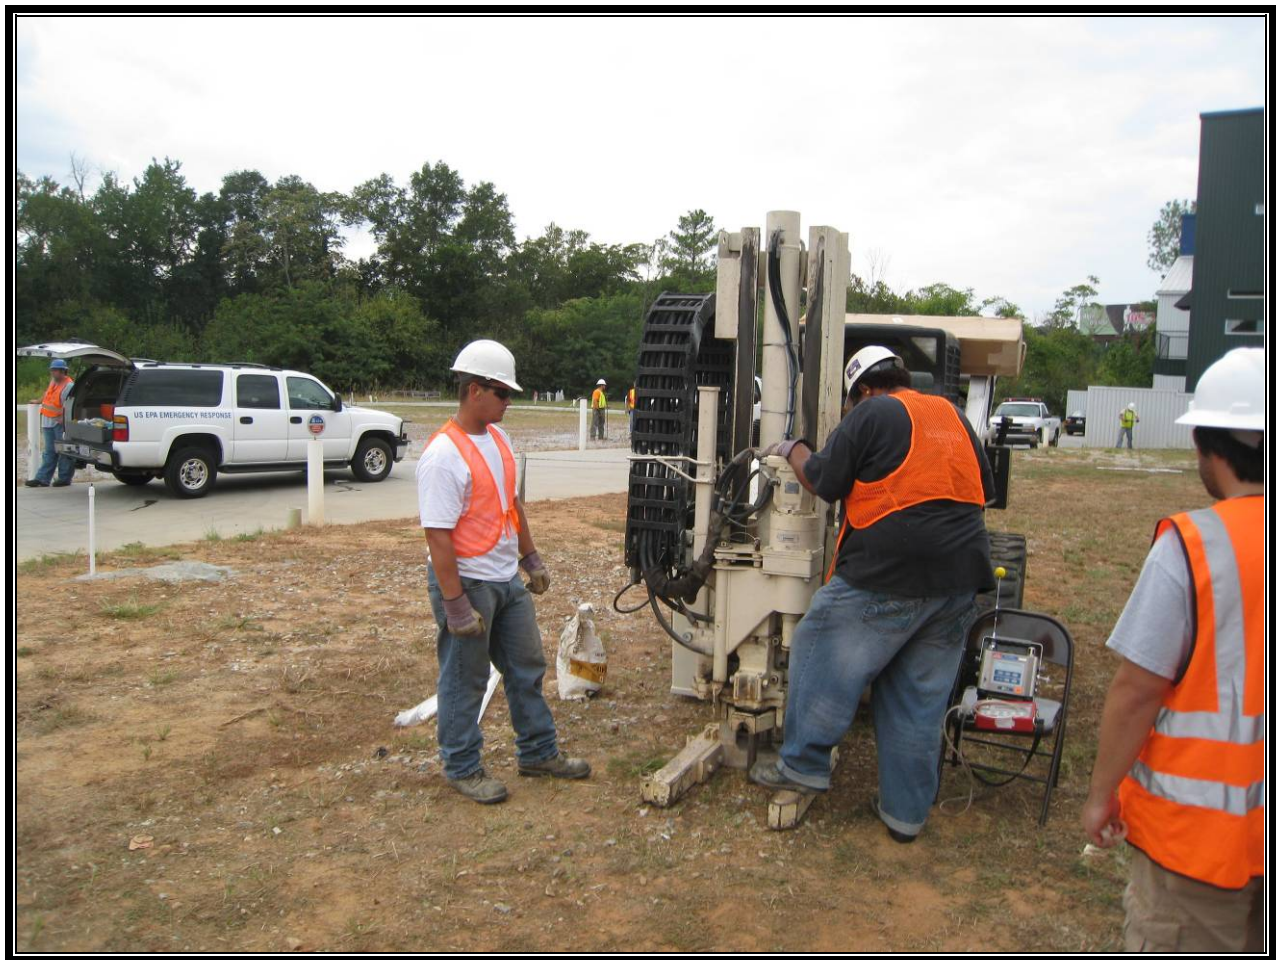
OFFICIAL PHOTOGRAPH NO. 9
U.S. ENVIRONMENTAL PROTECTION AGENCY

TDD Number:	TTEMI-05-001-0136	Location:	Maynard Terrace Methane Response
Orientation:	Southwest	Date:	September 23, 2010
Photographer:	Brian Croft, Tetra Tech	Witness:	Didi Fung, Tetra Tech
Subject:	GeoProbe boring advanced in the central portion of the site.

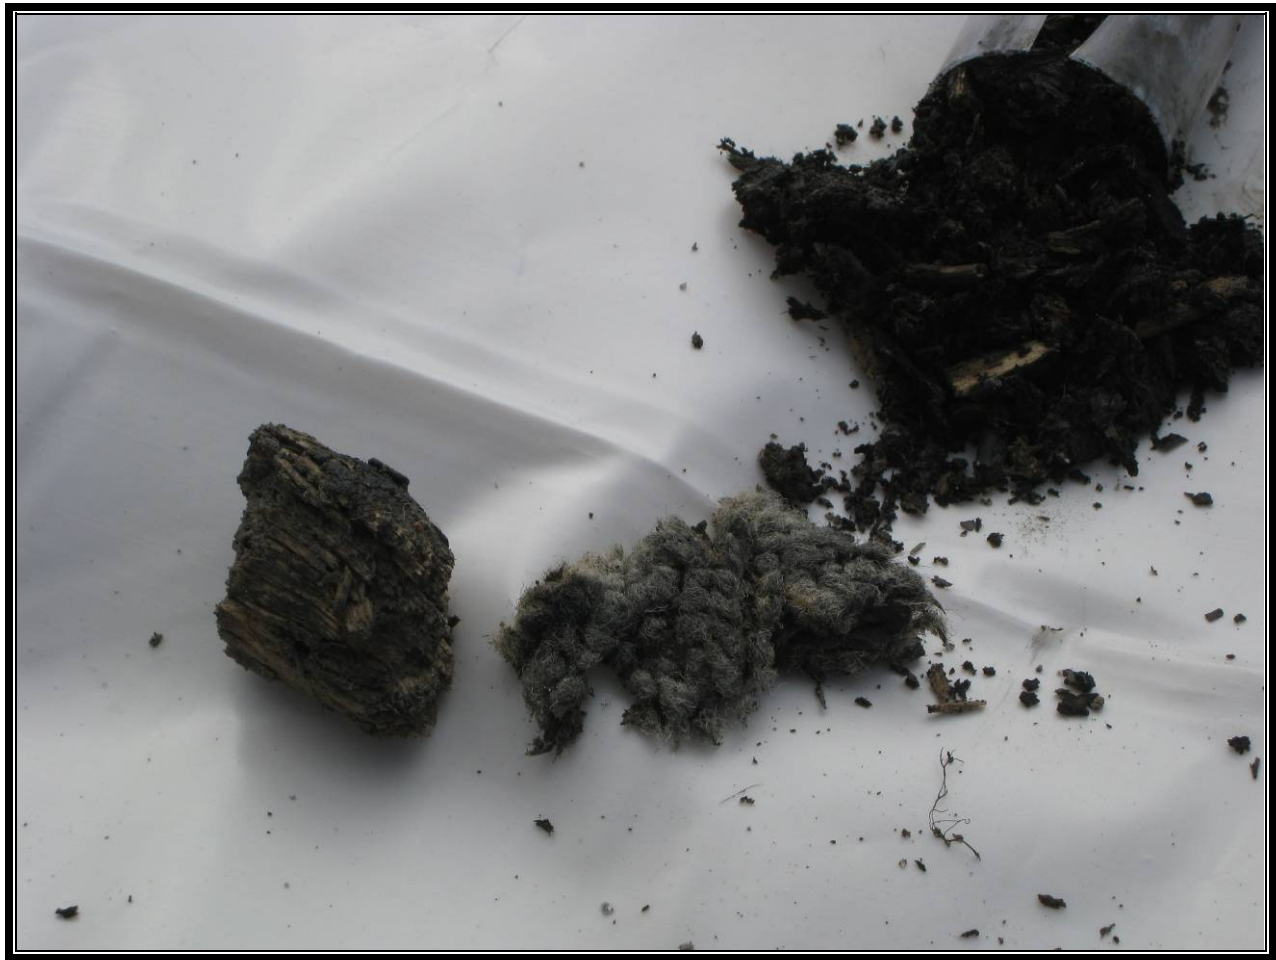
OFFICIAL PHOTOGRAPH NO. 10
U.S. ENVIRONMENTAL PROTECTION AGENCY

TDD Number:	TTEMI-05-001-0136	Location:	Maynard Terrace Methane Response
Orientation:	Down	Date:	September 23, 2010
Photographer:	Brian Croft, Tetra Tech	Witness:	Didi Fung, Tetra Tech
Subject:	Wood and a piece of carpet observed in a coring from a GeoProbe boring at approximately 20 feet below ground surface.

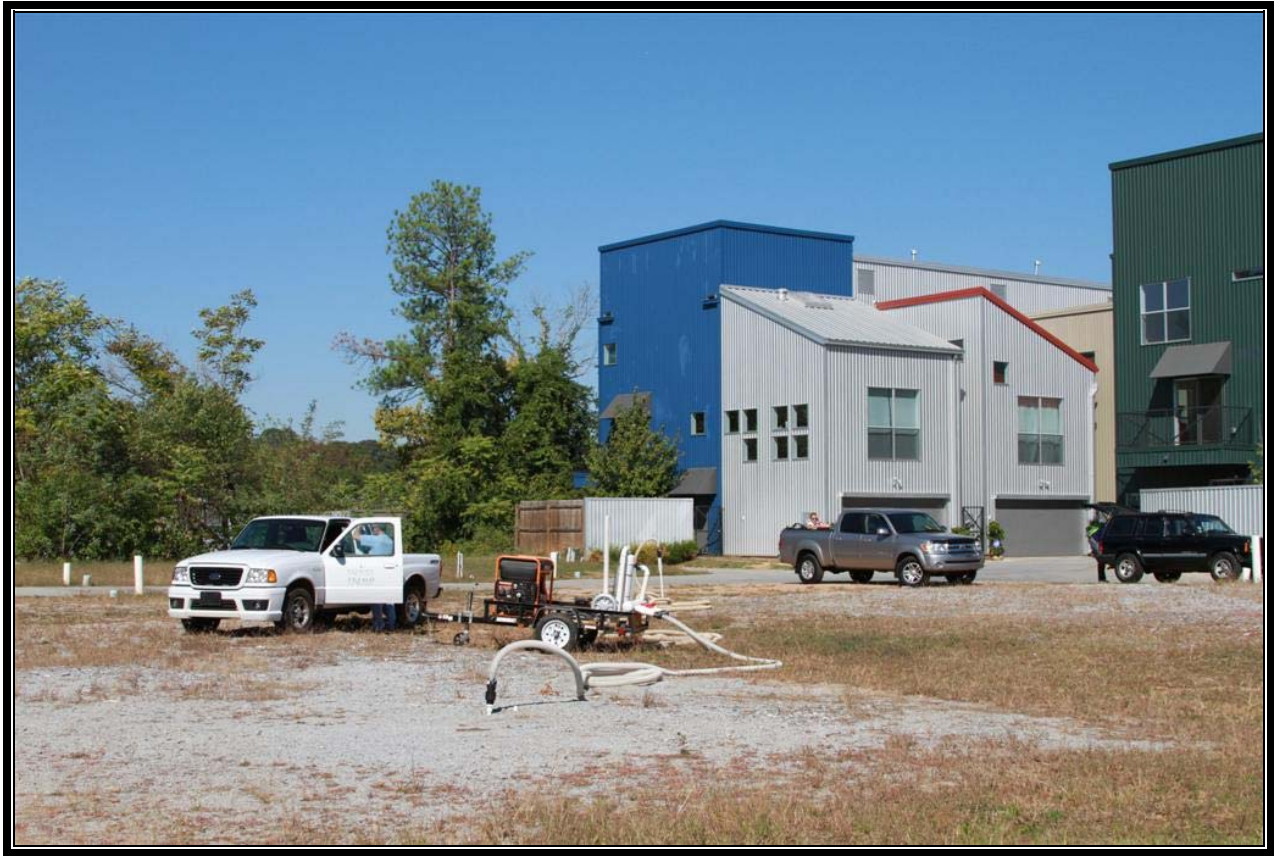
OFFICIAL PHOTOGRAPH NO. 11
U.S. ENVIRONMENTAL PROTECTION AGENCY

TDD Number:	TTEMI-05-001-0136	Location:	Maynard Terrace Methane Response
Orientation:	Northwest	Date:	October 8, 2010
Photographer:	Eric Turner, Tetra Tech	Witness:	Randy Nattis, EPA
Subject:	Pumping operations being performed by a contractor on behalf of the potentially responsible party.

Activities conducted by the PRP on October 8 included pumping air from the subsurface using the existing GeoProbe borings and piezometers through a filtration system to vent methane from the ground. Air monitoring conducted by Tetra Tech START prior to this pumping indicated a maximum methane concentration of 63.8 percent by volume; while air monitoring conducted after the pumping indicated a maximum methane concentration of 30.3 percent by volume.

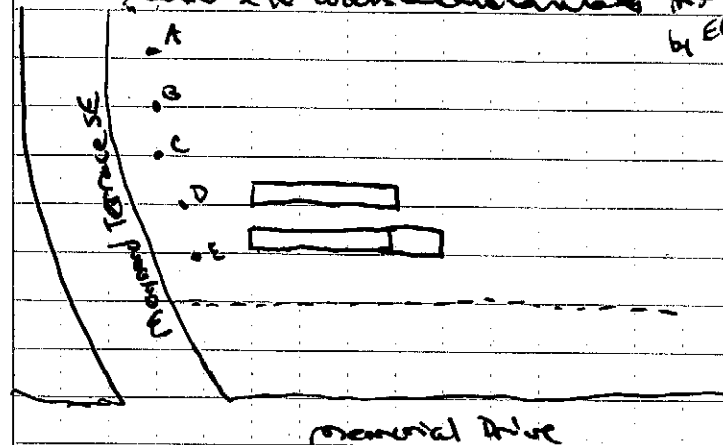
ERM hand auger / PVC pipe sensors locations -

A - LEL = 0 $CH_4 = 0.1\%$	D LEL = 4 $CH_4 = 0.1\%$
B - LEL = > 100 $CH_4 = 11.4\%$	E LEL = 0 $CH_4 = 0\%$
C - LEL = 75 100 $CH_4 = 44.7\%$ $CO_2 = 29\%$
