**Subject: Site Assessment Report
 Rock-Tenn Site
 Otsego, Allegan County, Michigan
 Technical Direction Document No. TO-01-11-11-0027
 OTIE Contract No. EP-S5-10-10**

**SITE ASSESSMENT REPORT
ROCK-TENN SITE
OTSEGO, ALLEGAN COUNTY, MICHIGAN**

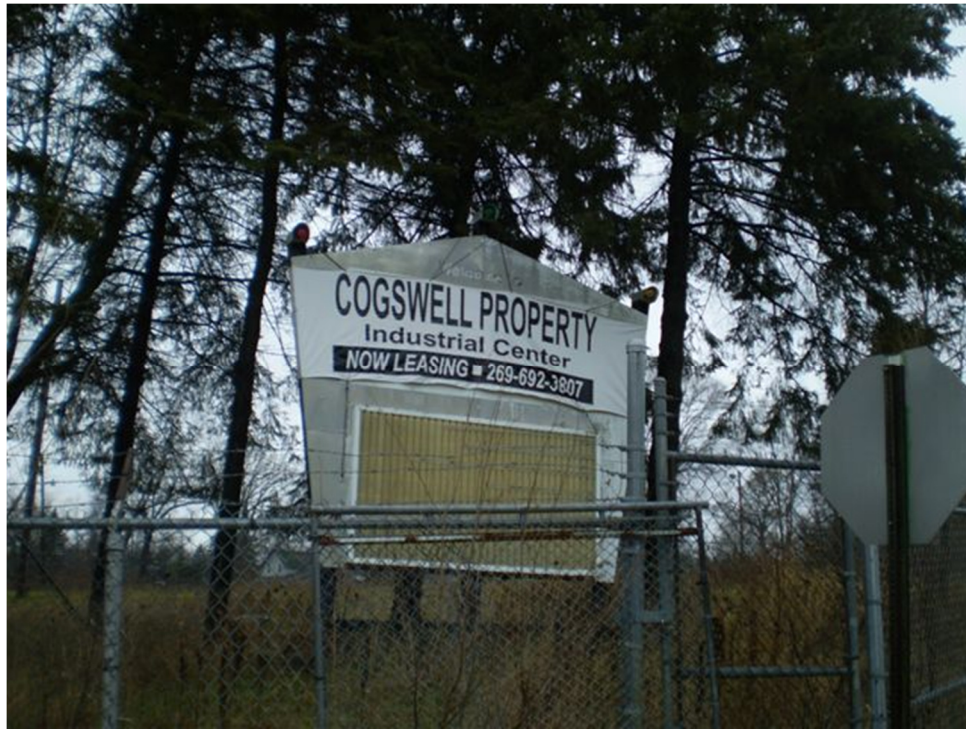
Photograph No.: 1 **Photographer:** Caitlin Ruza **Orientation:** West
TDD Number: TO-01-11-11-0027 **Contract:** EP-S5-10-10, OTIE **Date:** December 14, 2011
Site Name & Location: Rock-Tenn Site, Allegan County, Michigan.
Subject: Cogswell Property Sign located at east entrance of the Site property.

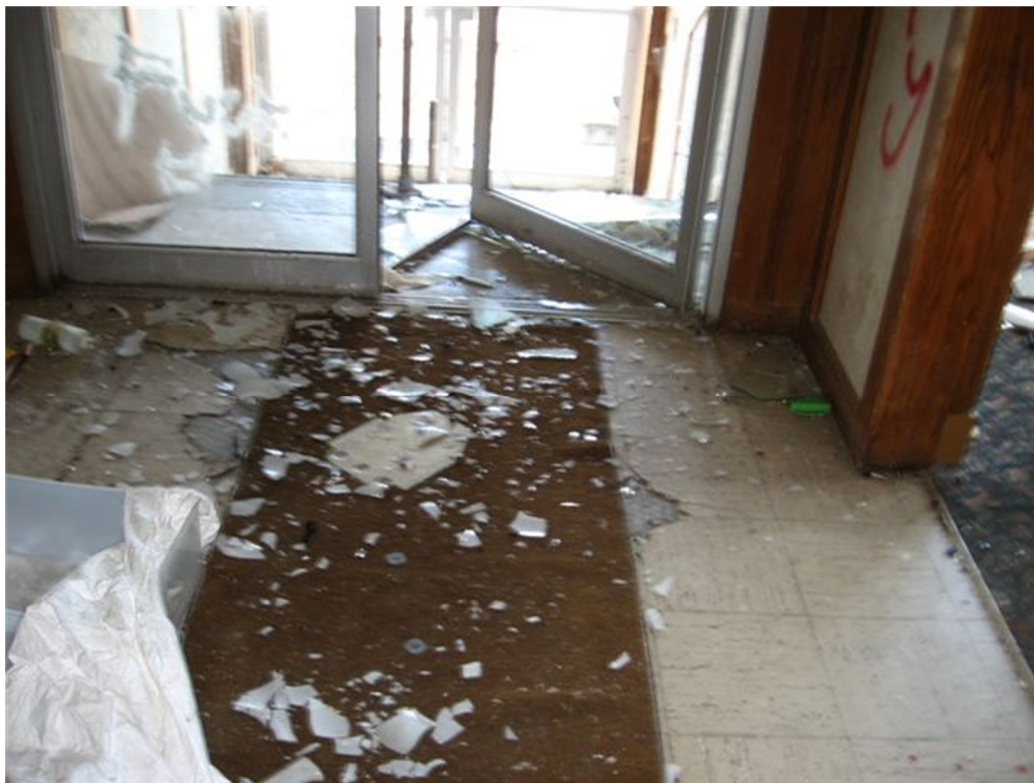
Photograph No.: 2 **Photographer:** Naren Babu **Orientation:** North
TDD Number: TO-01-11-11-0027 **Contract:** EP-S5-10-10, OTIE **Date:** November 16, 2011
Site Name & Location: Rock-Tenn Site, Allegan County, Michigan.
Subject: Broken glass in doorway of facility.

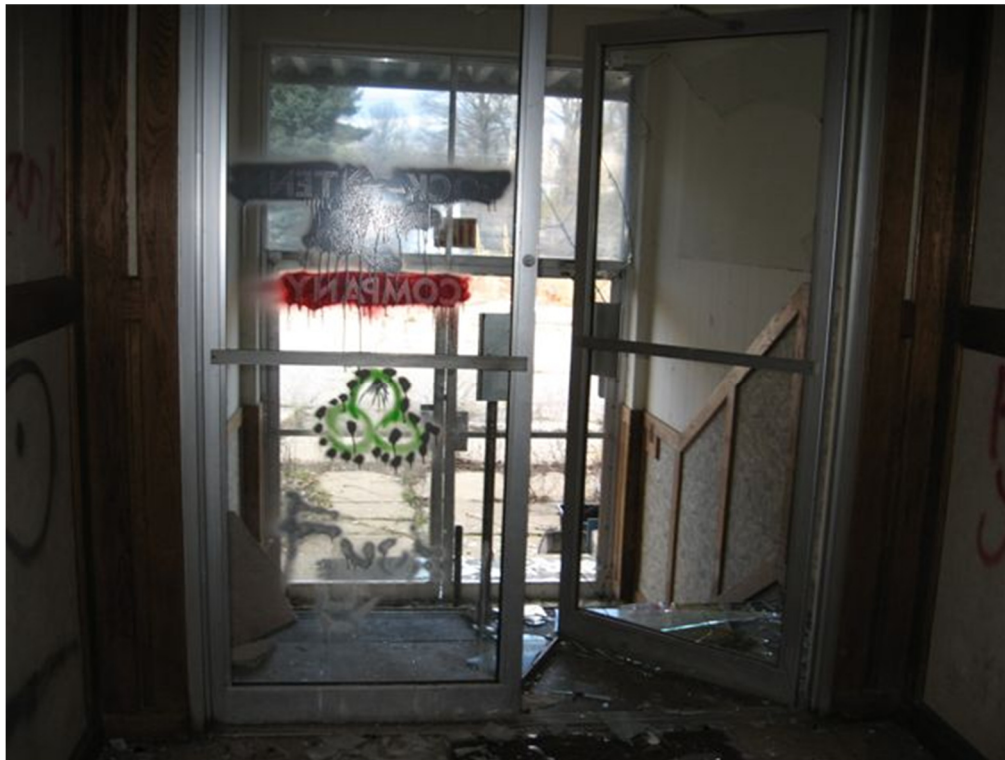
Photograph No.: 3 **Photographer:** Naren Babu **Orientation:** North
TDD Number: TO-01-11-11-0027 **Contract:** EP-S5-10-10, OTIE **Date:** November 16, 2011
Site Name & Location: Rock-Tenn Site, Allegan County, Michigan.
Subject: Broken glass in doorway and graffiti on glass door.

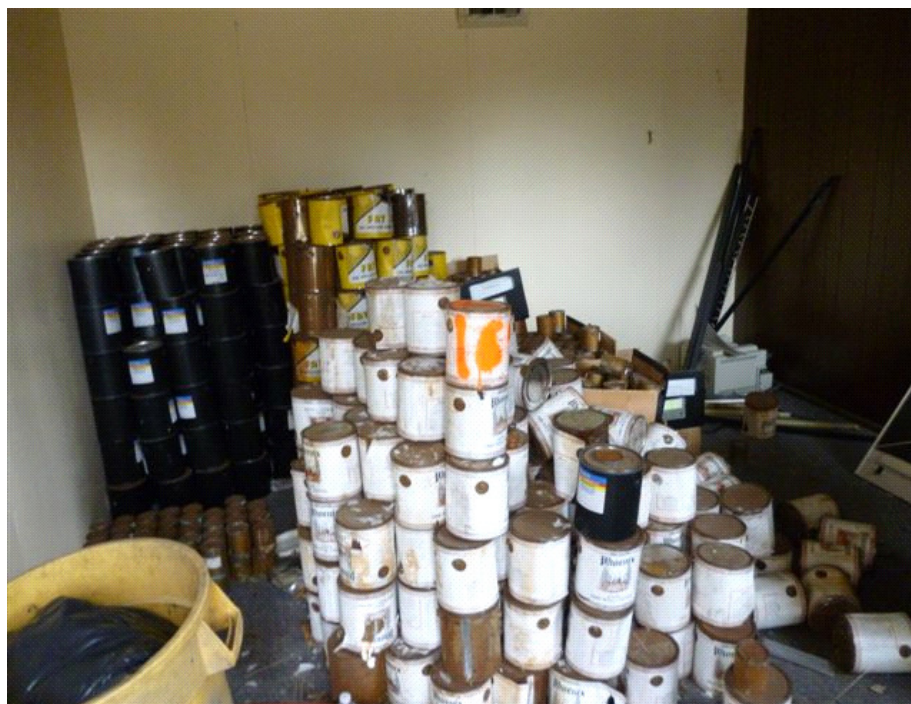
Photograph No.: 4 **Photographer:** Naren Babu **Orientation:** West
TDD Number: TO-01-11-11-0027 **Contract:** EP-S5-10-10, OTIE **Date:** November 16, 2011
Site Name & Location: Rock-Tenn Site, Allegan County, Michigan.
Subject: View of small paint containers; one of them was sampled for flashpoint

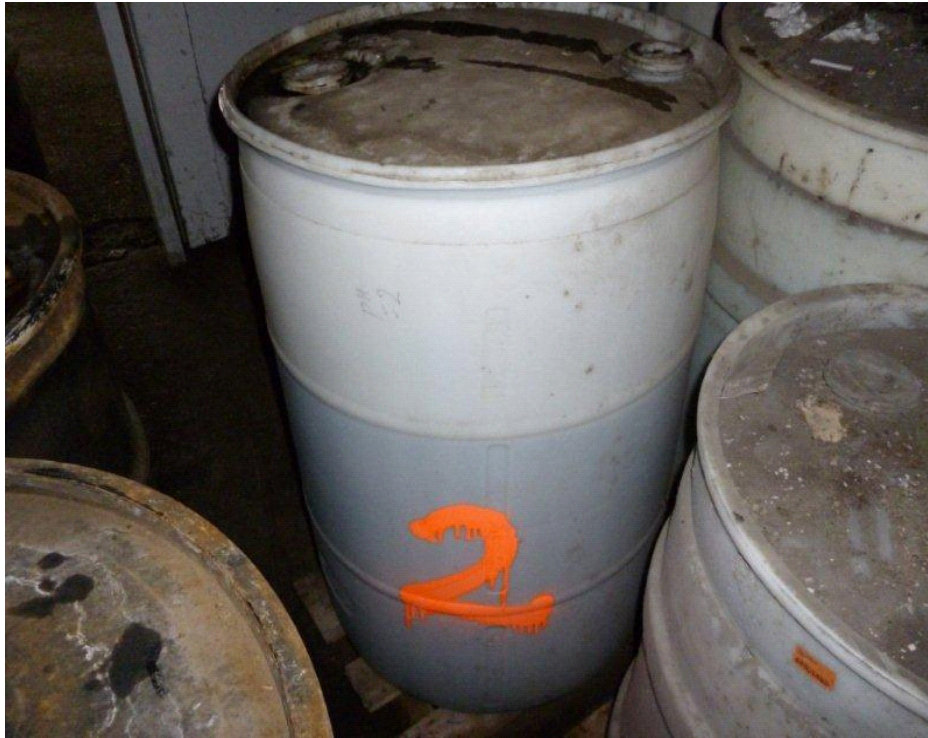
| Photograph No.: | 5 | Photographer: | Naren Babu | Orientation: | Looking Down |

| Subject: | Poly Drum with acid material; pH test showed a result below 2 | | | | |

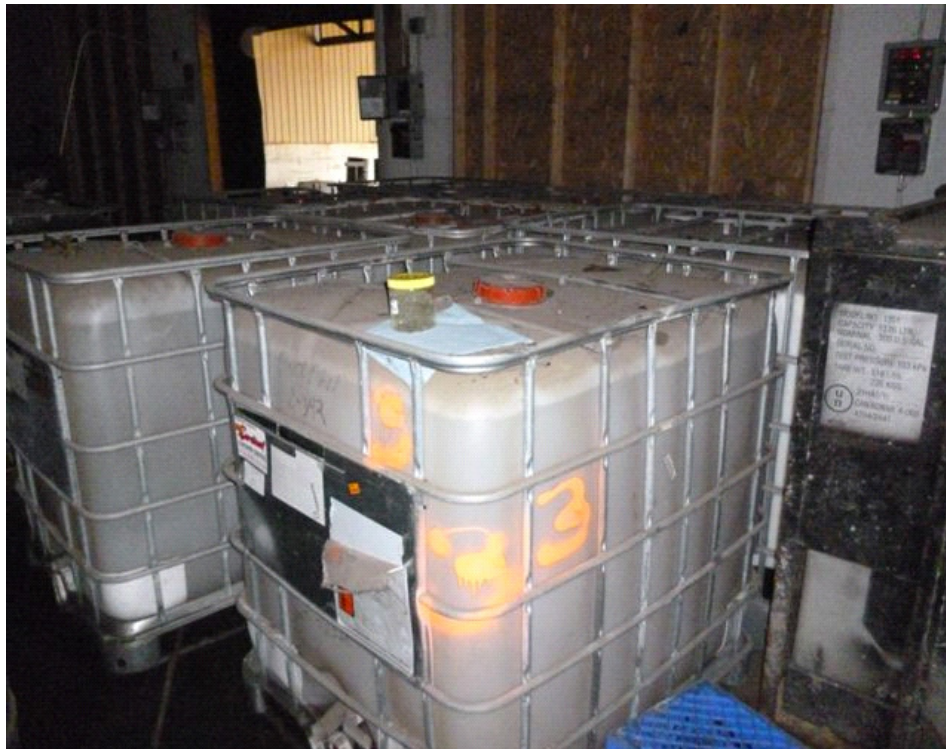
| Photograph No.: | 6 | Photographer: | Naren Babu | Orientation: | Southwest |

Near the loading dock on the west end of the building #53, 18 totes and 45 drums were observed with standing water on the floor. Several drums were observed with the following labels: Corrosive “UN1824”, Corrosive “UN1760”, “and PARACOL” paraffin wax emulsion. A total of 12 drums stored in this area were labeled as “non-hazardous”. Field pH tests conducted on a poly drum with dark liquid indicated a pH of 2 (Photo #5). Field pH tests conducted on a drum material with a UN1760” label indicated a pH of 4. Field pH test results for liquid material in two totes with a “UN1824” label were between 8 and 9. Hissing noise was observed when the bung on a blue-colored drum was opened. Field screening conducted inside the bung opening of the blue colored metal drum indicated 15.8% O₂ and 26 ppm CO. Several of the containers were labeled Rock-Tenn Company and included Rock-Tenn’s former address. Field screening conducted on the tote indicated elevated levels of VOCs at 201 ppm (Photos #6 and #7).

| Subject: | Poly tote that had high VOC readings | | | | |

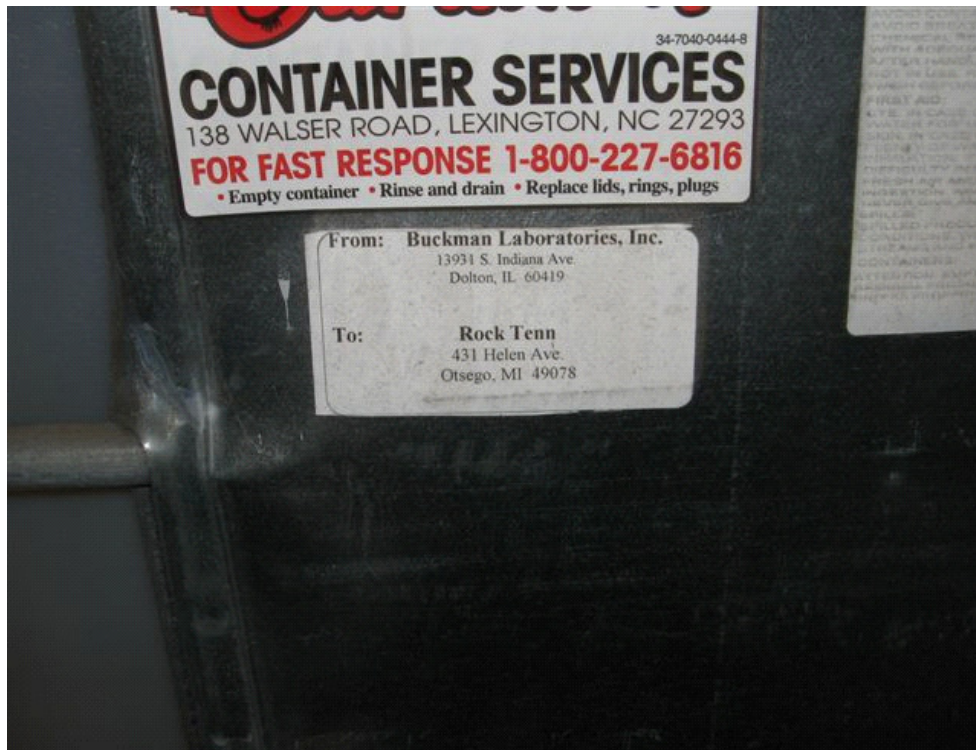
Photograph No.: 7 **Photographer:** Naren Babu **Orientation:** West
TDD Number: TO-01-11-11-0027 **Contract:** EP-S5-10-10, OTIE **Date:** November 16, 2011
Site Name & Location: Rock-Tenn Site, Allegan County, Michigan.
Subject: View of a label showing that a drum was sold to Rock-Tenn

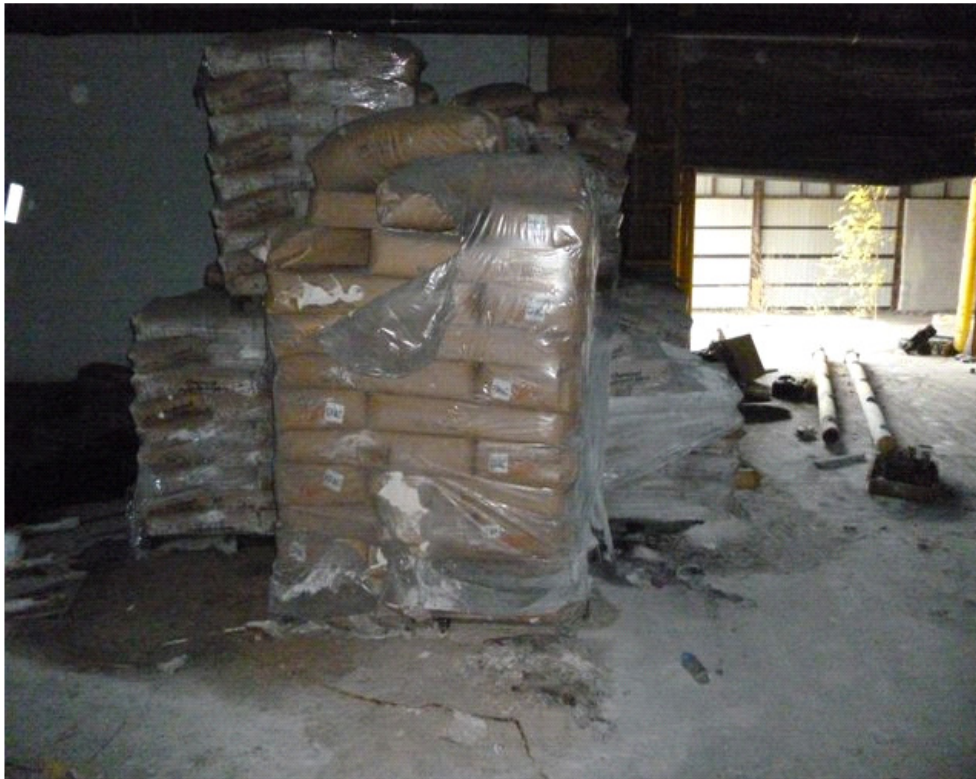
Hydrated lime was stored in several paper bags near an open garage door of the loading dock on the north side of Building #34A (Photo # 8). The pH of the lime was tested and results indicated that the lime material was basic in nature (Photo # 9). A possible run-off path from the lime was also observed.

Photograph No.: 8 **Photographer:** Naren Babu **Orientation:** North
TDD Number: TO-01-11-11-0027 **Contract:** EP-S5-10-10, OTIE **Date:** November 16, 2011
Site Name & Location: Rock-Tenn Site, Allegan County, Michigan.
Subject: View of the hydrated lime stored near the garage door.

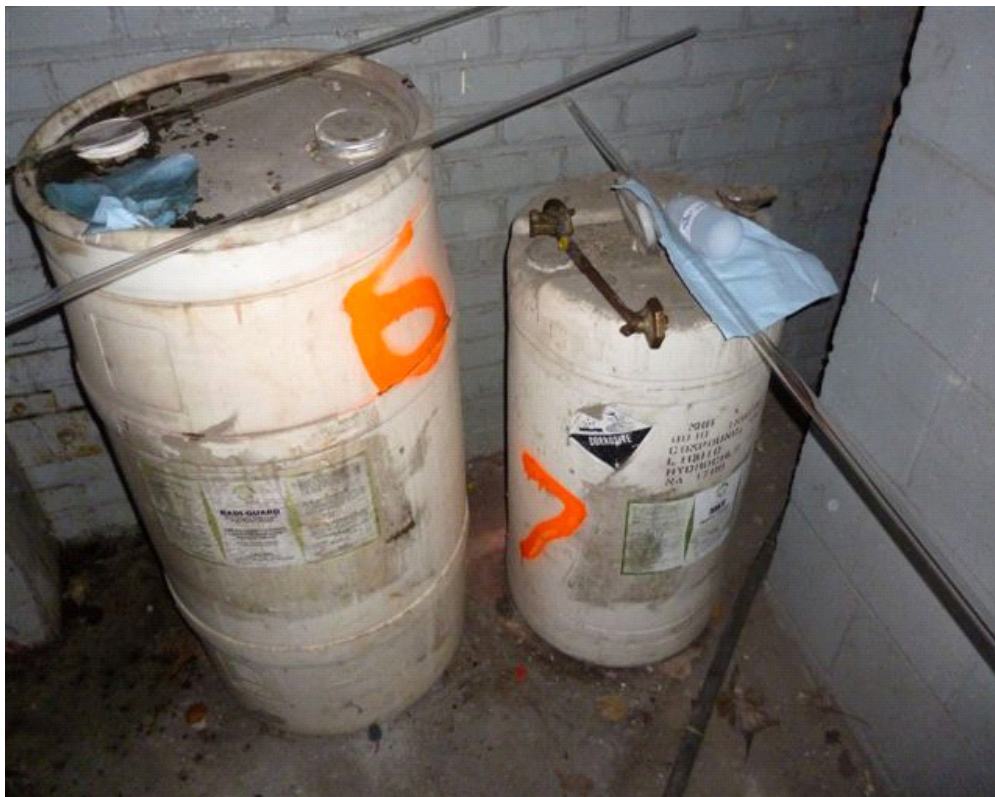
Two poly drums were observed in Building #39. A field screening pH test was performed on two of the drums. The results indicated that one drum contained liquid with a pH <2 SU and the other drum contained liquid with a pH >12 SU. These highly acidic and basic liquid drums were next to each other (Photo #10). Three 55-gallon metal drums with used oil were observed in building #18 (Photo #11). One of the drums had a field screening result of 57 ppm VOCs.

Photograph No.: 10 **Photographer:** Naren Babu **Orientation:** Looking Down
TDD Number: TO-01-11-11-0027 **Contract:** EP-S5-10-10, OTIE **Date:** November 16, 2011
Site Name & Location: Rock-Tenn Site, Allegan County, Michigan.
Subject: Acid and Base Drums stored next to each other.

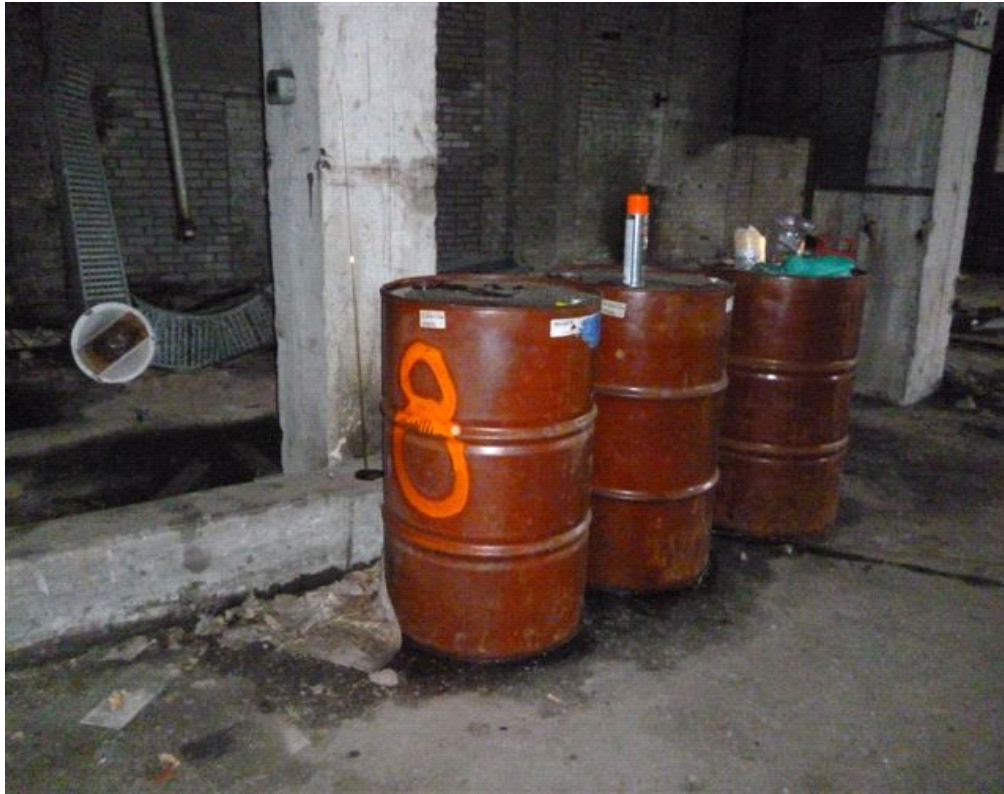
Photograph No.: 11 **Photographer:** Naren Babu **Orientation:** East
TDD Number: TO-01-11-11-0027 **Contract:** EP-S5-10-10, OTIE **Date:** November 16, 2011
Site Name & Location: Rock-Tenn Site, Allegan County, Michigan.
Subject: Drums with crude motor oil.

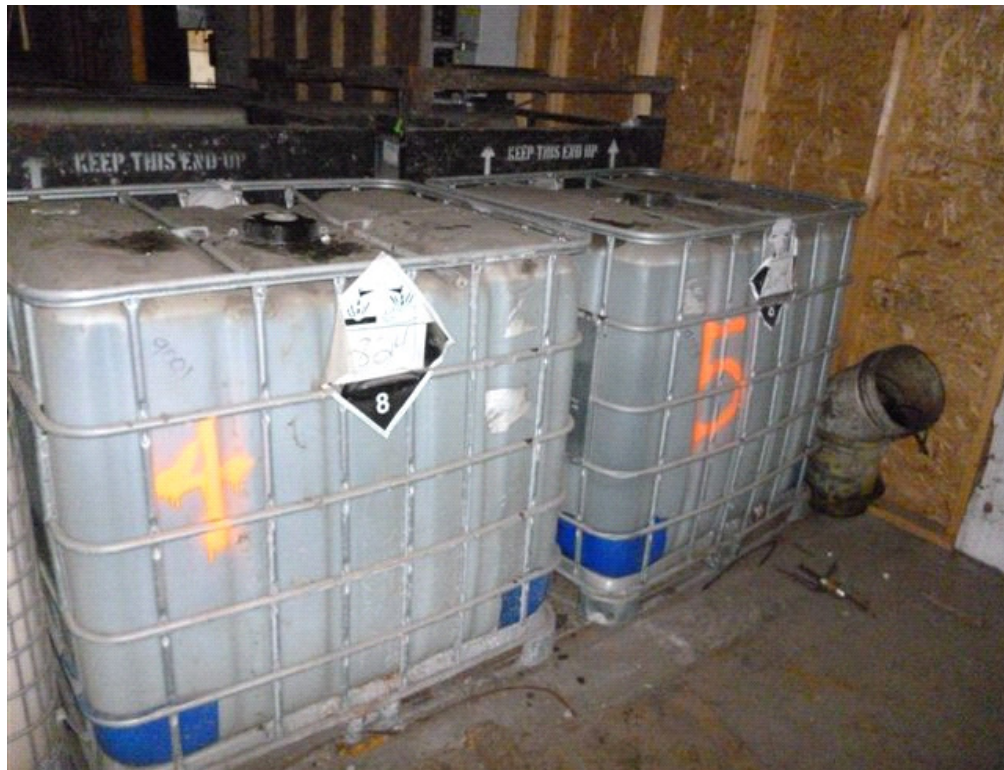
Photograph No.: 12 **Photographer:** Naren Babu **Orientation:** Southwest
TDD Number: TO-01-11-11-0027 **Contract:** EP-S5-10-10, OTIE **Date:** November 16, 2011
Site Name & Location: Rock-Tenn Site, Allegan County, Michigan.
Subject: Basic totes with corrosive label 1824.
