**Subject:       Site Assessment Report  
                  Lovers Lane Lead Site  
                  Comstock Park, Kent County, Michigan  
                  Technical Direction Document No. TO-01-11-11-0028  
                  OTIE Contract No. EP-S5-10-10**

**SITE ASSESSMENT REPORT  
LOVERS LANE LEAD SITE  
COMSTOCK PARK, KENT COUNTY, MICHIGAN**

TDD No.:	TO-01-11-11-0028
Date Prepared:	March 9, 2012
Contract No.:	EP-S5-10-10
Prepared by:	OTIE
START Project Manager:	Naren Babu
Telephone No.:	(312) 220-7000
U.S. EPA On-Scene Coordinator:	Jeffrey Lippert
Telephone No.:	(734) 692-7682

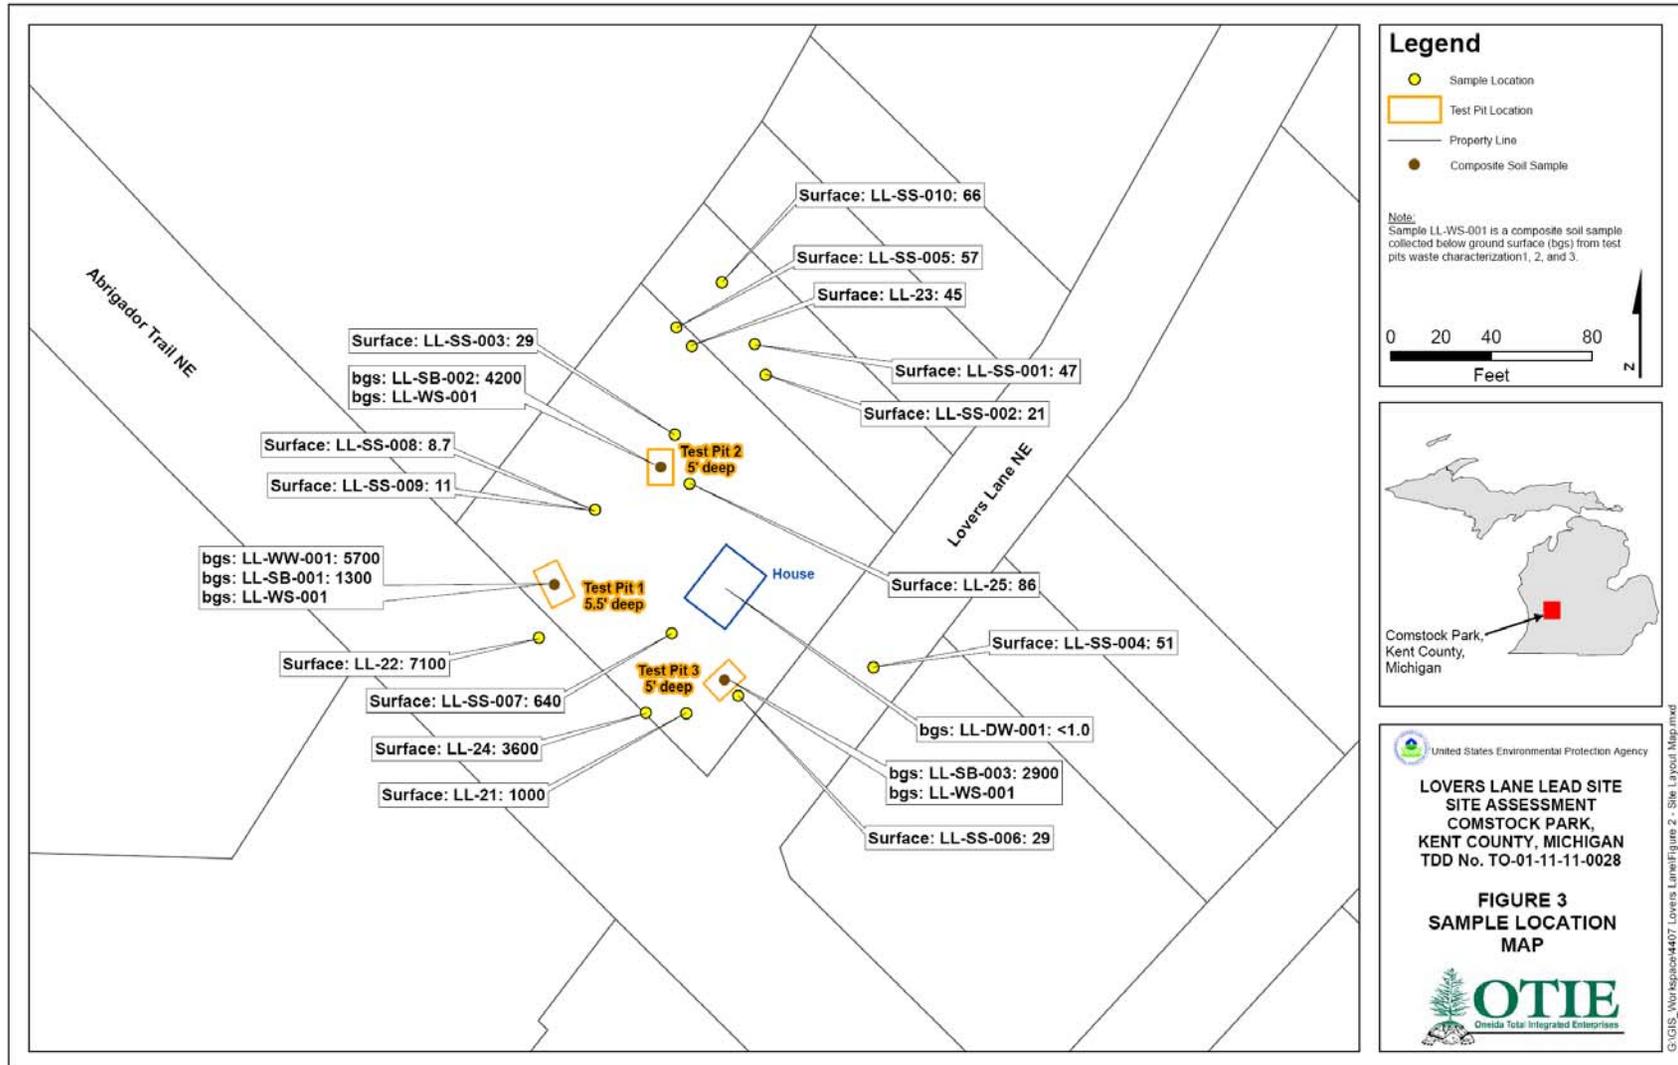
For a complete list of the sample locations and descriptions see Table 1. All sample locations are shown in Figure 3.

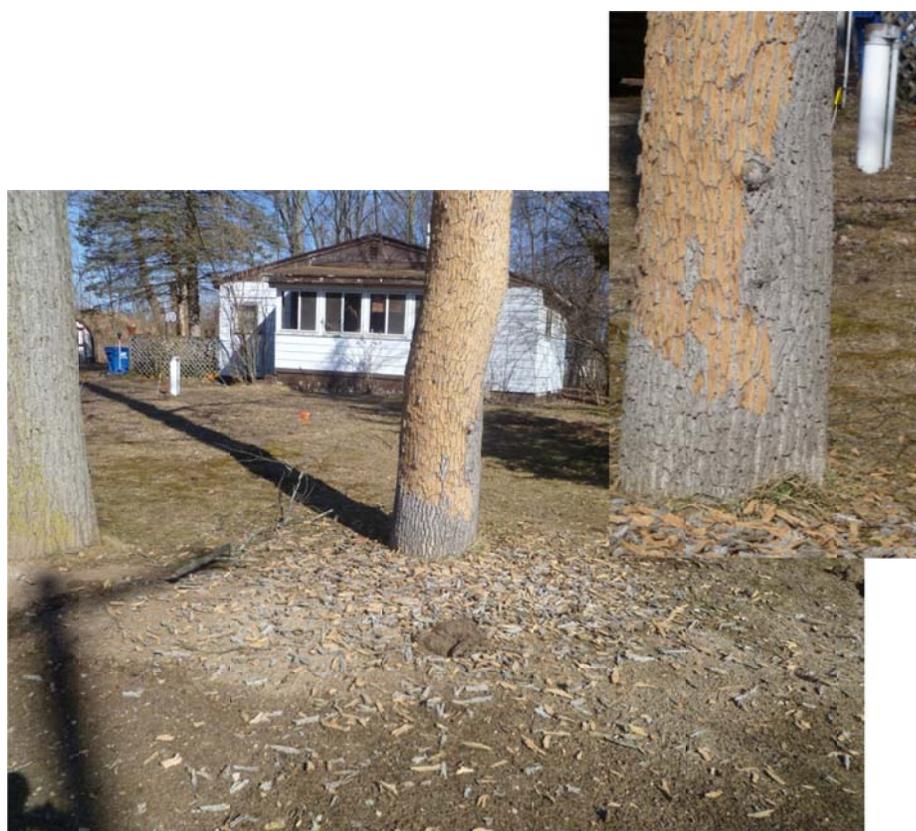
One house and a storage shed are located on the Site property. A tree in front of the house (south corner) appeared to be dying. (Photo 1 in Appendix A). A drinking water well is located in the middle of the front yard. A basketball hoop and a fire-pit were observed northeast of the house. Broken lead-acid battery casings were observed in the yard at several locations. MultiRAE® readings were all below background levels for VOCs, CO, H<sub>2</sub>S, and LEL. O<sub>2</sub> was around 20.9% throughout the Site reconnaissance.

**Photograph No.:** 1      **Photographer:** Carly Schulz      **Orientation:** Northeast  
**TDD Number:** TO-01-11-11-0028      **Contract:** EP-S5-10-10, OTIE      **Date:** 02/09/2012  
**Site Name & Location:** Lovers Lane Site, Kent County, Michigan.  
**Subject:** Tree that appears to be dying in front yard near well. The residential house is visible in the background.

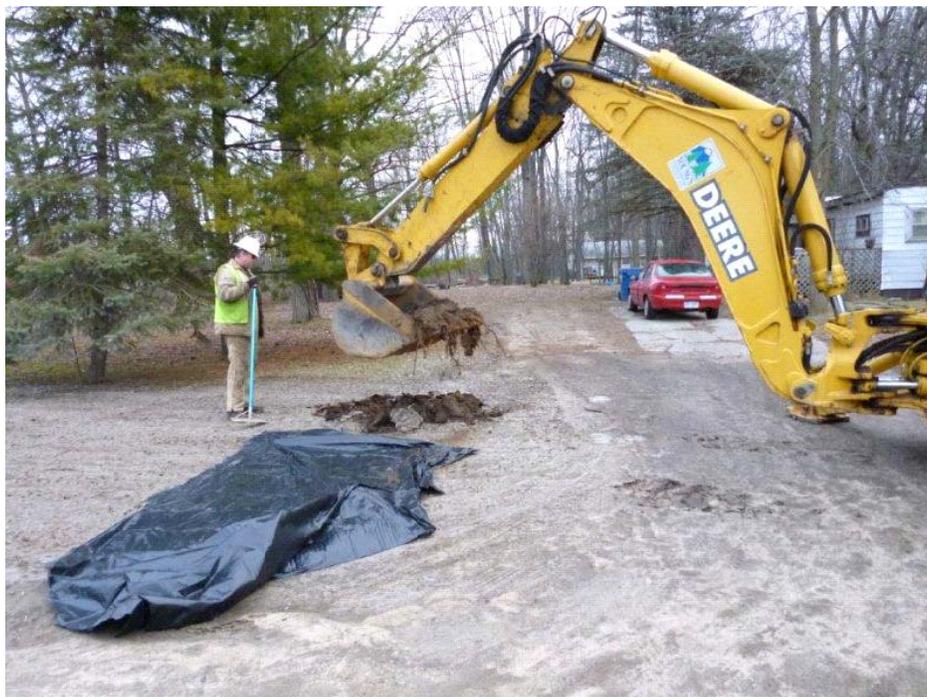
**Photograph No.:** 2      **Photographer:** Naren Babu      **Orientation:** Northeast  
**TDD Number:** TO-01-11-11-0028      **Contract:** EP-S5-10-10, OTIE      **Date:** 12/20/2011  
**Site Name & Location:** Lovers Lane Site, Kent County, Michigan.  
**Subject:** View of Test Pit #1, excavated just northwest of the driveway in the front yard.

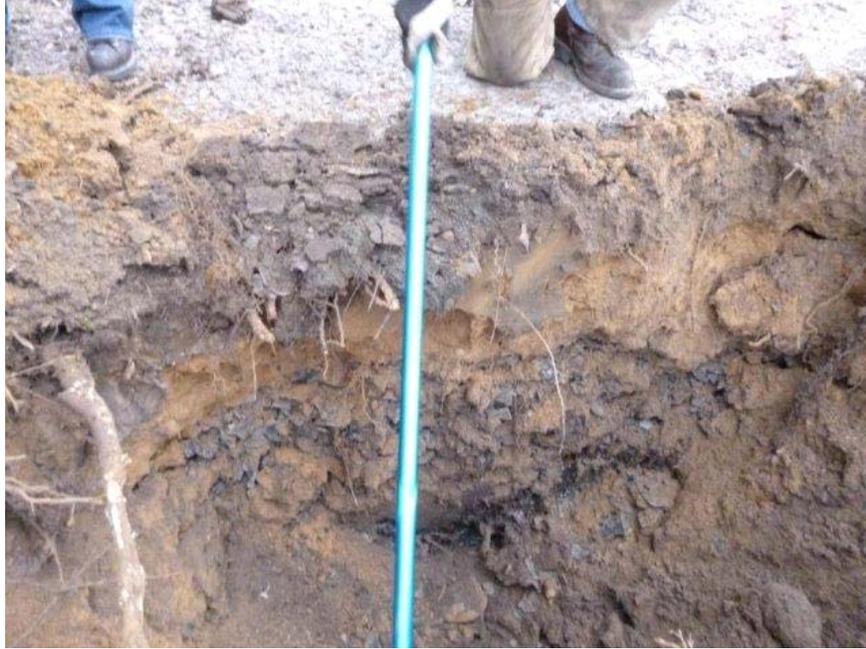
**Photograph No.:** 3      **Photographer:** Naren Babu      **Orientation:** Downward  
**TDD Number:** TO-01-11-11-0028      **Contract:** EP-S5-10-10, OTIE      **Date:** 12/20/2011  
**Site Name & Location:** Lovers Lane Site, Kent County, Michigan.  
**Subject:** View of layers of soil inside Test Pit #1.

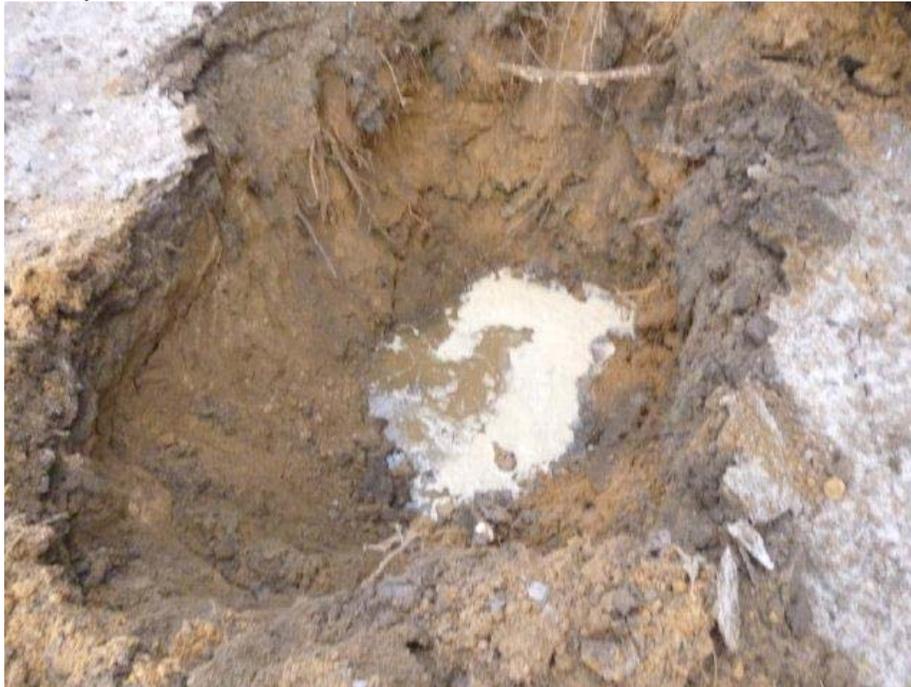
Analytical results of the metals in tap water sample, LL-DW-001, were below the federal MCL limits. Lead was detected at 5,700  $\mu\text{g/L}$  in the infiltrated water sample, LL-WW-001, collected from Test Pit #1. There is no lead value listed by MDEQ under Groundwater Contact Criteria (GCC) due to insufficient data to develop the criterion. GCC is determined for exposure to groundwater contaminants by a utility worker during work activities such as utility line repair, maintenance, and installation etc.

**Photograph No.:** 4      **Photographer:** Naren Babu      **Orientation:** Downward  
**TDD Number:** TO-01-11-11-0028      **Contract:** EP-S5-10-10, OTIE      **Date:** 12/20/2011  
**Site Name & Location:** Lovers Lane Site, Kent County, Michigan.  
**Subject:** Infiltrated groundwater at approximately five feet bgs inside Test Pit #1.

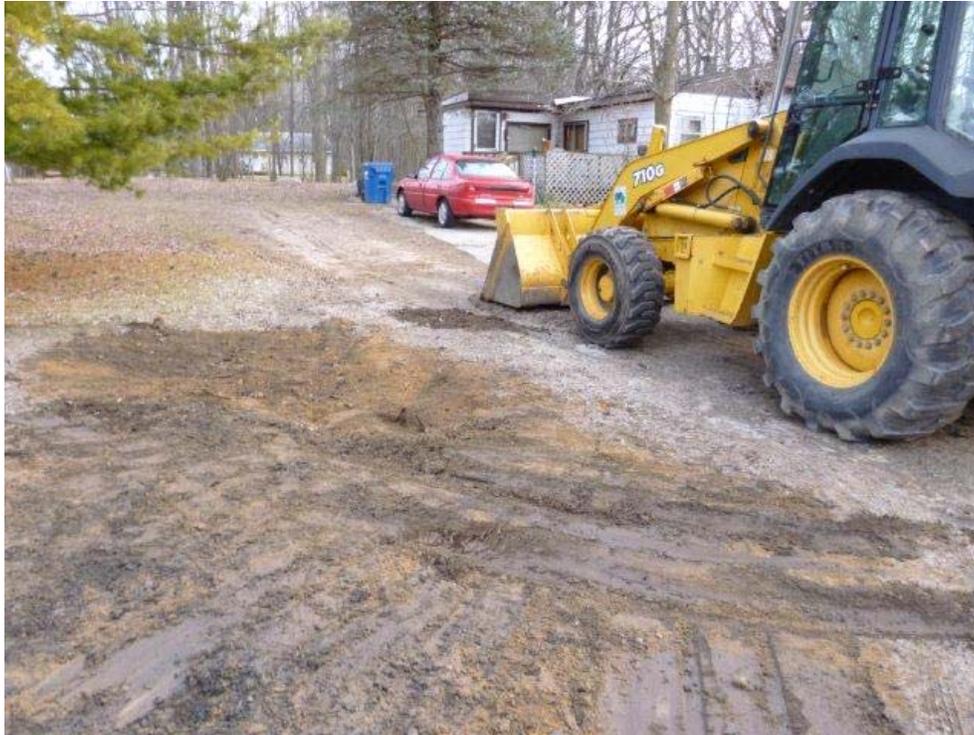
**Photograph No.:** 5      **Photographer:** Naren Babu      **Orientation:** Northeast  
**TDD Number:** TO-01-11-11-0028      **Contract:** EP-S5-10-10, OTIE      **Date:** 12/20/2011  
**Site Name & Location:** Lovers Lane Site, Kent County, Michigan.  
**Subject:** View of Test Pit #1 after backfills.

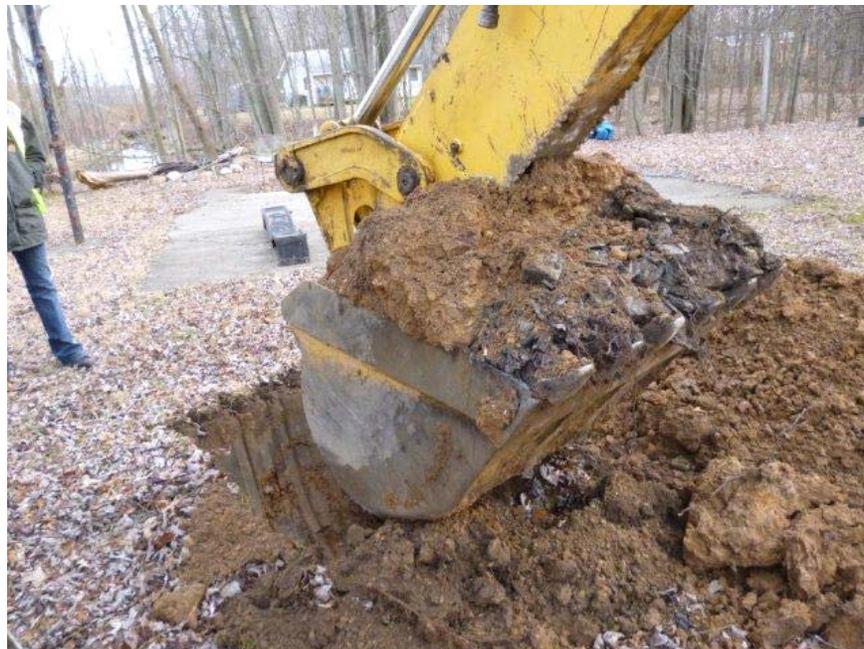
Test Pit #2 was excavated on the north side the house. Broken battery casings were observed between one and five feet bgs. No water was encountered during excavation in the second Test Pit. A composite soil sample, LL-SB-002, was collected from the soil excavated from Test Pit #2. START also collected the second aliquot of soil for waste characterization analysis.

**Photograph No.:** 6      **Photographer:** Naren Babu      **Orientation:** Northeast  
**TDD Number:** TO-01-11-11-0028      **Contract:** EP-S5-10-10, OTIE      **Date:** 12/20/2011  
**Site Name & Location:** Lovers Lane Site, Kent County, Michigan.  
**Subject:** View of broken lead-acid battery casings and soil in the bucket excavated from Test Pit #2.

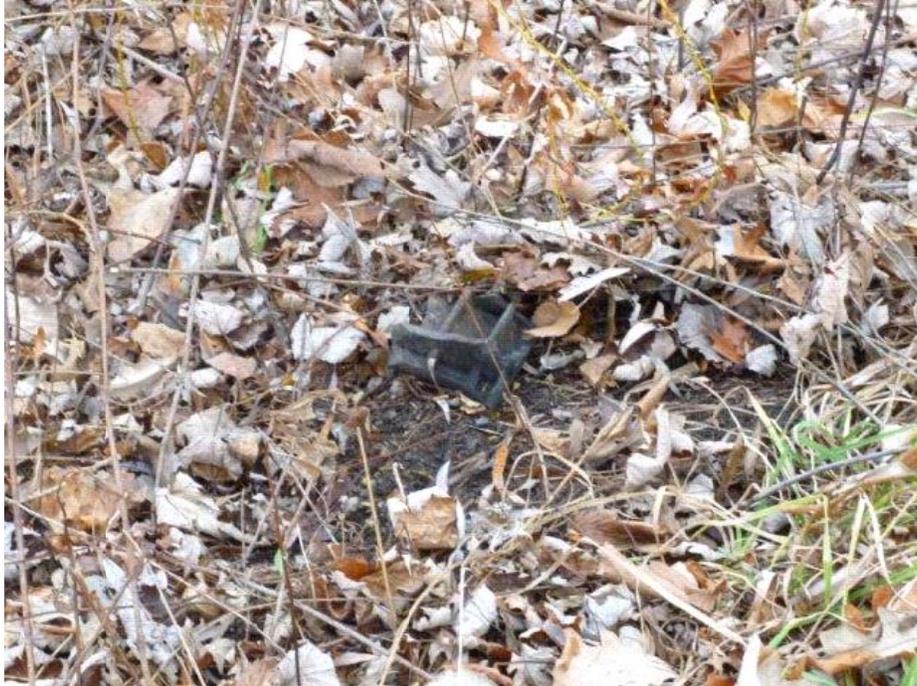
During the Site Assessment, broken pieces of lead battery casings were spotted on the top surface of the yard at several locations all around the property. Layers of lead battery casings were found at 1-foot to 5-foot bgs in three of the four test pit locations. Total metals analytical results of five surface soil samples collected during the site assessment exceeded the MDEQ Part 201 residential DCC of 400 mg/Kg for lead. TCLP metals analytical results of seven surface and subsurface soil samples collected during the SA exceeded the federal TCLP hazardous characteristic limit of 5 mg/L for lead. A sample of the water infiltrated into one of the test pits was reported with 5,700 µg/L lead.

**Photograph No.:** 7                      **Photographer:** Naren Babu                      **Orientation:** Downward  
**TDD Number:** TO-01-11-11-0028   **Contract:** EP-S5-10-10, OTIE                      **Date:** 12/20/2011  
**Site Name & Location:** Lovers Lane Site, Kent County, Michigan.  
**Subject:** Plastic lead-acid battery casing found on top of soil throughout site.

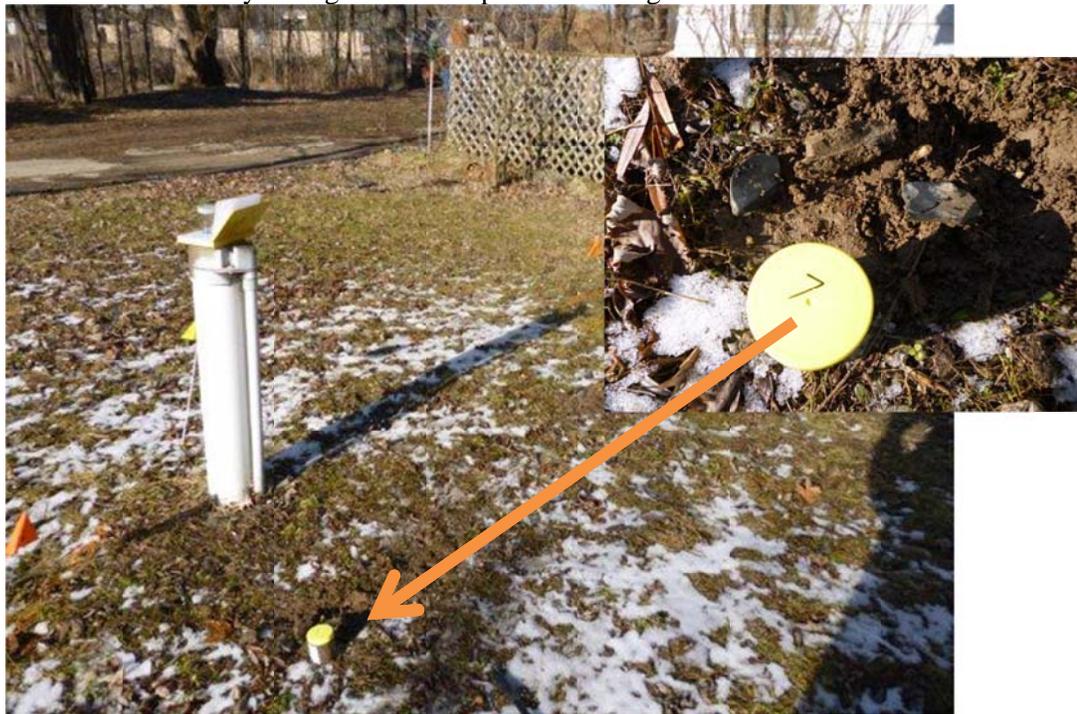
The total lead analytical results exceeded the MDEQ Part 201 residential DCC for four surface soil samples. Surface soil samples LL-SS-007, LL-21, LL-22, and LL-24 exceeded the MDEQ Part 201 residential DCC of 400 mg/Kg for lead with reported values of 640 mg/Kg, 1,000 mg/Kg, 7,100 mg/Kg, and 3,600 mg/Kg, respectively.

**Photograph No.:** 8                      **Photographer:** Naren Babu                      **Orientation:** North  
**TDD Number:** TO-01-11-11-0028   **Contract:** EP-S5-10-10, OTIE                      **Date:** 01/05/2012  
**Site Name & Location:** Lovers Lane Site, Kent County, Michigan.  
**Subject:** Soil Sample LL-SS-007 collected southeast of the well in front of the house.

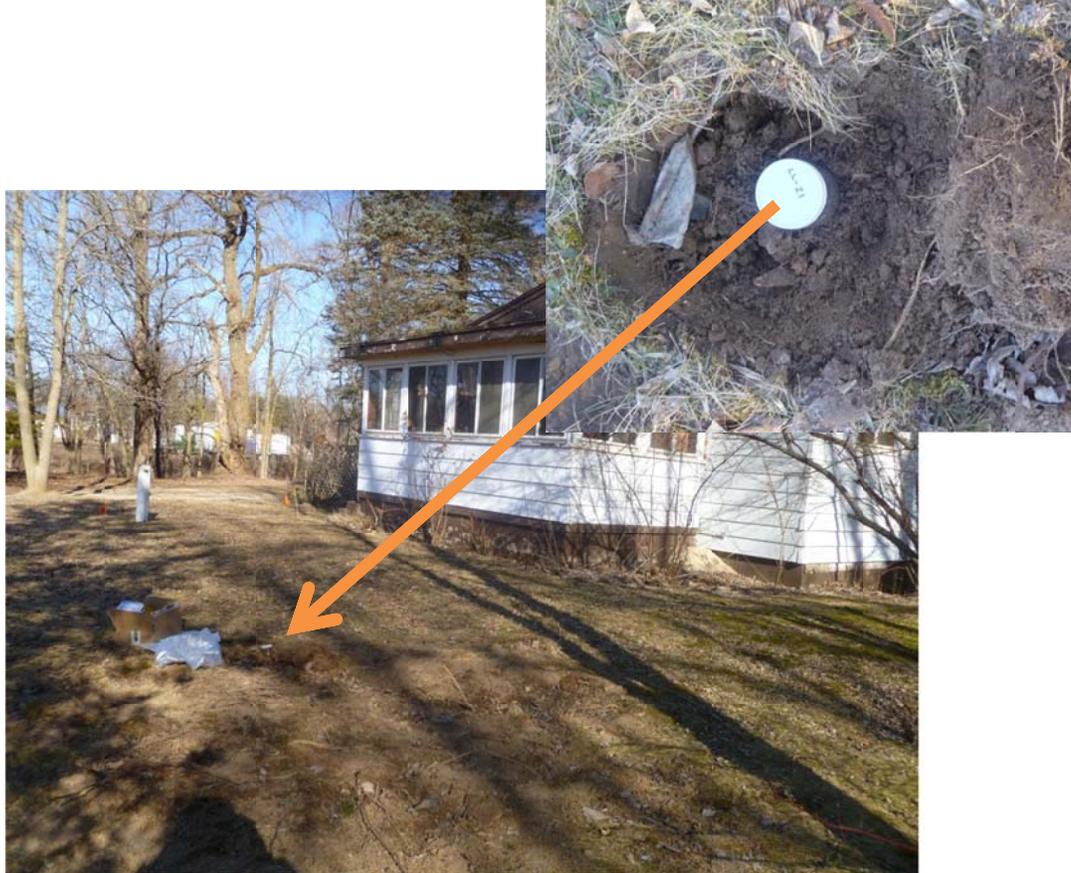
**Photograph No.:** 9      **Photographer:** Carly Schulz      **Orientation:** North  
**TDD Number:** TO-01-11-11-0028      **Contract:** EP-S5-10-10, OTIE      **Date:** 02/09/2012  
**Site Name & Location:** Lovers Lane Site, Kent County, Michigan.  
**Subject:** Surface soil sample LL-21 collected southwest of the house near Lovers Lane Street NE.

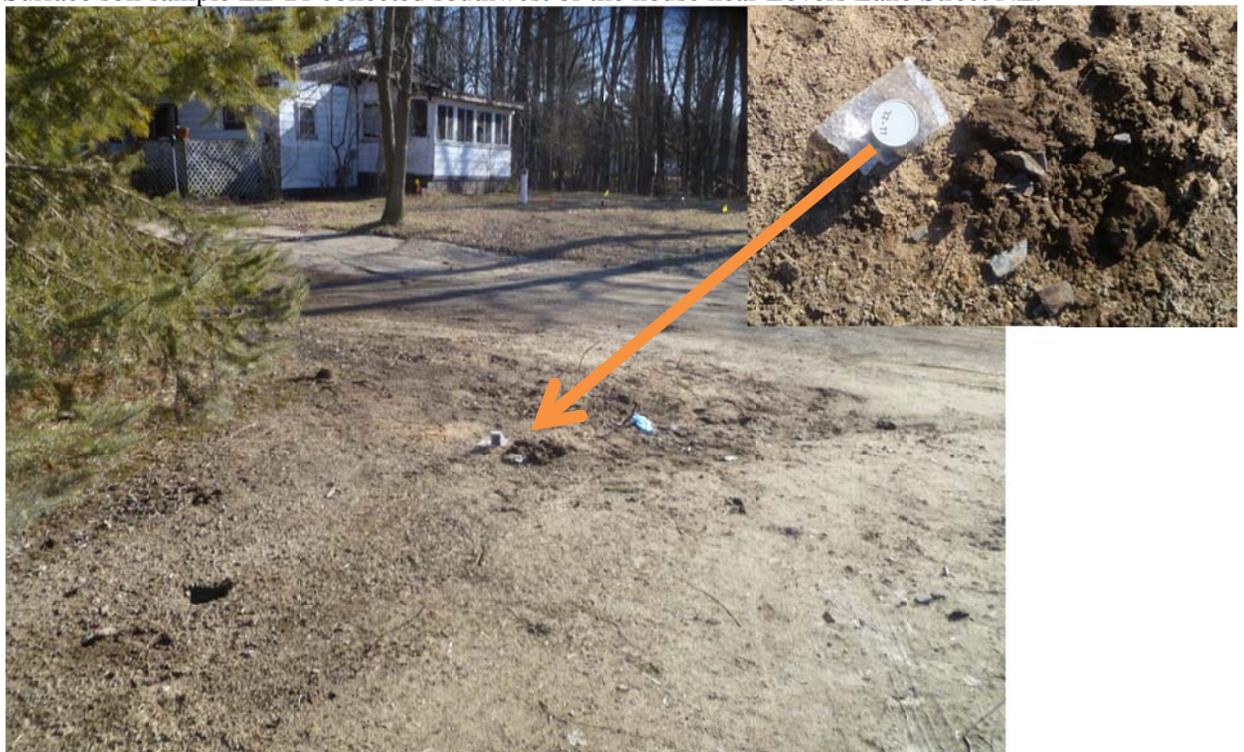
**Photograph No.:** 10      **Photographer:** Carly Schulz      **Orientation:** East  
**TDD Number:** TO-01-11-11-0028      **Contract:** EP-S5-10-10, OTIE      **Date:** 02/09/2012  
**Site Name & Location:** Lovers Lane Site, Kent County, Michigan.  
**Subject:** Surface soil sample LL-22 collected in front of house northwest of the driveway.
