**Subject: Removal Action Oversight Letter Report
Vermiculite Exfoliation GAO 144 PRP Removal
Atlanta, DeKalb County, Georgia
Contract No.: EP-W-05-054
TDD No.: TTEMI-05-001-0156**

ENCLOSURE 3
PHOTOGRAPHIC LOG
(41 Pages)

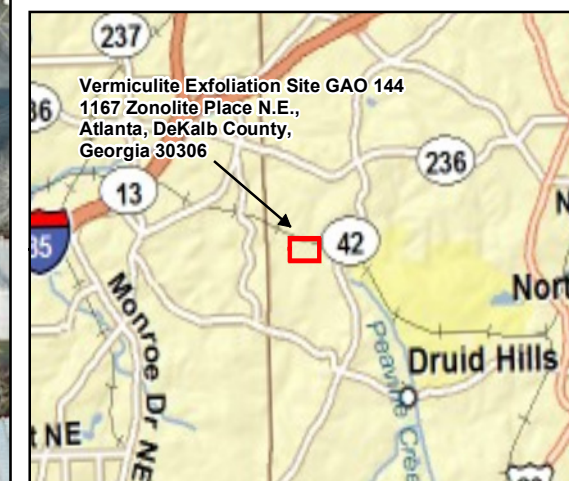
**FIGURE 2
SITE LAYOUT**

The GAO 144 site is located at 1167 Zonolite Place NE, in Atlanta, DeKalb County, Georgia (see Enclosure 1, Figure 1). The geographic coordinates for the site are latitude 33.8053 degrees north and longitude 84.3422 degrees west. The GAO 144 site is located about four miles northeast of downtown Atlanta, Georgia, in a developed urban area of mixed light-industrial, commercial, and residential use. The site occupies about 16 acres, some or all of which were the former location of a vermiculite exfoliation (expansion) plant. The GAO 144 site is bordered to the south by Dalon Road, a landscape services and garden business, and the south fork of Peachtree Creek. To the west of the GAO 144 site is the creek and several residences. The GAO 144 site is bordered to the north by railroad tracks and a complex containing numerous commercial and light industrial businesses. The eastern portion of the GAO 144 site is occupied by the Atlanta Soto Zen Center; beyond the Zen Center lie additional light industrial and commercial businesses. Residential communities are located to the south beyond the south fork of Peachtree Creek, to the west, and to the north beyond the railroad tracks. Enclosure 1, Figures 1 and 2 show the site location and general site layout.

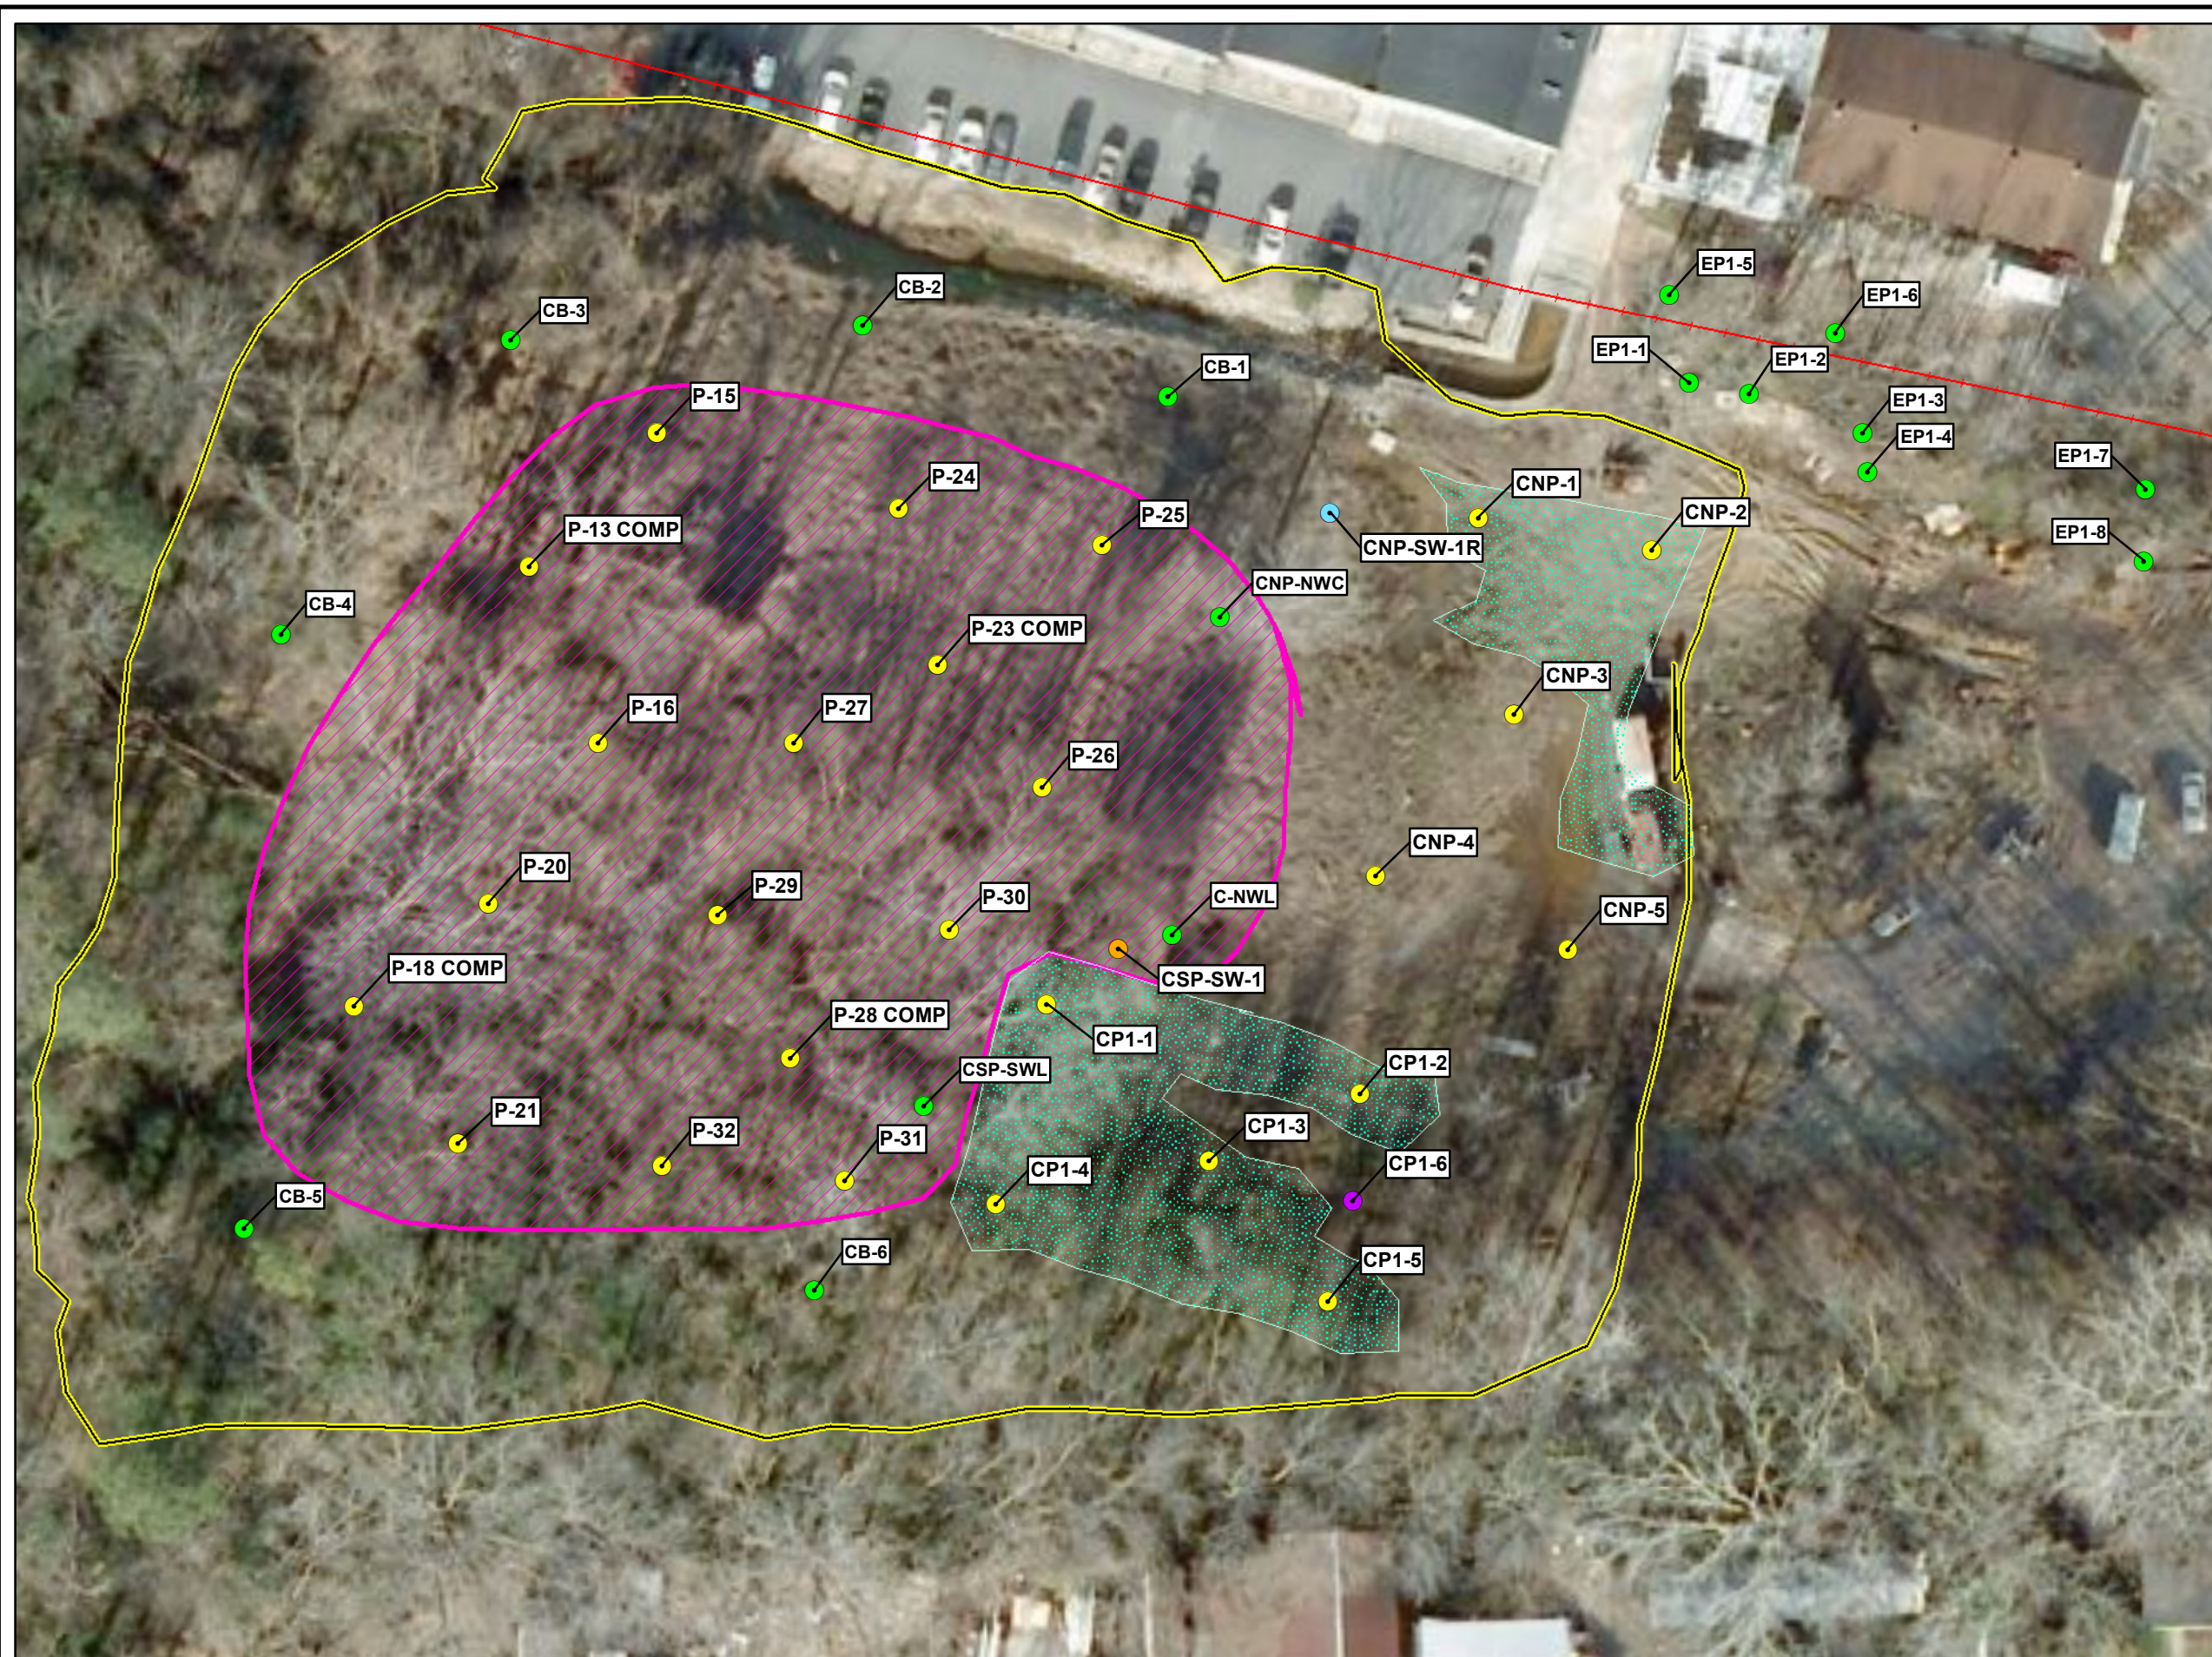
**FIGURE 3
BULK SAMPLING
LOCATIONS**

Tetra Tech START, URS, and One Group collected several bulk composite and bulk grab samples during removal activities. These samples were used to assess the extent of contamination, further characterize the site and provide confirmation of ACM removal following excavation activities. Enclosure 1, Figure 3 illustrates the sample locations and Enclosure 2, Table 1 list the sample results.

- Bulk Grab Sample (Grace)
- Bulk Composite Sample (EPA/Grace Split)
- Bulk Grab Sample (EPA/Grace Colocated)
- Bulk Grab Sample (EPA/Grace Split)
** After excavation by Winter contractors, Tetra Tech START & URS split a bulk soil sidewall sample, CNP-SW-1R results were below site specific action limit of 0.25% Asbestos
- Bulk Grab Sample (EPA/Grace Split)
- Concrete Pad
- Excavation Pit
- Final Excavation Extent and Exclusion Zone
- Approximate location of former railroad spur (eastern extent is unknown)

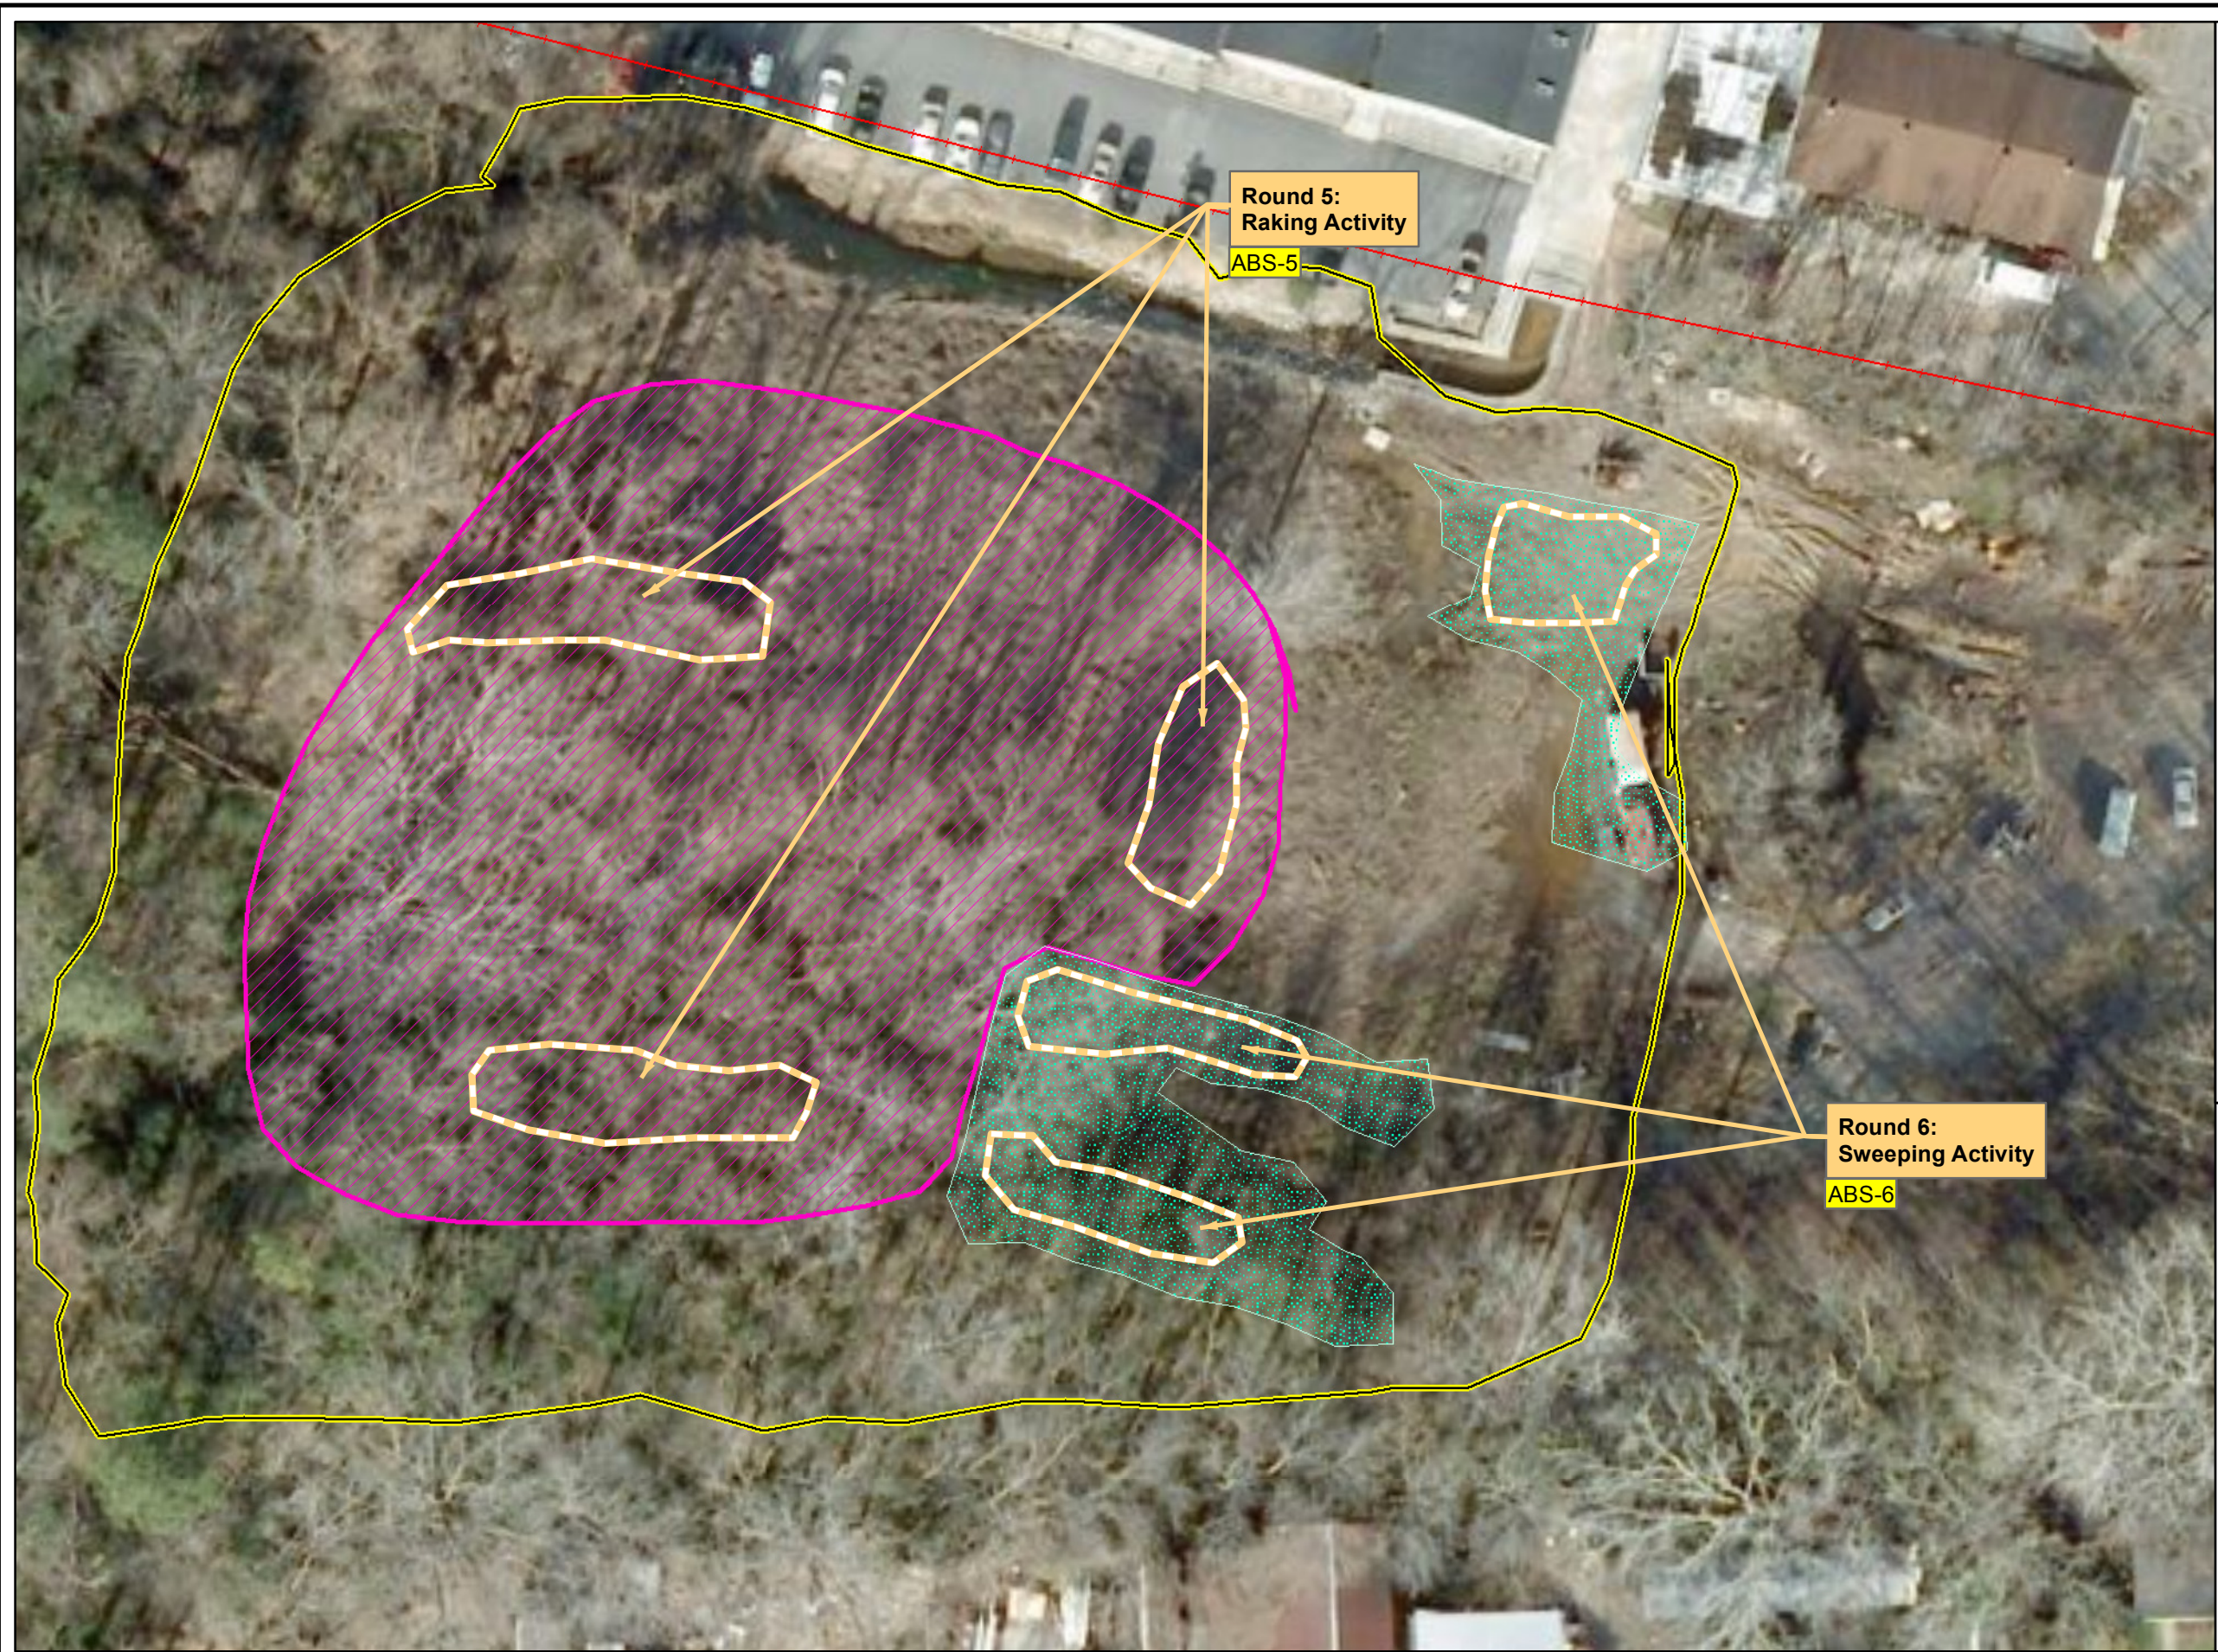
**FIGURE 4
ACTIVITY BASED
SAMPLING**

The site was segregated into two distinct removal areas, including the excavation pit area and the concrete pad area (see Enclosure 1, Figure 4).

- Activity Areas
- Concrete Pad
- Excavation Pit
- Final Excavation Extent and Exclusion Zone
- Approximate location of former railroad spur (eastern extent is unknown)

- On February 6, 2012, after ACM removal activities in the excavation pit, One Group personnel conducted ABS air sampling simulating a raking activity inside the boundaries of the excavation pit using three personnel. The excavation pit was divided into three smaller areas because of ground water intrusion which caused some areas of the excavation pit to be inaccessible. Each ABS participant worked in a specific area for 40 minutes and then switched with another participant, who was working in an adjacent area. This sequence was repeated three time until the entire 120 minute ABS event was completed. Each person carried a 3-liter per minute pump and a 10-liter per minute pump, each affixed with a 25-millimeter, 0.8-micron mixed cellulose ester (MCE) filter cassette. In addition, each One Group representative carried an extra set of pumps, including one duplicate set supplied by Tetra Tech START for the collection of a co-located high and low volume air sample set. Analytical results obtained by W.R. Grace from MAS indicated that asbestos was not detected at concentrations above the action level of 0.02 f/cc for any of the samples collected. Analytical results from Batta indicated that asbestos was not detected (see Enclosure 2, Table 2).

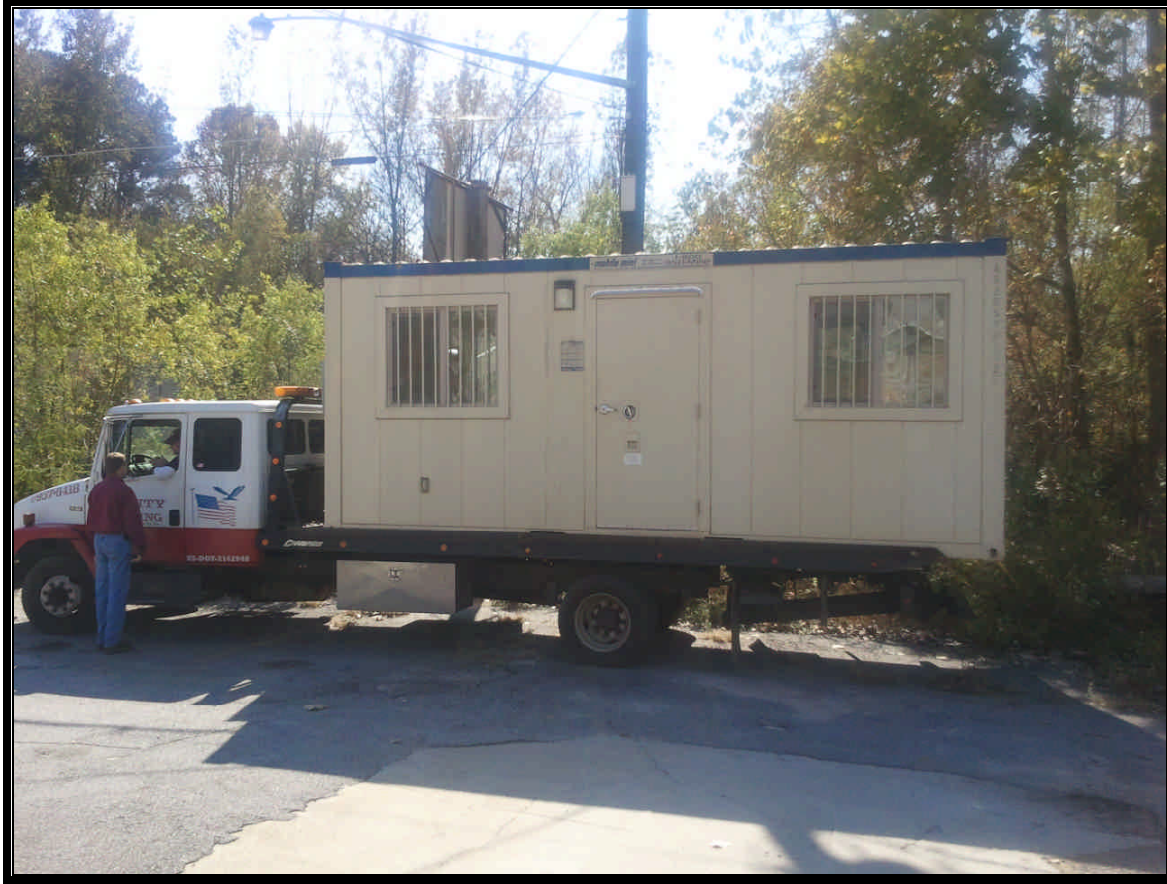
OFFICIAL PHOTOGRAPH NO. 1
U.S. ENVIRONMENTAL PROTECTION AGENCY

Subject: A mobile mini office trailer was procured and delivered to the site by Grace contractor Winter Environmental.

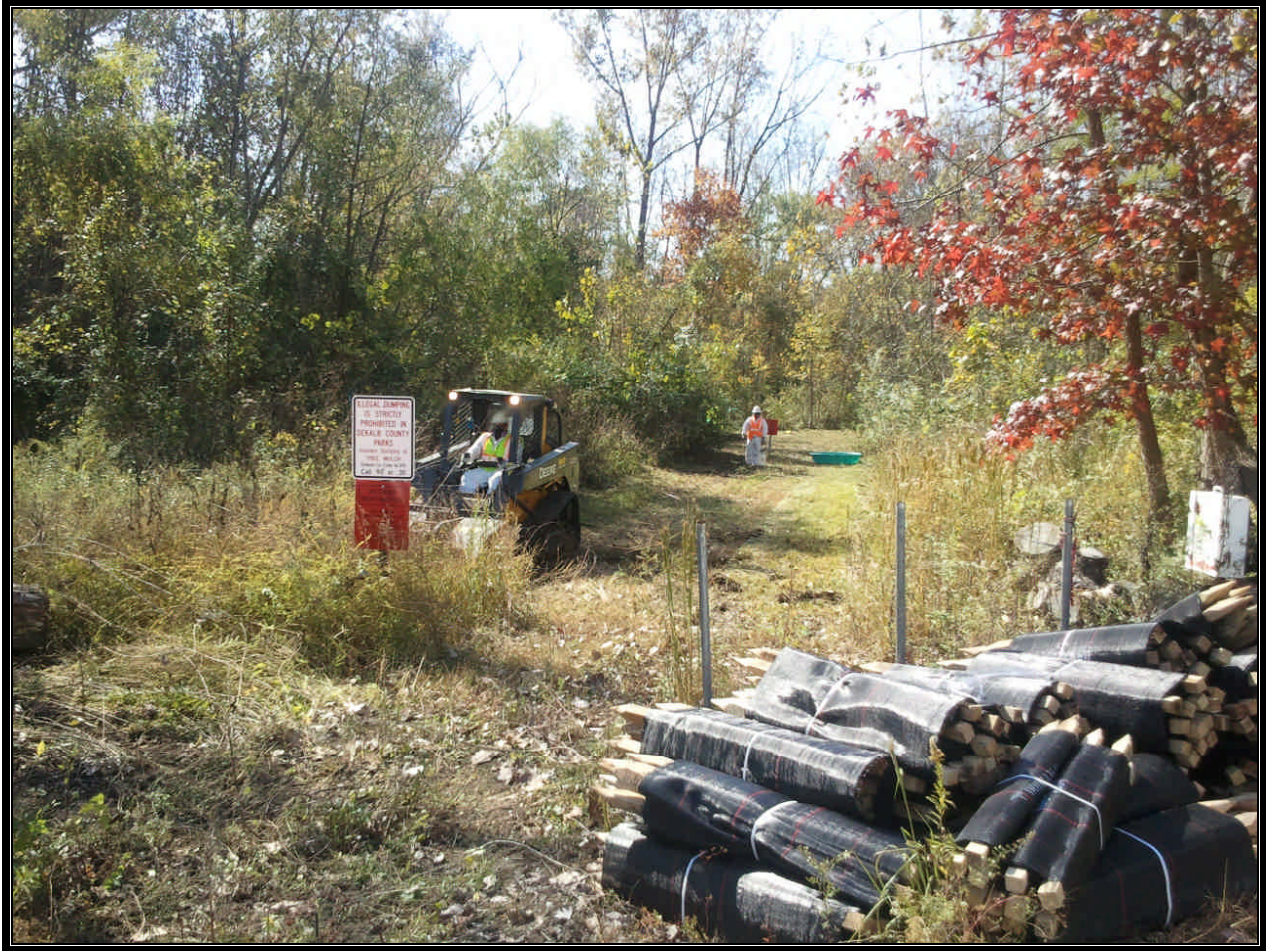
OFFICIAL PHOTOGRAPH NO. 2
U.S. ENVIRONMENTAL PROTECTION AGENCY

Subject: Silt fencing was delivered to the site and Winter environmental began brush-cutting the entrance road to the site.

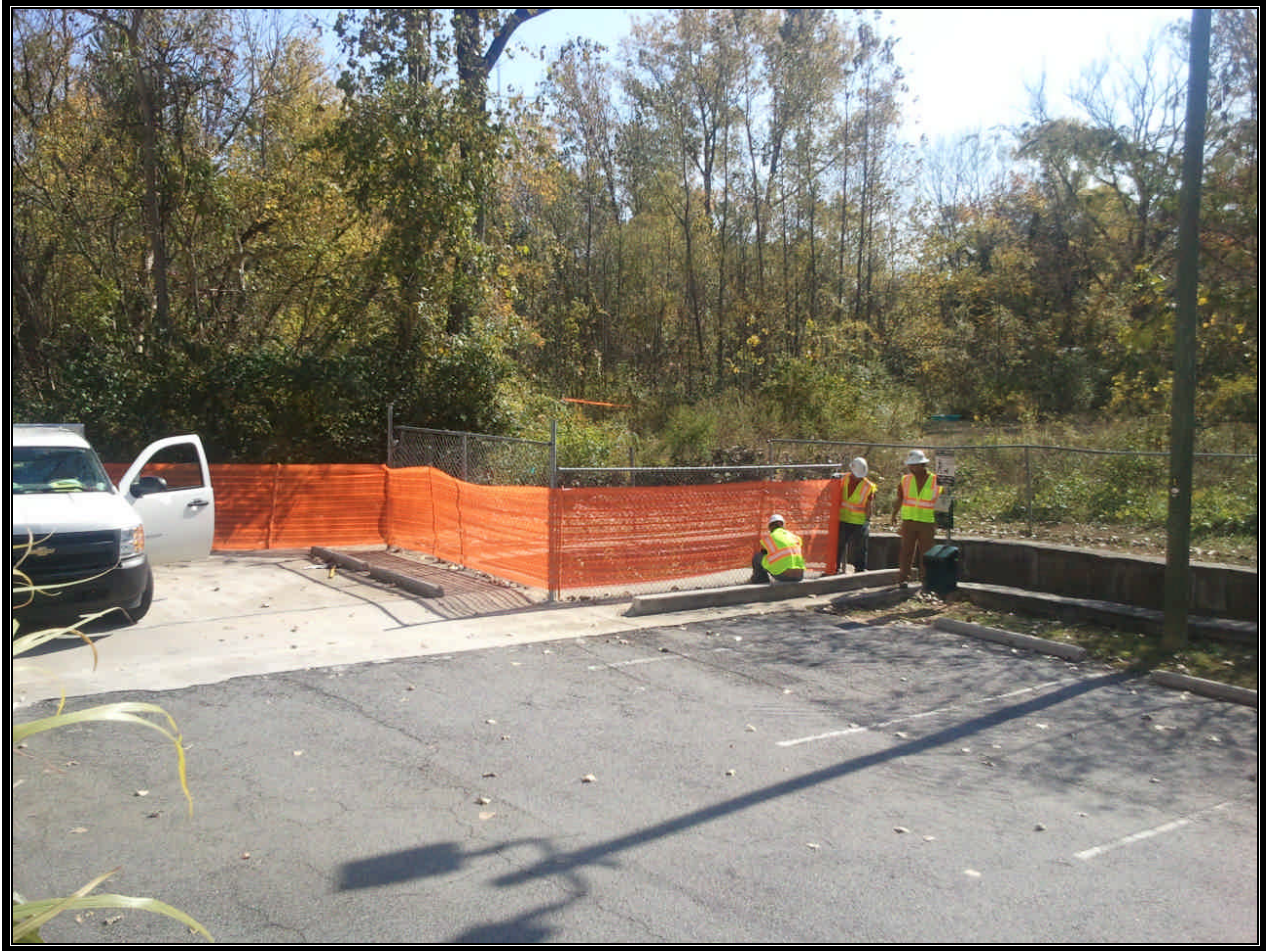
OFFICIAL PHOTOGRAPH NO. 3
U.S. ENVIRONMENTAL PROTECTION AGENCY

Subject: Winter contractors began installation of silt fencing along the northern perimeter of the site.

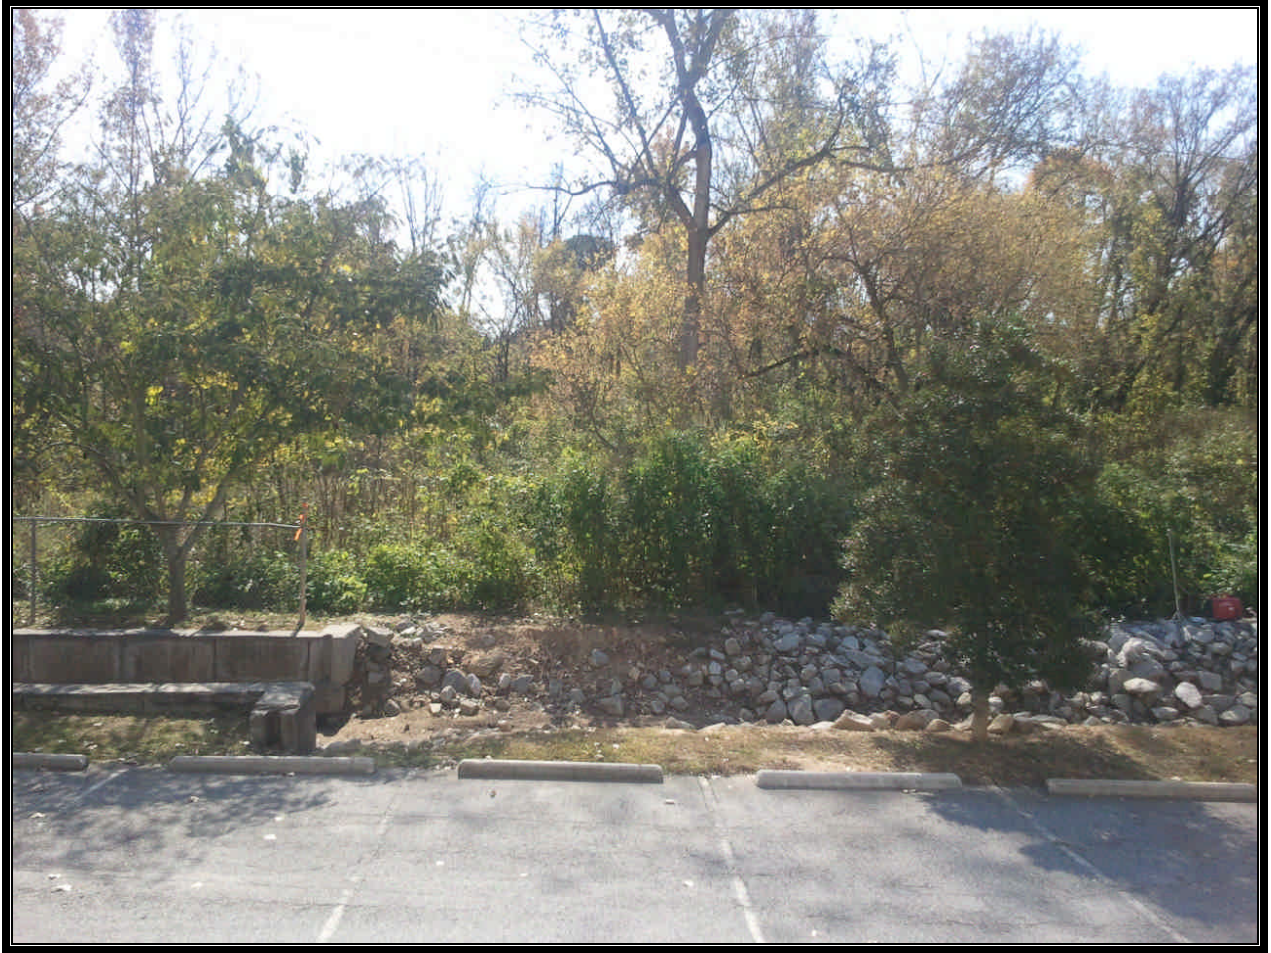
OFFICIAL PHOTOGRAPH NO. 4
U.S. ENVIRONMENTAL PROTECTION AGENCY

Subject: The overgrown foliage and trees will be removed from the north-eastern portion of the site as needed.

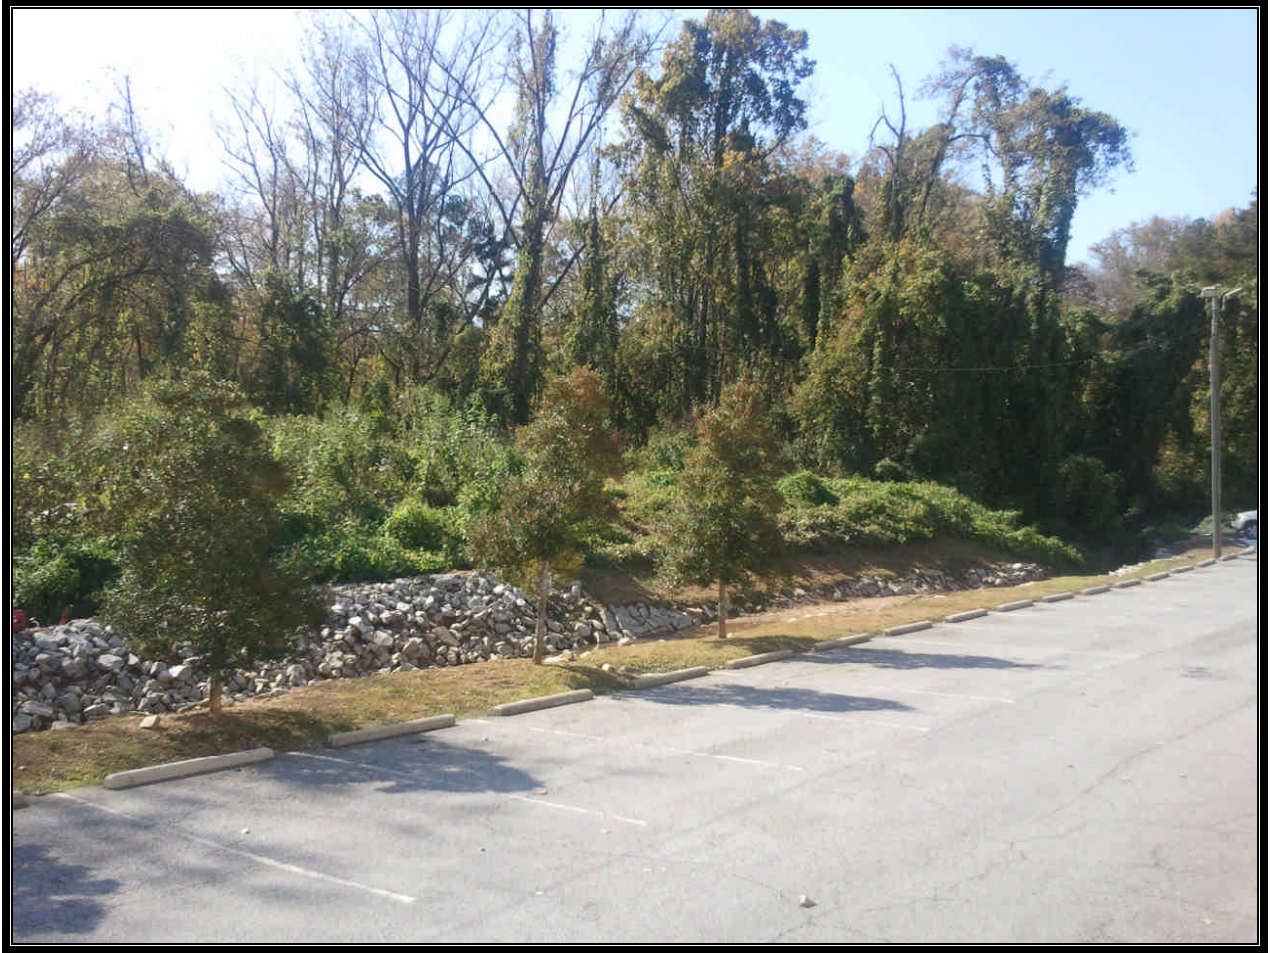
OFFICIAL PHOTOGRAPH NO. 5
U.S. ENVIRONMENTAL PROTECTION AGENCY

Subject: The overgrown foliage and trees will be removed from the north-western portion of the site as needed.

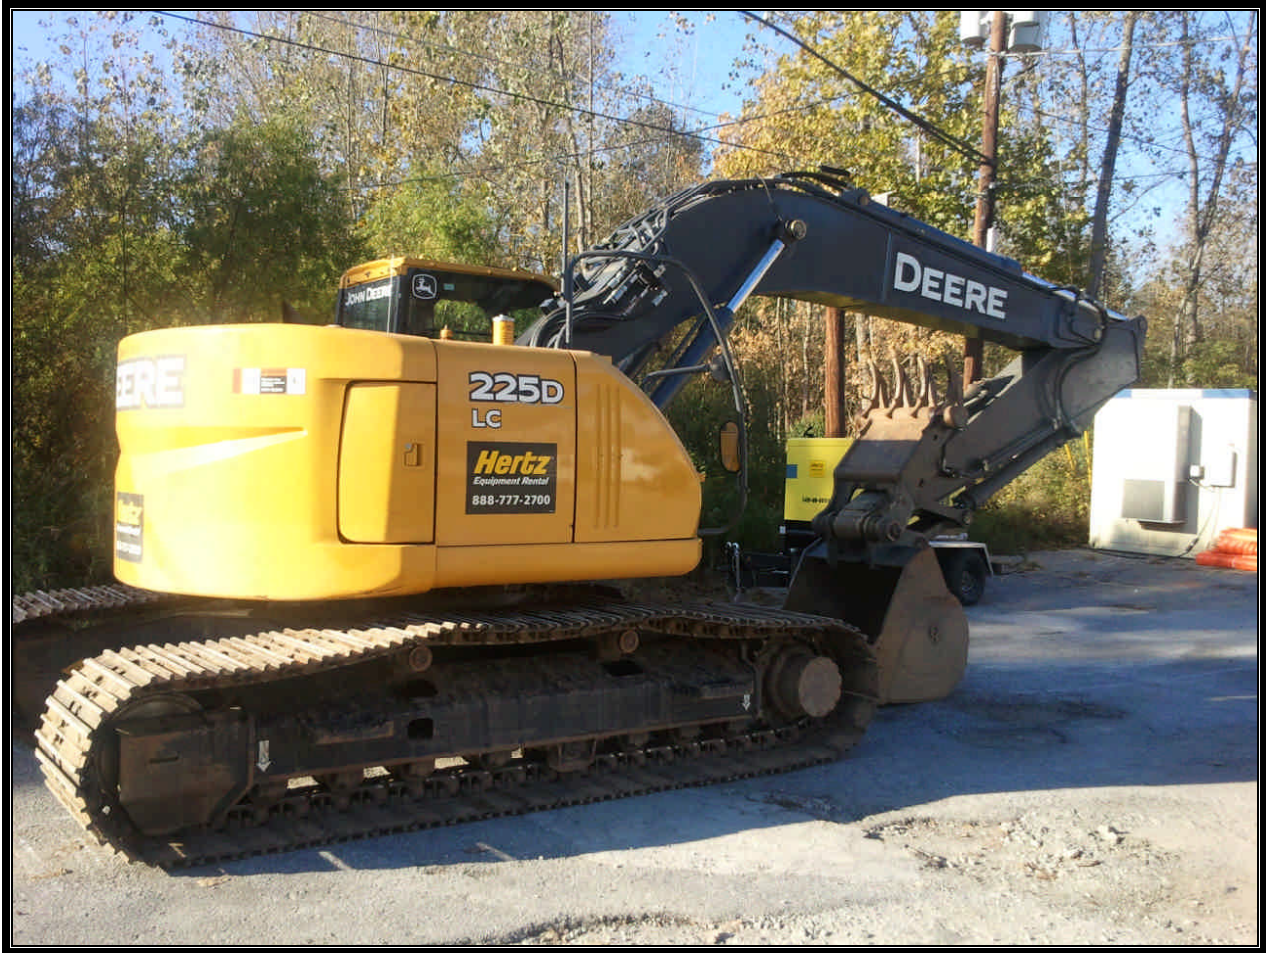
OFFICIAL PHOTOGRAPH NO. 6
U.S. ENVIRONMENTAL PROTECTION AGENCY

Subject: An excavator was delivered to the site to perform asbestos-containing material (ACM) removal.

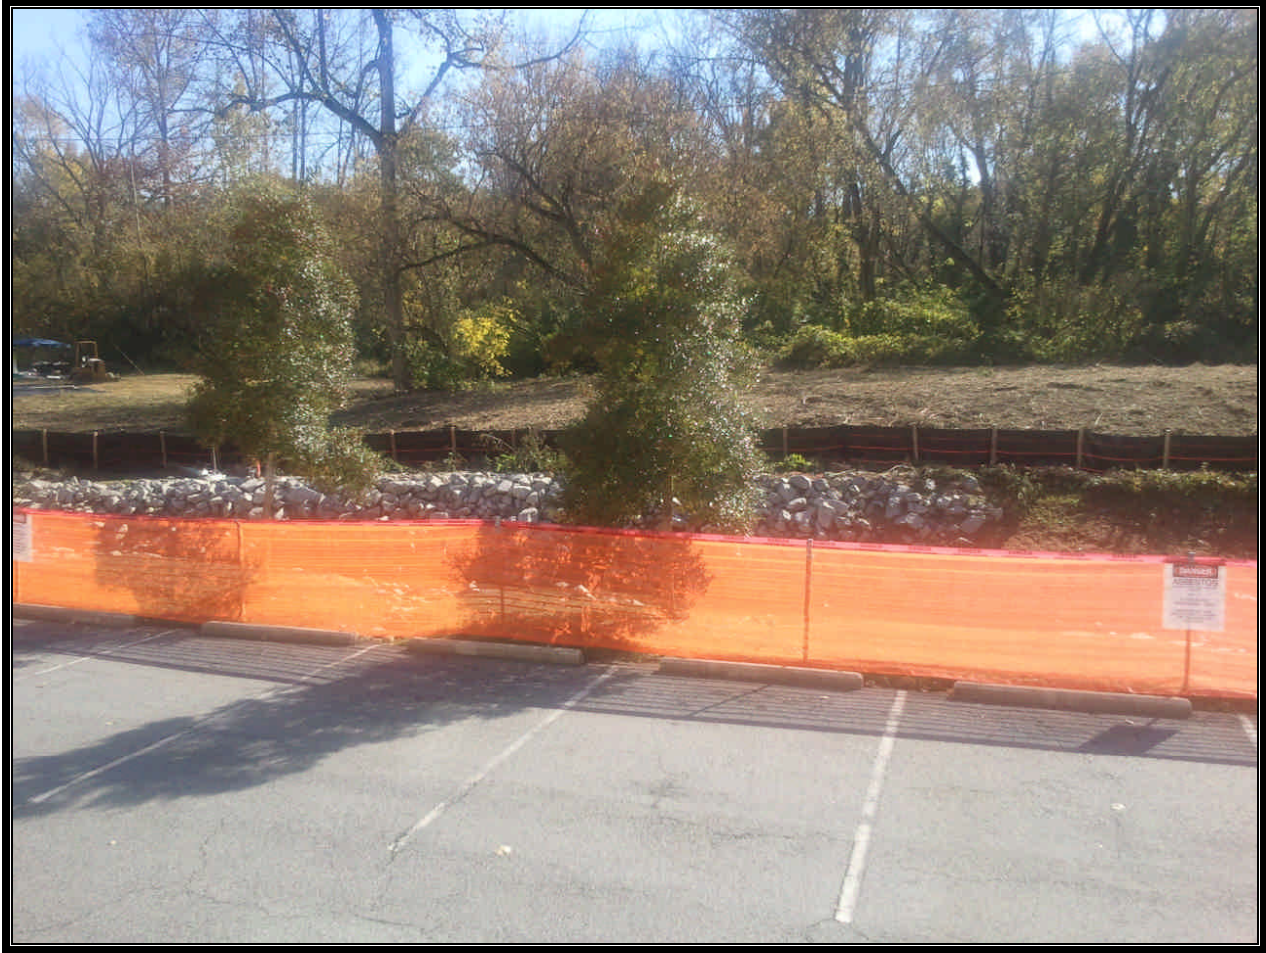
OFFICIAL PHOTOGRAPH NO. 7
U.S. ENVIRONMENTAL PROTECTION AGENCY

Subject: Silt fencing, orange security fencing, and "Warning" signage was placed along the northern perimeter of the site. Initial brush-cutting and foliage removal was performed on the center and north-eastern portions of the site.

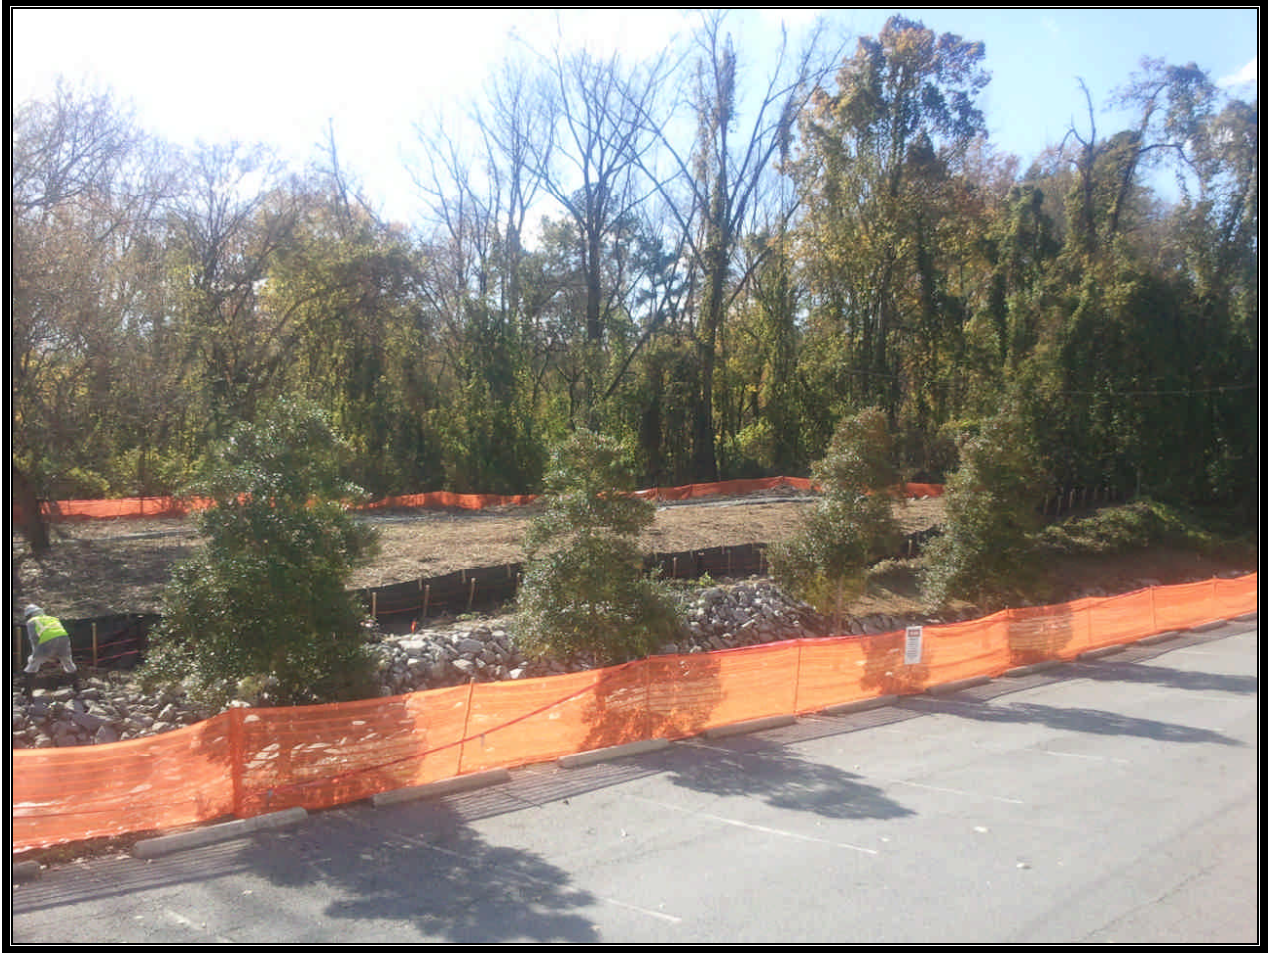
OFFICIAL PHOTOGRAPH NO. 8
U.S. ENVIRONMENTAL PROTECTION AGENCY

Subject: Silt fencing, orange security fencing, and "Warning" signage was placed along the northern and western perimeter of the site. Initial brush-cutting and foliage removal was performed on the north-western portion of the site.

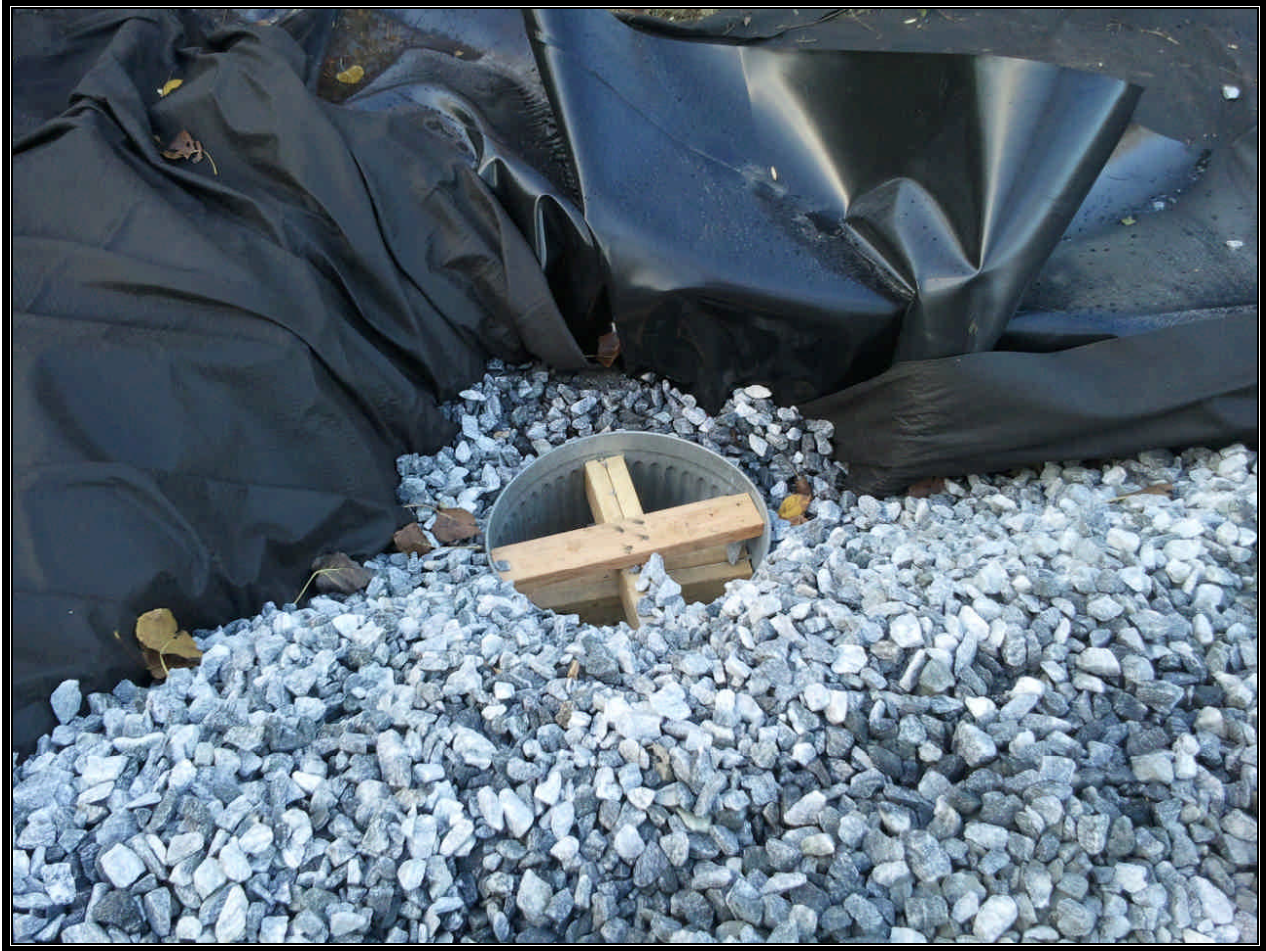
OFFICIAL PHOTOGRAPH NO. 9
U.S. ENVIRONMENTAL PROTECTION AGENCY

Subject: A decontamination sump was placed near the entrance of the contaminated area, to collect and filter ACM during truck washing; prior to exiting the site.

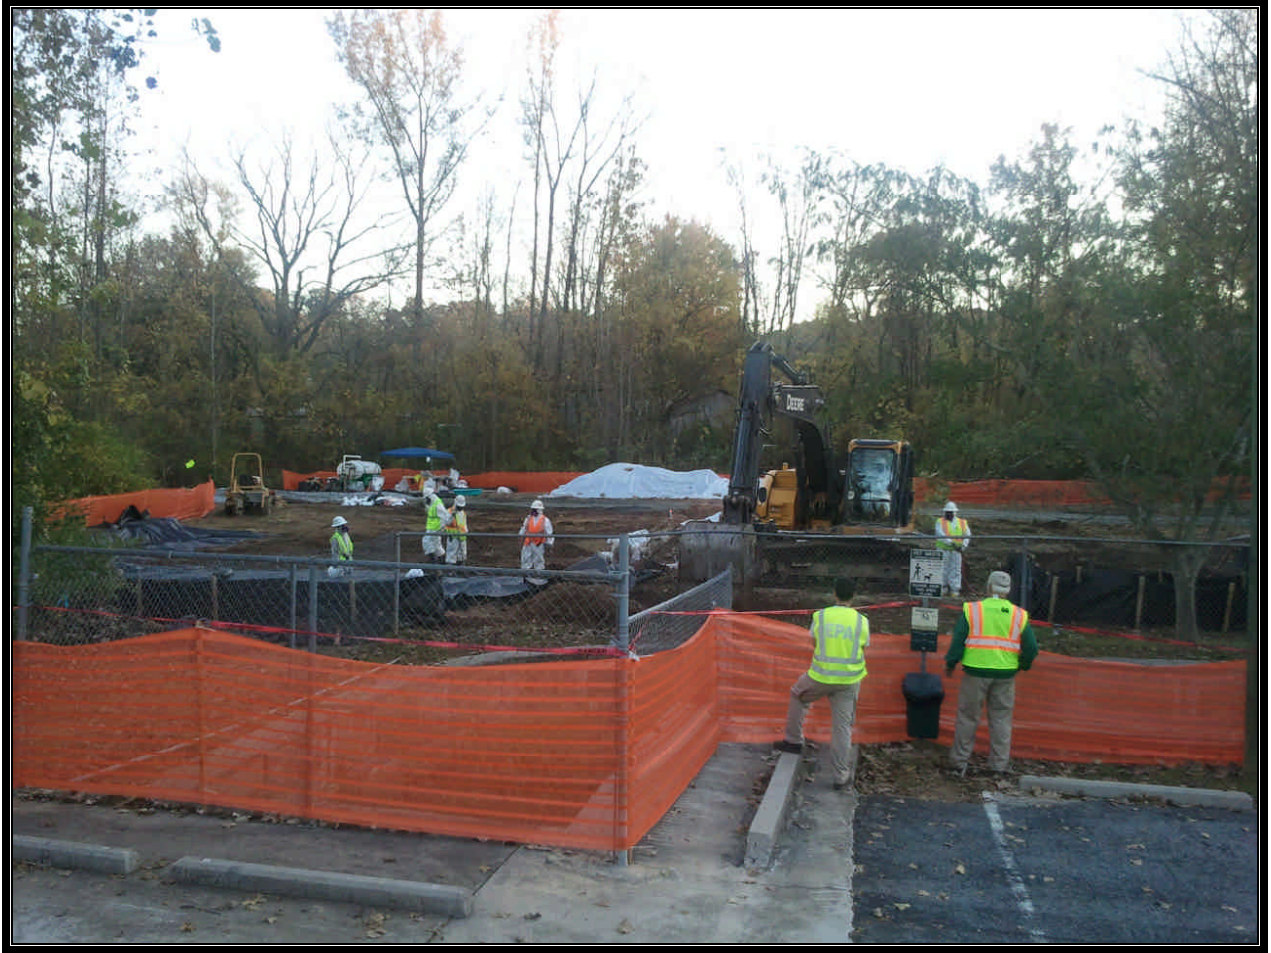
OFFICIAL PHOTOGRAPH NO. 10
U.S. ENVIRONMENTAL PROTECTION AGENCY

Subject: Winter contractors began construction of a sediment basin to collect and filter on-site storm water.

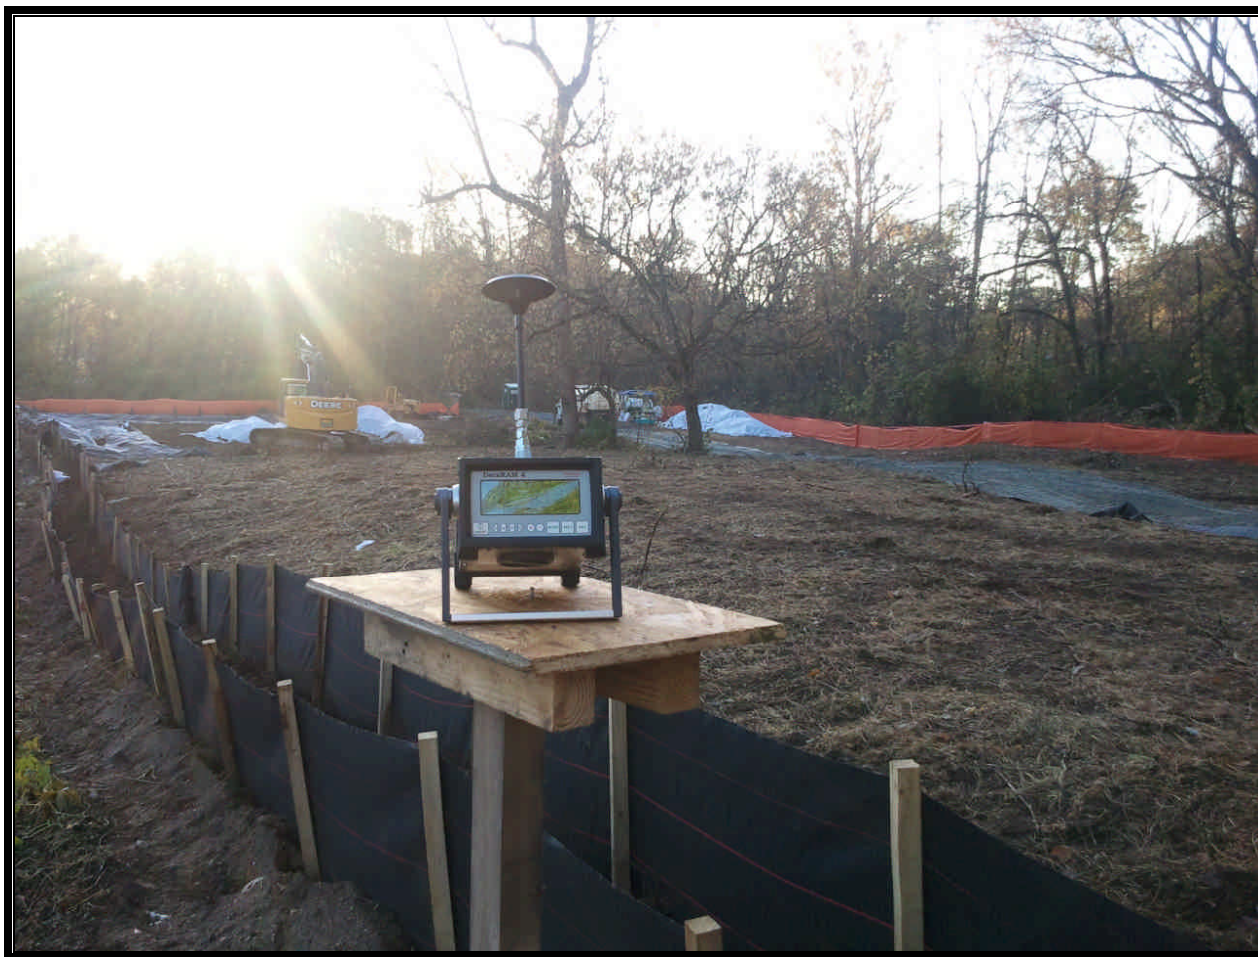
OFFICIAL PHOTOGRAPH NO. 11
U.S. ENVIRONMENTAL PROTECTION AGENCY

Subject: Tetra Tech START began using DataRam particulate monitors, placed around the perimeter of the site, to measure possible particulate migration off-site at the request of EPA.
