**Subject: Removal Action Oversight Letter Report
Vermiculite Exfoliation GAO 144 PRP Removal
Atlanta, DeKalb County, Georgia
Contract No.: EP-W-05-054
TDD No.: TTEMI-05-001-0156**

ENCLOSURE 3
PHOTOGRAPHIC LOG
(41 Pages)

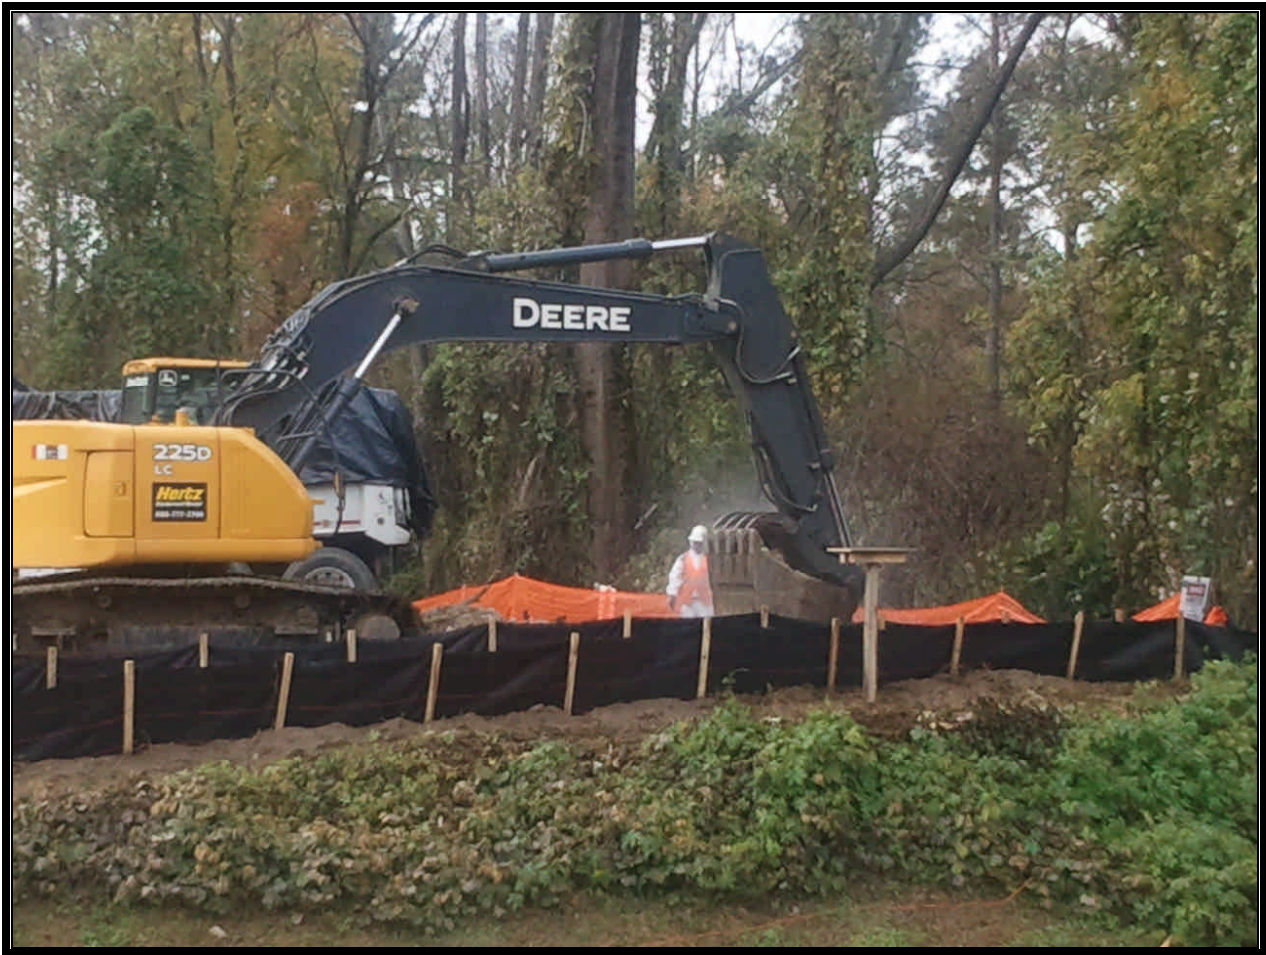
OFFICIAL PHOTOGRAPH NO. 12
U.S. ENVIRONMENTAL PROTECTION AGENCY

Subject: Winter contractors began ACM removal in the northwest corner, at the plateau's highest elevation.

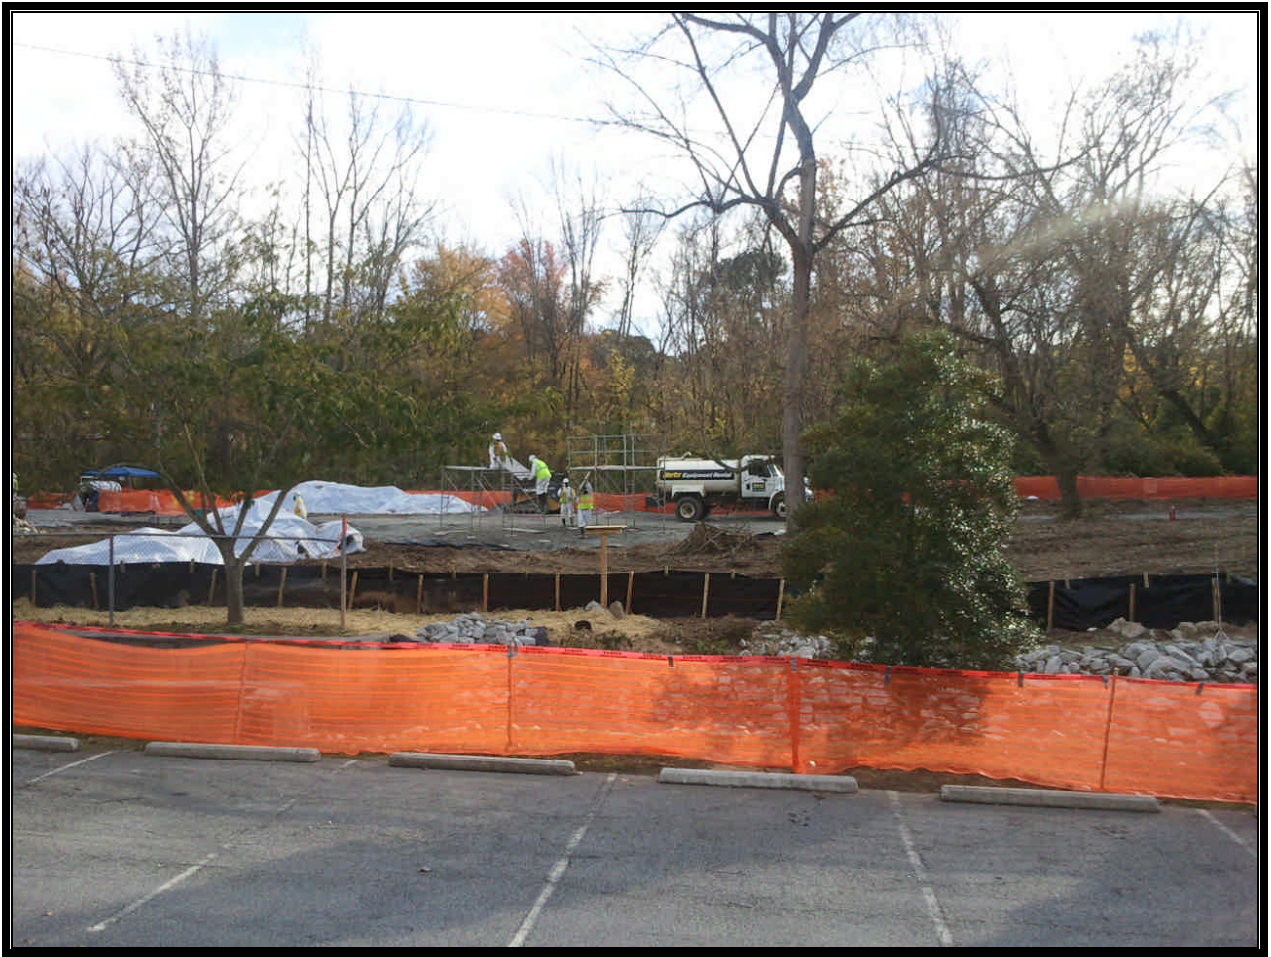
OFFICIAL PHOTOGRAPH NO. 13
U.S. ENVIRONMENTAL PROTECTION AGENCY

Subject: Based on removal work plans and recommendations by EPA, Winter construction acquired and began set-up of scaffolding to assist with lining and sealing of the dump trucks used for removal of ACM.

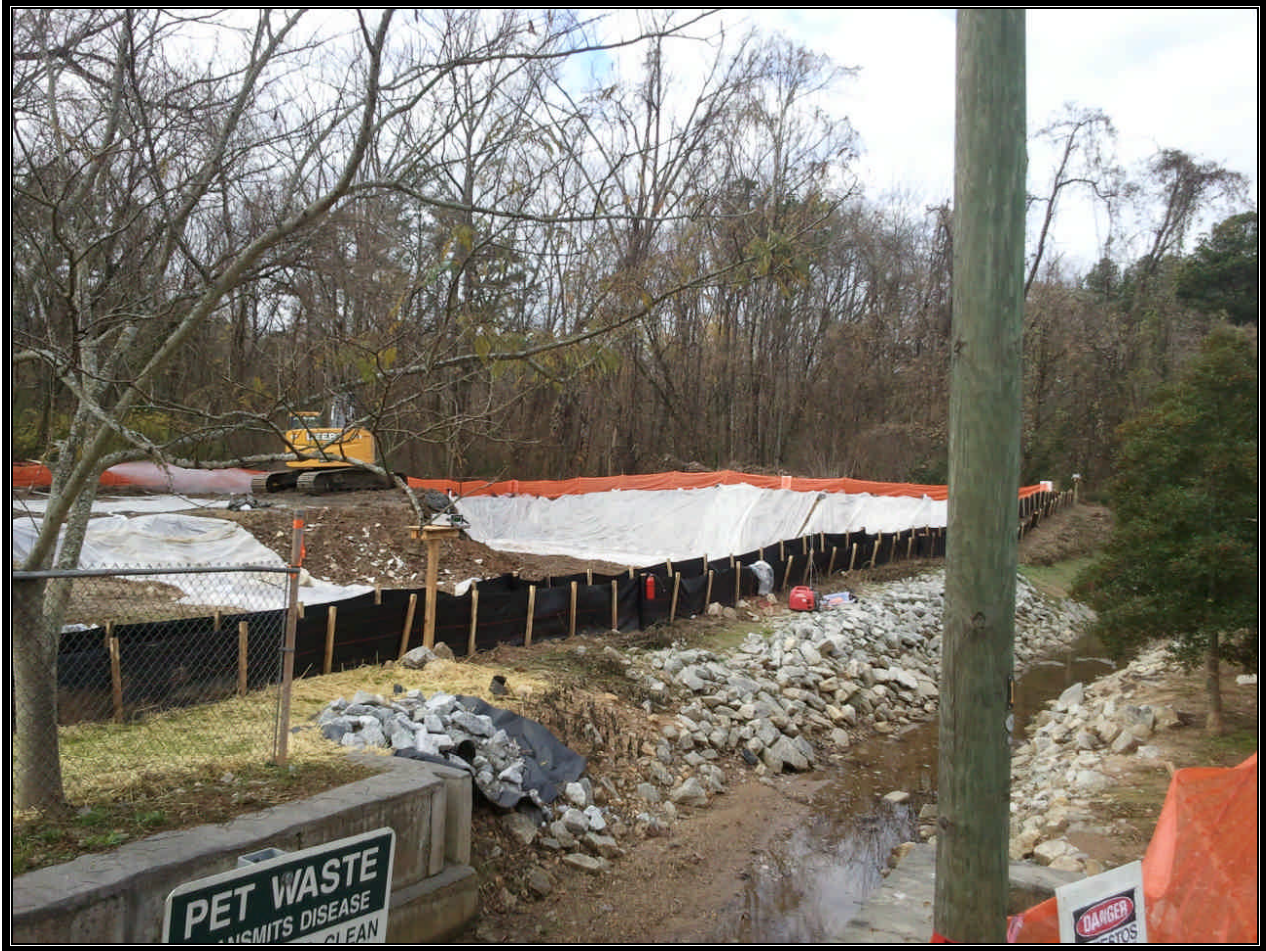
OFFICIAL PHOTOGRAPH NO. 14
U.S. ENVIRONMENTAL PROTECTION AGENCY

Subject: Winter contractors use clear polyethylene to cover excavated areas to minimize airborne particulate and dust migration off-site.

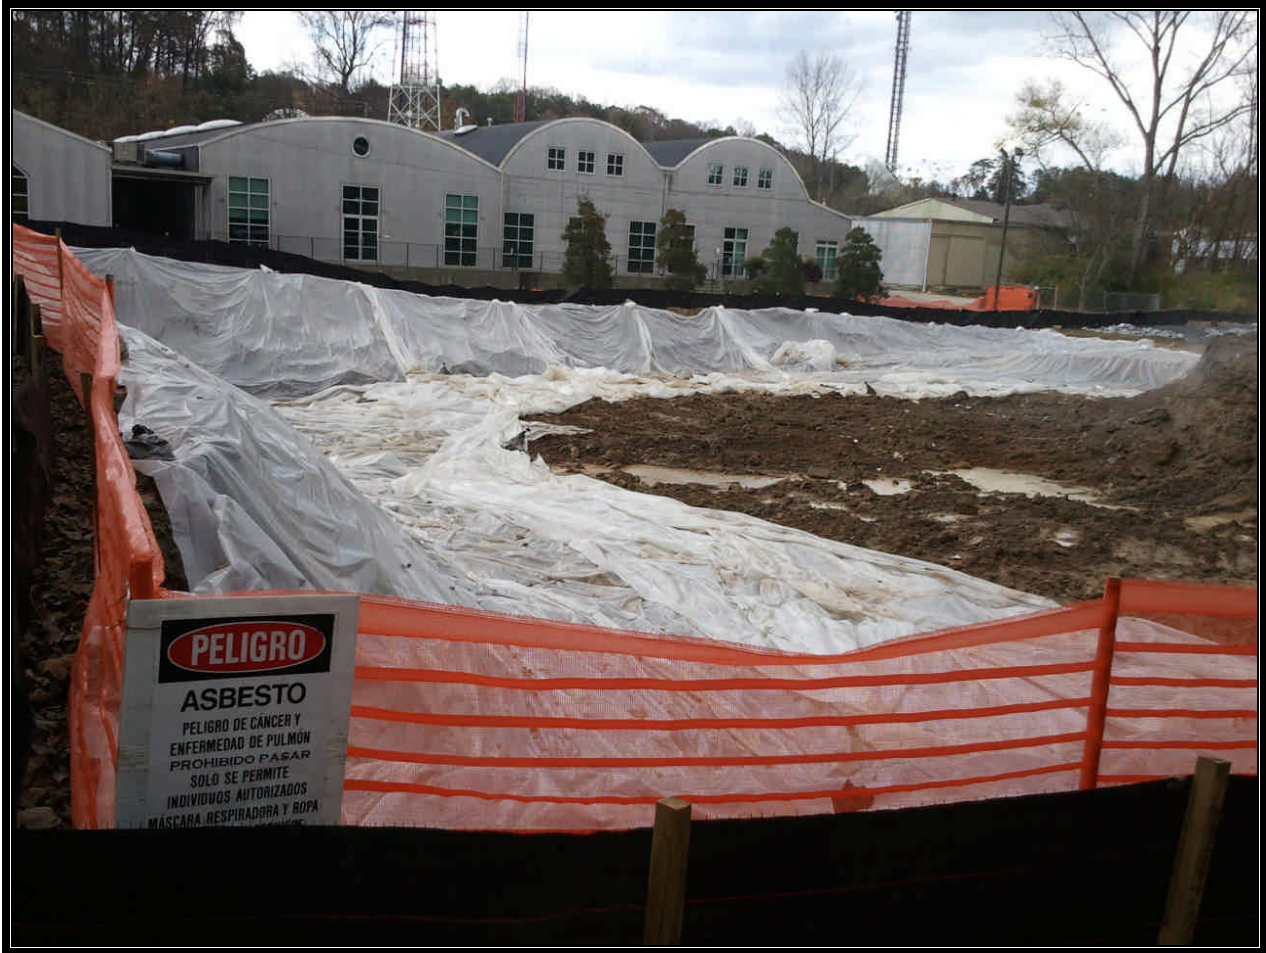
OFFICIAL PHOTOGRAPH NO. 15
U.S. ENVIRONMENTAL PROTECTION AGENCY

Subject: Winter performs excavation along the southern tree line of the existing excavation area prior to expansion of the excavated area, based on visual observations and soil sample results.

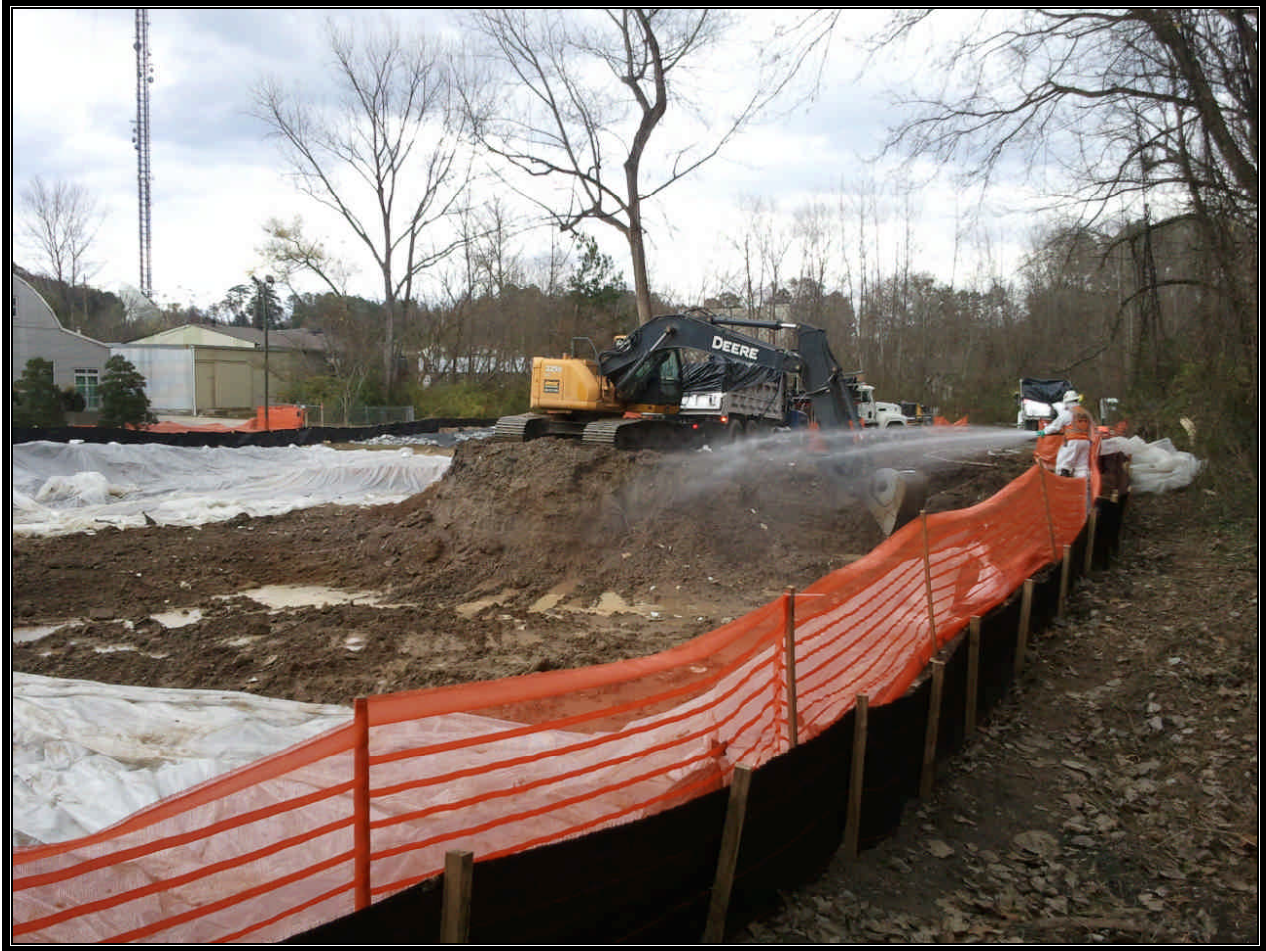
OFFICIAL PHOTOGRAPH NO. 16
U.S. ENVIRONMENTAL PROTECTION AGENCY

Subject: Winter performs excavation along the southern edge of the original designated ACM area. Dust control measures are also being conducted in and around the excavated areas.

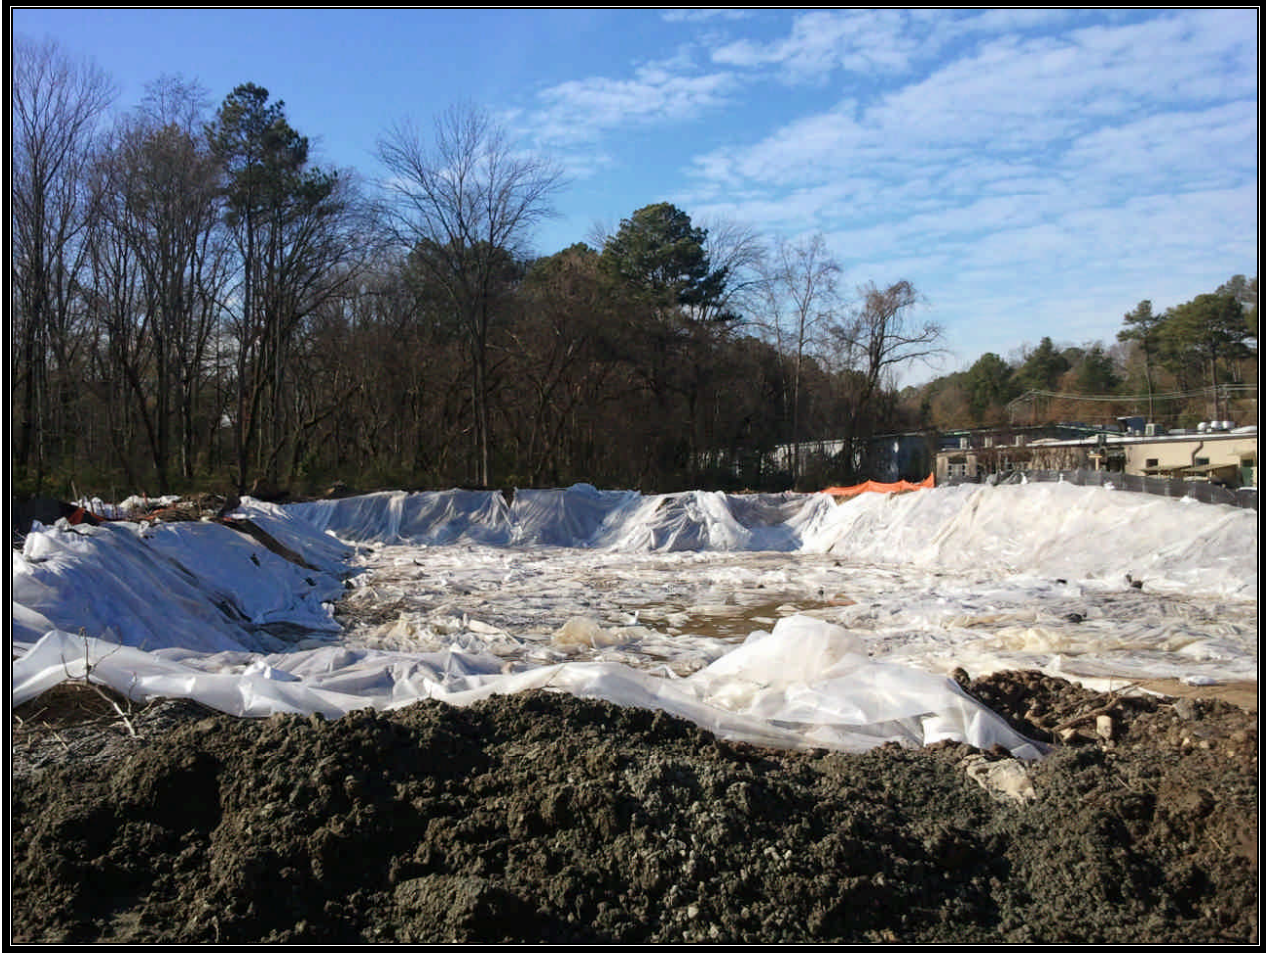
OFFICIAL PHOTOGRAPH NO. 17
U.S. ENVIRONMENTAL PROTECTION AGENCY

TDD Number:	TTEMI-05-001-0156	Location:	1167 Zonolite Place NE Atlanta, Georgia 30306
Orientation:	West	Date:	December 08, 2011
Photographer:	Leland J. Meadows	Witness:	EPA OSC Eichinger
Subject:	Original ACM area after excavation.

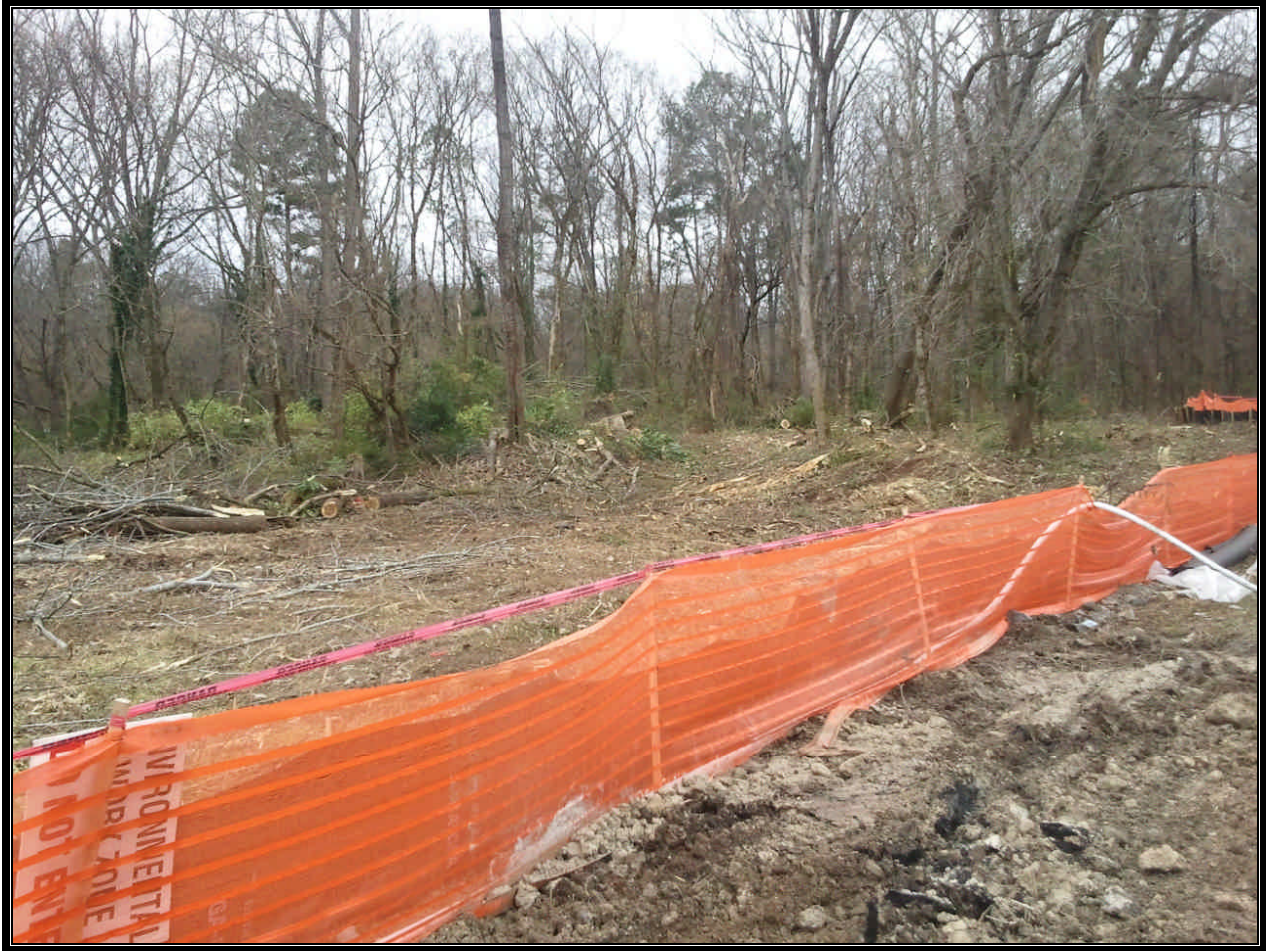
OFFICIAL PHOTOGRAPH NO. 18
U.S. ENVIRONMENTAL PROTECTION AGENCY

Subject: Based on visual observations of ACM along the western and southern drainage ditch, the site was expanded towards the western and southern property boundaries.

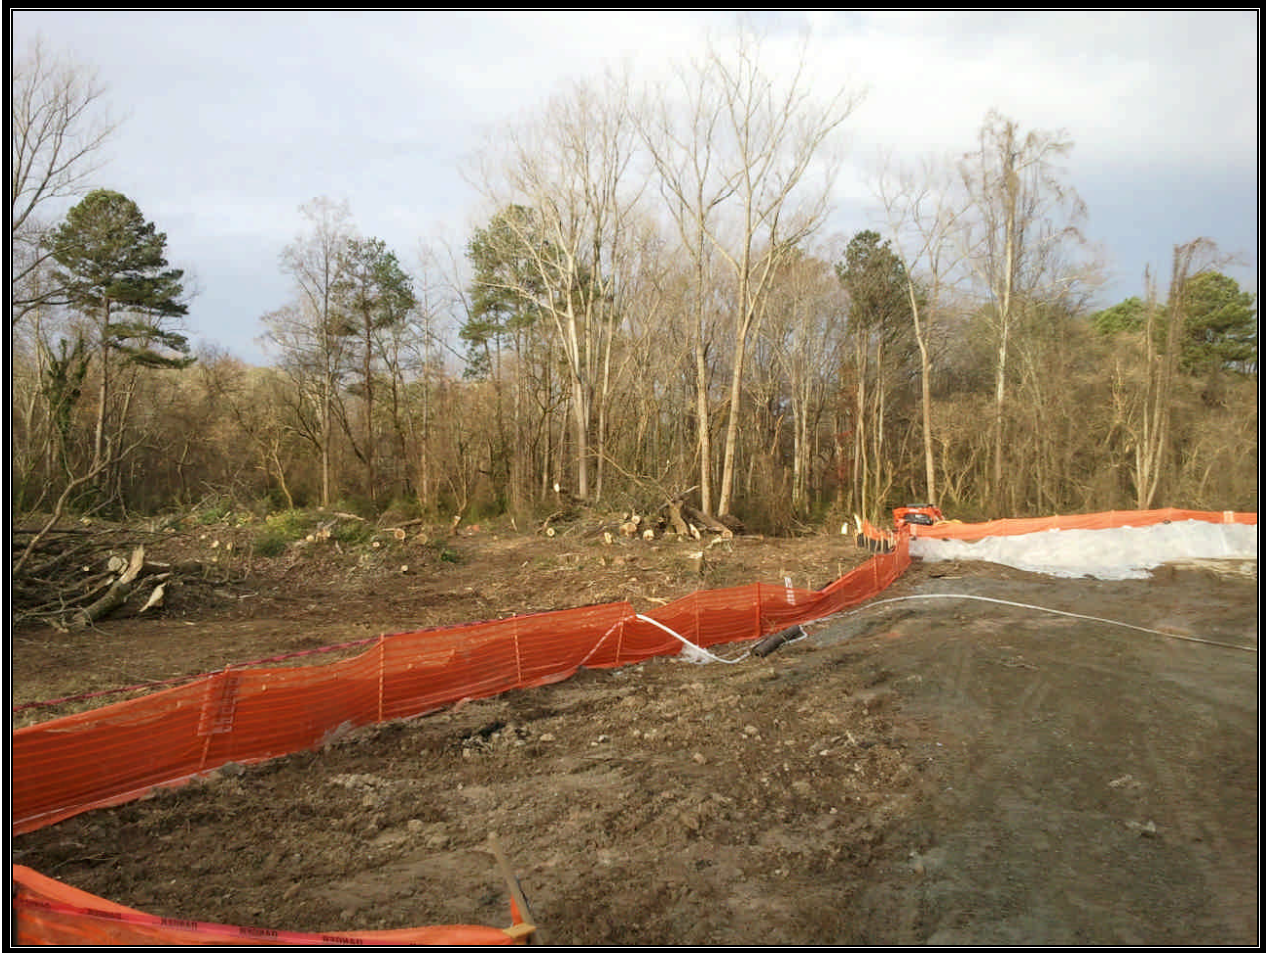
OFFICIAL PHOTOGRAPH NO. 19
U.S. ENVIRONMENTAL PROTECTION AGENCY

Subject: The original silt and security fencing will be reset to the west and south based on the expanded scope of removal activities because of visual observation and soil results for ACM.

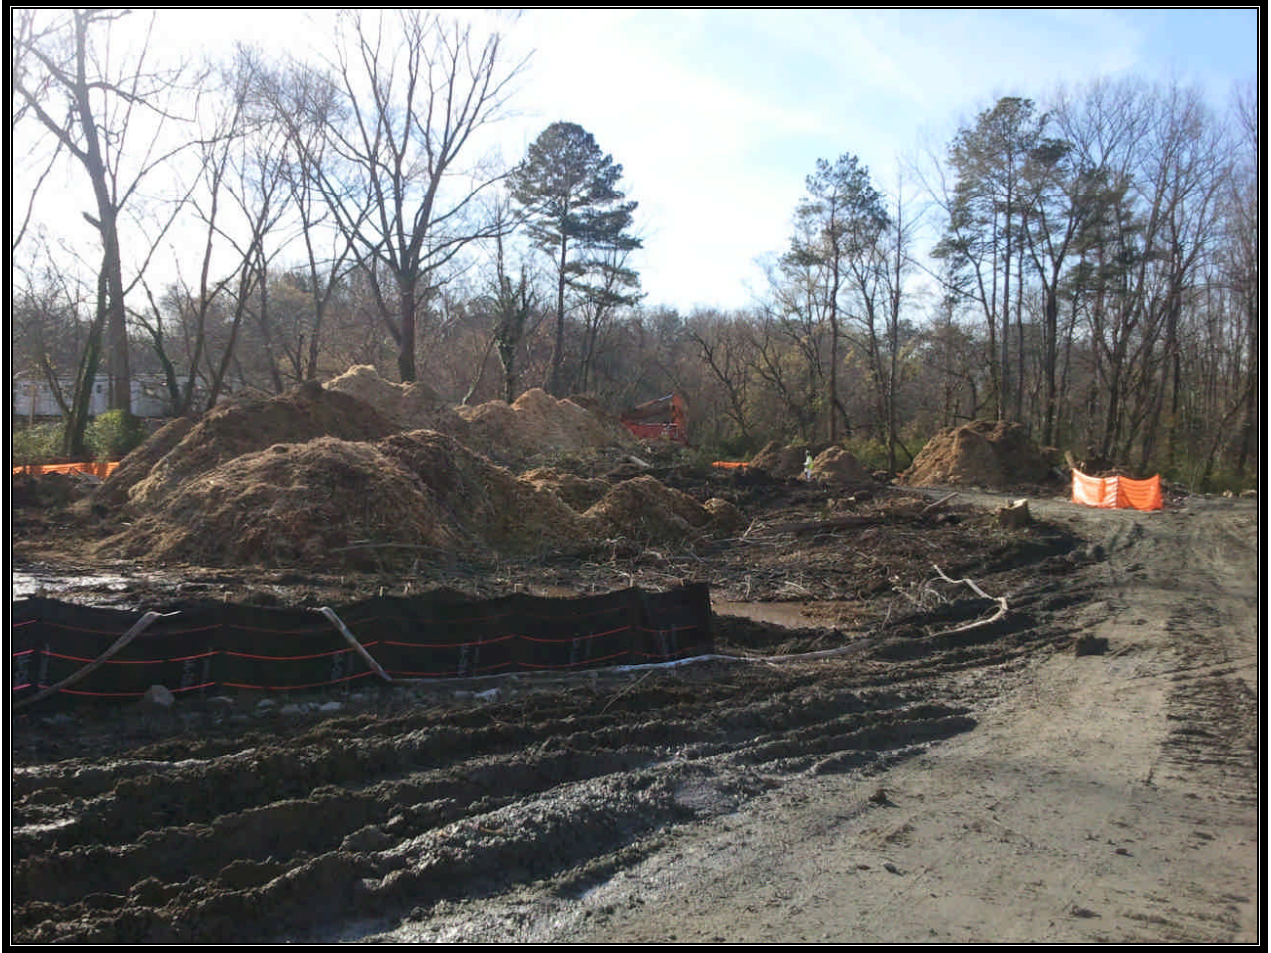
OFFICIAL PHOTOGRAPH NO. 20
U.S. ENVIRONMENTAL PROTECTION AGENCY

Subject: Due to the large amount of tree and brush removed, a decision to mulch the trees and brush was made by EPA, W.R. Grace, and DeKalb County representatives.

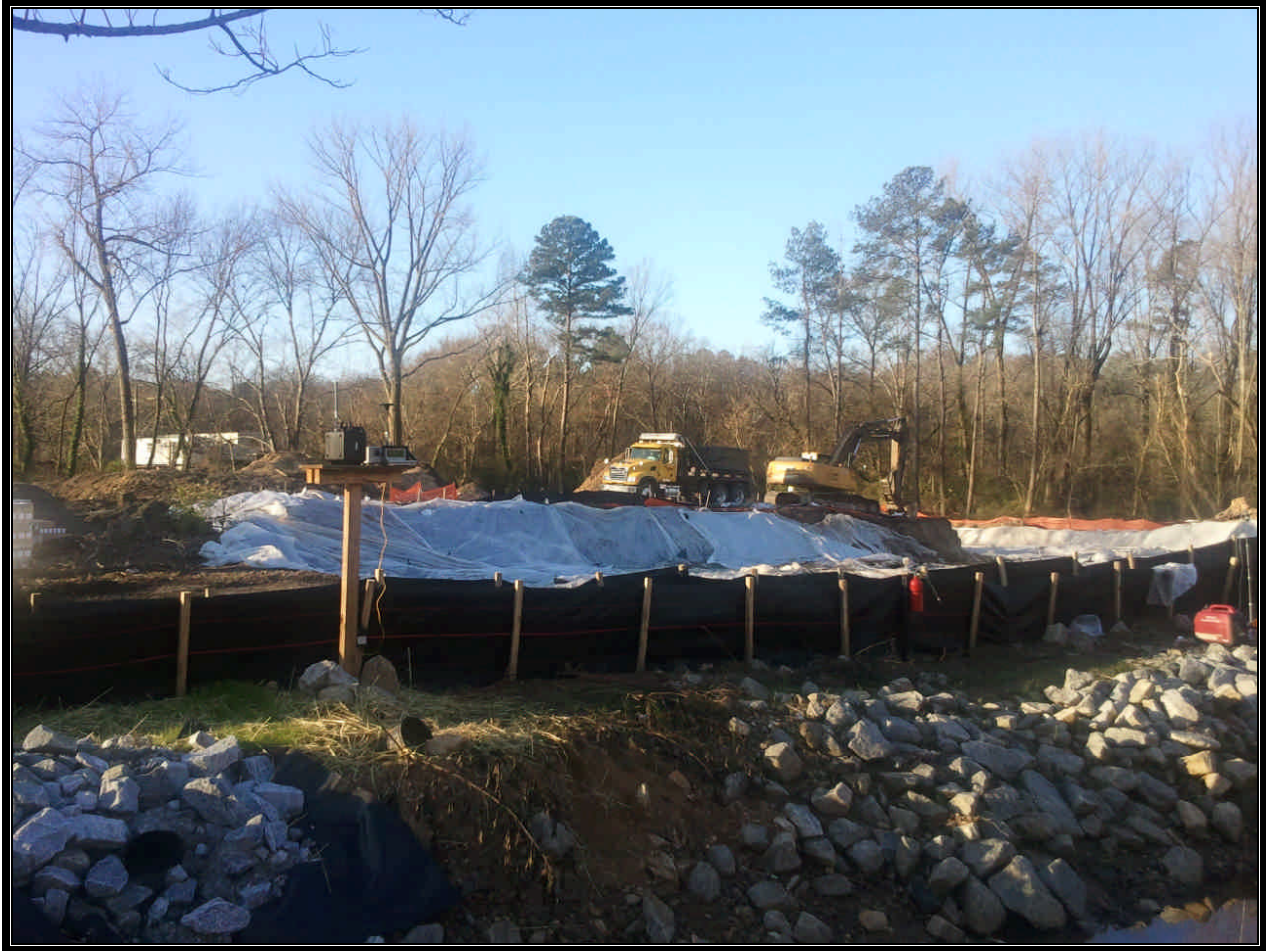
OFFICIAL PHOTOGRAPH NO. 21
U.S. ENVIRONMENTAL PROTECTION AGENCY

TDD Number:	TTEMI-05-001-0156	Location:	1167 Zonolite Place NE Atlanta, Georgia 30306
Orientation:	Southwest	Date:	December 13, 2011
Photographer:	Leland J. Meadows	Witness:	EPA OSC Eichinger
Subject:	Tetra Tech START continues particulate air monitoring during removal activities.

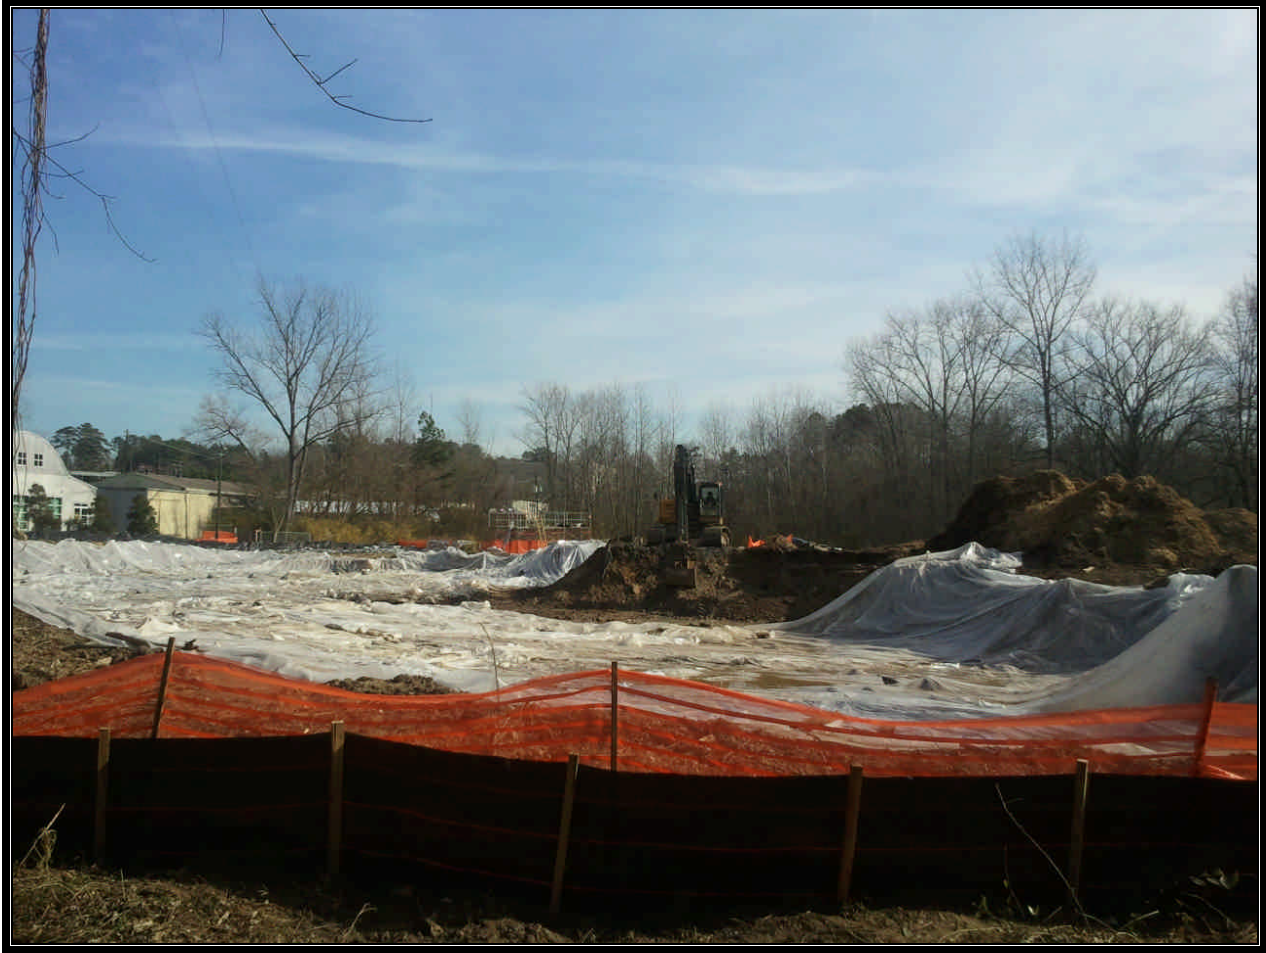
OFFICIAL PHOTOGRAPH NO. 22
U.S. ENVIRONMENTAL PROTECTION AGENCY

Subject: Winter contractors continue removal of ACM up to the concrete pad located near the eastern portion of the site.

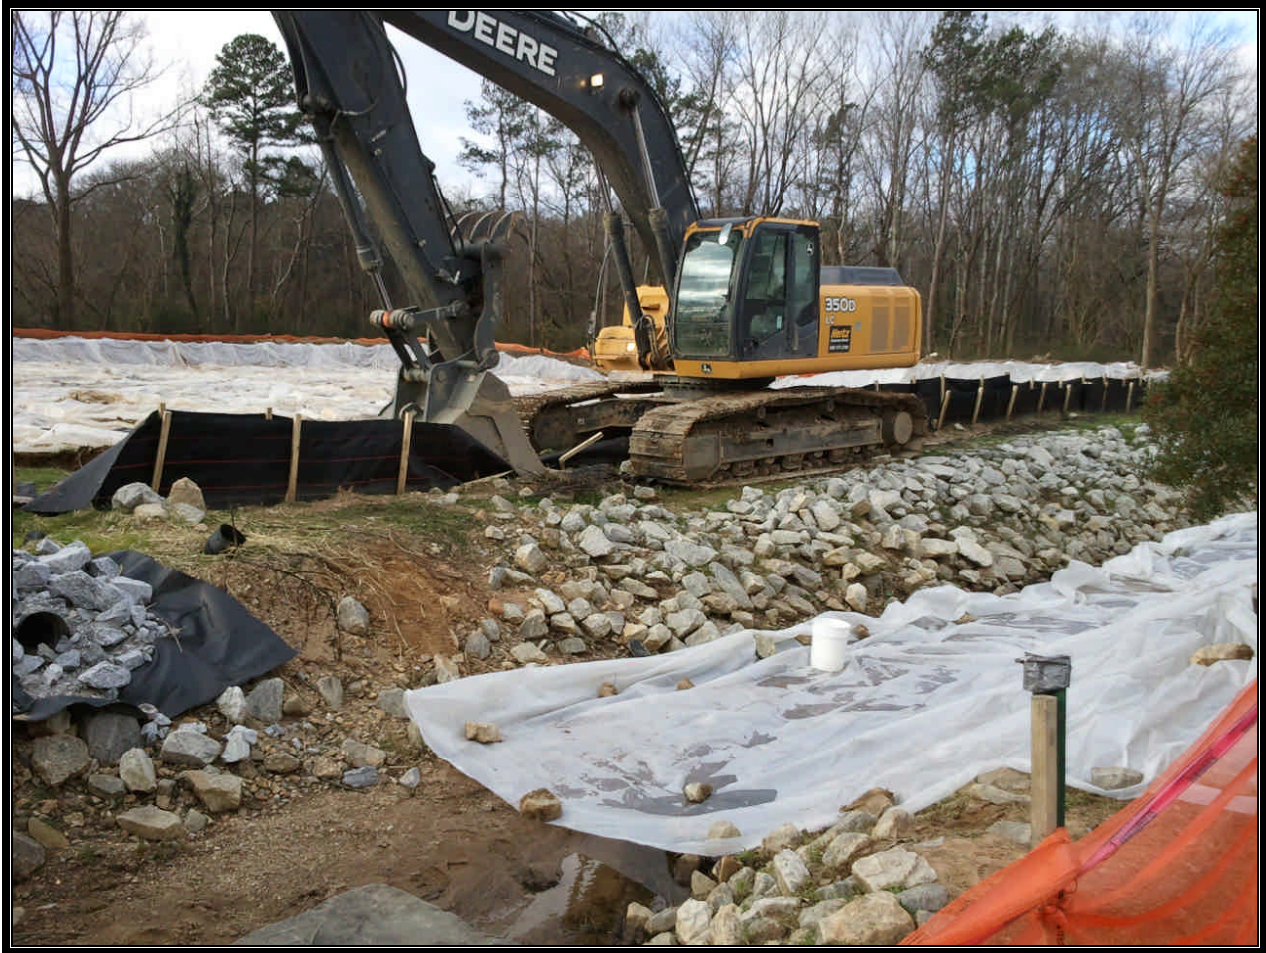
OFFICIAL PHOTOGRAPH NO. 23
U.S. ENVIRONMENTAL PROTECTION AGENCY

Subject: Winter began removal of the berm between the excavated area and the existing northern storm water drainage ditch.

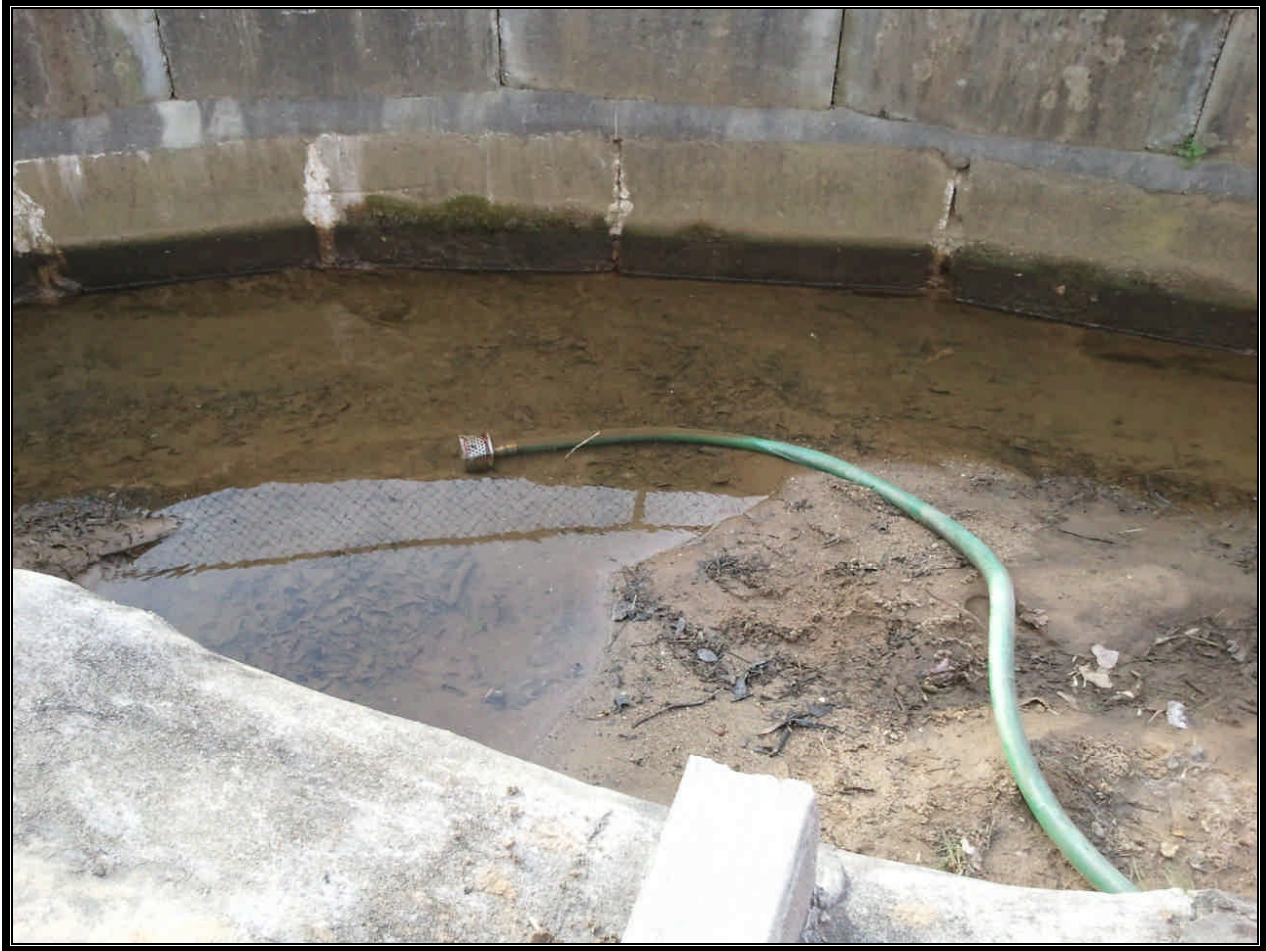
OFFICIAL PHOTOGRAPH NO. 24
U.S. ENVIRONMENTAL PROTECTION AGENCY

Subject: A three inch hose and pump was used to transfer storm water around the current excavation in order to minimize migration of excavated ACM along the existing northern storm water drainage ditch.

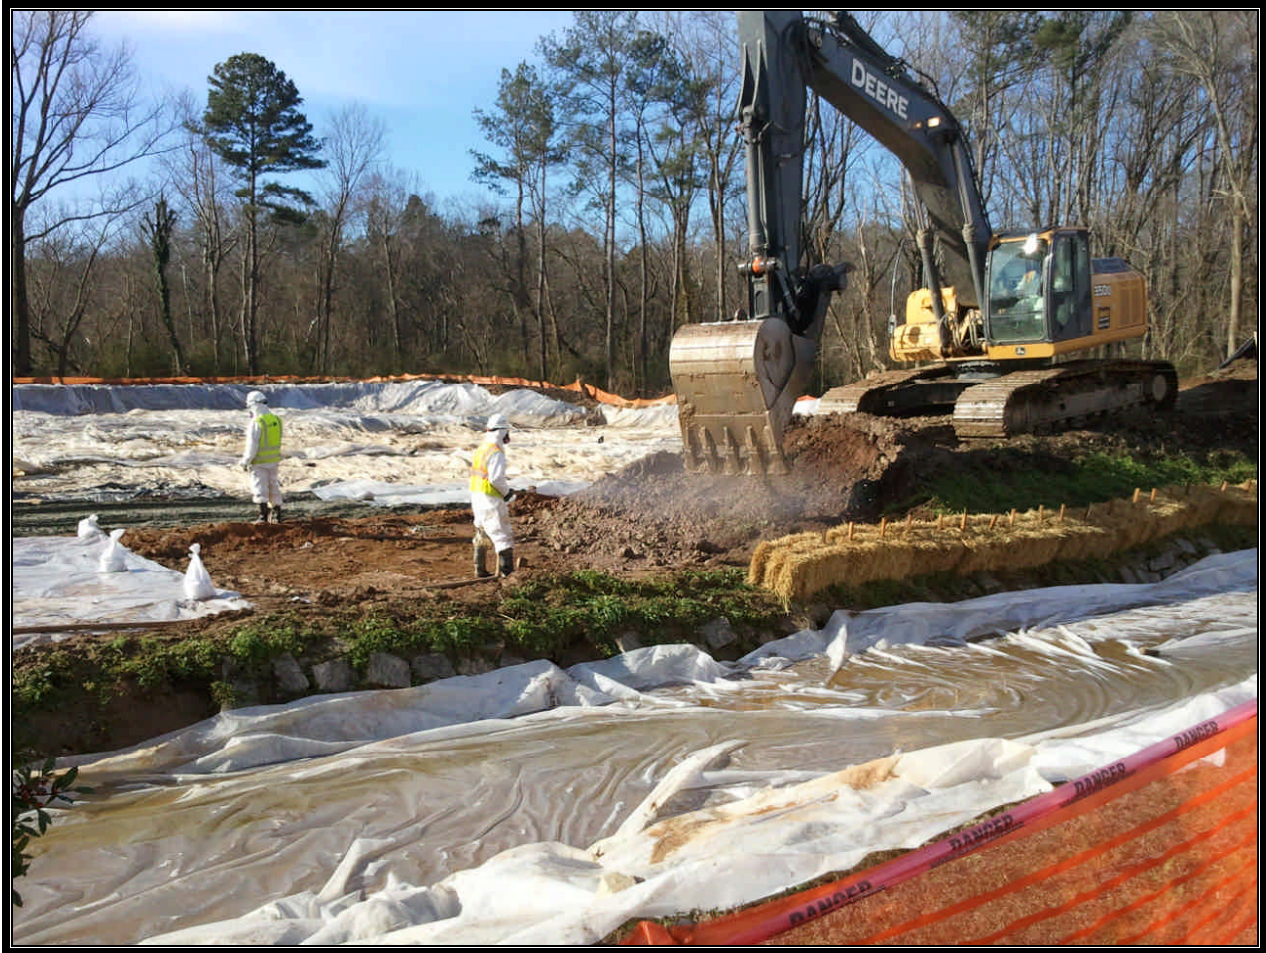
OFFICIAL PHOTOGRAPH NO. 25
U.S. ENVIRONMENTAL PROTECTION AGENCY

Subject: Winter continues excavation and dust suppression along the existing northern storm water drainage ditch.

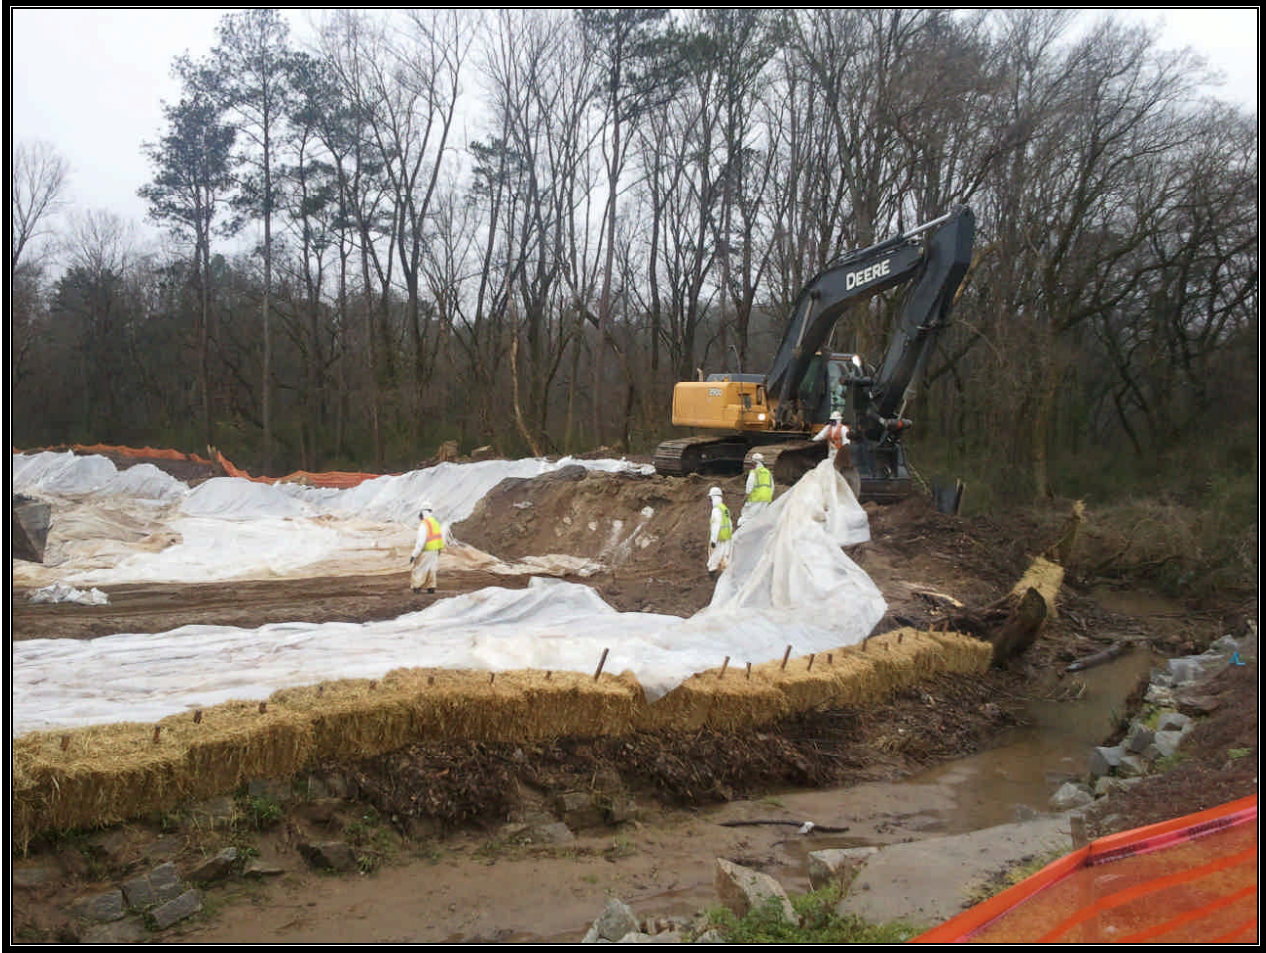
OFFICIAL PHOTOGRAPH NO. 26
U.S. ENVIRONMENTAL PROTECTION AGENCY

Subject: Hay bales were used to create a temporary berm in order to minimize off-site migration of ACM during removal activities along the north and northwestern portion of the excavation.

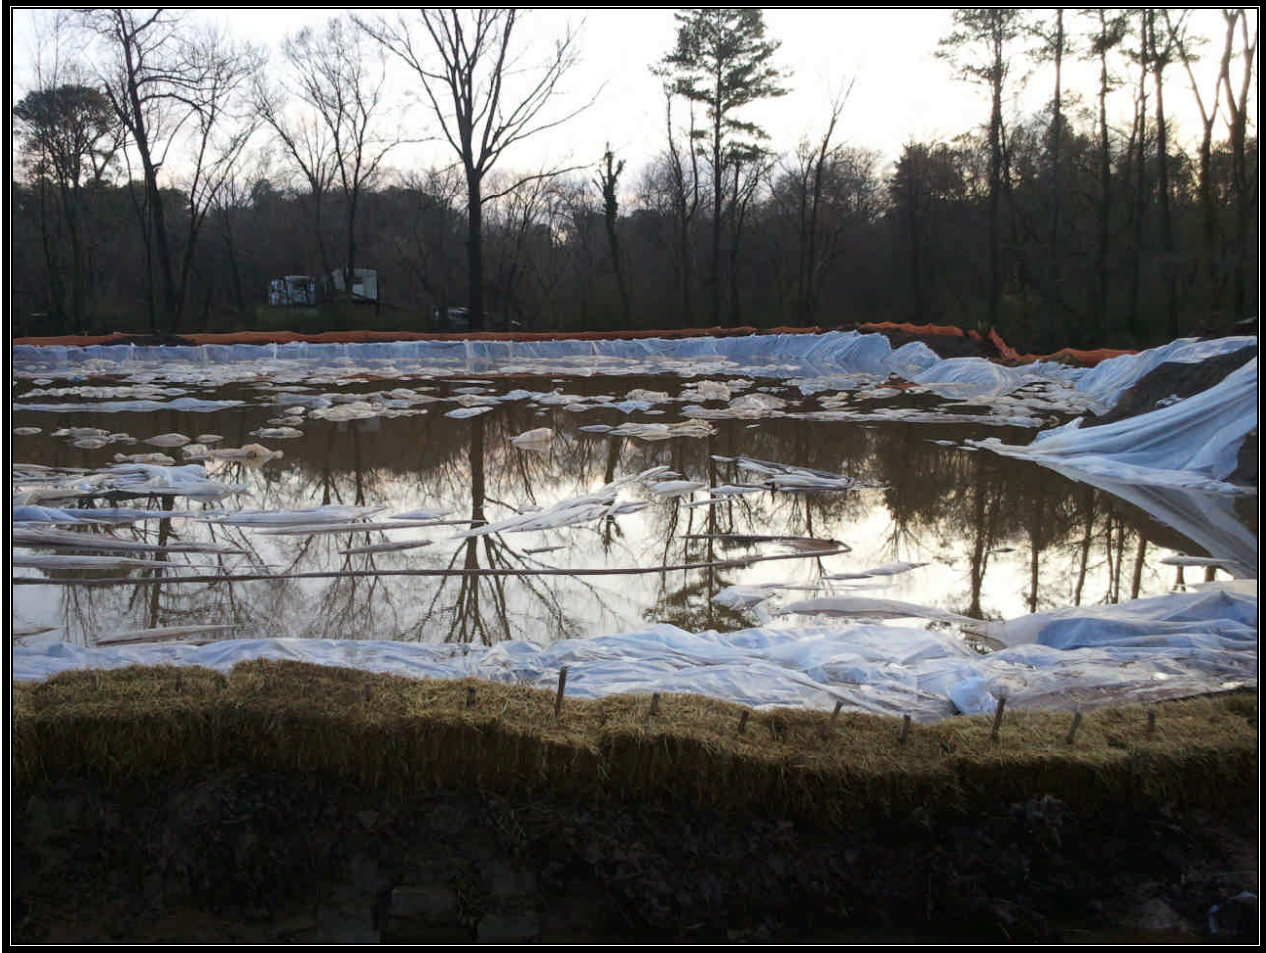
OFFICIAL PHOTOGRAPH NO. 27
U.S. ENVIRONMENTAL PROTECTION AGENCY

Subject: Winter excavated down to native soil and encountered ground water intrusion in several areas. With the addition of rain at various times throughout the project, Winter used 2 and 3 inch pumps to capture, filter and discharge on-site storm water and ground water intrusion into southern storm water drainage ditch.

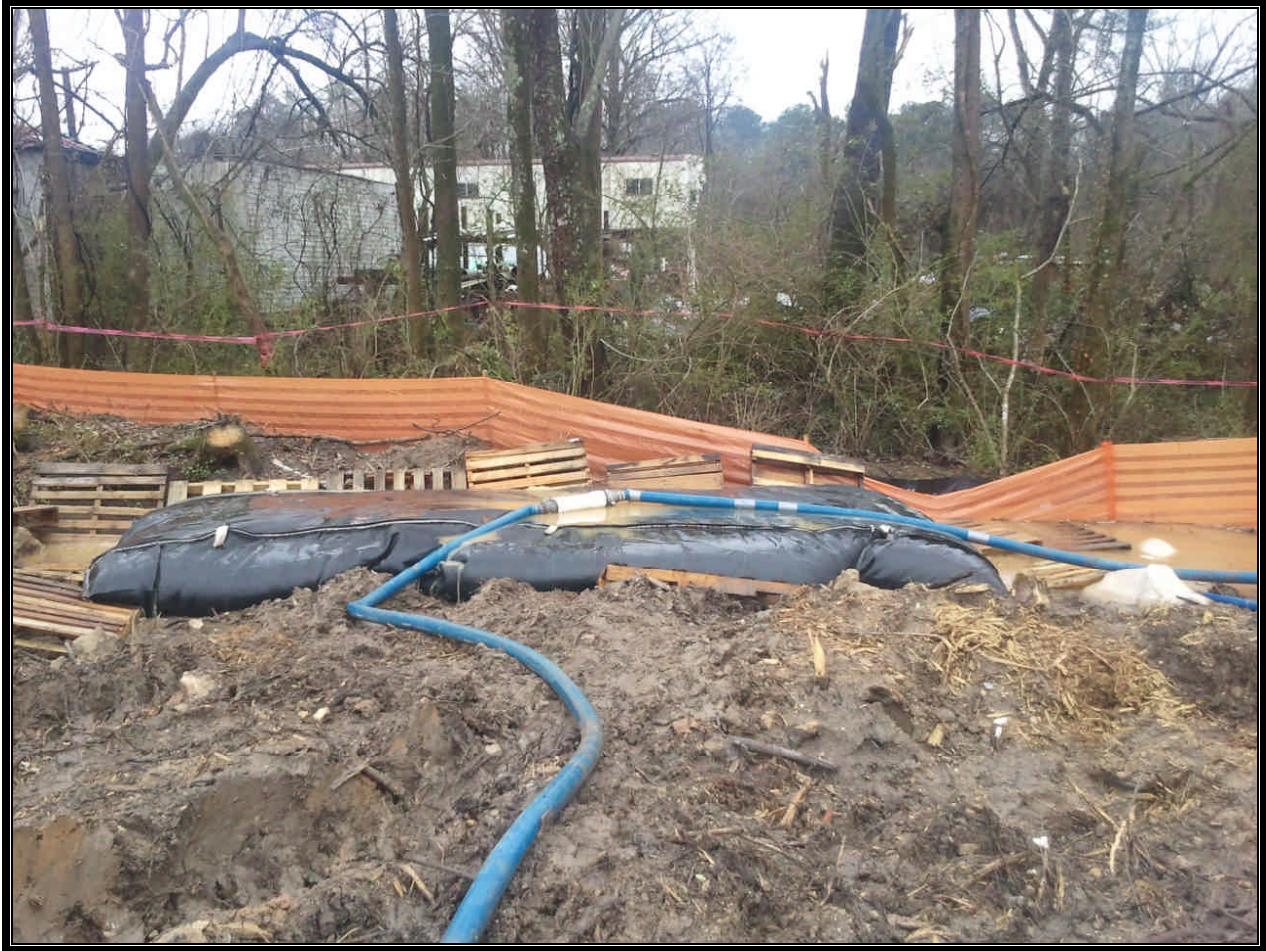
OFFICIAL PHOTOGRAPH NO. 28
U.S. ENVIRONMENTAL PROTECTION AGENCY

Subject: A geo-membrane filter was used to capture and discharge on-site storm water and groundwater into the adjacent southern storm water drainage ditch.

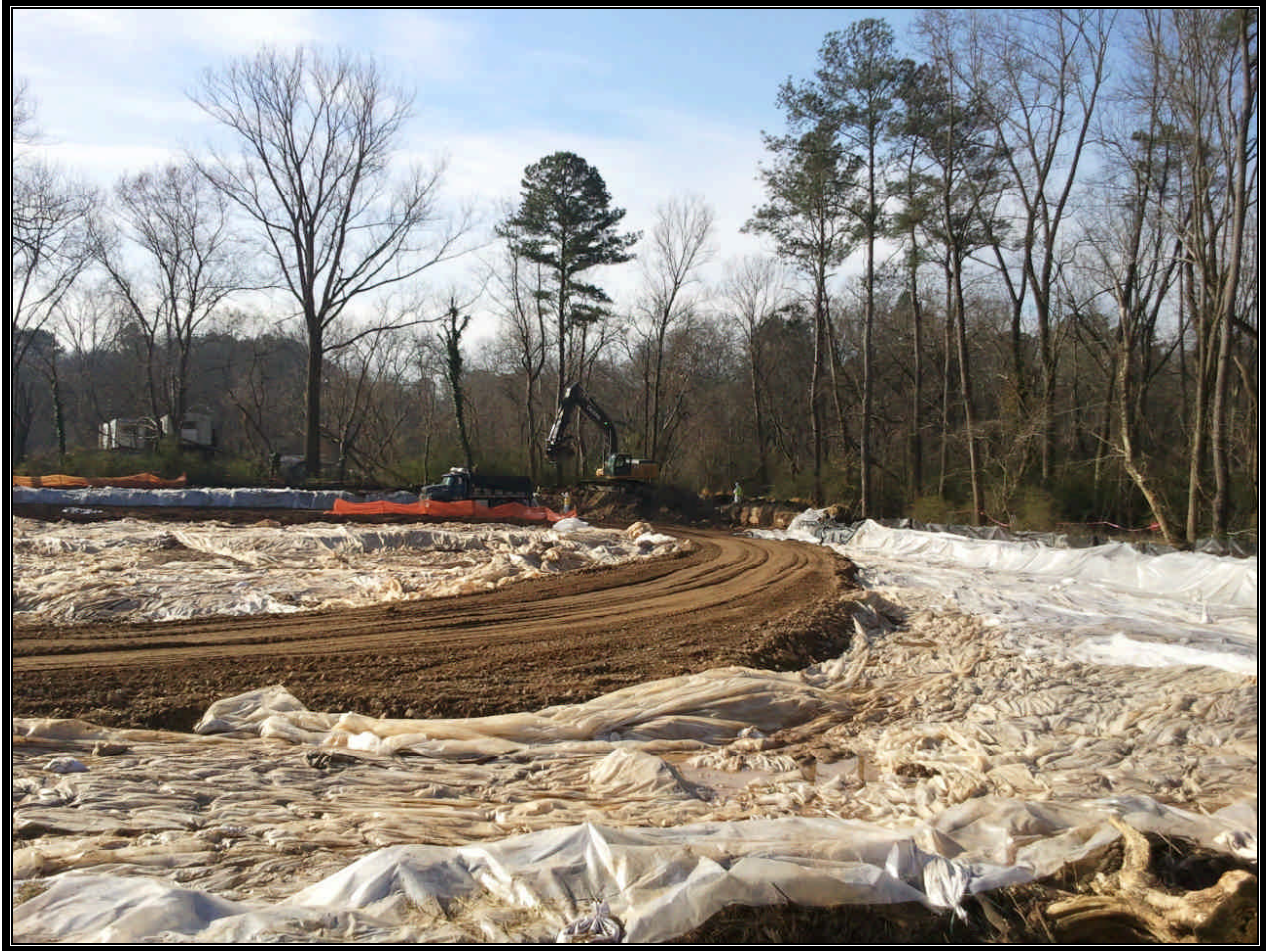
OFFICIAL PHOTOGRAPH NO. 29
U.S. ENVIRONMENTAL PROTECTION AGENCY

Subject: A dry haul road was constructed of concrete and soil mixture from the Newsome borrow pit. The haul road allowed dump trucks access to the full extent of the excavated area.
