**Subject: Removal Action Oversight Letter Report
Vermiculite Exfoliation GAO 144 PRP Removal
Atlanta, DeKalb County, Georgia
Contract No.: EP-W-05-054
TDD No.: TTEMI-05-001-0156**

ENCLOSURE 3
PHOTOGRAPHIC LOG
(41 Pages)

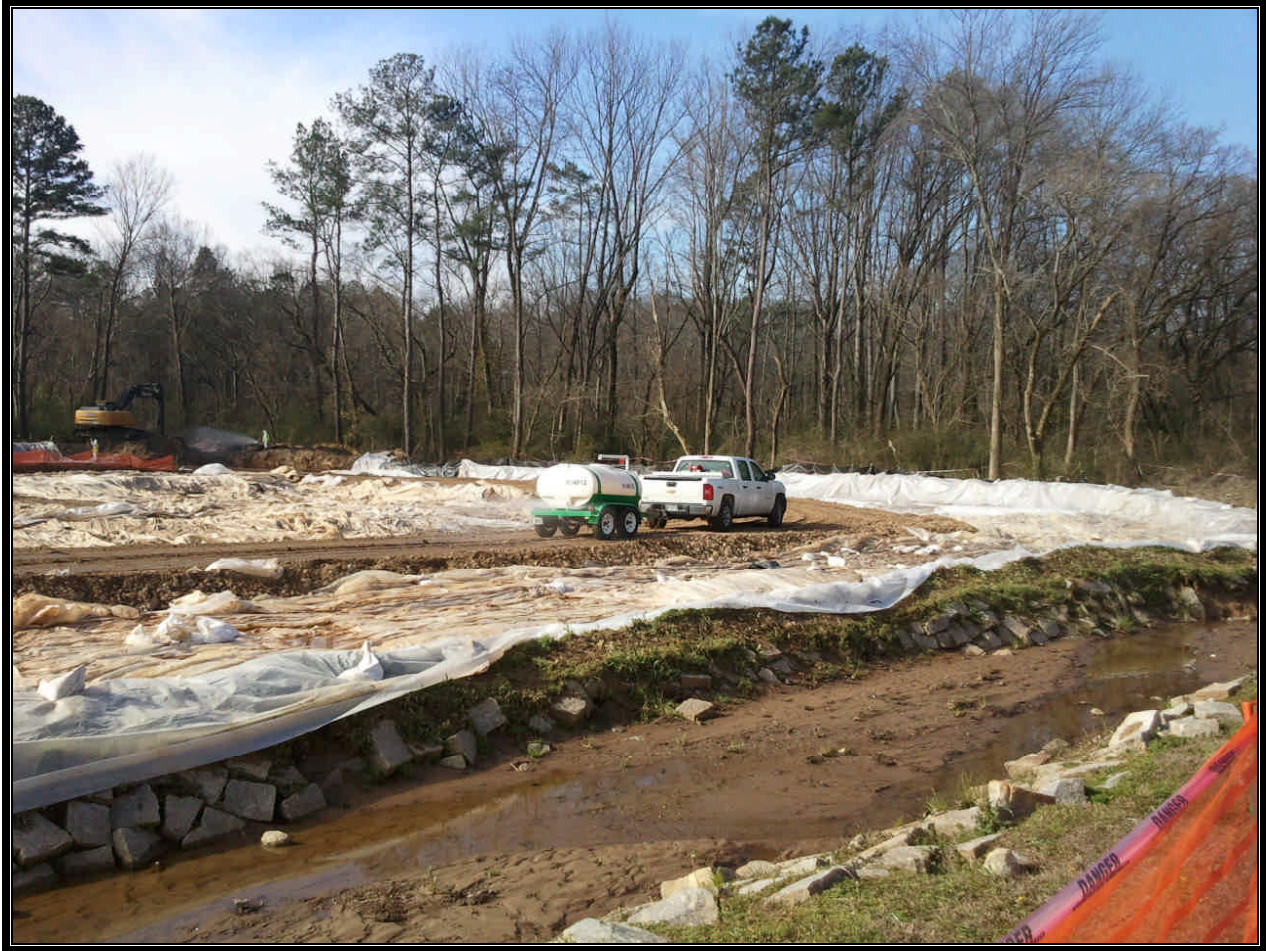
OFFICIAL PHOTOGRAPH NO. 30
U.S. ENVIRONMENTAL PROTECTION AGENCY

Subject: Based on dry conditions and visual dust along the haul road, EPA recommended dust suppression using a pick-up truck and water trailer.

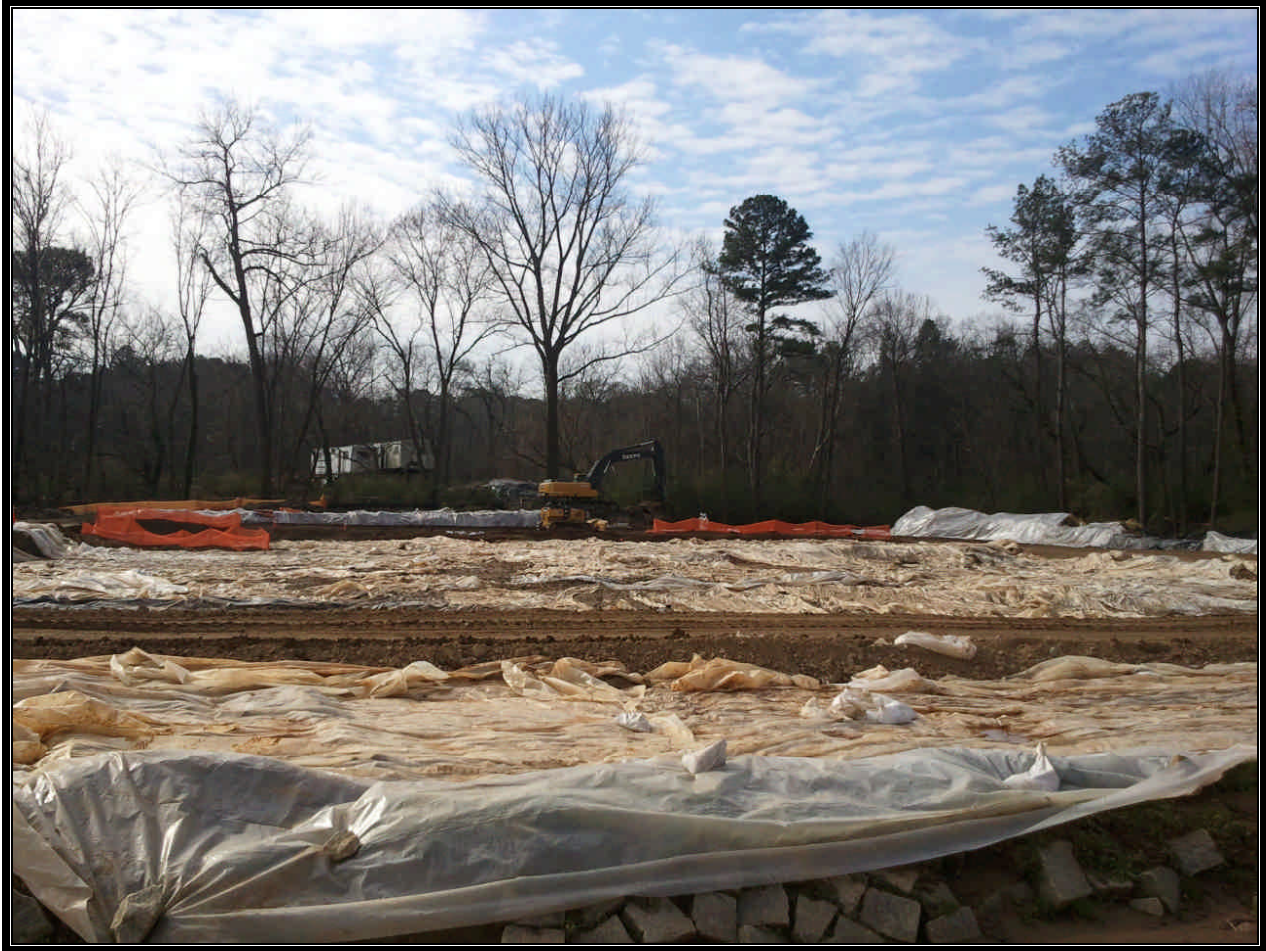
**OFFICIAL PHOTOGRAPH NO. 31
U.S. ENVIRONMENTAL PROTECTION AGENCY**

TDD Number:	TTEMI-05-001-0156	Location:	1167 Zonolite Place NE Atlanta, Georgia 30306
Orientation:	South	Date:	February 01, 2012
Photographer:	Leland Meadows	Witness:	EPA OSC Eichinger
Subject:	Winter continues removal of the southern drainage ditch to native soil.

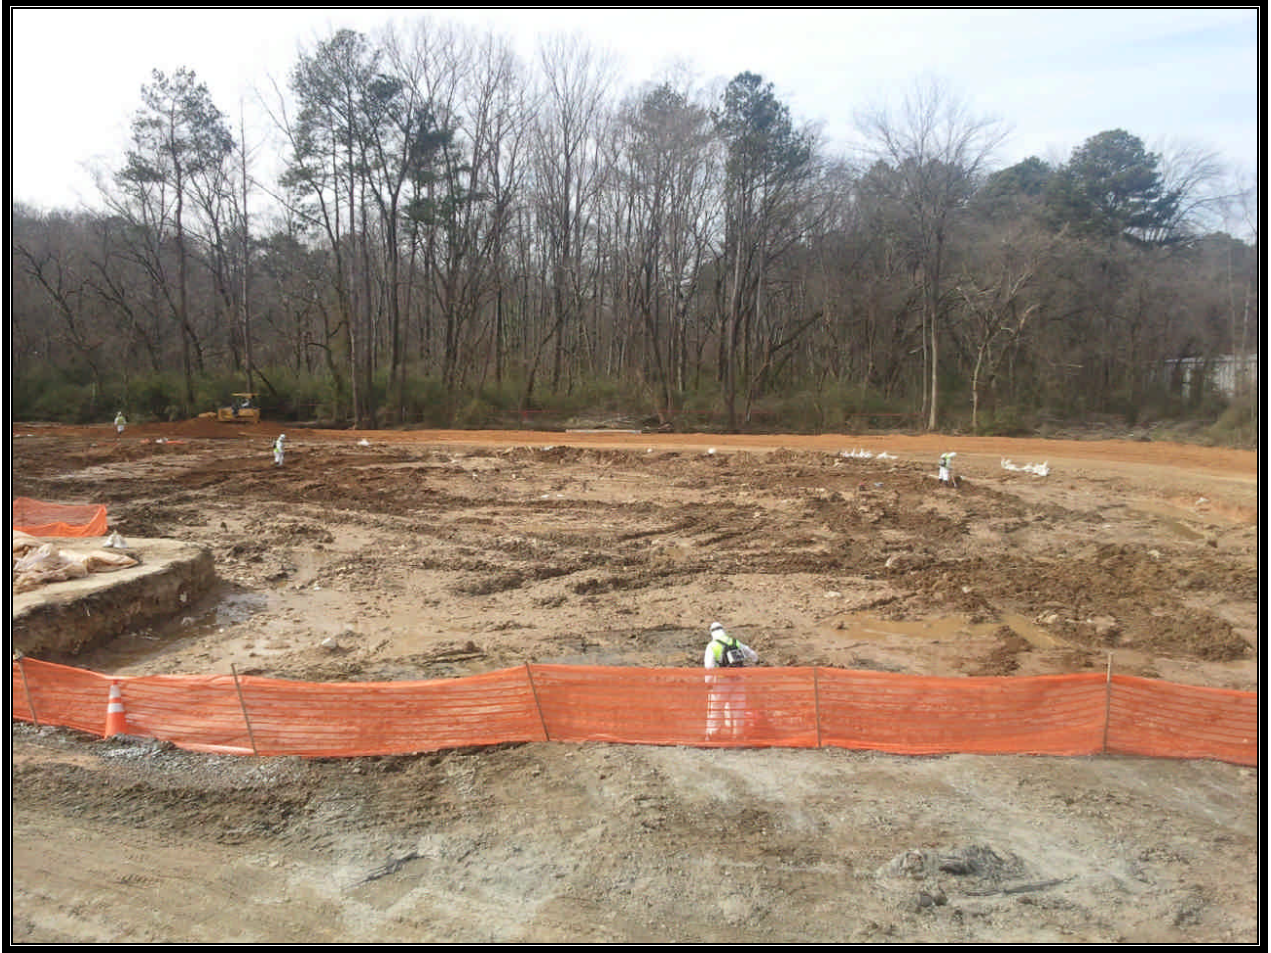
OFFICIAL PHOTOGRAPH NO. 32
U.S. ENVIRONMENTAL PROTECTION AGENCY

Subject: One Group Consultants performed activity-based sampling (ABS), Event 5, at the GAO 144 site in the excavated area in order to meet clearance criteria for airborne asbestos fibers as established by EPA.

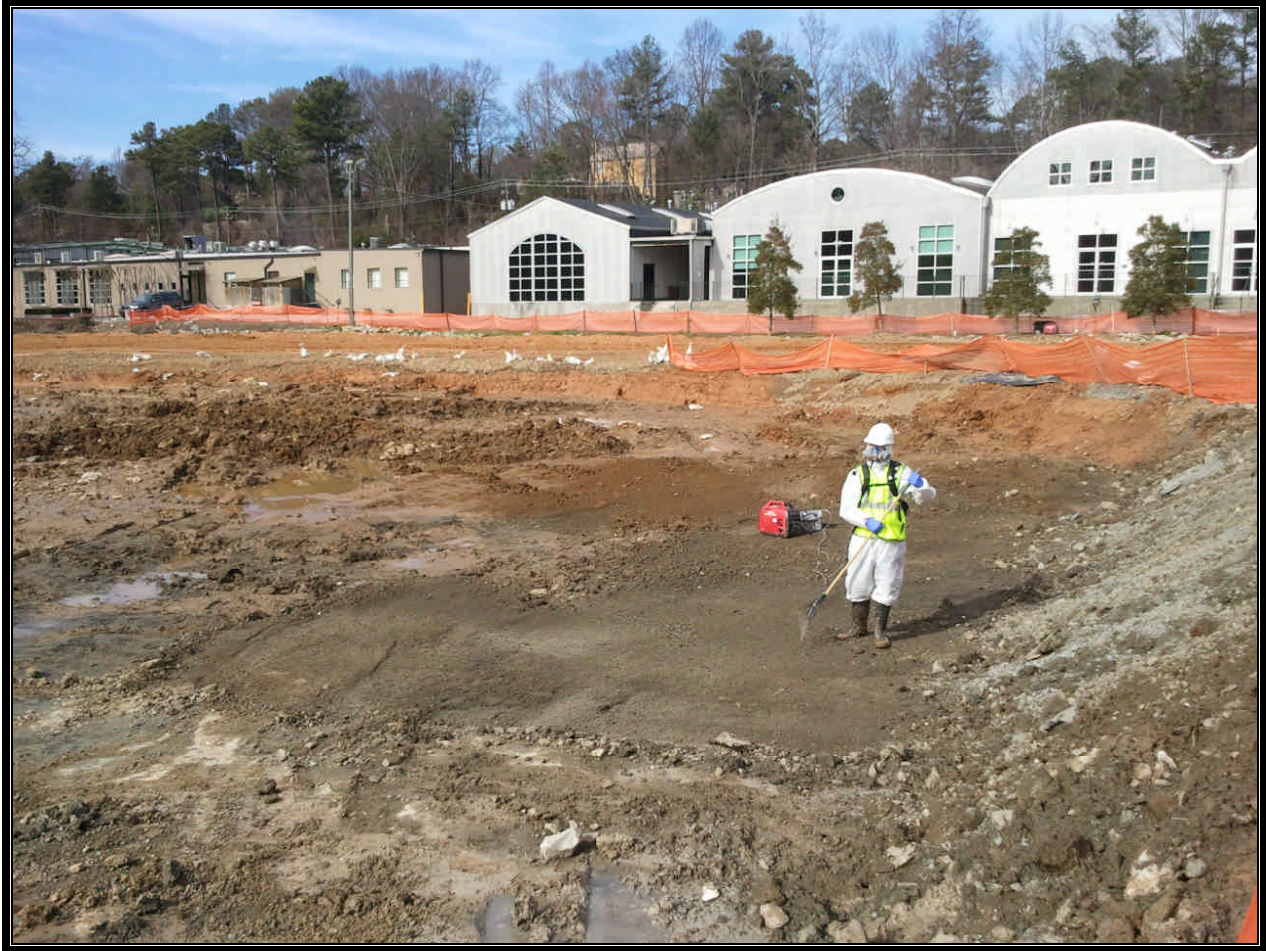
OFFICIAL PHOTOGRAPH NO. 33
U.S. ENVIRONMENTAL PROTECTION AGENCY

Subject: One Group Consultants performed activity-based sampling (ABS), Event 5, at the GAO 144 site in the excavated area in order to meet clearance criteria for airborne asbestos fibers as established by EPA.

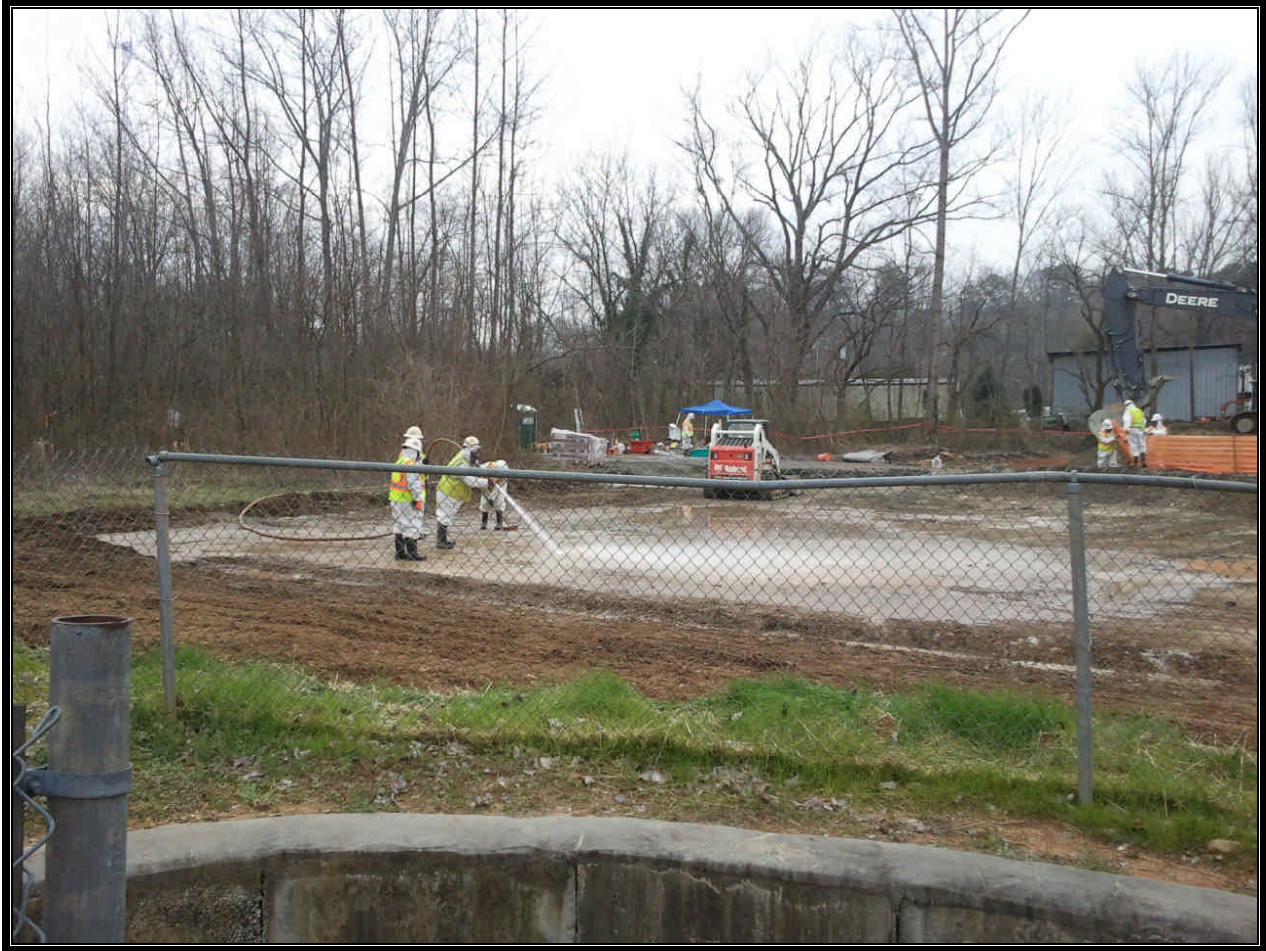
OFFICIAL PHOTOGRAPH NO. 34
U.S. ENVIRONMENTAL PROTECTION AGENCY

Subject: Winter pressure washes the north concrete pad located east of the excavated area, during site activities.

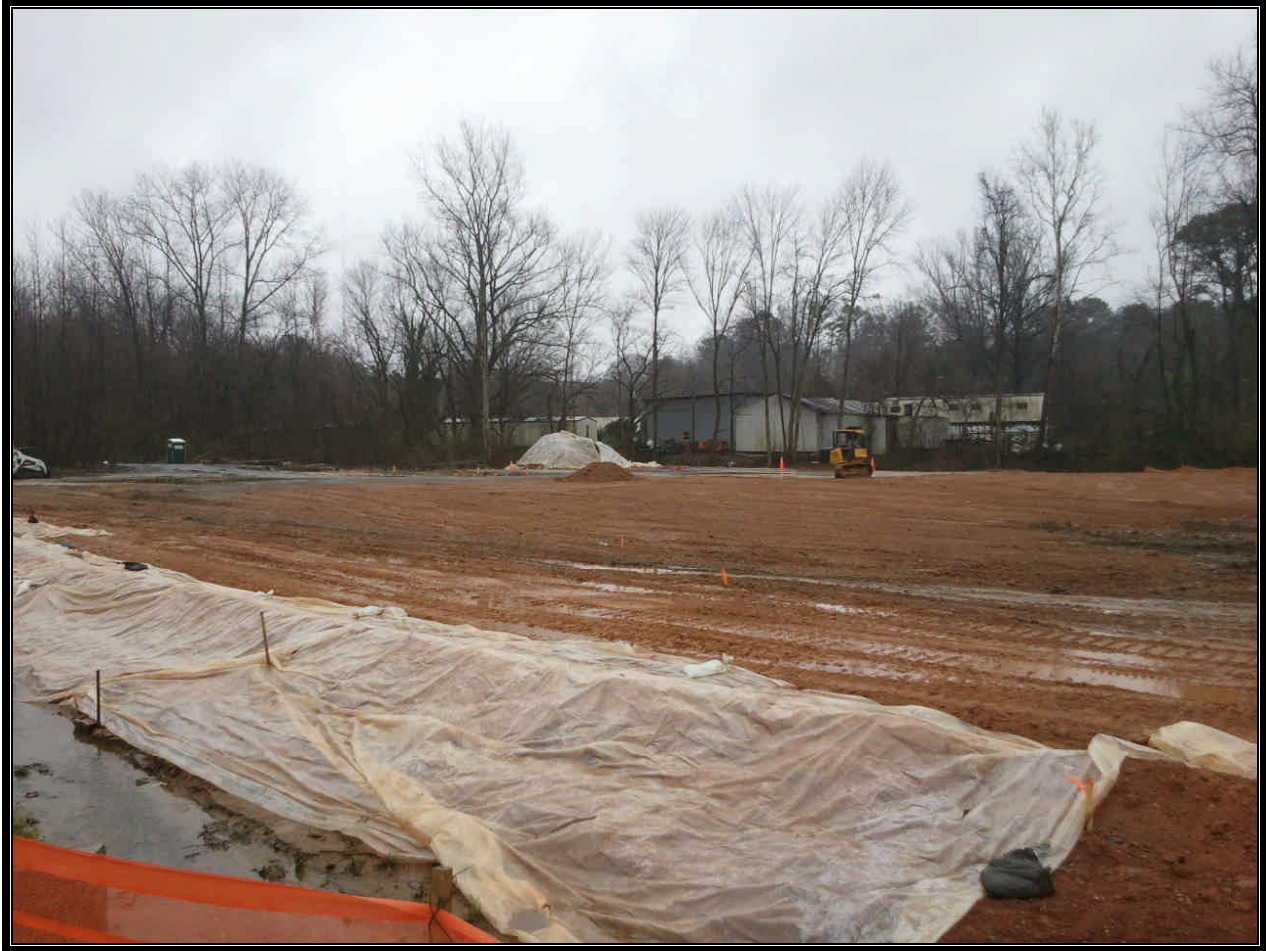
OFFICIAL PHOTOGRAPH NO. 35
U.S. ENVIRONMENTAL PROTECTION AGENCY

Subject: Geo-Survey, surveyed the site by setting grading stakes with orange flags in the ground at selected elevations based on the Final Grading Plan approved by EPA, W.R. Grace, and DeKalb County representatives.

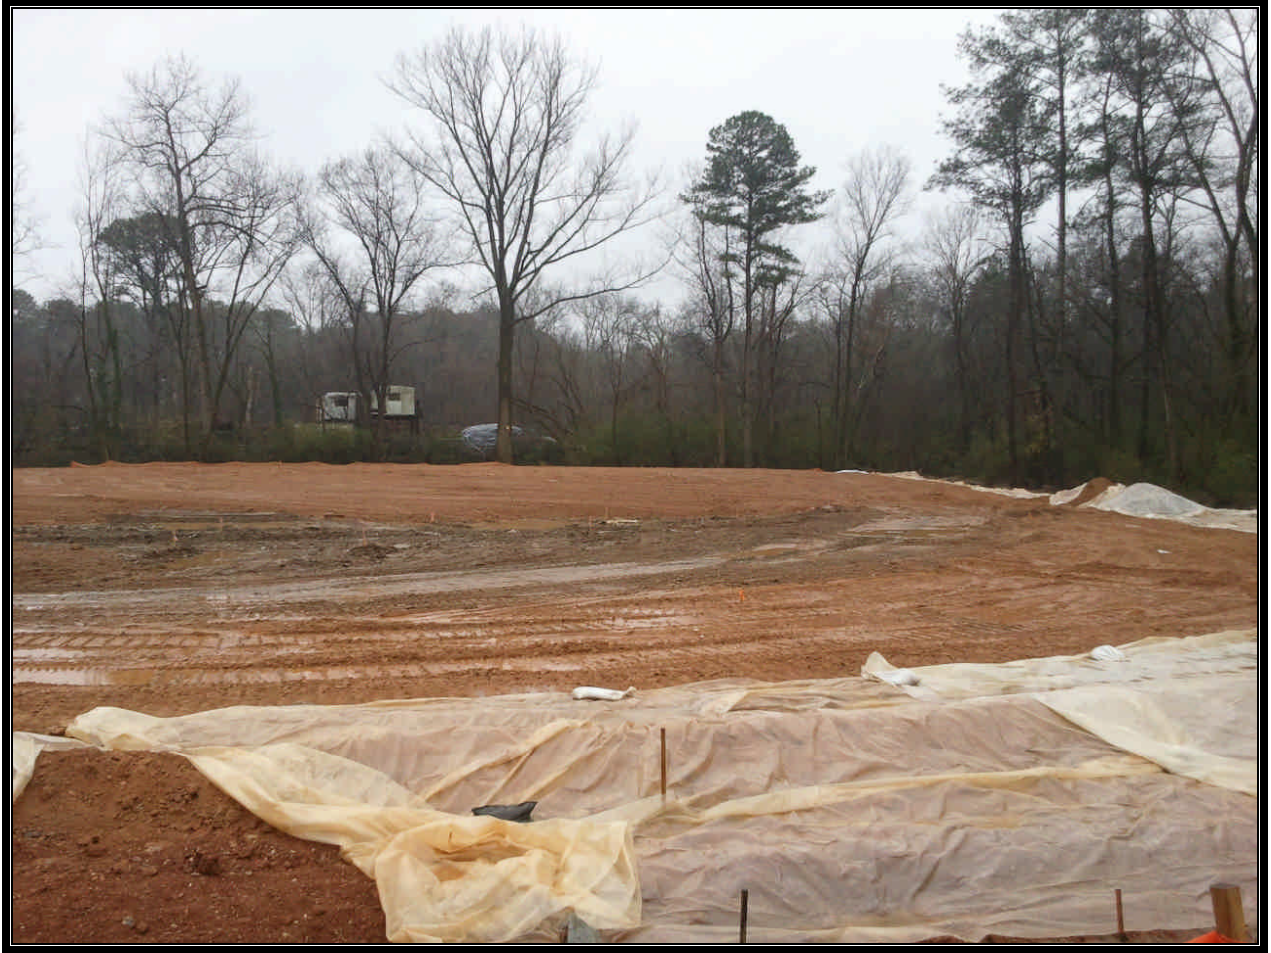
**OFFICIAL PHOTOGRAPH NO. 36
U.S. ENVIRONMENTAL PROTECTION AGENCY**

Subject: Geo-Survey, surveyed the site by setting grading stakes with orange flags in the ground at selected elevations based on the Final Grading Plan approved by EPA, W.R. Grace, and DeKalb County representatives.

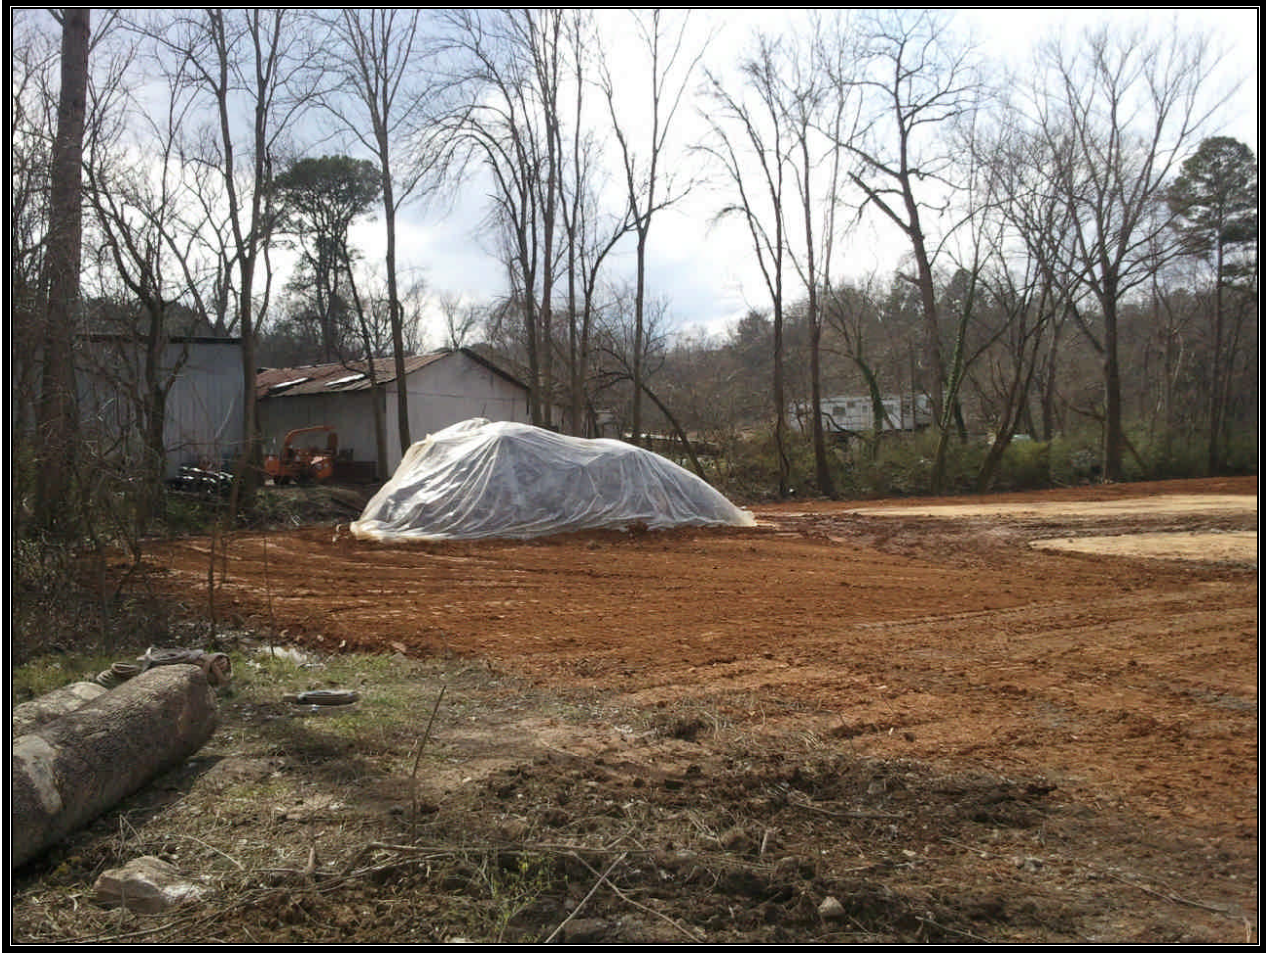
OFFICIAL PHOTOGRAPH NO. 37
U.S. ENVIRONMENTAL PROTECTION AGENCY

Subject: After excavation in the eastern portion of the site and surrounding concrete pad areas, clean borrow pit material was placed and graded. A large pile of mulch was request by DeKalb County for use during final grading and restoration activities. During excavation activities, this pile was covered using polypropylene sheeting.

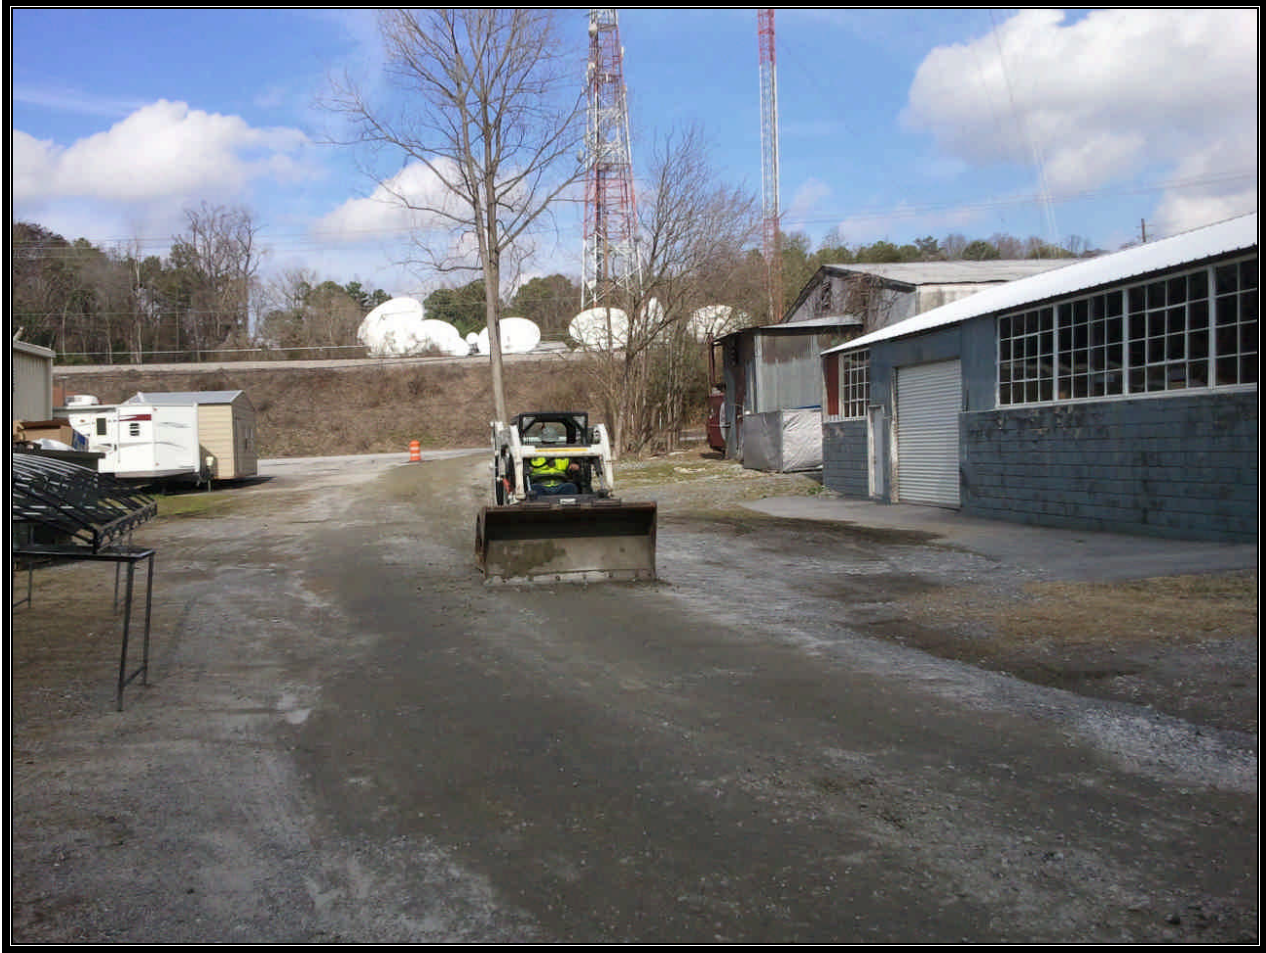
OFFICIAL PHOTOGRAPH NO. 38
U.S. ENVIRONMENTAL PROTECTION AGENCY

Subject: Winter performing restoration activities by adding crush and run concrete aggregate along the service road and entrance to the site.

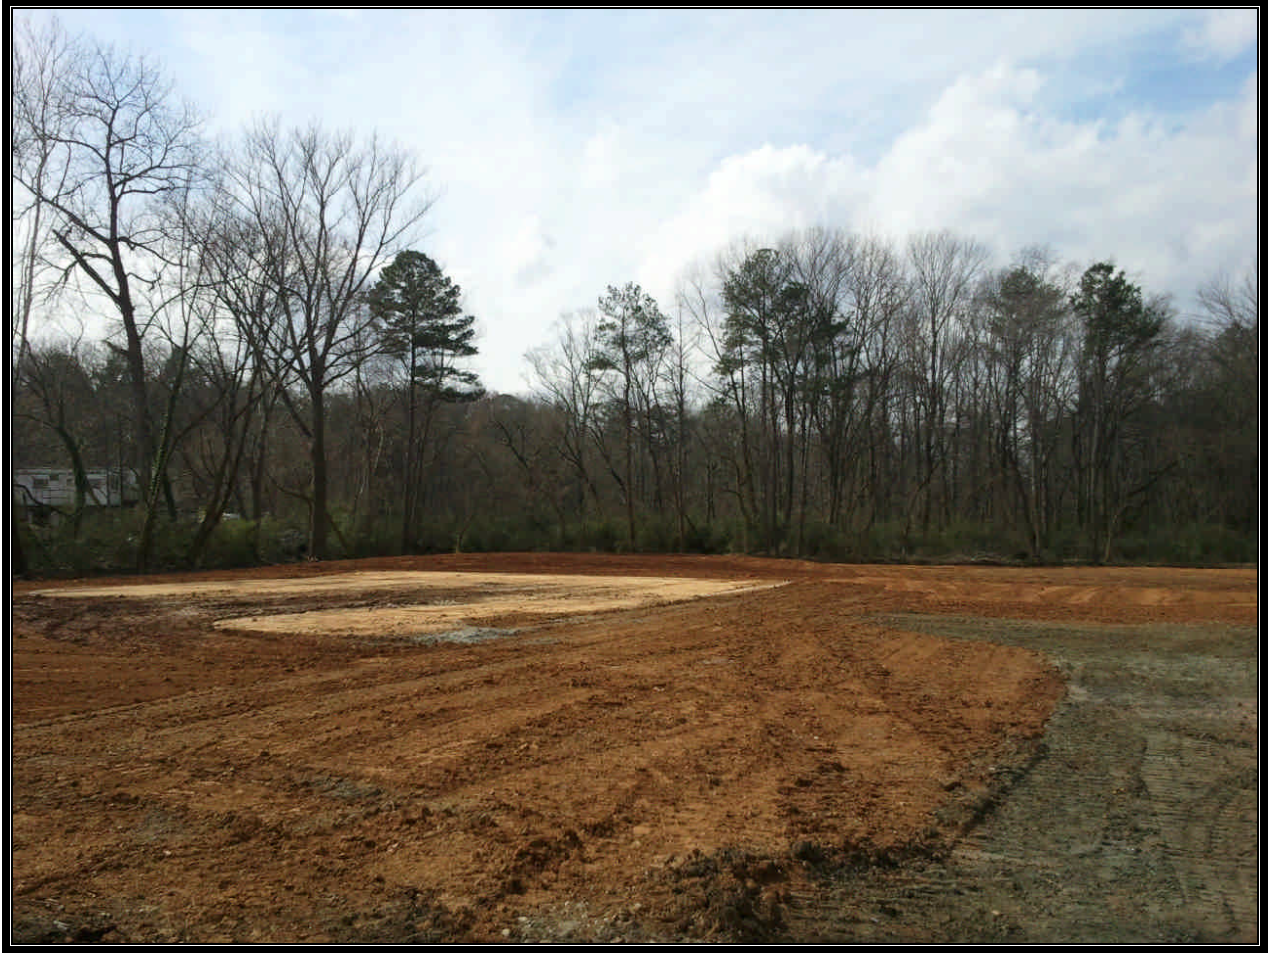
OFFICIAL PHOTOGRAPH NO. 39
U.S. ENVIRONMENTAL PROTECTION AGENCY

Subject: After excavation in the eastern portion of the site and surrounding concrete pad areas, clean borrow pit material was placed and graded.

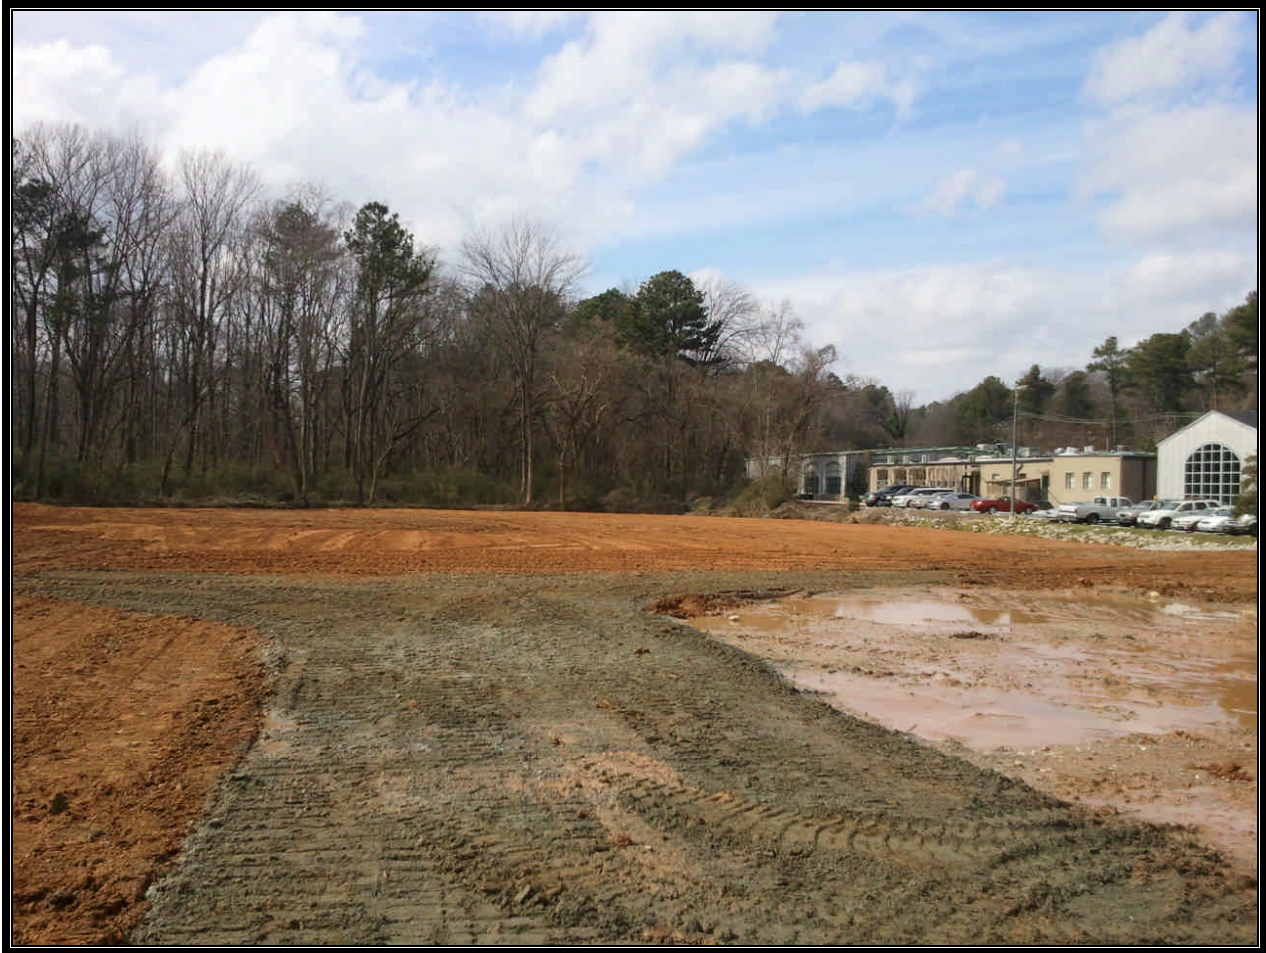
OFFICIAL PHOTOGRAPH NO. 40
U.S. ENVIRONMENTAL PROTECTION AGENCY

Subject: After excavation in the eastern portion of the site and surrounding concrete pad areas, clean borrow pit material was placed and graded.
