SUBJECT: TRIP REPORT – GEOPHYSICAL INVESTIGATION OF THE MOJAVE RIVER
PYROTECHNICS SITE, BARSTOW, CALIFORNIA,
WORK ASSIGNMENT SERAS-127

FIGURES
Mojave River Pyrotechnics Site
Trip Report
May 2001

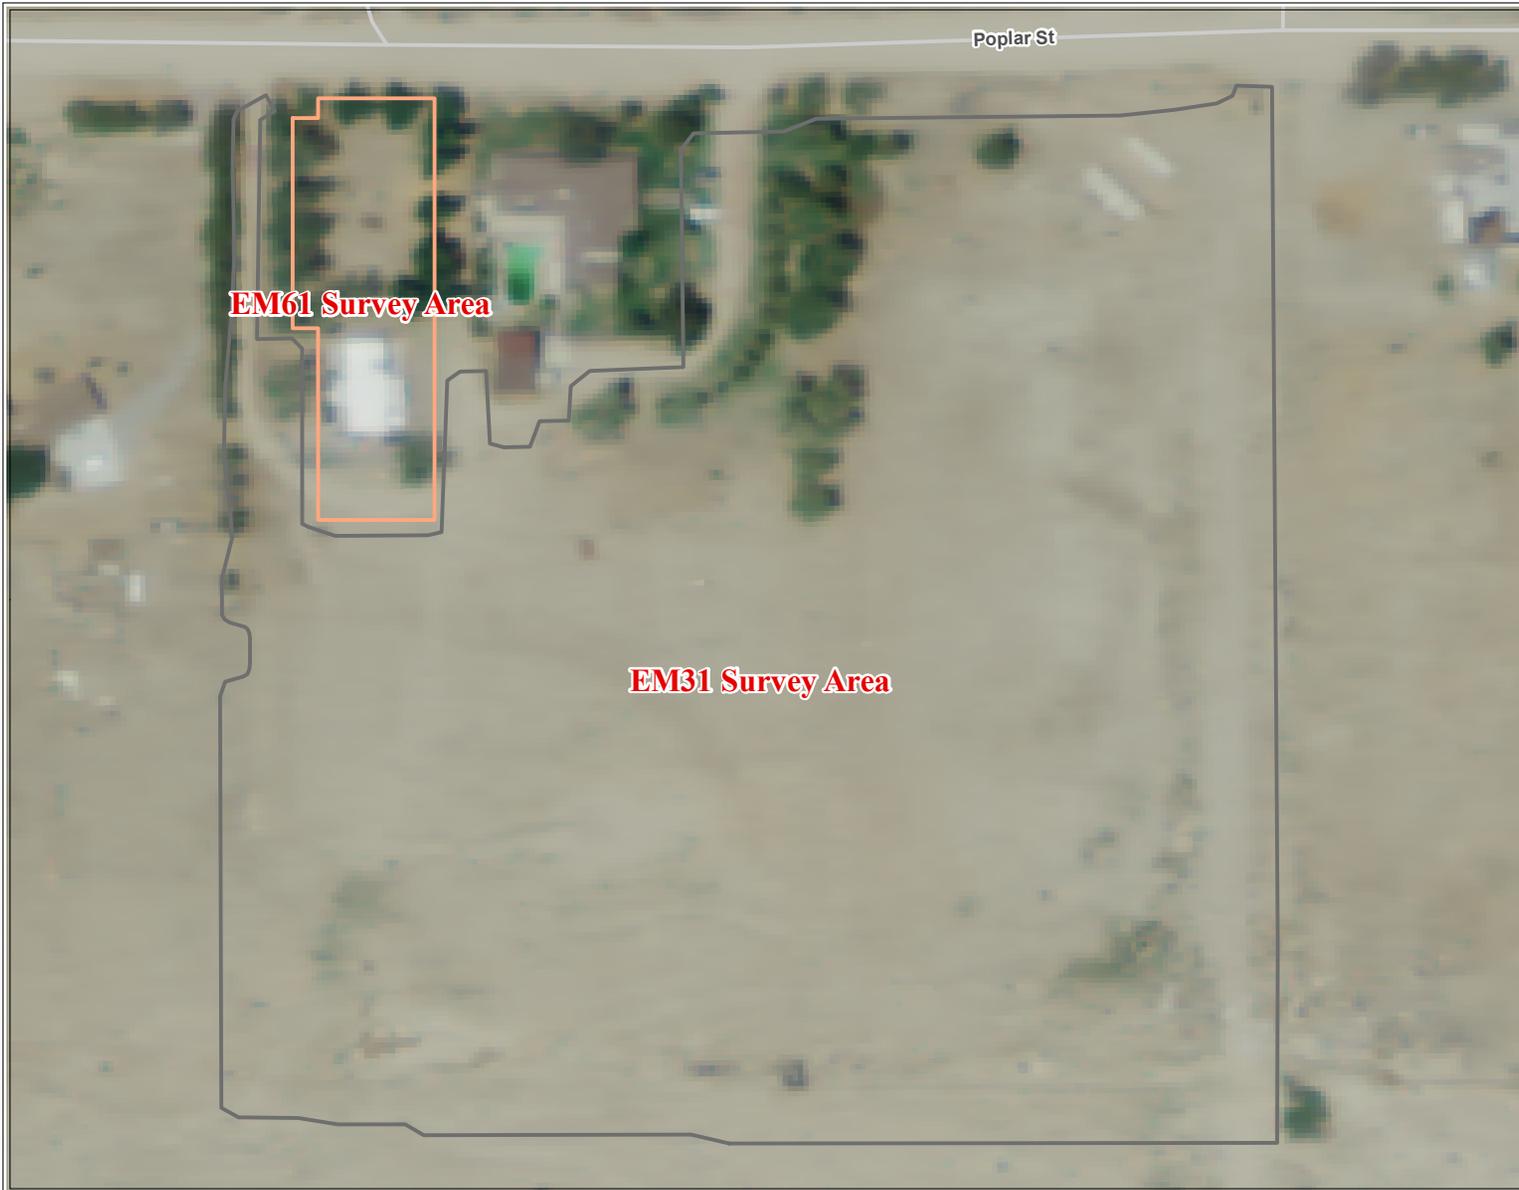
Figure 1
 Site Investigation Areas
 Mojave River Pyrotechnics Site
 Barstow, California

The EM61 was used to investigate the area within the wooden fence and around the mobile home in the northwest portion of the property (Figure 1). Measurements were collected across grids using fiberglass measuring tapes to define the spacing, boundaries and orientation of the survey lines. Measurements were collected along transects that were three feet apart and overlapped for complete coverage of the investigation area. The spacing between data points along the transects was determined by the odometer on a wheel of the transmitter-receiver assembly. The odometer was set to trigger the transmitter every 0.64 feet. The survey lines were limited by the wooden fence and the home that was within the survey area.

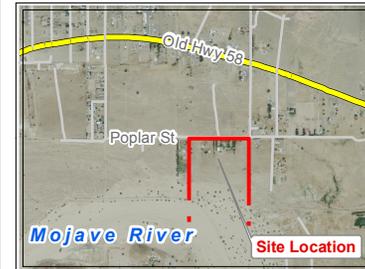
- EM31 Survey Area
- EM61 Survey Area
